## **Subject: Request for Additional Clarification in Interpretation 16-0166R**

- Photo Documentation: Gooseneck/Neck-over Hitch Configuration

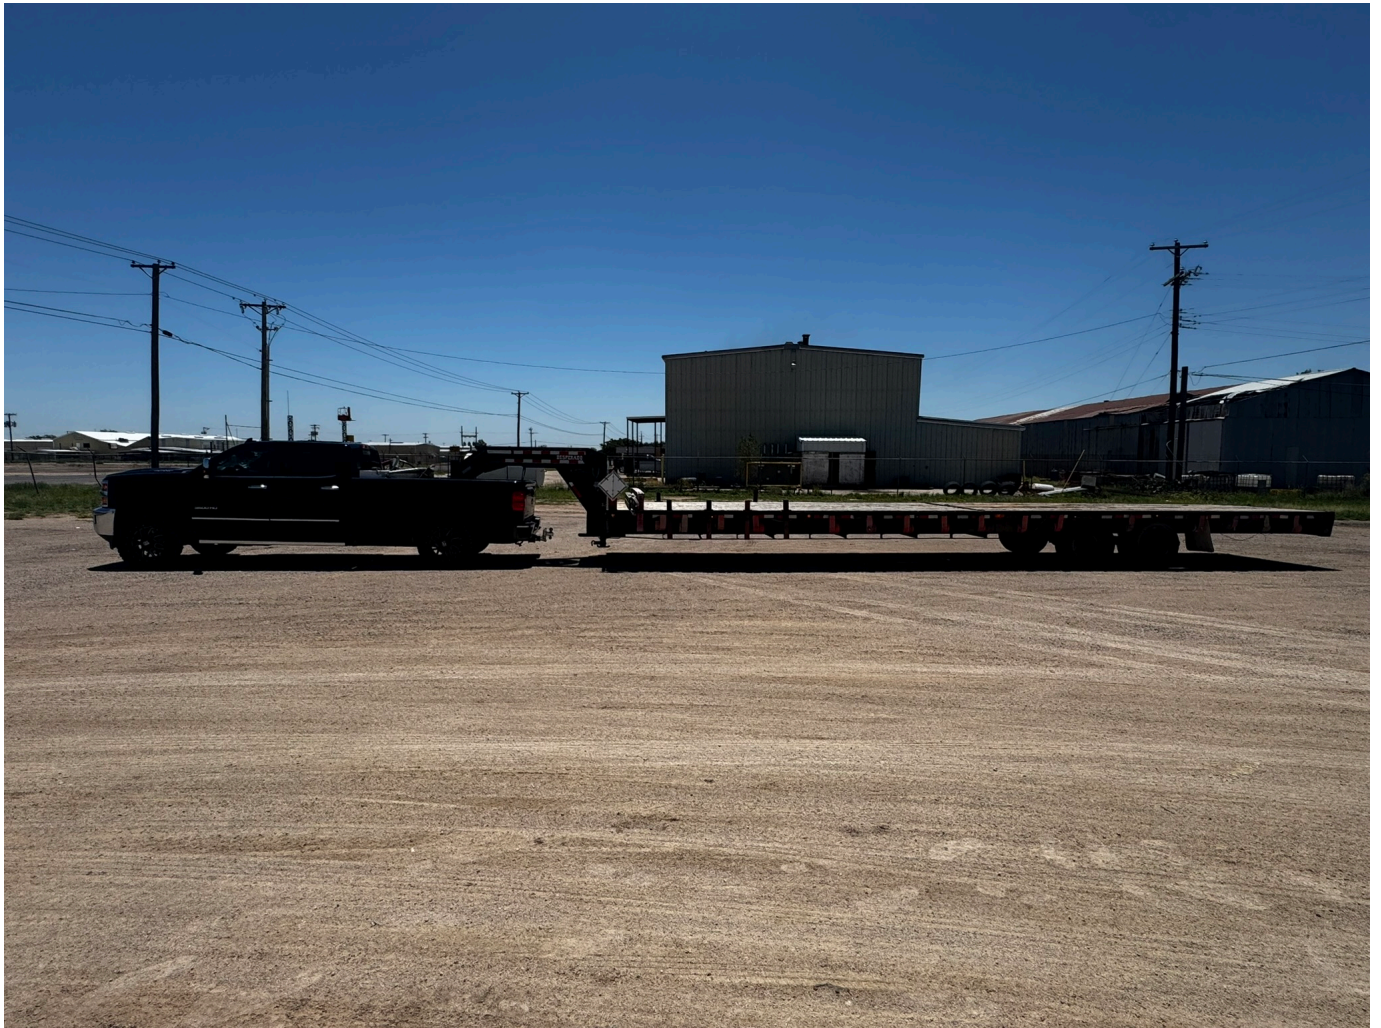
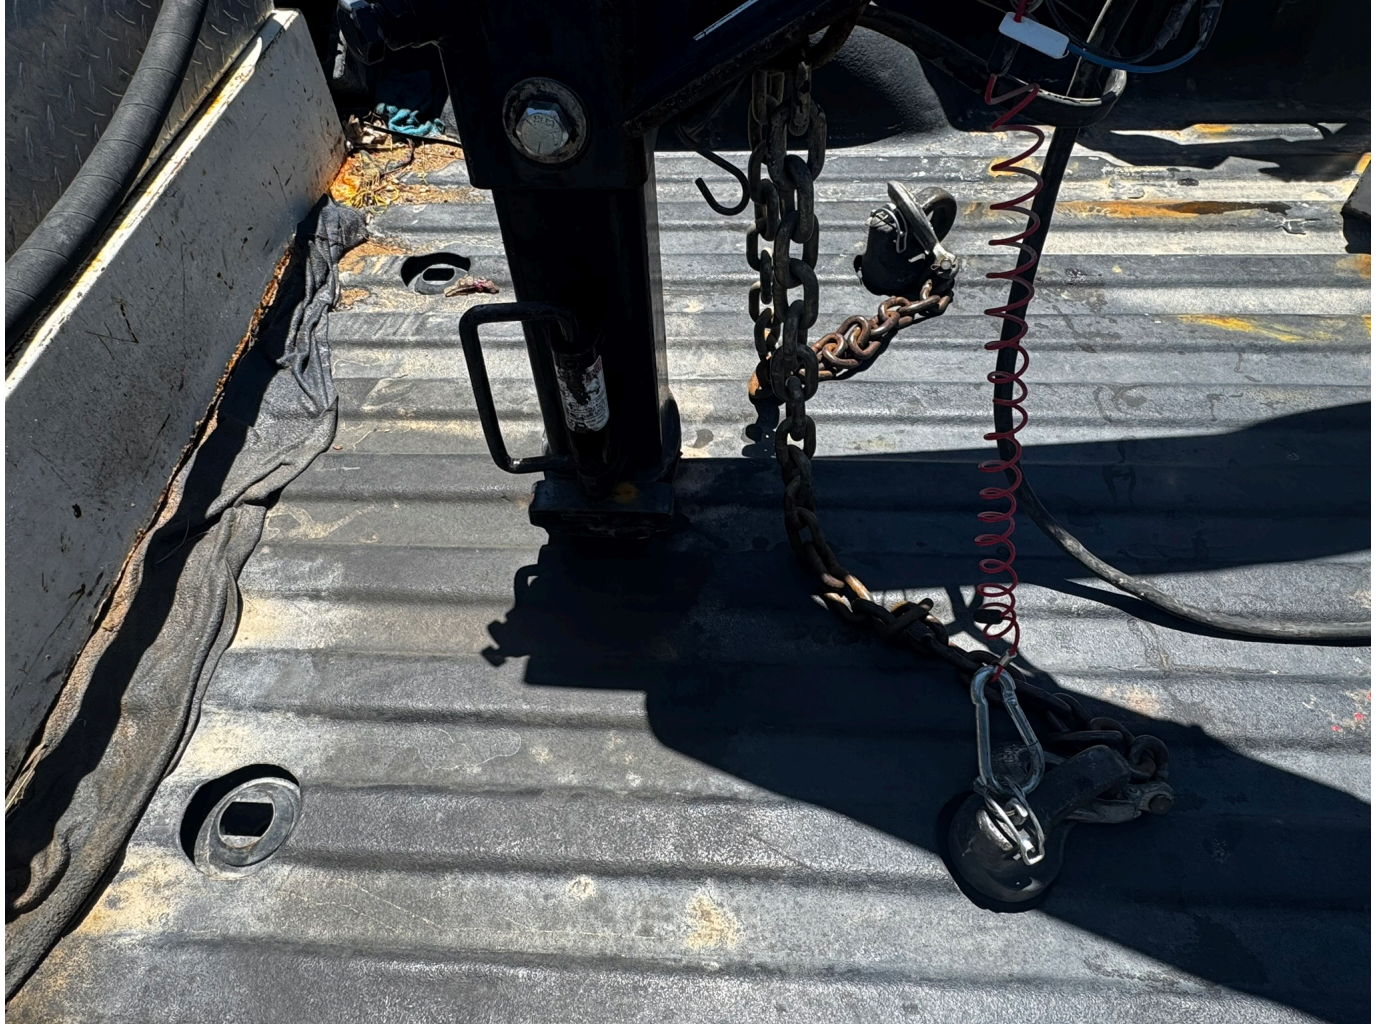
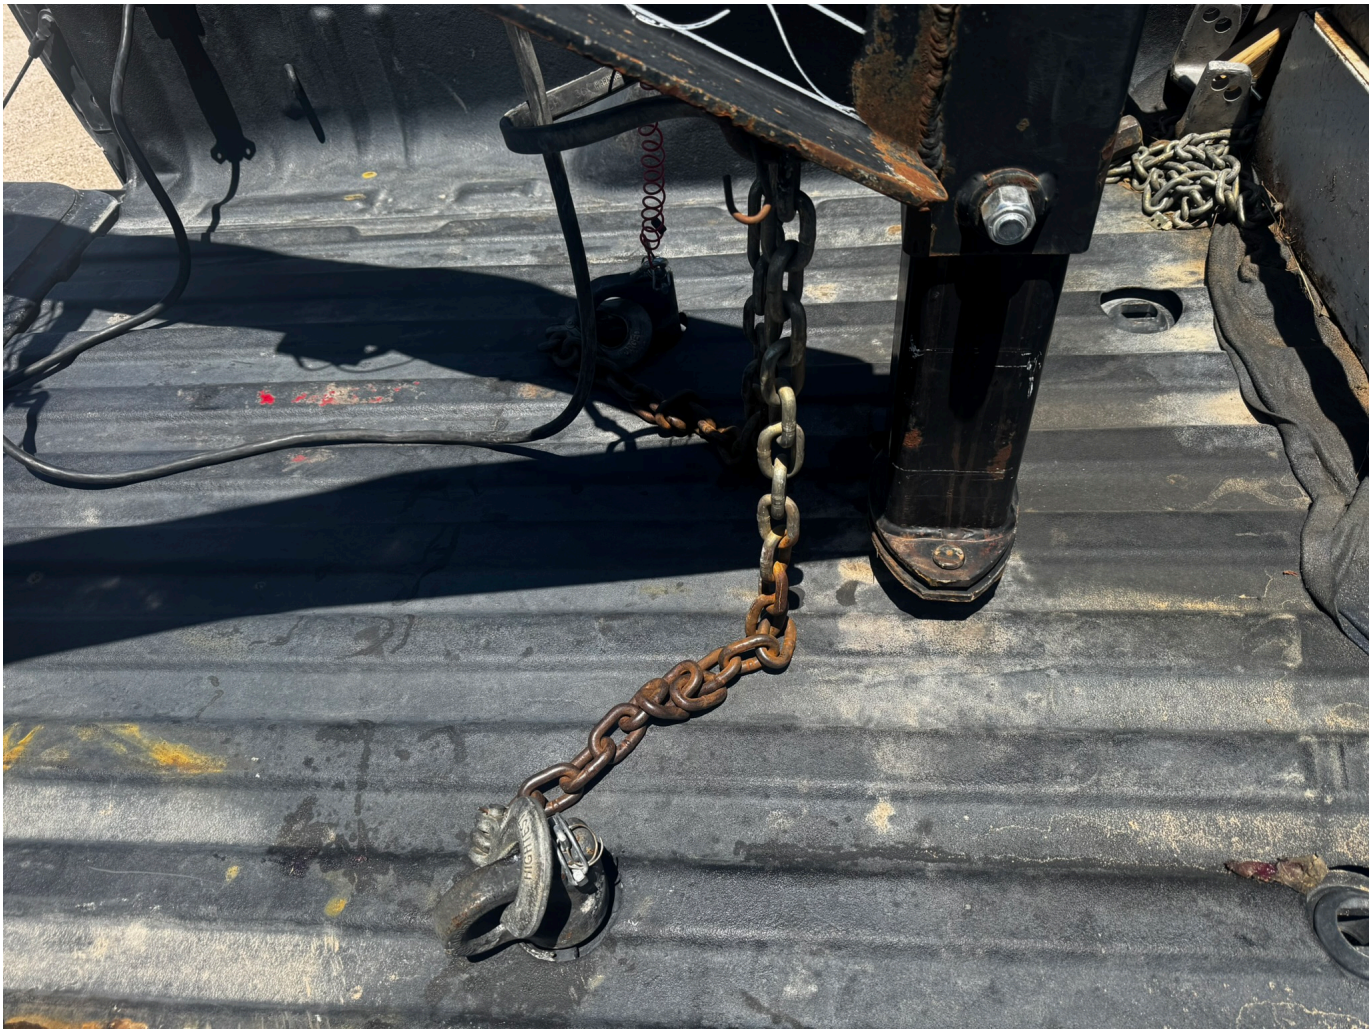
To aid in your review, I have attached photographs of a typical gooseneck (neck-over) hitch configuration. These images clearly show how the hitch occupies the truck bed space, rendering it unusable for general cargo and aligning functionally with the characteristics of a truck-tractor.

**Relevant Details:** The trailer is secured just forward of the rear axle via a gooseneck hitch, rendering the truck bed unusable for carrying cargo. The hazardous materials are Division 1.4 explosives and are transported solely on the trailer. The trailer is not detached during transport nor delivery, and the operation occurs on public highways. The placards on the trailer's sides and rear meet the visibility and attachment requirements of § 172.516(a) and (c). Importantly, gooseneck hitches functionally eliminate the truck bed's cargo-carrying capacity, much like a fifth wheel hitch does. This physical constraint aligns with the criteria often used to differentiate truck-tractors from other vehicle types. While fifth wheel hitches can be installed in one-ton class pickup trucks, they are more commonly used to tow recreational vehicle (RV) trailers. In contrast, gooseneck hitches are the standard in both agricultural and commercial heavy-duty hauling, offering superior strength, durability, and performance in severe service applications.
