# **ATK Development of a Practical Nondestructive Examination for Detection and Evaluation of an Impact Damage in *Fully Wrapped Carbon-Fiber Reinforce Aluminum-Line Cylinders (CFFC)***

## **Final Report –Phase I**

**22 August 2008**

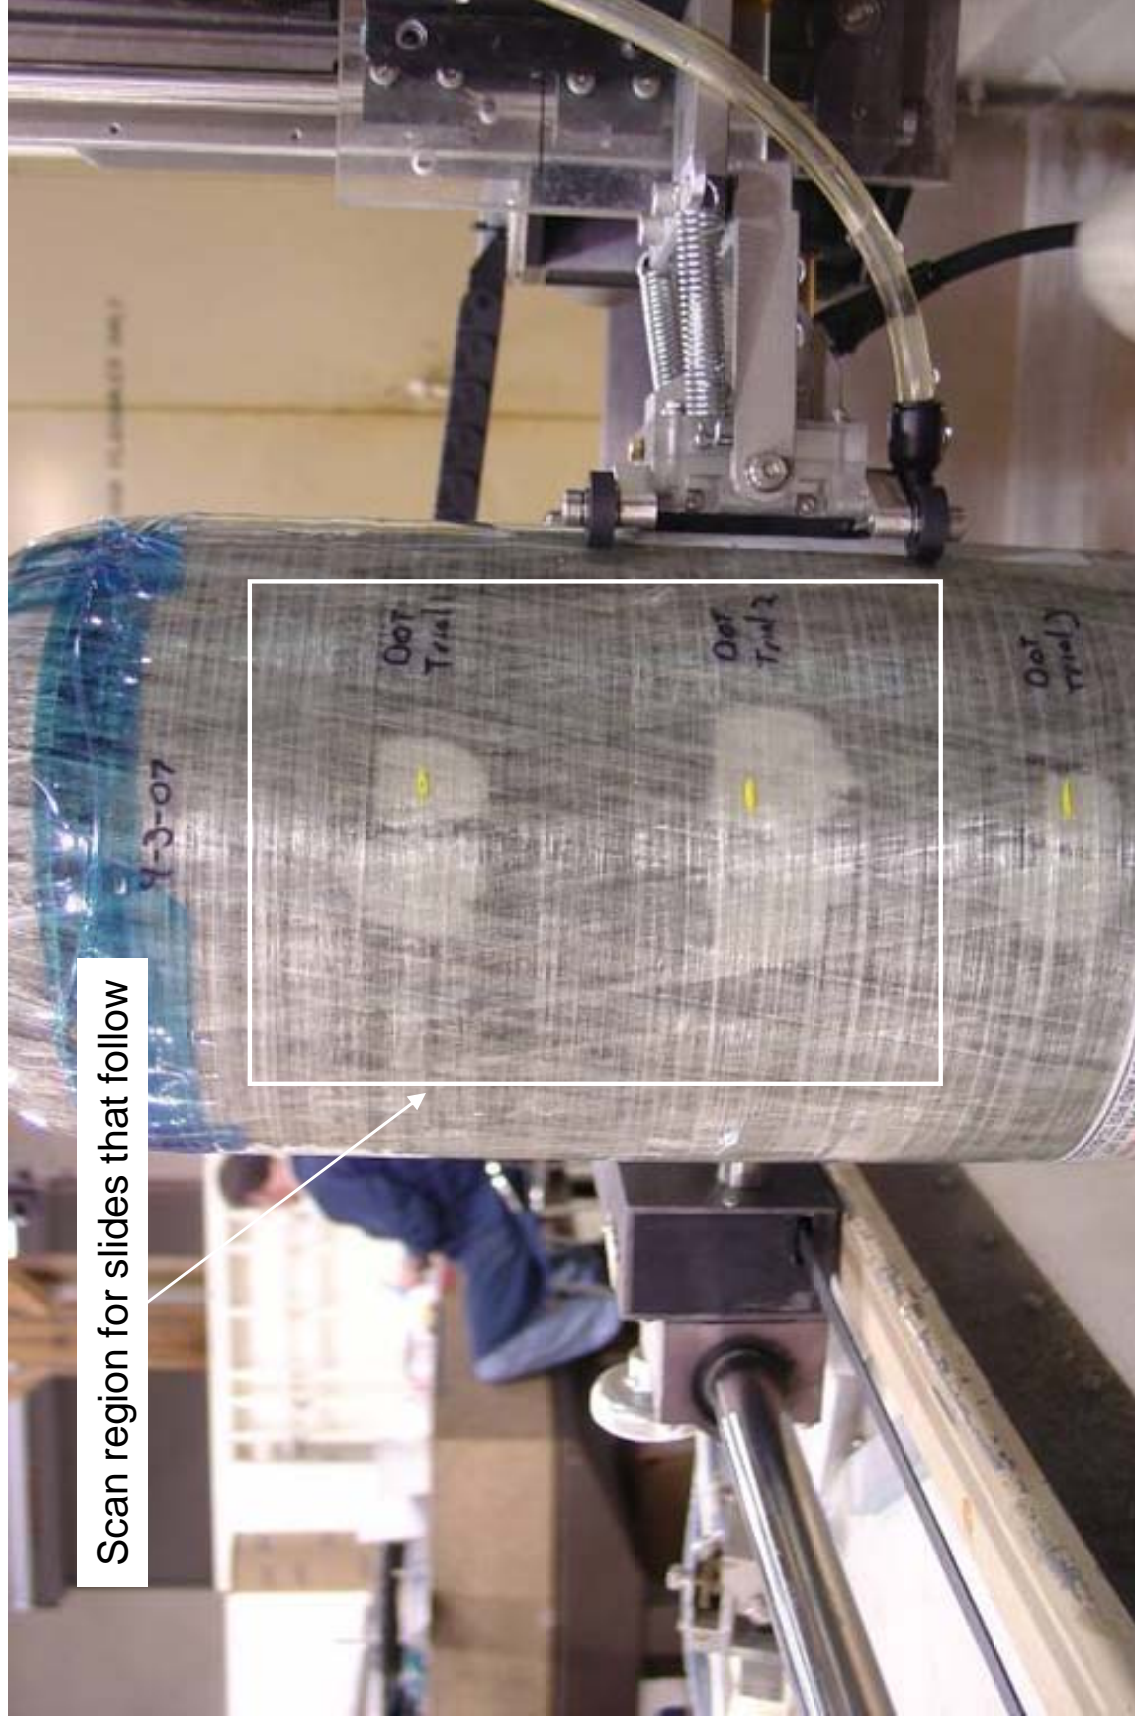
**Figure 2. Scan zone for two impact sites**

Scan region for slides that follow

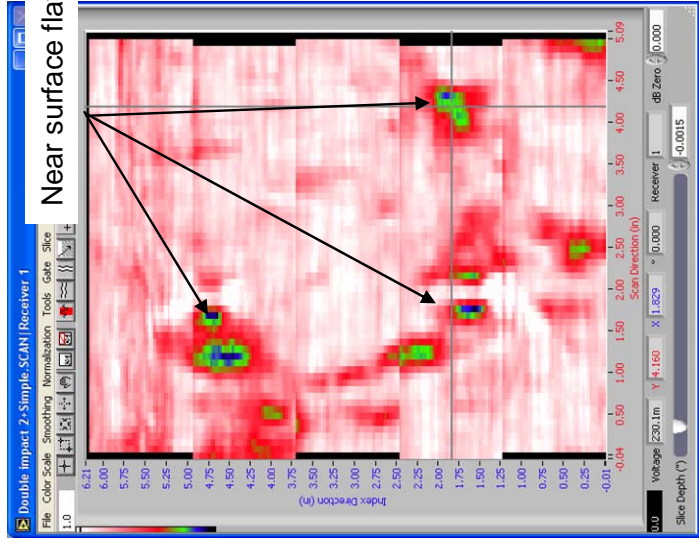
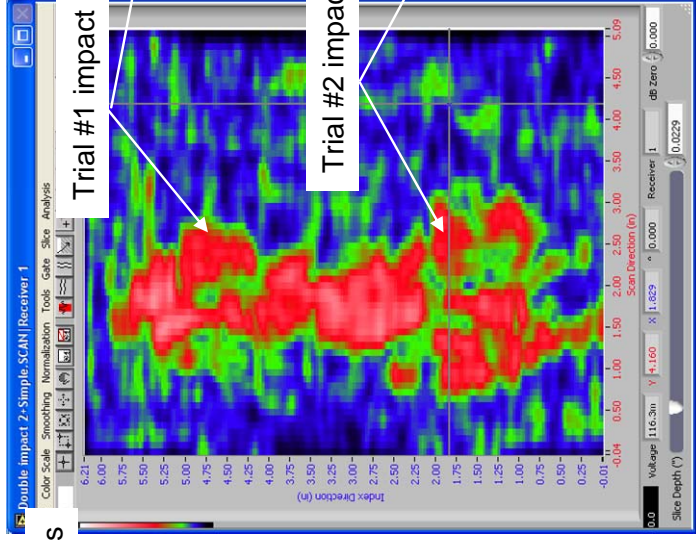
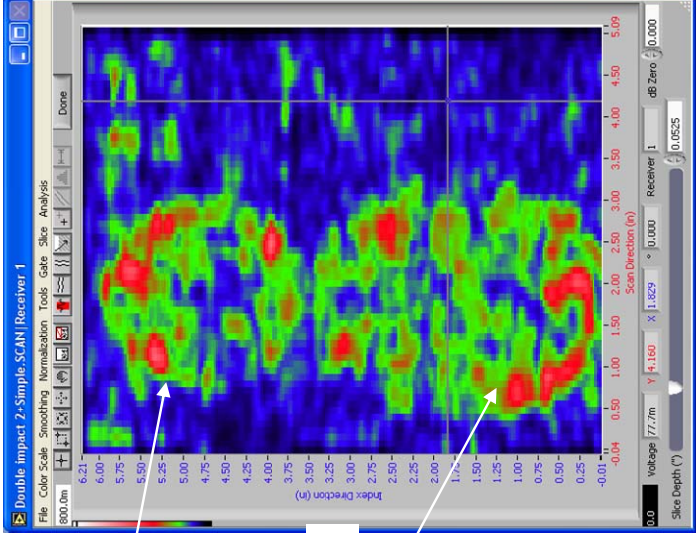
Figure 3. C-scan images for two impact sites

C-scan Images At Different Depths

Depth = 0"

Wavespeed = 61,900 in/s

Depth = 0.02"

Depth = 0.05"

The phased array technology provides fast, high spatial resolution data. Phased array ultrasonic scans performed two primary functions. First, it verified that strength test cylinders had no pre-existing damage prior to testing. Second, each impact site was scanned to provide delamination size, location, and depth. Figure 2 shows a photograph of three impact sites on cylinder 52082. The impact sites are distinguishable by the light colored regions. The white rectangular box is the scan area for a phased array scan. Figure 3 shows the phased array C-scans two impact sites. Note that the C-scan images clearly show lateral extent of the damage. The B-scan images in Figure 4 show depth of the delaminations. It should be noted that some stacked configuration of delaminations can't be imaged completely due to blockage of sound transmission.

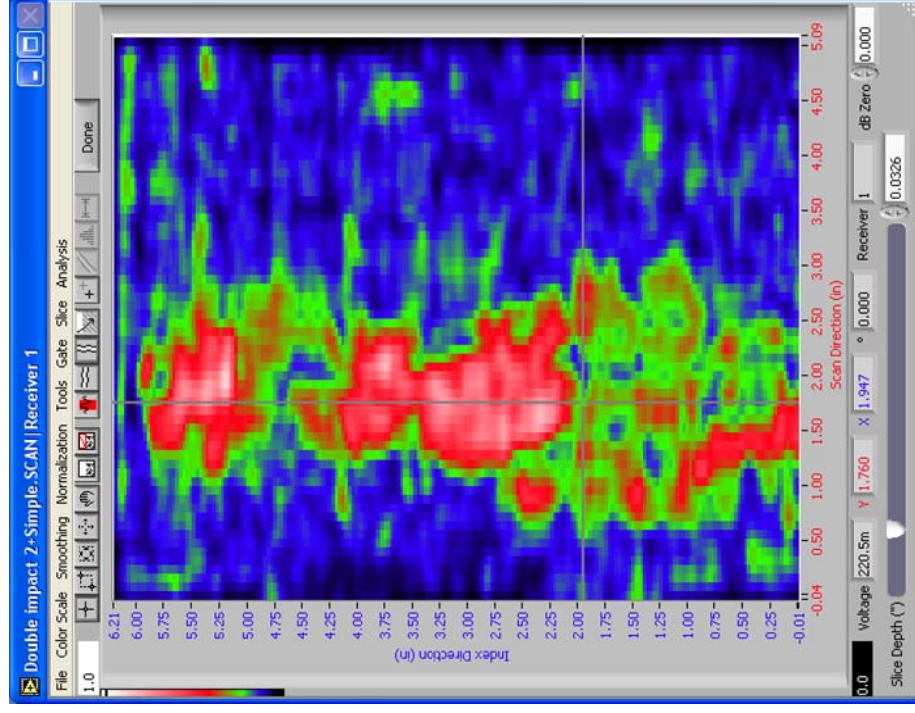
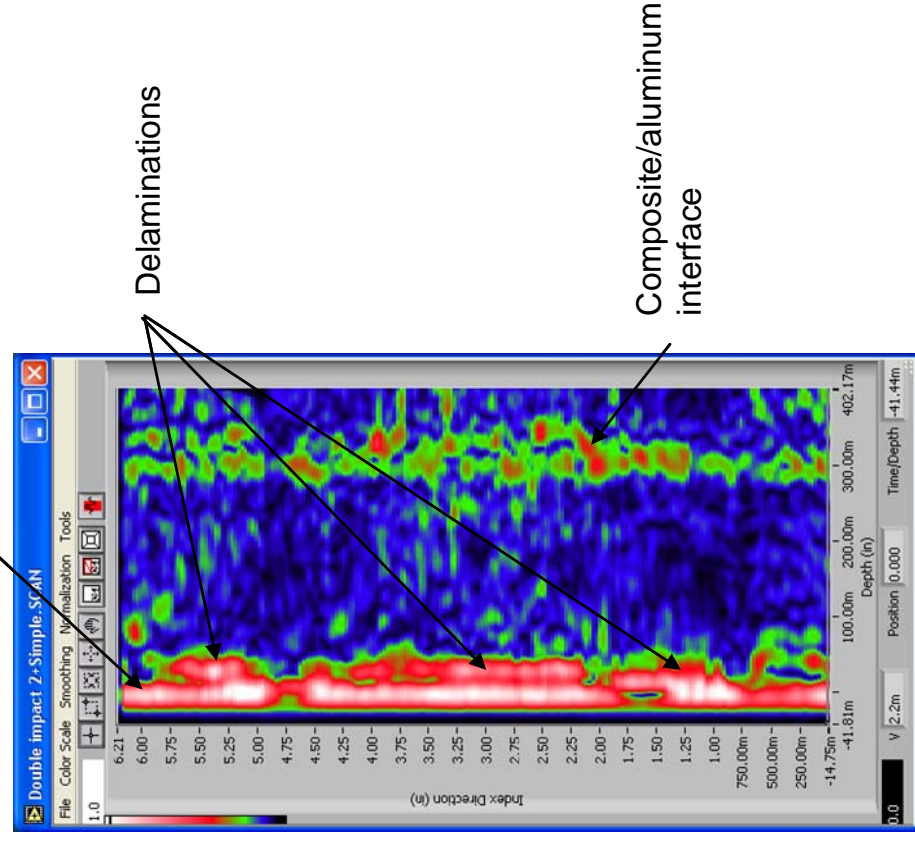
Figure 4. B-scan images show delamination depth

Depth slice = 0.03"

Front surface

C-scan of impact trial #1 and 2 impacts

B-scan (depth slice)

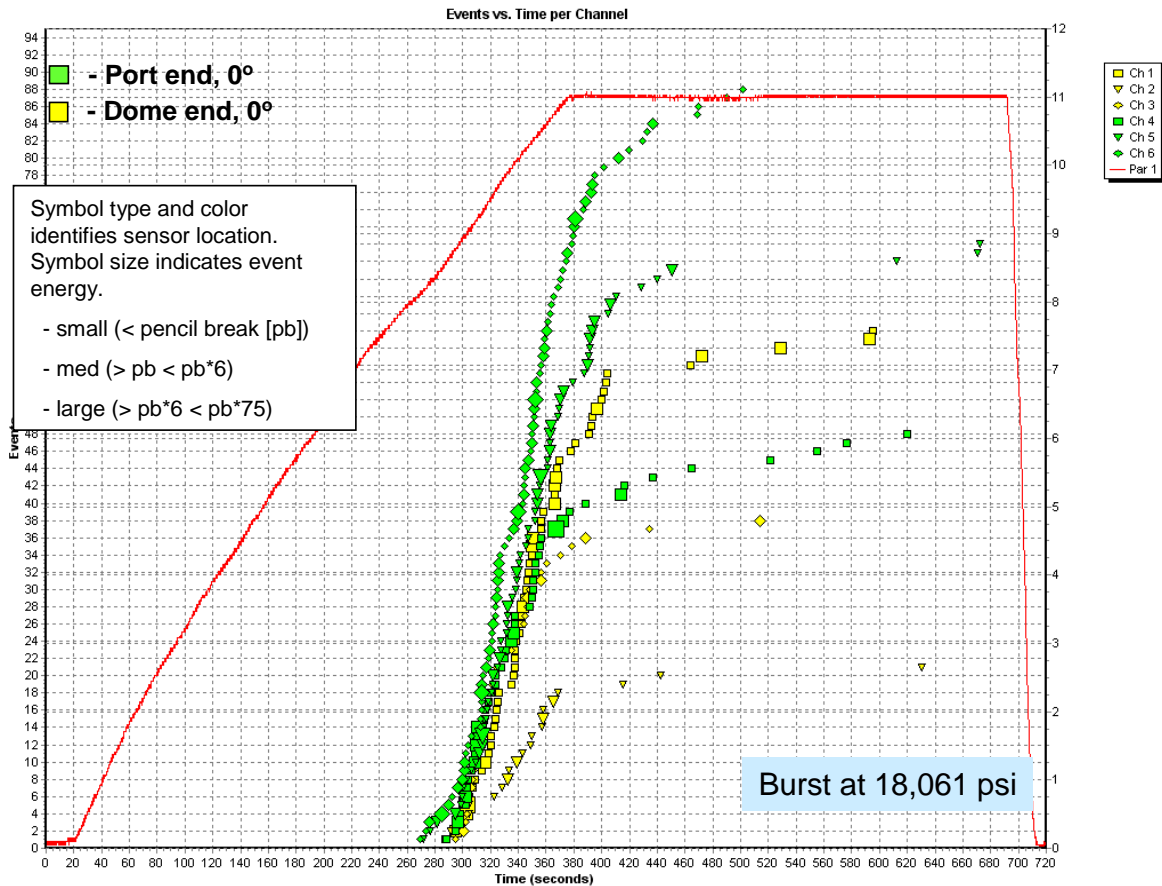
Figure 19. Typical undamaged cylinder AE results

Acoustic emission response of the undamaged composite over wrapped cylinders was typical of other composite pressure vessels that we test. This behavior is best visualized in the cumulative events versus time plot. The cumulative events versus time plot is shown in Figure 19 for cylinder 52075. Symbol type and color identifies the sensor location and symbol size identifies the event energy. Note that the events are uniformly distributed

between all six sensors and that most event energies are low (small symbols). This behavior is typical of matrix cracking events. Event rates for all sensors are also similar. These data suggest the cylinder has uniform composite properties. When the pressure hold is reached event rates quickly drop to zero. This behavior is typical of well-made, undamaged pressure vessels. Events versus time plots are shown together for 52075 and 52078 cylinders in Figure 20. Note that the same behavior patterns are apparent in each of the cylinders. The slight difference in the total number of events is not unusual.
