**Report to DOT/PHMSA Steering Committee on  
Collaborative Demonstration of Guided Wave Ultrasonics  
NYSEARCH**

**Controlled Tests & Data Analyses**

By  
Daphne D'Zurko  
Executive Director, NYSEARCH  
Version for Public Release  
April 2007

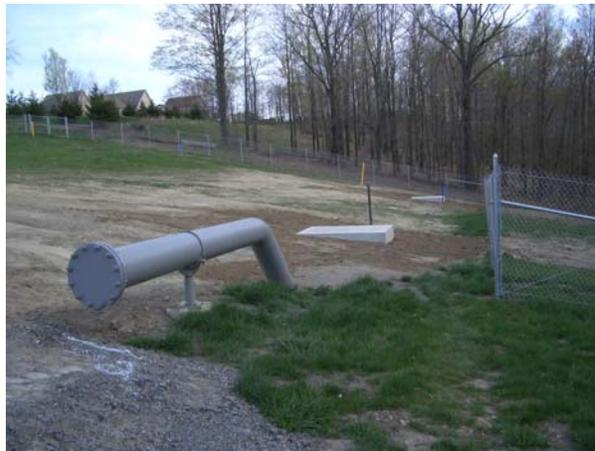
Figure 1. Access points for 12" Cased Pipe

It is worthy of note that two of the three 100' cased pipe sections are above-ground sections. The third is a 12" carrier pipe in a 16" casing in an underground network. In the 12" carrier pipe case, the vendors were notified that the guided wave transducer belt could be applied above-ground near the access point but between two 45-degree bends OR at the same level as the overall cased pipe section because of underground excavation vaults that had been constructed on both the North and South ends of the 12" cased pipe for the purpose of integrity inspection tests. Figure 1 illustrated both access points; in the foreground is the above-ground access point to the 12" pipe and in the background is one of the two underground vaults for direct straight-pipe access.

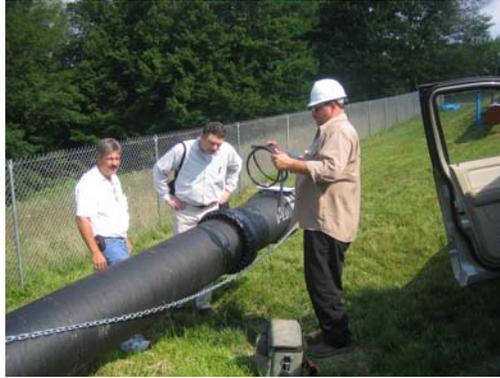
Figure 2 DOT and Industry Reps observe Application of transducer belt on 16" pipe

The tables below summarize the results from the findings of the tests performed on July 17 – 18. For illustration on one such test, see Figure 2. The detailed summaries, spreadsheets and layout drawings were provided to the Steering Committee as Confidential documents. The technology providers were also provided detailed results but the exact locations and sizes of defects that are present at the NYSEARCH/NGA test bed have not been provided to the vendors or any party who did not sign the NDA.
