DOT US Department of Transportation
PHMSA Pipeline and Hazardous Materials Safety Administration
OPS Office of Pipeline Safety
Southwest Region

Principal Investigator Gene Roberson
Region Director R. M. Seeley
Date of Report 7/ 11/2011
Subject Failure Investigation Report – Mid-Valley Pipeline Internal Corrosion

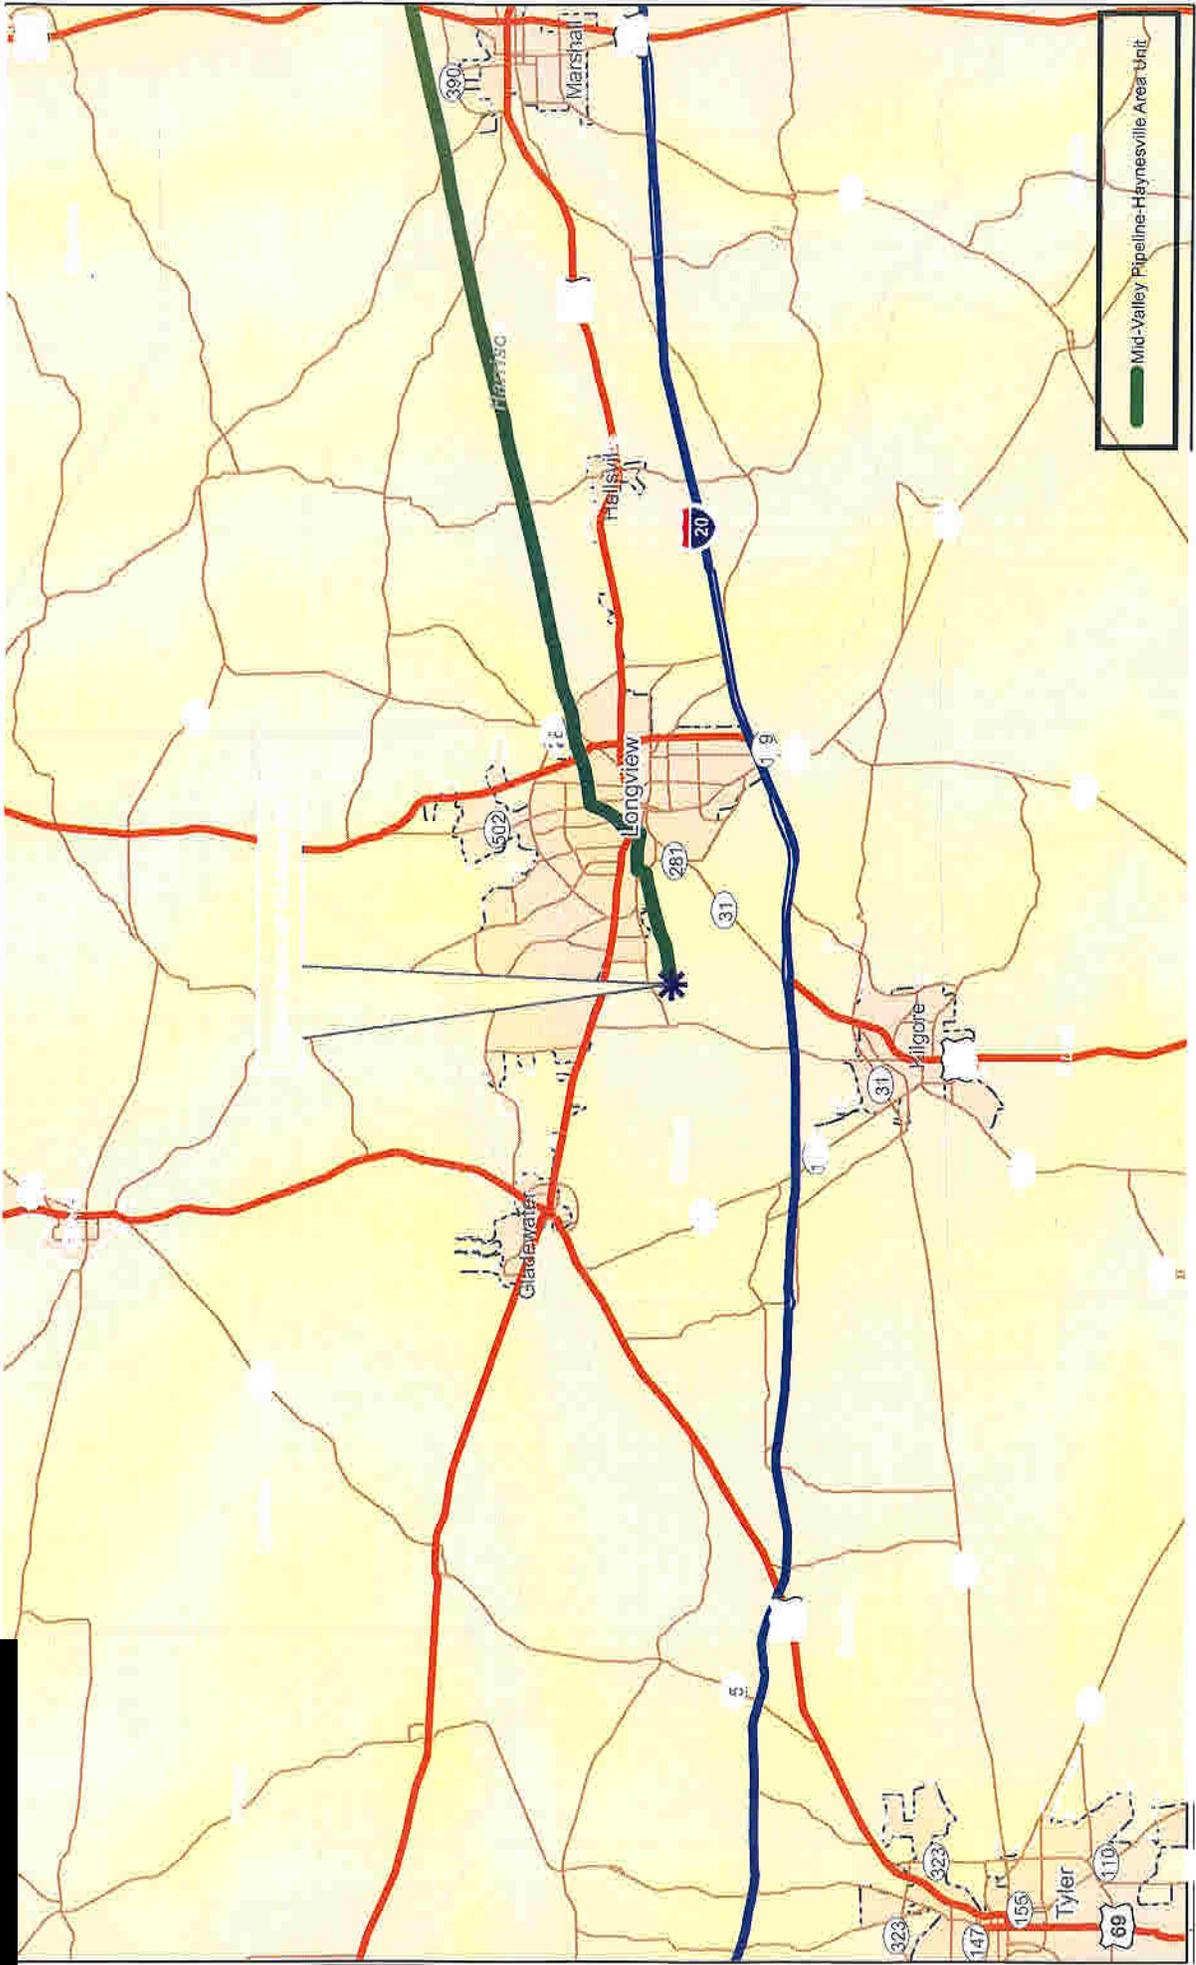
MID-VALLEY PIPELINE COMPANY FAILURE SITE

The section of pipe was not sent to a lab for analysis. Direct observation determined the failure was due to two localized spots of internal corrosion in the buried header. The failed section was a dead leg of pipe that was subject to pressure fluctuations with no flow during normal operations.

The failure initiated from 2 isolated incidences of internal spot corrosion, at the 6:00 o'clock position in the header. No other indications of internal corrosion were found in the header after it was removed and investigated.
