FINAL REPORT

TGP MLV 205-4 + 11.28 Failure – Root-Cause Analysis

November 16, 2011 Failure

Tennessee Gas Pipeline Company LLC

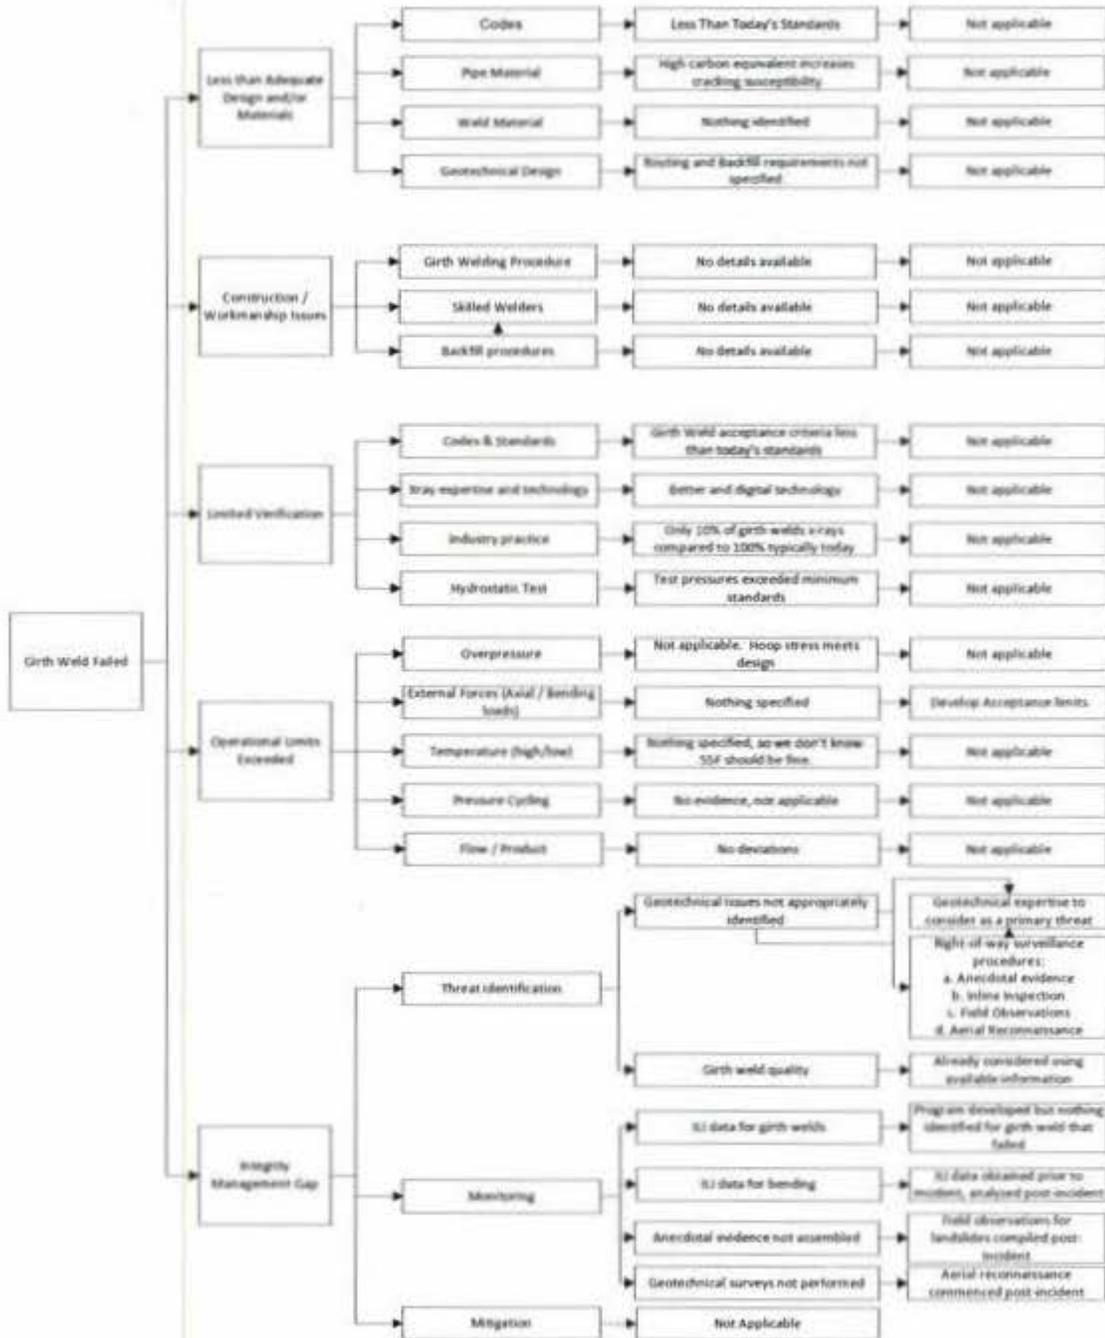
Figure 6. Flow Chart for RCA

In order to build on the lessons learned from the fault tree analysis, the RCA team flow charted the problem statement by asking simple relevant questions to ultimately answer the question "Why could this girth weld have failed." Results of this flow chart exercise were used in place of the fault tree analysis in order to determine the true root cause and contributing factors. This flowchart is provided in Figure 5.
