TC Oil

RCFA for the Keystone Milepost 14 Release

April 21, 2023

Final Report

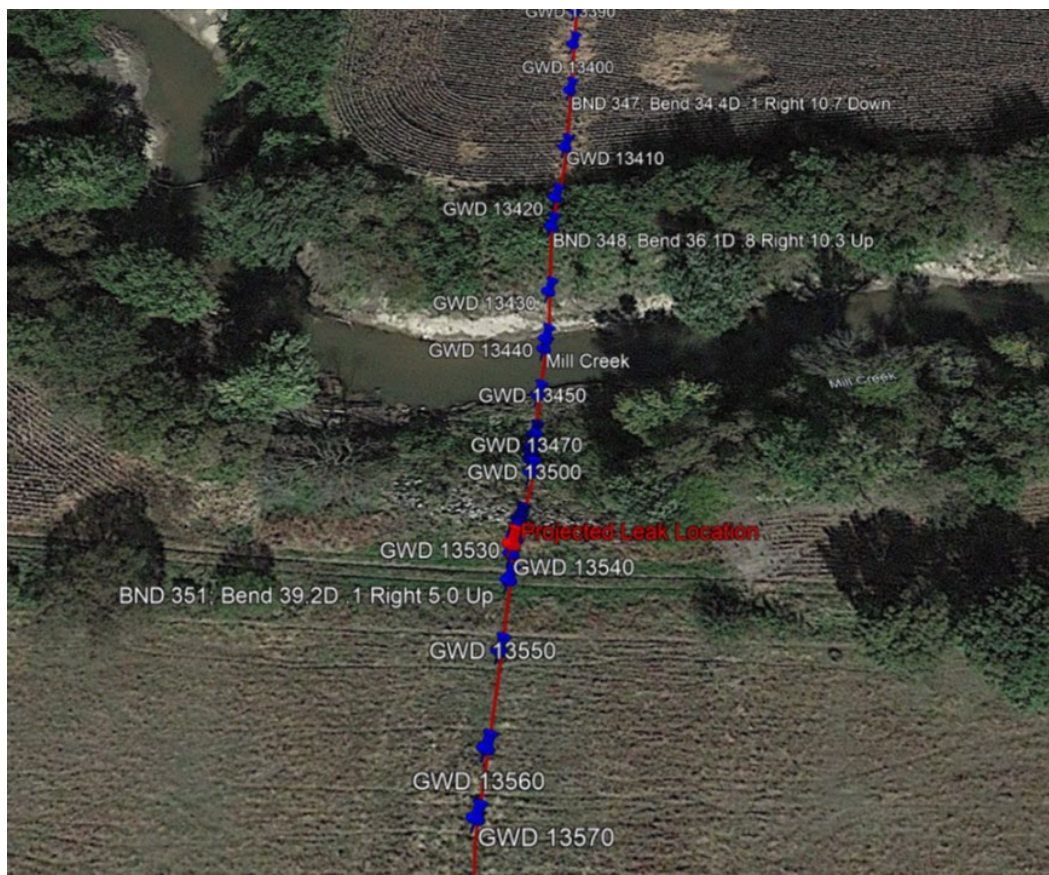
Figure 3. Overview of Release Area Showing the Location of GWD 13530

An as-built alignment map of the location where the leak occurred is provided in Appendix C and shows the pipeline profile, Mill Creek crossing, and the location of the 30°, 3D overbend where the failure occurred (station 732+57). The rupture occurred approximately 90 feet downstream and upslope from Mill Creek. The crude oil release entered Mill Creek and was carried downstream for approximately three miles. The oil was contained using multiple containment booms, skimmers, and underflow dams. Figure 3 provides an overview of the release area showing some key pipeline features, including the release site (GWD 13530), bend locations, and creek. The release did not occur within an HCA, and Mill Creek is not connected to any drinking water sources.

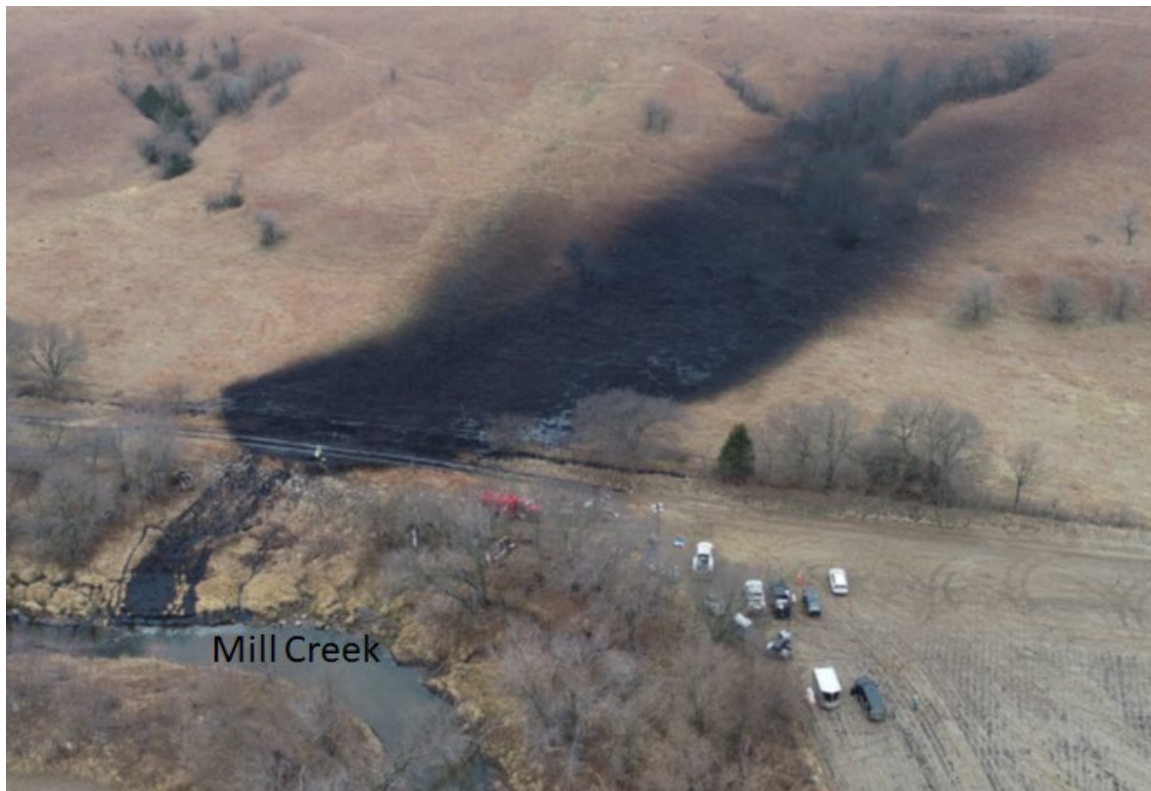
Figure 4. Aerial View of the Release Site Looking South from North of Mill Creek – December 9, 2022²³

On December 8, 2022, incident response teams were mobilized to the release site and oil containment, recovery, and cleanup began. The area was cordoned off and only accessible by authorized personnel through security checkpoints. Representatives from PHMSA, the Environmental Protection Agency (EPA), and local responders arrived on site to monitor the response, cleanup, and recovery efforts. Calls were also made to the construction contractor, non-destructive evaluation (NDE) personnel, and welders to install a stopple upstream of the release site to further isolate the affected segment in consideration of the elevation profile. An aerial view of the release site on December 9, 2022, prior to excavation of the pipeline and stopple installation, is shown in Figure 4.

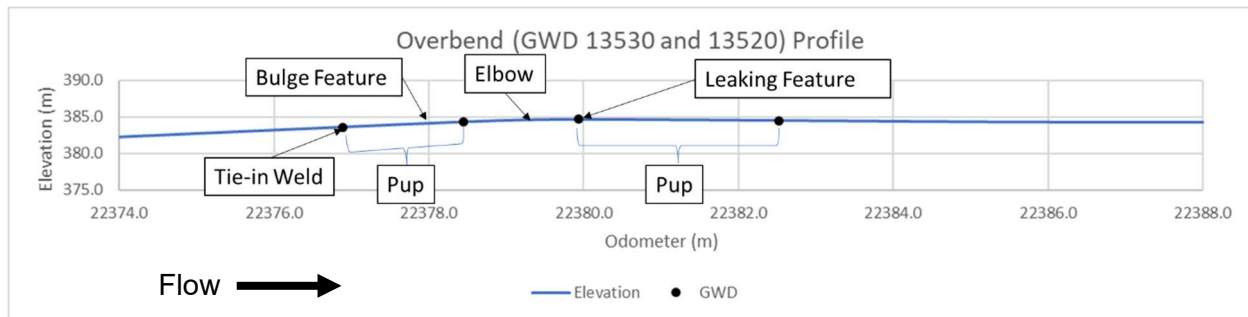
Figure 5. Pipeline Profile Schematic Looking East (pipeline flows north to south)²³

On December 13, 2022, the failure feature was first exposed. As shown schematically in Figure 5, the failure feature was confirmed to be a large crack in the girth weld (see Figure 6) connecting a 3D, 30° overbend to an approximately 8.5-foot-long pup (downstream) within a fabricated bend assembly (TAG 98). Upon further excavation, a wrinkle was also found just upstream of the overbend as shown in Figure 7. Between December 17 and 18, 2022, the bend assembly containing the failure feature and wrinkle was cut-out, removed, and prepared for shipment to Anderson & Associates (Anderson) of Houston, Texas for metallurgical evaluation to determine the direct cause of the rupture (see Figure 8 and Figure 9). The remaining pipe ends were prepared for welding of a new bend assembly as preparations for restarting the pipeline and cleanup operations continued. Restart of the pipeline began on December 29, 2022, under a temporary 20% pressure reduction in the actual operating pressure immediately prior to the failure on December 7, 2022 along the entire length of the affected segment.

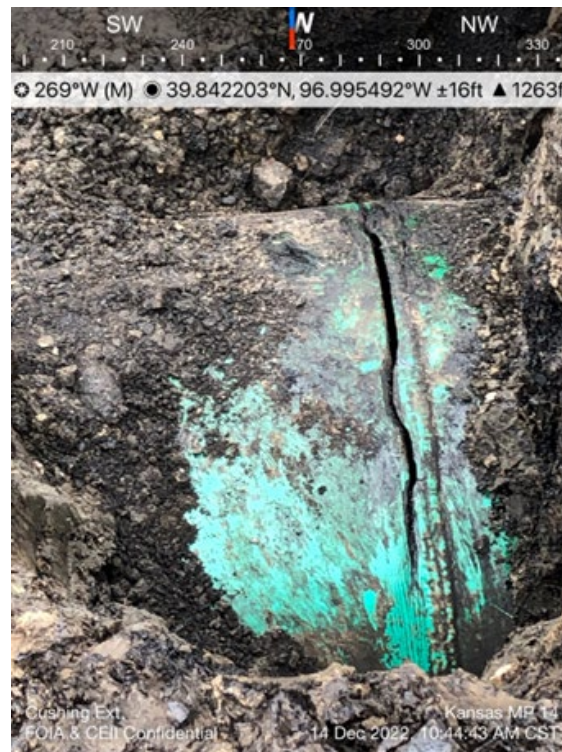
Figure 6. Excavated Failure Feature Showing Girth Weld Crack – December 14, 2022

Excavation at the failure feature revealed a circumferentially oriented crack at girth weld GWD 13530 (G59B) spanning the top of the pipe from 333° to 54°. A metallurgical failure investigation was performed by Anderson & Associates (Anderson)⁹ of Houston, Texas. The below details were reported or derived from information presented in Anderson's report. Three prominent elliptically shaped crack features were identified within GWD 13530. Crack 1 was the largest, measuring approximately 0.5-inch deep (97% of nominal wall thickness, NWT) by 8.7-inch long, centered approximately 4.5-inch (14.3°) clockwise from top dead center (TDC). The second largest crack, Crack 2, measured approximately 0.38-inch deep (74% NWT) by 4-inch long, with the deepest portion approximately 4.25-inch (13.5°) counterclockwise from TDC. Crack 3 was the smallest, measuring approximately 0.18-inch deep (35% NWT) by 4.0-inch long, with the deepest portion located approximately 13-inch (41.4°) clockwise from TDC. All three cracks appeared to be located entirely on the pup side of the girth weld. Separating each crack were two shear regions coincident with weld repairs. A wrinkle was also found in the pup upstream of GWD 13520. The wrinkle was centered at the bottom dead center of the pipe and spanned approximately 180°.

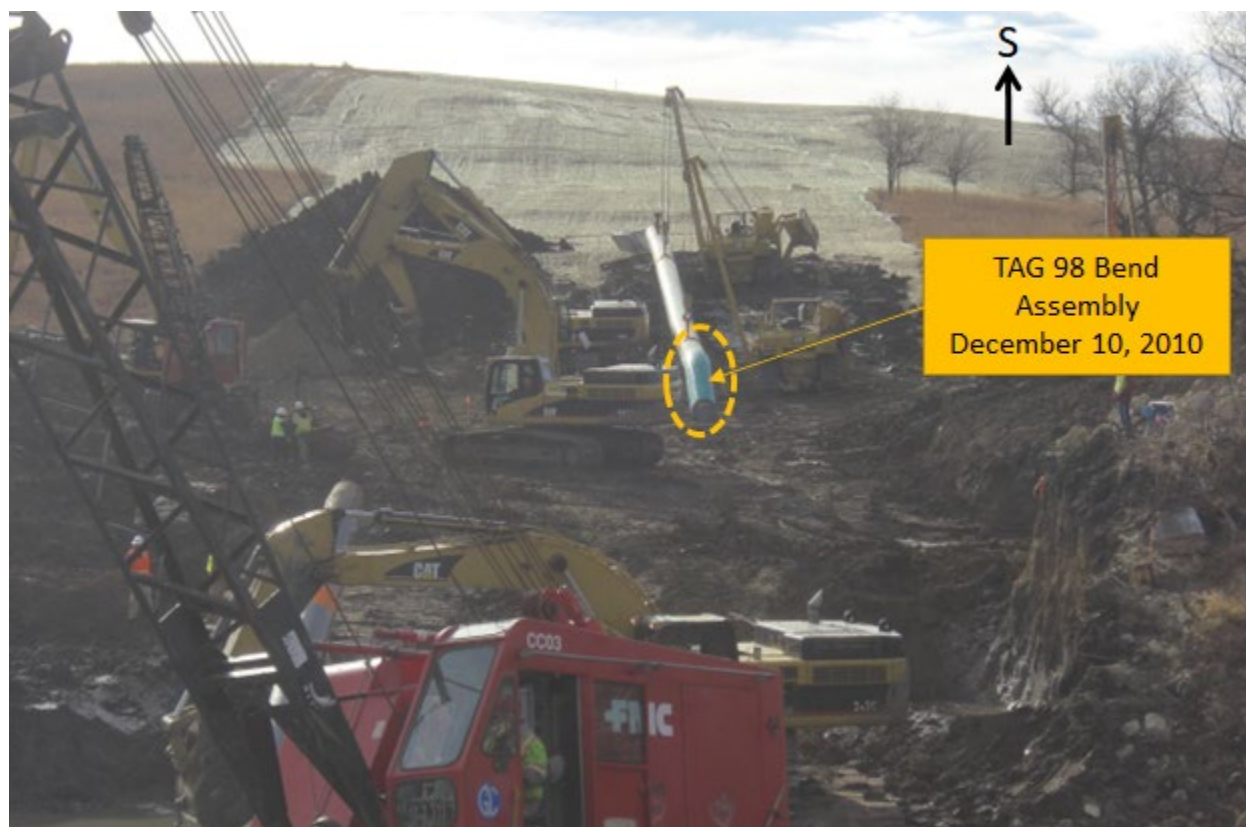
Figure 10. TAG 98 Bend Assembly (BND 350) During Replacement (December 10, 2010)

The elbow specific to this investigation (number 174469) was manufactured in November 2010 and the associated pups (number 0031378) were manufactured by [REDACTED] in April 2010. The bend assembly, TAG 98, was fabricated by [REDACTED] on November 19, 2010, and installed at the Mill Creek location in December 2010 by [REDACTED]. Figure 10 shows the TAG 98 bend assembly during installation but prior to tie-in. The bend assembly was successfully hydrostatically tested at the fabricator's facility to 94% SMYS and twice in the field to 100% SMYS. Operation of the Cushing Extension began in February 2011.

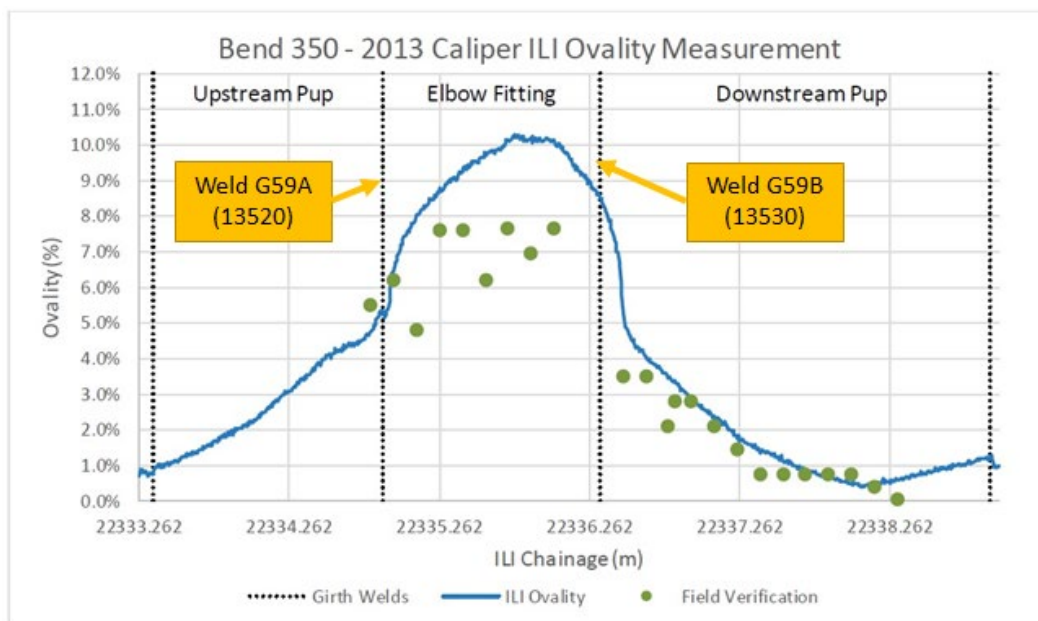
Figure 12. TAG 98 Bend Assembly (BND 350) ILI-Called Ovality and Actual Measurements³²

The 2012 profile caliper ILI tool identified a [REDACTED] ID restriction (due to ovality) in the TAG 98 bend assembly that had damaged the cleaner and gauge tools run prior to the caliper tool. An excavation was performed in March 2013 to evaluate the restriction. A [REDACTED] ovality was measured in the field and ultrasonic wall thickness measurements were taken. The ovality was determined not to be an integrity concern at the time as it pertained to future ILI runs and the bend assembly was backfilled without any further interventions. While the excavation was still open, discussions occurred between the Pipe Integrity team and ILI vendor about how best to proceed. Several possible options were evaluated including (1) having the ILI vendor modify their tool so that it would pass through the elbow, (2) using a multi-diameter tool, or (3) cutting out the ID restriction. The option to cut out the feature was determined not to be the most favorable option at the time. Instead, the vendor agreed that they could navigate the feature with a tool redesign. Subsequent ILI runs have successfully navigated the ID restriction without any significant issues.

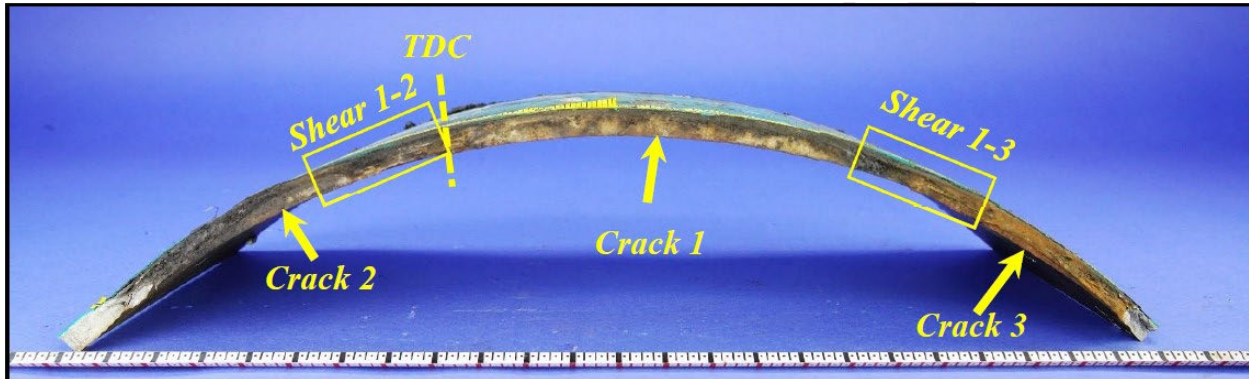
Figure 14. View of Downstream (Pup Side) of the Exposed Fracture.

The three crack features were identified as originating at or near the inner diameter (ID) toe of the GWD 13530 and had multiple, radially oriented crack initiation features (ratchet marks). Each crack showed evidence of progressive cracking in the form of multiple crack arrest features. Crack 1 and Crack 2 exhibited 10 to 15 distinct "beach marks" or macroscopic features marking the position of the crack front over time, characteristic of a progressive or fatigue cracking mechanism from the ID surface.

Figure 14 shows the exposed fracture surface on the pup side (downstream) of the failed girth weld (GWD 13530). Note the three distinct elliptical crack features. The top dead center (TDC) of the pipe is marked with the dashed yellow line.

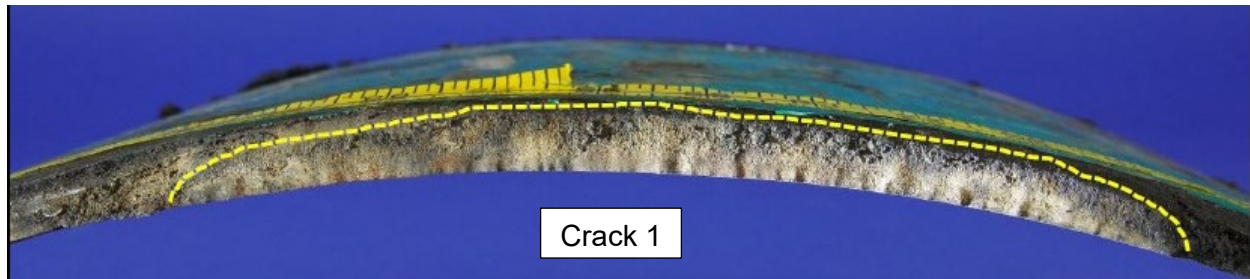
Figure 15. Magnified View of Crack 1 in GWD 13530 (G59B)

Figure 15, Figure 16, and Figure 17 show magnified views of the three elliptical crack features that were identified originating from the ID toe of girth weld GWD 13530 (G59B) on the thin wall side of the weld (pup side). The initiating features were coincident with LOF regions at the ID toe with a maximum depth of 0.008-inch (200 μm) and circumferential lengths presumed to extend the full length of each crack feature. LOF defects and fatigue crack extension were observed on both GWD 13530 and GWD 13520. The flat region of each crack exhibited multiple “beach marks” or macroscopic features marking the position of the crack front(s) over time, characteristic of a progressive or fatigue cracking mechanism from the ID surface. As shown in Table 1, the maximum depth of Crack 1 was measured as 0.50-inch (97.1% of the NWT). The total length of the flat, thumbnail feature was approximately 8.7-inches. The wall thickness at the location of the failure was approximately 0.540-inch.

Crack	Depth [in]	Depth % of NWT	Length [in]	Location (deepest part of feature from TDC)
Crack 1	0.50	97.1%	8.70	14.3°
Crack 2	0.38	73.8%	4.25	346.5°
Crack 3	0.18	34.9%	4.00	41.4°

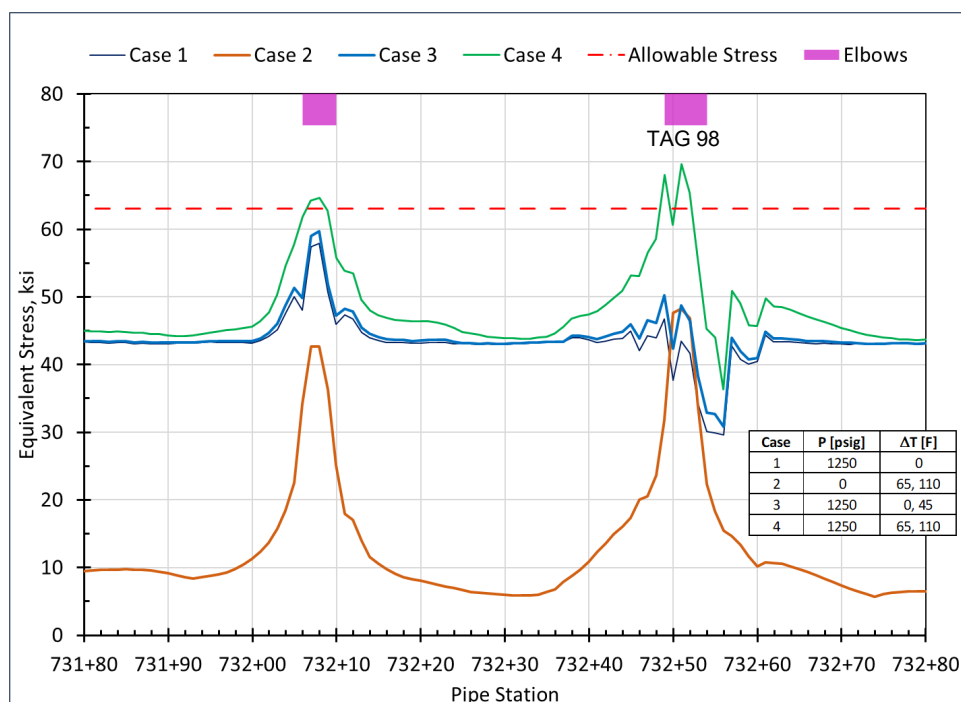
Figure 28. FEA von Mises Stresses with Elbow Elements and Lower-Bound Soil Properties (worst-case)

The worst-case results for the four loading combinations are shown in Figure 28 (model using elbow elements and lower-bound soil conditions). The purple boxes in Figure 28 show the locations of the upstream (TAG 114C; BND 349) sag bend and the TAG 98 (BND 350) overbend and the dashed dotted red line shows the 90% SMYS longitudinal stress limit for restrained pipe. The longitudinal stress results indicate maximum compressive stresses of 38.1 ksi (263 MPa) and maximum strain of 0.14% for the TAG 98 (BND 350) overbend. The maximum equivalent stress is high (69.6 ksi; 99.4% SMYS), and, although it exceeds the allowable combined stress for the pipe material, it is insufficient to cause permanent deformation in the form of ovalization and a wrinkle.

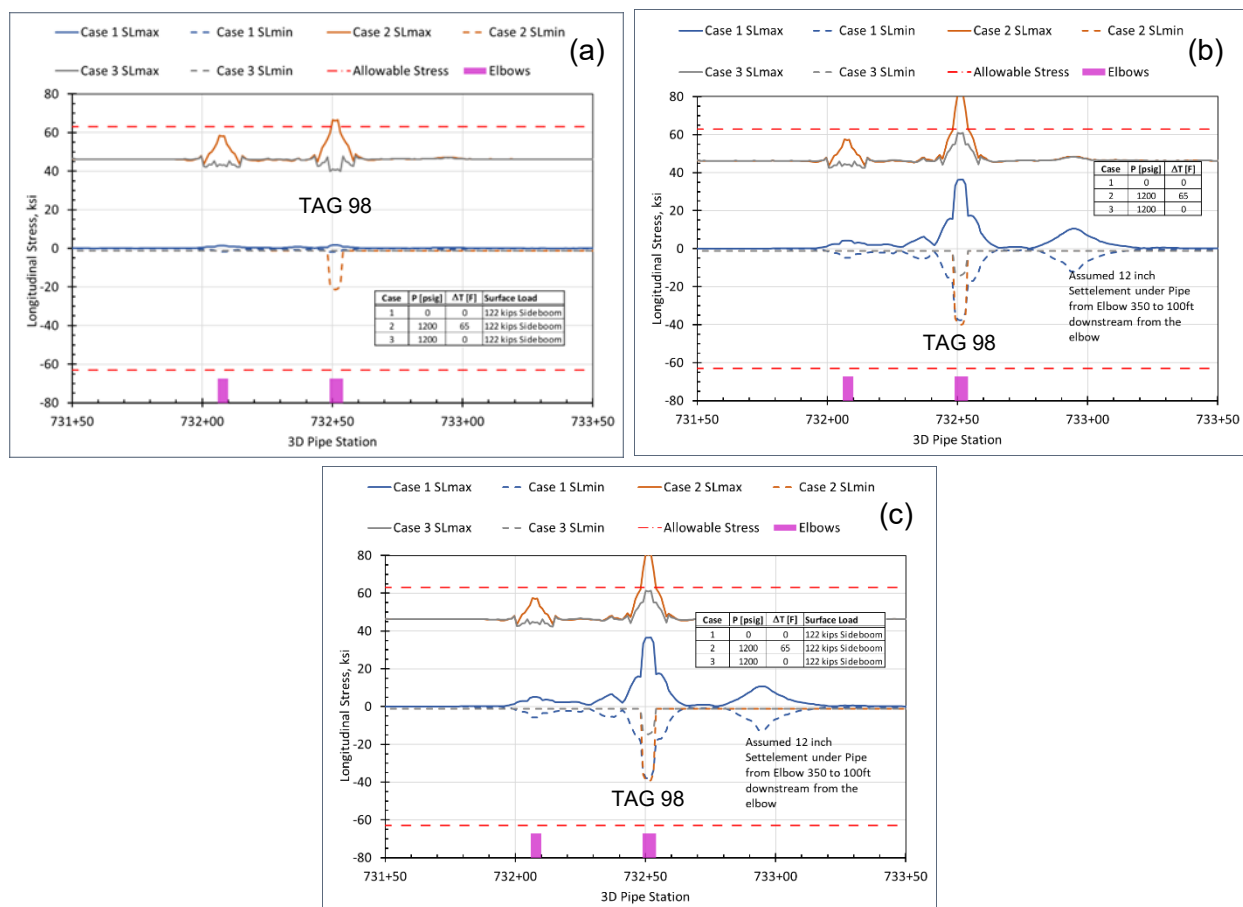
Figure 31. FEA Longitudinal Stresses with Elbow Elements and Lower-Bound Soil Properties (a) Side Boom Load Only, (b) Settlement Load Only, and (c) Side Boom and Settlement Loads

The post-construction settlement or gap under the pipeline can explain the out-of-roundness of the elbow. However, this scenario does not explain the wrinkle as the amount of compressive stress at the elbow is not excessive. For ground settlement to cause a wrinkle, the amount of movement should be around 24-inches or more. It is also possible that the wrinkle was formed later due to thermal cycles or ground movement, but that would require two independent coincidences both affecting the same location of the pipeline at different times, which although is possible it decreases the overall likelihood of the scenario. In addition, the bending strain analysis from the IMU data and assessments by Geotech SMEs did not find evidence of ground movement near the TAG 98 elbow.

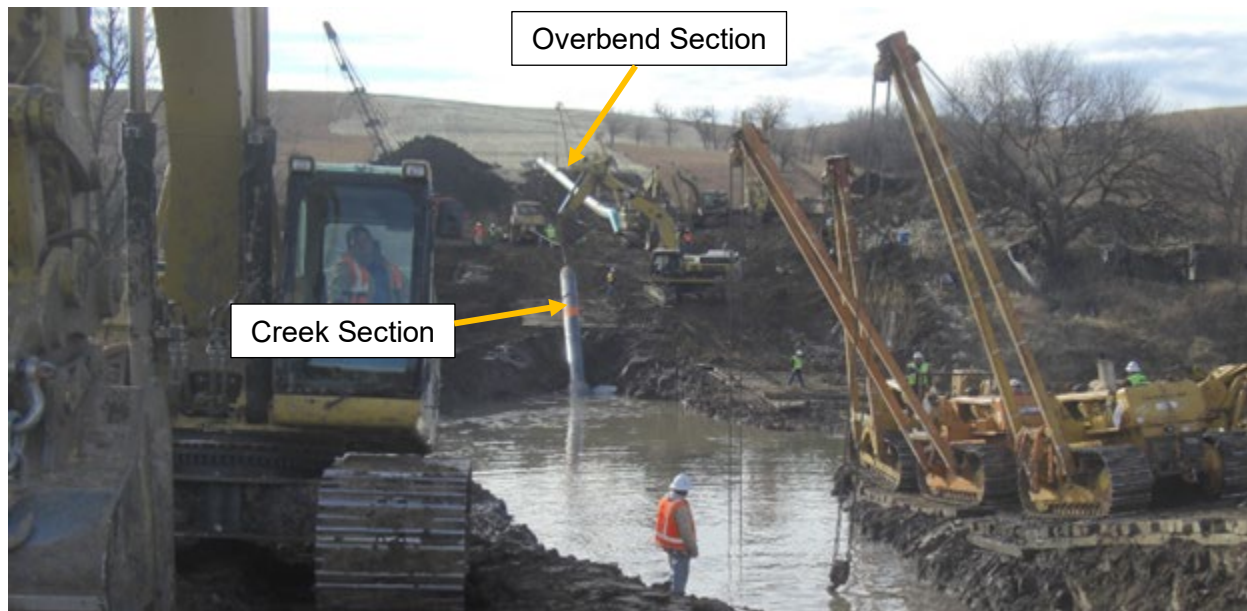
Figure 32. Use of Sidebooms During Replacement of TAG 98 (December 10, 2010)

A review of photographs during the December 2010 replacement shows that two side booms were used to hold the overbend section above the ground over the south-slope (see Figure 32).

The creek portion was buried but the downstream overbend section was most likely exposed during the hydrostatic test and free to move because the final tie-in weld had not yet been made. A note in the daily inspection report from December 11, 2010, suggests that the side booms may have been demobilized prior to the hydrostatic test, however, these records are unclear as to how the pipeline was placed in the ditch and supported during the hydrostatic test. Discussions with the Field Engineer onsite during the hydrostatic test indicated that the side booms would have been removed and the pipe supported with cribbing or soil supports. The potential for inadequate support during the hydrostatic test or fit-up creating a cantilever beam-bending effect was studied to estimate the potential bending stresses.

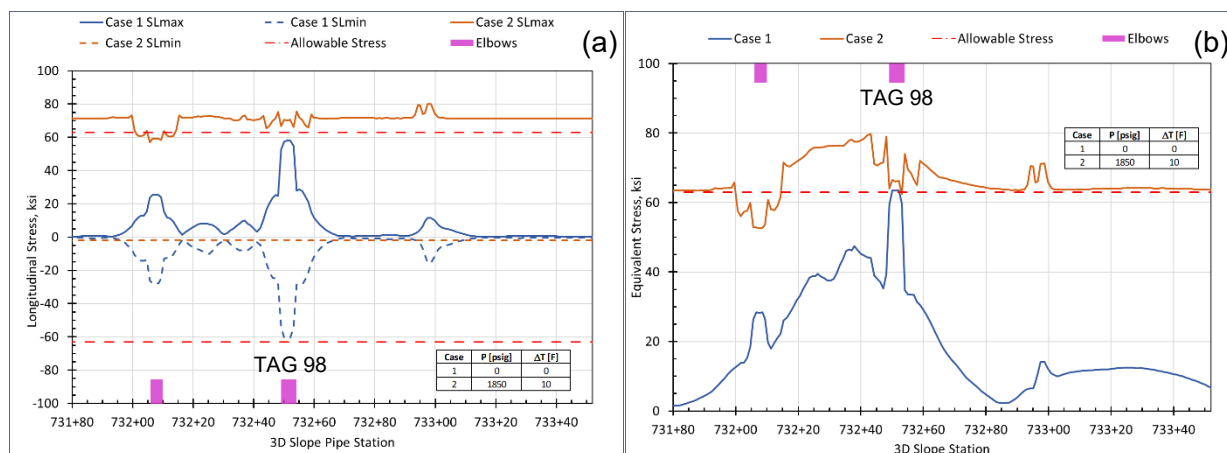
Figure 35. FEA (a) Longitudinal Stresses with 6-ft End Deflection and (b) von Mises Stresses with 6-ft End Deflection (Elbow Elements and Lower-Bound Soil Properties)

The results of the FEA for the end deflection scenario are shown in Figure 35. Various amounts of gap in the contact elements (cantilever end deflection) were examined to determine how much end deflection would be required to overstress the elbow. The results of the cantilever model with a 6-ft gap are shown in Figure 35(a) for the longitudinal stresses and Figure 35(b) for the equivalent stresses. The results show that cantilever action could have over-stressed the

TAG 98 (BND 350) elbow if the end deflection was at least 6-ft. This amount of end deflection is excessive and could only happen if the pipe length on the south slope was supported above ground before the hydrostatic test and lost the support after it was filled with water. This type of movement would have been noticeable by construction crews and most likely would have resulted in a safety shutdown (which there is no evidence of in the daily inspection reports).

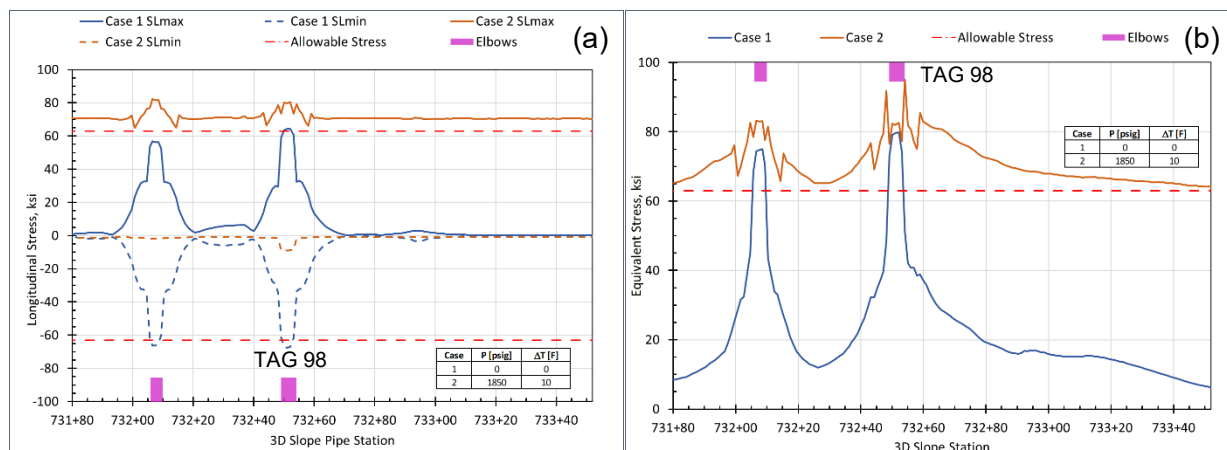
Figure 36. FEA (a) Longitudinal Stresses with 6-inches of Sliding Displacement and (b) von Mises Stresses with 6-inches of Sliding Displacement (Elbow Elements and Lower-Bound Soil Properties)

The results of the FEA for the sliding displacement scenario are shown in Figure 36. A sliding displacement of 6-inches in the downhill direction was applied to the end of the cantilever length and the model was run to calculate stresses. The results of this analysis are shown in Figure 36(a) for the longitudinal stresses and Figure 36(b) for the equivalent stresses. The results show that sliding of the pipeline down the slope can also create excessive bending stress at the elbow; however, the weight of the pipe filled with hydrostatic water is insufficient to cause the sliding. In other words, some outside loading had to act on the pipeline to force it to slide.

In summary, RSI analyzed two possible cantilever-type scenarios to determine the potential for high bending stresses to have occurred during hydrostatic testing (1) end deflection and (2) sliding displacement. Under Scenario 1 it was assumed that the pipeline was supported (e.g. with side booms or cribbing) at some distance above the ground and undergoes cantilever bending due to loss of this support. Under Scenario 2, the pipeline was assumed to slide down the hill. Compared to the post-construction outside force scenario discussed in Section 4.2.1.2, the cantilever action (Scenario 1) required a large amount of end deflection, but it explained the ovality as well as the wrinkle (the compressive stress in Figure 35 is at 90% SMYS at the elbow). The sliding action (Scenario 2) also explained the ovality and wrinkle but required a large outside force to overcome ground friction and bending resistance of the elbow to initiate sliding. The post-construction outside force scenario, on the other hand, does not require excessive pipe deflection or outside force, but requires the presence of a long gap or soft soil layer under the pipeline or post construction settlement (or a combination thereof).

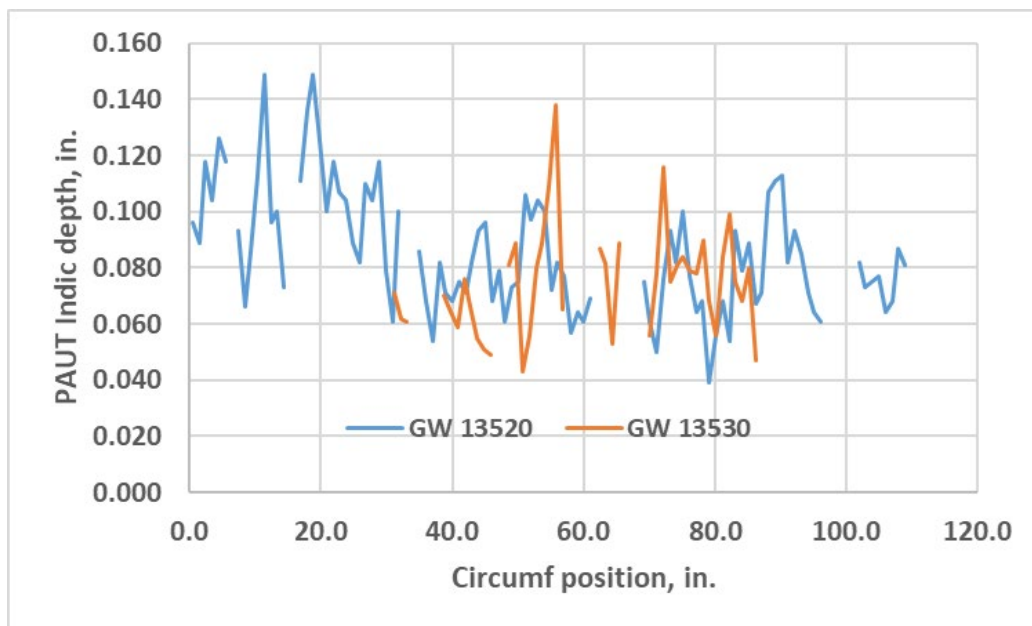
Figure 38. PAUT Indicated Flaw Depths for GWD 13520 and GWD 13530

RSI also examined the indicated flaw depth data from the PAUT NDE performed at Anderson (see Figure 38 for GWD 13530 and GWD 13520). The magnitudes and pattern of indications are similar for both welds. Since the indications appear on the intrados of both welds, they are unlikely to represent initial tearing or overload from loads applied when TAG 98 was installed. They are also unlikely to have been caused by thermal fatigue because the intrados would have been in compression under these loads. The left-hand side of the x-axis represents the TDC of the pipe and the scan direction is clockwise. The flaw depth measurements tend to decrease at the intrados and increase at the extrados which may be evidence of some influence of bending from the installation or thermal loads.

The fracture surfaces were not clear enough to discern if there was a region of initial tearing when the installation load that caused the ovality was applied, but it is plausible. Additionally, in comparison with actual cross-sections, the PAUT likely over-predicted depths by a factor of 2x to 10x. As shown in Figure 39, the depth of both flaws is approximately 0.008-inch (200 μ m) but the nearby PAUT indications are noted as (a) 0.055-inch and (b) 0.080-inch⁵². So, even where the PAUT indicates flaws that were much larger in GWD 13530 they in fact were similar in size to the LOF that initiated cracking and does not refute the fact that flaws were not reported by radiography at the fabrication shop.

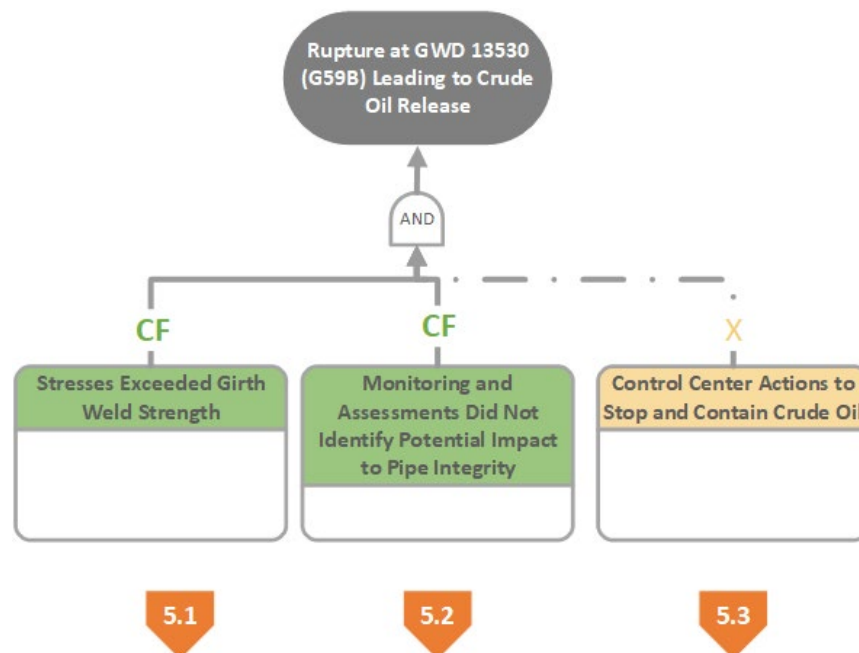
Figure 49. Simplified Cause and Effect Tree – MP 14 Incident

The simplified Cause and Effect Tree shown in Figure 49 and detailed Cause and Effect Trees provided in Appendix B serve as the basis for the conclusions drawn in this report. The evidence that supports the lines of inquiry evaluated during this investigation are provided in the following sections of the report.

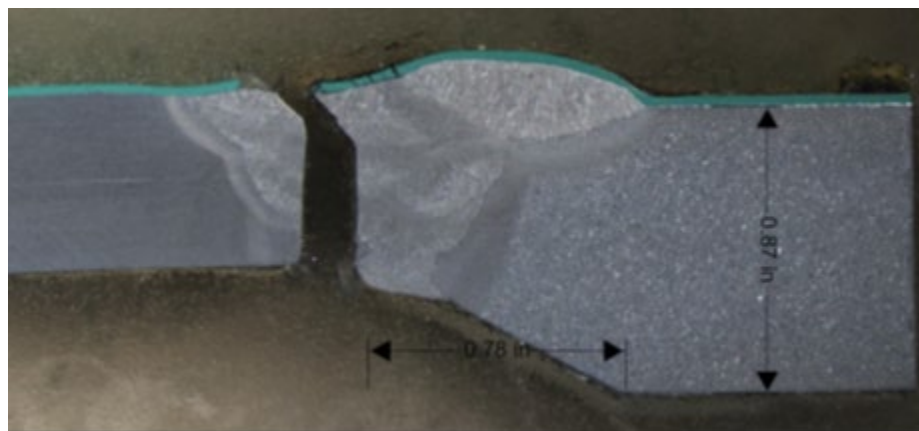
Figure 54. As-Fabricated Bevel Length for the TAG 98 Butt Weld Joint at Crack 2

Effect	Contributing Factors
Taper Transition Length	CTF1: The taper transition length on the TAG 98 (BND 350) elbow was less than the 1.00-inch minimum requirement in Figure 3 of MSS SP-75-2008 which can enhance stress concentration in the girth weld.

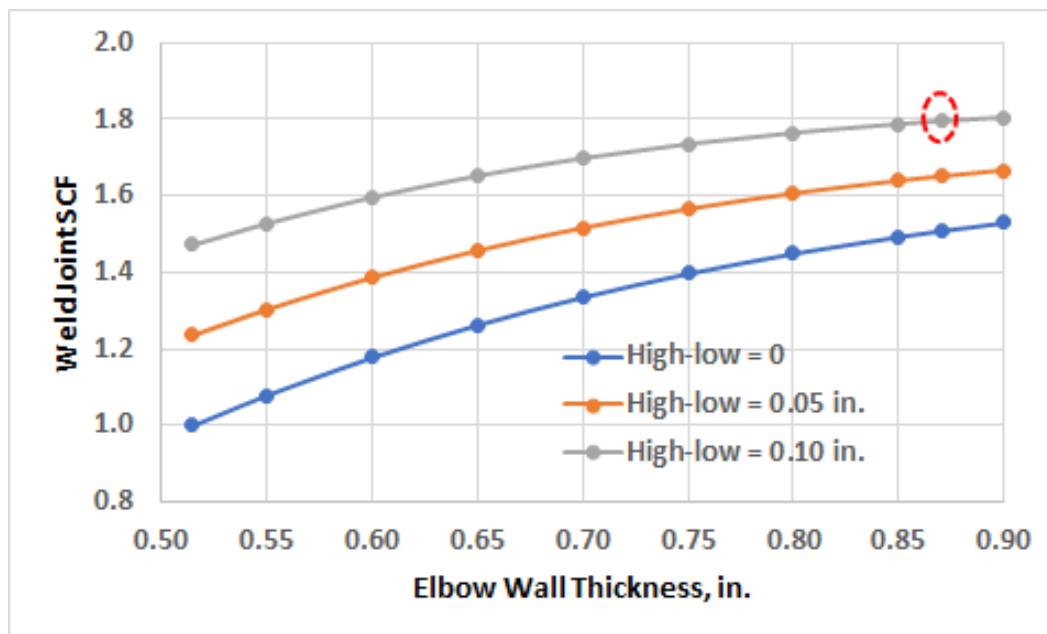
Figure 55. Local Weld Joint SCF, Effect of Elbow Wall Thickness and High-Low

Adding to the stress at the taper joint was the fact that the elbow wall thickness was higher than the minimum acceptable plate thickness for manufacturing (starting plate thickness of [REDACTED] per the MTR). The range of acceptable plate thicknesses was from 0.644-inch to 1.125-inch⁷⁶ per the as-built drawing in Figure 51. The thicker the elbow in comparison to the pup, the greater the stress concentrating effect at the thinner wall side of the taper transition joint. The weld joint SCF (calculated as described in Appendix D) varies as shown in Figure 55, with the actual configuration circled.

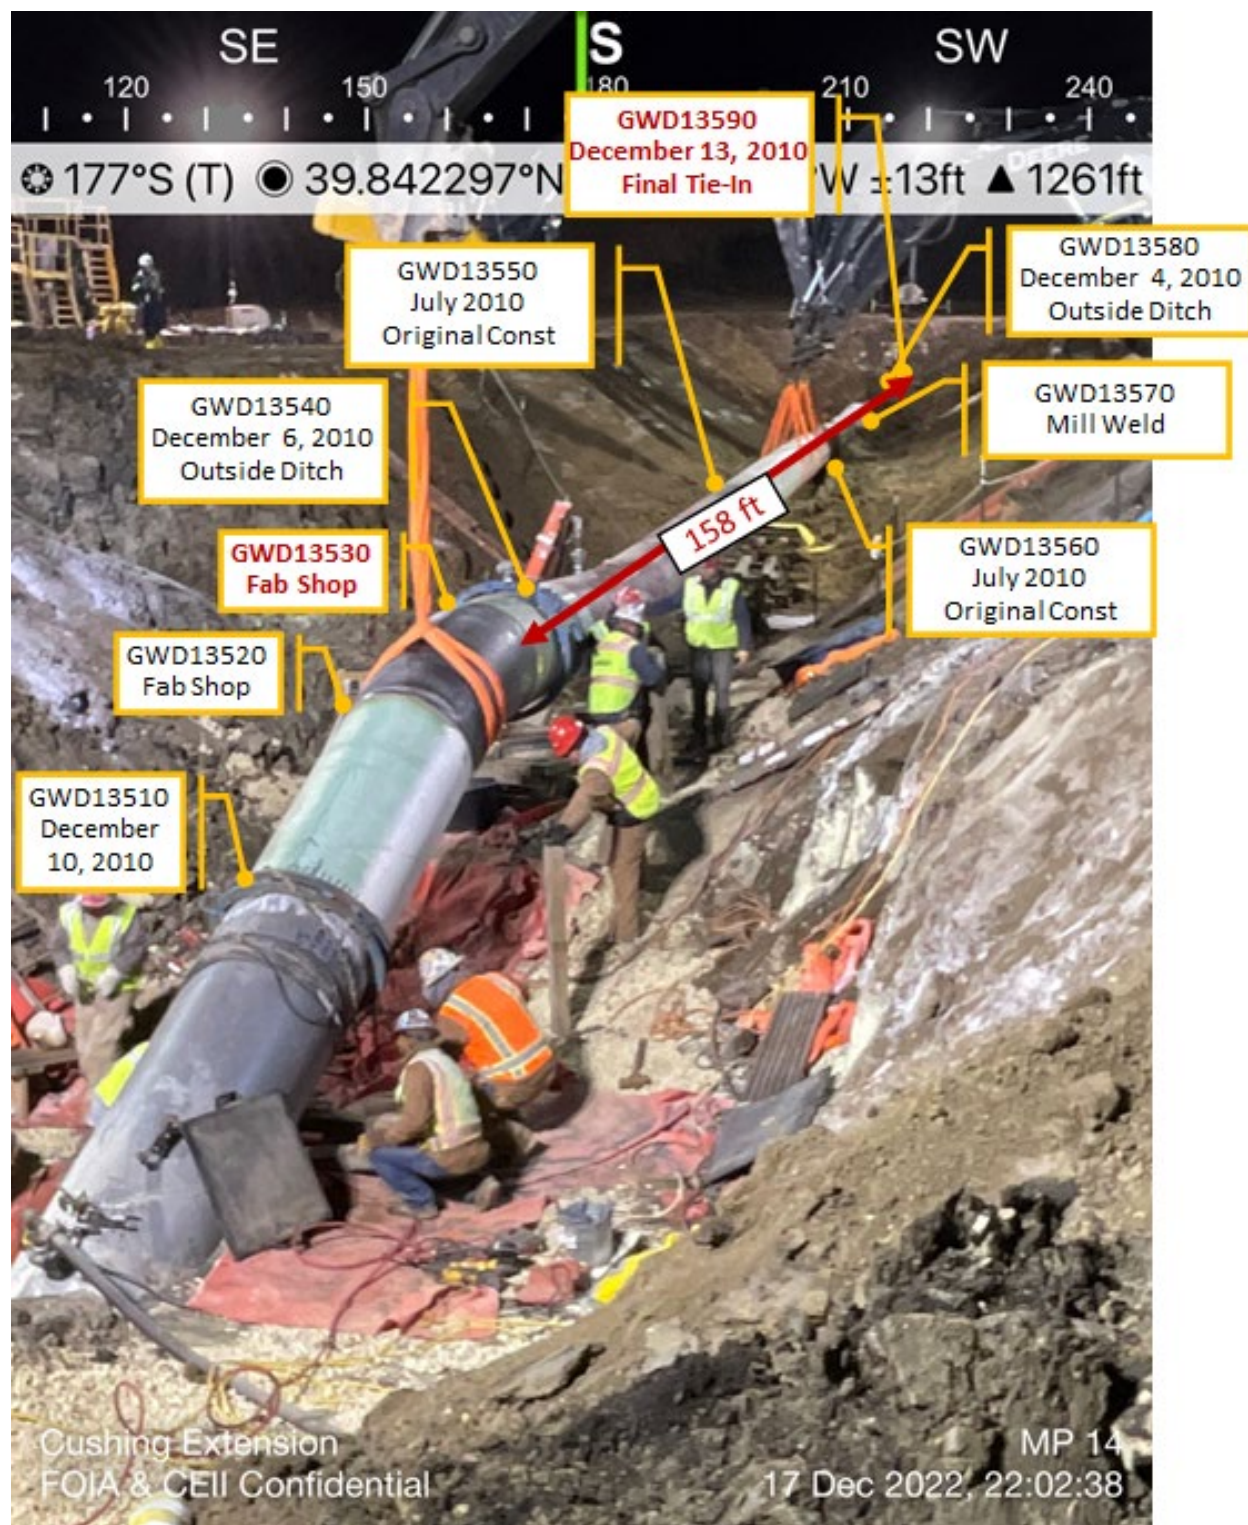
Figure 68. Key Girth Weld Installation Dates – Approximately 158 ft Between GWD 13530 and Final Tie-In Weld GWD 13590 (photo for illustrative purposes only, it is not from the time of construction)

As shown in Figure 68, the final tie-in (GWD 13590; 9GT-035) on the south side of Mill Creek was completed on December 13, 2010, after the hydrostatic test. Approximately 150-ft to 200-ft had been trenched on December 10, 2010, to replace the overbend section as described in the daily inspection records. Though daily inspection reports state that the fit-up was good and no issues were noted (see Figure 74), there is the potential that additional stress was applied to

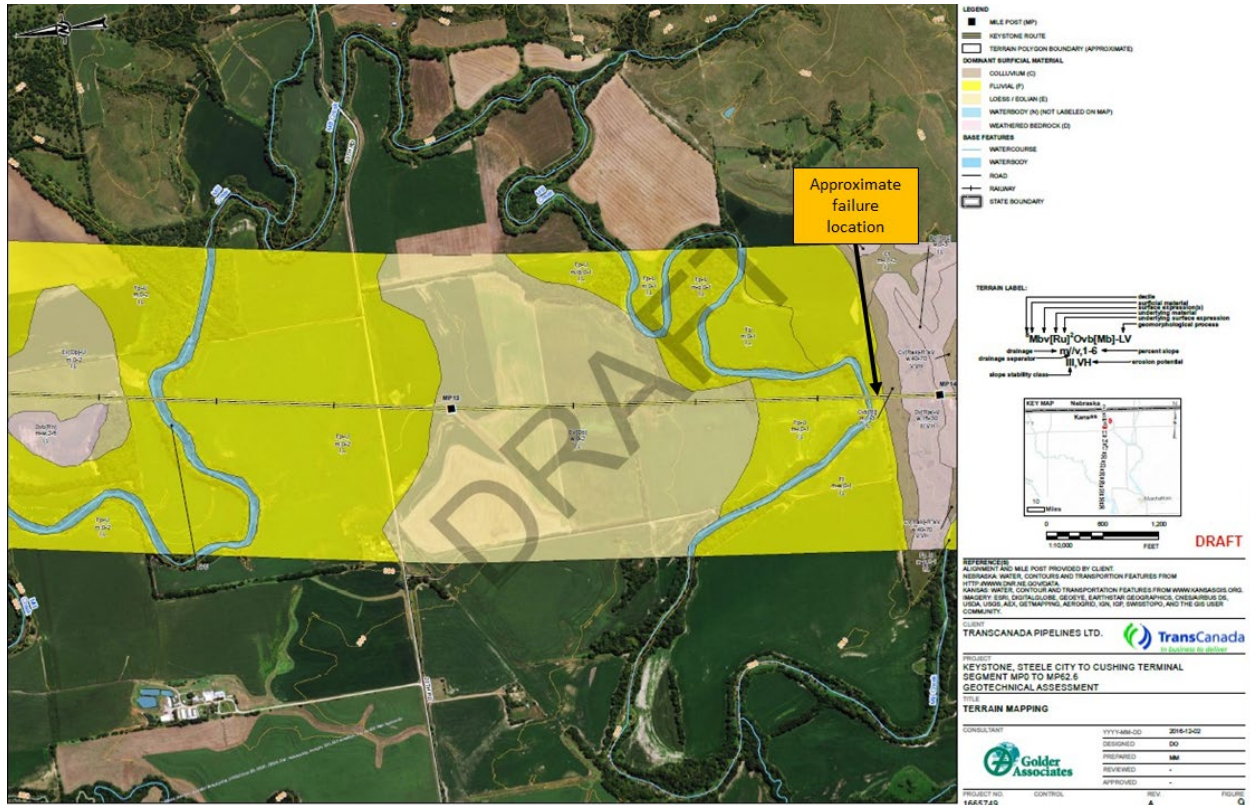
Figure 70. Geotechnical Assessment Near MP 14¹⁰⁷

As shown in Figure 70, the dominant soil types are fluvial/colluvium deposits in the area south of Mill Creek. This was confirmed by the Geotechnical SMEs onsite where they found clay-colluvium soils throughout. The US Department of Agriculture, Natural Resources Conservation Service (USDA NRCS) publishes a web soil survey¹⁰⁶ providing information on local soil data to make land use and management decisions. One of many soil data categories that is reported is soil susceptibility to compaction. The area south of Mill Creek is rated as 'medium' for soil compaction which indicates that the potential for compaction is significant and after compaction the soil can support standard equipment with only minimum increases in soil density. The area also has a moderate rating for frost action which is "the likelihood of upward or lateral expansion of the soil caused by the formation of segregated ice lenses (frost heave) and the subsequent

collapse of the soil and loss of strength on thawing...silty and highly structured, clayey soils that have a high water table in winter are the most susceptible to frost action.” The evidence supports that the soil in the area is appropriate for pipeline support but also may have been susceptible to frost action.

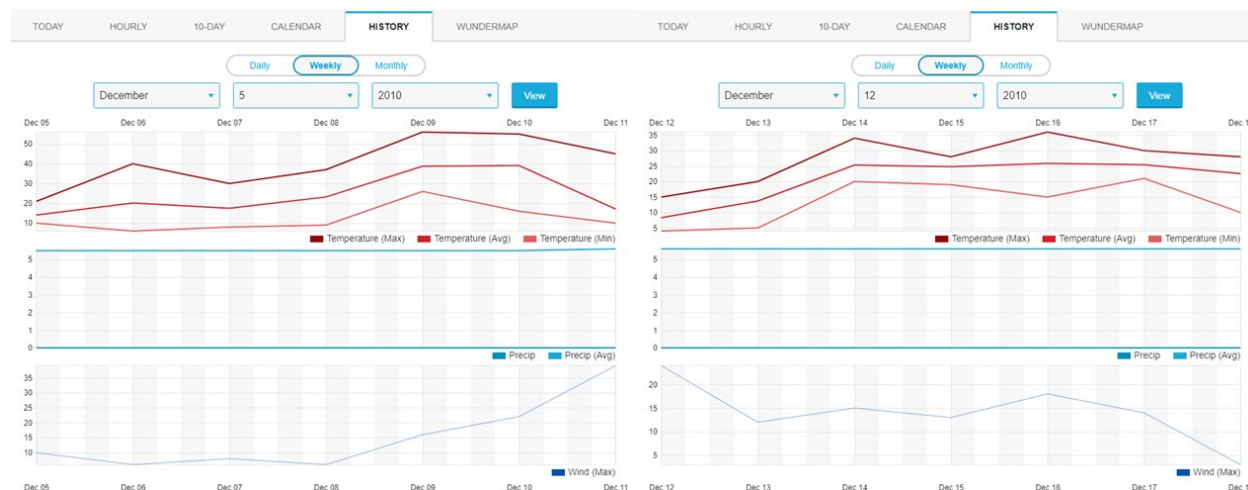
Figure 71. Historical Weather Conditions in Steele City, Nebraska (December 5-18, 2010)¹⁰⁹

As shown in Figure 71, the average temperature in nearby Steele City, Nebraska did not exceed 25°F (-4°C) between December 10, 2010, and December 14, 2010. The trench on the south side of Mill Creek was excavated December 10th and backfilled December 14th giving four to five days for the excavated soil to potentially freeze. Between those dates the newly installed overbend and creek sections were hydrostatically tested in the ditch with temperature maximums below 20°F (-7°C). No precipitation was noted, so crews were likely not dealing with snow or ice, but there was the potential for the ditch and the soil used as padding/backfill to freeze. The creek section had been backfilled prior to the hydrostatic test but the investigation team believes that the overbend section remained unburied so that any potential leaks at tie-in welds could be visually identified.

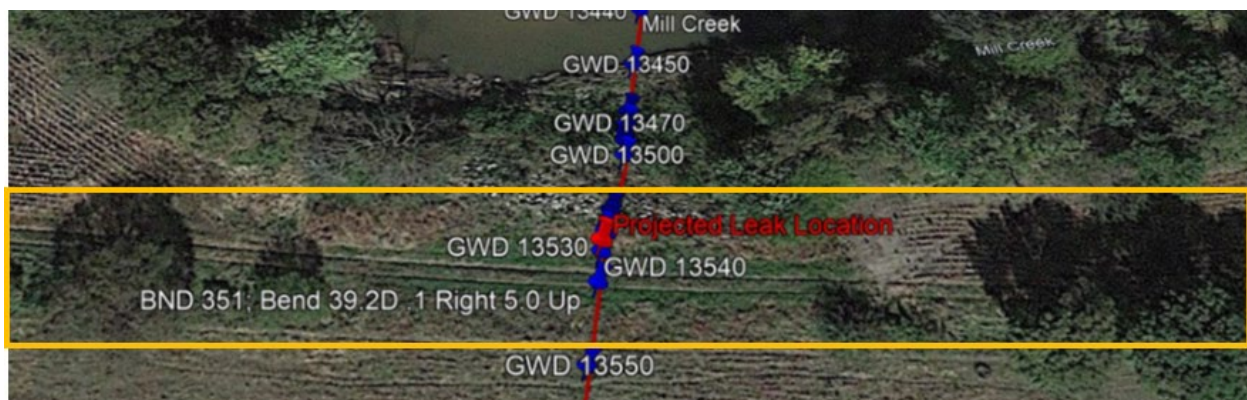
Figure 77. Aerial View of Site Highlighting the Two-Track Road Near the MP 14 Incident

As shown in Figure 77, a two-track road running east-west crosses the pipeline approximately 9-ft downstream of the release location. The road is “closed” and is not maintained by the township but heavy farm-type equipment (tandem axle semi-truck, tandem axle grain trailer, and John Deere S670 combine; ~36,000-lb loads) crosses the uncased pipeline at a frequency of approximately 12 times per year each¹²³. The cyclic loads from vehicular traffic were considered to determine their potential impact. With a lateral distance 9-ft away and a depth of cover at the TAG 98 bend assembly of [REDACTED], the cyclic loads from vehicular traffic were likely minimal. Therefore, vehicle loads were determined not to be a causal or contributing factor to the MP 14 Incident.

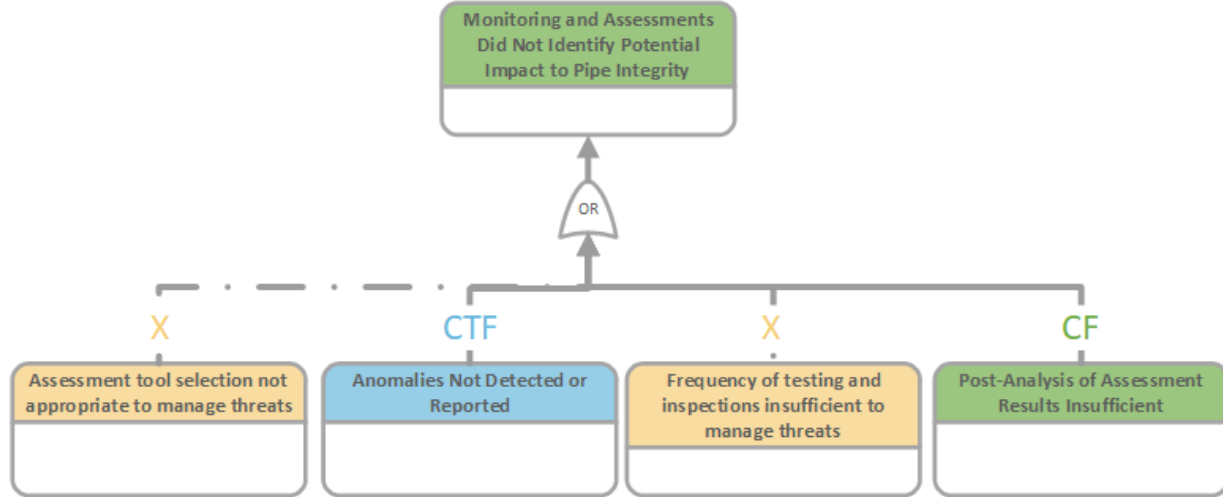
Figure 81. Simplified Cause and Effect – Monitoring and Assessments

Although multiple ILIs of the affected segment were completed between 2010 and 2022, including a metal loss ILI in 2018 that had capabilities to detect some anomalous girth weld conditions, the LOF and fatigue crack in GWD 13530 was not discovered prior to the rupture. The 2012 profile and 2013 caliper surveys did report the ID restriction (due to ovality) and an investigation was performed in March 2013; however, the severity of the threat was underestimated in terms of its potential effect on girth weld integrity. Several possible sequences of events were postulated as shown in Figure 81 (detailed Cause and Effect Trees are provided in Appendix B). Causal factors were identified related to post-analysis of

assessment results. The limitations of ILI technologies in detecting girth weld cracks in a 3D bend was a contributing factor to the cracks not being identified. The selected assessment tools and the frequency of inspections were adequate for the identified threats and therefore determined not to be causal.
