TC Oil

RCFA for the Keystone Milepost 14 Release

April 21, 2023

Final Report

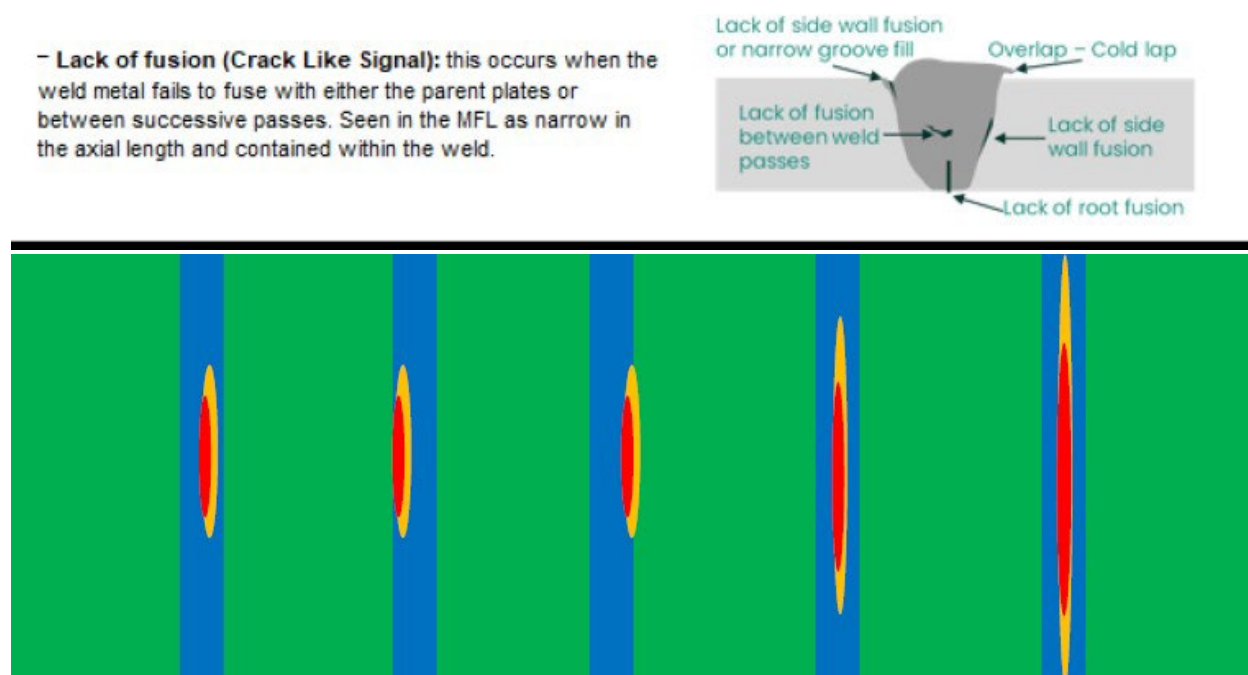
Analysis of features involves assigning a shape category: (1) narrow, linear features with metal loss signal equal to or less than the width of the girth weld signature and length around the circumference 0.6-inch (15 mm) or greater; (2) circular or oval features with metal loss signal greater than or equal to the width of the girth weld signature and length around the circumference with a ratio less than 2:1 between length and width; or (3) wide linear feature with metal loss signal greater than the width of the girth weld signature and length around the circumference 0.6-inch (15 mm). Then using the shape classification, the analyst selects the most likely hypothesis of the defect. For a LOF defect, the shape category would be a narrow, linear feature as shown schematically in Figure 86.

Figure 86. Schematic of Narrow Linear Feature MFL4 Signal Representing Crack-Like or LOF Defects in a Girth Weld¹⁴⁴

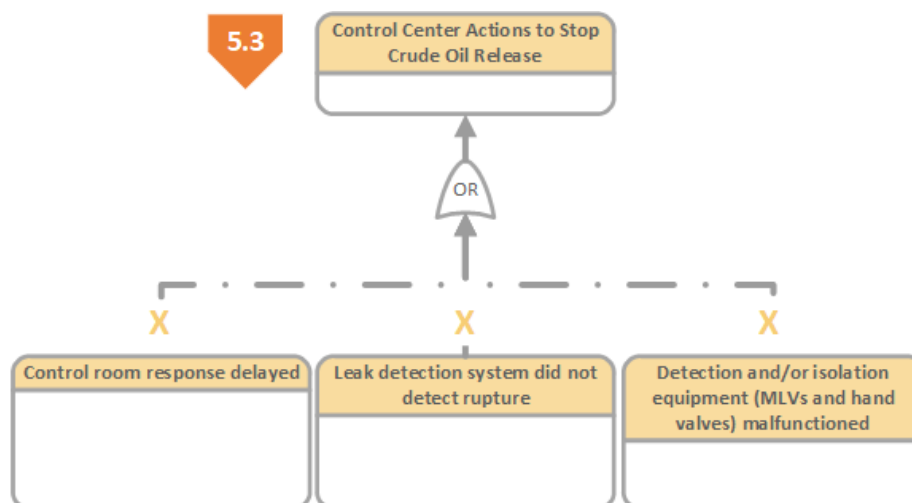
Images showing a ductile overload region on the metallographic section substantiate that the cracks in GWD 13530 had not leaked prior to the pipeline rupture. Therefore, the size of the release was dictated by the response of the control room in shutting down and isolating the pipeline. The control room response event sequence is shown in Figure 88. The investigation team determined that the control room response was appropriate and therefore not causal to the release volume.

**Figure 88. Control Room Response Event–Sequence - Cause and Effect Tree**

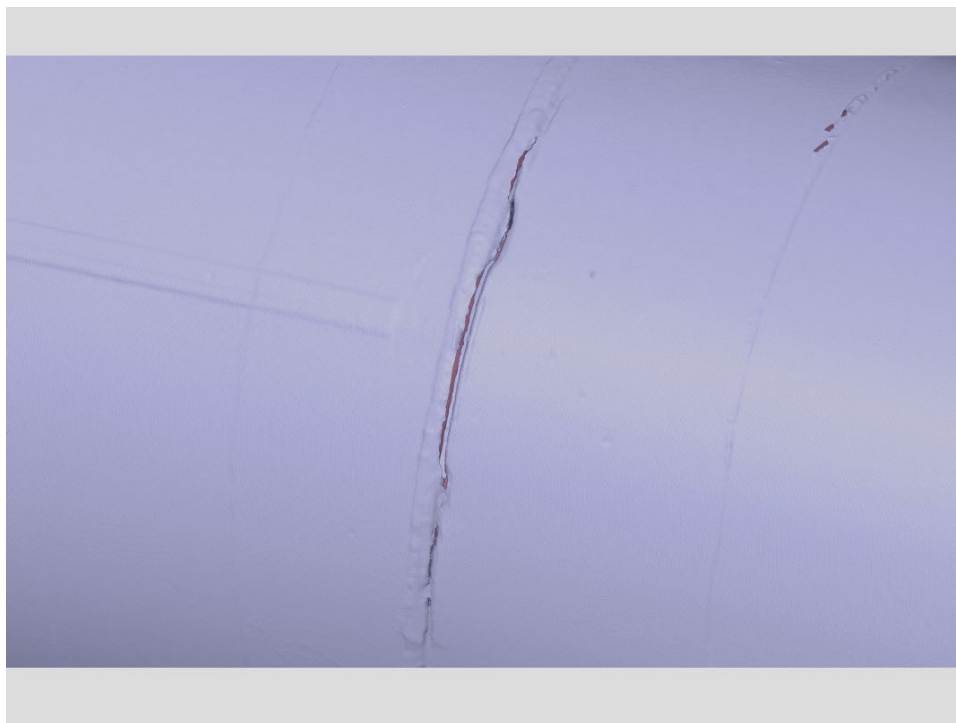
Figure D.4. A View of the Pipe Rupture Area in the STL Model. This Portion of the Model Was Removed and Replaced with a Patch. The Upper Right Portion of the Model Shows Another Example of Several Holes in the Data Which Needed to be Patched.

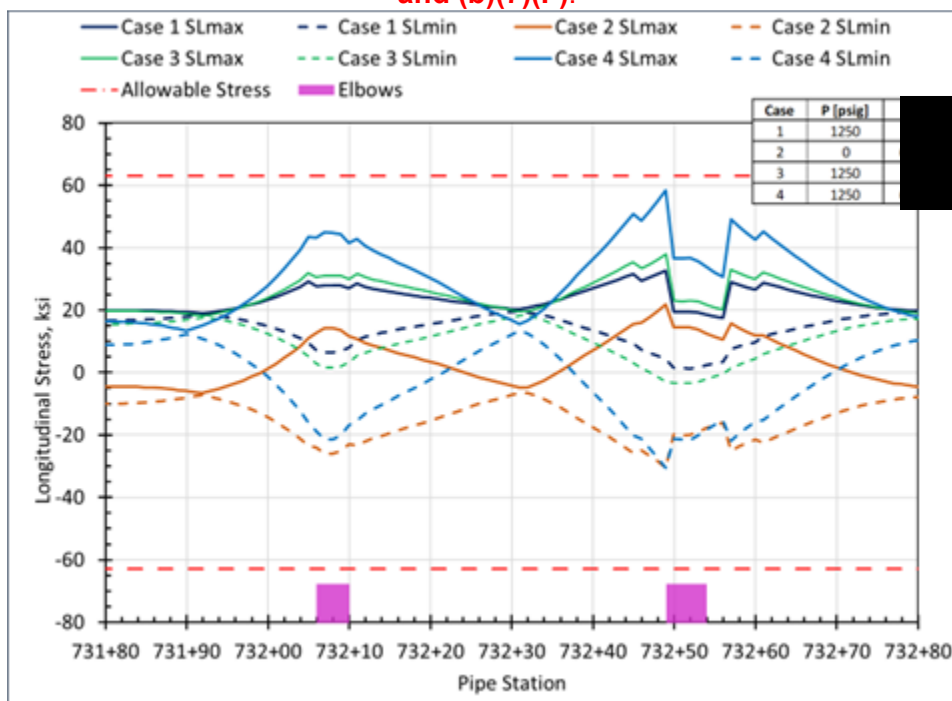
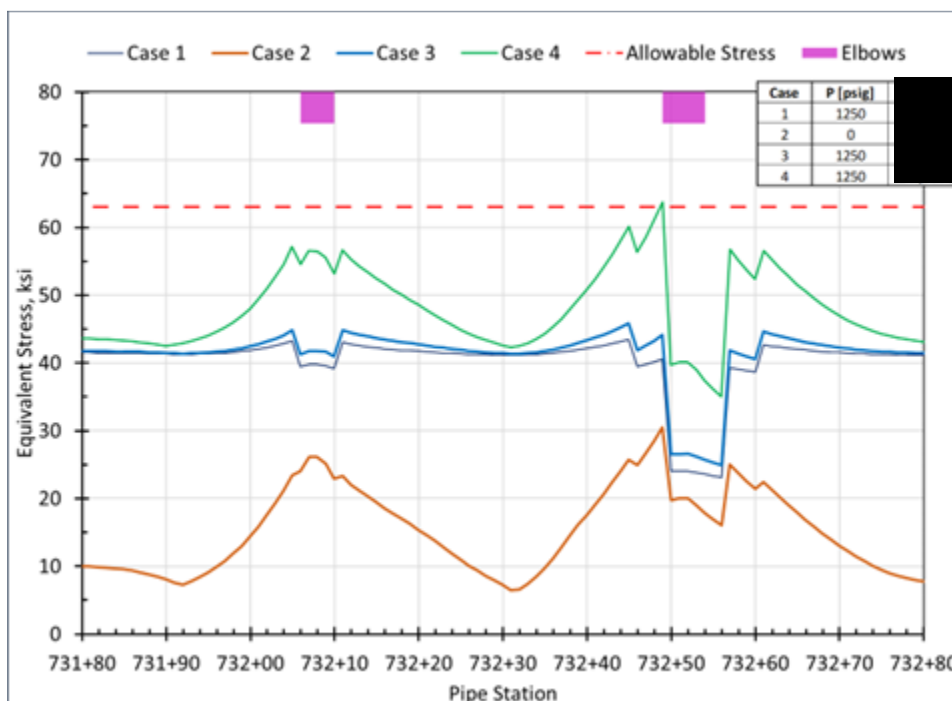
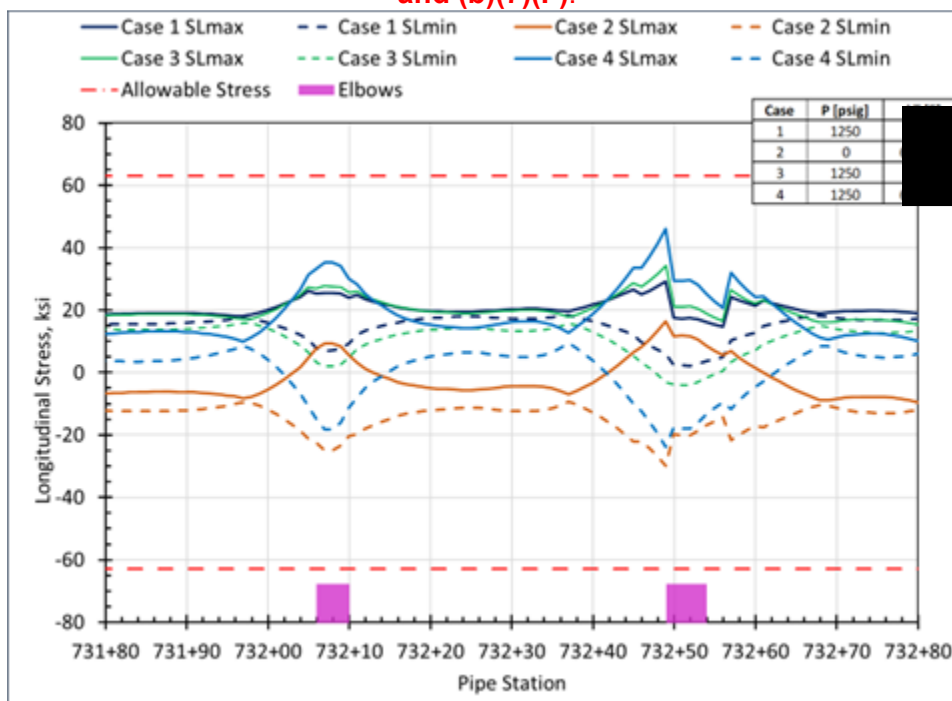
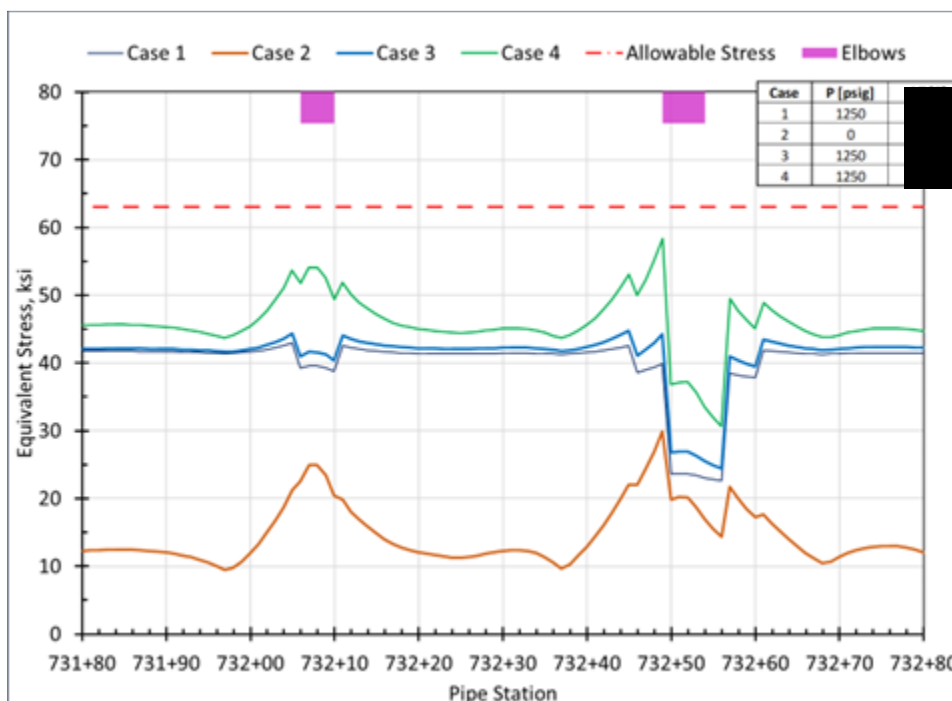
In the first analysis we used pipe elements (PIPE289) and the lower bound soil properties (see Table D.2). The results of this analysis are shown in Figure D.9 and Figure D.10. The x-axis in these figures is the 3D slope station of the pipeline and the y-axis shows the stresses in ksi for the four loading combinations listed in Table D.4. The analysis was conducted for approximately 10,000 feet of the pipeline length but in this report, we are only showing the results at and near the TAG 98 (BND 350) elbow (including the sagbend TAG 114C; BND 349). The purple boxes in these figures show the locations of the elbows along the segment, and the dashed dotted red line shows the 90% SMYS limit. Figure D.9 shows the maximum and minimum longitudinal stresses for the four loading scenarios and Figure D.10 shows the von Mises stresses. The longitudinal stress results indicate compressive stresses up to 30.6 ksi at the elbow. The amount of compression is well within the typical allowable stress of 90% SMYS and is not enough to cause the observed wrinkle. Although the von Mises stress is relatively high (64.7 ksi or 92% SMYS) at the wall thickness transition zone, these stress levels are not sufficient to cause permanent ovalization of the TAG 98 elbow.

The FEA results for the upper-bound soil properties (see Table D.3) with PIPE289 elements are shown in Figure D.11 and Figure D.12. The overall stresses are lower than those calculated with the lower-bound soil properties (see Table D.2) because a stiffer soil provides stronger support and a lower anchor length for the pipeline along bends and elbows. The normal pipe elements that were used in these analyses did not account for pipe cross-sectional warping and ovalization at the elbow. The following analyses address these effects by replacing the pipe elements with elbow elements.

The above results (i.e., the stress graphs in Figure D.9 through Figure D.16 and the compressive strain limit from Equations 9 and 10) shows that although the equivalent stress exceeds the allowable stress of the pipe material, it is insufficient to cause pipe ovality or a wrinkle. Based on the FEA results, RSI concluded that the TAG 98 wrinkle and ovality most likely did not occur because of pipeline operational loads.

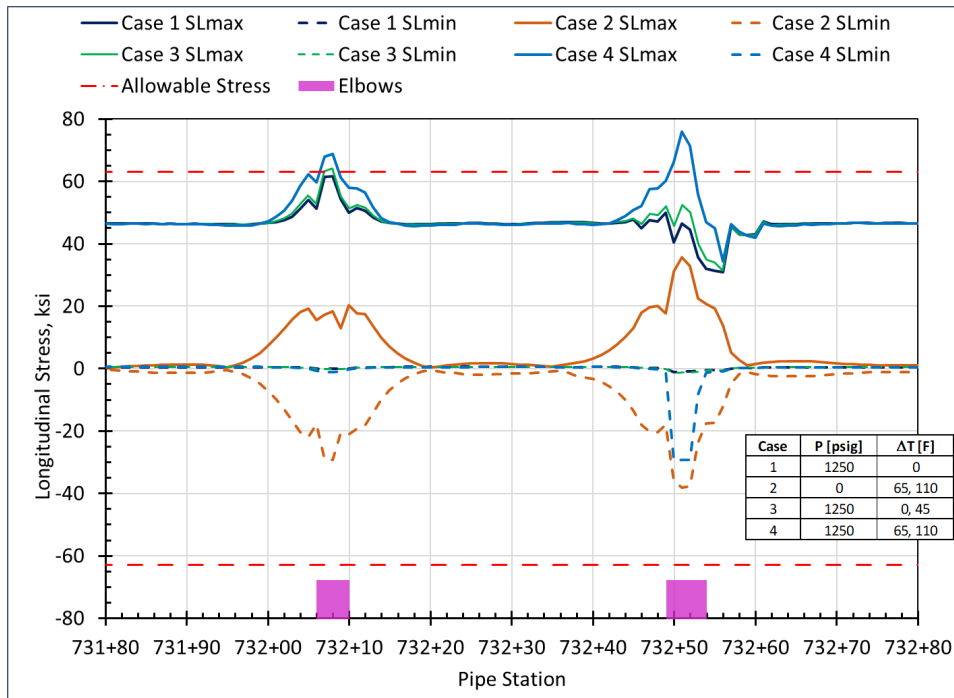
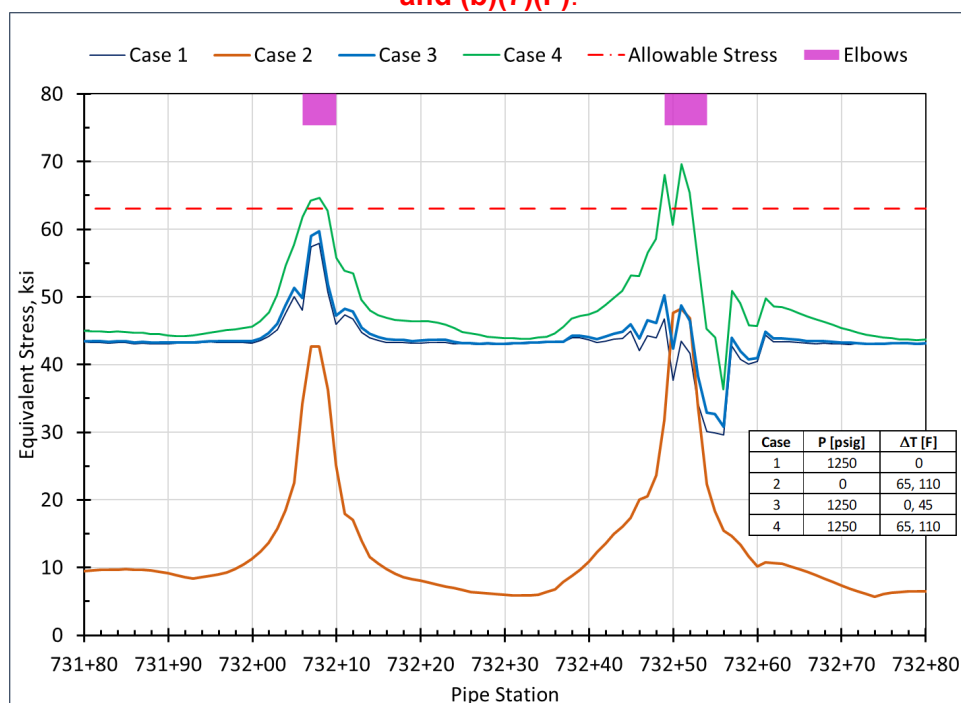
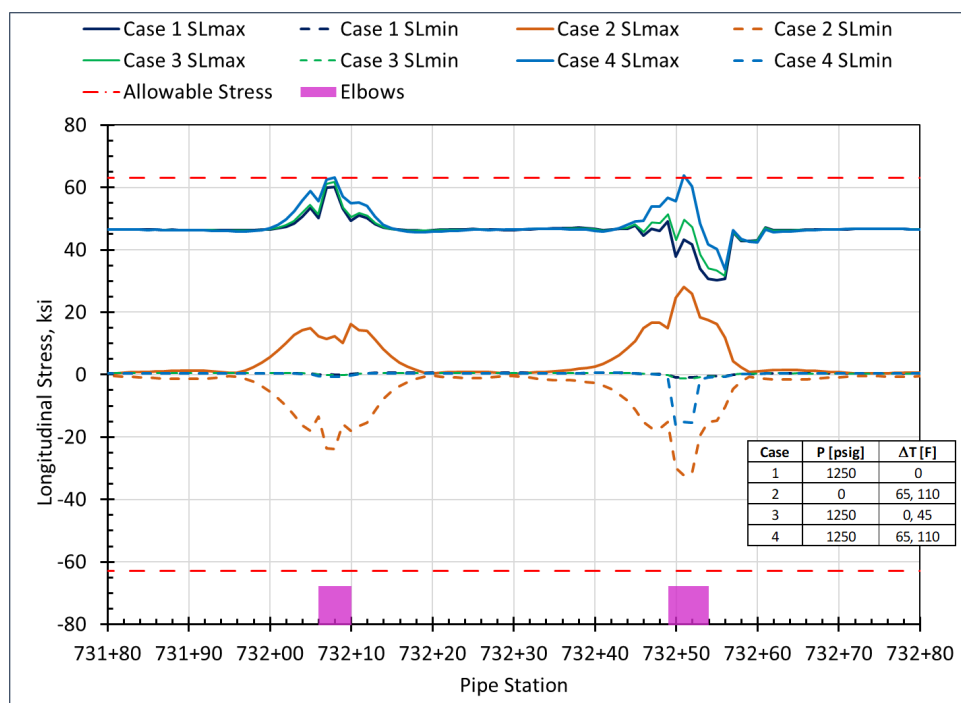
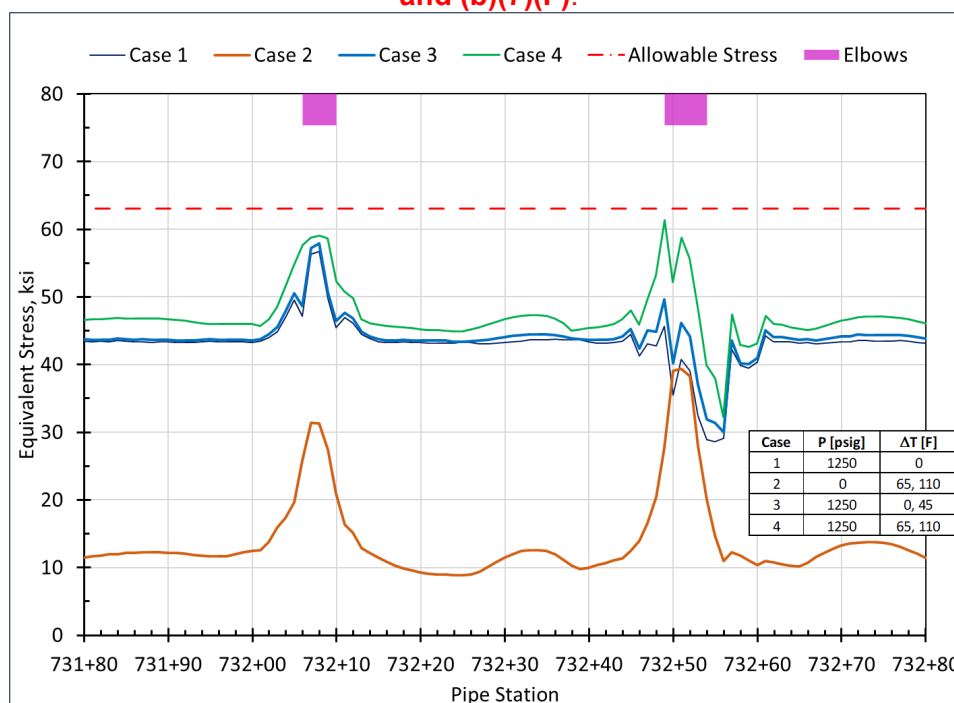
In the above equations, D is pipe outer diameter (inch), P is the pipe operating pressure (psig), S is the yield strength (psi), and t is pipe wall thickness (inch). The above equations result in allowable compressive strains ranging from 0.4% to 0.6%. The calculated compressive strains in the longitudinal direction of the elbow and the pups were all less than 0.14%. The maximum equivalent stress from the ELBOW290 analysis (see Figure D.14) was 69.6 ksi (99.4% SMYS). Figure D.15 and Figure D.16 show the results for upper-bound soil properties. The stresses are lower compared to those associated with the lower-bound soil properties.

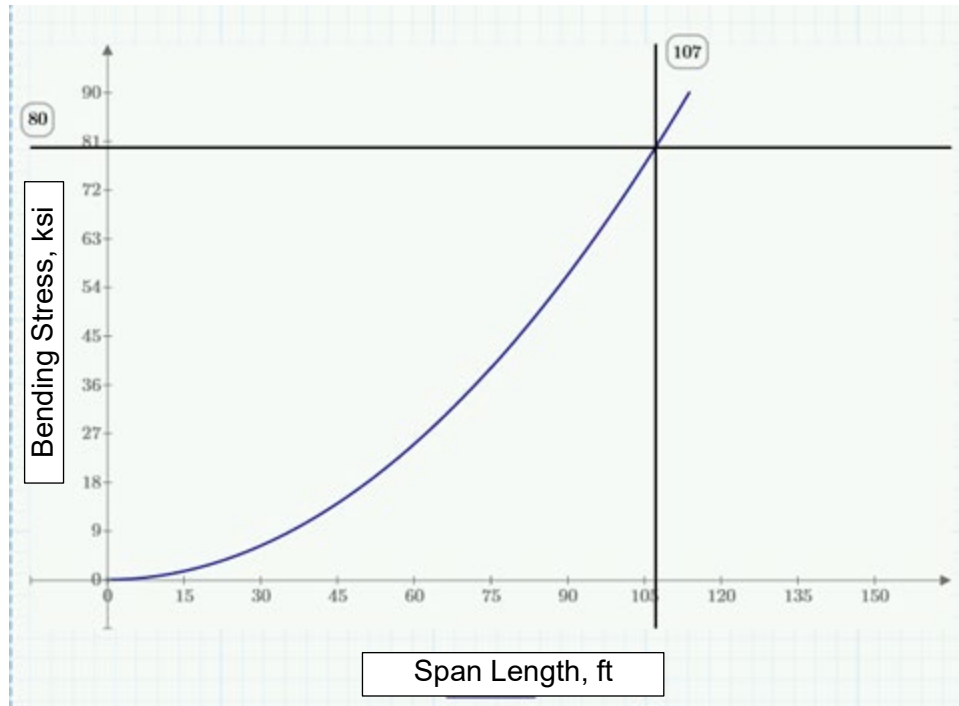
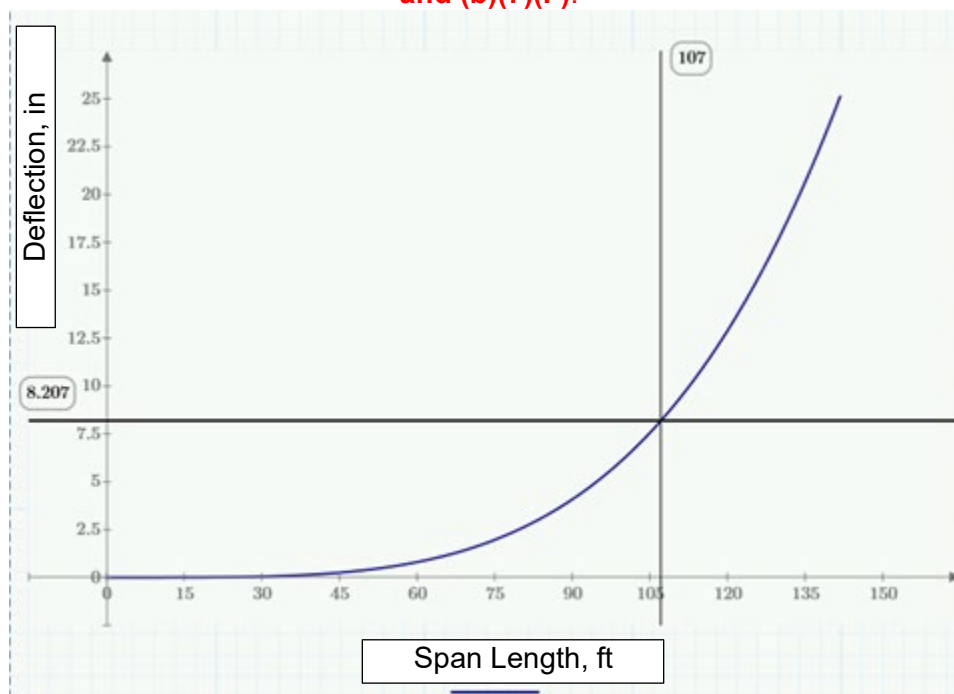
RSI first performed an analytical parametric study of the replacement segment using the beam equations (Equation 1 through Equation 8). The first possibility considered was that a gap was left underneath the replacement pipe segment, which allowed the pipeline to sag under soil overburden pressure, causing excessive bending. For this assessment the fixed-fixed beam equations and a soil overburden of 8-ft with a mass density of 130 lbm/ft³ were used. The weight of the pipe and product was also considered in this assessment. Figure D.17 shows the maximum bending stresses in ksi which is located at the fixed ends as a function of the span length in feet (not the length value along the beam). Figure D.18 shows beam deflections in

inches as a function of the span length (not the length value along the beam). The results show that it is possible to have high levels of bending stress that exceed the material yield strength. However, in order to generate bending stresses high enough to cause significant plastic deformation, the span length must be around 100-ft or longer, and beam deflections must be several inches. Although, in theory this scenario is possible, in practice it is very unlikely that such a long and wide gap under the pipeline would have gone unnoticed before placement of the overburden soil.

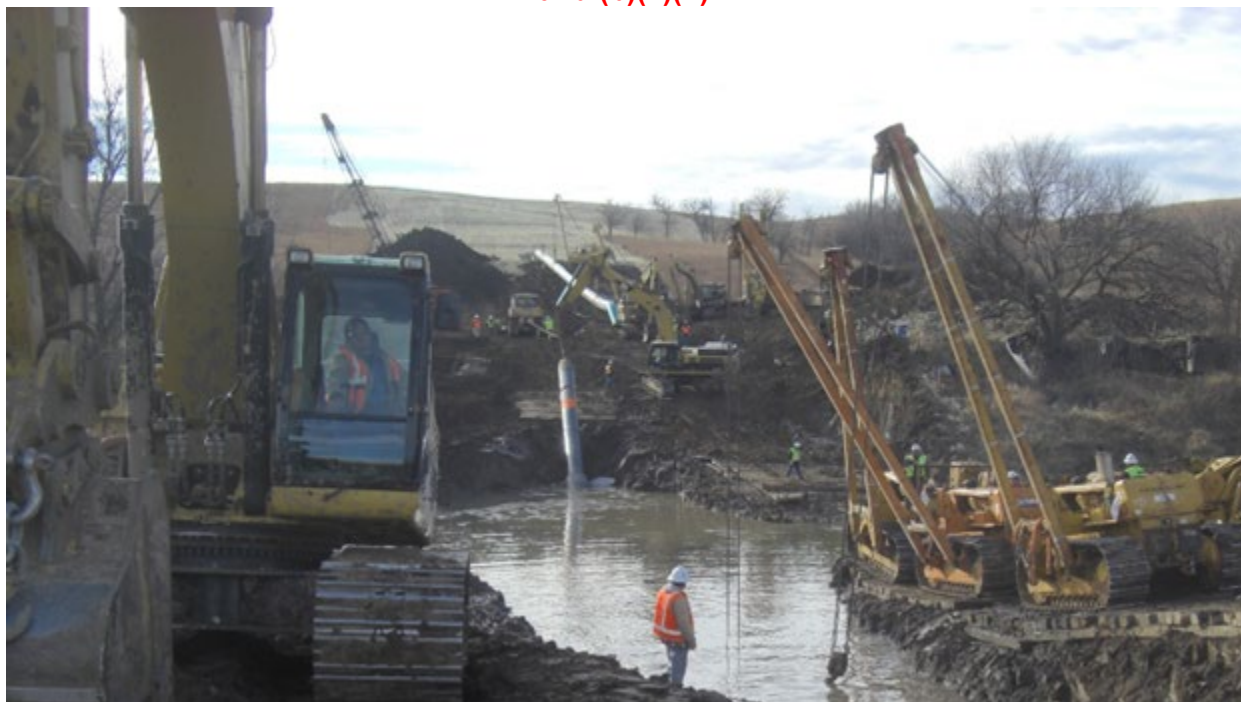
The second scenario considered is cantilever bending of the replacement segment after the upstream tie-in weld was complete but before the final tie-in weld was made downstream. A review of photographs during the December 2010 replacement of TAG 98 show that two side booms were used to hold the pipe segment above the ground over the south-slope (Figure D.19). It is also known that the creek portion of the replacement segment was buried with 5-ft of soil but the downstream overbend section was likely exposed during the hydrostatic test on December 11, 2010. Furthermore, the downstream tie-in weld (GWD 13590; 9GT-035) was completed after the hydrostatic test on December 13, 2010. A note in the daily inspection report from December 11th suggests that the side booms may have been demobilized (prior to the hydrostatic test), however, these records are unclear as to how the pipeline was placed in the ditch or how it was supported during the hydrostatic test. Improper operation of side booms can sometimes create high levels of bending stress. To assess this hypothesis, RSI first performed several analytical cantilever beam-bending analyses. Figure D.20 shows a schematic of the assumed model. The cantilever assessment model included (1) an accidental load at some distance from the fixed end and (2) the weight of the pipeline and hydrostatic test water. It was assumed that the free end of the beam will, after some amount of deflection, touch the ground generating an end reaction force. The model was set-up in Mathcad Prime, allowing us to define the point load, weight per unit length of the pipe, and the end reaction as variables. The span length in all the cantilever analyses were set to 170-ft.

Figure D.19. Use of Sidebooms During Replacement of TAG 98 (December 10, 2010)

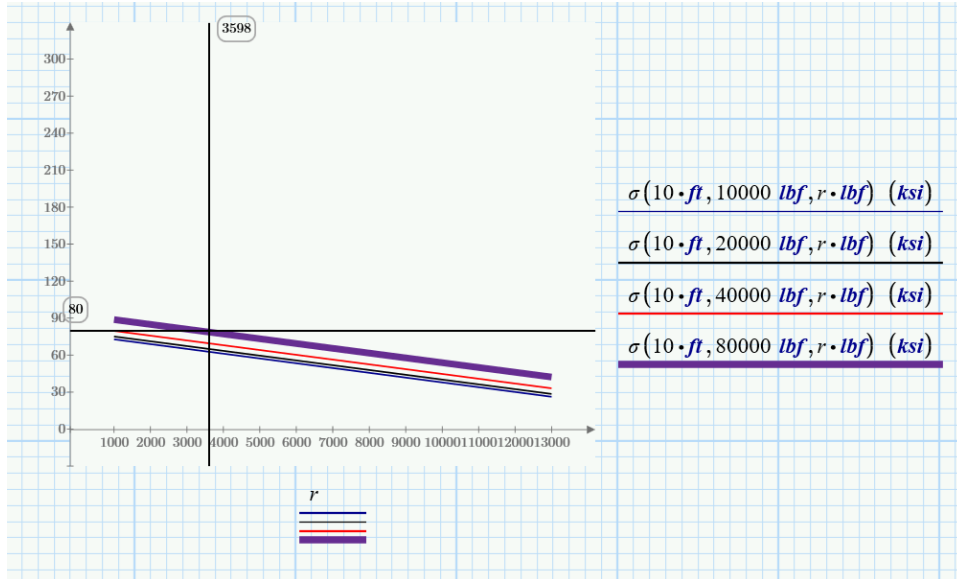
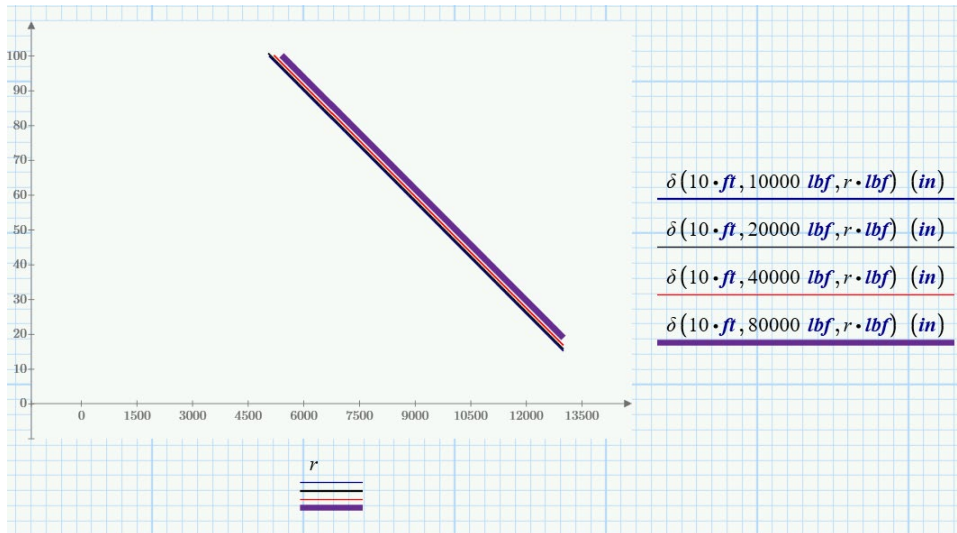
zero reaction represents a beam with a completely free end. A reaction force of about 14,500 lbf represents a beam with one fixed end and one pinned end (i.e. this is equivalent to the south end of the pipe segment sitting on the ground). The results suggest that high accidental loads can cause sufficient bending stress such that it exceeds the yield strength of the material. However, as seen in Figure D.23 the amount of deflection associated with high bending stress levels is relatively high (i.e. greater than 100-inches).

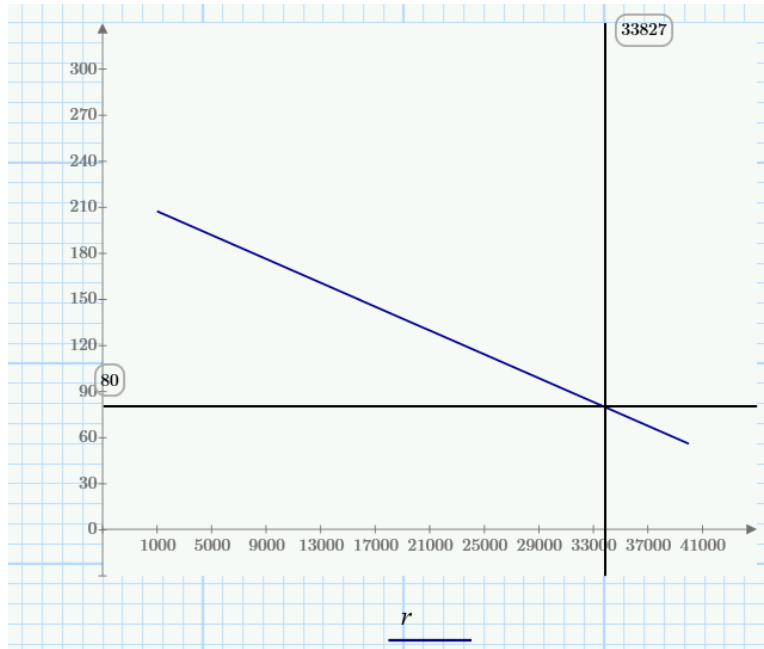
Another potential scenario is the excessive bending stress during the hydrostatic test. The results of this scenario are shown in Figure D.24 and Figure D.25. The results indicate that high bending stresses (e.g. 80 ksi) would be possible when the pipe segment was filled with hydrostatic water if it lacked proper support.

Figure D.24. Cantilever Beam Bending Stress for Pipe Filled with Hydrostatic Test Water. The x-axis in this figure is end reaction force in lbf, and the y-axis is the bending stress in ksi.

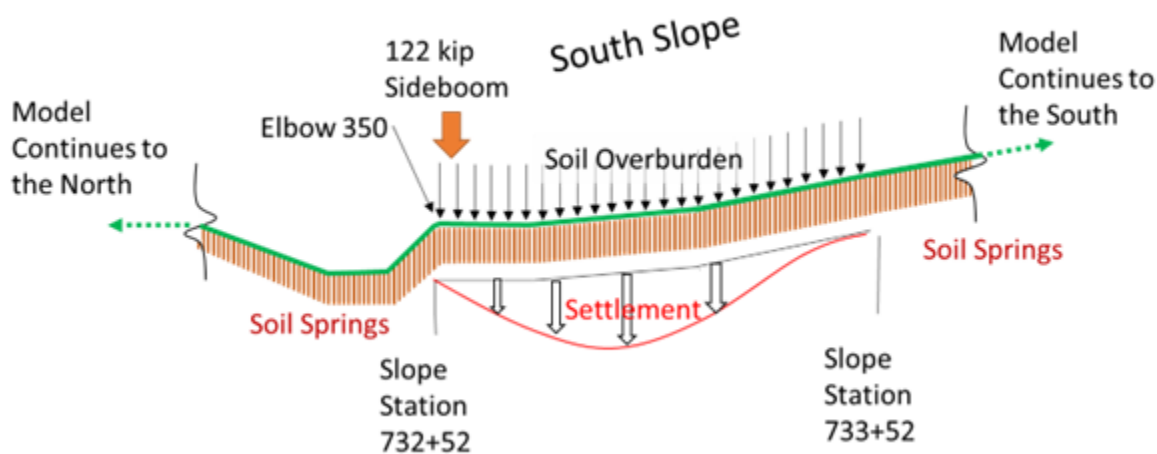
Figure D.26. Schematic of the Gap Scenario FEA Model (Scenario 1)

The effect of a gap or extremely weak soil under a pipeline is similar to that of ground settlement as in both cases the pipeline will sag. To examine the gap scenario, ground settlement analysis was performed in which settlement displacements were applied to the end of the vertical soil spring that represents soil support. The settlement profile was assumed to span a 100-ft distance starting from the subject elbow (TAG 98) to the south slope. The soil pressure from a 122 kip side boom crossing the pipeline was also included in the analysis. A schematic of the soil-pipe interaction gap model is shown in Figure D.26. Figure D.27 shows the assumed settlement profile. Three sets of analyses were performed to examine the effects of the side boom and settlement, namely (1) load from the largest side boom with no settlement, (2) settlement only (no side boom load), and (3) settlement and side boom load. Each set of analyses used the three loading combinations listed in Table D.6. The analysis also used the ELBOW290 model (see Section D.2 'Soil-Pipe Interaction Model' and Section D.4 'Pipeline Stress Analysis under Operating Loads' for details). The FEA results are shown in Figure D.28 through Figure D.33.

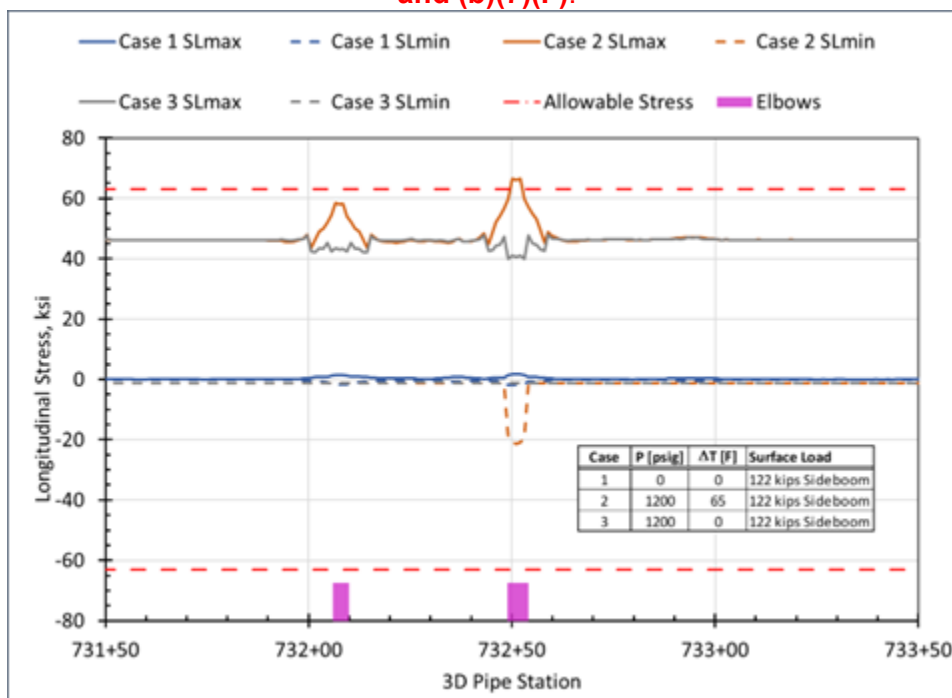
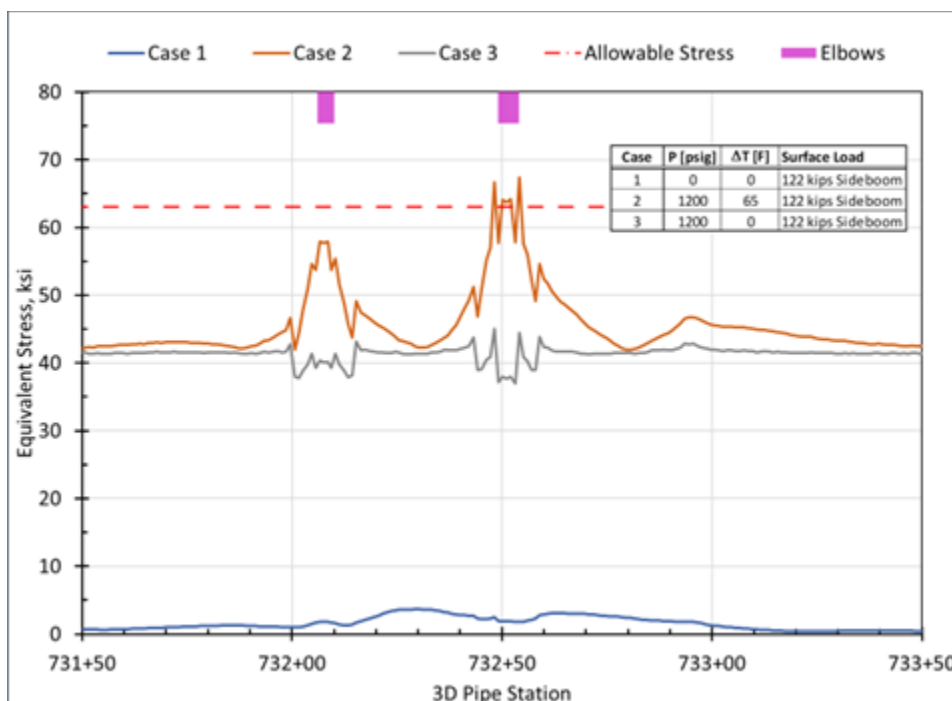
Figure D.28. FEA Longitudinal Stresses for Post-Construction Analysis with Side Boom Load Only

Figure D.29. FEA von Mises Stresses for Post-Construction Analysis with Side Boom Load Only

The results show that the surface loading from the side boom alone would not induce high stress levels (Loading Case 1 in Figure D.28 and Figure D.29). In contrast, post-construction ground settlement could have produced enough bending and axial stresses to bring the elbow to yielding (Figure D.30 and Figure D.31). The longitudinal stress plot for Load Case 1 in Figure D.30, shows that although the bending stresses are generated near the middle of the span (~ Sta 732+95), it is lower than the bending stress at the elbow. This is due to the shape of the assumed settlement profile which is skewed towards the elbow (see Figure D.27) and the stress concentration at the elbow. The peak settlement that was assumed in this analysis was 12-inches which may appear excessive, however, since a gap under the pipeline would have a similar effect 12-inches of settlement could have been the result of a small gap under the pipeline plus some post-construction consolidation settlement.

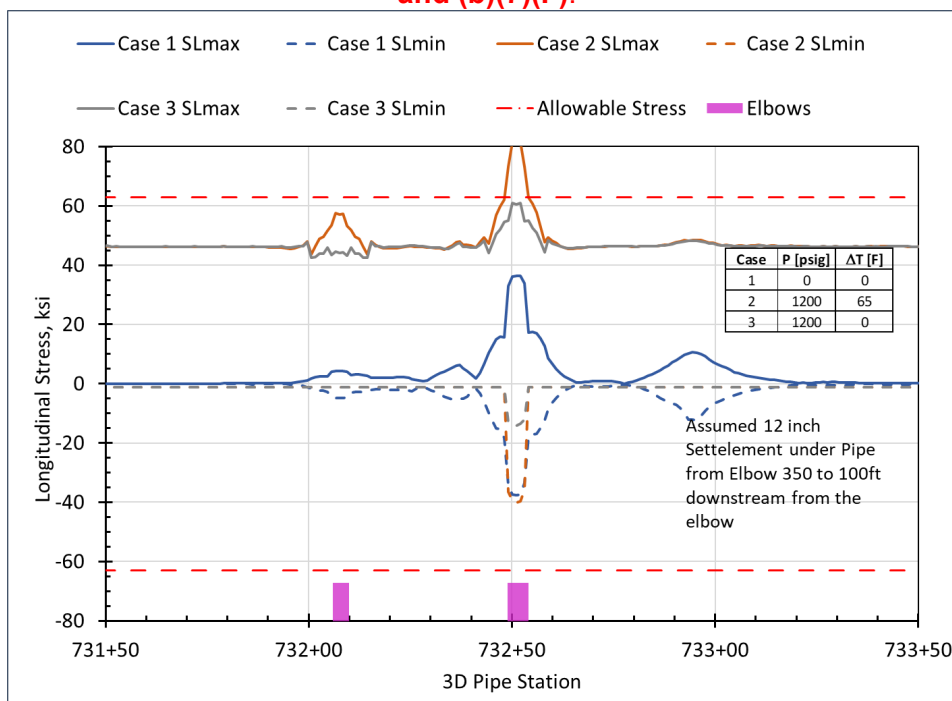
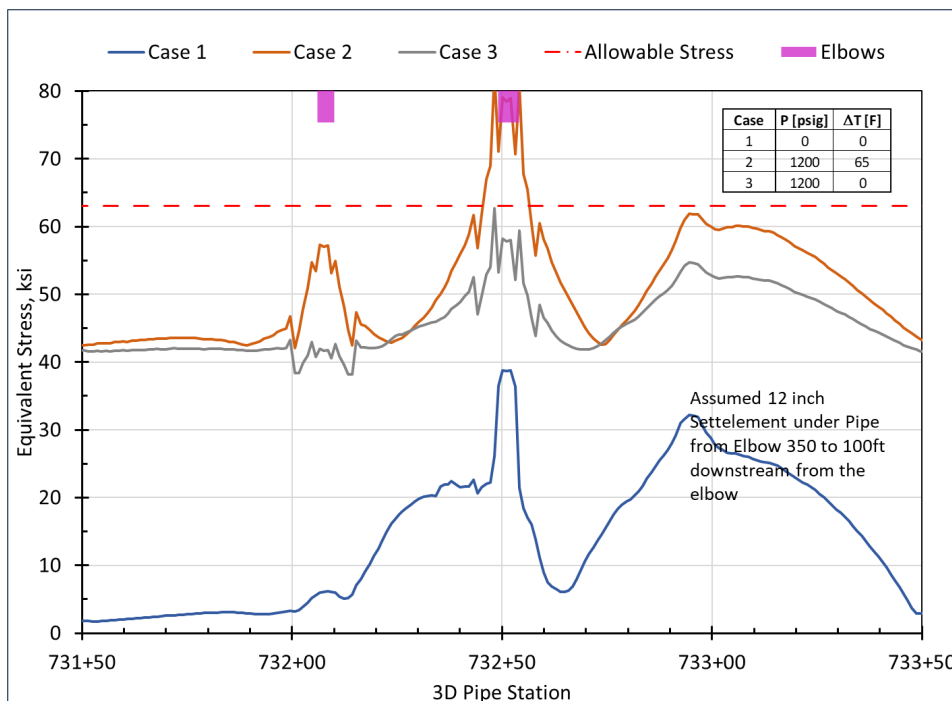
Figure D.30. FEA Longitudinal Stresses for Post Construction Analysis with Ground Settlement Only

Figure D.31. FEA von Mises Stresses for Post Construction Analysis with Ground Settlement Only

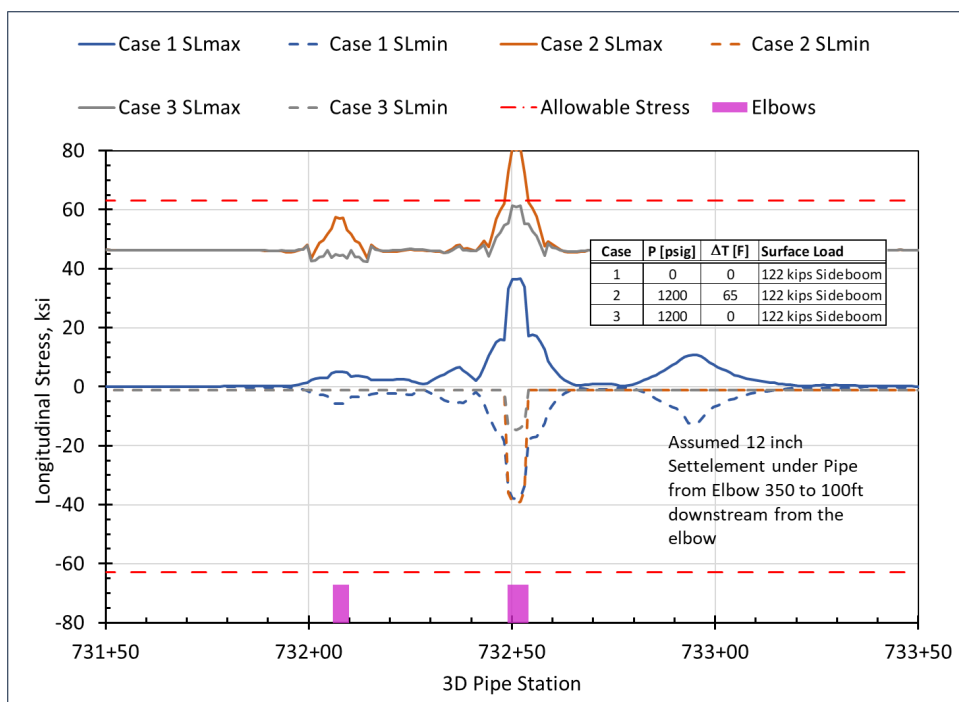
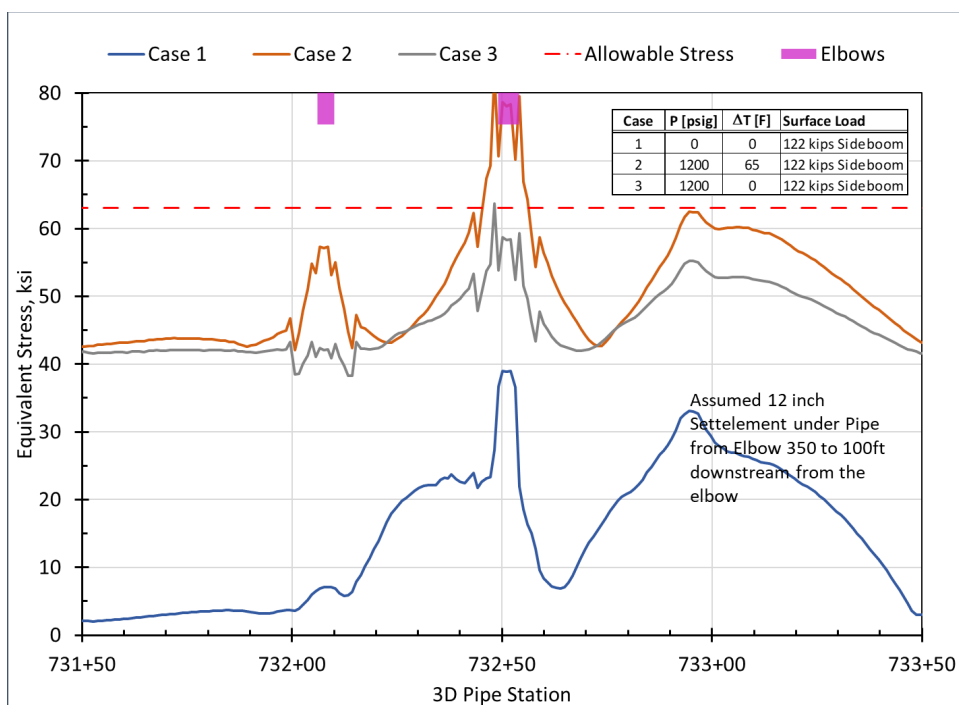
Figure D.32. FEA Longitudinal Stresses for Post Construction Analysis with Ground Settlement and Side Boom Load

Figure D.33. FEA von Mises Stresses for Post Construction Analysis with Ground Settlement and Side Boom Load

The post-construction settlement or gap under the pipeline can explain the out-of-roundness of the elbow. However, this scenario does not explain the wrinkle as the amount of compressive stress at the elbow is not excessive (Figure D.28, Figure D.30 and Figure D.32). In order for ground settlement to cause a wrinkle, the amount of movement should be around 24-inches or more. It is also possible that the wrinkle was formed at a later time due to thermal cycles or ground movement, but that would require two independent coincidences both affecting the same location of the pipeline at different times, which although is possible it decreases the overall likelihood of the scenario. In addition, the bending strain analysis from the IMU data and assessments by Geotech SMEs did not find evidence of significant ground movement near the TAG 98 elbow.

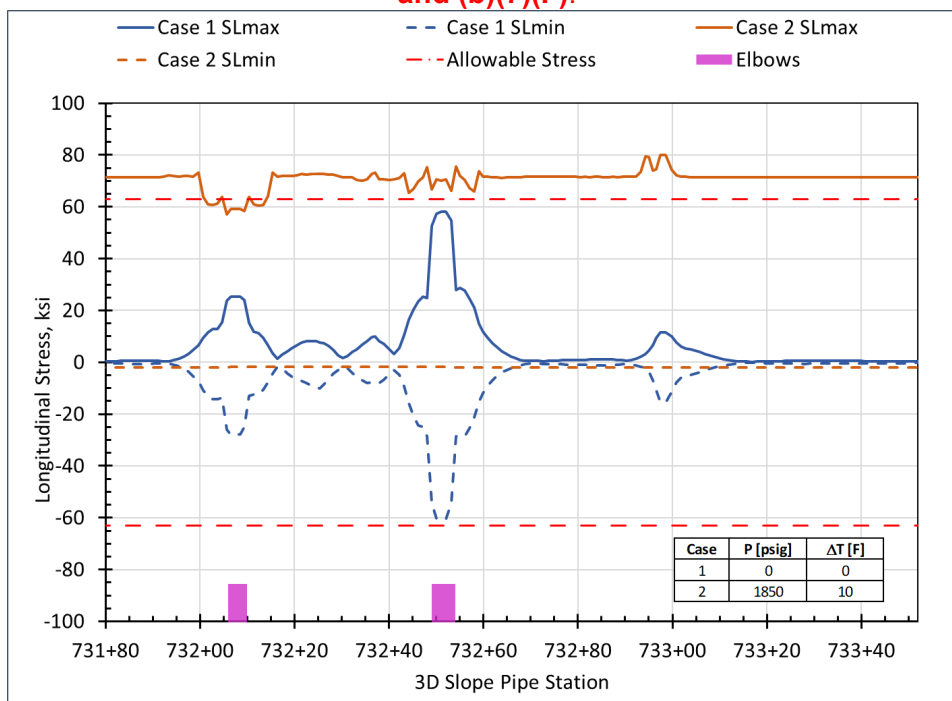
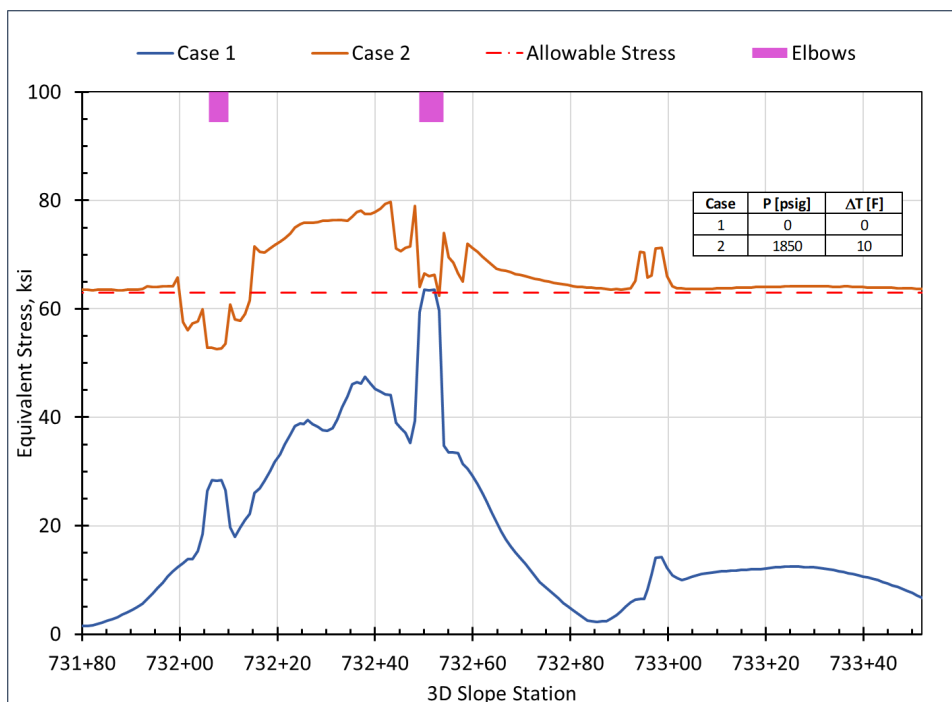
Figure D.36 for the equivalent stresses. The results show that cantilever action could have overstressed the TAG 98 (BND 350) elbow if the end deflection was at least 6-ft. This amount of end deflection is excessive and could only happen if the pipe length on the south slope was supported above ground before the hydrostatic test and then lost the support after it was filled with water. This type of movement would have been noticeable by construction crews and most likely would have resulted in a safety standdown (which there is no evidence of in the daily inspection reports).

Figure D.35. FEA Longitudinal Stresses with 6-ft End Deflection

Figure D.36. FEA von Mises Stresses with 6-ft End Deflection

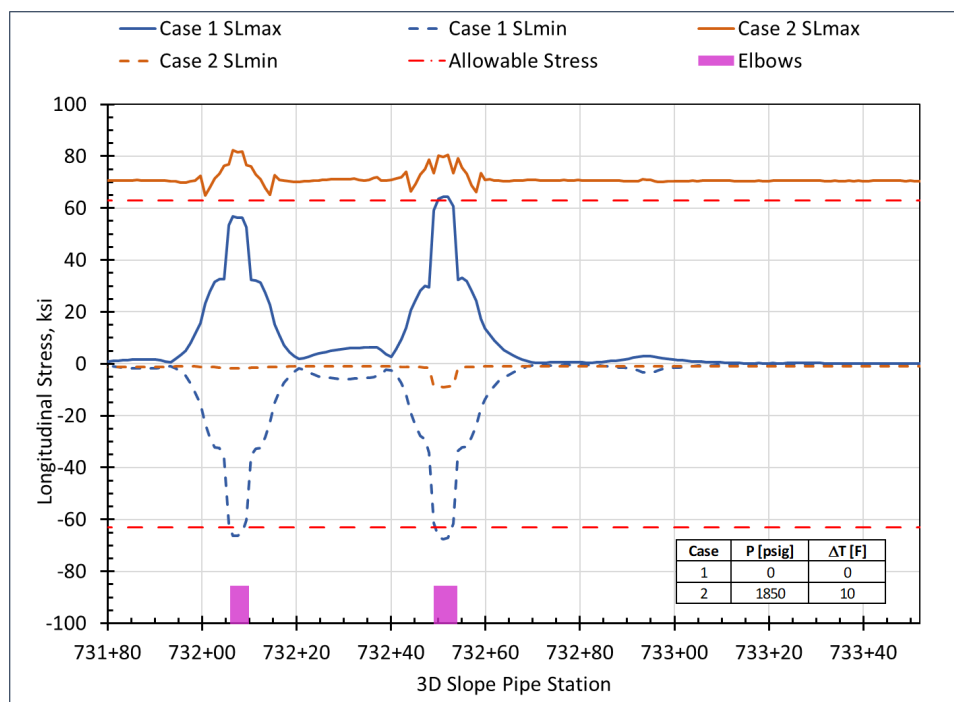
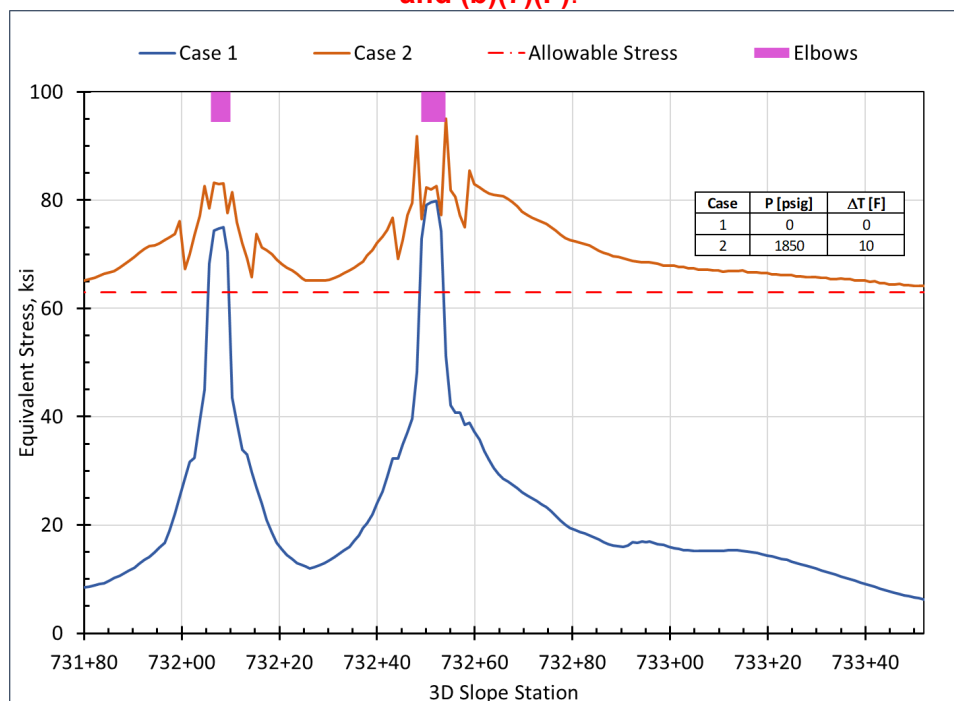
A sliding displacement of 6-inches in the downhill direction was applied to the end of the cantilever length and the model was run to calculate stresses. The results of this analysis are shown in Figure D.38 and Figure D.39. The results show that sliding of the pipeline down the slope can also create excessive bending stress at the elbow, however, the weight of the pipe filled with hydrostatic water is insufficient to cause the sliding. In other words, some outside loading had to act on the pipeline to force it to slide.

Figure D.38. FEA Longitudinal Stresses with 6-inches of Sliding

Figure D.39. FEA von Mises Stresses with 6-inches of Sliding
