TC Oil

RCFA for the Keystone Milepost 14 Release

April 21, 2023

Final Report

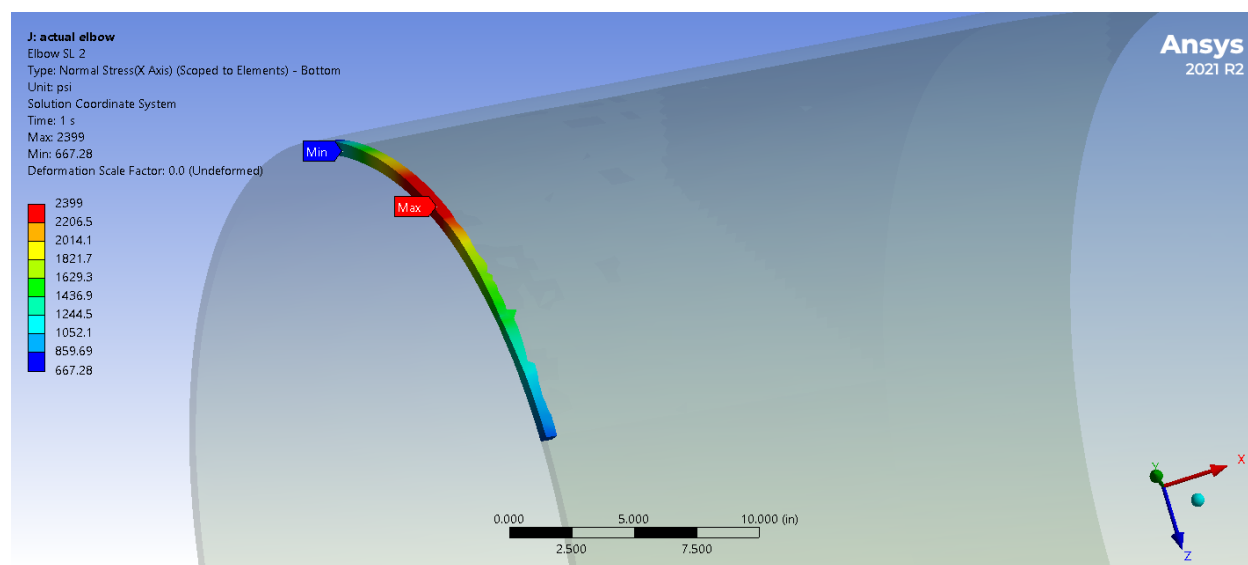
The wall thickness transition and geometrical features of the subject elbow, including the wrinkle and ovality, are expected to have caused stress concentration at the girth-weld, intensifying the stress ranges calculated in the previous section. Three sources for the SCF were identified after reviewing Anderson's metallurgical report, the laser scanner STL files, and other information including elbow out-of-roundness, wall thickness transition, and weld hi-lo. The three-dimensional (3D) shell model described under Section D.3 'Shell Model' was used to calculate the SCF associated with elbow out-of-roundness. This was achieved by applying a uniform bending moment to the end of the model (the end closer to the subject girth-weld), fixing the other end, and solving the model to calculate longitudinal stresses around the girth-weld. The highest tensile stress from this analysis was calculated as 2,399 psi (Figure D.44)¹⁵⁷. Then another shell model was built with similar dimensions and wall thickness values to the actual elbow model but with ideal geometry (i.e., a perfectly circular cross-section). The ideal elbow model was analyzed under the same boundary conditions to calculate the longitudinal stresses at the girth weld. The highest tensile stress from this model was calculated as 2,199 psi (Figure D.45). The ratio of these two stresses is the SCF due to out-of-roundness¹⁵⁸:

Figure D.44. FEA Longitudinal Stresses at the Hot-Spot of the Subject Girth-Weld Under a Uniform Bending Moment of 1×10^6 ft-lb – Actual Elbow with Out-of-Roundness

¹⁵⁸ The SCF for out-of-roundness was calculated using the actual elbow geometry from the 3D laser scan data measured at Anderson post-incident. The ovality was larger when measured in the field in 2013 and likely relaxed when the failure occurred as well as when the pipe was cut-out for metallurgical analyses. Therefore, the SCF for out-of-roundness prior to failure was likely higher than the SCF calculated by the FEA.

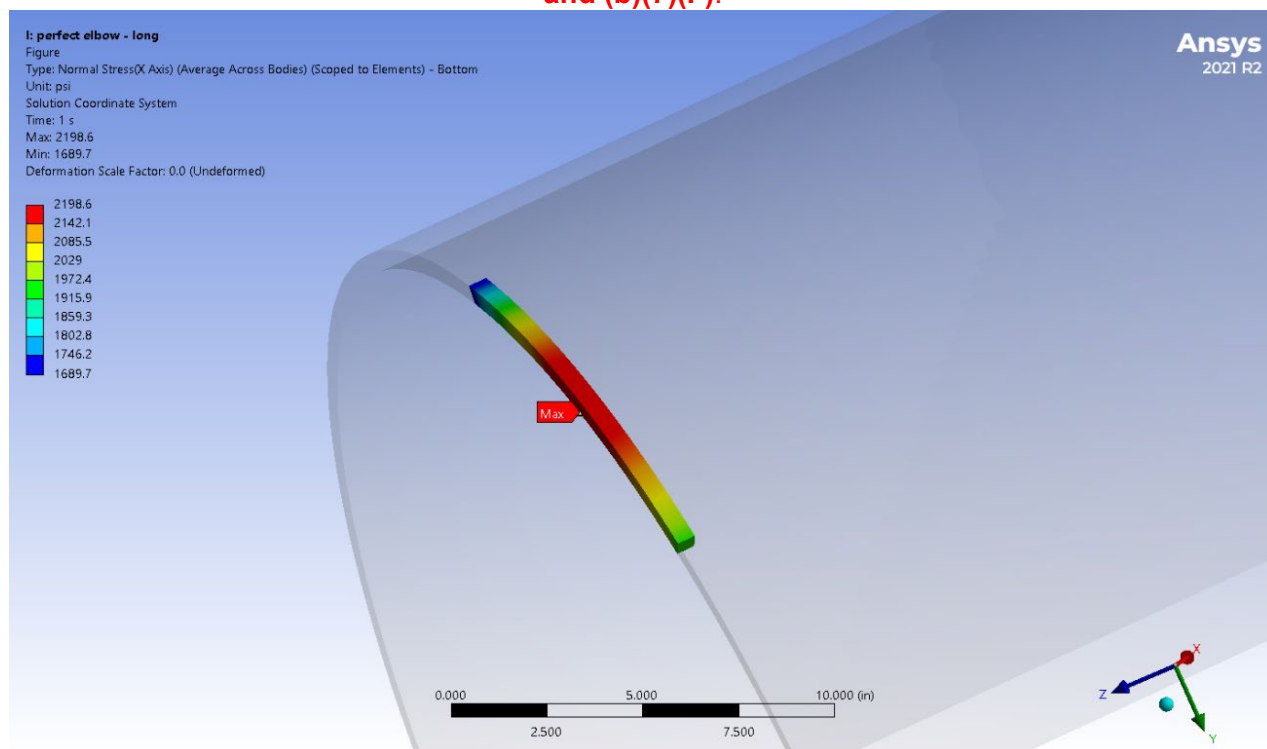
Figure D.45. FEA Longitudinal Stresses at the Hot-Spot of the Subject Girth-Weld Under a Uniform Bending Moment of 1×10^6 ft-lb – Idealized Elbow Geometry

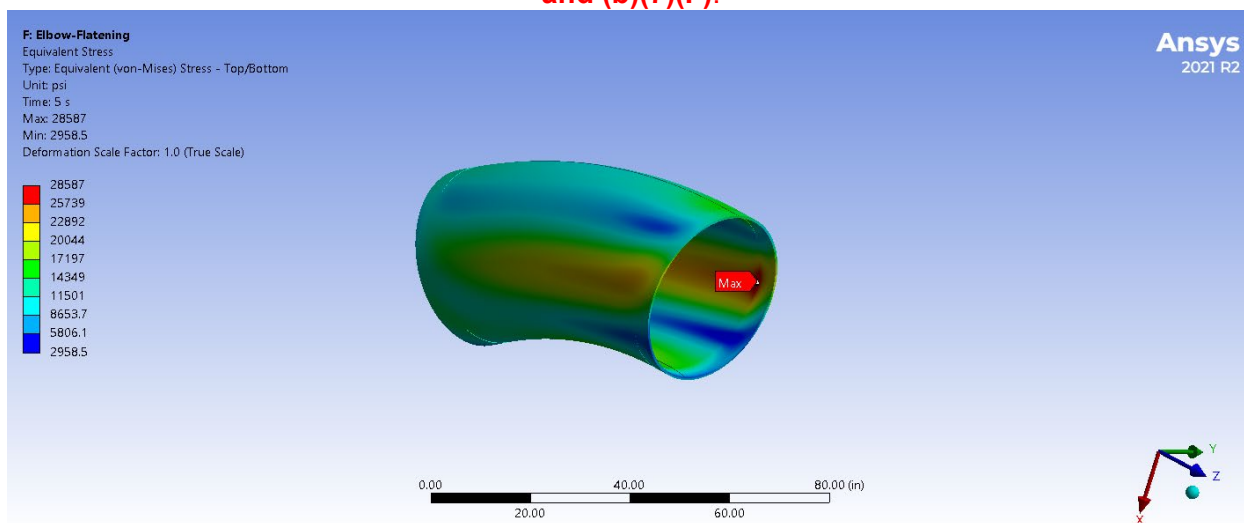
The results show a maximum von Mises stress of 28.6 ksi in the elbow (Figure D.52), which is insufficient to cause plastic deformations. In conclusion, typical construction equipment would not be able to exert pressures and forces high enough to cause permanent deformation of the elbow.

Figure D.52. Calculated von Mises Stress in the Elbow under a Concentrated Load of 100,000 lbf.
