Date: 6 January 2023
From: **Redacted by TC Energy**
To: **File**
CC: **Redacted by TC Energy**
RE: STL CB MP14 Review of Prior ILI Results
Revision: 0

The purpose of this memo is to document the review of prior in-line inspection (ILI) results following the MP 14 incident as per CPF No. 3-2022-074-CAO (“CAO”), Required Correction Action number 3 – Review of Prior ILI Results.

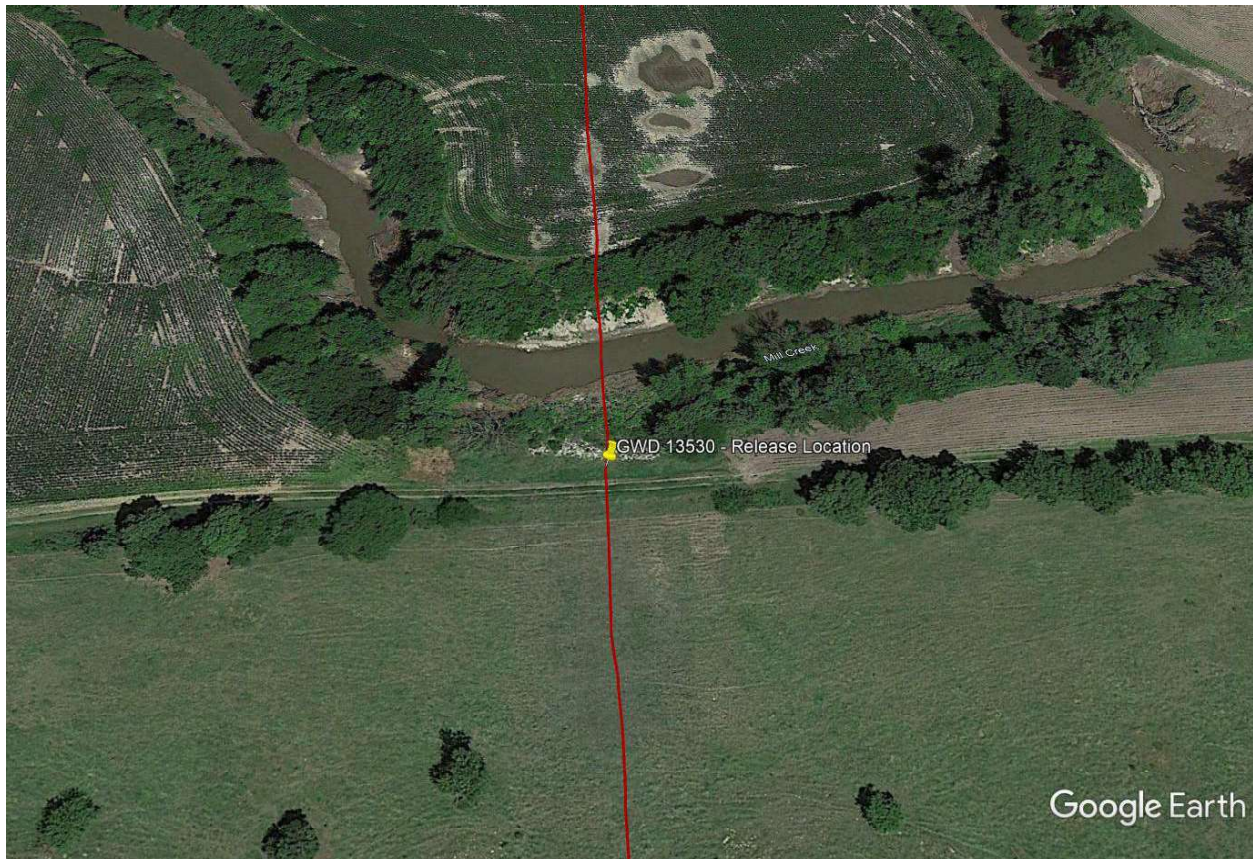
Figure 1: Overview Image of Release Location

On December 7, 2022, TC Energy experienced an accident on the NPS 36 Keystone Pipeline south of the Steele City pump station at MP 14 in Washington County, KS. There was no ignition, no fatalities and no injuries reported as a result of the failure. An approximate location of the release point is shown in Figure 1. The release was approximately 100 ft downstream of the Mill Creek 3 crossing.
