U.S. Department of Transportation

Office of Pipeline Safety – Accident Investigation Division

# Failure Investigation Report Marathon Pipe Line, LLC.

Natural Gasoline Release – Girth Weld Failure

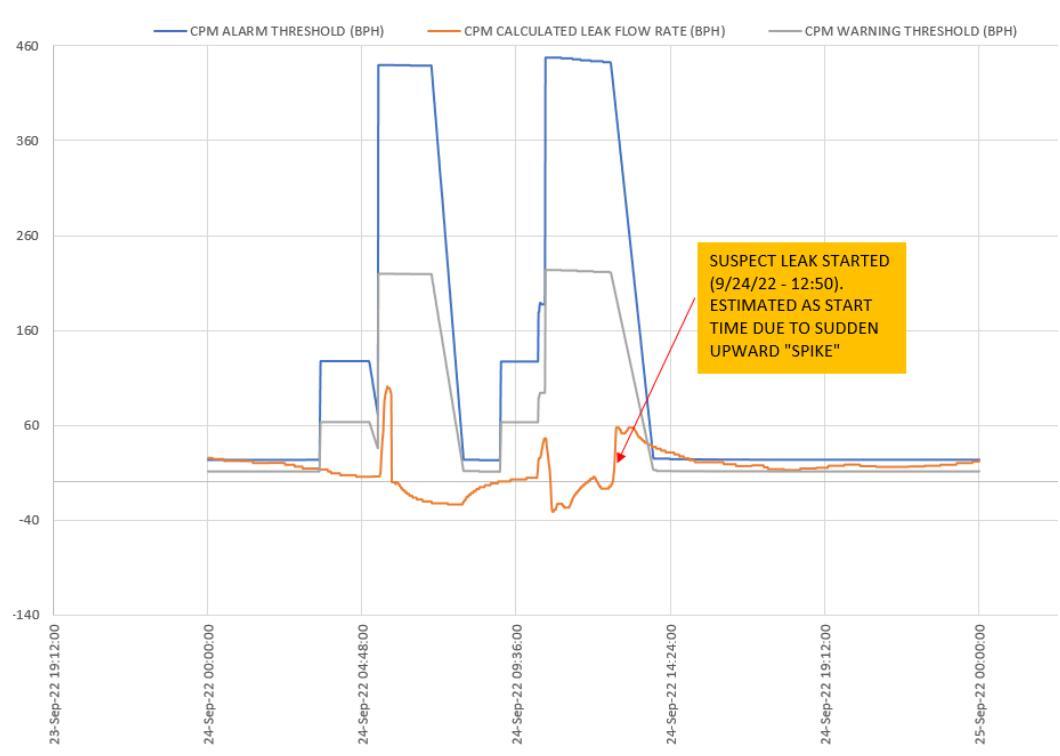
Marathon indicated that the SCADA information was reviewed after the accident and it is determined that the leak began at 1:50 p.m. on September 24, 2022, based on a sudden upward spike in CPM calculated leak flow rate (barrels per hour). Refer to **Figure 7**.

Figure 7. CPM Leak Flow Rate (bph), from Marathon.<sup>9</sup>

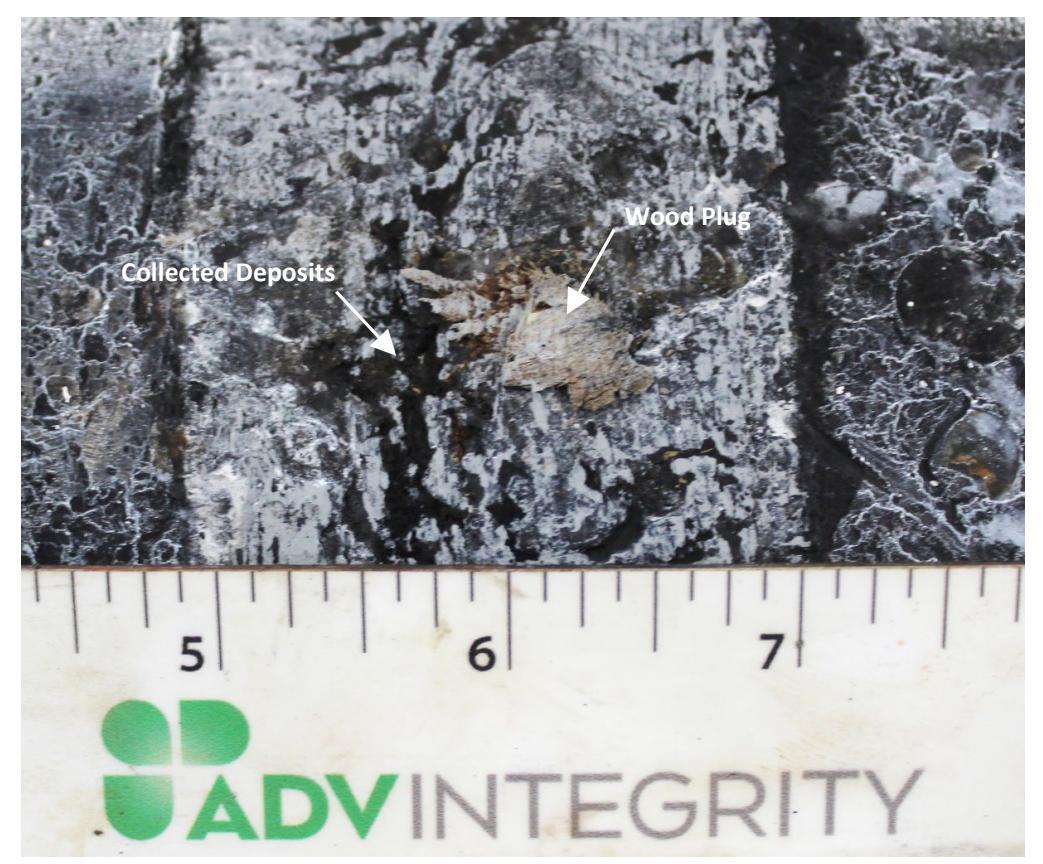
Figure 2-7: Photograph of wood plug present. Numbered scale divisions are inches.

- Black deposits adjacent to the leak, shown in Figure 2-7
- Fine white deposits present adjacent to the girth weld, shown in Figure 2-8
- Larger white deposits present adjacent to the girth weld, shown in Figure 2-9

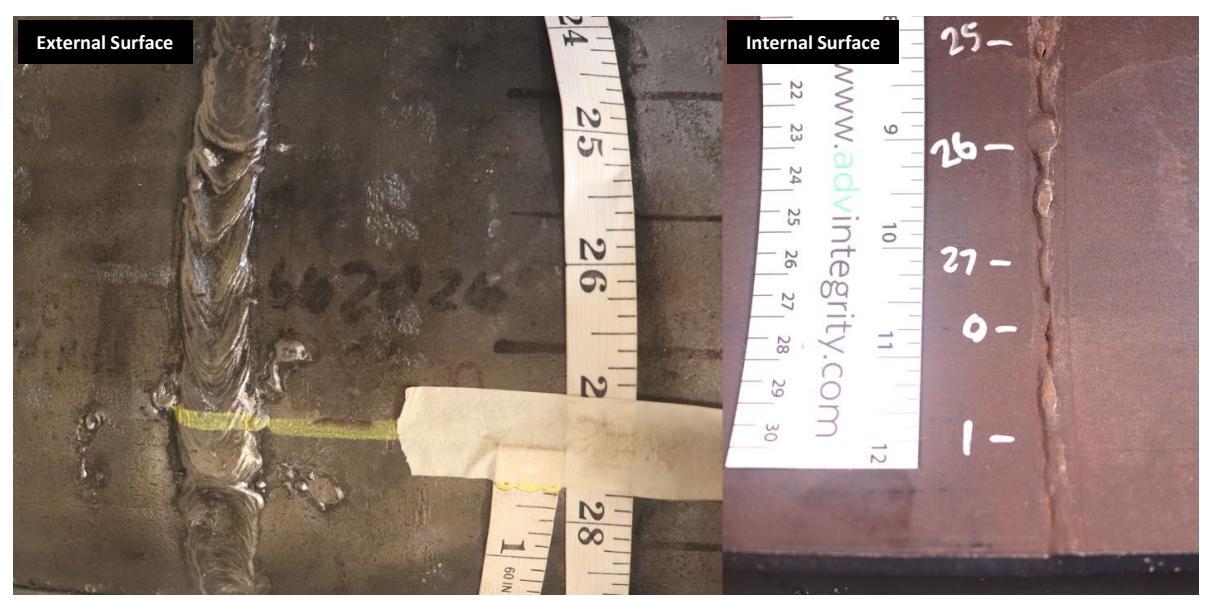
- External weld cap concavity (such as Figure 4-2)
- External weld repairs (such as Figure 4-3)
- External arc burns (such as Figure 4-2)
- Internal weld suckback and burnthroughs (such as Figure 4-3 and Figure 4-5)
- Internal weld undercut (such as Figure 4-6)
- Internal weld incomplete penetration (such as Figure 4-6)

Figure 4-2: Photograph of external (left) and internal (right) weld surface. Numbered scale divisions are inches.

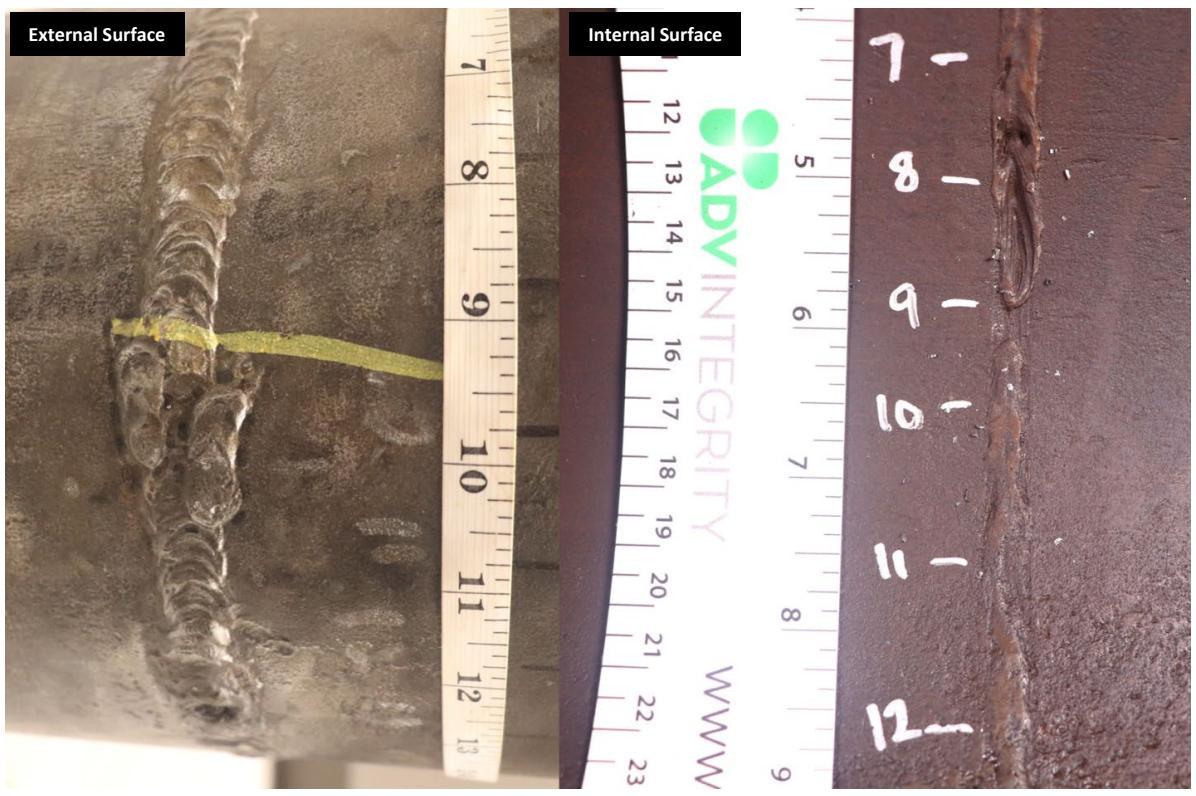
Figure 4-3: Photograph of external (left) and internal (right) weld surface. Numbered scale divisions are inches.

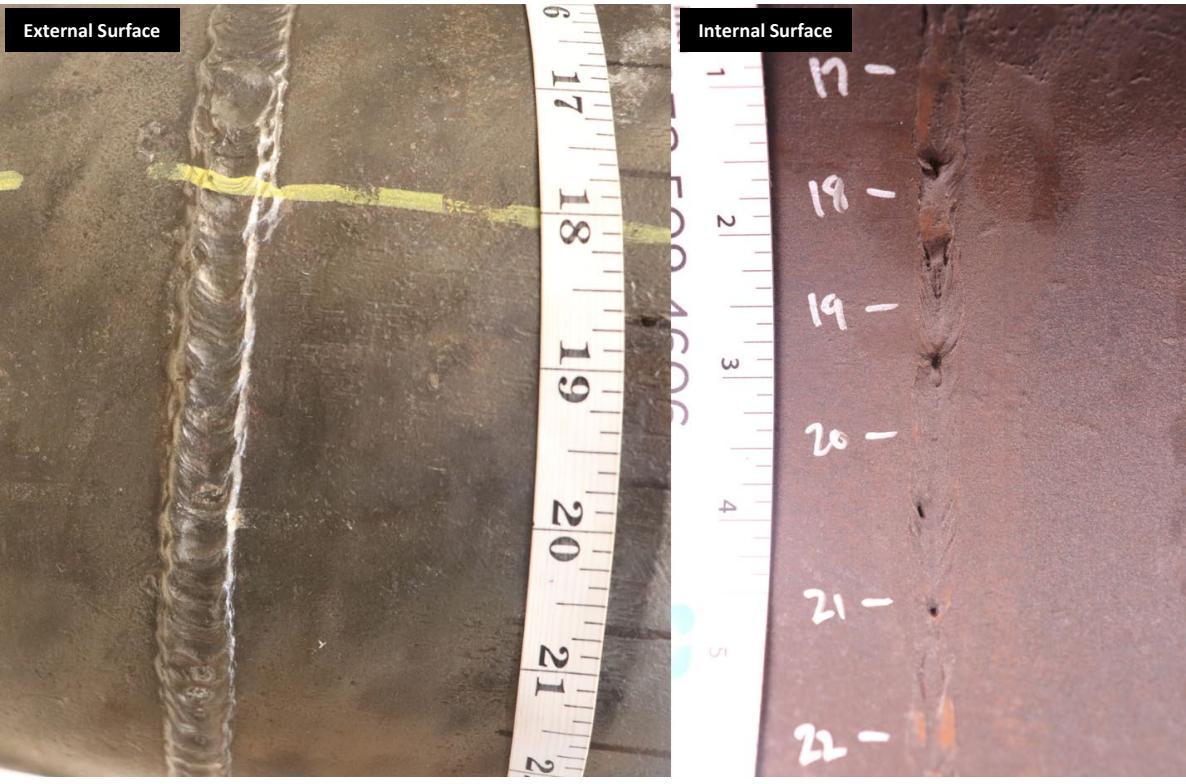
Figure 4-5: Photograph of external (left) and internal (right) weld surface. Numbered scale divisions are inches.

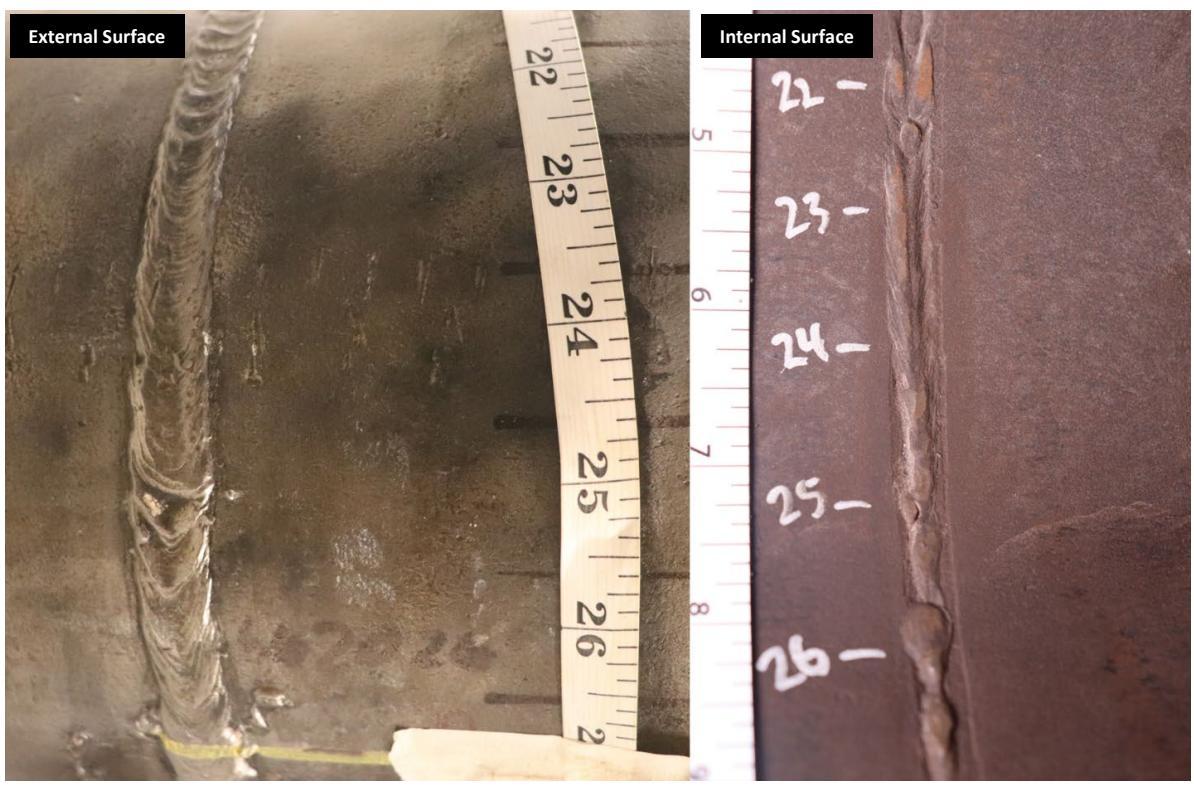
Figure 4-6: Photograph of external (left) and internal (right) weld surface. Numbered scale divisions are inches.

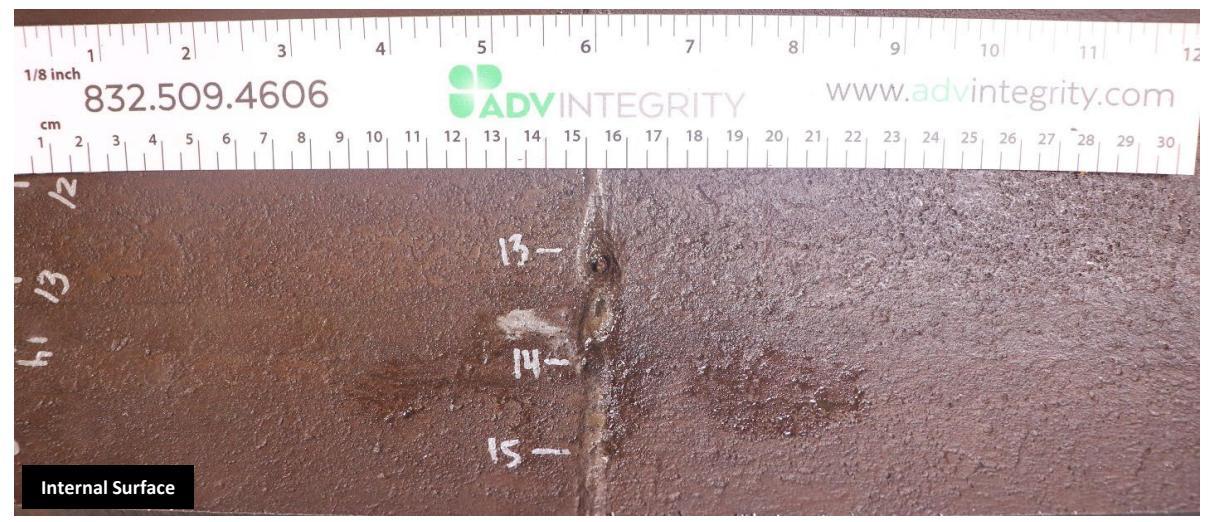
The leak was identified just adjacent to the external cap tie in between the passes on either side of the pipe. The internal pipe surface contained a region of minor internal corrosion along the bottom of the pipe, approximately 5:00 o'clock to 7:00 o'clock (inch mark 11-17), shown in Figure 4-7. No deposits were collected from the internal pipe surface as there was insufficient present for examination. The external and internal pipe surface around the leak is shown in Figure 4-8. The internal surface contained a teardrop-like area of wall loss at the identified leak.

Figure 4-7: Photograph of the internal pipe surface. Upper numbered scale divisions are inches.

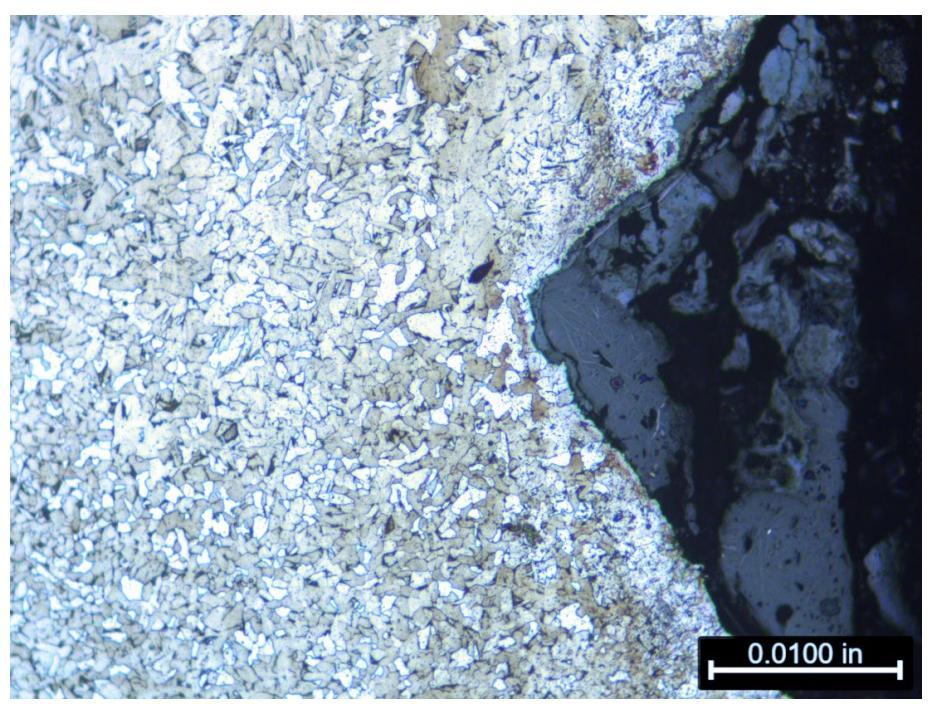
Figure 5-2: Photomicrograph along leak's cross section. Etchant is 2% Nital; original magnification is 100x.

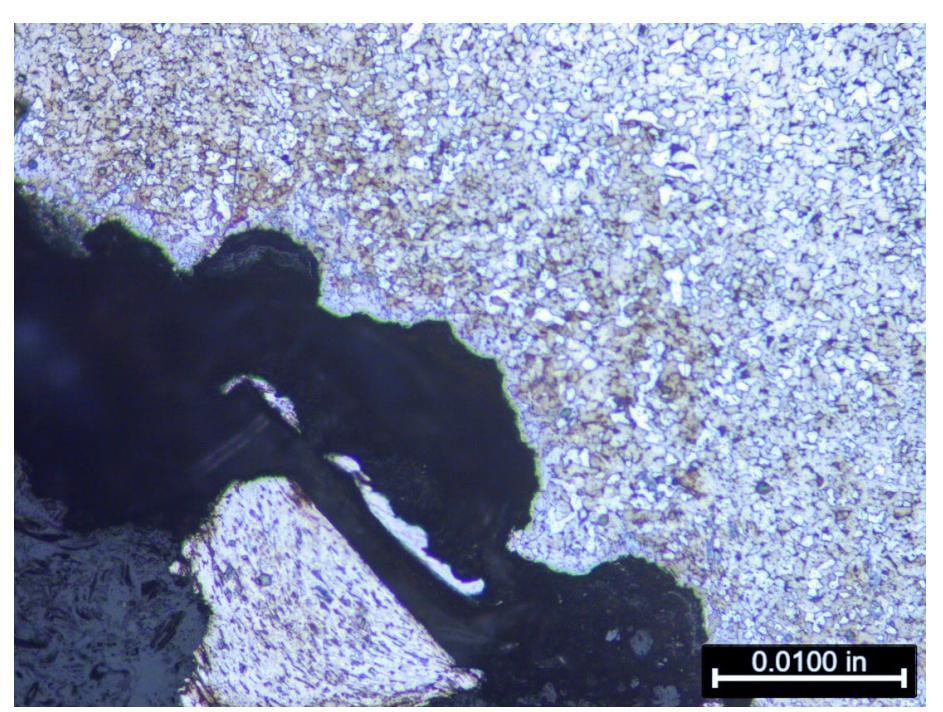
Figure 5-3: Photomicrograph along leak's cross section. Etchant is 2% Nital; original magnification is 100x.

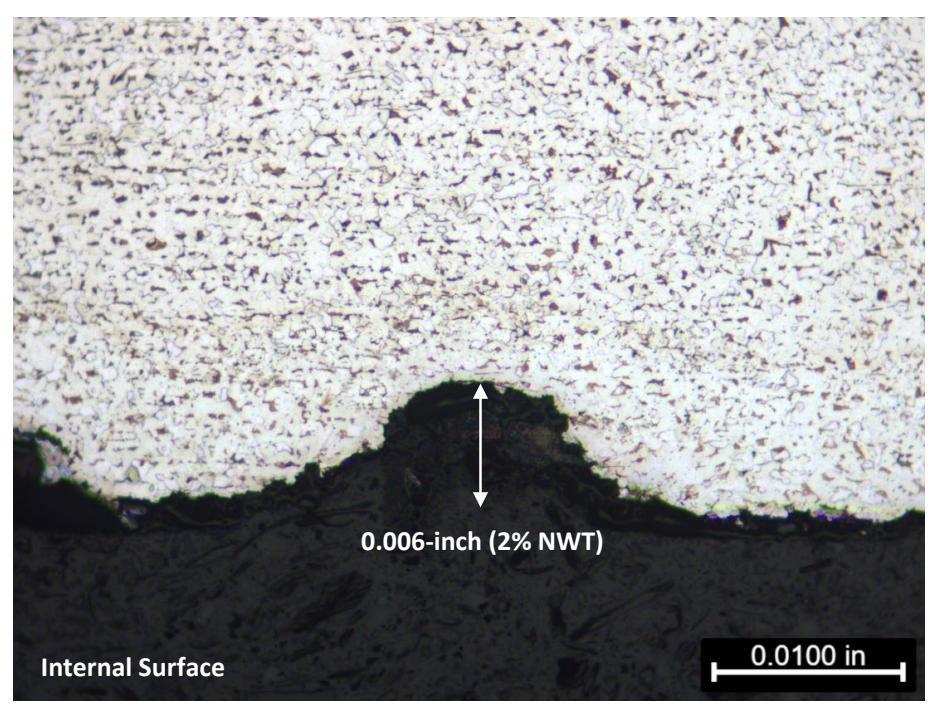
Figure 5-4: Photomicrograph along internal pipe surface adjacent to the leak. Etchant is 2% Nital; original magnification is 100x.

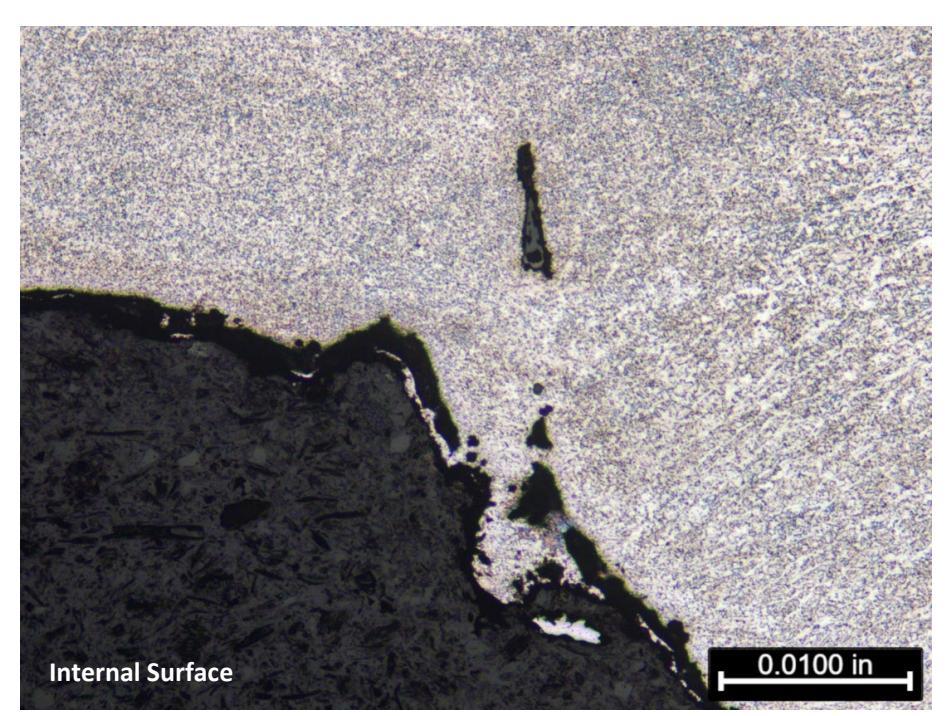
Figure 5-8: Photomicrograph of internal surface connected weld feature. Etchant is 2% Nital; original magnification is 100x.

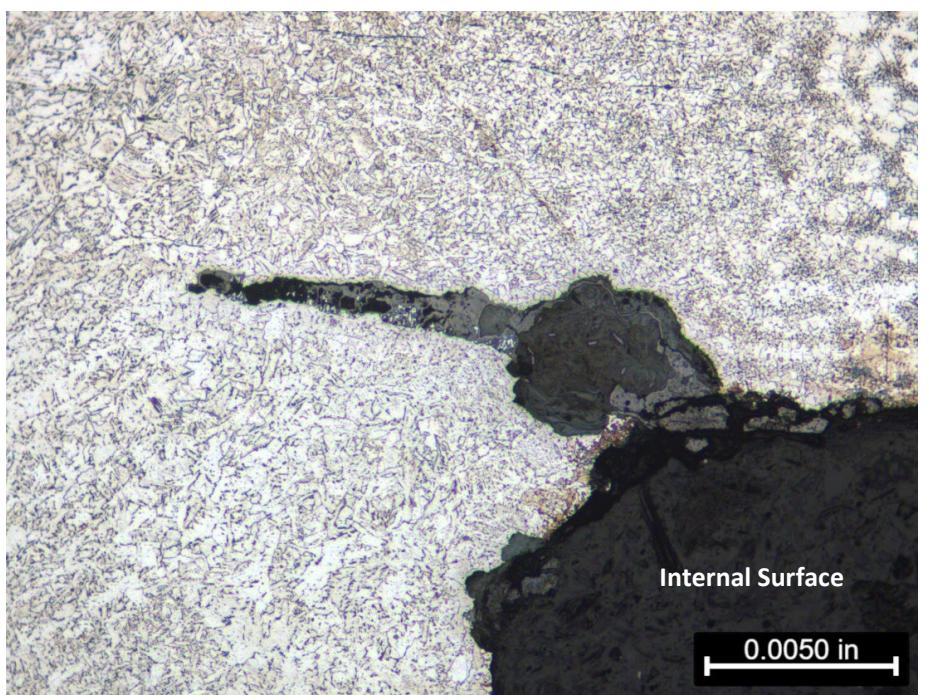
Figure 5-9: Photomicrograph of internal surface connected weld feature. Etchant is 2% Nital; original magnification is 200x.

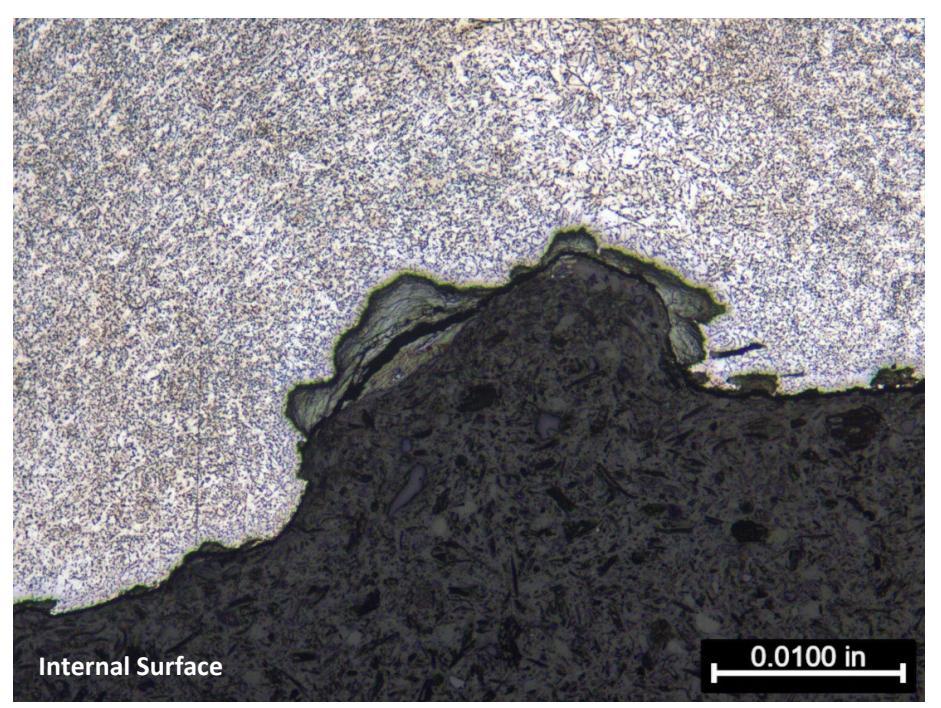
Figure 5-12: Photomicrograph of internal surface connected weld feature. Etchant is 2% Nital; original magnification is 100x.

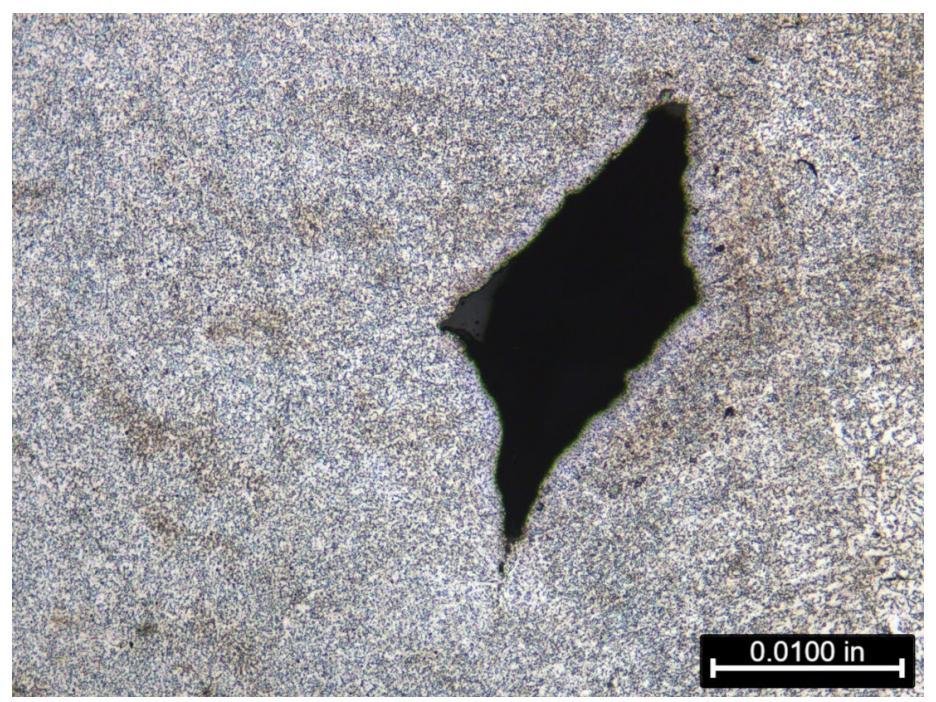
Figure 5-13: Photomicrograph of volumetric feature present within weld metal. Etchant is 2% Nital; original magnification is 100x.

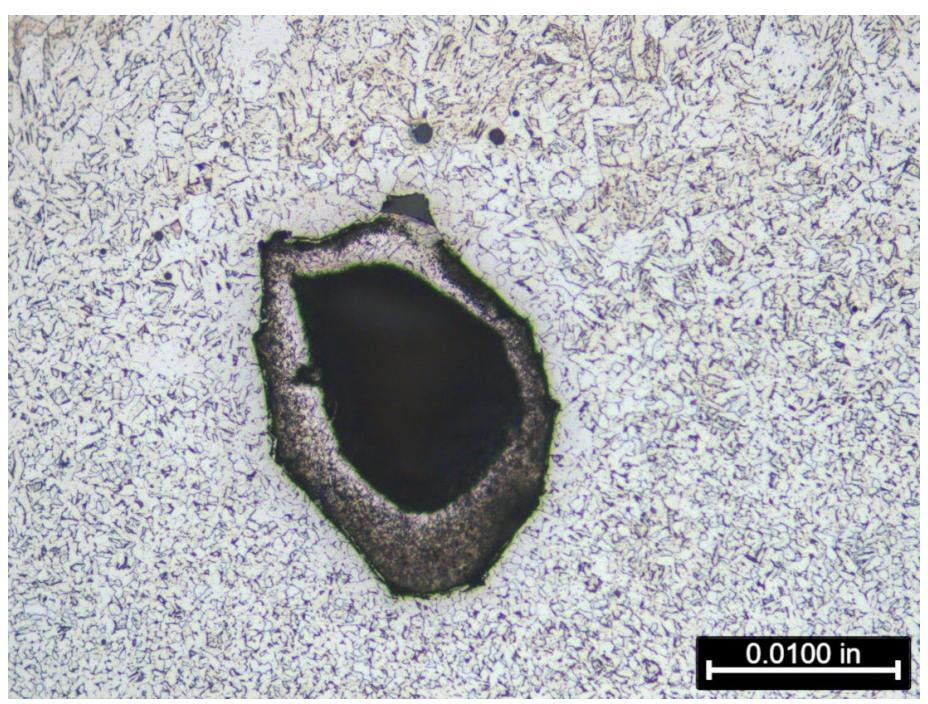
Figure 5-16: Photomicrograph of volumetric feature present within weld metal. Etchant is 2% Nital; original magnification is 100x.

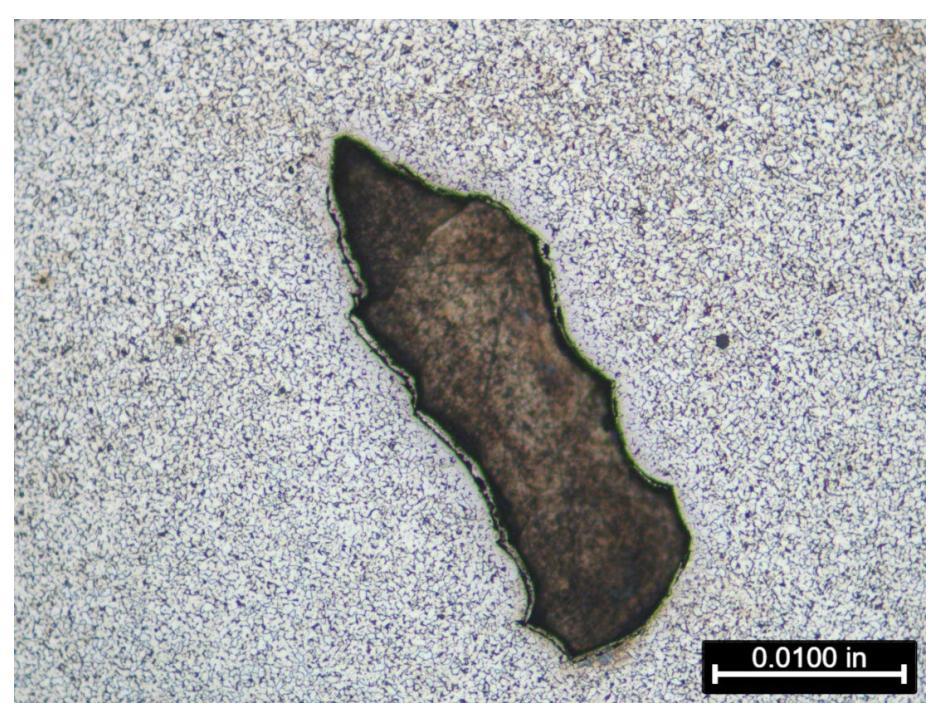
Figure 5-17: Photomicrograph of volumetric feature present within weld metal. Etchant is 2% Nital; original magnification is 100x.

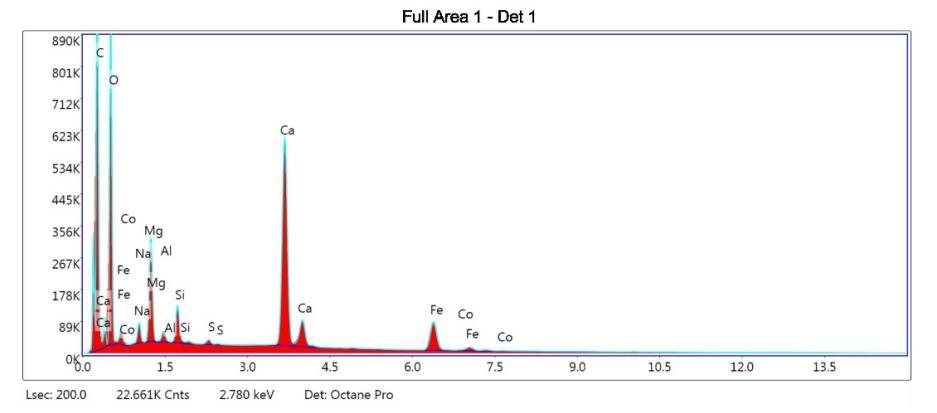
Project: M22-337 Client: ADV Integrity Contact: David Futch Payment: PO#2022-1830 Sample ID: M22-337-02 Sample Description: Black Gritty powder, ID: Deposits On Pipe

Element	Weight %	Atomic %	Error %	
СК	31.16	46.65	6.95	
ОК	32.42	36.43	9.18	
NaK	1.11	0.86	7.39	
MgK	3.92	2.90	5.50	
AIK	0.35	0.23	6.10	
SiK	1.23	0.79	3.58	
SK	0.20	0.11	3.44	
CaK	19.72	8.85	1.76	
FeK	9.70	3.12	2.59	
CoK	0.18	0.06	19.19

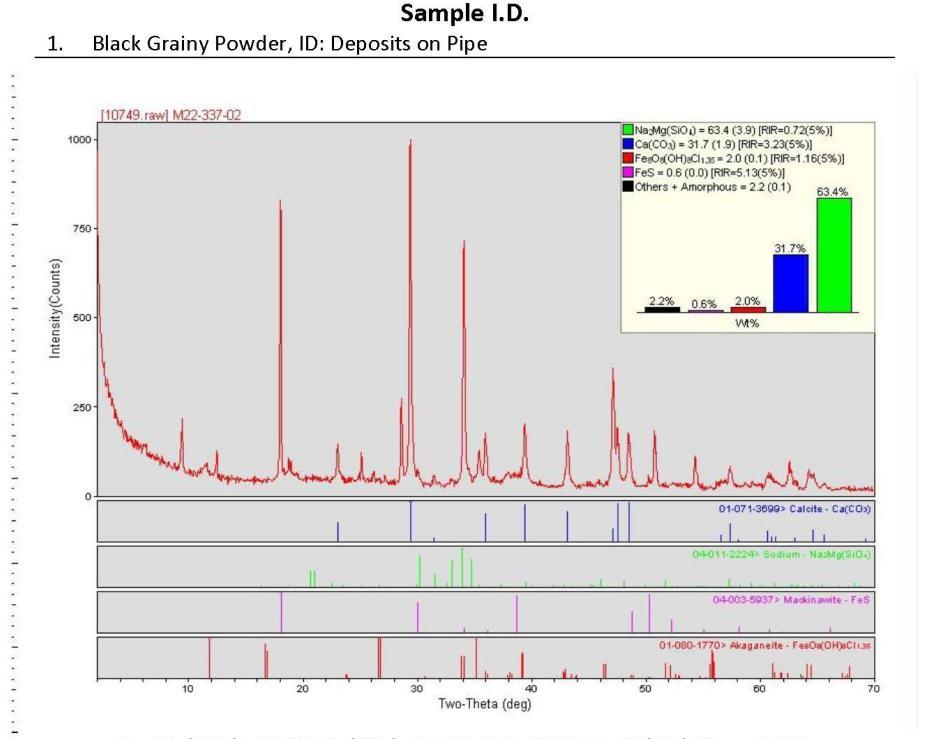
Client:	ADV Integrity	EPI MTG Job#:	M22-337
Contact:	David Futch	Lab Ref:	M22-337-02
PO #:	2022-1830	Date:	November 22, 2022

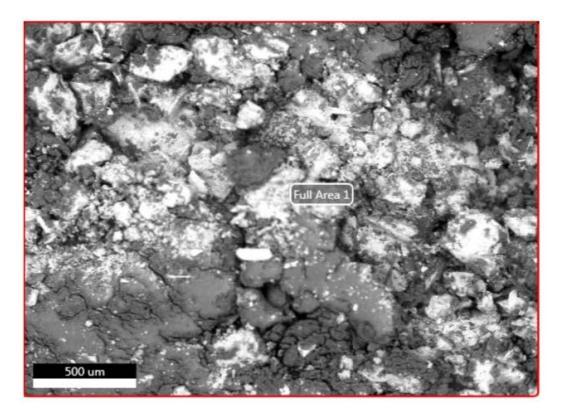
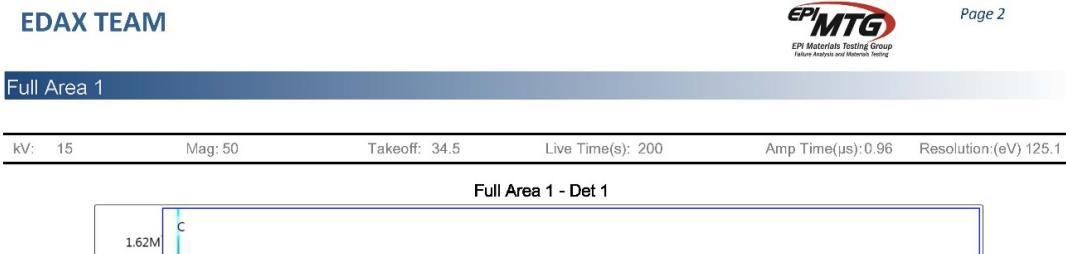
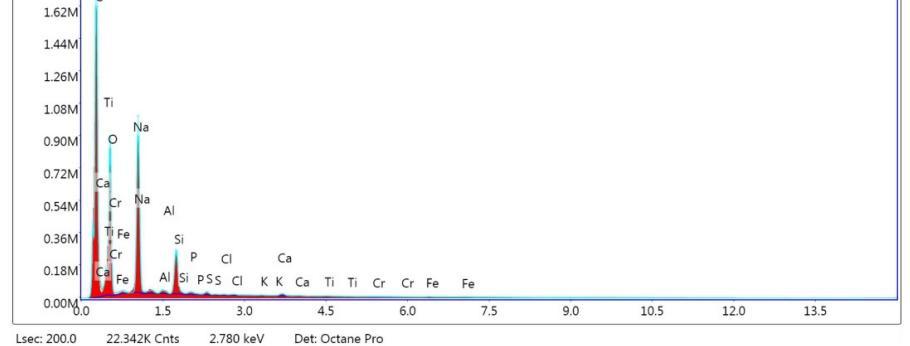
Project: M22-337 Client: ADV Integrity Contact: David Futch Payment: PO#2022-1830 Sample ID: M22-337-01 Sample Description: White chalky powder, ID: White Deposit

Element	Weight %	Atomic %	Error %	
СК	53.19	63.52	6.84	
ОК	28.92	25.92	8.94	
NaK	13.94	8.70	5.55	
AIK	0.19	0.10	6.73	
SiK	2.66	1.36	3.00	
ΡK	0.11	0.05	11.56	
SK	0.21	0.10	3.50	
CIK	0.04	0.02	8.47	
ΚК	0.05	0.02	12.93	
CaK	0.36	0.13	3.45	
TiK	0.07	0.02	12.39	
CrK	0.05	0.01	17.65	
FeK	0.20	0.05	9.13

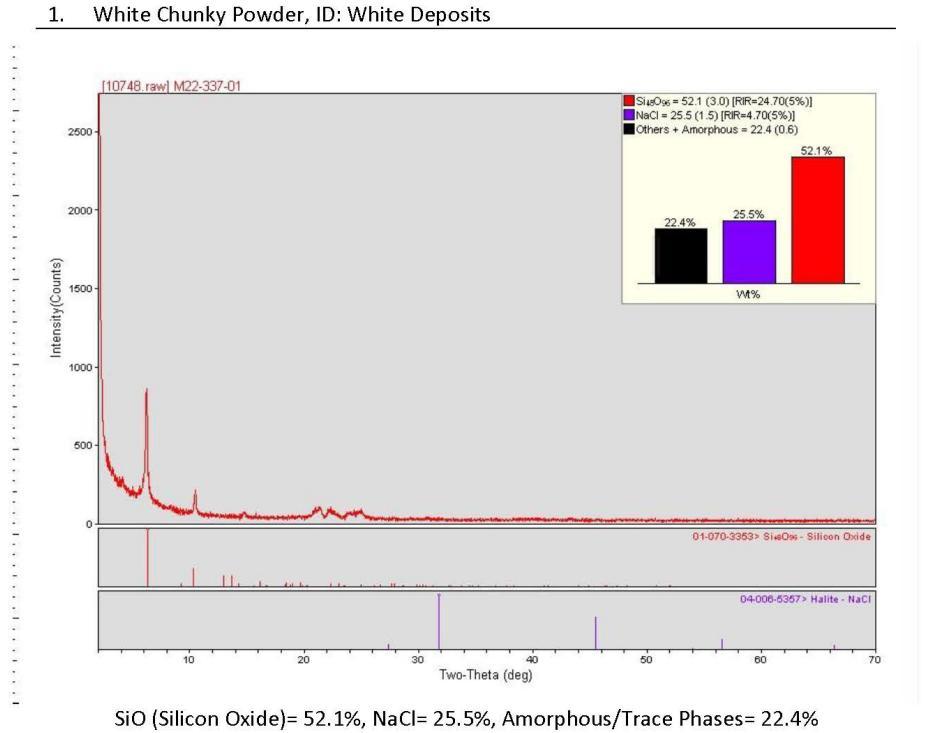
Client:	ADV Integrity	EPI MTG Job#:	M22-337
Contact:	David Futch	Lab Ref:	M22-337-01
PO #:	2022-1830	Date:	November 22, 2022
