CONSULTING METALLURGICAL ENGINEERS AND TESTING LABORATORY

Re: 250145 South Bow - Metallurgical Analysis of NPS-30 MP-171 Pipeline Incident

Pursuant to your request, this report details the findings of the metallurgical investigation of the Keystone Pipeline rupture near MP-171 near Fort Ransom, North Dakota.

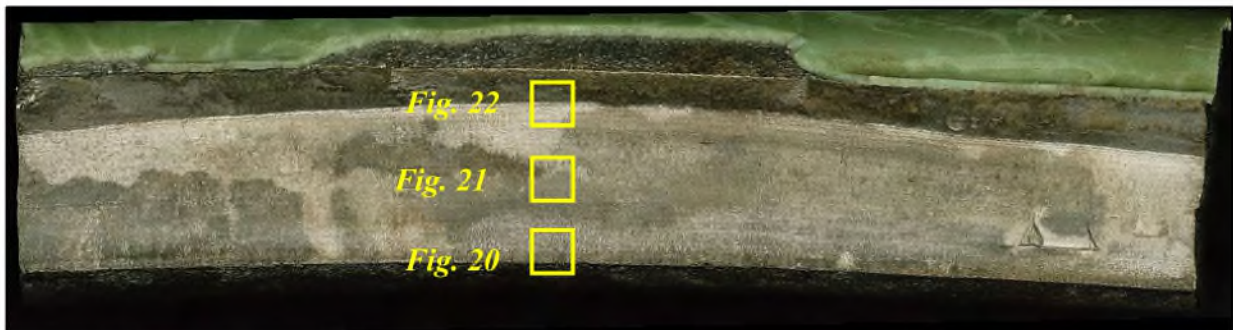
Following the EDS examination of the surface of SEM-1, the section was cleaned using a combination of a dilute 2% Alconox solution and an ultrasonic bath. The purpose of the cleaning was to remove any residual hydrocarbon residue and debris that would obscure a direct observation of the fractured surface. Various regions of each sample were examined as shown in Figure 19, beginning with the crack initiation along the ID toe of the weld. As shown in Figure 20, radially oriented ratchet marks identifying multiple fatigue crack initiation points were observed. Some, but not all of the ratchet marks coincided with micro-pitting along the ID surface. Overall, the micro-pits exhibited hemispherical morphologies. The approximate depth the micro-pit shown in Figure 20b was less than 100 μ m in depth, or approximately the diameter of a human hair. Fractographic examination of the other two sections of the fracture exhibited identical fracture morphologies.

Figure 19 – Low magnification view of SEM-1 post-cleaning showing the locations examined in the associated Figures.

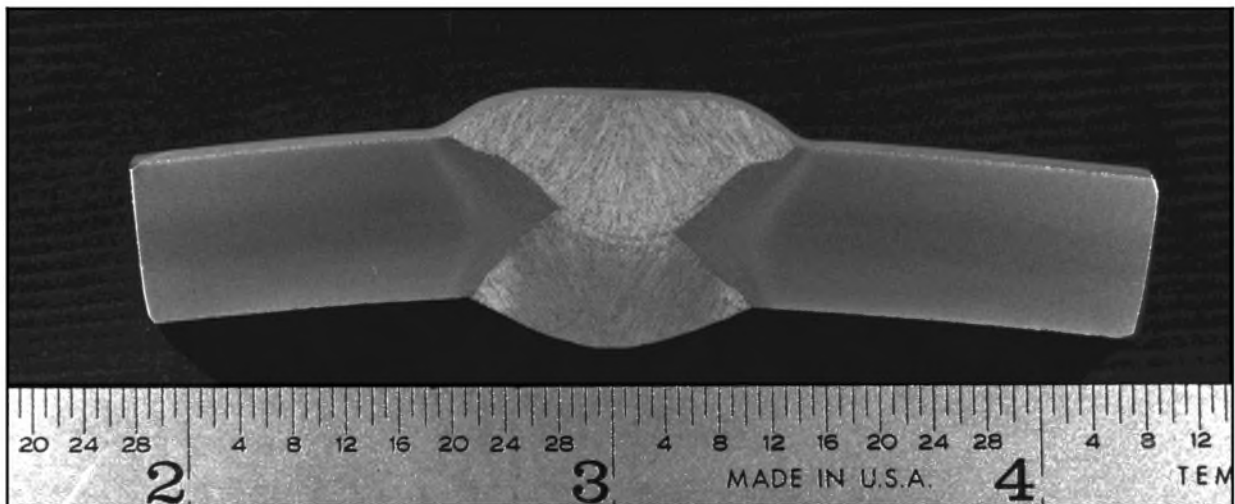
It was assessed that the pipe was a double submerged arc weld (DSAW) construction, having been welded initially from the inner diameter (ID) and secondly from the outer diameter (OD). Each section was individually evaluated and each was found to be of good quality, showing no evidence of lack-of-fusion, cracking, porosity, or non-metallic inclusions. It was noted that there was significant (~3.8mm) weld misalignment between the centerlines of the ID and OD weld deposits on the failed joint, however there was complete fusion present.

Figure 30 – Metallographically prepared Upstream Joint macro section.

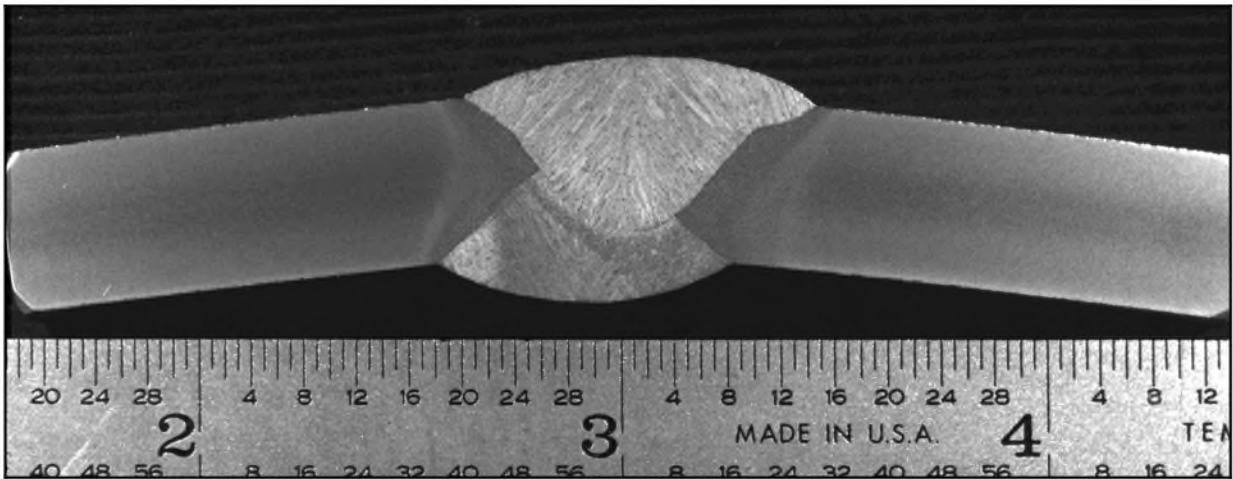
Figure 31 – Metallographically prepared transverse seam weld macro removed from the failed joint upstream of the rupture.

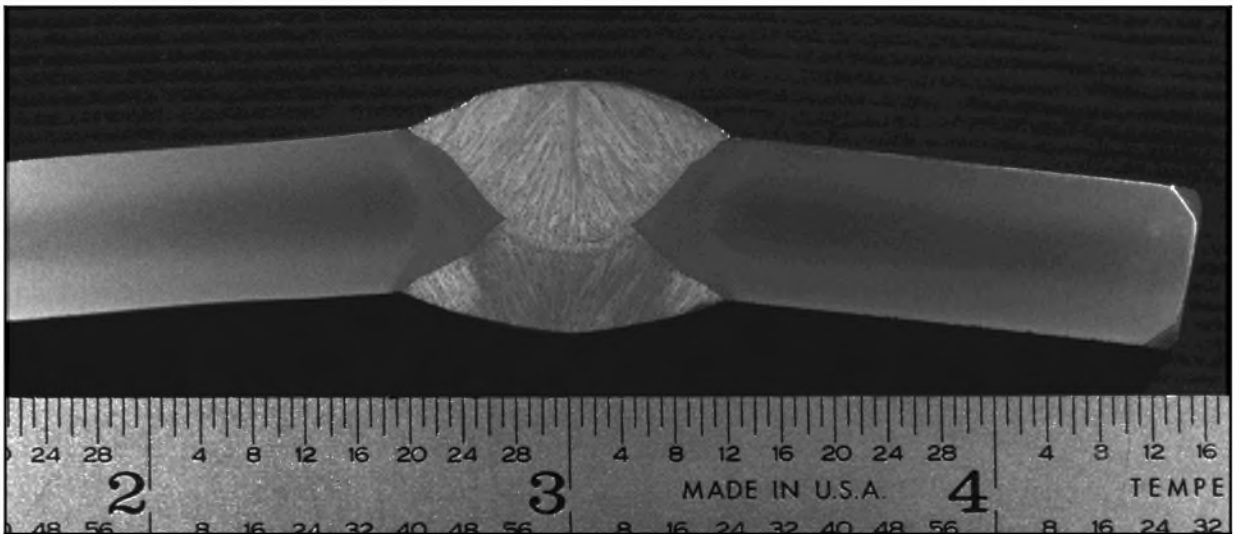
Figure 32 – Metallographically prepared Downstream Joint macro section.

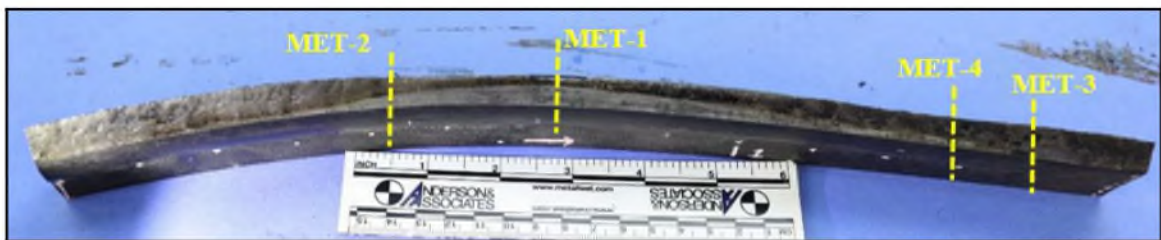
Mated cross sections from the fatigued region of the crack were also metallographically prepared. Sections were cut from the region of deepest fatigue crack penetration (MET-1), ~50% fatigue crack wall penetration (MET-2), minimal fatigue crack wall penetration (MET-3), and one additional section encompassing a perpendicular crack in the fatigue section adjacent to the location where the minimal fatigue section was cut (MET-4). An overall view of the seam-side of the fracture showing the locations of each mated metallographic section is shown in Figure 33. Each metallographic section is addressed below.

Figure 33 – Overall view of the seam-side panel containing the fatigue crack detailing the locations of the sections cut for metallographic examination.

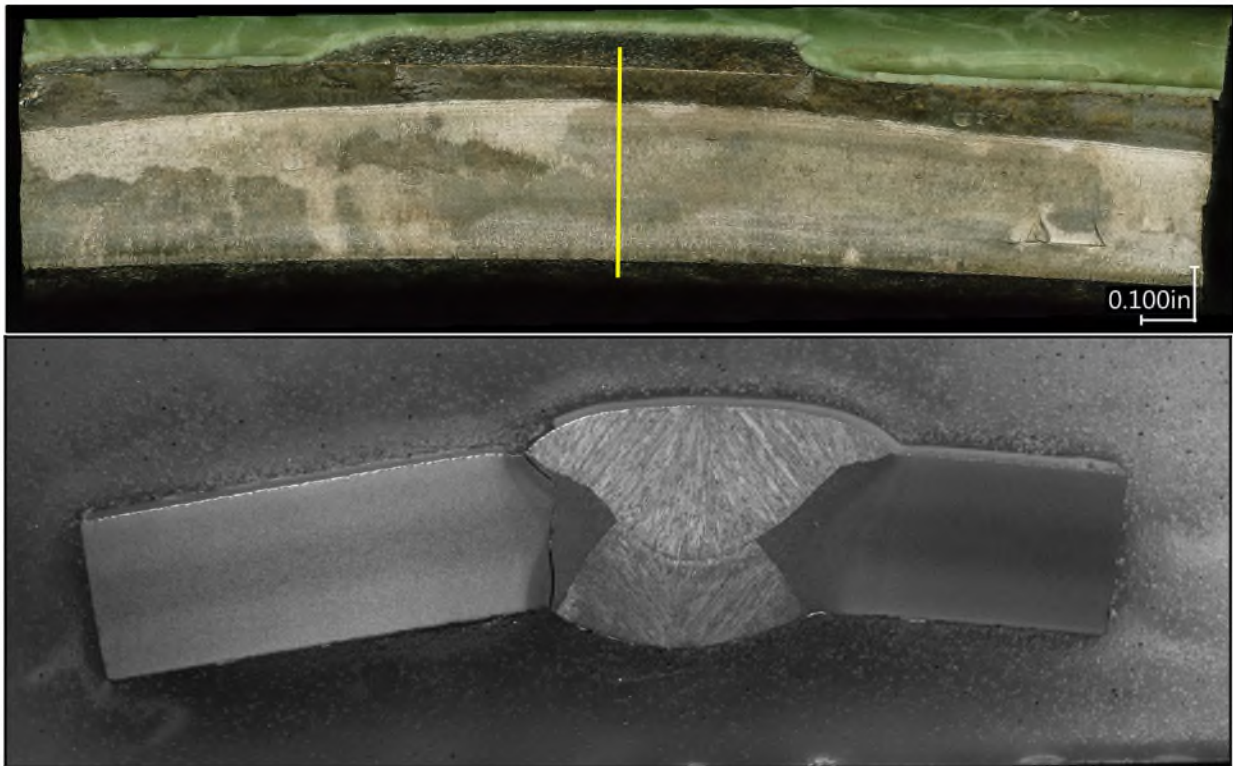
The location of the metallographic section and overall view of the prepared specimen are shown in Figure 34, the general observations were that the FBE coating on the OD surface appeared intact and tightly adhered with the exception of the area immediately surrounding the rupture location and that there was no evidence of general corrosion present on the ID surface. As shown in Figure 35, the crack propagated through the HAZ, and that no secondary or branched cracks were evident. Figure 36 details the crack initiation coincident with the weld toe, and that there were no defects or metallurgical anomalies present in the initiation location. Figure 37 shows the shear overload region at the OD surface, again demonstrating no metallurgical anomalies or defects were present, but a small secondary tear at the OD surface was present and likely associated with the plastic deformation of the pipe as it ruptured. Also evident at the OD surface was a lack of corrosion pitting or corrosion product accumulation.

Figure 34 – Low magnification views showing the location of the cross section and the metallographically prepared mated specimen.

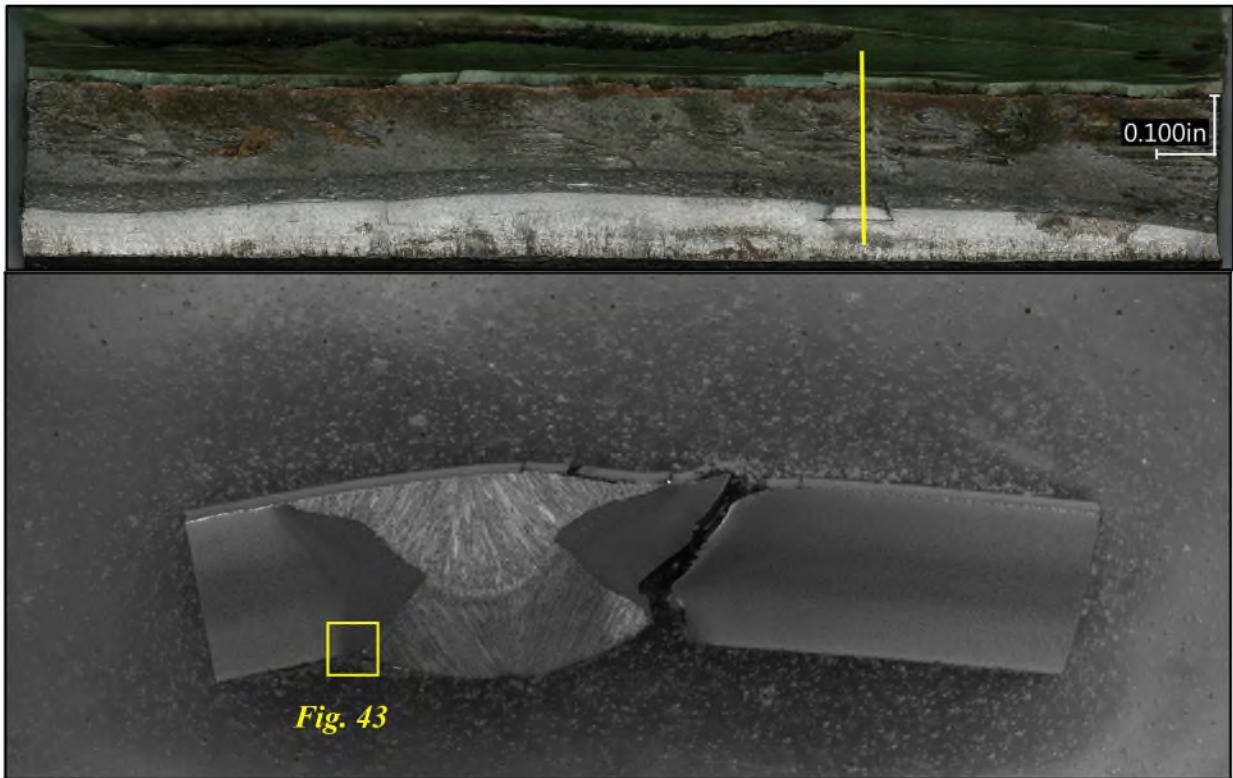
The cut location and metallographically prepared section are shown overall in Figure 41. The pronounced nature of the secondary crack was evident in cross section, but not metallurgical or microstructural anomalies were identified to be associated with this feature as detailed in Figure 42. Coincidentally, this section intersected a small corrosion pit on the ID of the opposite toe of the weld, and upon closer inspection, a small crack was observed to be originating from the corrosion pit as detailed in Figure 43.

Figure 41 – Location and metallographically prepared section through the 25% fatigue crack penetration location coincident with a large secondary crack.

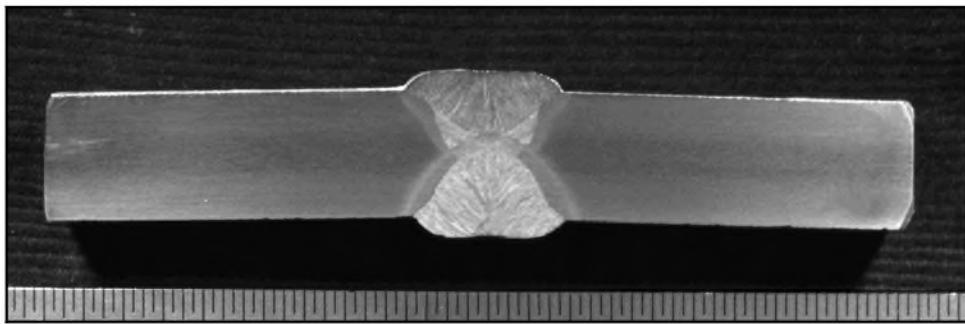
Three, cross girth weld sections from GW610 were removed for metallographic examination were prepared at approximately 120° intervals. Each section was found to be metallurgically sound, having no inclusions, porosities, or lack-of-fusion defects. The girth welds were also a DSAW construction, welded first from the OD and second from the ID. There appeared to be a double weld pass present on the OD. Photographs showing the macro-etched sections are provided in Figures 54 – 56.

Figure 54 – Cross girth weld section taken from the ~39° location on the pipe. The failed joint side is on the left.

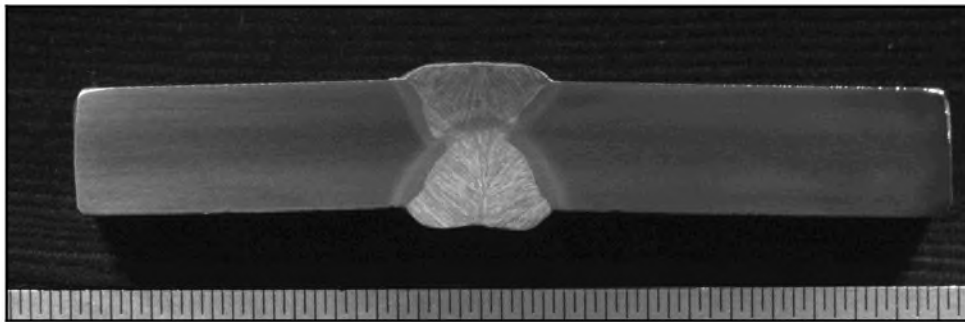
Figure 55 – Cross girth weld section taken from the ~159° location on the pipe. The failed joint side is on the left.
