# Final Report

# Root Cause Analysis of the MP 171 Fort Ransom Keystone Pipeline Rupture

**Date:**  
September 15, 2025

**Project Number:**  
SOB-25-003

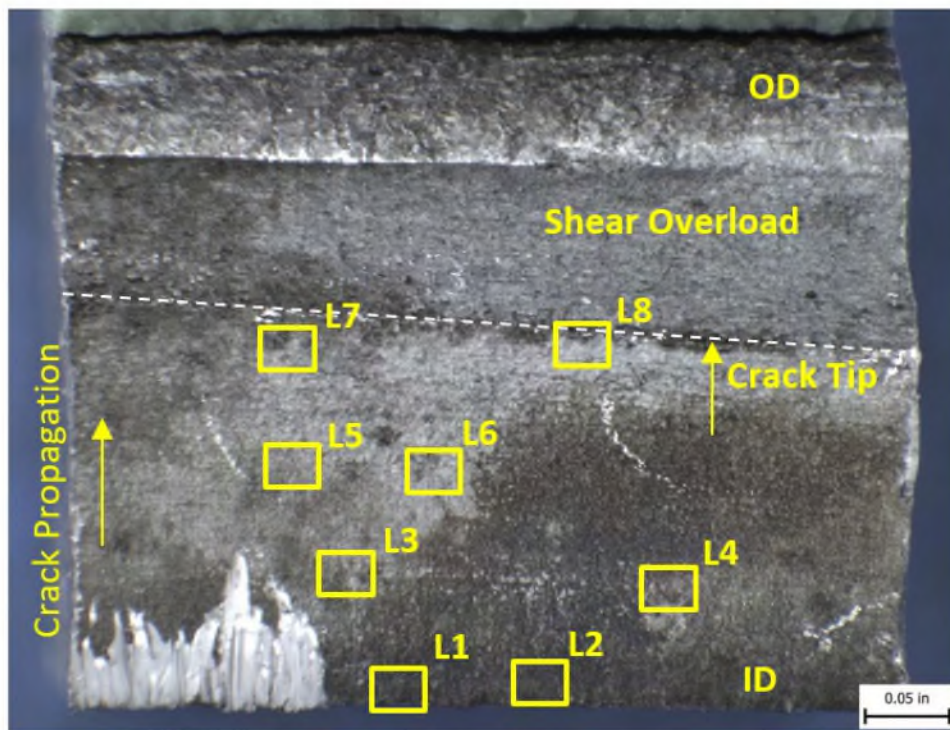
Figure 7: SEM image map from ID to OD

Figure 7 is a stereo image map of SEM image locations taken to demonstrate general changes in crack morphology and mechanism. Locations L1 and L2 depict high-cycle fatigue with fine striation spacing. These striations are consistent with fatigue in air or in a mild environment. Locations L3 and L4 show increasing area fractions of cleavage and quasi-cleavage; however, fine striations are still evident in L4. In Figure 9, Locations L5 through L8 fatigue striations are challenging to identify, as the microstructure is dominated by crystallographic fracture.

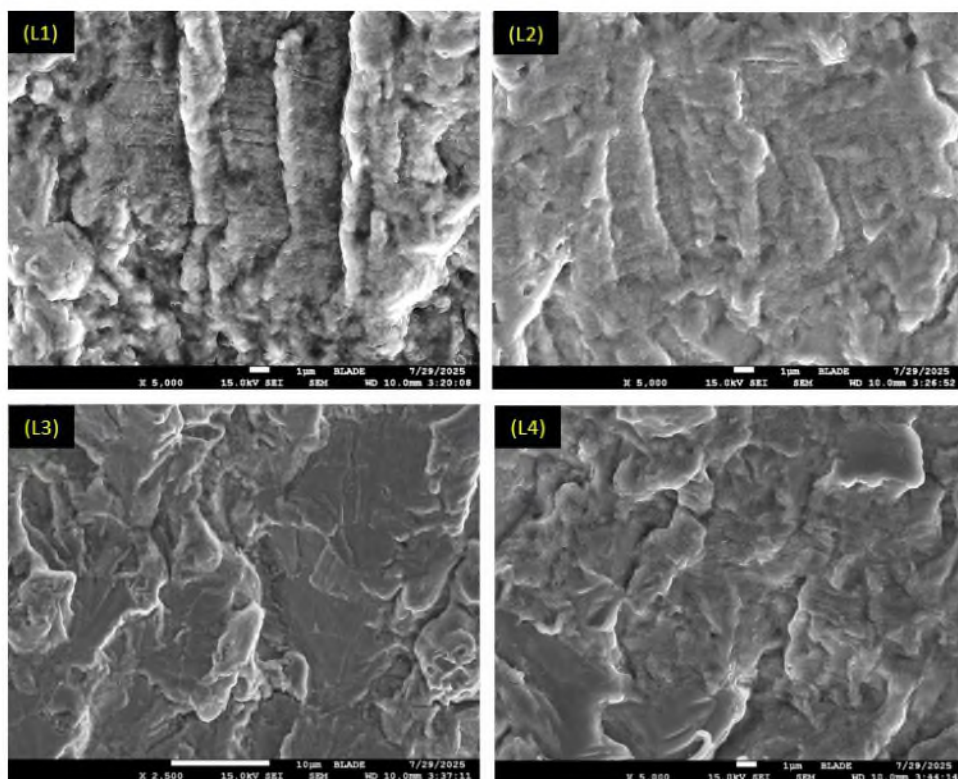
Figure 8: SEM images of locations L1 to L4, lower region of crack growth

Please note that magnification was purposely varied to best present the intended features in any given region of interest. Fatigue striations require a higher magnification. Therefore, locations L1, L2, and L4 in Figure 8 are presented at 5000X. The cleavage and quasi-cleavage regions depicted in L3 in Figure 8 and L4 and L5 through L8 in Figure 9 are presented at 2500X to zoom out and demonstrate a distinct change in fracture morphology and crack advance mechanism.

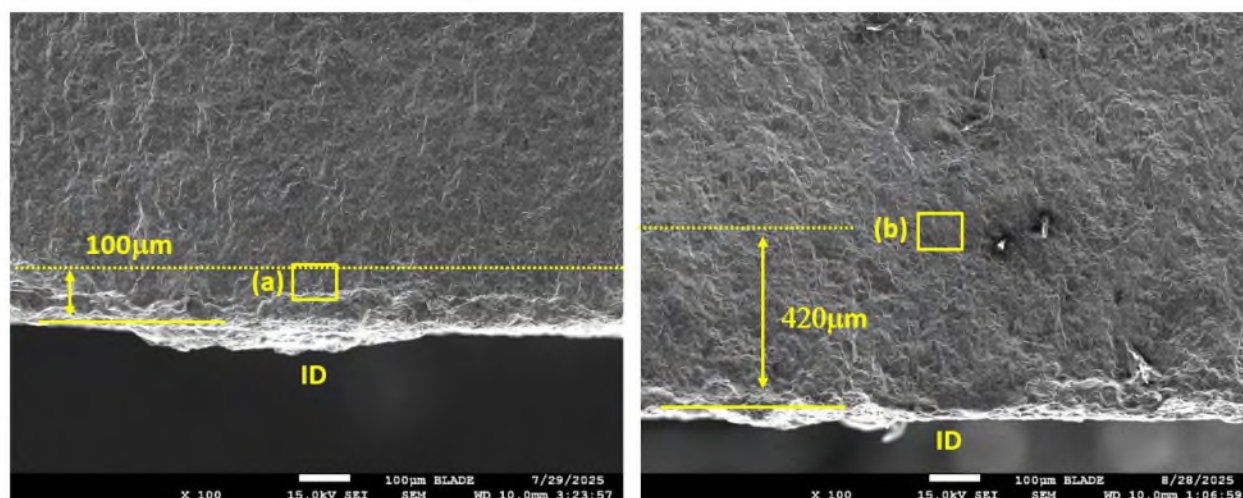
Figure 11: SEM fractograph map, fracture face, crack Initiation

Figure 10 (left) shows the fatigue crack initiated at the ID near the weld toe in the inside CGHAZ, propagated through alternating regions, reaching a critical length as it approached the outside CGHAZ. At that point, the remaining ligament failed by shear overload through the outside CGHAZ zone adjacent to the outer cap weld. This assessment is in agreement with Anderson and Associates [2]. The fractographic locations (a) through (f) are mapped on Figure 10 (right). Figure 10 (left) demonstrates the variance in grain structure and phase fractions as the crack grew from the ID to the OD. The fracture response of the material is a complex interaction of environment, stress intensity, and microstructure. Figure 11 is a map of two locations evaluated under the SEM at <10% WT near the ID.

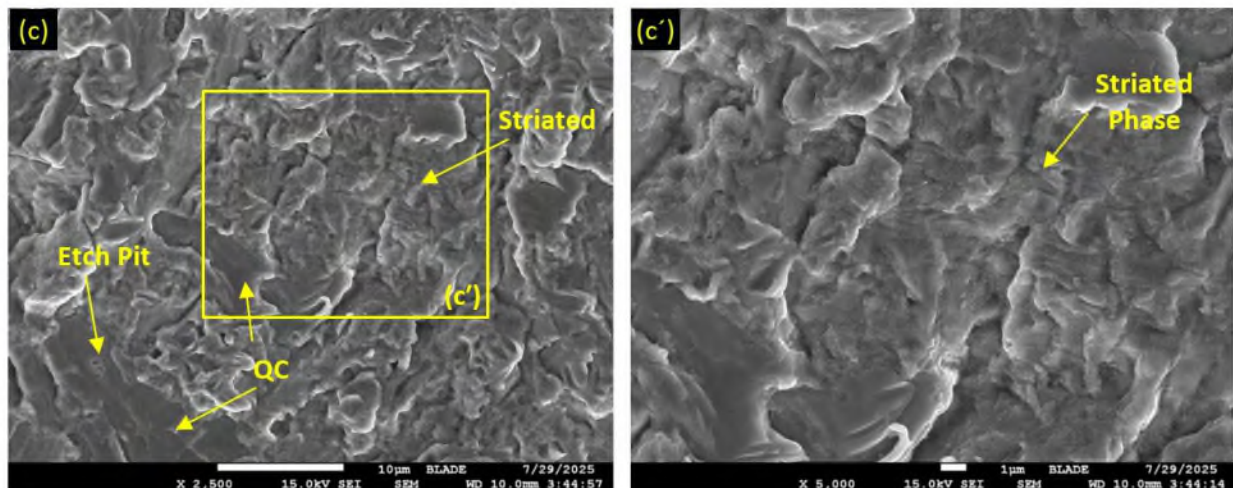
Figure 15: SEM fractography, 20% WT

SEM fractography of crack depth at 20 to 30% WT is shown Figure 15 and Figure 16, respectively. The fractography shown in these figures represents crack propagation that may enter a FGHAZ. Anderson did not take high magnification optical micrographs of this region, so a detailed optical analysis or comparison could not be made.

Location (c) Figure 15 exhibits fatigue striations on similar phase structures to Location (a) Figure 15 . However, there is a greater area fraction of quasi-cleavage (QC) crystallographic fracture. The striation spacing is slightly larger in (c) than in (a), suggesting a slight advance in radical crack growth rate. The greater area fraction of the cleaving ferrite phase may be increasing the crack growth rate by redistributing the load to the residual phases. Further research is required to confirm this assertion. Figure 15 appears to show the onset of different fracture mechanisms in addition to cleavage. Figure 18 maps the two locations evaluated by SEM near the crack tip.

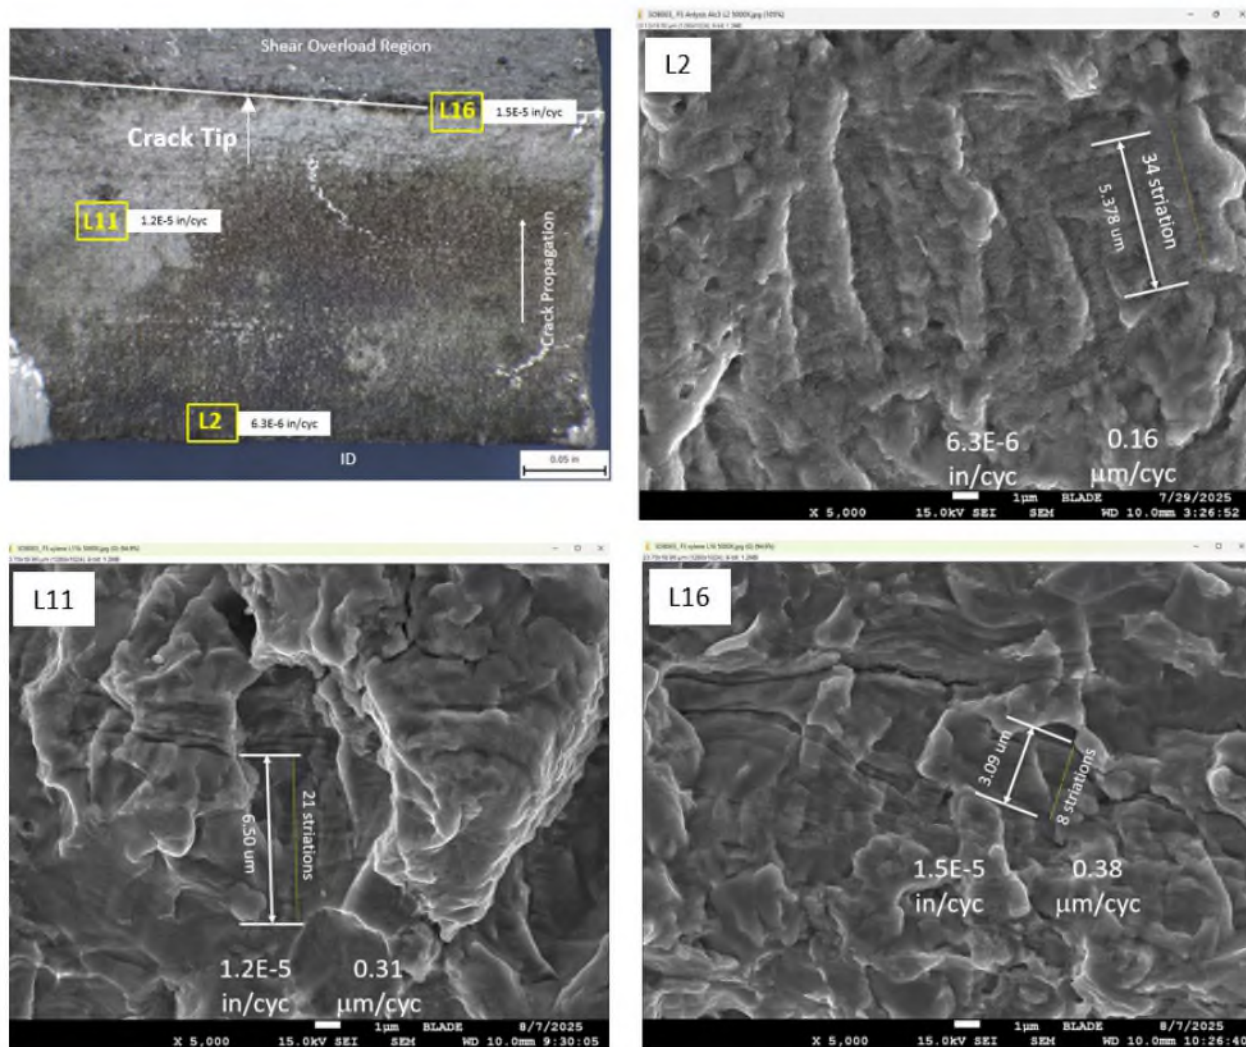
Figure 20: Striation counts

A first iteration striation count was performed using three micrographs of progressive crack lengths, including the ID, midwall, and crack tip just before failure. The locations evaluated and results are shown in Figure 20. A steady increase in striation spacing is evident. It is worth noting that, as a secondary effect, in regions with increasing area fractions of phases that experience crystallographic fracture, isolated striation counts/spacing may misrepresent or underestimate the overall crack growth rate.

Ritchie et.al. [12] showed that high mean stress in steel under carefully controlled conditions can promote cleavage in microphases, where a combination of striated growth in some phases and isolated cleavage “bursts” in other phases works in concert to produce a faster apparent crack growth rate than measured at lower mean stress in a completely striated matrix. Comparative fractography in [12] shows fatigue striations in a striated crack growth, and in partially striated fracture exhibits similar spacing at different  $da/dN$  rates. Ritchie makes the statement that striated growth may be independent of  $K_{max}$  (maximum stress intensity) at the crack tip.

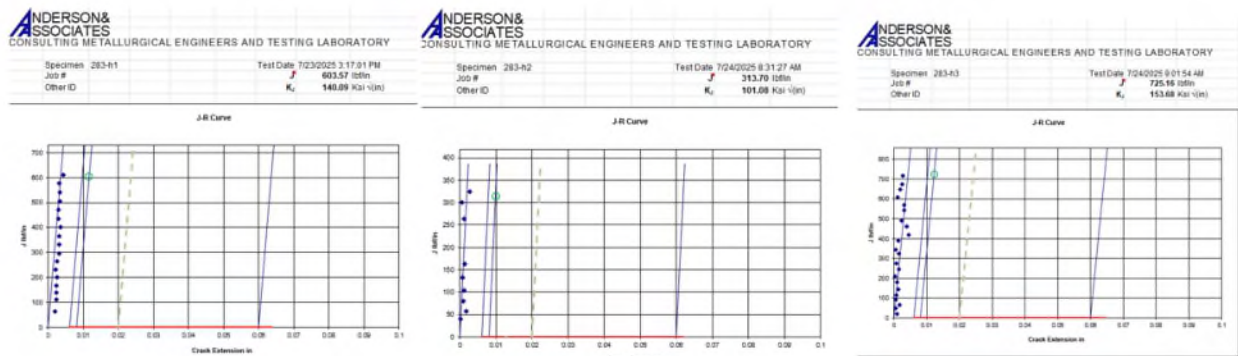
Figure 24: J-R test data at -5°C for unused Berg pipe HAZ

- HAZ specimens from the failed joint, shown in Figure 22. The  $J_u$  ranges from (b)(4) as shown in Figure 22.
- HAZ specimens from the failed joint, Bake out at  $400^{\circ}\text{F}$  for 30 minutes. The  $J_u$  ranges from (b)(4) (b)(4) as shown in Figure 23.
- HAZ specimens from an unused Berg joint. The  $J_u$  ranges from (b)(4) as shown in Figure 24.

J-R tests with the crack located in the HAZ exhibited cleavage behavior, while some welds remained ductile. For this reason, further investigation of the HAZ was warranted.

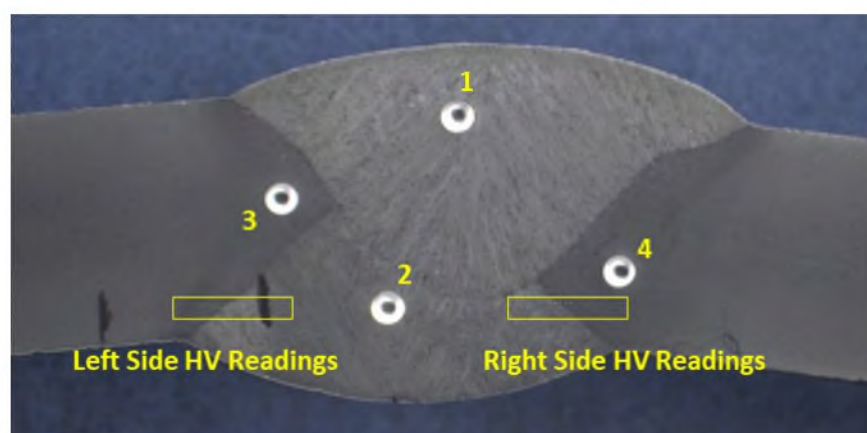
Figure 34: Tabletop plastometer indentation locations

Figure 34 shows the indentation locations on a weld extracted from the failed joint. Table 4 shows the estimated yield and tensile strengths. The HAZ and weld regions are consistent with the base metal values presented in Table 2. Note that the HAZ region is slightly lower than the base metal, but not enough to consider differences in the material behavior.

Vicker's microhardness readings were also taken across the weld on the left and right sides near the ID. Figure 34 shows the left and right indent regions. The values show that the hardness does not vary significantly between the base metal, HAZ, and weld regions. The minimum and maximum hardness values are 185.1 HV<sub>0.5</sub> and 275.3 HV<sub>0.5</sub>, respectively. These values correspond to 90.1 HRB for the minimum value and 26.5 HRC for the maximum. On average, the HAZ region is slightly lower (212.1 HV<sub>0.5</sub>) than the weld region (236.0 HV<sub>0.5</sub>), which is consistent with the plastometer results.

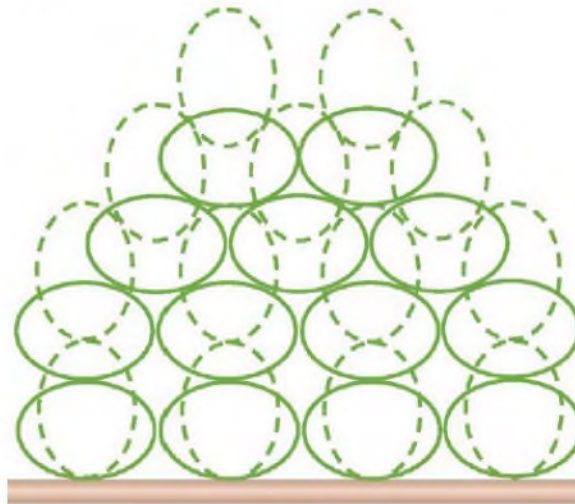
Figure 44: Vertical vibration of a pipe stack [19]

Blade did not perform a transportation fatigue analysis to determine if a crack could initiate and grow during the transportation from the mill to the construction site. Instead, Blade relied on the work conducted by RSI for the Edinburg failure. RSI performed an FEA for the failed weld and a random vibration analysis to assess the potential for transportation fatigue. Figure 44 is a schematic from the RSI report showing the pipe stacking and deflected shape for the transportation analysis. RSI concluded that:

The MP 171 failed pipe had a similar weld geometry to the failed Edinburg pipe, suggesting that the MP 171 failed pipe was susceptible to transportation fatigue if positioned at a high stress area (near a contact point). It was not possible to determine the position of the failed joint in the pipe stack or the orientation of the seam relative to the contact points. The analysis only shows that initiation due to transportation fatigue is possible.

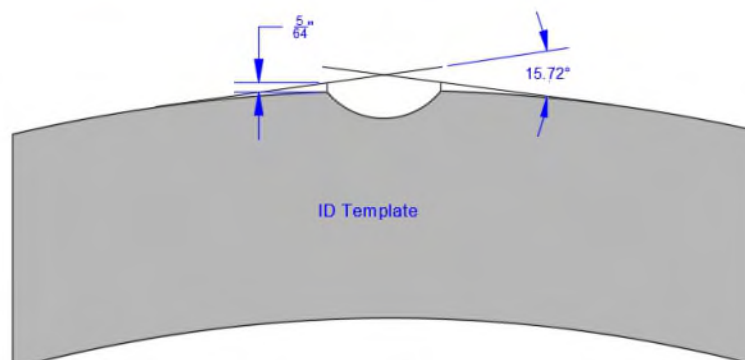
**Figure 48: Angular misalignment limit based on ID template and TES-PIPE-SAW-US 7.2.2**

Figure 48 shows a schematic estimating the maximum misalignment angle permitted by the TES-PIPE-SAW-US specification using the ID gauge, given the allowable deviation of 5/64 in. (2 mm). The schematic indicates that the maximum misalignment angle at the ID is (b)(4). All but one of the values in Table 11 were below the estimated limit of 15.7°. The cross-section that failed the requirement had an angular misalignment of 15.9°, which is slightly above the limit. However, it should be noted that it is a reconstructed cross-section, meaning it is a fractured section that was put back together in the mount, which may cause errors in the measurement.

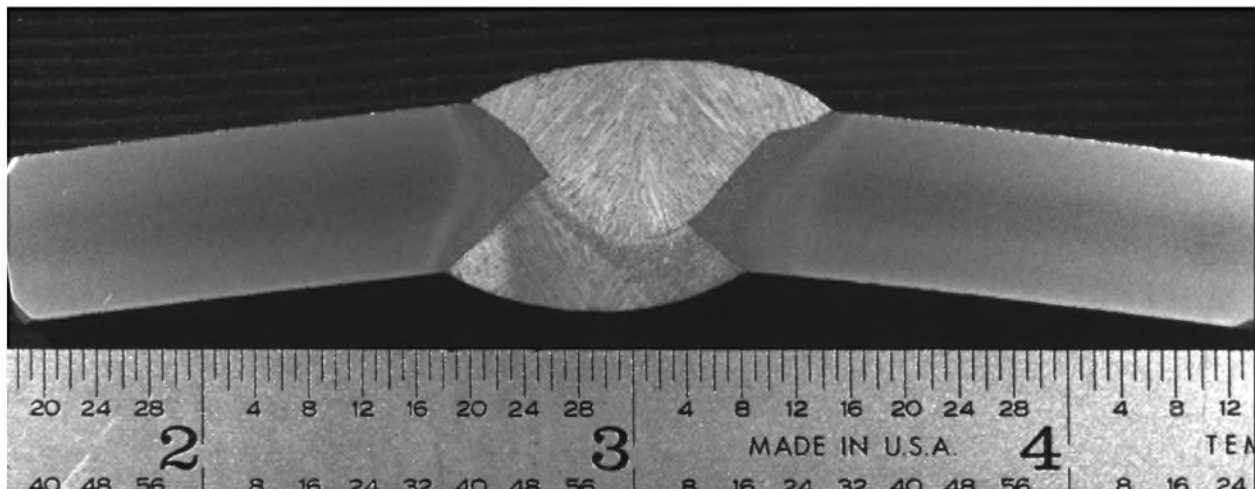
Figure 49: Model 2 - cross-section of seam weld through intact section of failed joint

Models 2 and 3 were representative cross-sections taken from the Anderson report. Model 2 was scaled from the section shown in Figure 49, which was extracted from the failed joint upstream from the failure location. Model 3 was scaled from the section shown in Figure 50, which was a cross-section extracted through the middle of the fatigue crack at its deepest penetration. Note that the cross-section has been reconstructed since it is through a failed region. The OD toe and ID root radii were estimated as shown in Figure 51. The ID root radius was approximately 0.003 in. while the OD toe was 0.010 in. The weld root radius is challenging to determine from the micrographs and is an approximation.

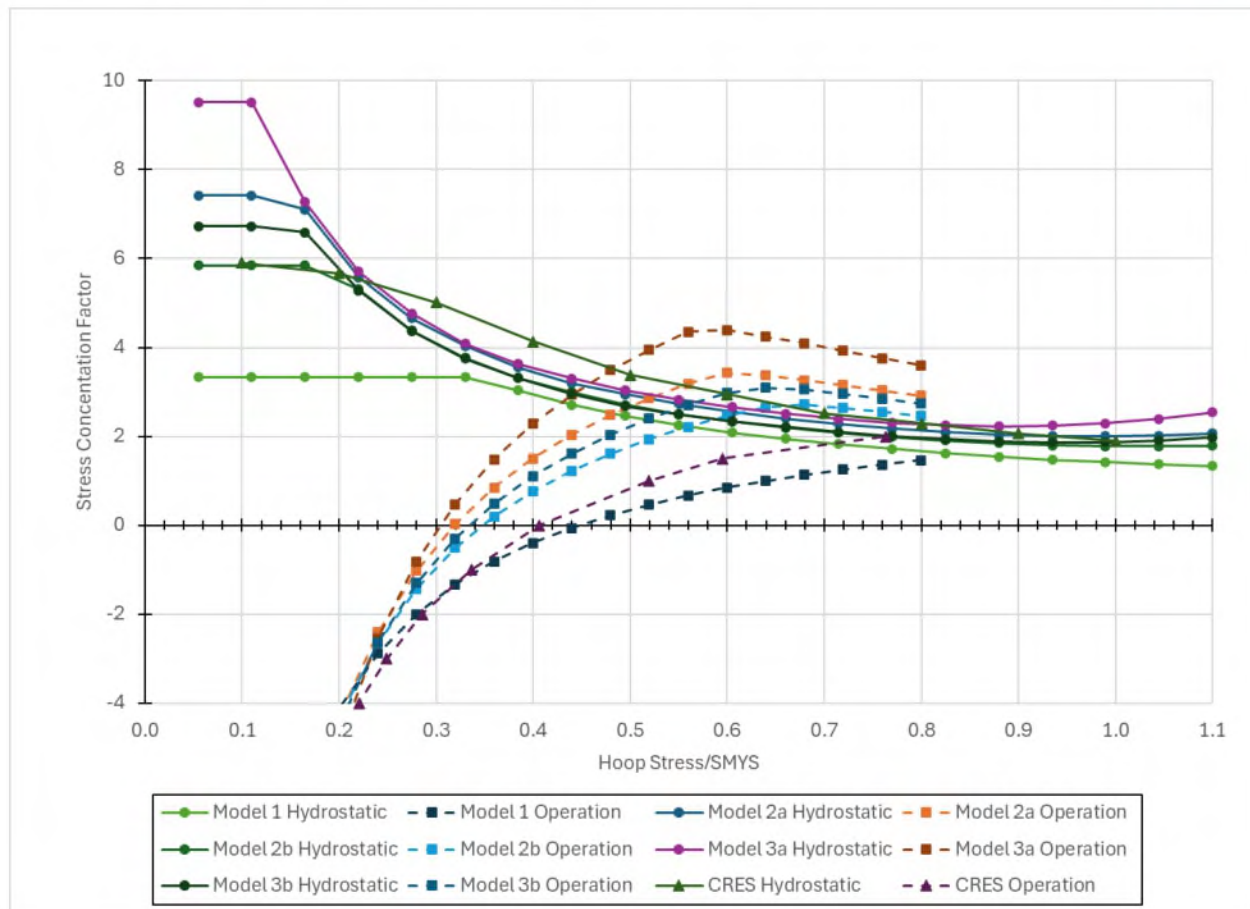
Figure 57: SCF versus percent SMYS

Figure 57 shows a plot of SCF versus hoop stress normalized by SMYS. The plot shows that the SCF can range from approximately 3 to 9 at low pressures during a hydrotest, but will trend to approximately 2 at higher pressures due to local plasticity. CRES performed a similar assessment for the Edinburg failure, and their results are included for reference. The Blade results are consistent with CRES and show that the SCF is dependent on weld geometry.

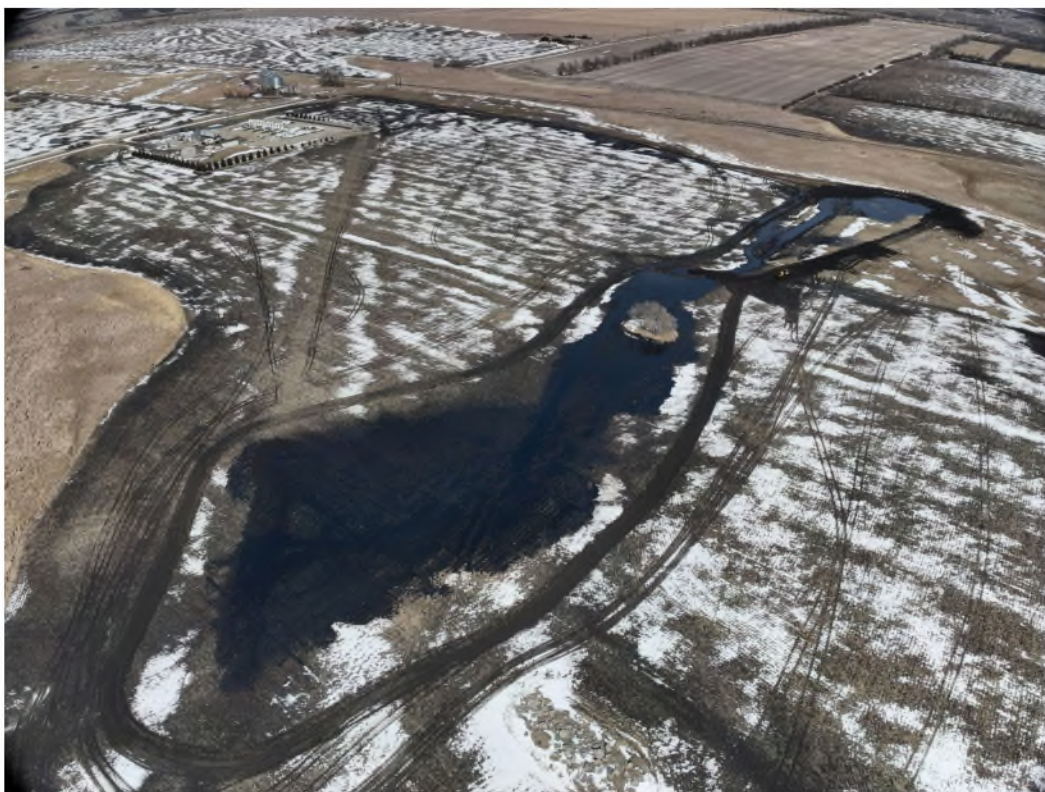
The spill extents are shown within the bermed areas in Figure 60 and Figure 61. A release volume of 3500 barrels (bbl) of crude oil was estimated [22]. The closest High Consequence Area (HCA) is located approximately 3,800 ft south and the closest Contributory Pipeline Segment (CPS) is approximately 1,776 ft downstream (south) of the rupture location. The rupture was not located within a CPS that could affect an HCA.

Figure 61: Spill extents – aerial photo of spill
