## 7 Crude Oil Environment

### 7.1 Crude Oil Chemistry Analysis

## 7.2 Fracture Surface Scale Analysis

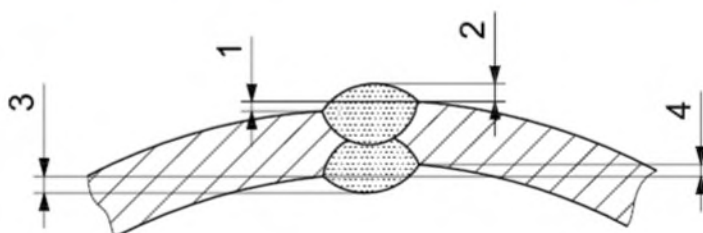
**Figure 82: Radial offset as per API 5L [API 5L 2007] [42]**

When welding the longitudinal plate edges of the formed open can, a radial offset occurs when the centerlines of the abutting plate edges are not perfectly aligned. This misalignment is also known as "hi-lo". As per recent API 5L standards, radial offset (hi-lo), where the two plate edges are out of line through the wall, so one side sits higher or lower at the joint as shown in Figure 82 (a). Misalignment at the longitudinal weld seam can appear in four ways as shown in Figure 82 (b). These schematic pictures are extracted from API 5L 44<sup>th</sup> editions because no figures are provided to the manufacturer in the API 5L 43rd Edition. It explains the basic idea of seam setup, where two plate edges are joined, ensuring they align through the wall so that the joint doesn't leave the wall any thinner than what the specification allows.

Geometric measurements of seam welds checked using macro examination near the failure region are within specified limits for radial offset, out-of-line weld bead, and cap height per API 5L 43rd edition.

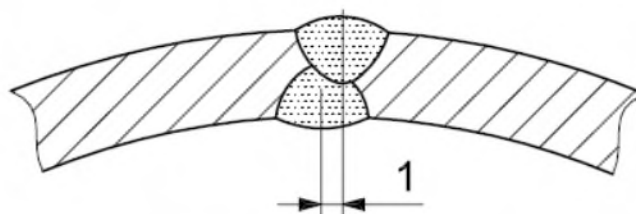
**Figure 83: Misalignment of SAW welds [API 5L 2007] [42]**

As per API 5L 43<sup>rd</sup> edition [40], out-of-line weld bead (off-seam weld) shall not be the cause for rejection, provided that complete penetration and complete fusion have been achieved, as indicated by nondestructive inspection.

An off-seam weld bead by itself (i.e., lateral shift of the bead) does not increase stress at the weld toe/root provided two conditions are met: (a) the joint has complete penetration and fusion, and (b) the through-thickness alignment and contour (radial offset/hi-lo, peaking) remain within acceptance criteria. In that case, the local stress concentration is governed mainly by bead shape and any step or peak in the base metal, not by the bead's lateral position, and API allows acceptance on that basis.

The risk arises when an off-seam bead is a result of tracking/fit-up issues that produce misalignment or fusion defects, which becomes a credible crack-initiation driver.

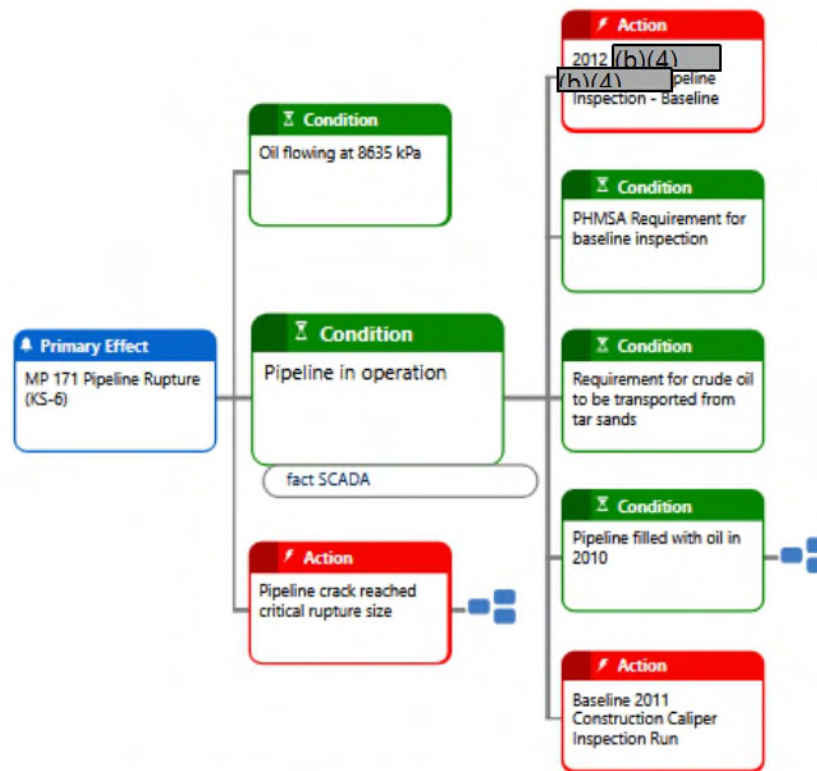
**Figure 89: Causes for the pipeline in operation**

The oil flowing at 1252 psig (8635 kPa) is terminated as a desired condition. However, the Pipeline in operation is continued further. The cause for the pipeline to be in operation was due to four different causes as shown below in Figure 89:

- 2012 (b)(4) baseline inspection.
- PHMSA requirement for a baseline inspection.
- Pipeline is required to transport crude oil
- Pipeline filled with oil in 2010
- Baseline caliper inspection run was completed

Except for the pipeline filled with oil, the other causes are terminated.

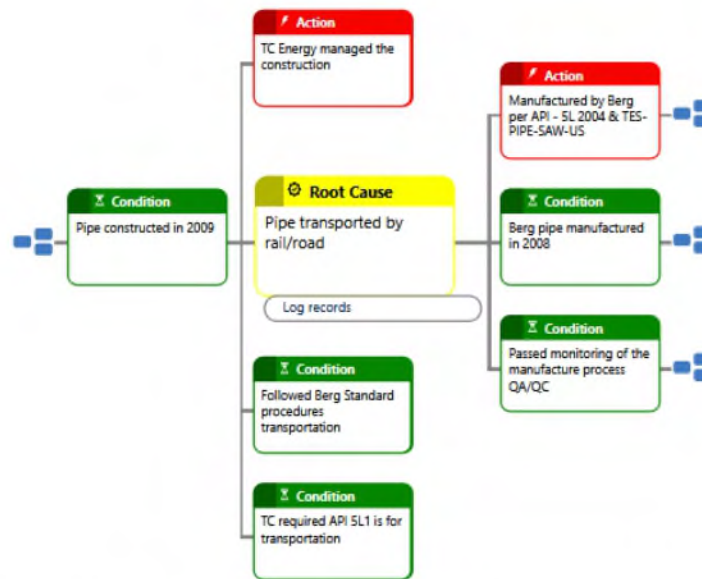
Figure 90: Causes for the pipe being transported by rail/road

The pipe was manufactured in 2008, pipeline constructed between 2008 and 2010, and consequently required transportation by rail for the first 1605 miles and then by truck for the final 27 miles. The causes, as shown in Figure 90 :

- TC Energy managed the pipeline, and it was constructed. This is terminated as a desired condition.
- Pipe was transported by rail/road. This occurred because Berg manufactured the pipe to the API 5L 2004 edition and TC specification, TES-PIPE-SAW-US. Berg manufactured the pipe in 2008. Furthermore, the pipe met the QA/QC requirements for the pipe.
- Berg followed AAR Open Top Loading Rules Manual 2007 train transportation guidelines. The Berg facility was over 1500 miles away, and rail transport was necessary. This is terminated as a desired condition.
- TC required API 5L1 for transportation. The API 5L1 guideline directs to the AAR transit guidelines in the event of a conflict between the two requirements. This is terminated as a desired condition.

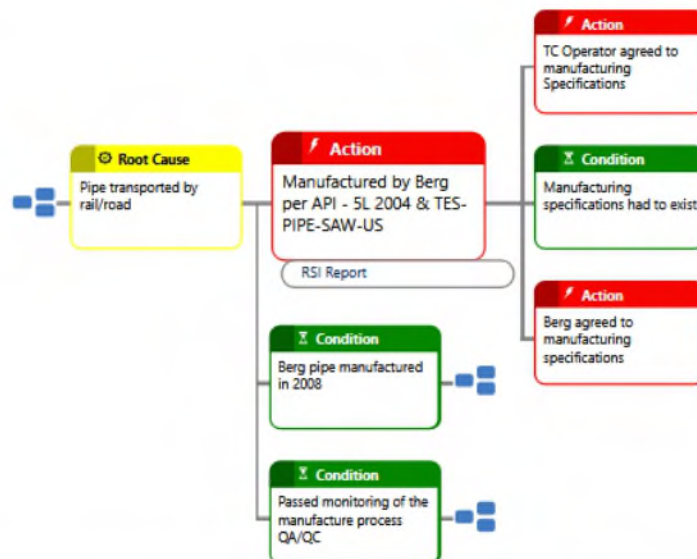
Figure 91: Causes for pipe to be manufactured to API 5L 2004 and TC specification

The causes for Berg to manufacture the pipe to the API 5L 2004 and TC specification that was incorporated into the MPS were as follows, as shown in Figure 91:

- TC Operator and Berg agreed on the manufacturing specifications, and this was a termination point
- Manufacturing specifications are a regulatory requirement and an industry standard. This was also a desired condition.

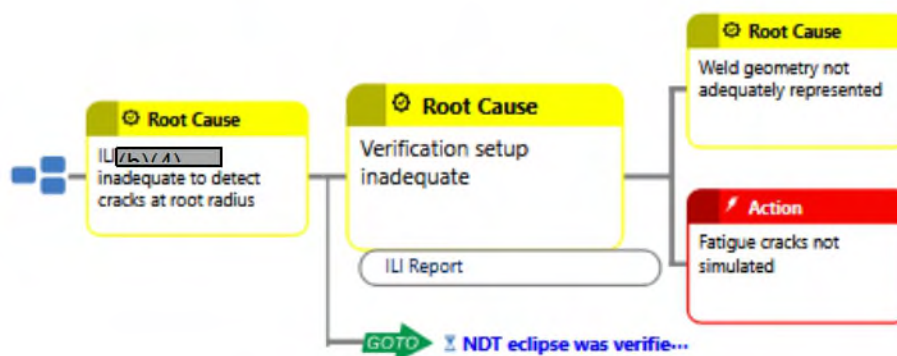
Figure 97: Causes for verification setup were inadequate.

The causes for the ILI not detecting the cracks are shown in Figure 96. The (b)(4) was run in September 2020. The tool was inadequate for detecting cracks in the weld root radius due to weld peaking and a corresponding radial tilt of the crack. There was an extensive effort to verify the tool's efficacy; (b)(4) The inadequacy was possibly due to the weld geometry not being adequately modeled experimentally as a combination of the peaking angle and radial tilt of the flaws, and/or the fatigue cracks not being simulated adequately, as shown in Figure 97. These are terminated due to a lack of control.

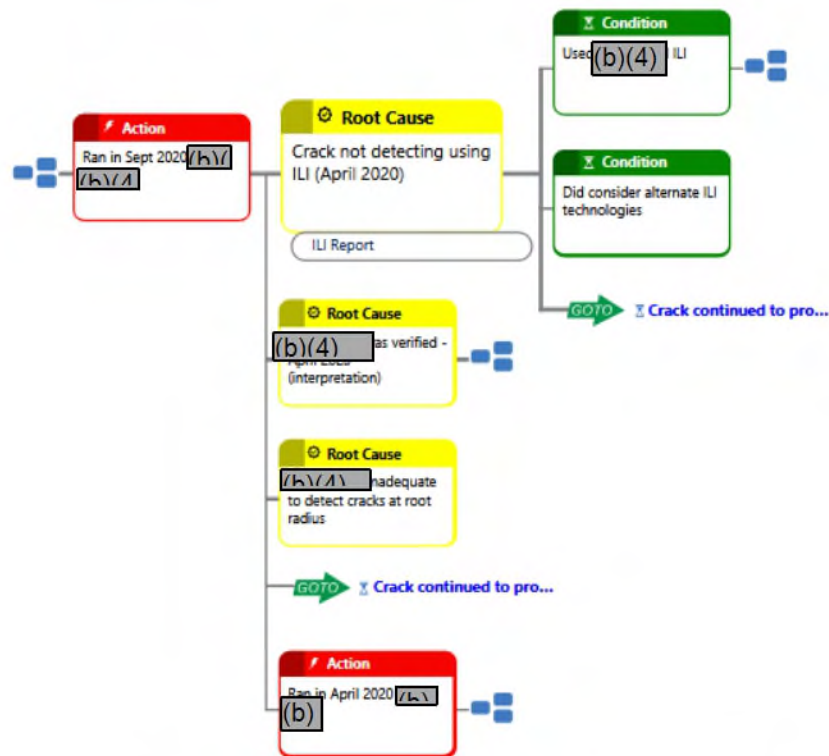
Figure 98: Causes for the September 2020 (b)(4)

The cause for running the September 2020 (b)(4) is explored below in Figure 98. They include the following:

Further exploring why the crack wasn't detected in April 2020, (b)(4) ILI was used, and alternate technologies and tools were assessed. (b)(4)

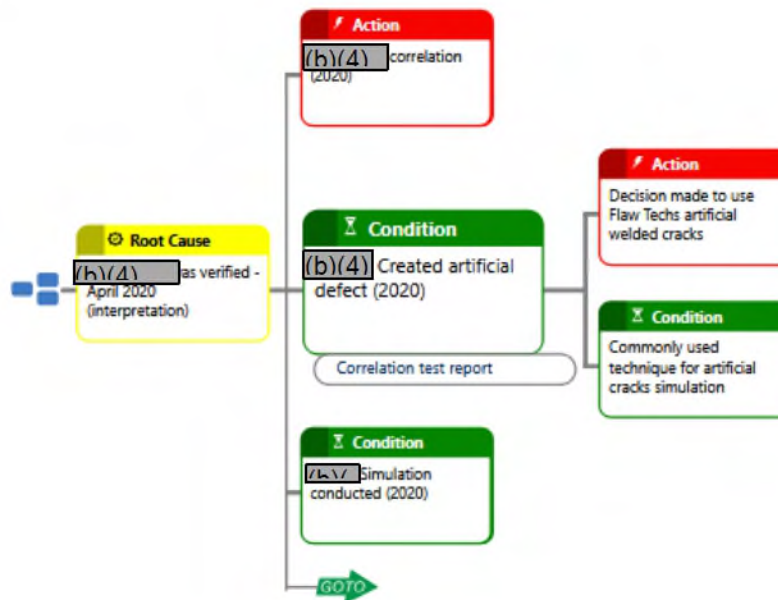
Figure 99: Causes for (b)(4) verification

(b)(4) was verified by (b)(4) conducting a simulation, and TC Energy conducted tool verification using correlation spools. The correlation spools had artificial defects in a peaking weld that was manufactured. The decision was based on multiple inputs from modeling to tool verifications.

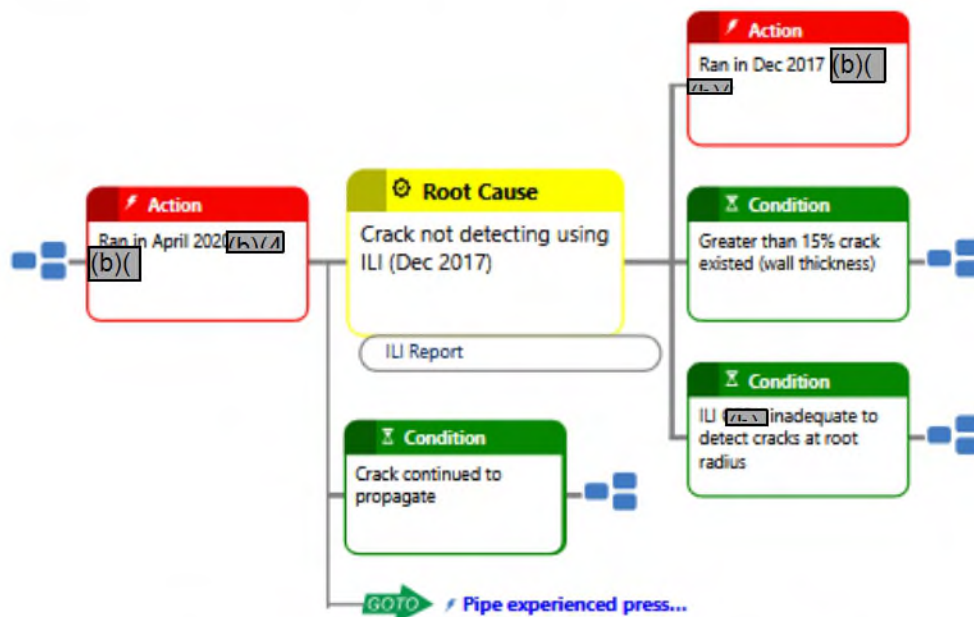
Figure 100: Causes for running the April 2020 (b)(4)

The causes for running the April 2020 (b)(4) are summarized in Figure 100. The rationale for this would be as follows:

- No seam weld cracks were detected using the (b)(4) tool in 2017. The crack depth estimate was around 15% of wall thickness in 2017, and the tool was run in December of that year. Furthermore, the (b)(4) tool was inadequate to detect the cracks at the root radius.
- The other cause was that the crack continued to propagate.
