## Failure Investigation Report

### South Bow Infrastructure Operations Inc.

### 1. Summary of the April 8, 2025, South Bow Failure

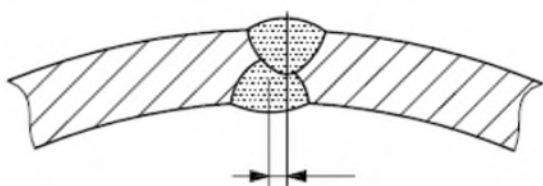
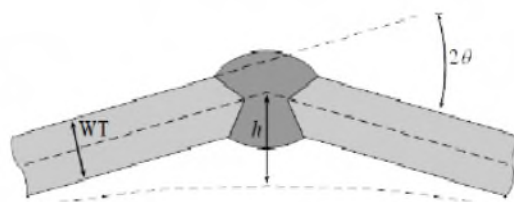
**Figure 8.** Example depiction of weld bead misalignment

A depiction of weld bead misalignment is shown below in **Figure 8**, and an example depiction of angular misalignment is shown in **Figure 9**. The DSAW long seams from the two failures showed very similar weld bead misalignment (**Figures 10 and 11**). Finally, there was angular misalignment observed on both pipes, shown in **Figures 12 and 13**.
