DOT	US Department of Transportation
PHMSA	Pipeline and Hazardous Materials Safety Administration
OPS	Office of Pipeline Safety
	Central Region

Principal Investigator	Dan Munthe (MNOPS)
PHMSA Investigators	Bryan Louque/Karen Butler
Region Director	David Barrett/Allan Beshore
Date of Report	05/30/2015
Subject	Failure Investigation Report—Enbridge Energy, Limited Partnership— Line 1 Leak, Equipment Failure

Failure Investigation Report – Enbridge Energy, Limited Partnership – Leak, Equipment Failure

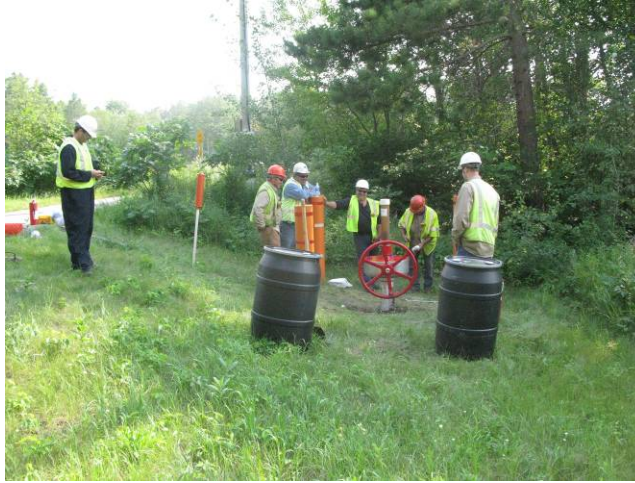
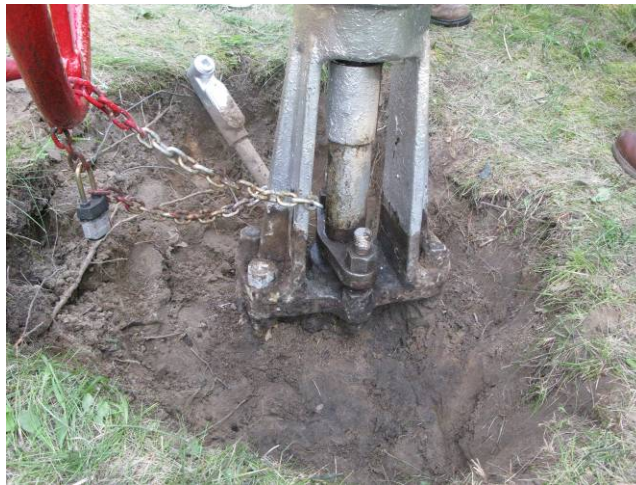
Appendix A - Map and Photographs

The Enbridge Line 1 leak at MP 958.33 was caused by equipment failure that allowed crude oil to leak through a worn valve stem packing on a gate valve located at the mainline valve setting. The gate valve was originally installed in 1951. The valve stem packing was replaced on site and the pipeline was returned to service the same day.

Enbridge personnel were able to repack the valve stem on site without removing the valve from the pipeline. The repair required the packing seal retainer to be tightened. In addition to making the repairs, monitoring wells were installed.
