Principal Investigator Patrick Raichel – NYSDPS (Buffalo)
Kristi Fogle – NYSDPS (Buffalo)
Senior Accident Investigator Michael Yazemboski
Region Director Byron E. Coy
Date of Report 7/27/2015
Subject Failure Investigation Report – Buckeye Partners CD803RC Pipeline Leak

Failure Investigation Report – Buckeye Partners CD803RC Pipeline Leak

144745 Appendix A - Maps and Photos and Leak Location

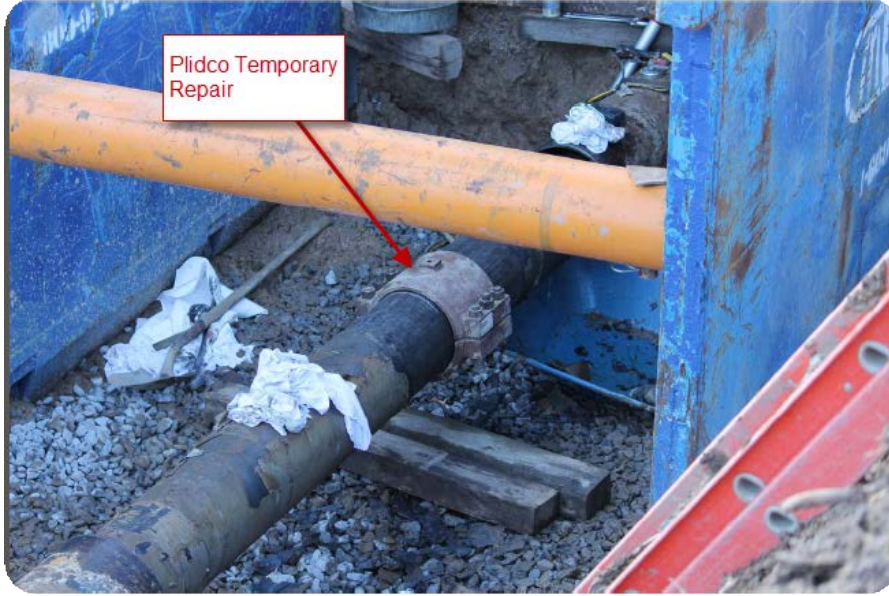
7. The cut out section and a portion of the casing were sent to Kiefner & Associates, Inc. (Kiefner) for examination. Metallurgical analysis of the anomaly showed a pronounced heat affected zone along the surfaces of the hole, along with melted and re-solidified metal. The pit had a smooth surface appearance and no evidence of corrosion or corrosion product. These taken together are significant evidence of an electrical discharge being the cause of the metal loss.

Approximately 22 feet of carrier pipe and 70 feet of casing were shipped to Kiefner for visual inspection, metallurgy and pipe material property testing (Appendix-H). Kiefner determined that the leak was attributable to an electrical discharge creating a pinhole in the external pipe wall. No evidence of corrosion or corrosion products existed near the anomaly. Pipe dimensions, properties and composition met the requirements of the 12th Edition of API 5L. The electrical discharge resulted in localized heating of the pipe wall above the melting point of the steel. Kiefner determined that the heat affected zone was continuous and uniform suggesting that the metal loss occurred immediately during a single electrical discharge event such as a lighting strike or AC power line fault.

Metallographic section taken through the leaking anomaly
