Failure Investigation Report – Columbia Gas Transmission Rupture – Activity ID 122980

Principal Investigator Dave McMillan, PHMSA ER
Regional Director Byron Coy
Date of Report 2/18/2011
Subject Failure Investigation Report – Columbia Gas
Transmission Pipeline Rupture

On November 5, 2008, at approximately 2:10 p.m., Columbia Line 1278 failed near Milford, PA, during an uprating procedure to increase the pressure in the line from a reduced 800 psig operating pressure back to the original 1000 psig MAOP of the pipeline. Columbia had recently been given authorization by PHMSA to increase the pressure in the pipeline back to the original MAOP after demonstrating that the integrity of the pipeline was adequate. The pipeline failure resulted in a rupture that involved three lengths of pipe in a wetland area. The failure occurred in the northern portion of the pipeline between Weber Road, Pike County, PA and Millrift, PA, 46 miles from the upstream compressor station at Easton, PA.

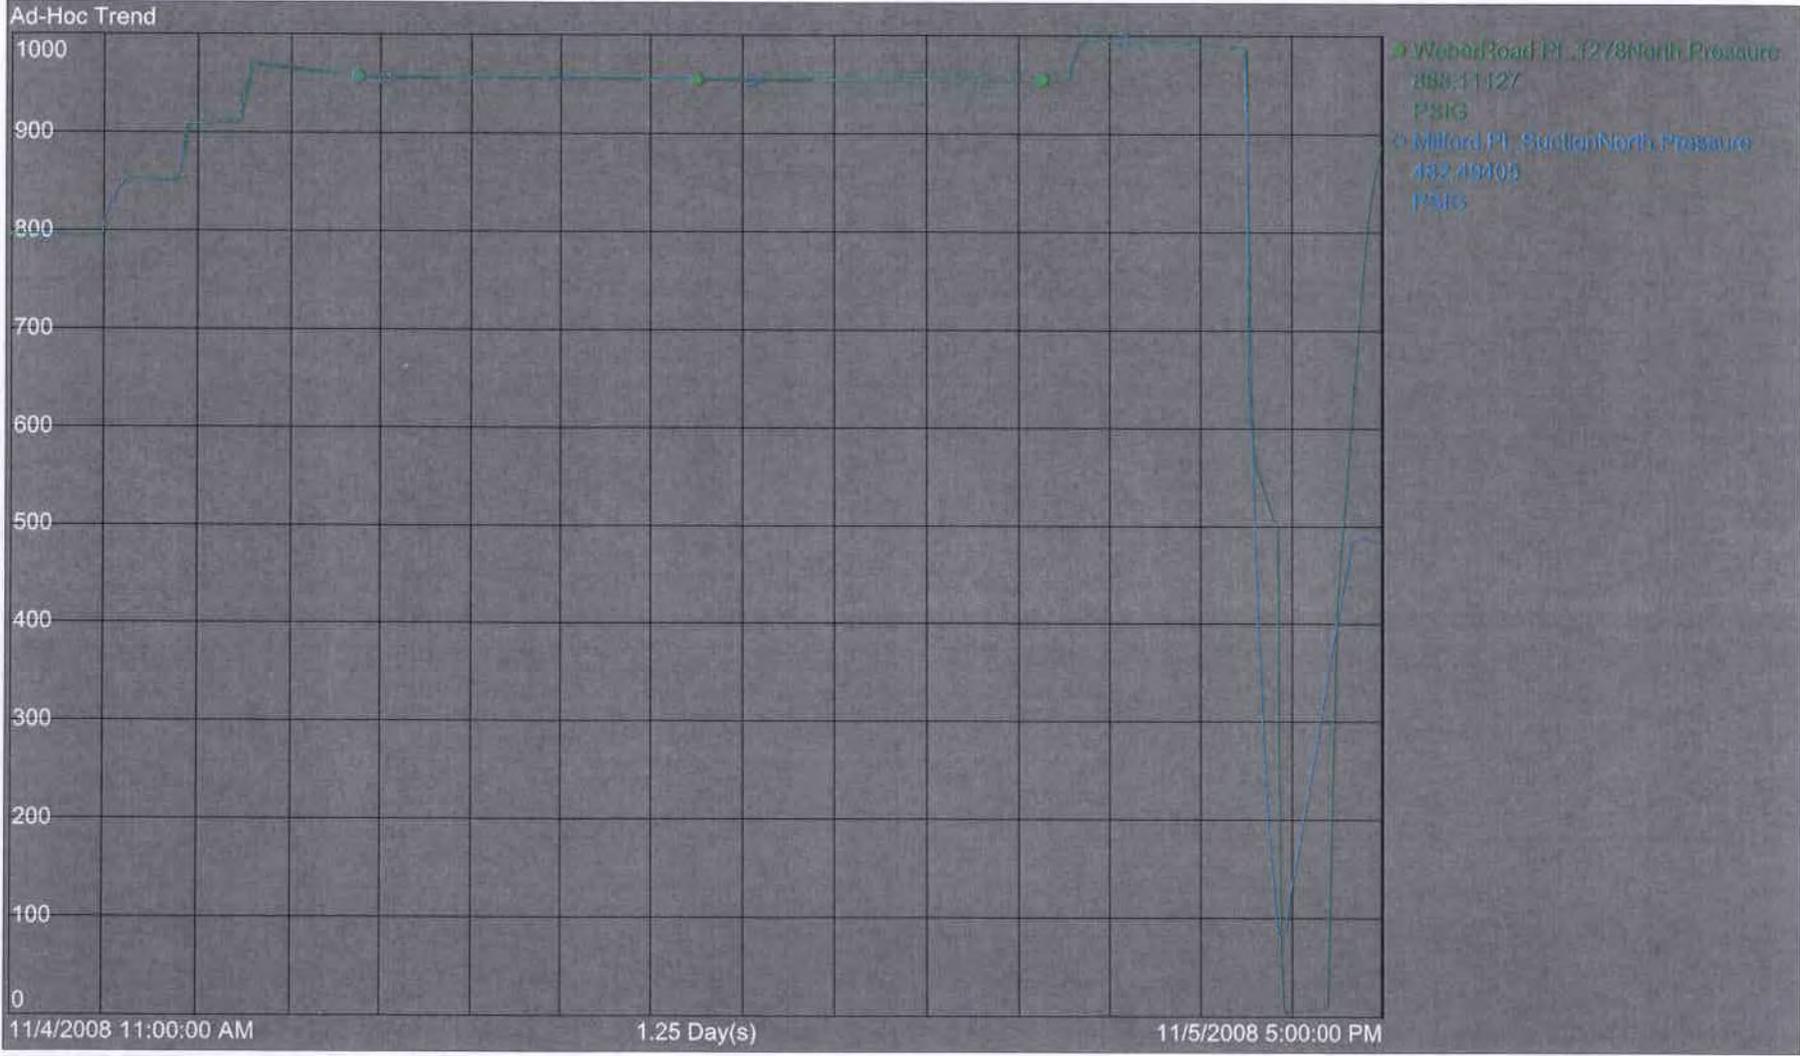
122980 Appendix 4 Columbia Pipeline Pressure test Graph

Pressure in the pipeline had been increased from 800 psig to 1000 psig in 50 psig increments. The operator then began to reduce the pressure, and at 986 psig the pipeline failed. There were no injuries. There was no ignition of gas. Valves were shut in both directions. No customers had service interrupted as a result of the pipeline failure. The failure occurred in a rural area.

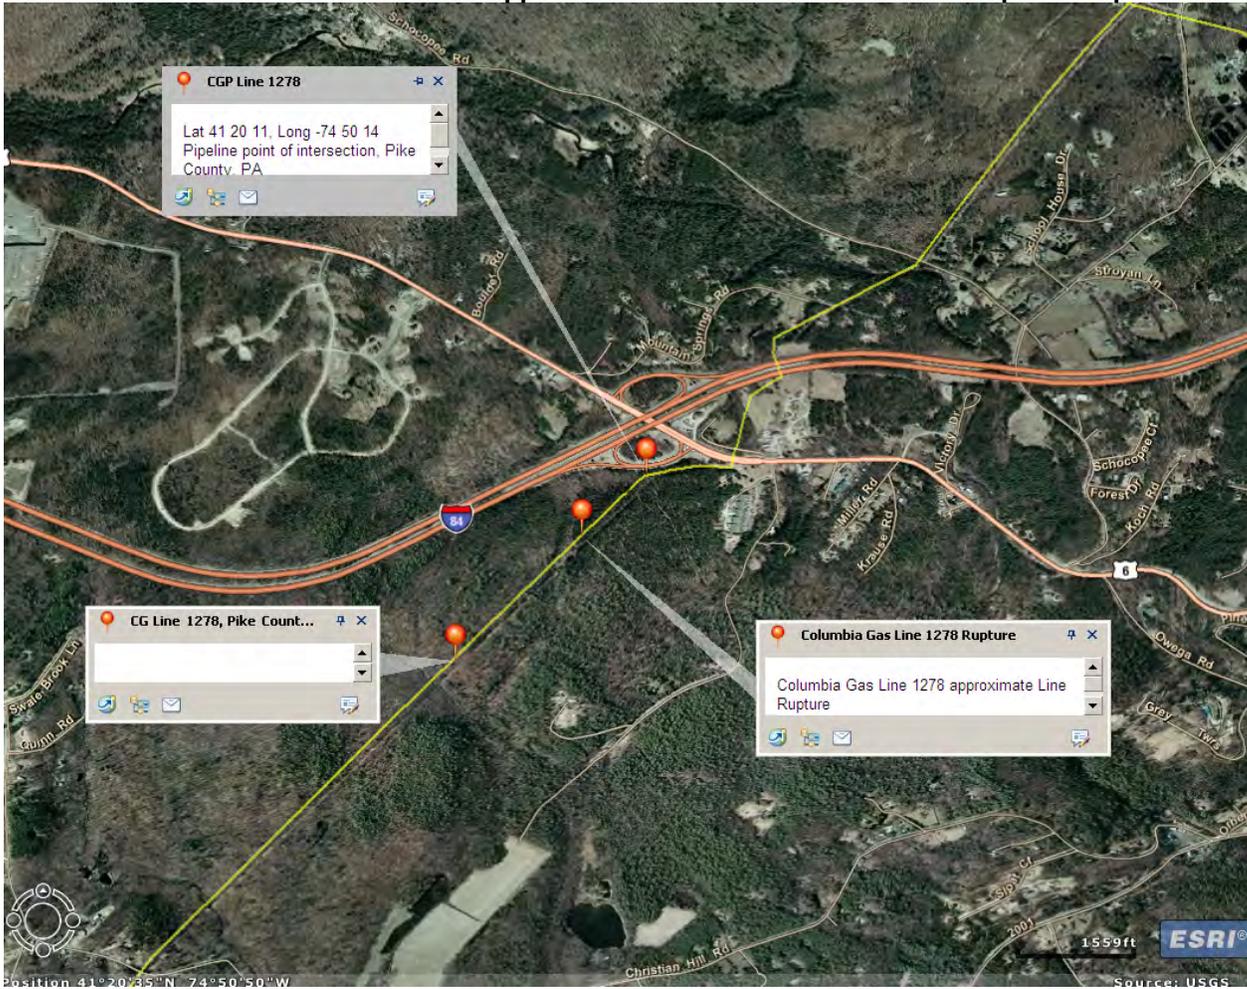
122980 Appendix 5 - Columbia Gas Line 1278 Rupture map

MP 7339+85 - 11/05/2008
Failure Location in Pike Co.
MP 7338+17 - 7343+27
replaced 510 ft with 14" pipe

After the failed section was isolated, Columbia began its investigation of the incident and its remediation to restore the line to service. Columbia installed 510 feet of new 14-inch, coated, steel pipeline in the wetland area to replace the pipe that failed. On December 6, 2008, service was restored in the pipeline.
