DOT **US Department of Transportation**
PHMSA **Pipeline and Hazardous Materials Safety Administration**
OPS **Office of Pipeline Safety**
 Eastern Region

Principal Investigator Edwin Clarkson - WV PSC
Region Director Byron Coy
Date of Report 8/5/2011
Subject Failure Investigation Report – Columbia Gas Transmission Ripley Valve Failure

Date of Failure 11/16/2009
Commodity Released Natural Gas
City/County & State Ripley/Jackson County WV
OpID & Operator Name 2616 – Columbia Gas Transmission
Unit # & Unit Name 65951 - Ripley & Rockport Storage Fields - WV
SMART Activity # 129902
Milepost / Location Latitude 38.84527 Longitude -81.69804
Type of Failure Leak - Failed cap screws on Pig Valve
Fatalities 0
Injuries 0
Description of area impacted Class 2 area, non-HCA
Property Damage \$5,167

Failure Date 11/16/2009

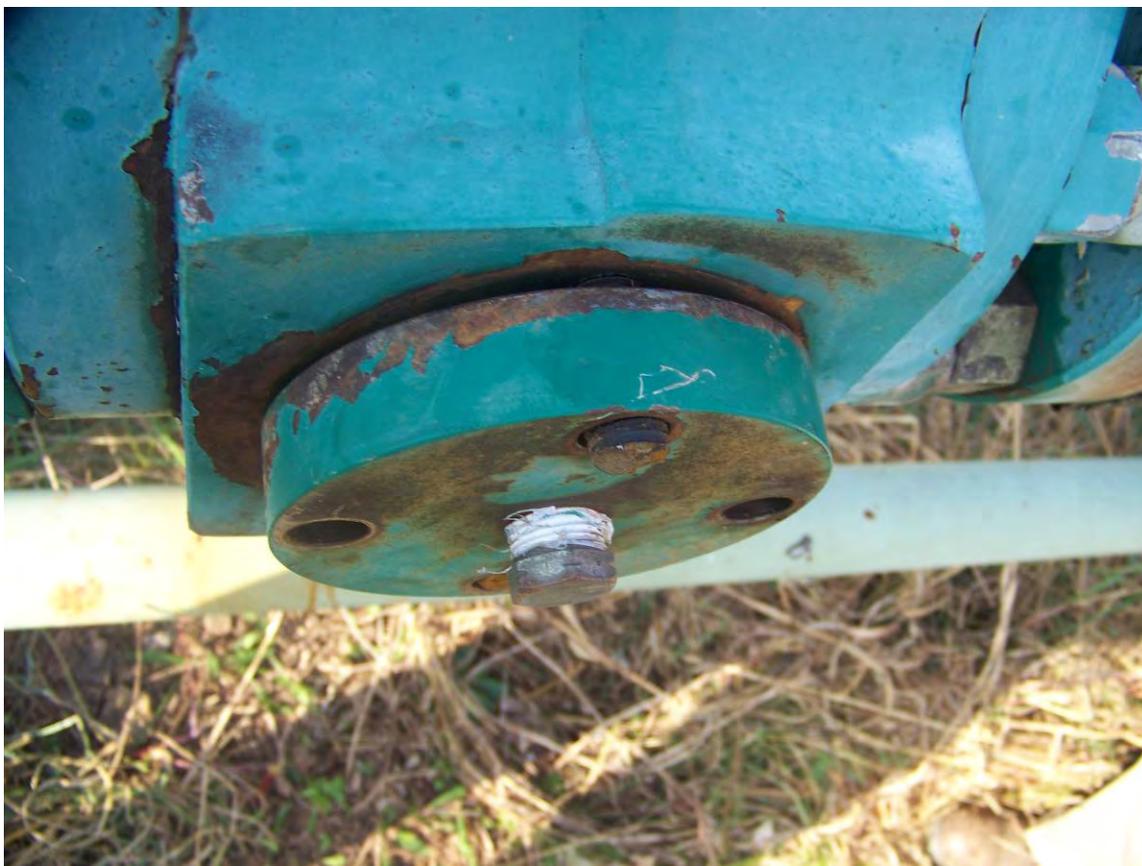
Photo 5
Columbia Gas Transmission
Ripley Storage valve failure
Manufacturer Tulsa Valve
ANSI 900 4 inch
Trunnion cover cap
Photo by ED Clarkson
West Virginia Gas Pipeline Safety

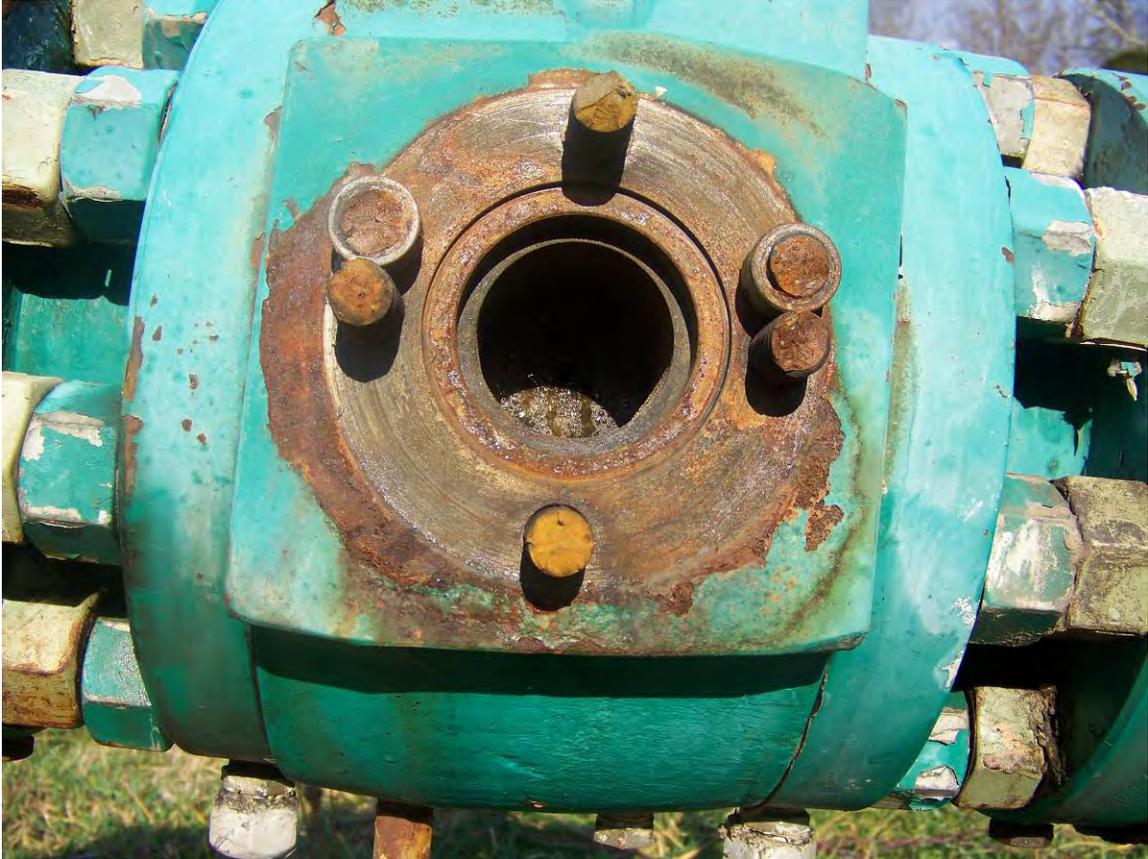
Photo 11
Columbia Gas Transmission
Ripley Storage valve failure
Manufacturer Tulsa Valve
ANSI 900 4 inch
Valve cover plate
Photo by ED Clarkson
West Virginia Gas Pipeline Safety
