**Principal Investigator** Stephen Bender  
**Senior Accident Investigator** Peter Katchmar  
**Regional Director** Chris Hoidal  
**Date of Report** 6/7/2011  
**Subject** Failure Investigation Report – Chevron Pipe Line Crude Oil Release

**Date & Time of Failure:** 12/1/2010  
**Commodity Released:** Crude Oil Condensate  
**City/County & State:** Salt Lake City/Salt Lake County, UT  
**OpID & Operator Name** 2731 Chevron Pipe Line Company  
**Unit # & Unit Name** 225 Crude System  
**SMART Activity #:** 132398  
**Milepost / Location** Milepost 175.0  
**Type of Failure:** Leak caused by Inadequate Procedures for Draining Water  
**Fatalities:** 0  
**Injuries** 0  
**Description of area impacted** Adjacent to University of Utah Campus  
**Property damage** \$7,334,364

## Failure Investigation Report – Chevron Pipe Line Co Crude Oil Release

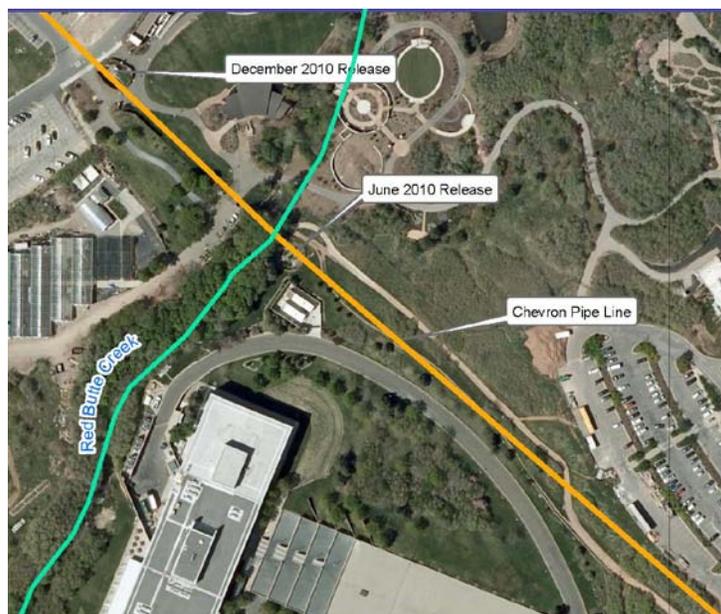
After shutdown, Chevron personnel were dispatched to patrol the right-of-way (ROW). They discovered a release of crude oil from their Number 2 line at their Red Butte Block Valve installation adjacent to the University of Utah's arboretum and 100 yards uphill from Red Butte Creek. The valve is in a below-grade open vault. The released crude oil filled the vault, spilled out of the fenced area and flowed down hill toward Red Butte Creek. The low temperatures experienced that night congealed the crude making it more viscous. The crude oil did not appear to have reached the creek.

The crude oil release occurred at a damaged 6-inch valve that “stubbed” off of the Number 2 pipeline in the Red Butte block valve vault. The failed valve served as the water injection valve for the stand up water test performed in June 2010, after the first crude oil release in this area. The valve was in the closed position at the time of the release. Forensic lab analysis of the valve confirmed that the formation of ice inside the valve opened a leak path for the oil to flow through the valve, and escape through an opening between the bonnet and valve body. The damaged bonnet/clamp ring assembly was consistent with internal pressure caused by freezing water. The failure resulted in a release of crude oil when the line was restarted but prior to detection and shut down of the line. Due to the line’s topography and the fact the leaky valve was immediately upstream of the mainline block valve, oil continued to flow out the ruptured 6-inch valve even after the shut down. The final spill amount at the time of this writing is 500 barrels, of which 250 were recovered.
