Pipeline Failure Investigation Report
OPID 2714; Unit ID 3261; NRC #N/A; Activity #127584

Pipeline System: H-197 **Operator:** Dominion Transmission
Location: Taylor Ridge, Marshall County **Date of Occurrence:** October 23, 2008
Medium Released: Natural Gas **Quantity:** Not Provided

While constructing a new cross-over connection between existing transmission lines H-197 and TL-558 the backhoe operator snagged the top of an abandoned tap on H-197 about 3" below grade. The existence of the tap was unknown to the construction crew and was not shown on the existing plant drawings. The "original" drawing (5-29-1958) did not show the existence of the 2" tap, but did note modifications done to the yard piping in 1990. The 2" tap is believed to be a pre-code component that pre-dates the drawing. The tap was damaged sufficiently to cause a leak, but the gas did not ignite. The dig-in occurred with the line in service and operating at 250 psig. Pressure was reduced to 50 psig to allow the line to be repaired. The dig-in occurred at 10:10 AM and repairs were completed at 3:30 PM. Crews left the site at 6:30 PM, October 23.

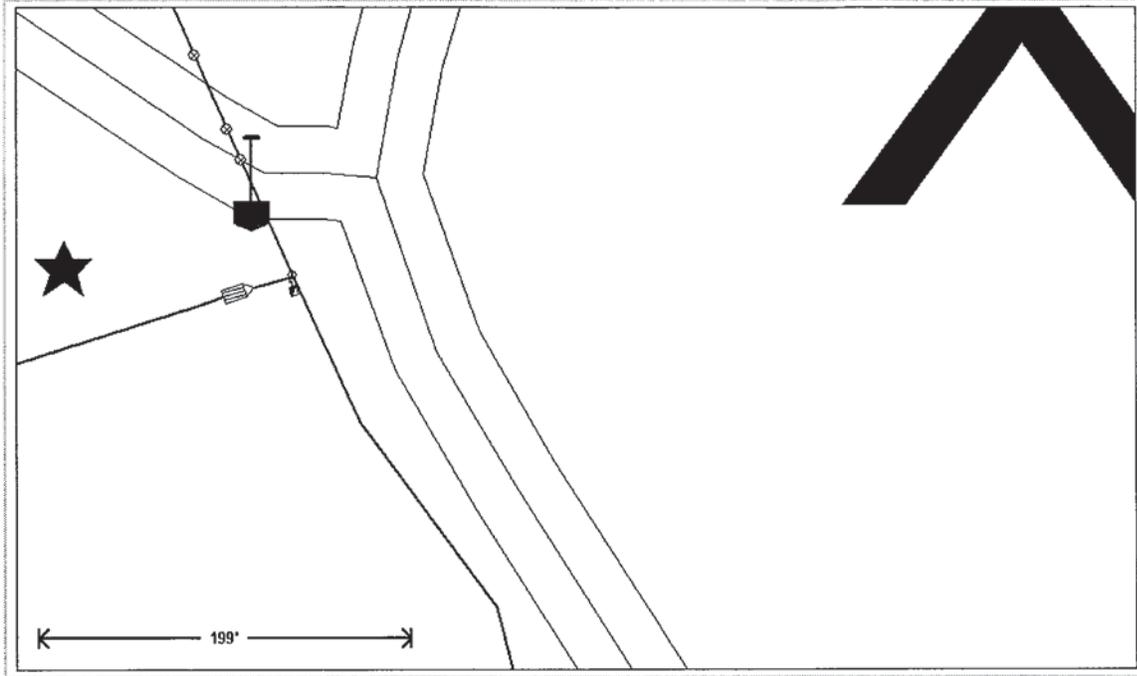
Sketch

TFIR Report No.	Inspection Date	Resp. Center	County	Township	TFIR User ID	Co. One Call Ticket No.	Ext. One Call Ticket No.	Facility in HCA?
36971	8/29/08	Bridgeport Station	Marshall	Franklin	jose415	2380341		No
Foreign/Company Facility		Facility Type	Facility Class	*	Pipeline Number	Class Location		
		Pipeline	Transmission	TL	558	Class 1		
Reason For Report	Bellhole Type	Defect Type	Discovered By	Pipe Cover	Soil Type			
In-House Construction				Soil	Earth			
SAMS Sys ID	Survey Station	Physical Location	GPS Latitude	GPS Longitude	Dist. to Nearest Structure			
		TAYLOR RIDGE	39.83879	-80.77055				
Damage Description	Property Damage	Reportable Incident Type	Report Number	WBS Type	WBS Number			
					39066.1.2			
Remarks								
TL558 PRE EVALUATION OF PIPING FOR HOT TAP
