Memorandum

U. S. Department
of Transportation
**Pipeline and
Hazardous Materials
Safety Administration**

Subject: Incident Report – Enterprise Products Operating LLC
Operator Number 31618, Unit Number 60534
Accident Location: Port Bolivar Galveston, TX
Date of Accident: December 23, 2009, NRC Number: 926954
SMART Activity # 128212 IO3

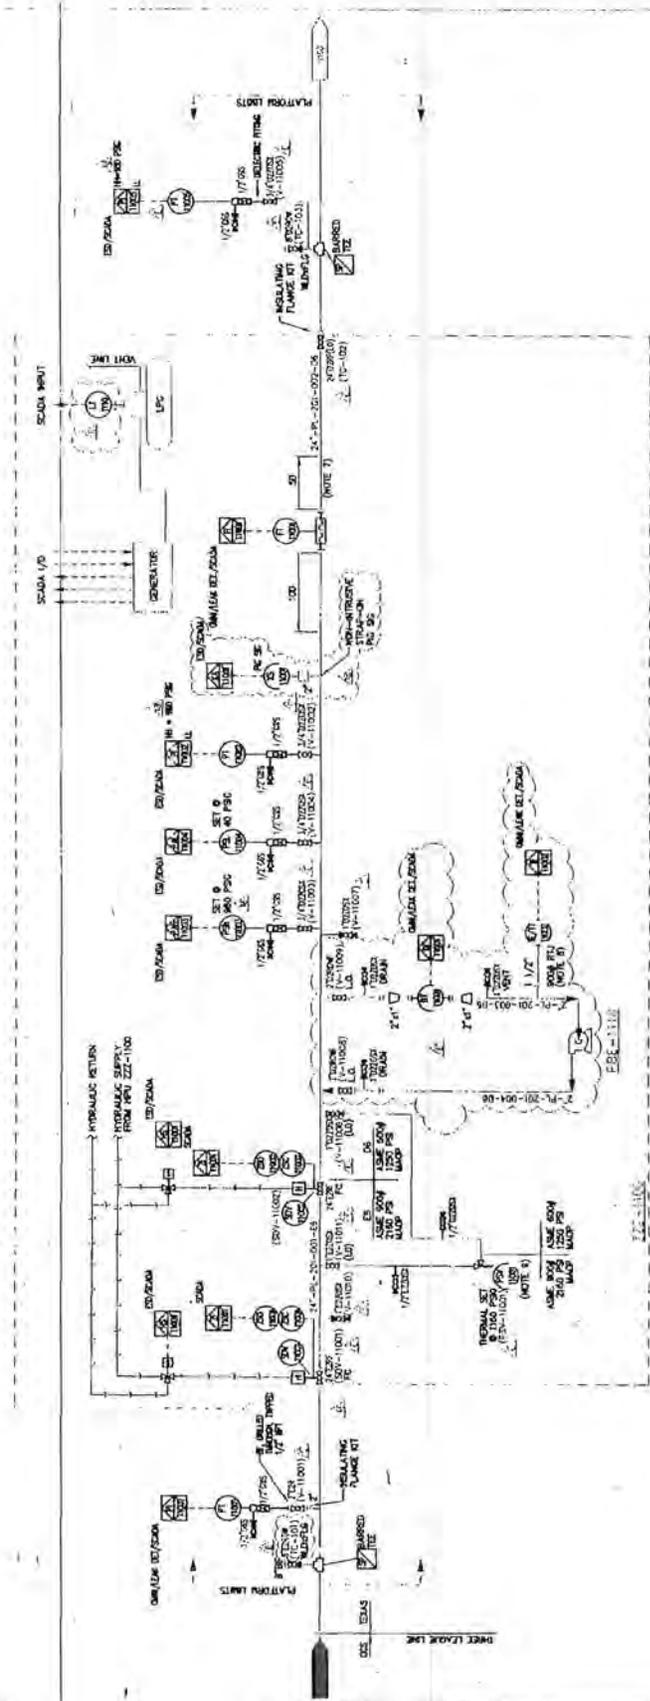
Port Bolivar Galveston station P&ID & Product Specification for the Pressure Switch that failed allowing crude oil to be released

On December 23, 2009, at approximately 7:15 am, the Galveston City Fire Department (GFD) was notified by a citizen of crude oil spraying up to 15 feet in the air at the Enterprise Products Operating LLC (Enterprise) Bolivar station in Bolivar, TX which is part of the Enterprise (EPCO) Cameron Highway Oil Pipeline System (CHOPS) crude oil transmission system. GFD arrived at the accident site at 7:30 am. The Galveston County Sheriff Department promptly notified Enterprise of the release at approximately 7:48 am. Enterprise instructed GFD not to close any valves. At approximately 8:10 am, Enterprise started shutting off crude oil from High Island A5 platform going to Bolivar station, and isolated the CHOPS system segment A5. There was no fire or explosion as a result of the accident, and an estimated 120 bbls crude oil were released to the environment (110 bbls crude oil were recovered via a vacuum truck). There was impact to the public as crude oil sheen was discovered on State Road (SR) 87 (adjacent to the Bolivar Station) causing traffic safety issues, and SR 87 was closed to the public by the Galveston County Sheriff Department (GCSD) from approximately 9:00 AM to 11:00 PM on December 23, 2009. There was impact to the environment as a result of the crude oil release, and crude oil recovery and soil remediation was completed on December 25, 2009. The nearest residential area to the accident site is ¼ mile away. The cause of the crude oil release was determined to be the failure of cap screws in a pressure switch, PSH-11003, due to hydrogen assisted cracking promoted by galvanic corrosion.

- 09:00 AM CST** – Highway 87 (in front of Bolivar Station) is closed to the Public as a result of the crude oil release. Three EPCO Field Operation Specialists arrived at the Bolivar Station. They closed ¾ inch (V-11003) Whitney ball valve, located on top of the 24 inch-line, that is used to isolate the failed pressure switch PSH-11003 to stop the product release to the environment.
