DOT US Department of Transportation  
PHMSA Pipelines and Hazardous Materials Safety Administration  
OPS Office of Pipeline Safety  
Western Region

**Principal Investigator** Peter J. Katchmar  
**Regional Accident Coordinator** Peter J. Katchmar  
**Region Director** Chris Hoidal  
**Date of Report** October 30, 2012  
**Subject** ExxonMobil Silvertip Pipeline Crude Oil Release into the Yellowstone River in Laurel, MT on 7/1/2011

## **Executive Summary**

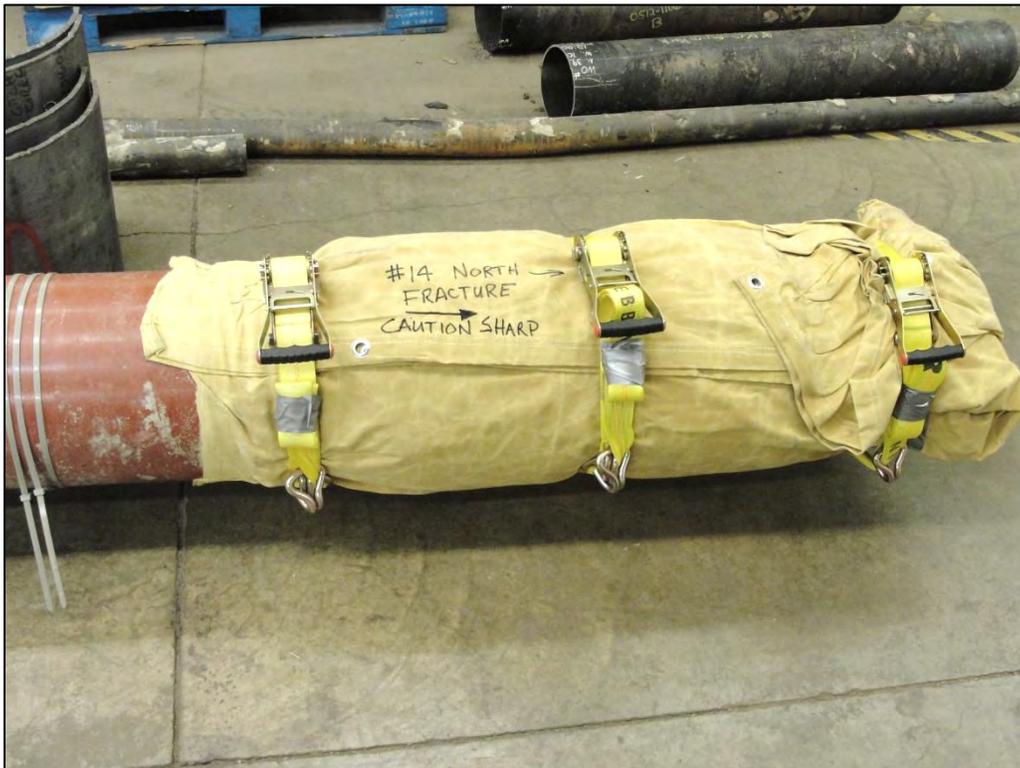
**Figure 3. Fractured end of Pipe 014 as received**

The pipe samples as received are shown in Figure 2 below. The failure occurred at a girth weld joining Pipe 014 (Tag 014) and Pipe 024 (Tag 024). These two pipe samples arrived with the fractured ends covered with a heavy fabric tarp that was held in place with ratchet straps. The wrapping was removed from piece 024 to remove a rubber bladder that had been installed in the field during the removal process. The bladder had been frozen in place prior to shipment and KAI was requested to extract the bladder and return it to the field site. The removal of the bladder was also video recorded. Other than this activity, the pipe ends were not disturbed until the examination began on May 7. Select photographs from the investigation are presented below. All photographs taken during the investigation are presented in Appendix 4.

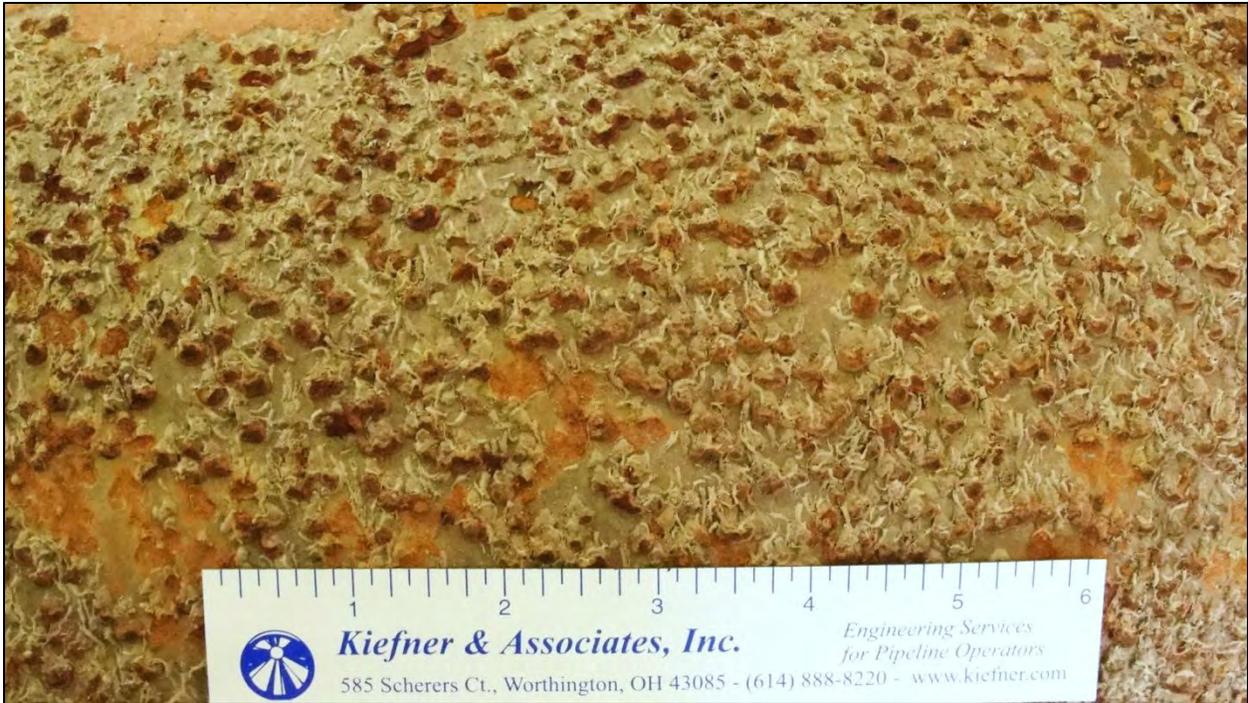
**Figure 6. Organisms on Surface of Pipe 024**

The bare steel surfaces were covered with numerous white colored elongated objects, each approximately 1/8 to 1/2 inch long, that appeared to be the remains of some type of fresh-water biota presenting worm-like or tube-like features emanating from adhered masses. We were unable to identify the species. The remains of the organisms (“worms”) were present in prolific quantities on most pipe exterior surfaces where the coating was absent, some interior surfaces, and the fracture surfaces of the failed girth weld. The adhered organisms are shown in Figure 6 through Figure 8 on the pipe exterior. The pipe surface was pitted underneath the individual masses associated with the organisms, as shown in Figure 9.

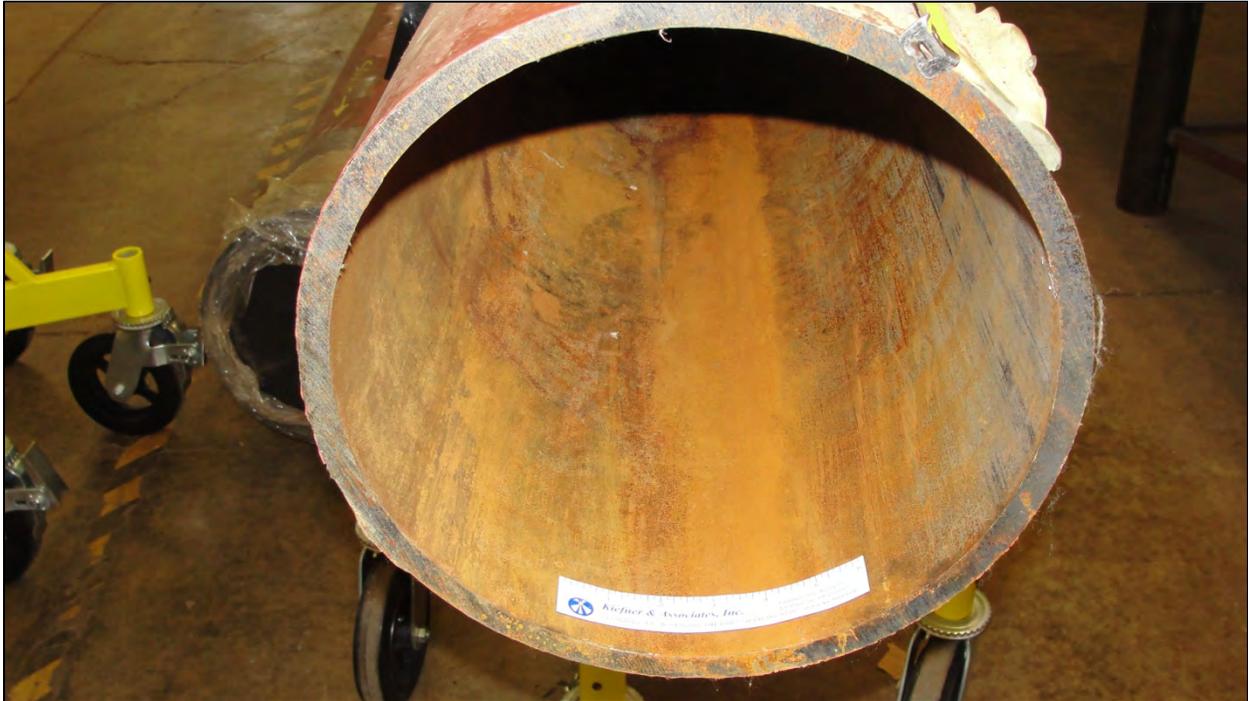
**Figure 10. Internal surface of Pipe 024**

The protocol called for examining the interior surface of Pipe 014 and Pipe 024 near the fracture. The interior of the pipe was bare and was covered in a layer of orange-colored film, likely a surface rust from exposure to water and air, visible in Figure 10 as observed typically. The interior pipe surfaces exhibited light surface pitting, similar to the pitting observed on the exterior surface of the pipe where the coating had been removed. The metal loss was superficial in depth.

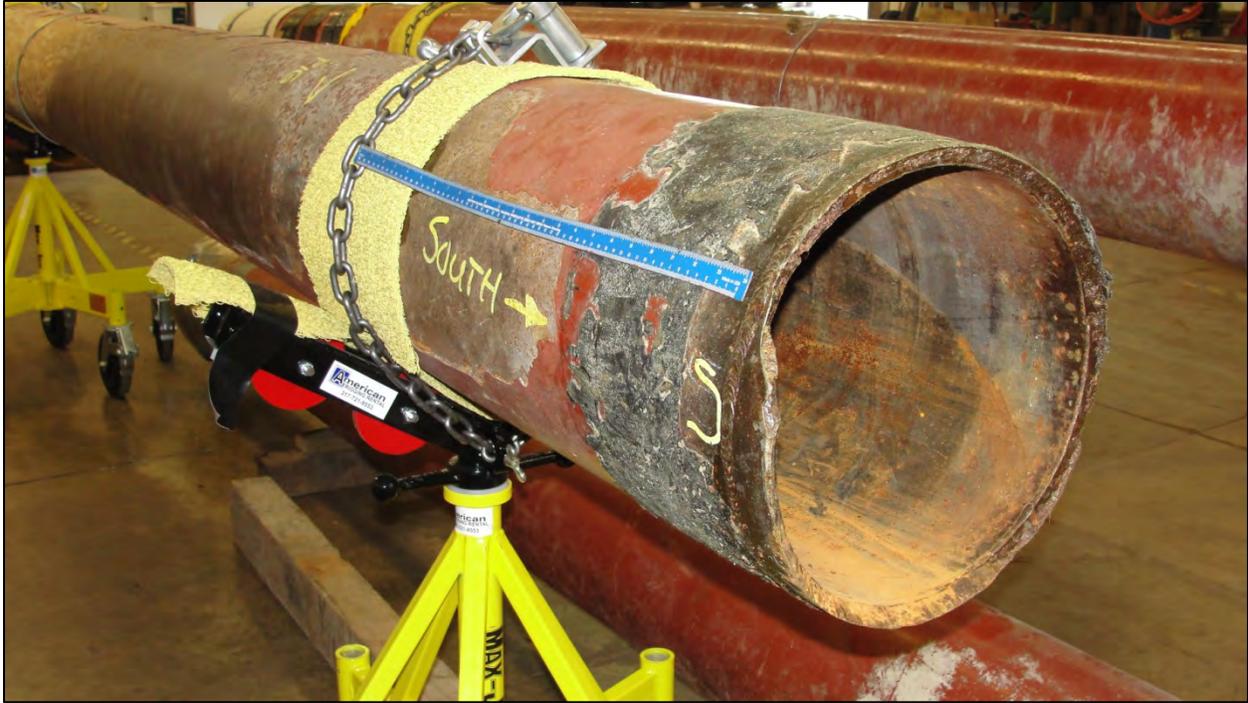
**Figure 12. Fractured end of Pipe 024**

The failure occurred as a circumferential fracture in and adjacent to the girth weld joining Pipe 014 and Pipe 024. The fracture propagated in the girth weld for a distance of approximately 28 inches and in the adjacent pipe (Pipe 014) for a distance of approximately 12 inches. The fracture is shown in Figure 12 through Figure 14. The markings visible in the figures indicate the orientation of the pipe in service. The positioning in Figure 14 is approximately the same as in service.

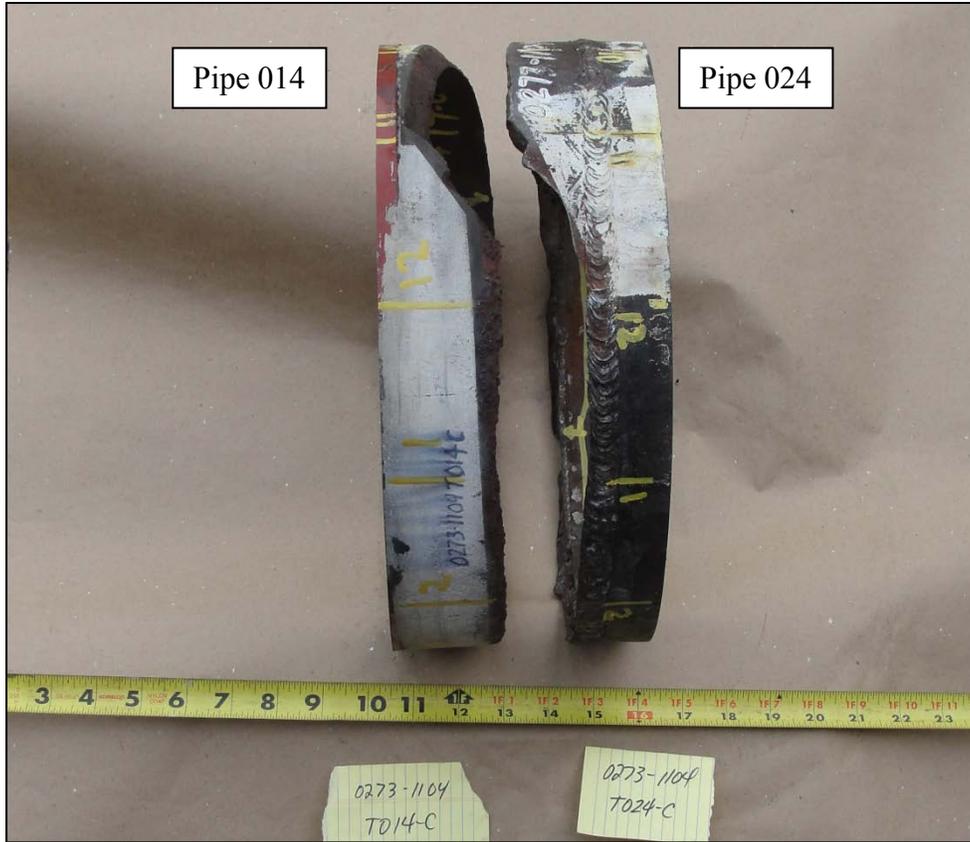
**Figure 19. Pipe rings containing fracture surfaces**

The fracture surfaces were cut from the parent pipe samples in stages. A short pup containing the fracture was cut from the longer pipe with a plasma torch. Hot cuts, such as those made with a plasma torch, were kept a minimum of 12 inches away from the fracture surfaces. The pups were put on a band saw to cut out the fracture surfaces. The resultant rings of pipe containing the fracture surfaces are shown in Figure 19 through Figure 21.

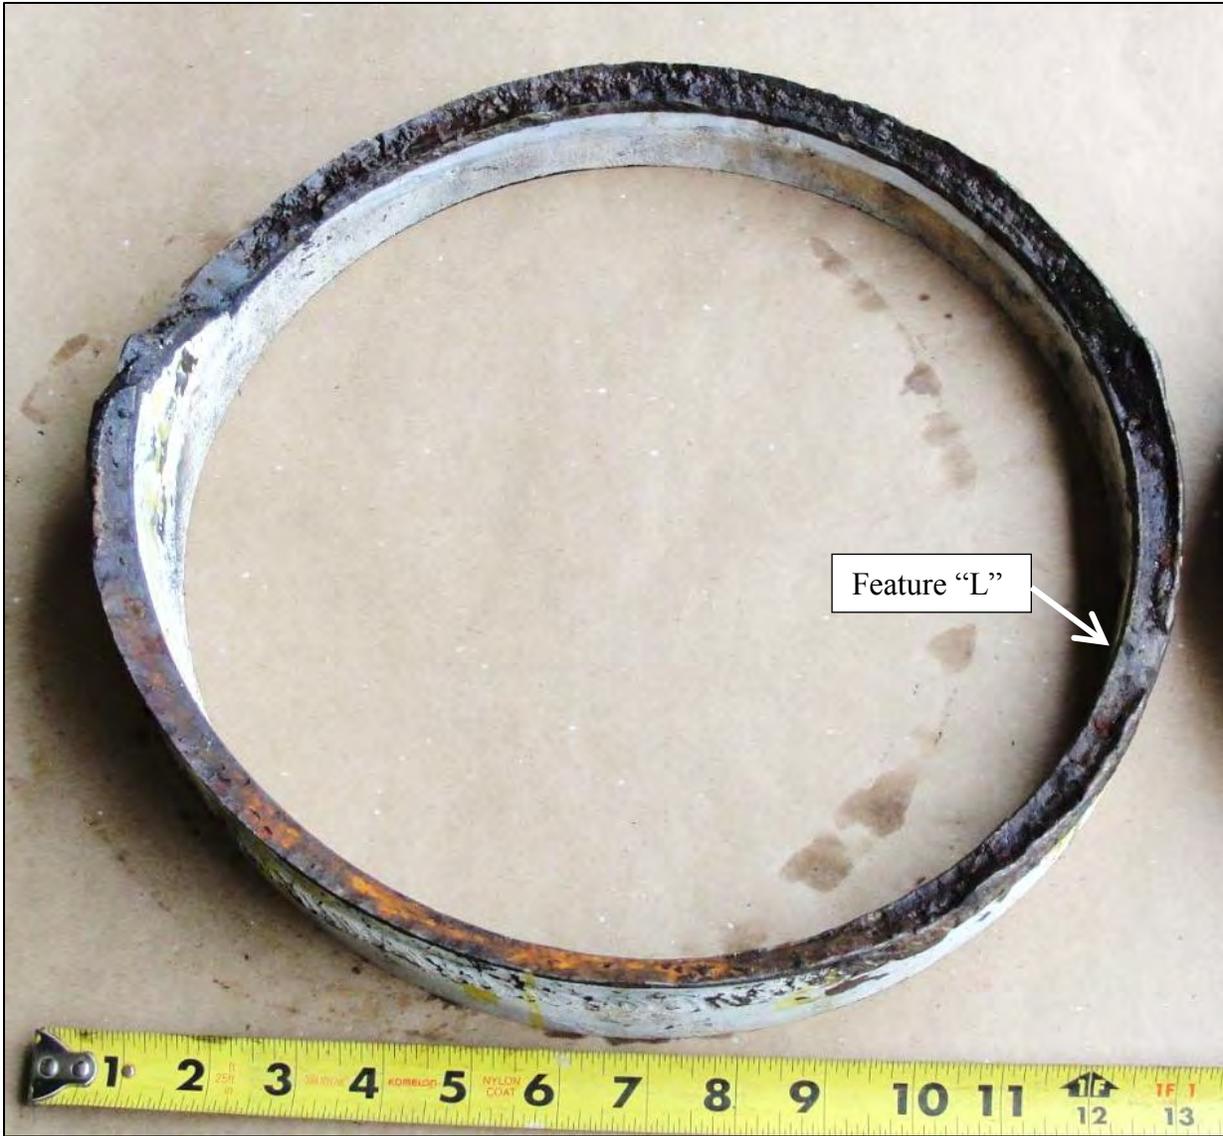
**Figure 20. Fracture surface of Pipe 024**

The fracture surfaces were examined visually and with an optical microscope. The fracture appeared to propagate in the girth weld for a distance of approximately 28 inches and in the pipe base metal for a distance of 12 inches. The portion of the fracture that propagated in the pipe exhibited a ductile, 45 degree slant fracture appearance. The appearance of the portion of the fracture that propagated in the girth weld was ductile along the outer portion of the wall thickness, near the girth weld cap. The balance of the propagating fracture surface was too obscured by the biota masses, protective coating, and corrosion to determine the mode of fracture.

Two areas of relatively flat fracture were present on the fracture surfaces. The areas were not in equal condition, such that one feature was more visible on one side of the fracture, and the other feature was more visible on the opposite side. The larger of the two features, labeled feature “L”, is shown in Figure 20 and measured 10.5 inches long on the interior pipe surface. This feature was through-thickness near the mid-length. The smaller of the two features, labeled feature “S” is shown in Figure 21 and measured 3.1 inches long by approximately 70% of the wall thickness in depth.

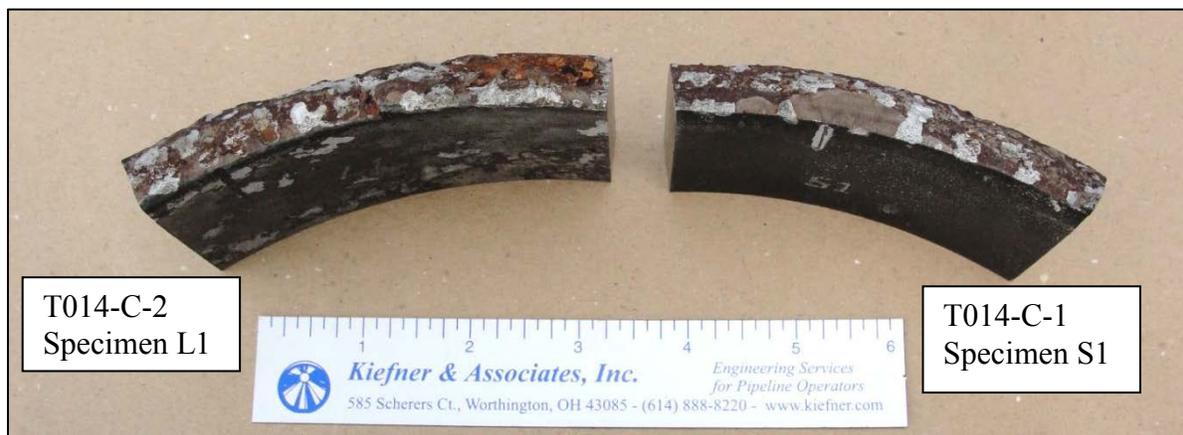
**Figure 25. Specimens S1 and L1 after Cleaning**

Figure 25 shows coupons T014-C-2 and T014-C-1, specimens L1 and S1 respectively, after cleaning. Bright pitted areas were present under each organism that was removed. The fracture surfaces of specimens S1 and L1 are shown in detail as they appear post-cleaning in Figure 26 and Figure 27, respectively.

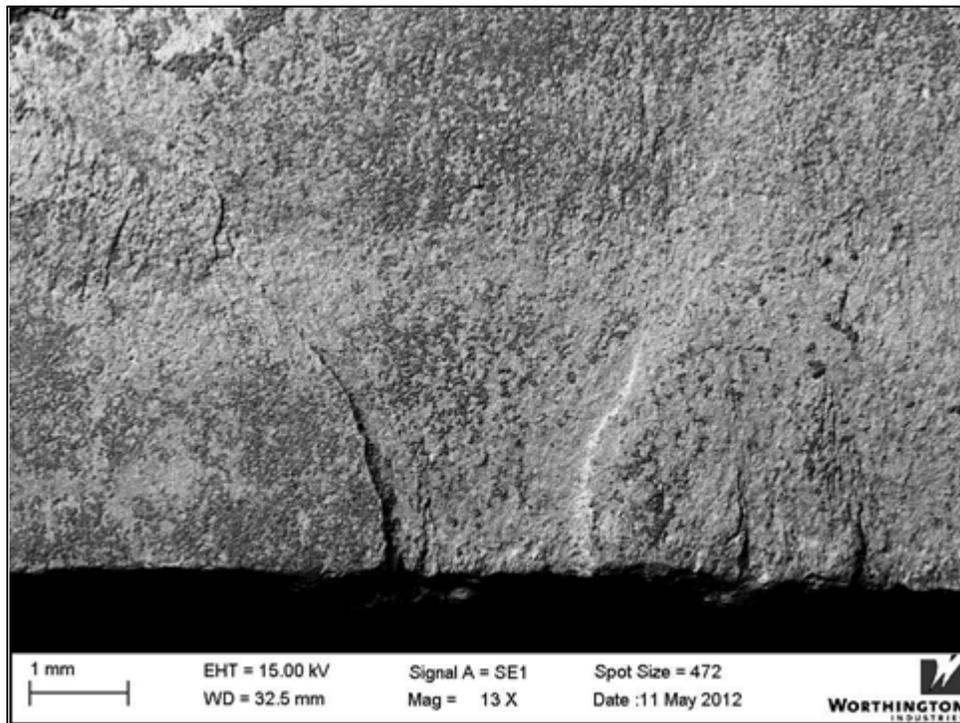
**Figure 29. SEM Image, Feature S1, Origin (13X)**

A detail of the origin region of the flat feature S1 is shown in Figure 29. Radial fracture features are prominently visible. Figure 30 shows the surface of the flat region at midwall. It appears to be corroded and covered with adherent deposit. Figure 31 shows the outer edge of the flat feature. A striated or banded feature is prominently visible. Pitting is visible above the banded feature. Figure 32 and Figure 33 show details of the banded feature at higher magnification. Figure 34 and Figure 35 present an elemental analysis using energy-dispersive spectroscopy (EDS) of the dark and light regions in the banded feature. The EDS analysis shows that the dark bands are a foreign deposit consisting primarily of calcium (Ca), silicon (Si), and oxygen (O). The regions between the dark bands are primarily iron (Fe) with traces of oxide. Figure 36 is a detail of the pitted region above the banded feature. Figure 37 is a detail of the surface within the pit, showing primarily etched surface. An EDS analysis shows the pit surface to be exposed metal with no deposits, Figure 38.

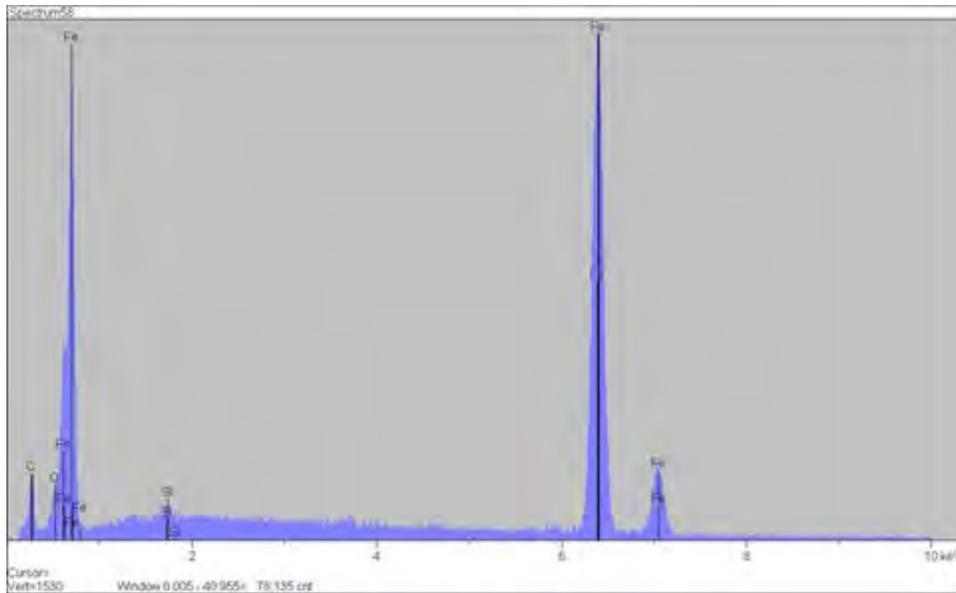
**Figure 38. EDS Analysis, Pitted Surface**

The SEM examination was unable to confirm a mode of crack growth and fracture, due to the corroded surfaces. Significant pitting occurred under regions where biotic species had adhered to the steel. The pitted surfaces were severely etched, suggesting a low-pH environment.

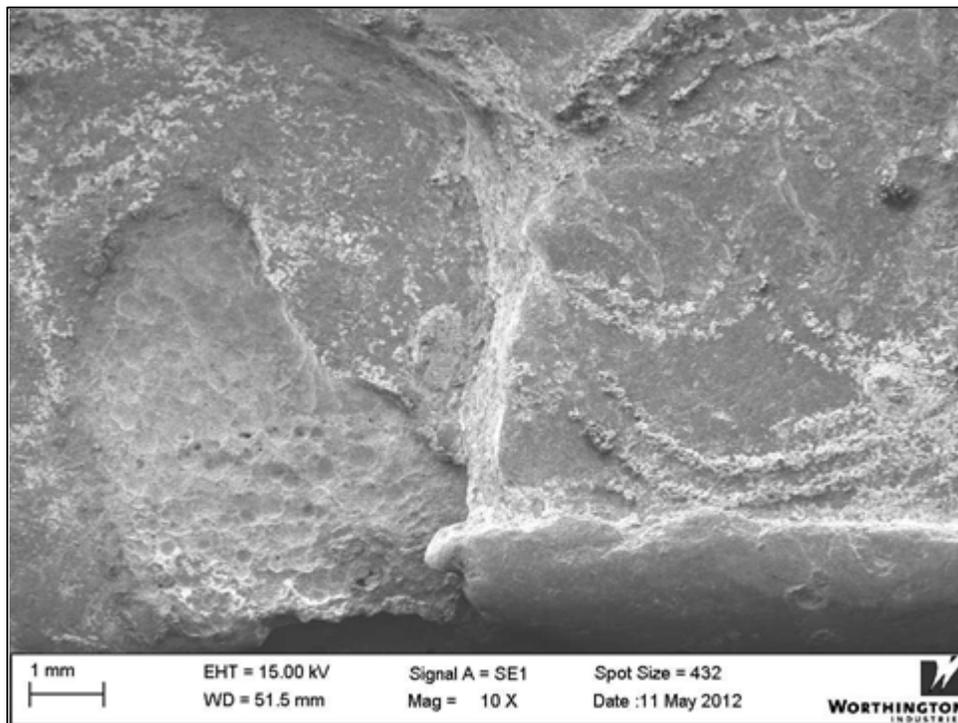
**Figure 39. SEM Image, Specimen L1, Thumbnail Near Pipe ID**

Specimen L1 was also examined in the SEM. Its surface was in worse condition than Specimen S1 and yielded virtually no information about fracture modes. Traces of biotic residue were plentiful, e.g. Figure 39, typical. Figure 40 and Figure 41 show details of this feature in backscatter and normal modes. Figure 42 presents an EDS analysis of the feature.

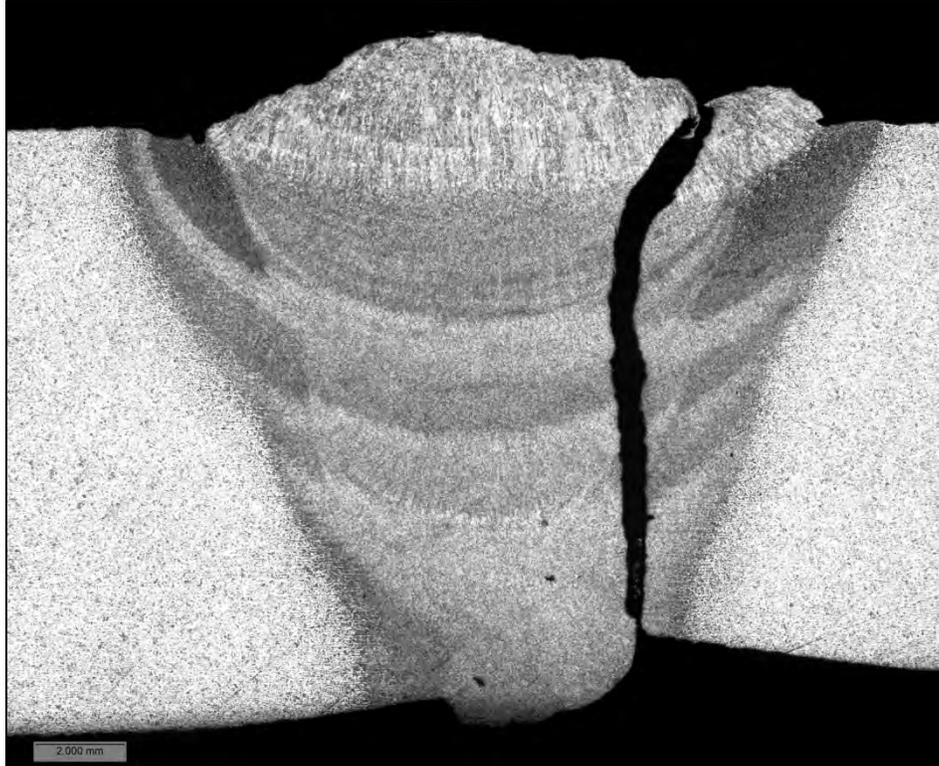
**Figure 51. Metallographic section through Feature L**

The metallographic section through Feature L, Figure 51, shows approximately the same morphology. The feature, a crack, initiated at the toe of the root pass and propagated relatively flat and straight through approximately 80% of the deposited girth weld metal thickness before exhibiting ductile shear fracture in the outer 20% of the weld thickness.

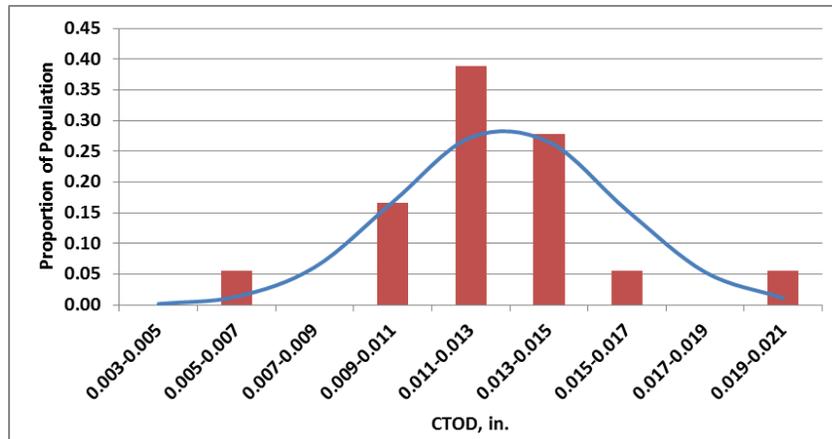
**Figure 54. Distribution of CTOD Measurements**

The results of the CTOD tests are given in Table 11 and Table 12. The CTOD test reports are presented in Appendix 7. The CTOD results were similar in WM and HAZ samples, and did not vary greatly among the three welds. The mean value was 0.013 inch with a standard deviation of 0.0028 inch. The minimum and maximum single observed CTOD were 0.006 and 0.020 inch, respectively, corresponding to the mean plus or minus 2.5 standard deviations (approximately). The distribution of observed CTOD appears to be normally distributed, as shown in Figure 54. All observed CTOD measurements were in the ductile range.

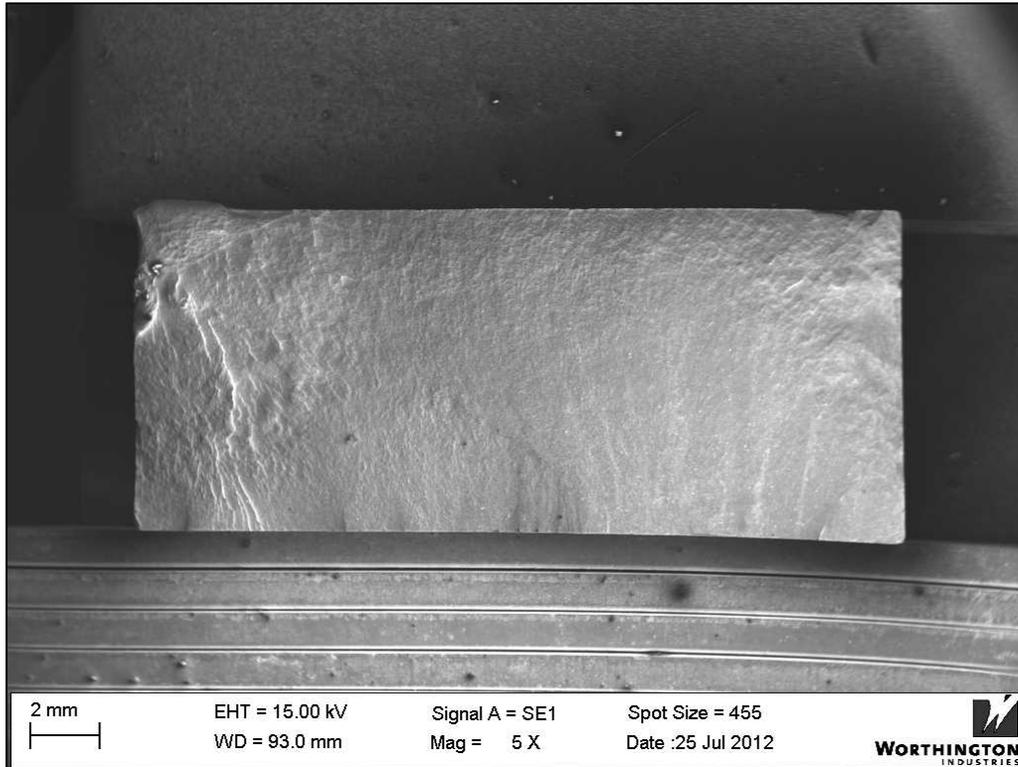
**Figure 56. Overview of Cracked CTOD Specimen Viewed on SEM**

A portion of the CTOD specimen containing the crack surface was cut off to facilitate examination in the SEM. The surface was cleaned in an ultrasonic cleaner in a solution of Alconox and water. The surface exhibited features similar to those of feature S, including surface corrosion damage. Figure 56 shows an overview of the cracked surface of the CTOD sample. No

weld defect was present on the surfaces. The upper left corner of the specimen was the intact portion that broke during machining. Figure 57 shows the leading edge of the crack near this corner at 100X magnification. A detail of this area is shown in Figure 58. The fracture surface shows evidence of corrosion damage even in the part of the crack that would have been expected to be tight and most protected from corrosion damage.

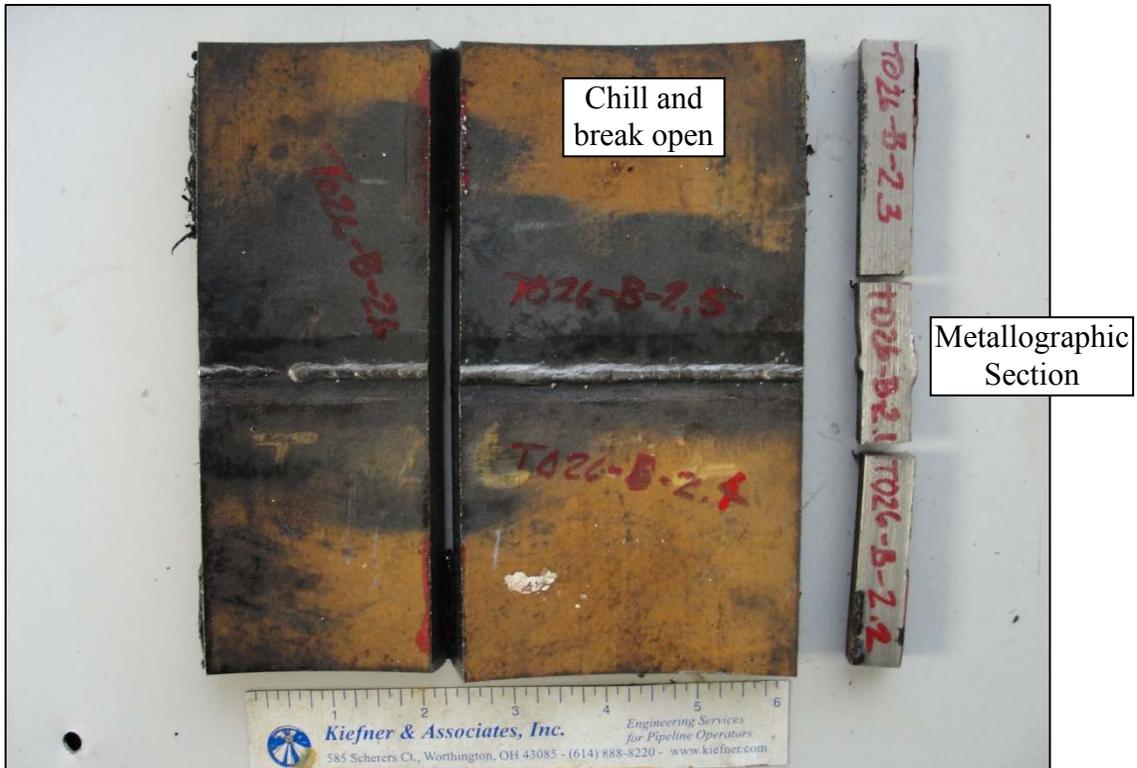
**Figure 60. Coupon T026-B-2 cut for additional examination**

The coupon was cut to provide a sample for metallographic examination and the remaining portion was chilled and broken open. Figure 60 shows how the coupon was cut and the locations of the metallographic section and the sample that was broken open.

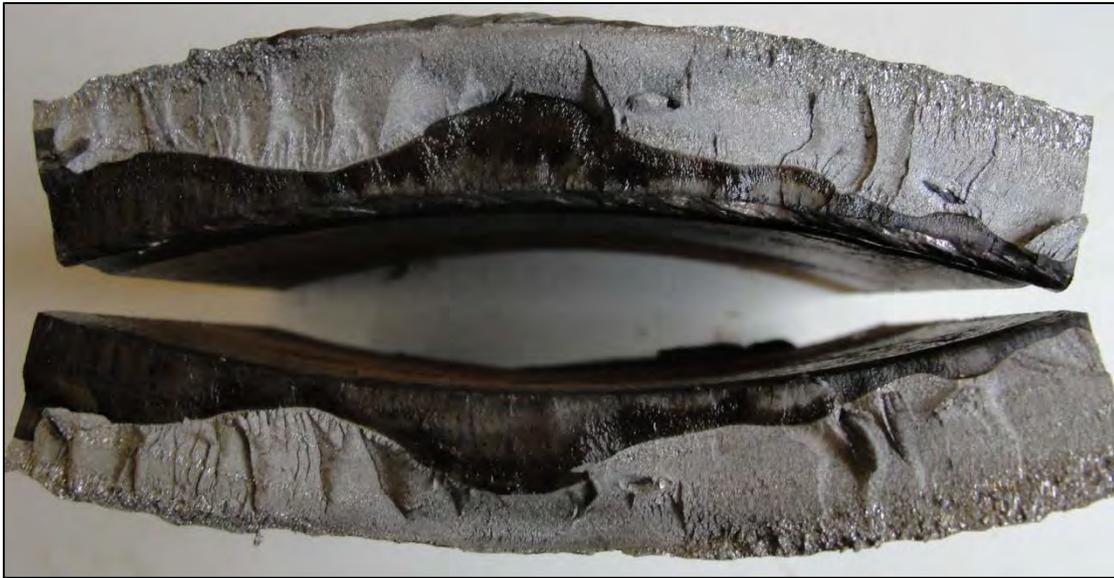
**Figure 63. Crack surfaces, Coupon T026-B-2 after breaking open**

A portion of the crack indication was chilled in liquid nitrogen to promote brittle behavior and broken open to reveal the surfaces of the crack. The exposed surfaces are shown in Figure 63 placed ID to ID. The crack is seen to be continuous along the internal pipe surface with varying depth along its length. The crack is stained a dark color and appears to contain crude oil along the deepest portion of the crack. The crack surfaces are relatively smooth and flat with radially-oriented features.

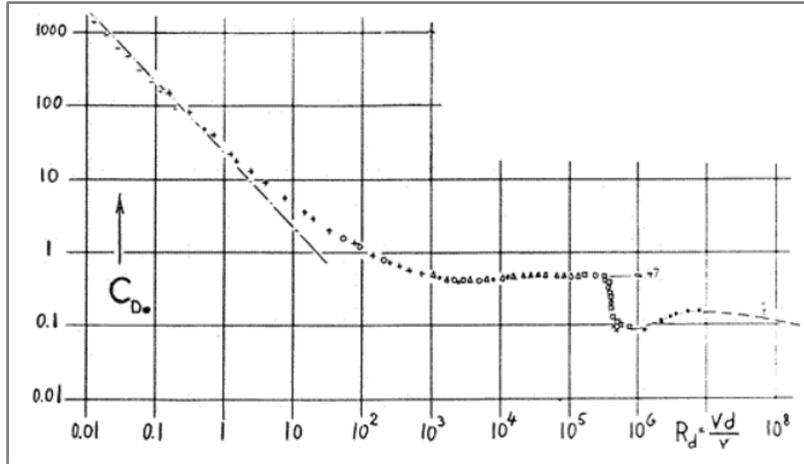
**Figure 64. Coefficient of Drag**

The drag coefficient  $C_D$  was estimated in accordance with published data as summarized in the curve shown in Figure 64.<sup>2</sup> The resultant of the steady drag force with the buoyant weight was determined, as shown in Figure 65. A gap between the pipe and the river bottom of less than one pipe diameter can reduce the velocity of the fluid acting against the pipe and the resulting drag forces. The actual bottom separation during the flood was not known so this effect, if present, was unaccounted for.

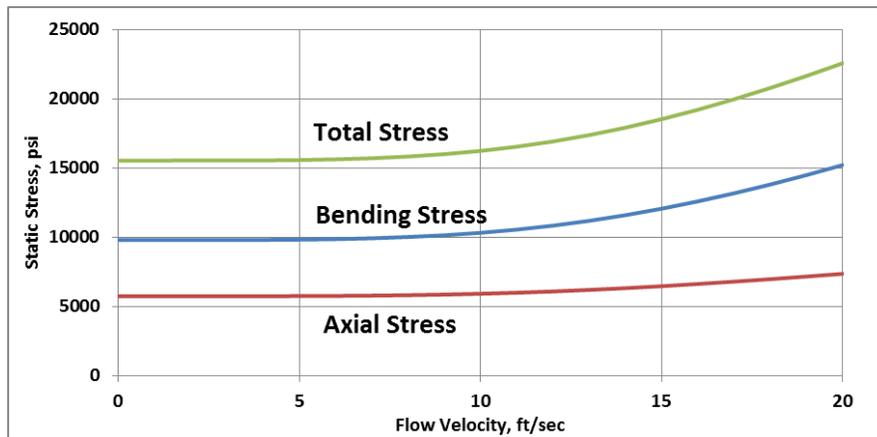
**Figure 66. Static Stresses Due to Spanning and Current Impingement**

The stress due to buoyant weight acts in the vertical plane and produces a net stress of 15,524 psi and a sag or deflection of 2.29 ft in the 207-ft exposed span length. The axial and bending stress induced by flow impingement varies with the stream velocity, which acts in the horizontal plane. The resultant produces the net static stress due to spanning. These are shown in Figure 66, not including the axial stress due to internal pipe pressure. The effect of the flow-induced drag forces on total stress is minor with flow velocities below 10 ft/sec.

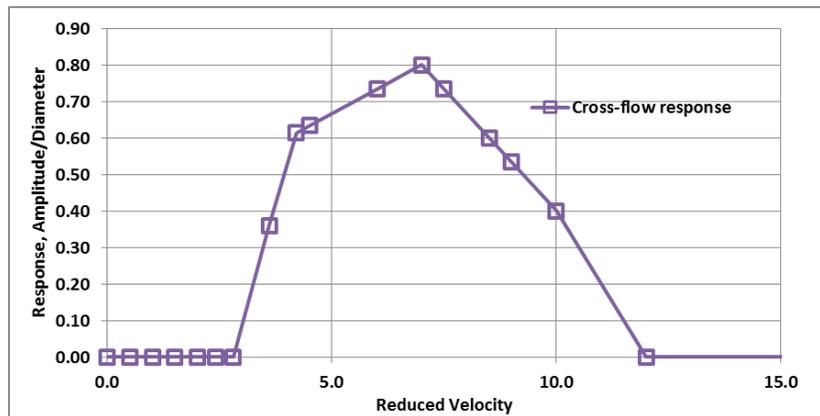
**Figure 67. Cross-flow Dynamic Response**

amplitude applied in this analysis<sup>6</sup> is shown in Figure 67 as a function of Reduced Velocity. Susceptibility to VIV is greatest where  $V_r$  is between values of 4 and 10.

The first-mode peak response of A/D = 0.8 from Figure 67 corresponds to a stress in the pipe of around 5.8 ksi based on the ratio of static stress and deflection. Second and third modes would broaden the response to higher water velocities with peak responses around 7 and 10 ft/sec, respectively. Concurrent excitation of higher modes would add to the dynamic stresses.

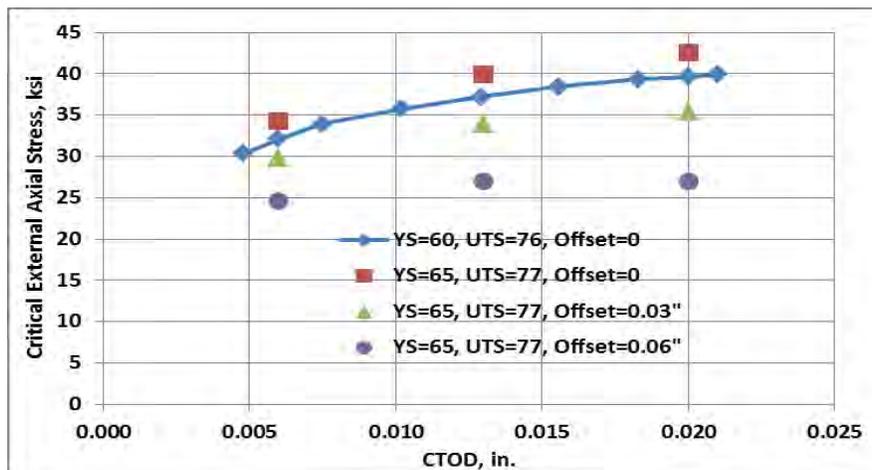
Figure 68. API 579 Critical Load Analysis

API 579, a recognized fitness for service standard,<sup>10</sup> was used to estimate the critical load that would cause failure in the remaining pipe cross section. The analysis applied the Failure Assessment Diagram (FAD) approach for a circumferentially-oriented surface crack on a pipe cross section, in accordance with Section C.13.5. Mechanical strength and weld ductility data from the exemplar welds, reported earlier, were used with the analysis. The analysis was performed for a circumferential flaw 10 inches long and having a depth of 80% of the wall thickness approximately representing the large fatigue crack at the 5:30 position. The smaller fatigue crack at the 1:00 position was not accounted for. The estimated critical stresses are presented in Figure 68.

The solid curve gives results considering the lowest observed yield strength (YS) and ultimate tensile strength (UTS), and using the mean CTOD (0.013 inch) plus or minus one, two, and three standard deviations, and also the lowest (0.006 inch) and highest (0.020 inch) measured CTOD. The square symbols above the curve represent results considering the highest YS and UTS, and the lowest, average, and highest CTOD. The triangle and circle symbols represent the same strength and ductility properties but with high-low across the weld joint of 0.03 inch (1/32 inch) and 0.06 inch (1/16 inch), respectively, which bracket the amount of high-low observed in metallographic cross sections where high-low was present.

API 579 is generally conservative. Actual stresses to cause failure could be greater than predicted by 25% to 50%.<sup>11,12</sup> Taking this inherent conservatism into account, the results indicate that applied stresses on the order of 30 ksi or more would have been required to cause the final fracture, which exceeds the sum of static and dynamic stresses estimated above, unless water velocities were very high. This suggests that larger loads had developed on the pipe than what was estimated for the effects of spanning for water flowing over the pipe. Such loads could have developed from the effect of water flow impinging on debris trapped against the exposed pipe, such as trees and brush, building materials, or other items washed in from upstream. The debris might alter or stop the oscillation pattern of the pipe, but would increase the net tension acting on the pipe over time as more debris accumulates.
