DOT US Department of Transportation
PHMSA Pipeline and Hazardous Materials Safety Administration
OPS Office of Pipeline Safety
Eastern Region

Principal Investigator Robert Burrough
Senior Accident Investigator Michael Yazemboski
Region Director Byron Coy
Date of Report 07/25/2013
Subject Failure Investigation Report
Buckeye Partners Pipeline Gasoline Leak

Line 620 Gasoline Leak

Hillsborough, NJ

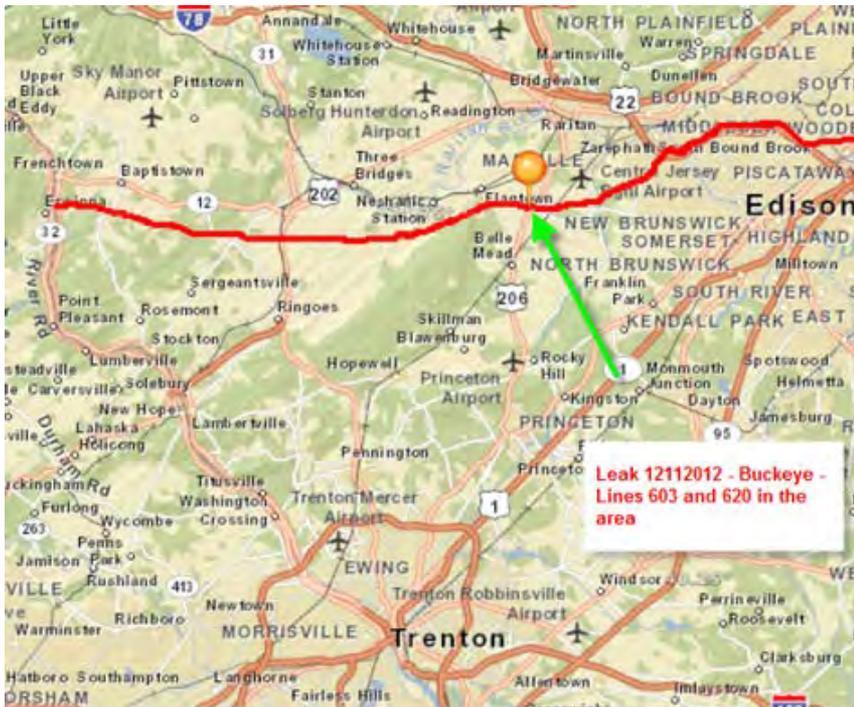
Map of Hillsborough, NJ Area and Buckeye Pipelines 603 and 620

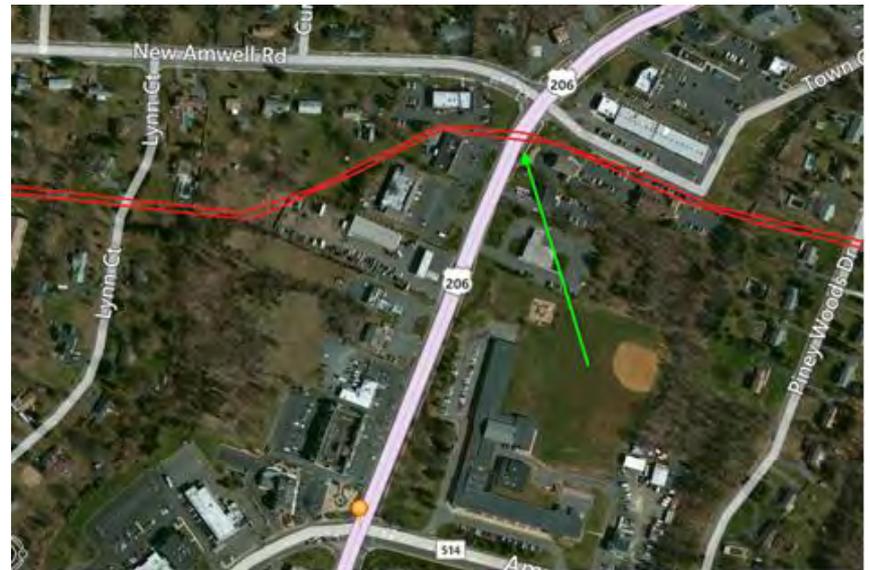
West Side of Rt 206. Excavation of Line 620. PSE&G Nat Gas Distribution pipeline crosses above BPL's line at an angle. Looking from west to east under Rt 206. 20" pipeline with 24" casing. Date 12/13/2012
