DOT US Department of Transportation
PHMSA Pipelines and Hazardous Materials Safety Administration
OPS Office of Pipeline Safety
Southwest Region

Date of Report October 23, 2013
Subject Failure Investigation Report – Mobil Pipe Line Company; Pegasus Pipeline, Mayflower, AR

Failure Investigation Report – Mobil Pipeline Pegasus Rupture
March 29, 2013

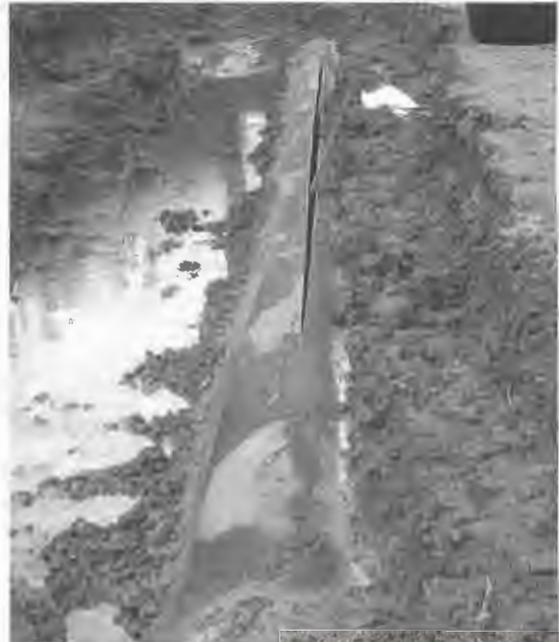
Figure 5 Failed Pipe Section – MP 314.77

The failed pipe section was examined at the site. There was no apparent external damage, and no signs of significant internal or external metal loss. The coating was intact, and generally well adhered. The failure was a longitudinal split originating near the ERW long seam at roughly the 12:00 position, and extended on either side for a total length of approximately 22 feet along the seam and 3 inches into the base metal. The widest opening in the tear was approximately 1 and 3/8 inches.

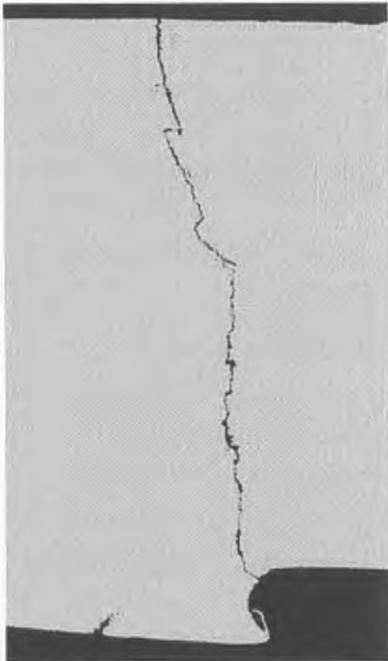
Figure 6 – Hook Crack at Failure Site

The pipe exhibited hook cracks in the ERW seam. Hook cracks are defined by API Bulletin 5TL as “metal separations resulting from imperfections at the edge of the plate or skelp, parallel to the surface, which turn toward the inside diameter or outside diameter pipe surface when the edges are upset during welding.” From a metallurgical standpoint, the “defect” in the pipe is the upturned grains containing brittle martensite, which were formed during the welding process. The hook cracks occurred due to this undesirable or defective grain flow in the ERW seam.

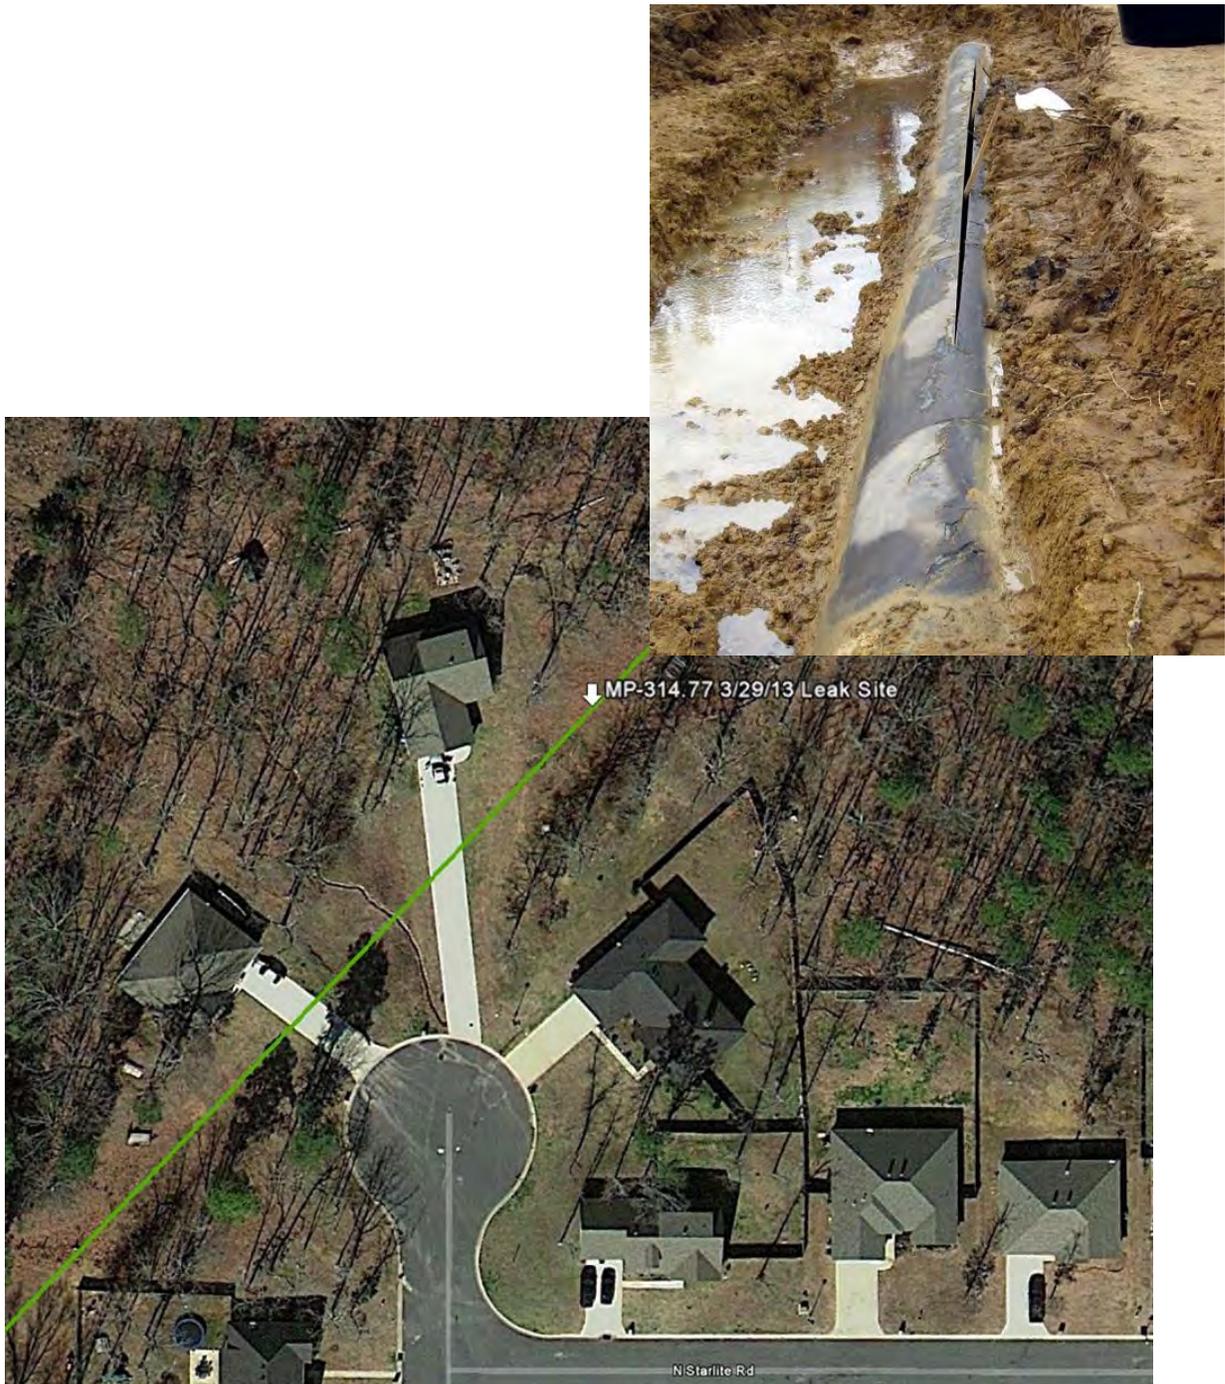
Photograph No. 1

The photographs provided by EMPCo of the 20" O.D. x 0.312" wall pipe at Milepost 314.77 of the Conway to Corsicana Pegasus crude oil pipeline, which failed on Friday, March 29, 2013 at 2:47 pm CST in Mayflower, Arkansas, display a straight, linear crack at approximately the 12:00 o'clock position.

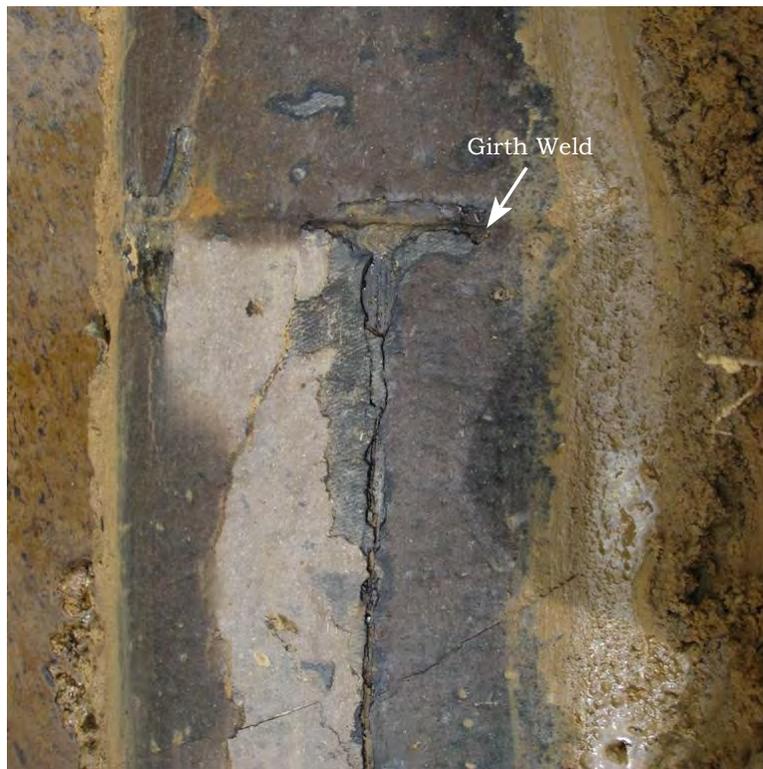
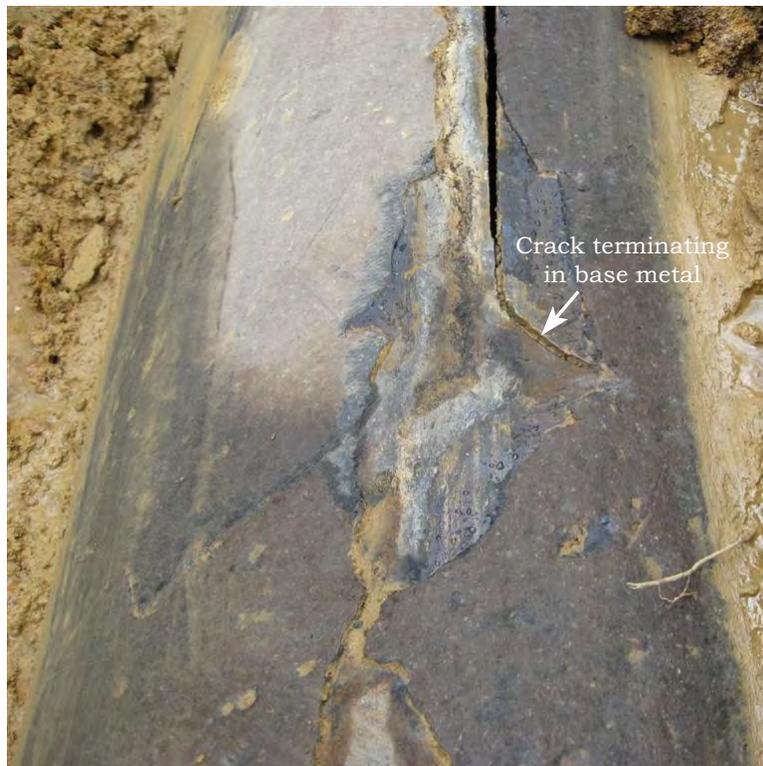
The photographs display close-up views of the crack tips near the north girth weld in the ERW seam of the pipe and the south end in the base metal, respectively.

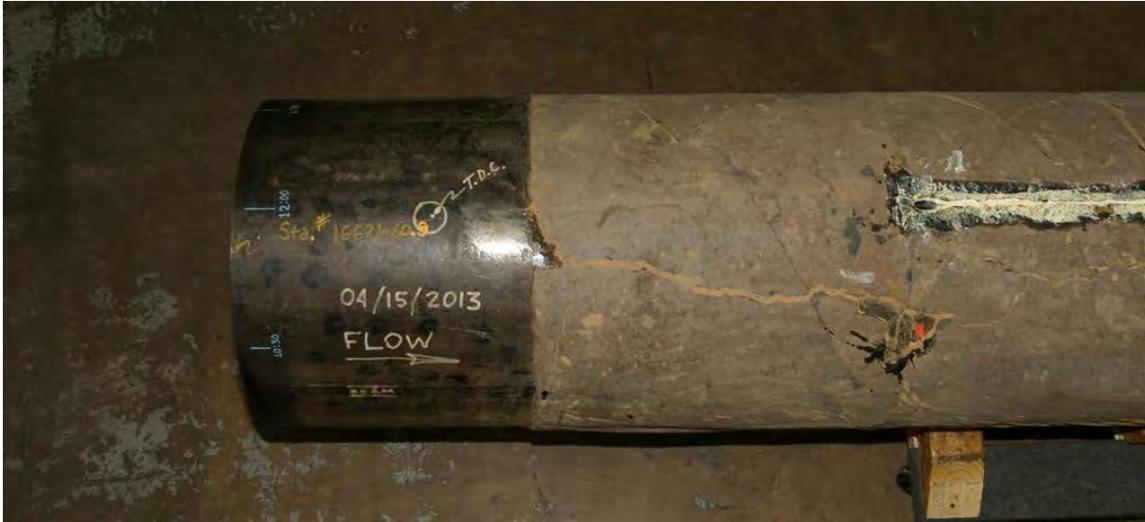
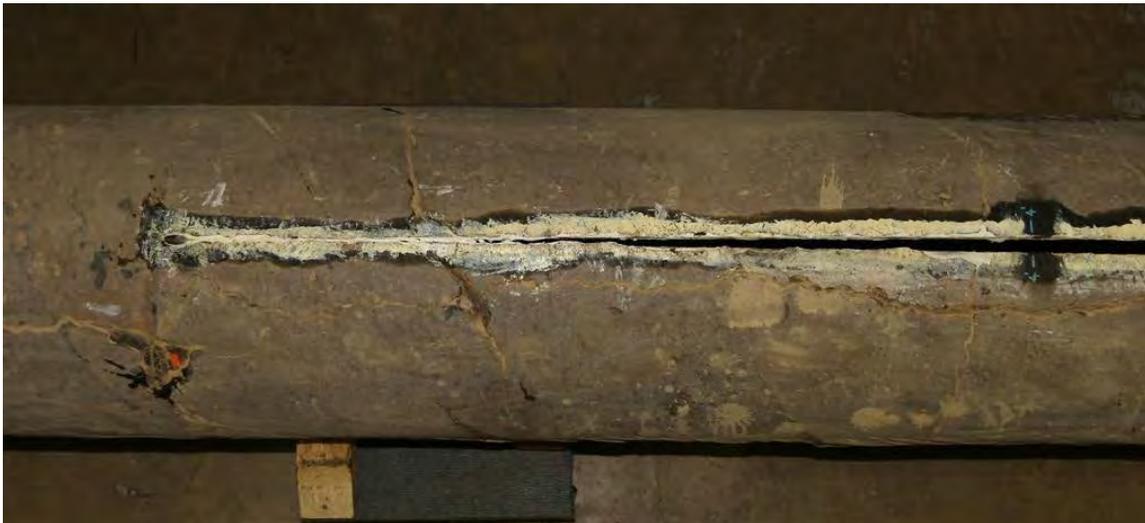
The photographs display overall top views of the pipe adjacent to the fractured pipe from approximately 3' north of the north girth weld (-3') to the center of the north girth weld (0'), and the fractured pipe from the center of the girth weld to 4' south of the north girth weld, respectively, in the as-received condition prior to removing the coating. The fracture in the pipe along the ERW seam terminated at the north girth weld. The fracture was extremely tight at the girth weld but was measured to be approximately 13/16" in width approximately 4' south of the north girth weld. Relatively narrow longitudinal and transverse splits were present in the coating. The coating had been removed from the adjacent intact pipe prior to sectioning approximately 3' north of the north girth weld.

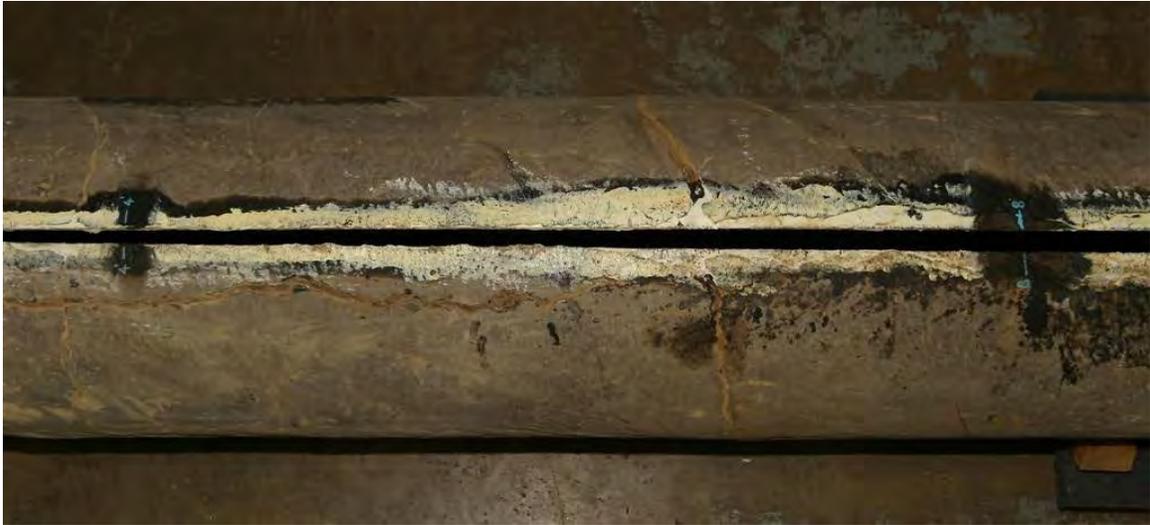
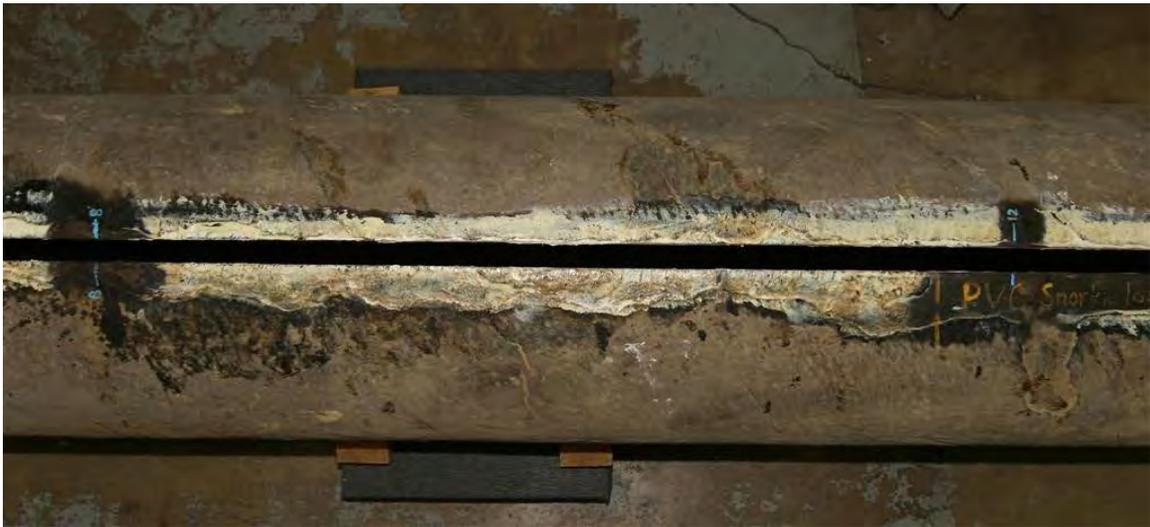
The photographs display overall top views of the fractured pipe from 4' south to 8' south of the north girth weld, and from 8' south to 12' south of the north girth weld, respectively, in the as-received condition prior to removing the coating. Longitudinal and transverse splitting is present in the coating, and some of the coating is missing on either side of the fracture.

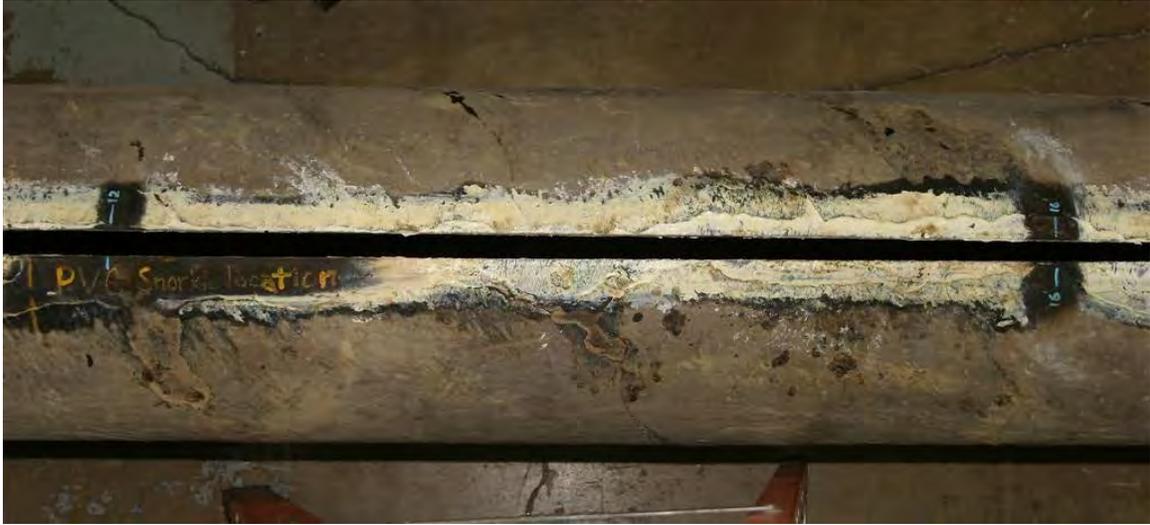
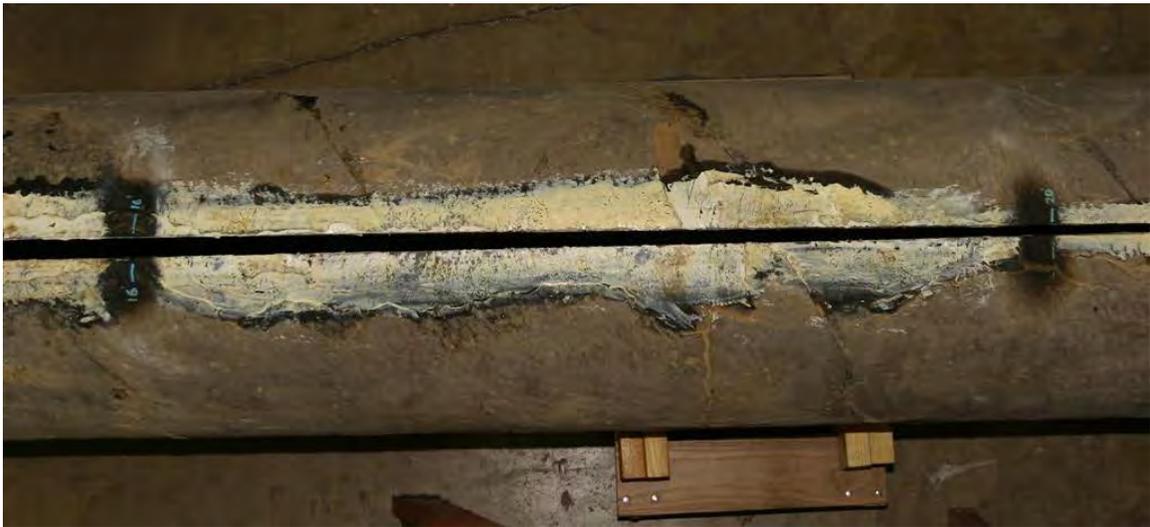
The photographs display overall top views of the fractured pipe from 12' south to 16' south of the north girth weld, and from 16' south to 20' south of the north girth weld, respectively, in the as-received condition prior to removing the coating. Longitudinal and transverse splitting is present in the coating, and some of the coating is missing on either side of the fracture.

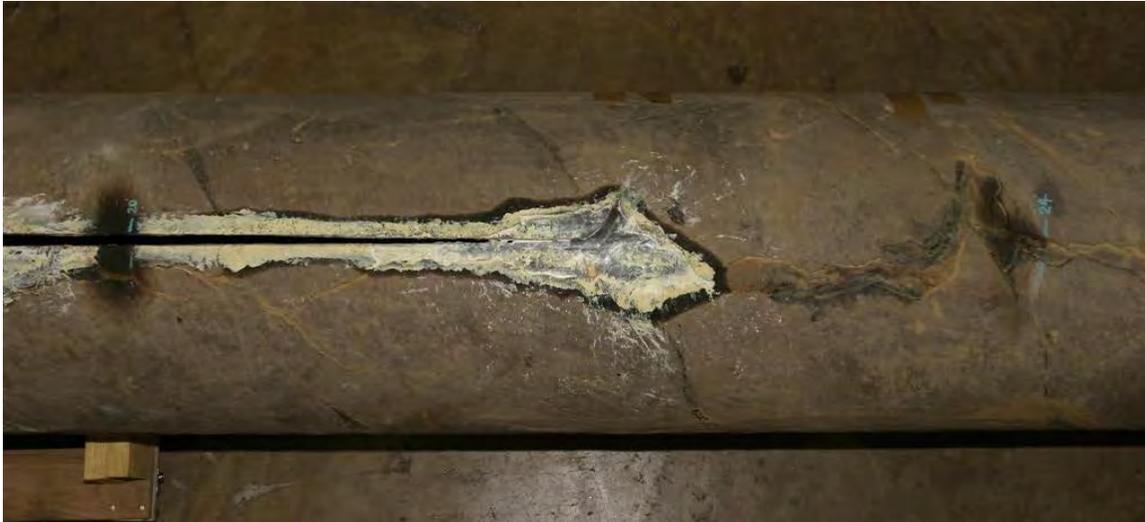
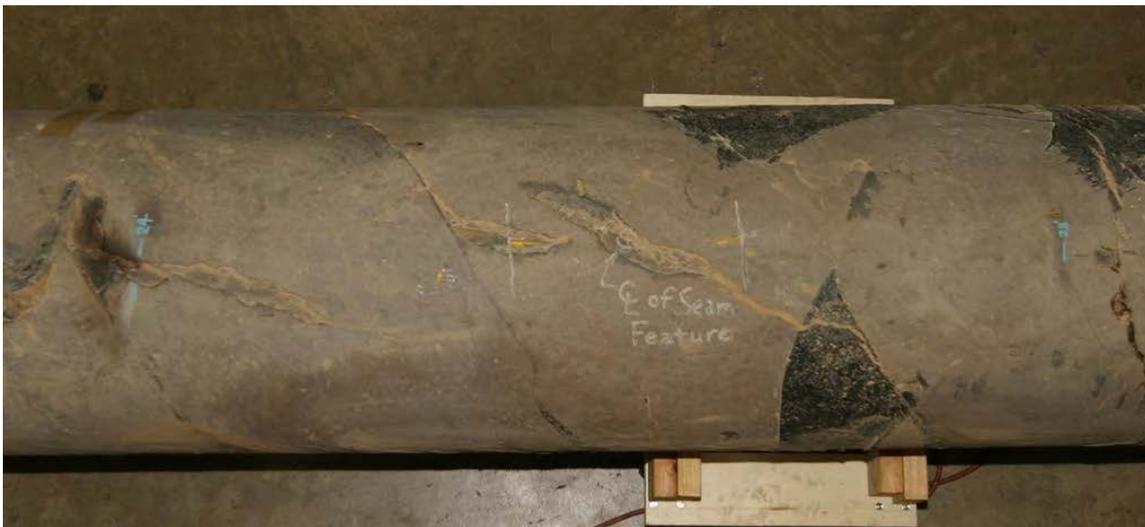
The photographs display overall top views of the fractured pipe from 20' south to 24' south of the north girth weld, and from 24' south to 28' south of the north girth weld, respectively, in the as-received condition prior to removing the coating. At approximately 22' south of the girth weld, the fracture in the ERW seam turned into the pipe material, progressing several inches prior to terminating. The damaged area of coating near the pipe fracture extended longitudinally past the fracture tip several feet.

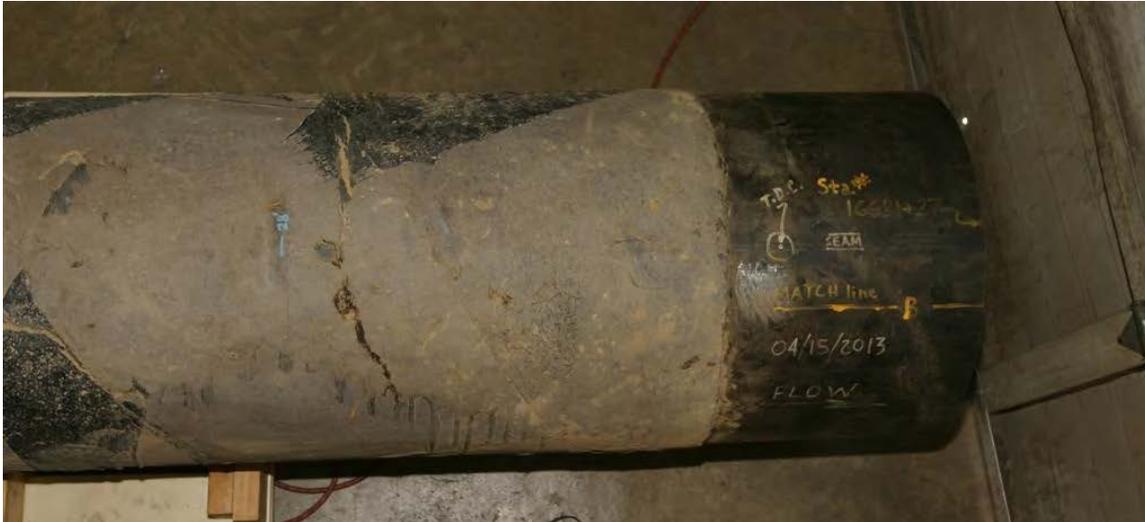
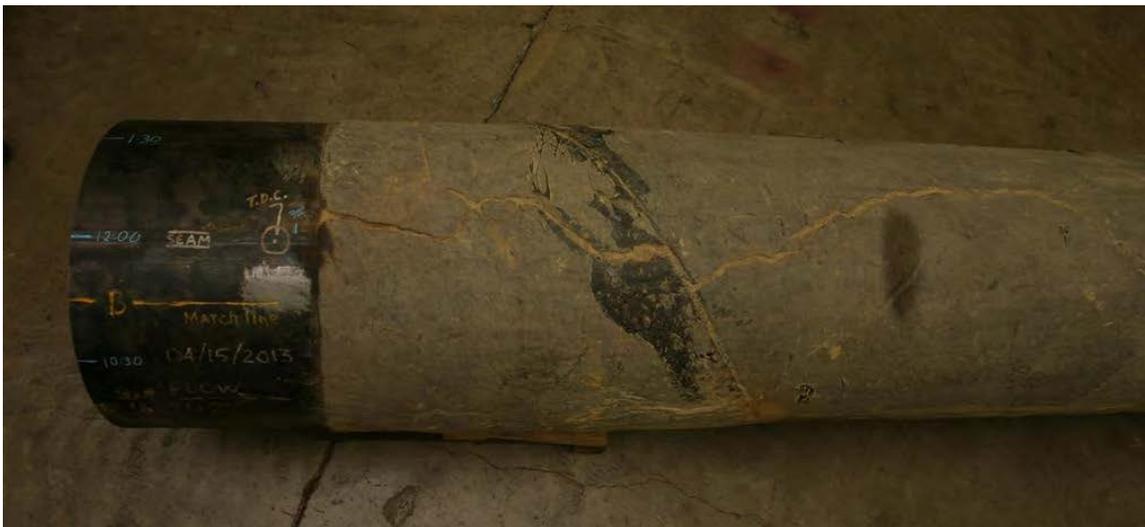
The photographs display overall top views of the fractured pipe from 28' south to 31' south of the north girth weld, and from 31' south to 35' south of the north girth weld, respectively, in the as-received condition prior to removing the coating. The approximately 49' 9-1/2" long pipe was sectioned in the field transversely approximately 31' south of the north girth weld. The coating was removed in the field approximately 13" in either direction from the transverse cut prior to sectioning.

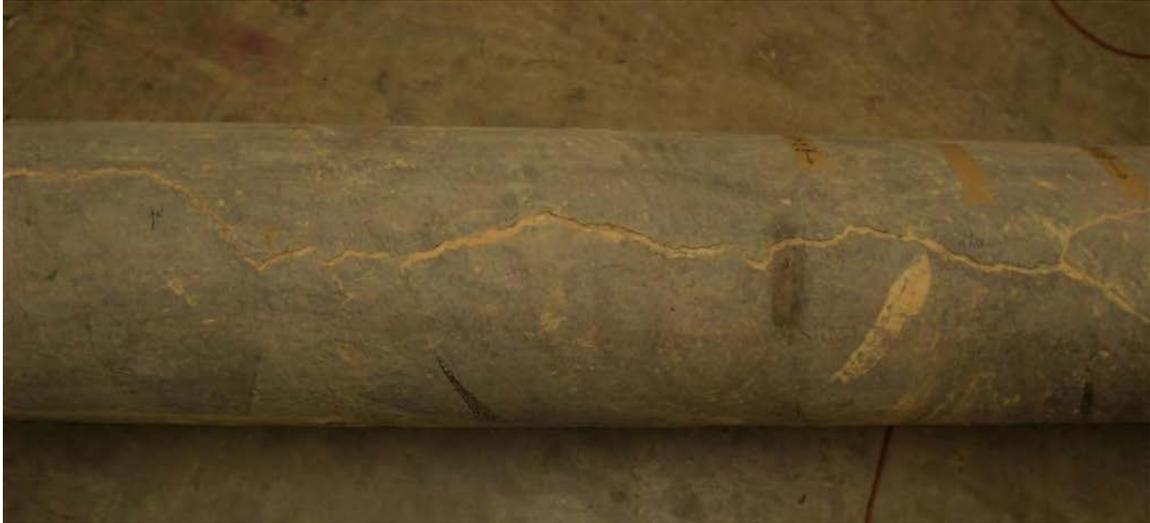
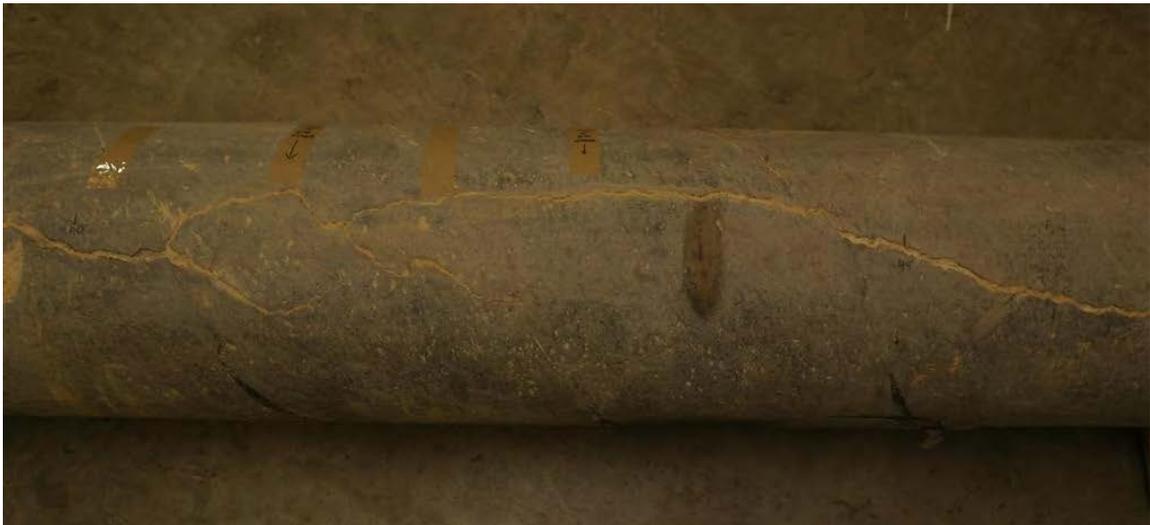
The photographs display overall top views of the fractured pipe from 35' south to 39' south of the north girth weld, and from 39' south to 43' south of the north girth weld, respectively, in the as-received condition prior to removing the coating. Longitudinal splitting is visible on the surface of the coating.

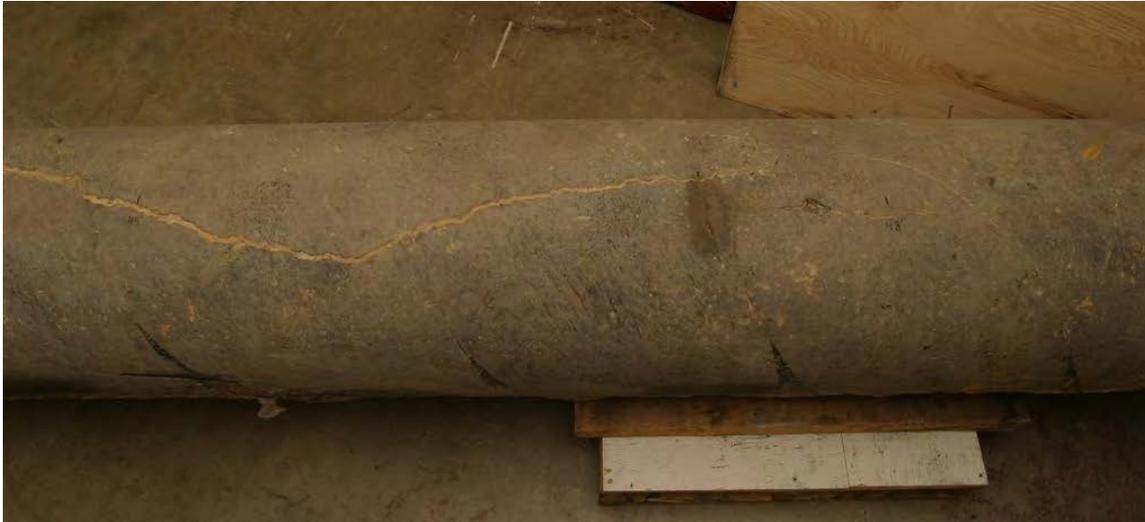
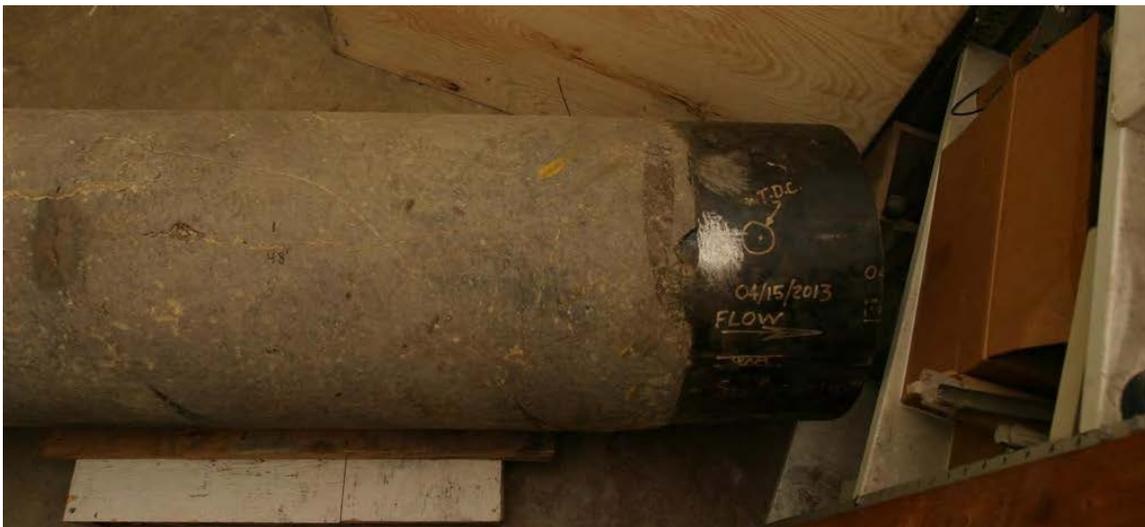
The photographs display overall top views of the fractured pipe from 43' south to 47' south of the north girth weld, and from 47' south to 51' south of the north girth weld, respectively, in the as-received condition prior to removing the coating. Longitudinal splitting is visible on the surface of the coating. Some of the coating had been removed from the adjacent area pipe prior to sectioning.

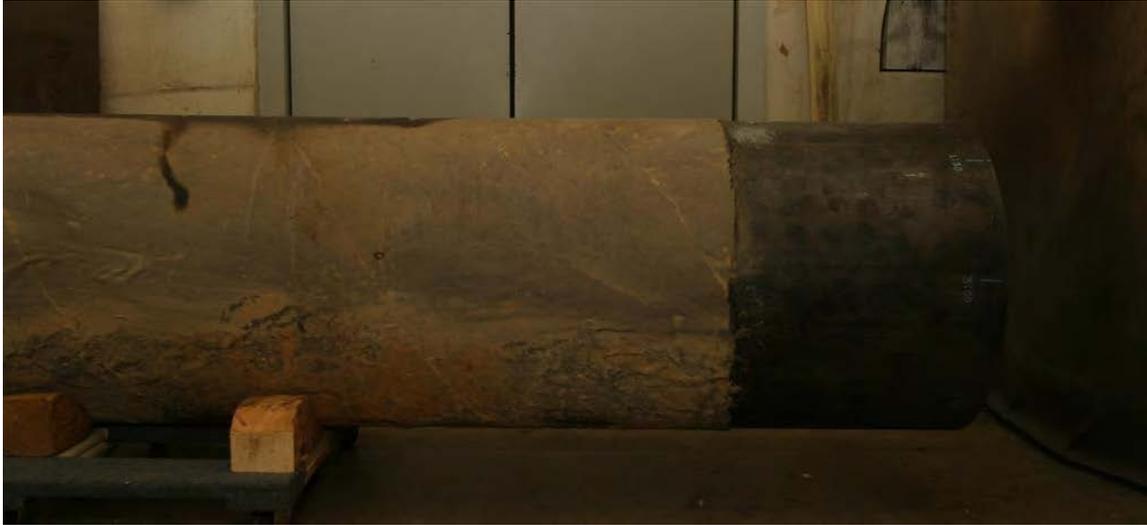
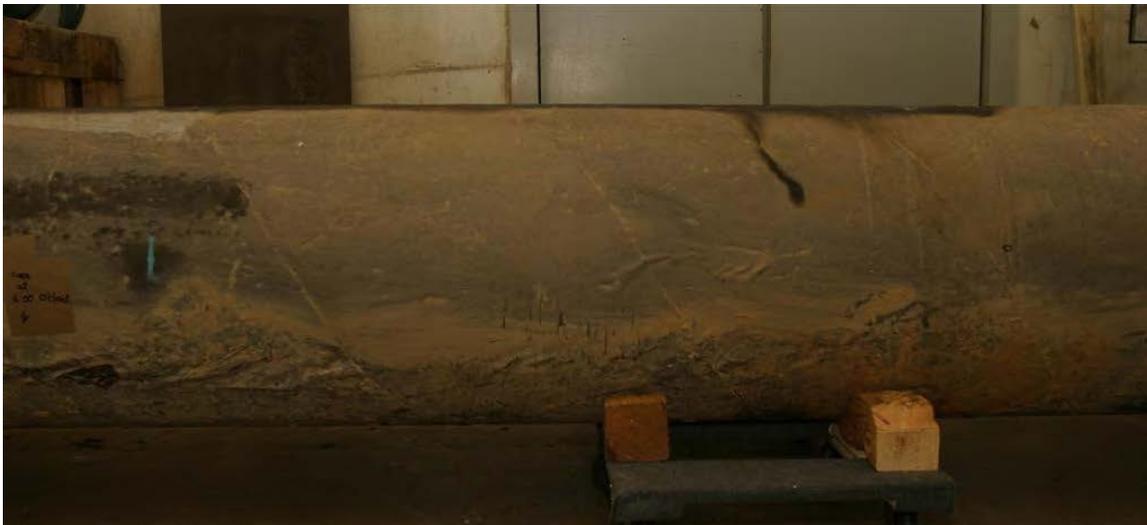
The photographs display overall views of the west side of the pipe from 7:30 to 10:30 o'clock, adjacent to the fractured pipe from approximately 3' north of the girth weld (-3') to the center of the north girth weld (0'), and the fractured pipe from the center of the girth weld to 4' south of the north girth weld (+4'), respectively, in the as-received condition prior to removing the coating. The lower half of the pipe contains disbonded and wrinkled coating.

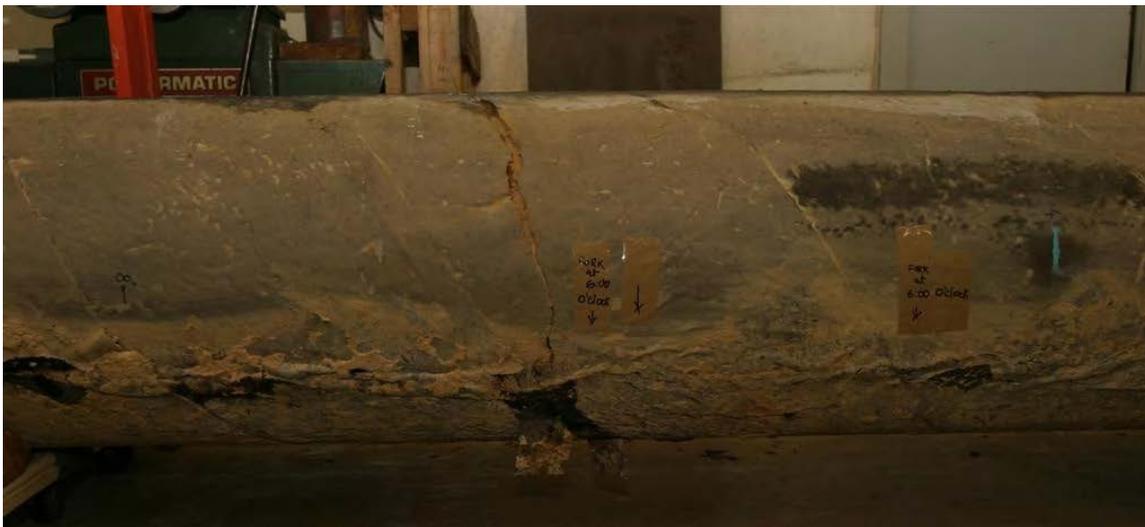
Photograph No. 26

The photograph displays an overall view of the west side from 7:30 to 10:30 of the fractured pipe from 4' south to 8' south of the north girth weld in the as-received condition prior to removing the coating. The lower half of the pipe contains disbonded and wrinkled coating, and some openings in the coating are present where the coating had begun to sag.

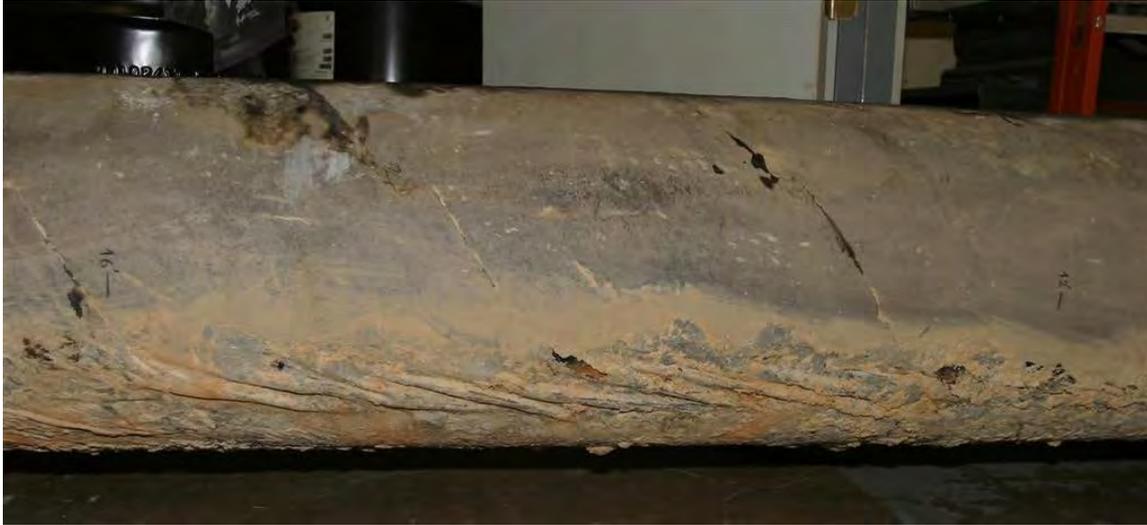
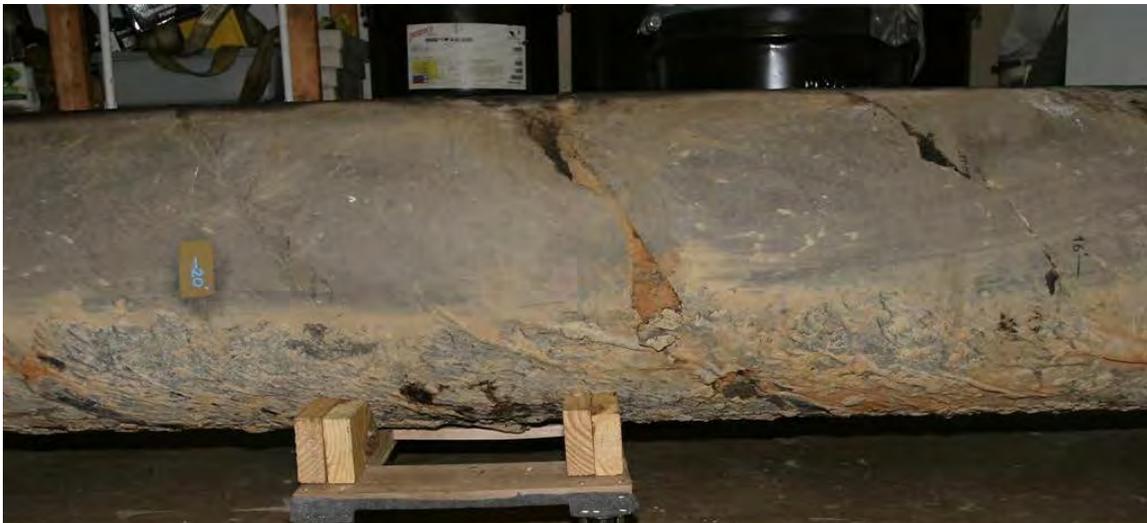
The photographs display overall views of the west side between 7:30 and 10:30 of the fractured pipe from 12' south to 16' south of the north girth weld, and from 16' south to 20' south of the north girth weld, respectively, in the as-received condition prior to removing the coating. The lower half of the pipe contains disbonded and wrinkled coating, along with some openings in the coating.

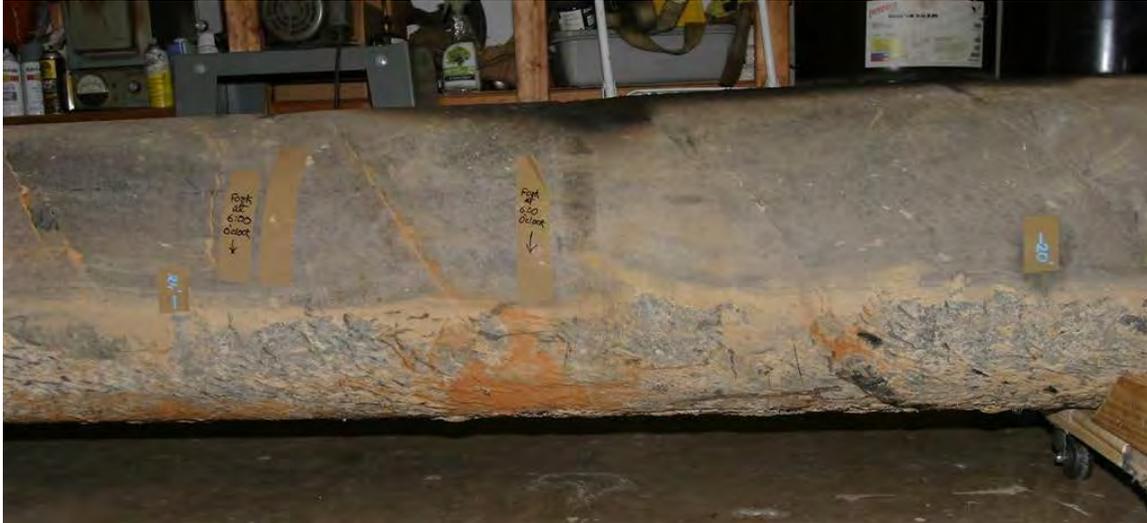
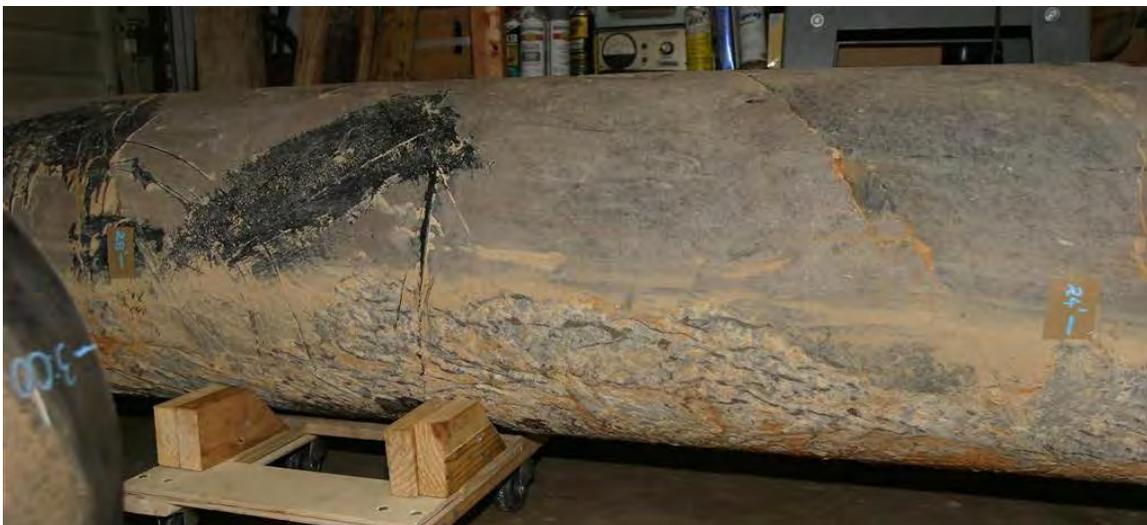
The photographs display overall views of the west side from 7:30 to 10:30 of the fractured pipe from 20' south to 24' south of the north girth weld, and from 24' south to 28' south of the north girth weld, respectively, in the as-received condition prior to removing the coating. The lower half of the pipe contains disbanded and wrinkled coating.

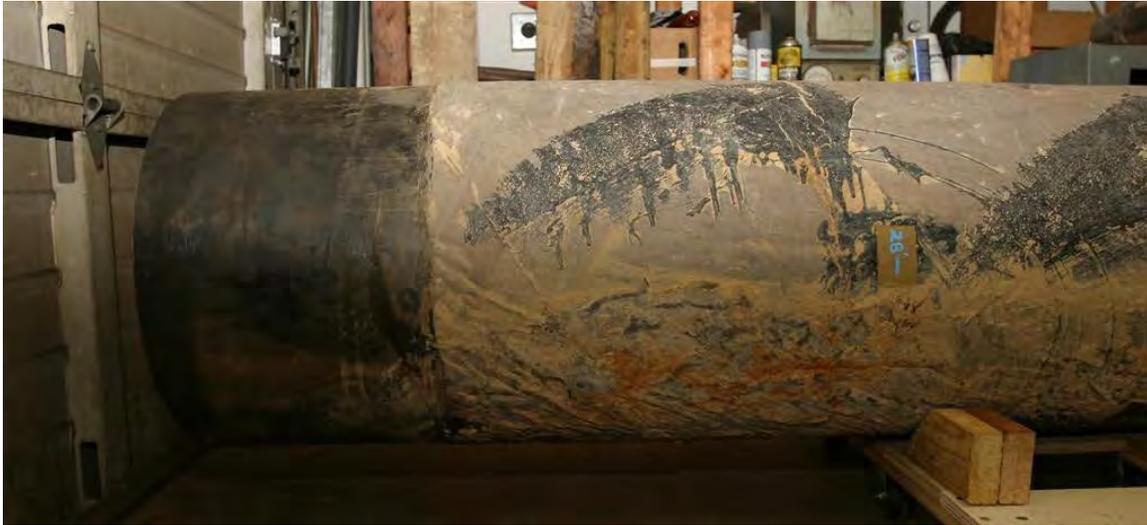
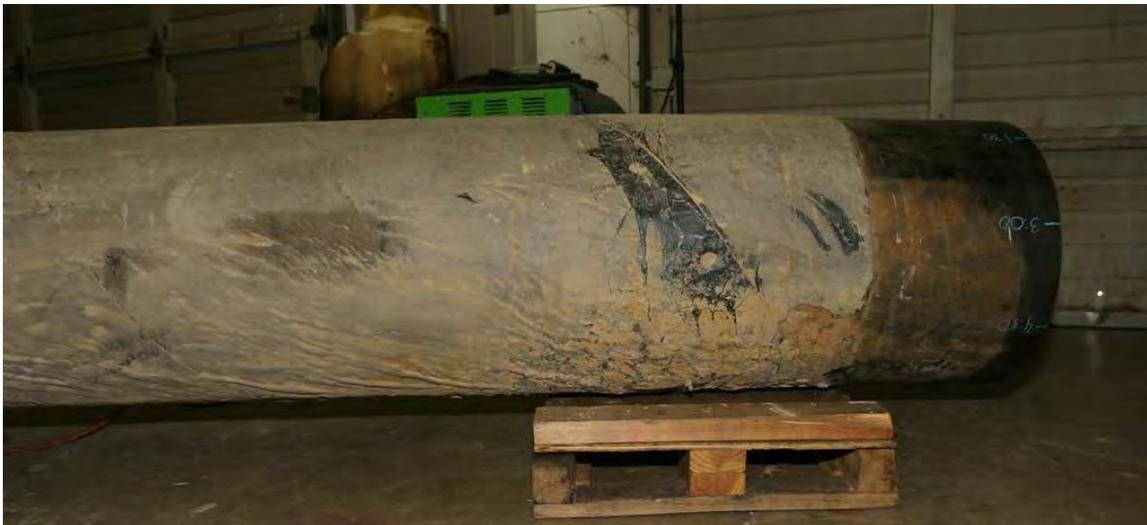
The photographs display overall views of the west side from 7:30 to 10:30 of the fractured pipe from 28' south to 31' south of the north girth weld, and from 31' south to 35' south of the north girth weld, respectively, in the as-received condition prior to removing the coating. The pipe had been sectioned transversely approximately 31' south of the north girth weld. The lower half of the pipe contains disbonded and wrinkled coating.

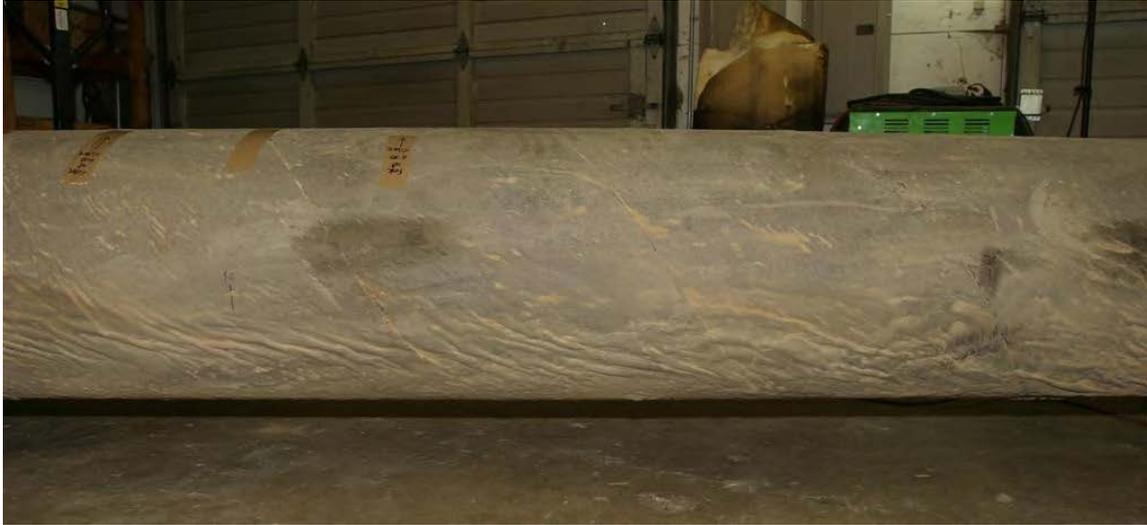
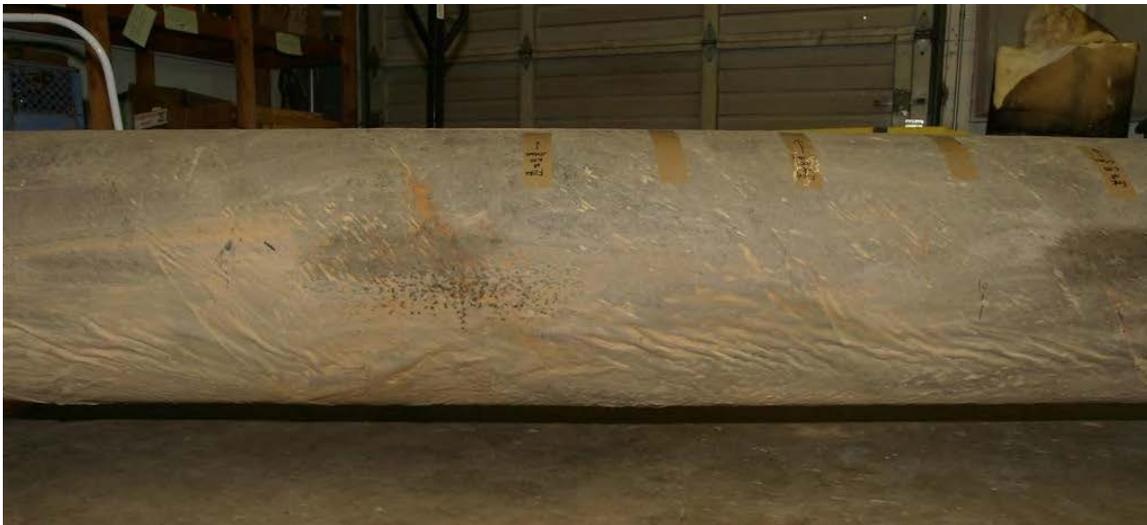
The photographs display overall views of the west side between 7:30 and 10:30 of the fractured pipe from 35' south to 39' south of the north girth weld, and from 39' south to 43' south of the north girth weld, respectively, in the as-received condition prior to removing the coating. The lower half of the pipe contains disbonded and wrinkled coating.

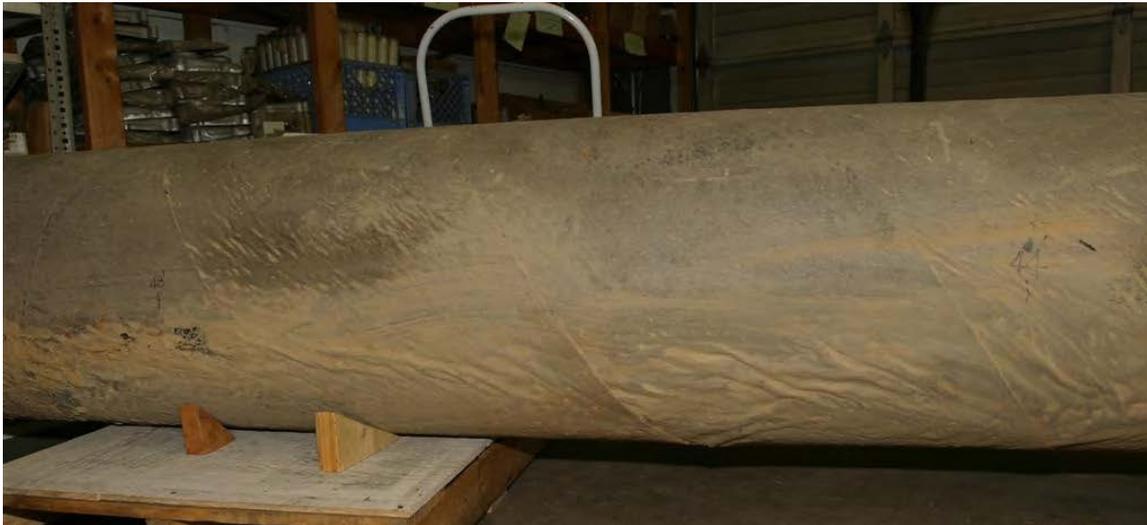
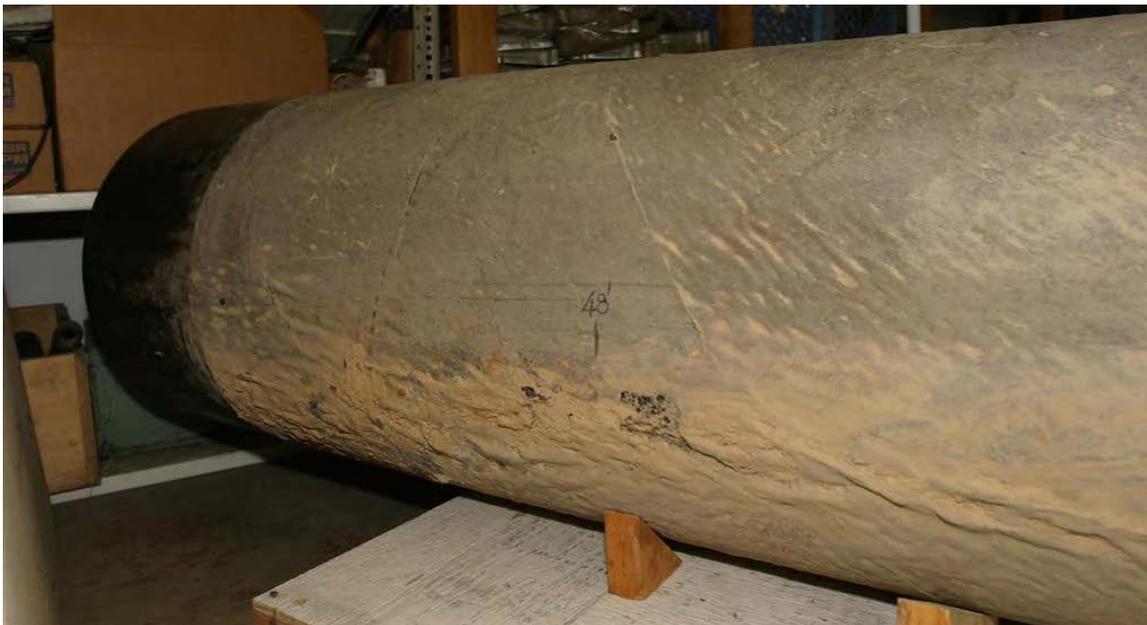
The photographs display overall views of the west side from 7:30 to 10:30 of the fractured pipe and adjacent intact pipe from 43' south to 47' south of the north girth weld, and from 47' south to 51' south of the north girth weld, respectively, in the as-received condition prior to removing the coating. The coating had been removed from the adjacent intact pipe prior to allow for sectioning. The lower half of the pipe contains disbonded and wrinkled coating.
