DOT US Department of Transportation
PHMSA Pipelines and Hazardous Materials Safety Administration
OPS Office of Pipeline Safety
Southwest Region

Date of Report October 23, 2013
Subject Failure Investigation Report – Mobil Pipe Line Company; Pegasus Pipeline, Mayflower, AR

Failure Investigation Report – Mobil Pipeline Pegasus Rupture
March 29, 2013

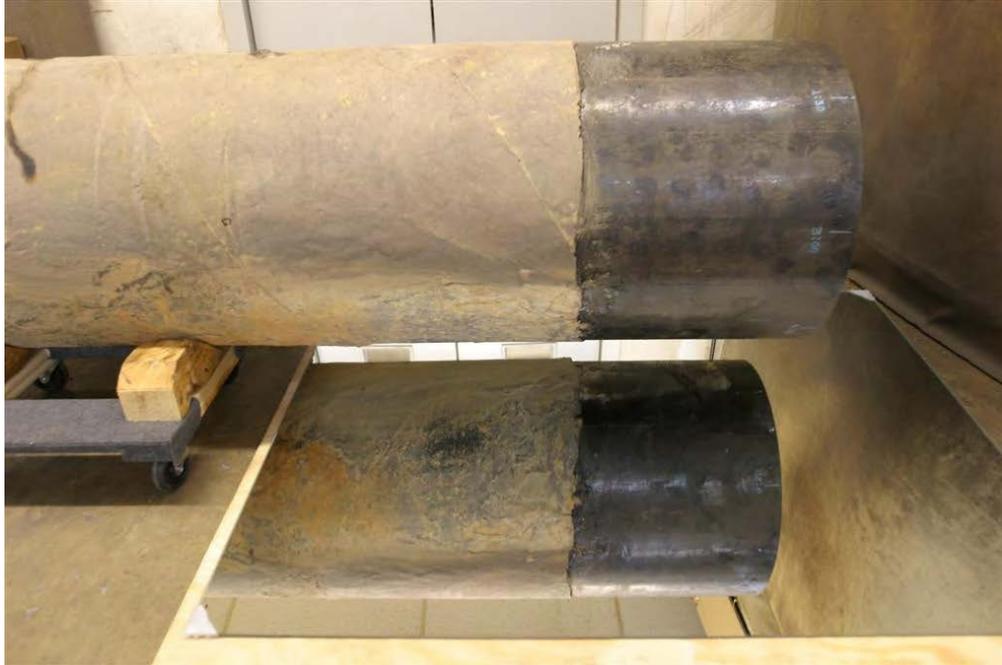
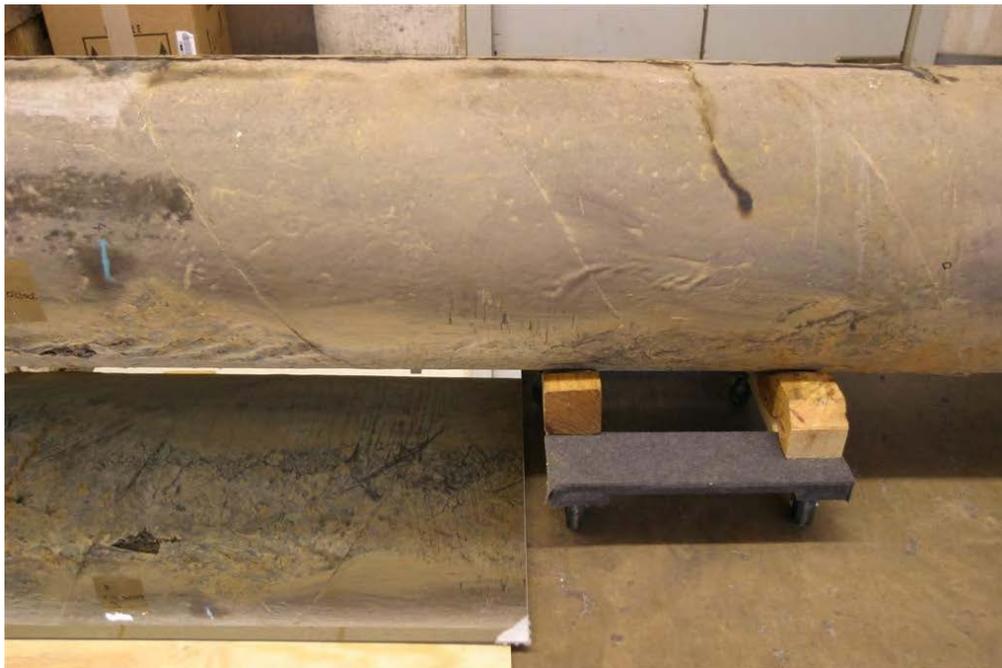
The photographs display overall bottom views of the pipe from 4:30 to 7:30 o'clock adjacent to the fractured pipe from approximately 3' north of the north girth weld (-3') to the center of the north girth weld (0'), and the fractured pipe from the center of the north girth weld to 4' south of the north girth weld (+4'), respectively, in the as-received condition prior to removing the coating. The coating had been removed from the adjacent intact pipe prior to sectioning in the field. The coating on the lower half of the pipe is sagging and contains wrinkles.

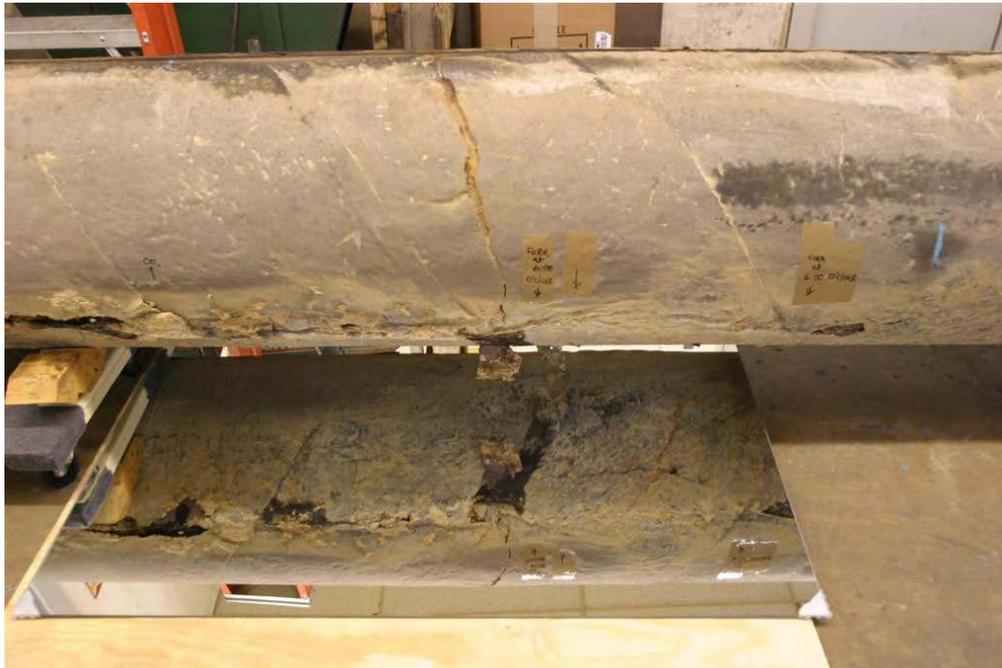
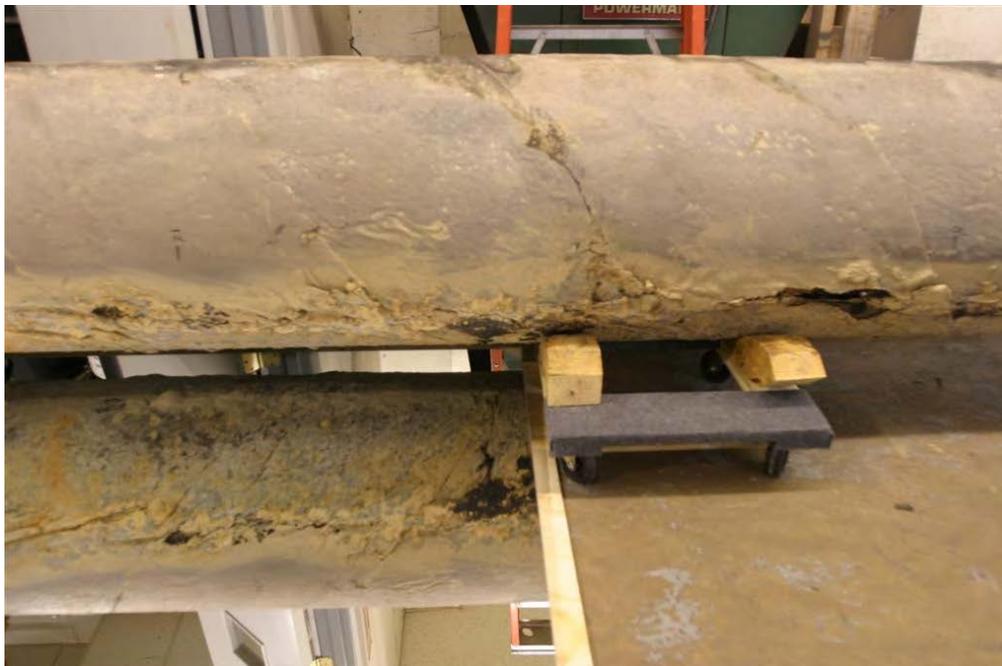
The photographs display overall bottom views of the fractured pipe from 4:30 to 7:30 from 4' south to 8' south of the north girth weld, and from 8' south to 12' south of the north girth weld, respectively, in the as-received condition prior to removing the coating. The coating on the lower half of the pipe is sagging and contains wrinkles.

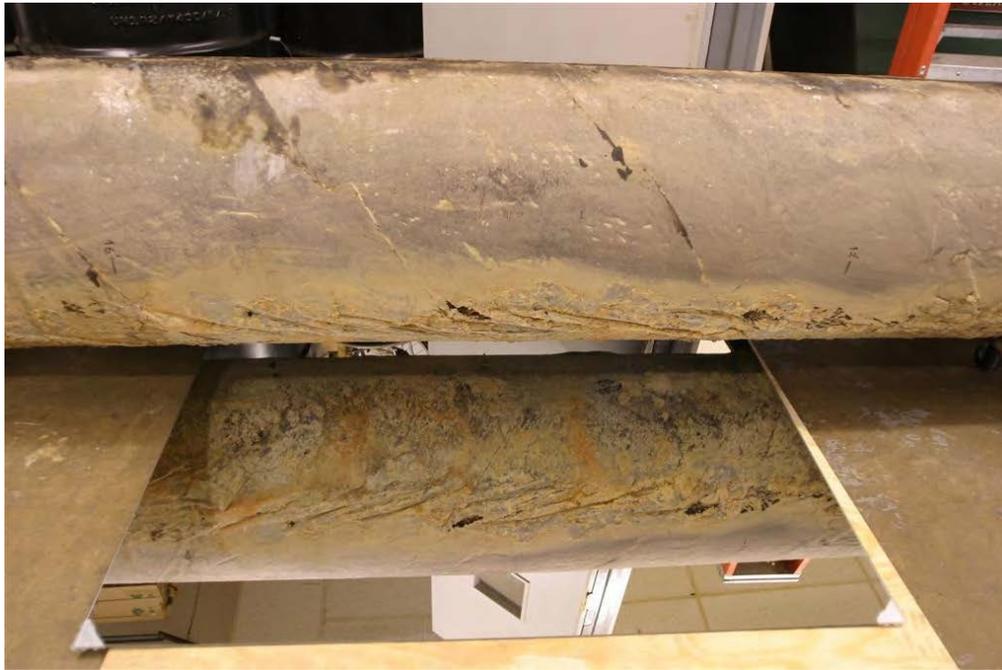
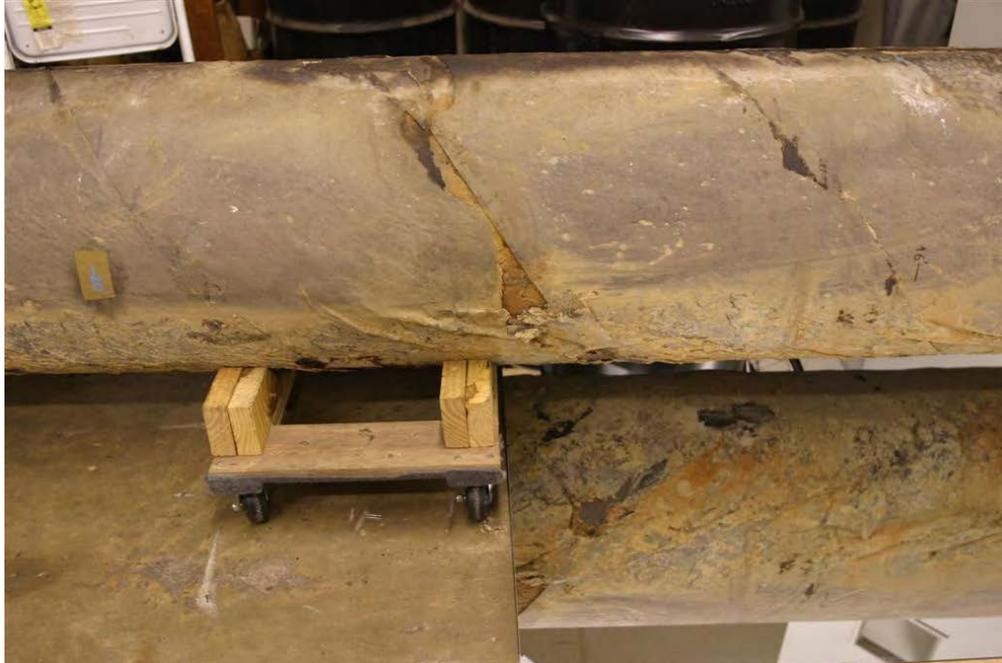
The photographs display overall bottom views of the fractured pipe from 4:30 to 7:30 from 12' south to 16' south of the north girth weld, and from 16' south to 20' south of the north girth weld, respectively, in the as-received condition prior to removing the coating. The coating on the lower half of the pipe contains wrinkles and has sagged.

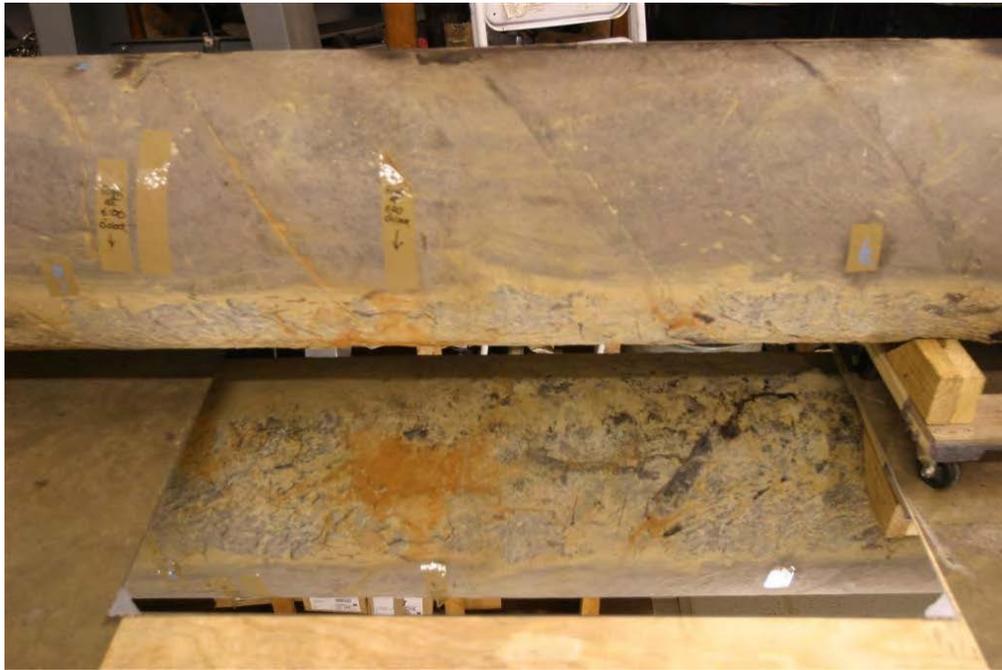
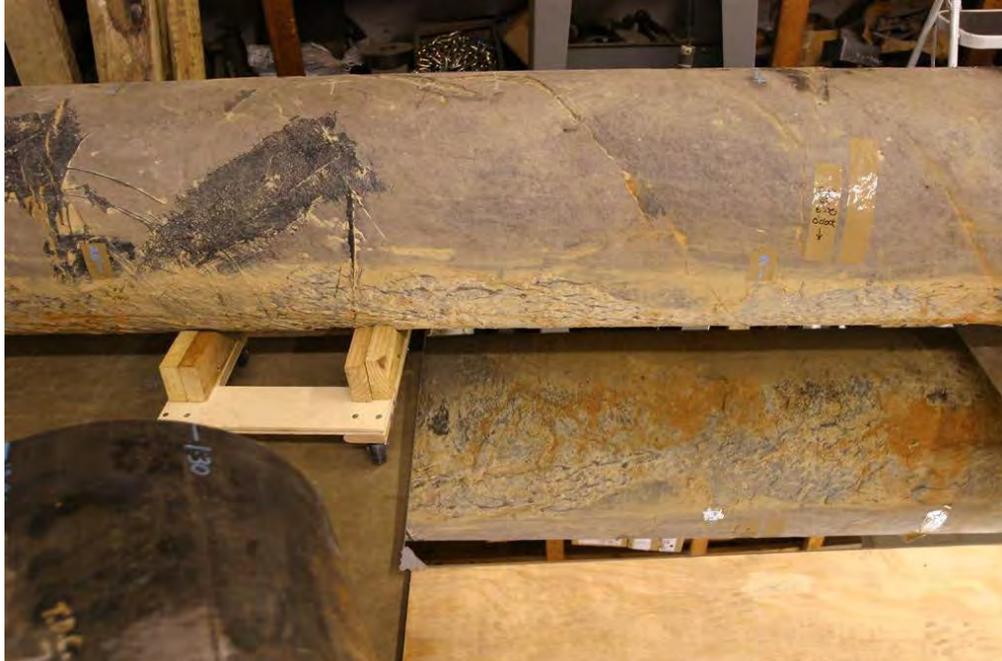
The photographs display overall bottom views of the fractured pipe from 4:30 to 7:30 from 20' south to 24' south of the north girth weld, and from 24' to 28' south of the north girth weld, respectively, in the as-received condition prior to removing the coating. The coating on the lower half of the pipe contains a significant amount of wrinkles and has sagged quite a bit.

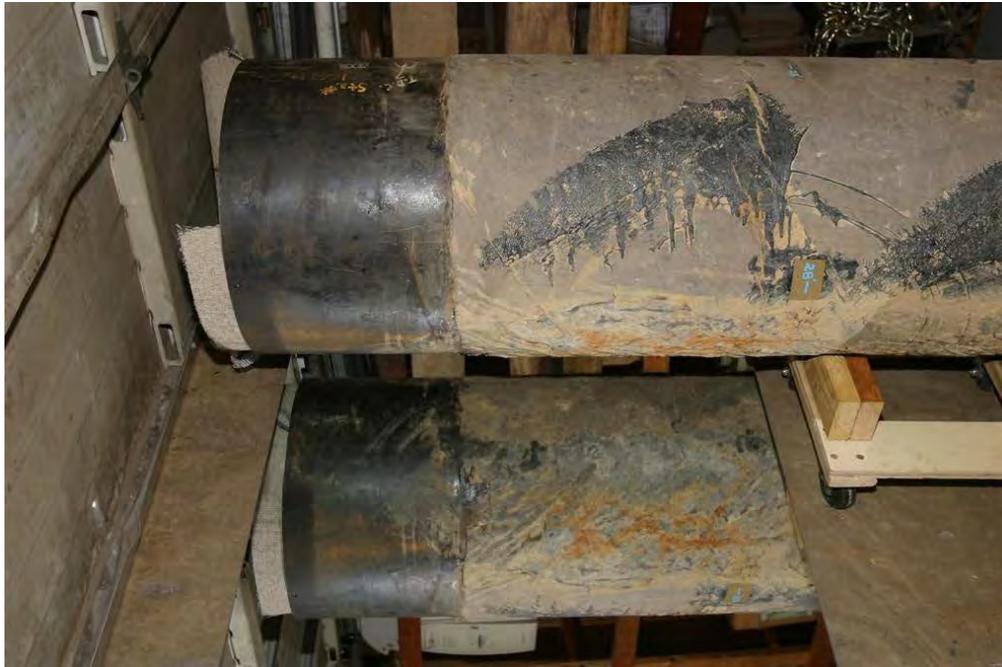
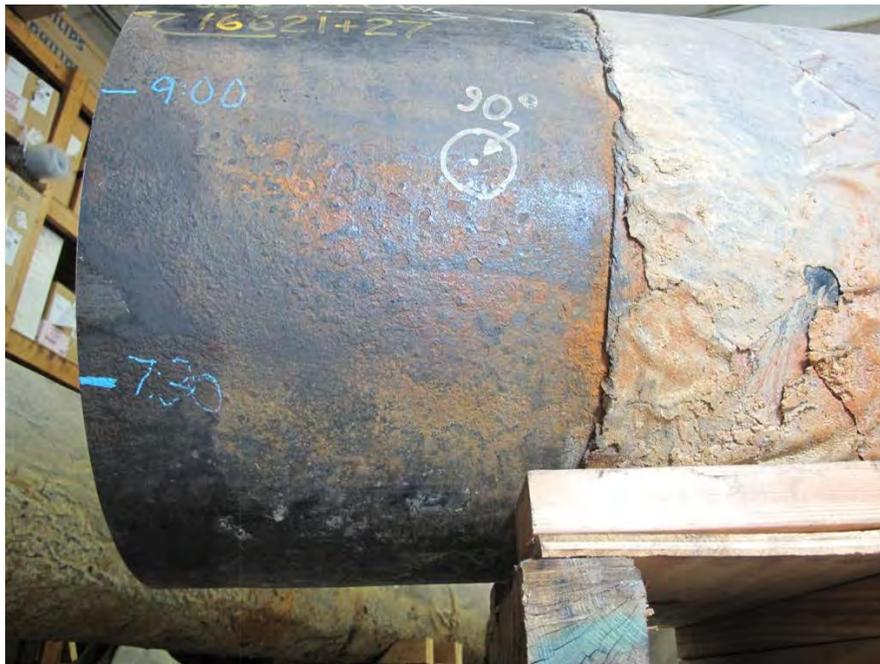
The photographs display overall bottom views of the fractured pipe from 4:30 to 7:30 from 28' south to 31' south of the north girth weld, and from 31' south to 35' south of the north girth weld, respectively, in the as-received condition prior to removing the coating. The fractured pipe was sectioned transversely approximately 31' south of the north girth weld into two sections.

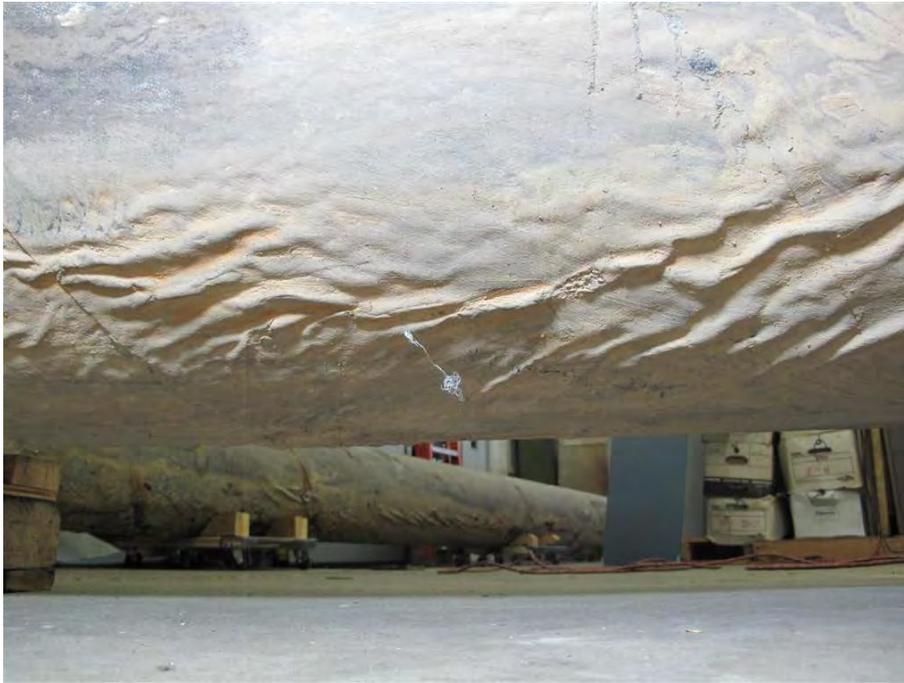
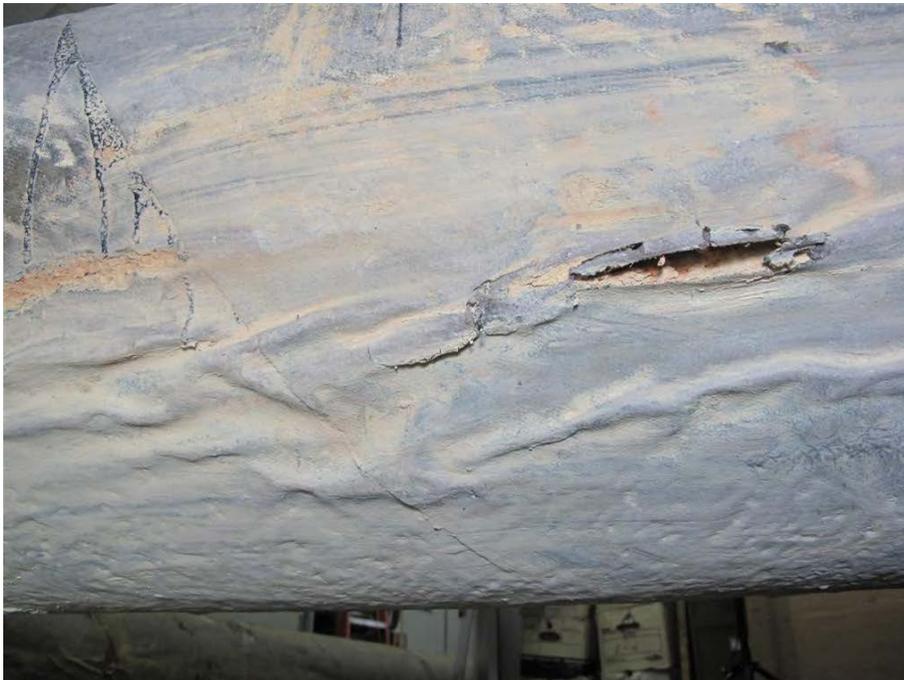
The photographs display overall bottom views of the fractured pipe from 4:30 to 7:30 from 35' south to 39' south of the north girth weld, and from 39' south to 43' south of the north girth weld, respectively, in the as-received condition prior to removing the coating. The coating on the lower half of the pipe had sagged quite a bit and contains a significant amount of wrinkles.

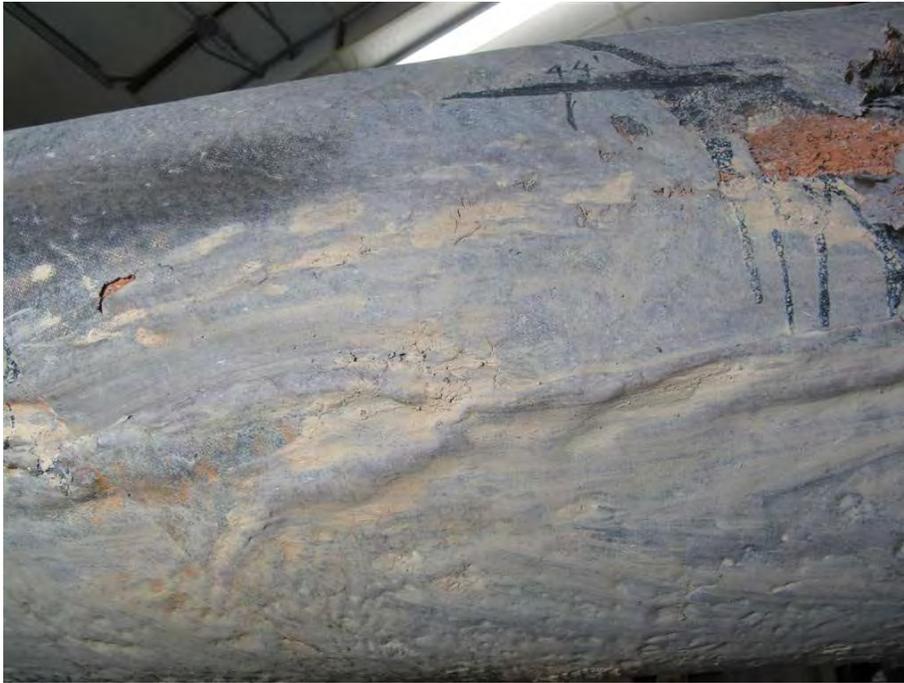
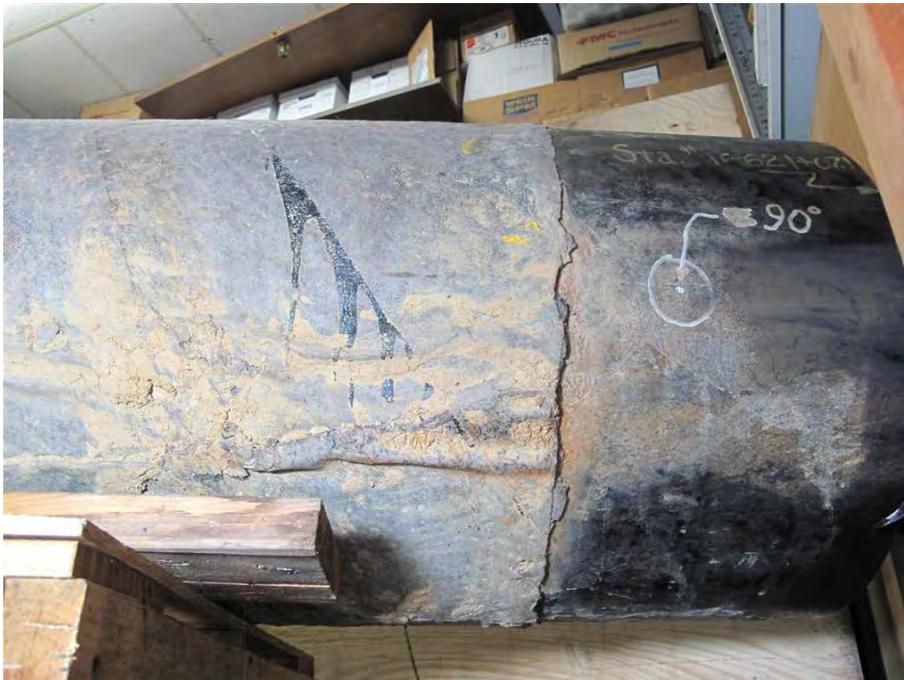
The photographs display overall bottom views of the fractured pipe from 4:30 to 7:30 and the adjacent intact pipe from 43' south to 47' south of the north girth weld, and from 47' south to 51' south of the north girth weld, respectively, in the as-received condition prior to removing the coating. The coating on the lower half of the pipe contains a significant amount of wrinkles. The coating on the lower half of the pipe contains wrinkles.

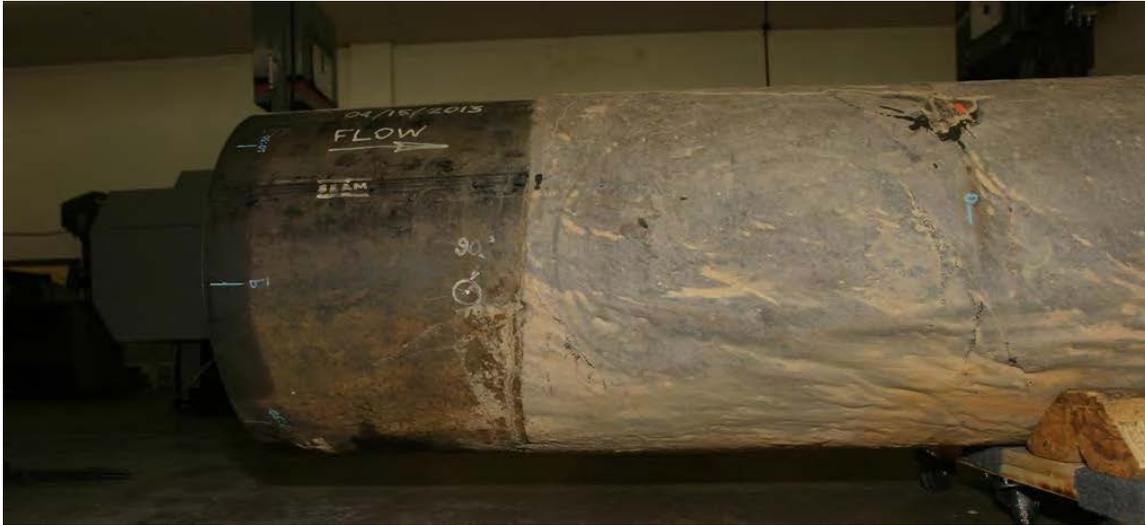
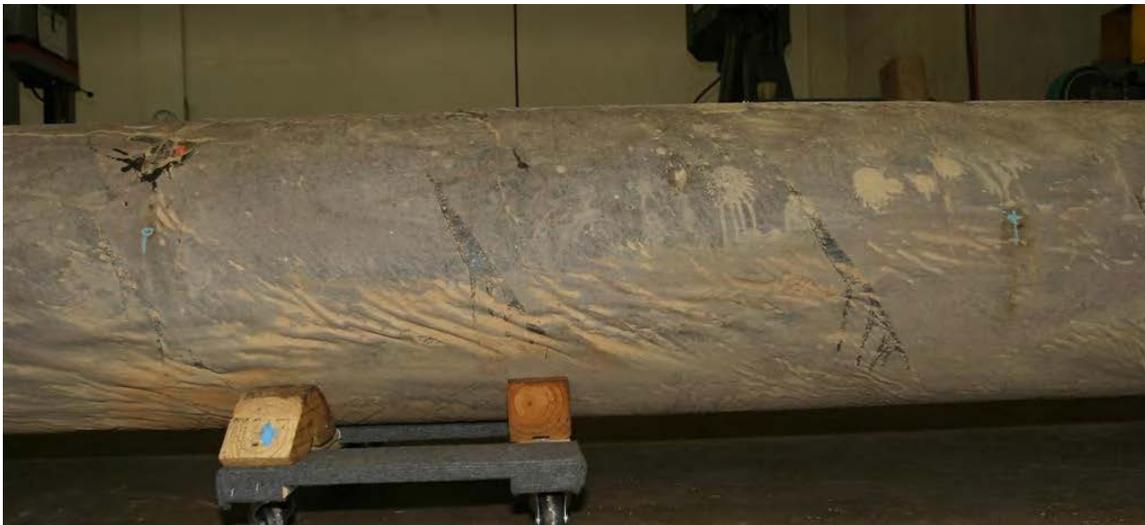
The photographs display overall views of the east side of a pipe from 1:30 to 4:30 adjacent to the fractured pipe from approximately 3' north of the north girth weld (-3') to the center of the north girth weld (0'), and the fractured pipe from the center of the north girth weld to 4' south of the north girth weld (+4'), respectively, in the as-received condition prior to removing the coating. The lower half of the pipe contains wrinkled coating.

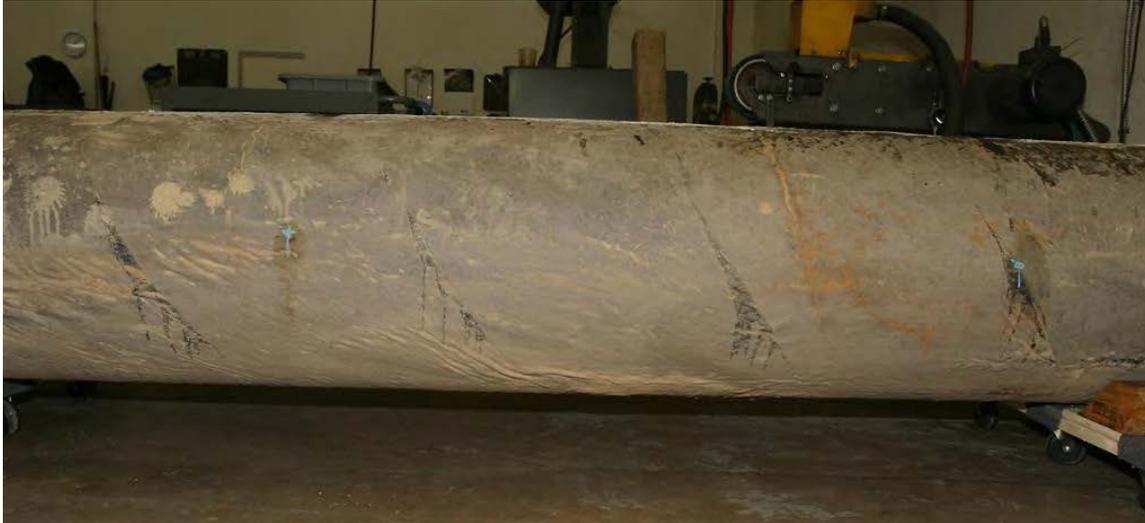
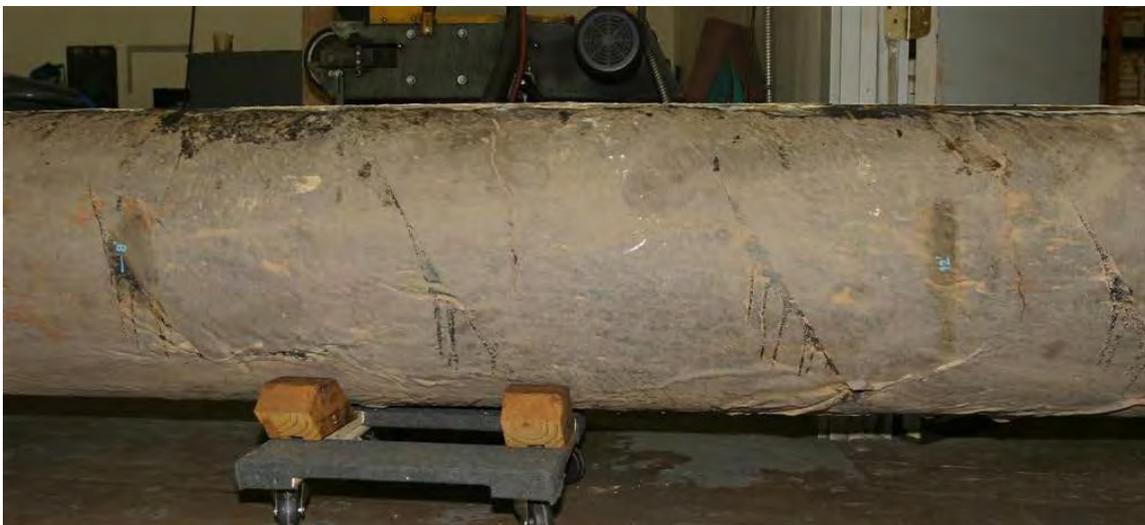
The photographs display overall views of the east side of the fractured pipe from 1:30 to 4:30 from 4' south to 8' south of the north girth weld, and from 8' south to 12' south of the north girth weld, respectively, in the as-received condition prior to removing the coating. The lower half of the pipe contains sagging and wrinkled coating.

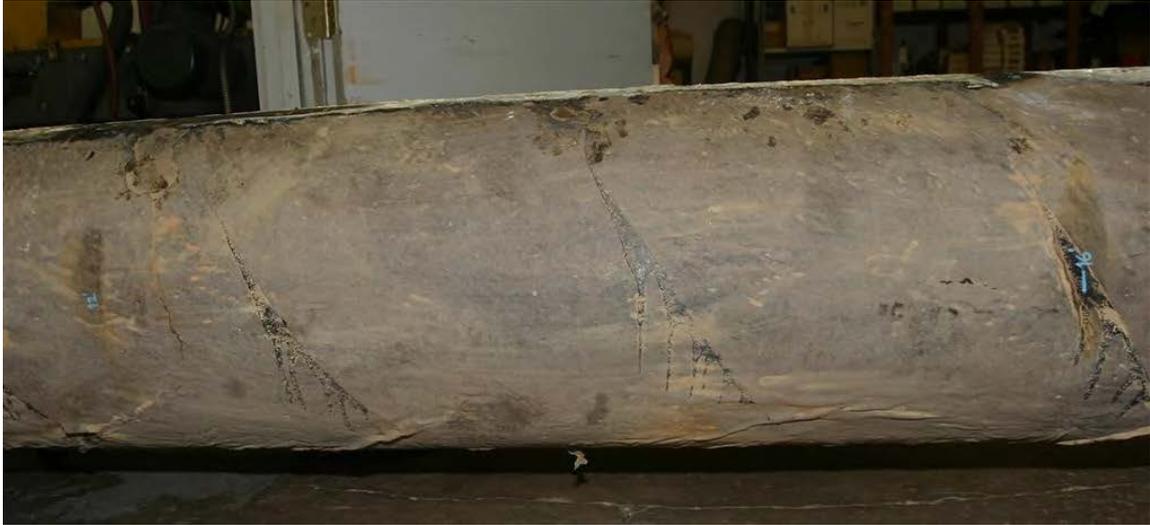
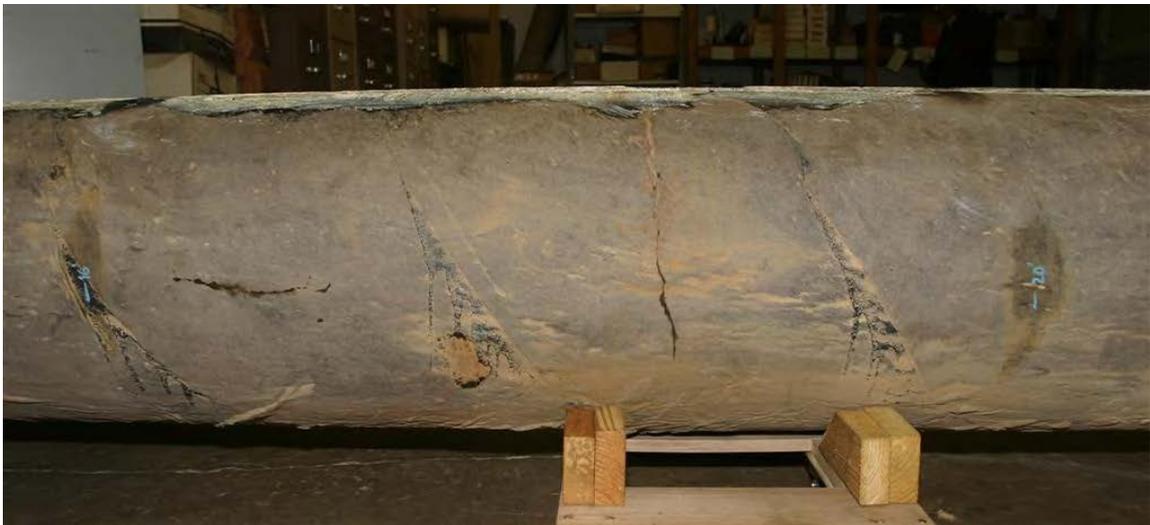
The photographs display overall views of the east side of the fractured pipe from 1:30 to 4:30 from 12' south to 16' south of the north girth weld, and from 16' south to 20' south of the north girth weld, respectively, in the as-received condition prior to removing the coating. The lower half of the pipe contains sagging and wrinkled coating.

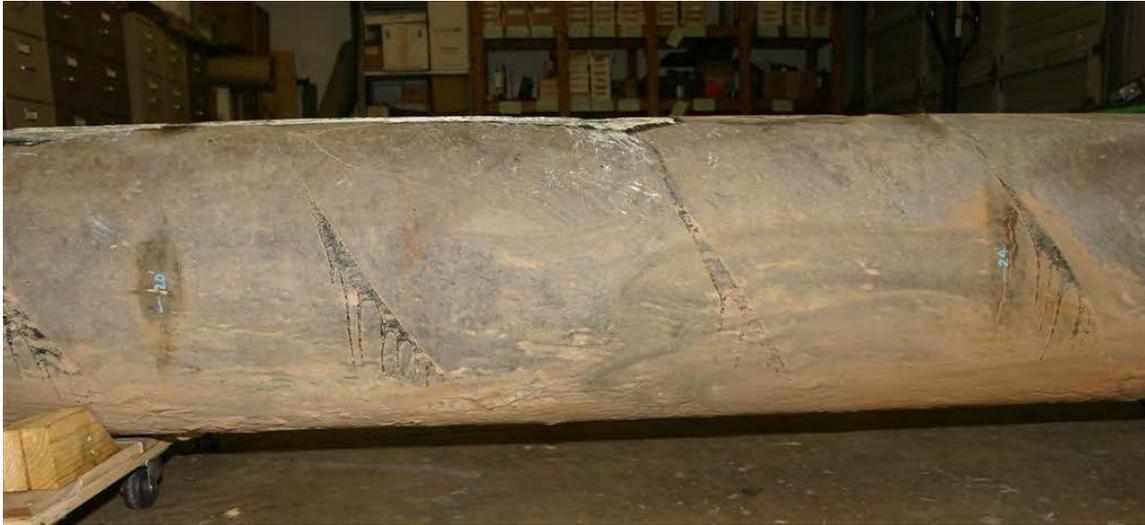
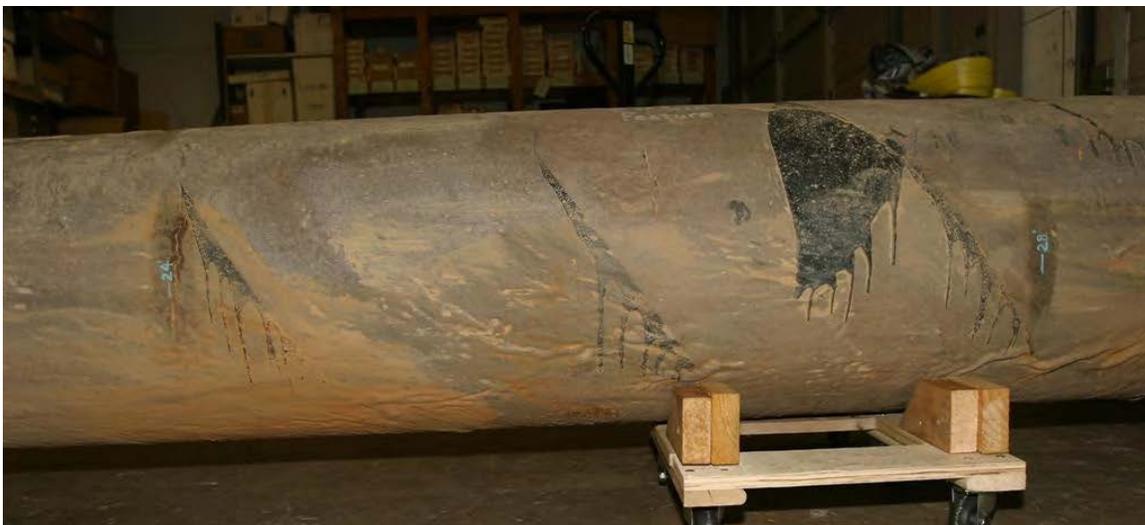
The photographs display overall views of the east side of the fractured pipe from 1:30 to 4:30 from 20' south to 24' south of the north girth weld, and from 24' south to 28' south of the north girth weld, respectively, in the as-received condition prior to removing the coating. The coating on the lower half of the pipe contains sagging and wrinkles.

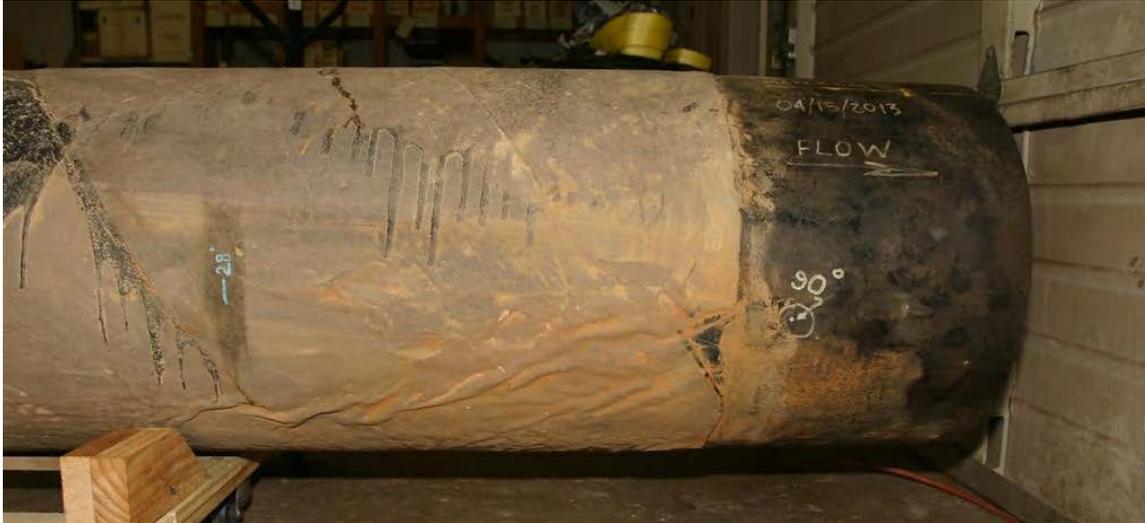
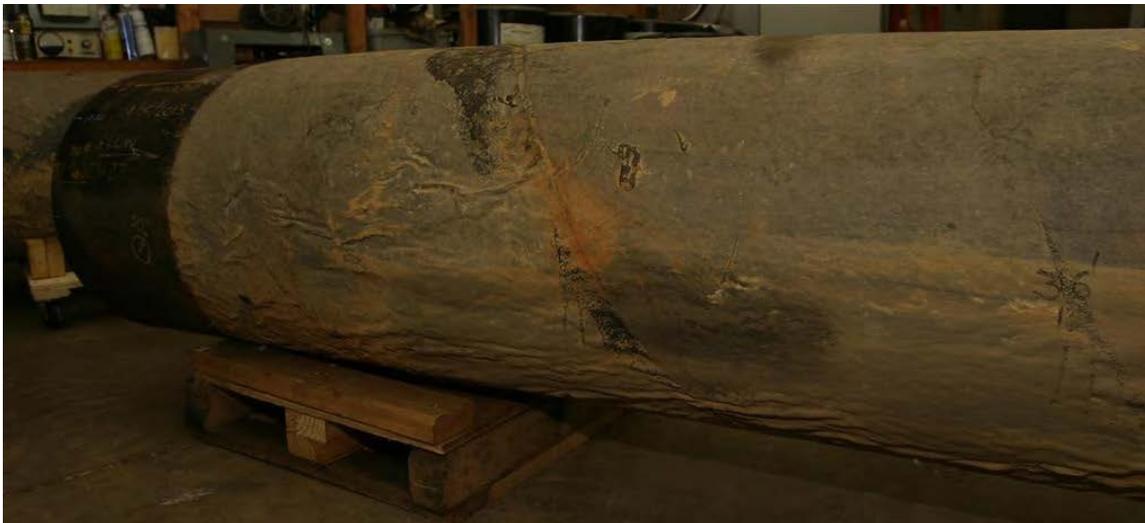
The photographs display overall views of the east side of the fractured pipe from 1:30 to 4:30 from 28' south to 31' south of the north girth weld, and from 31' south to 35' south of the north girth weld, respectively, in the as-received condition prior to removing the coating. The lower half of the pipe contains sagging and wrinkled coating.

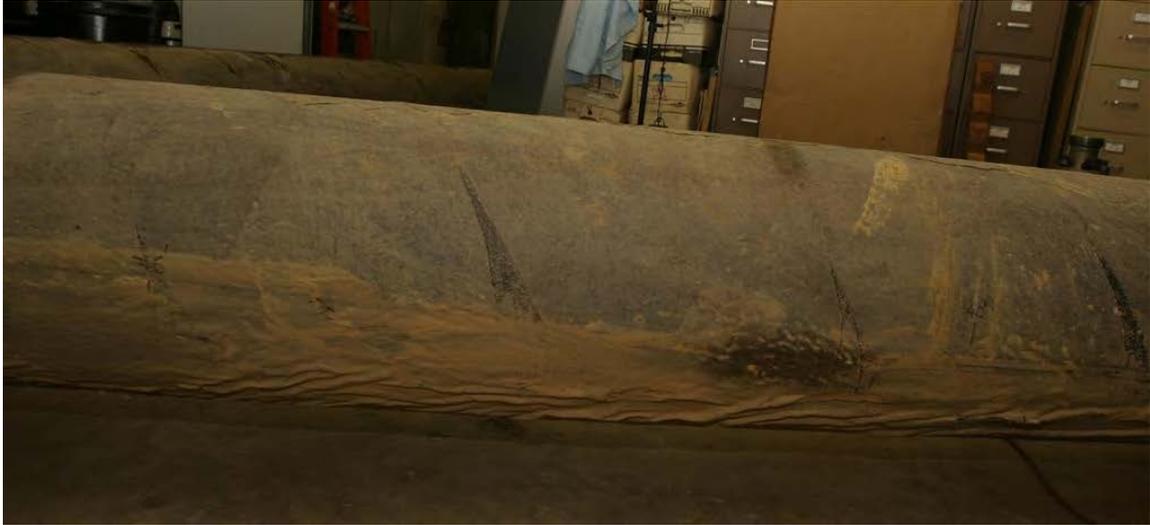
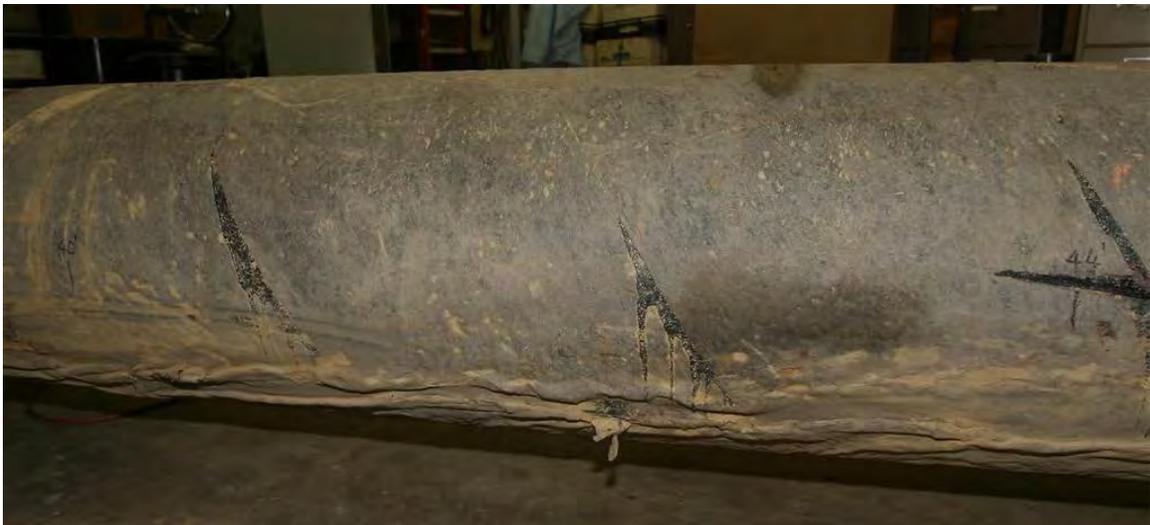
The photographs display overall views of the east side of the fractured pipe from 1:30 to 4:30 from 35' south to 39' south of the north girth weld, and from 39' south to 43' south of the north girth weld, respectively, in the as-received condition prior to removing the coating. The coating on the lower half is wrinkled and sagging.

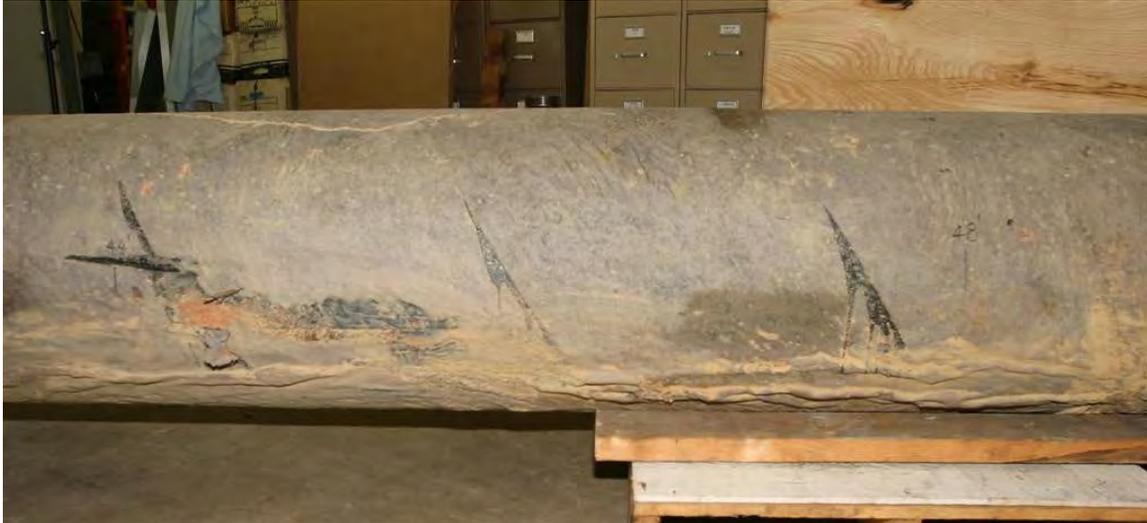
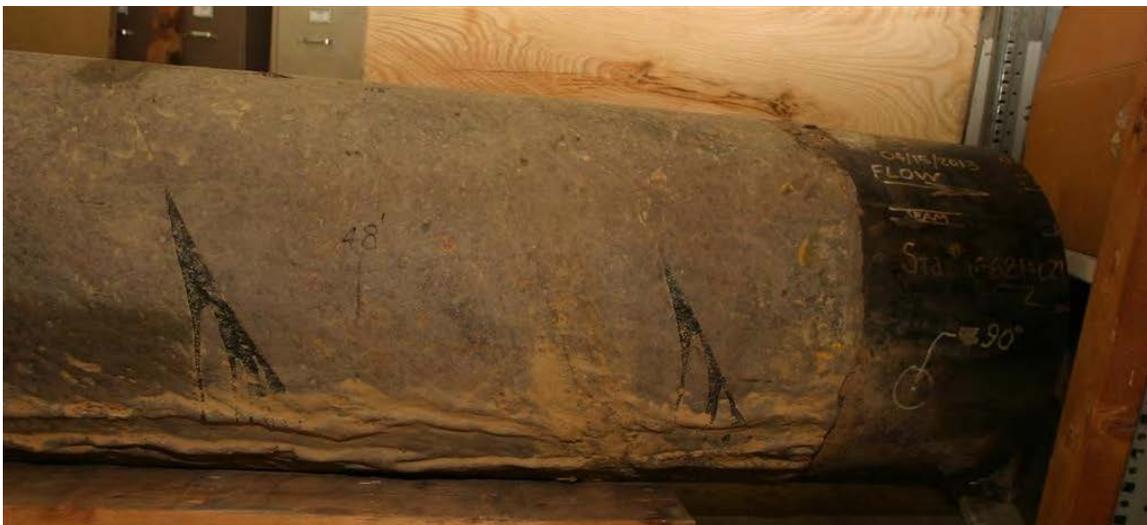
The photographs display overall views of the east side of the fractured pipe from 1:30 to 4:30 and adjacent intact pipe from 43' south to 47' south of the north girth weld, and from 47' south to 51' south of the north girth weld, respectively, in the as-received condition prior to removing the coating. The coating had been removed from the adjacent intact pipe prior to sectioning. The coating on the lower half of the pipe is wrinkled and sagging.

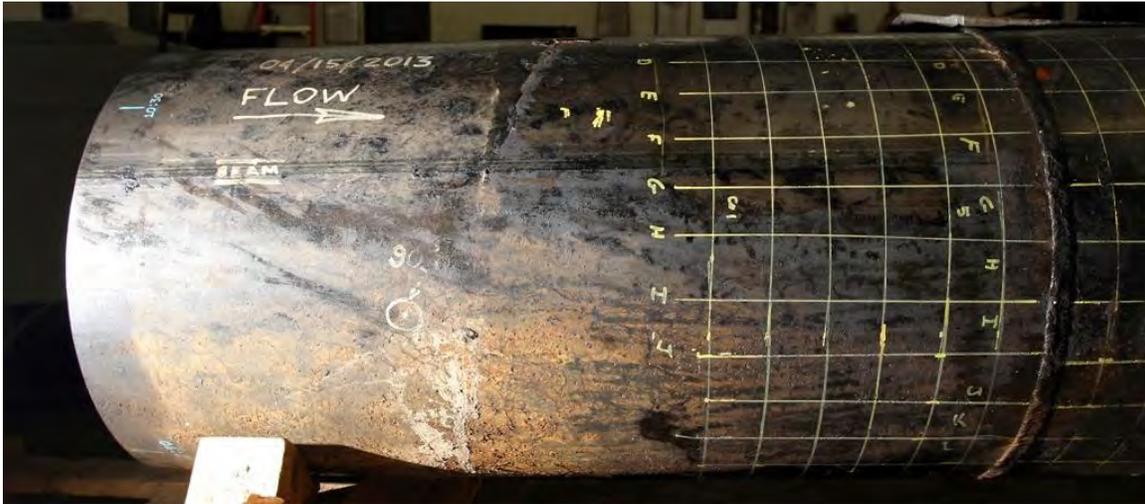
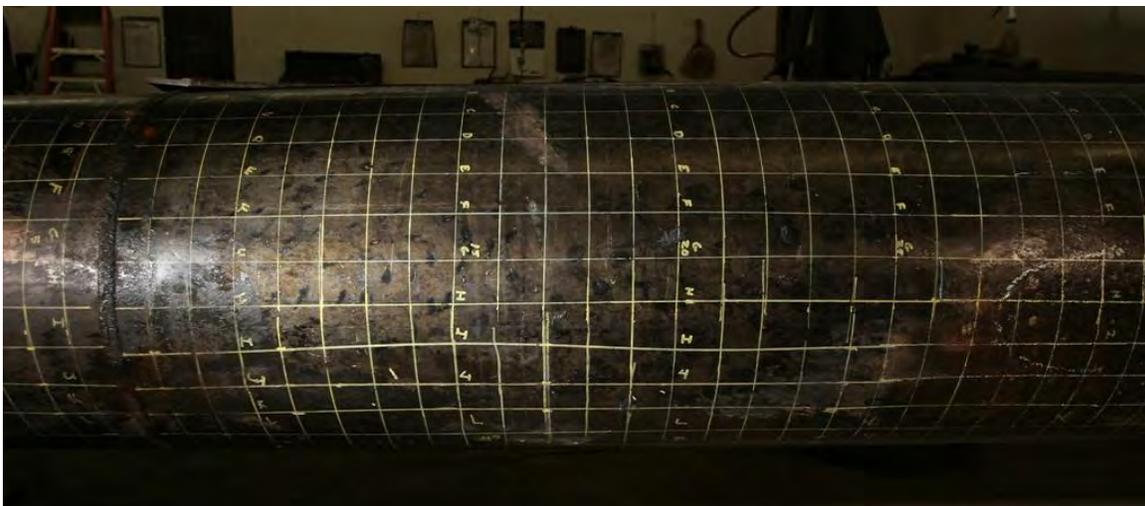
| Circumferential Location | Distance from North Girth Weld | Depth of Corrosion Pitting | | |
|---|---|---|---|---|
| 7:26 o'clock to 10:07 o'clock | 0' to 4' | 0.006" | 0.017" | 0.029" |

The photographs display overall views of the west side of the pipe adjacent to the fractured area of the pipe, from approximately 3' north of the north girth weld (-3') to the center of the girth weld (0'), and the fractured pipe from the center of the girth weld to 4' south of the girth weld (+4'), respectively, after the removal of the coating. The lower half of the pipe shows corrosion pitting on the O.D. surface where the coating had wrinkled and sagged.

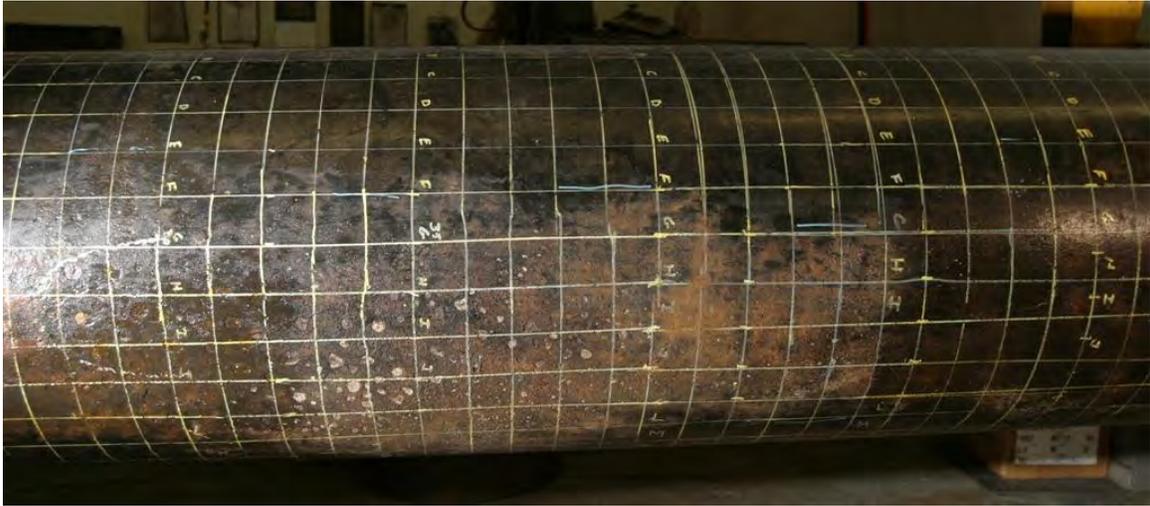
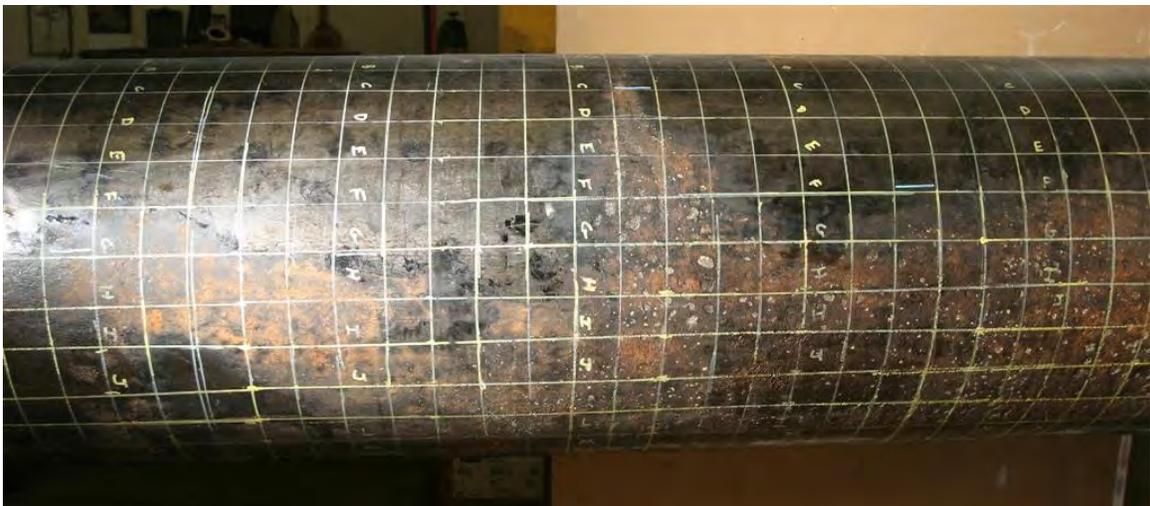
| Circumferential Location | Distance from North Girth Weld | Depth of Corrosion Pitting | | |
|---|---|---|---|---|
| 7:03 o'clock to 11:16 o'clock | 8' to 12' | 0.002" | 0.011" | 0.026" |

The photographs display overall views of the west side of the fractured pipe from 4' south to 8' south of the north girth weld, and 8' south to 12' south of the north girth weld, respectively, after the removal of the coating. The lower half of the pipe shows corrosion pitting on the O.D. surface where the coating had wrinkled and sagged.

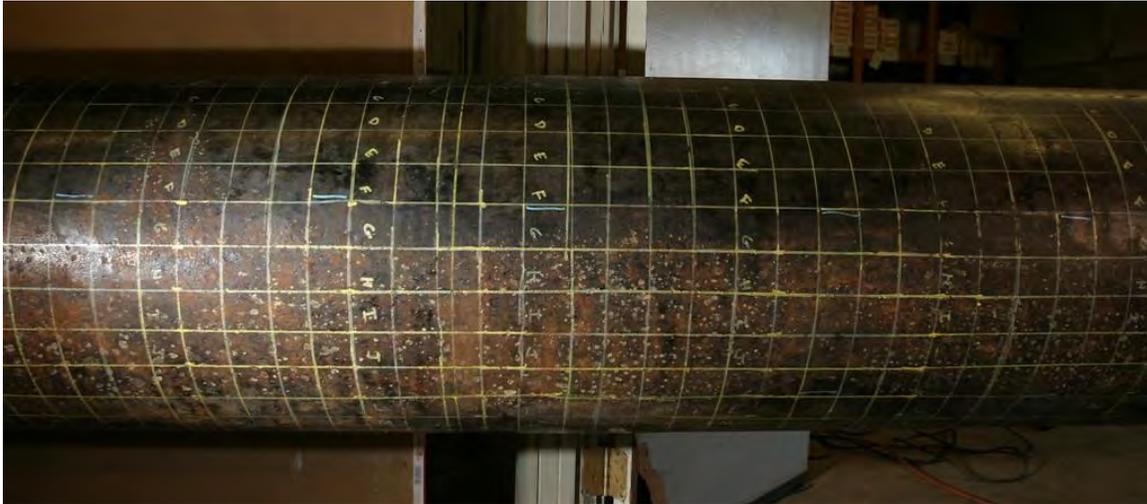
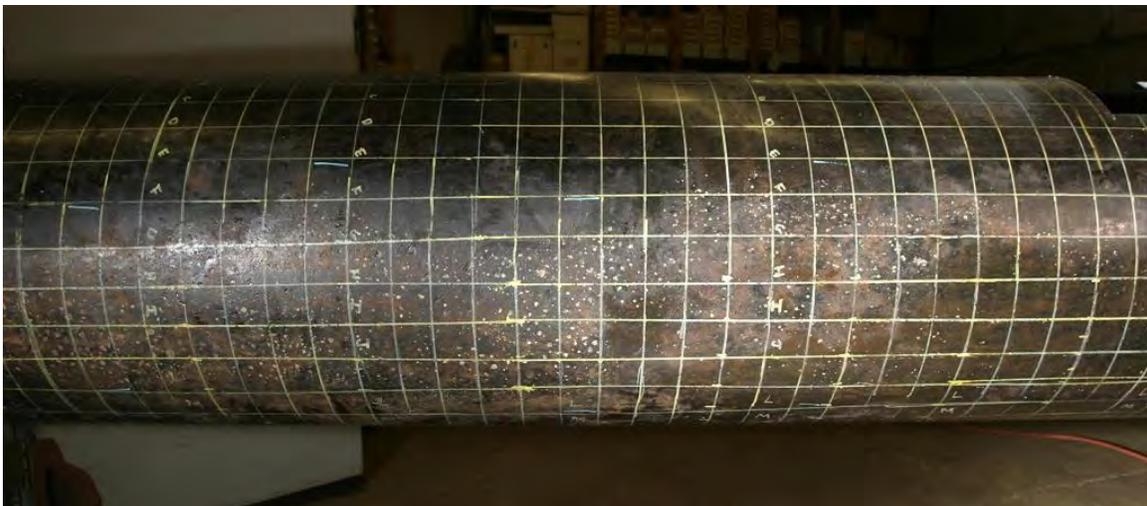
| Circumferential Location | Distance from North Girth Weld | Depth of Corrosion Pitting | | |
|---|---|---|---|---|
| 6:52 o'clock to 10:07 o'clock | 16' to 20' | 0.006" | 0.012" | 0.021" |

The photographs display overall views of the west side of the fractured pipe from 12' south to 16' south of the north girth weld, and 16' south to 20' south of the north girth weld, respectively, after the removal of the coating. The lower half of the pipe shows corrosion pitting on the O.D. surface where the coating had wrinkled and sagged.
