DOT US Department of Transportation
PHMSA Pipelines and Hazardous Materials Safety Administration
OPS Office of Pipeline Safety
Southwest Region

Date of Report October 23, 2013
Subject Failure Investigation Report – Mobil Pipe Line Company; Pegasus Pipeline, Mayflower, AR

Failure Investigation Report – Mobil Pipeline Pegasus Rupture
March 29, 2013

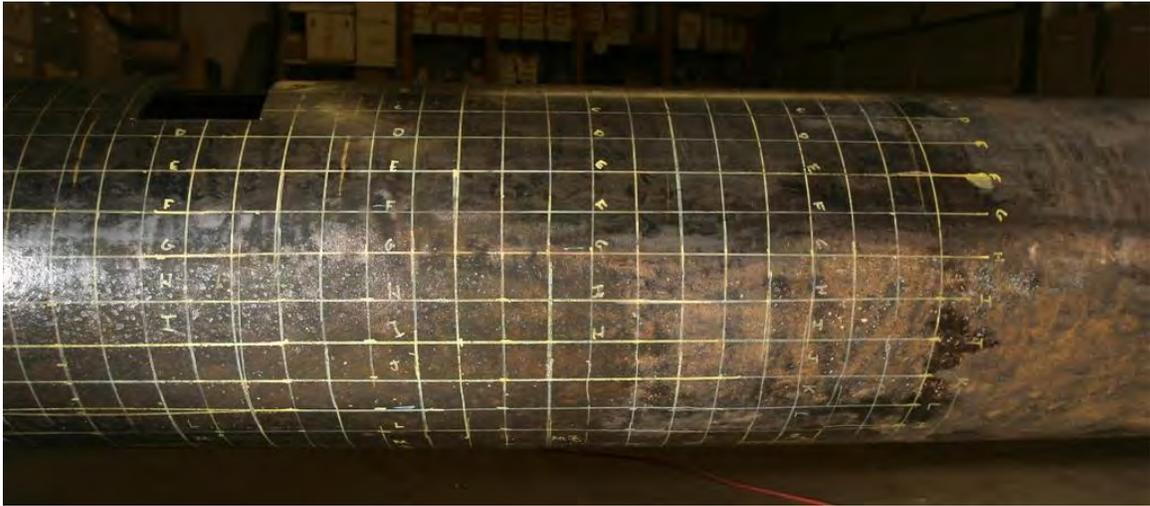
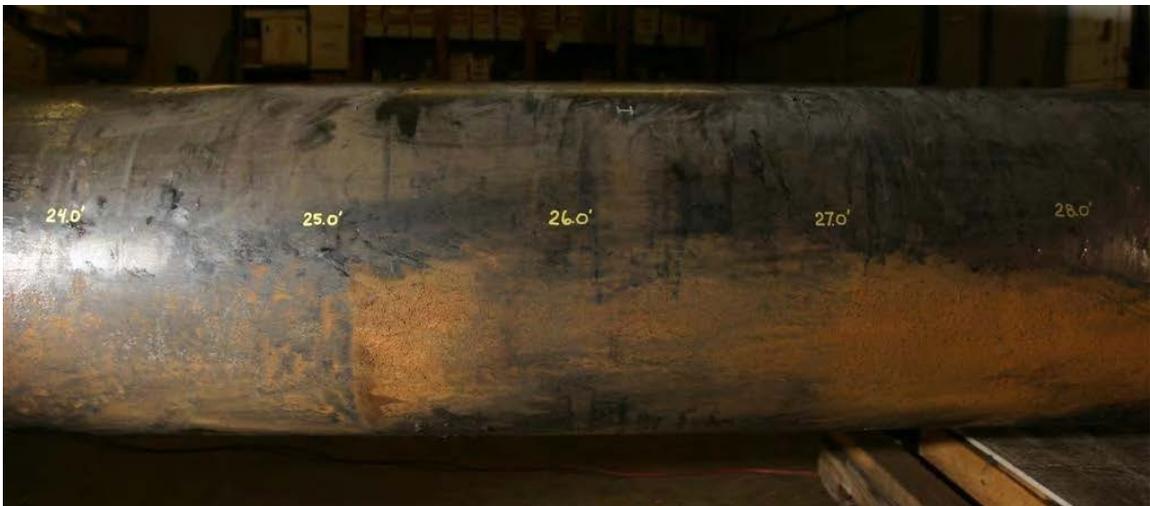
The photographs display overall views of the west side of the fractured pipe from 20' south to 24' south of the north girth weld, and 24' south to 28' south of the north girth weld, respectively, after the removal of the coating. The lower half of the pipe shows corrosion pitting on the O.D. surface where the coating had wrinkled and sagged.

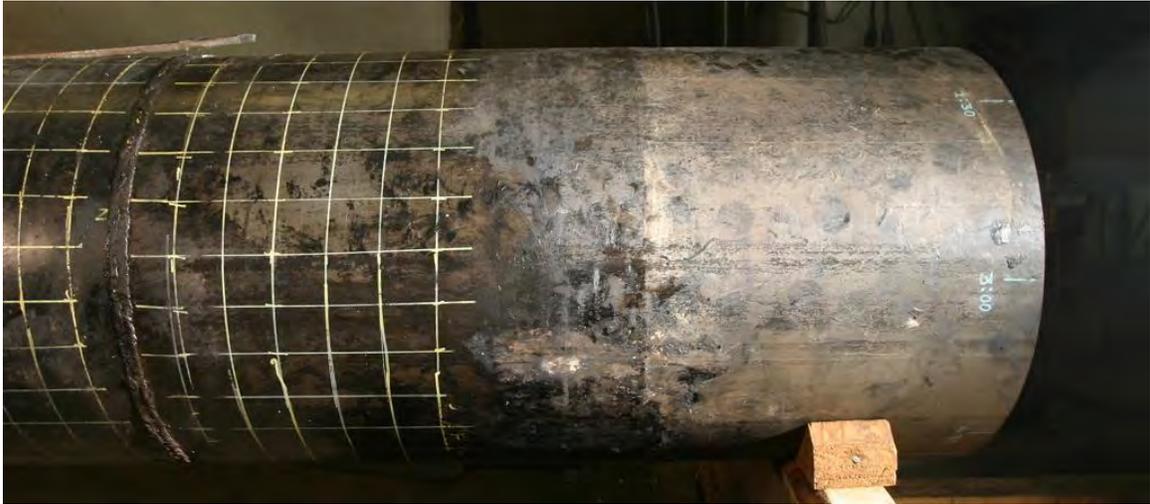
Photograph No. 74

The photograph displays an overall view of the west side of the fractured pipe from 28' south to 31' south of the north girth weld, respectively, after the removal of the coating. The fractured pipe was sectioned in the field transversely approximately 31' south of the north girth weld to allow for removal of the fractured section of pipe. No corrosion pitting is visible on the O.D. surface near the transverse cut at the south end of the fractured section of the pipe.

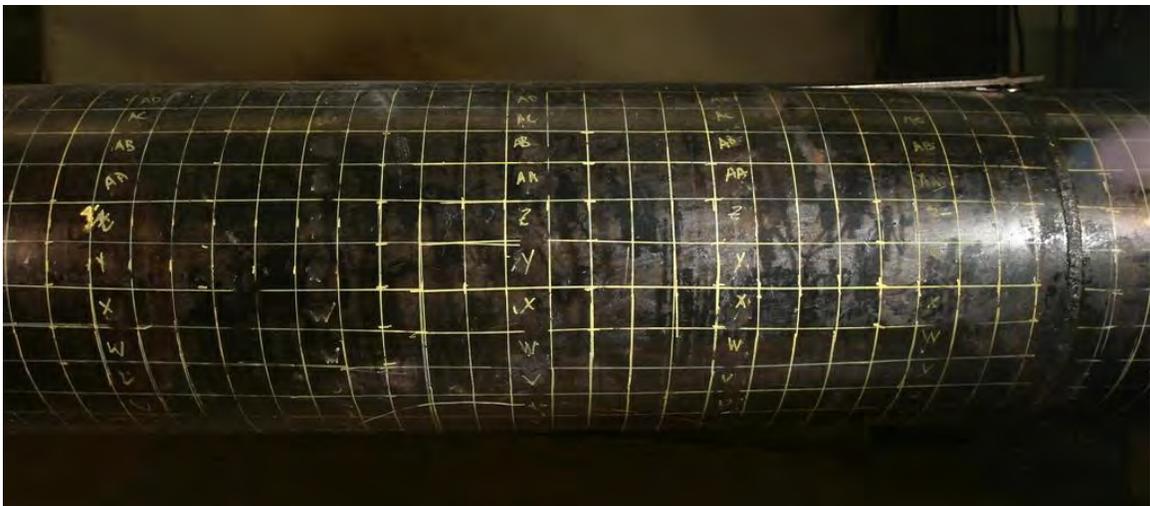
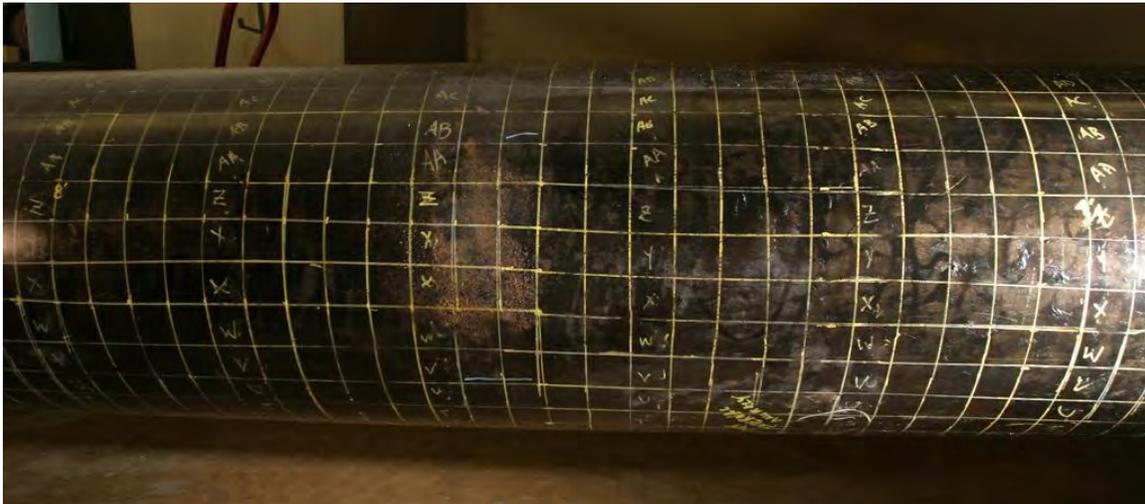
The photographs display overall views of the east side of the pipe adjacent to the fractured pipe from approximately 3' north of the girth weld (-3') to the center of the north girth weld (0'), and the fractured pipe from the center of the girth weld to 4' south of the north girth weld (+4'), respectively, after the removal of the coating. No corrosion pitting is visible on the O.D. surfaces on the fractured or intact pipe around the north girth weld.

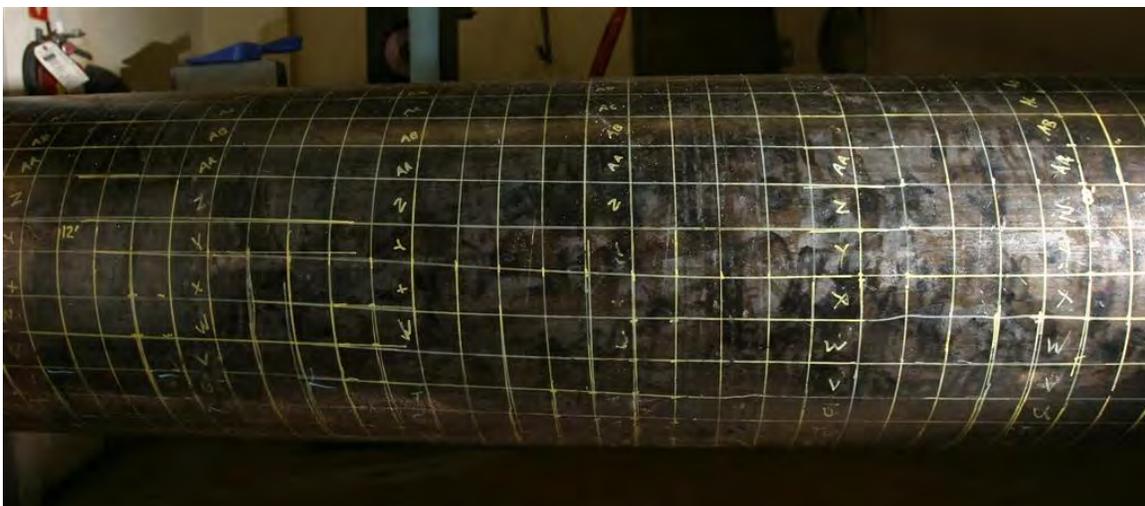
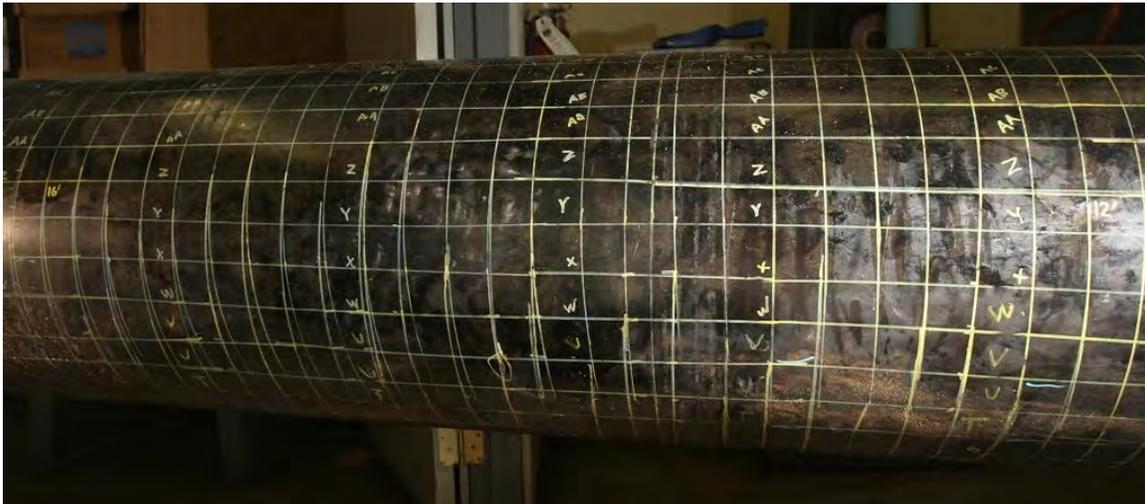
The photographs display overall views of the east side of the fractured pipe from 4' south to 8' south of the north girth weld, and 8' south to 12' south of the north girth weld, respectively, after the removal of the coating. The lower half of the pipe shows corrosion pitting on the O.D. surface where the coating had wrinkled and sagged.

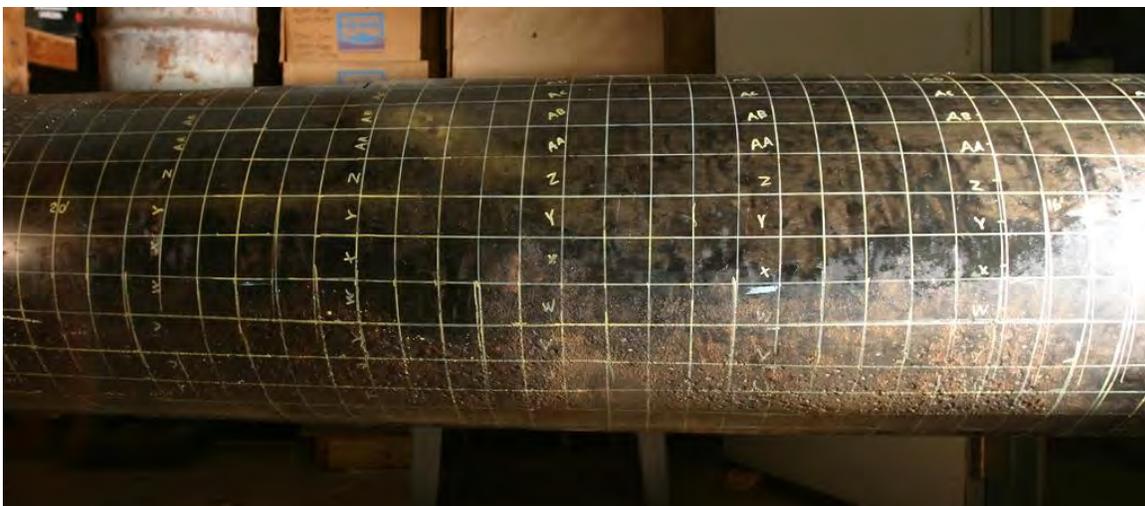
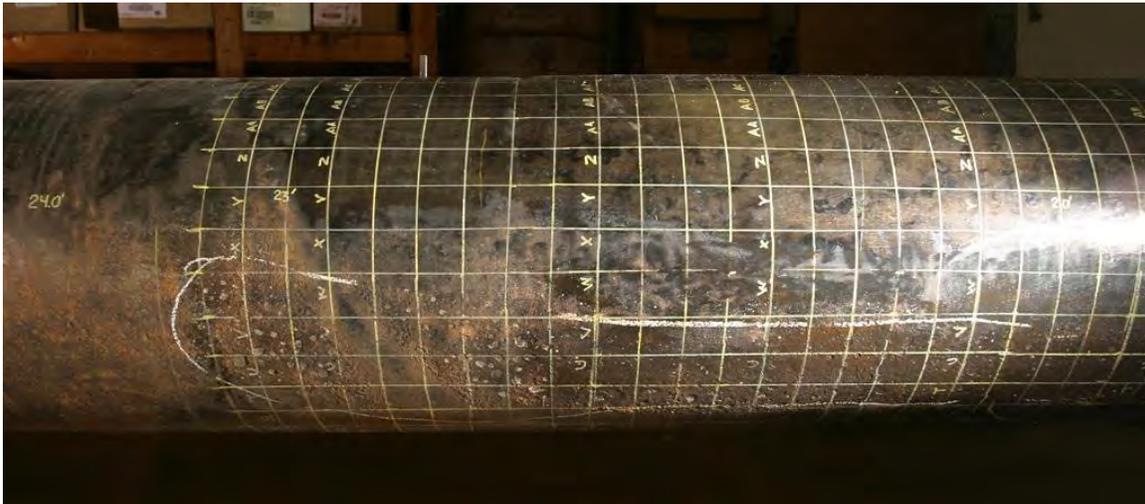
The photographs display overall views of the east side of the fractured pipe from 12' south to 16' south of the north girth weld, and 16' south to 20' south of the north girth weld, respectively, after the removal of the coating. The lower half of the pipe shows corrosion pitting on the O.D. surface where the coating had wrinkled and sagged.

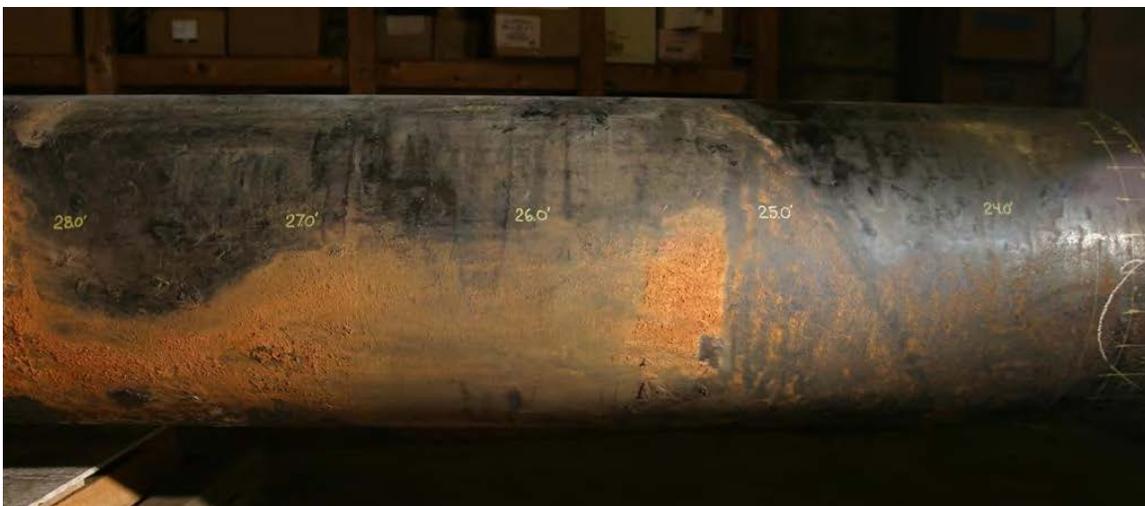
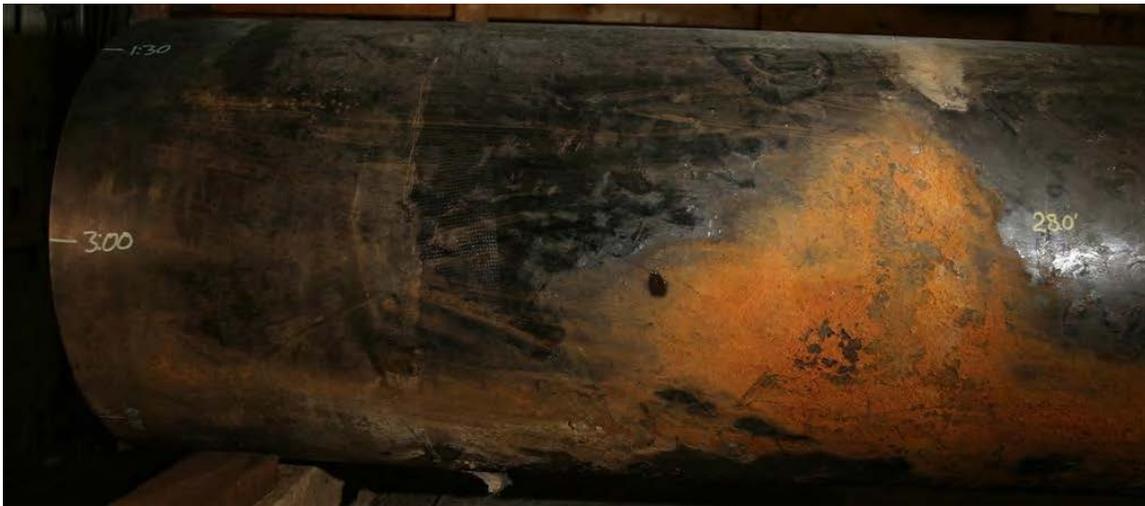
The photographs display overall views of the east side of the fractured pipe from 20' south to 24' south of the north girth weld, and 24' south to 28' south of the north girth weld, respectively, after the removal of the coating. The lower half of the pipe shows corrosion pitting on the O.D. surface where the coating had wrinkled and sagged.

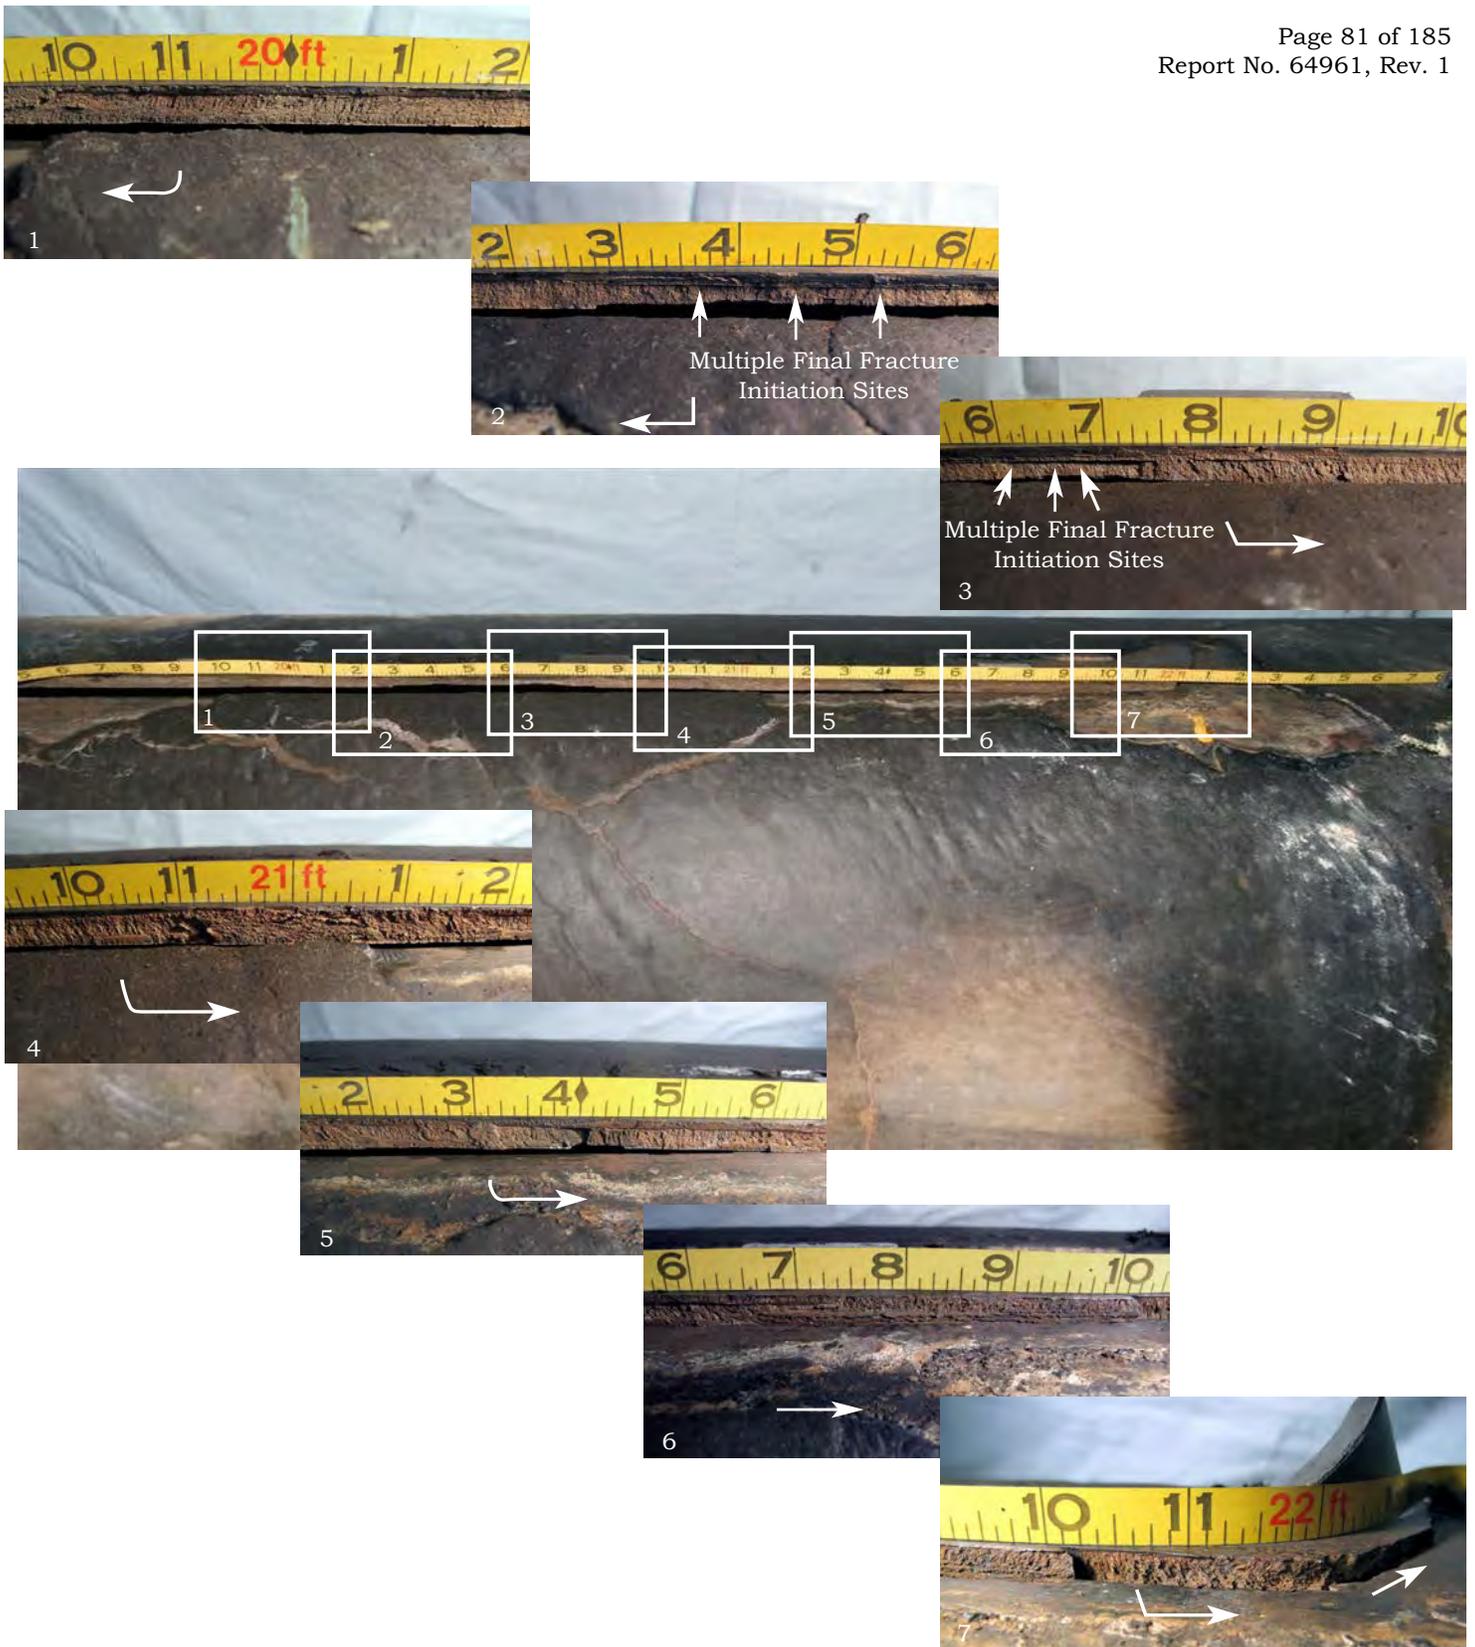
Photograph No. 87

The photographs display overall and close-up views of the 33' 11-1/2" long section of a fractured 20" O.D. x 0.312" wall pipe, which was removed from the Conway to Corsicana section of the Pegasus Crude Oil Pipeline at Milepost 314.77 in Mayflower, Arkansas.

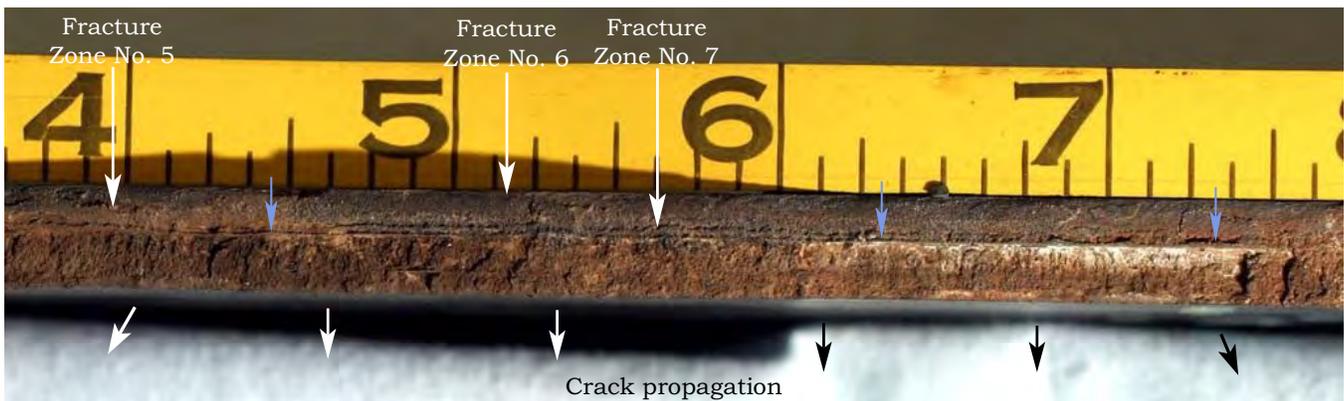
Photograph No. 103

The photographs display close-up views of the fracture face between a distance of 19' 10" and 20' 4" from the north girth weld, showing radial lines, marked by the blue arrows, which originated from hook cracks through the grain flow or banding formed during manufacturing the ERW seam.

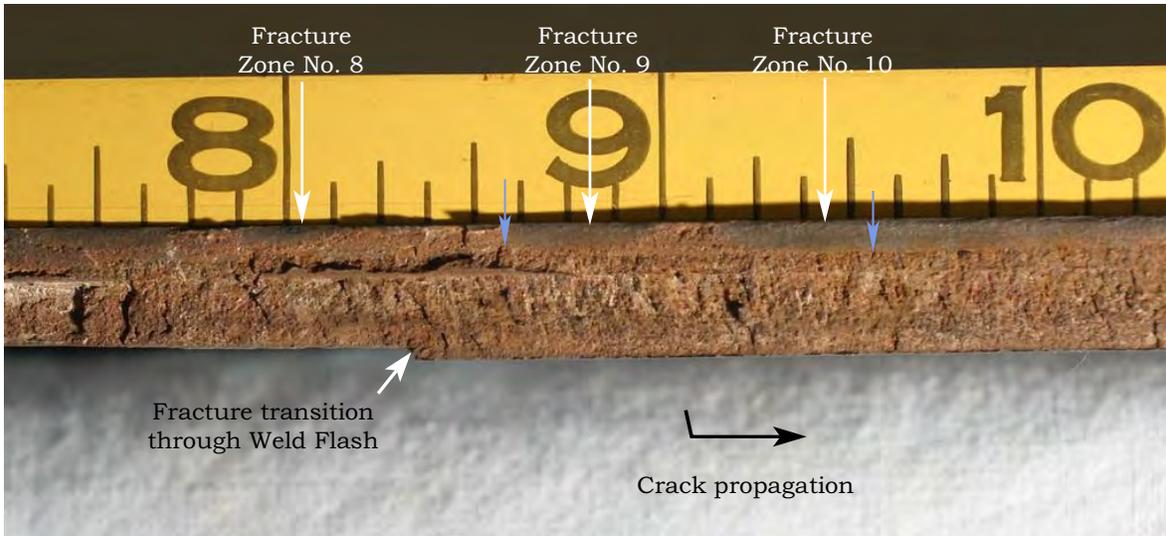
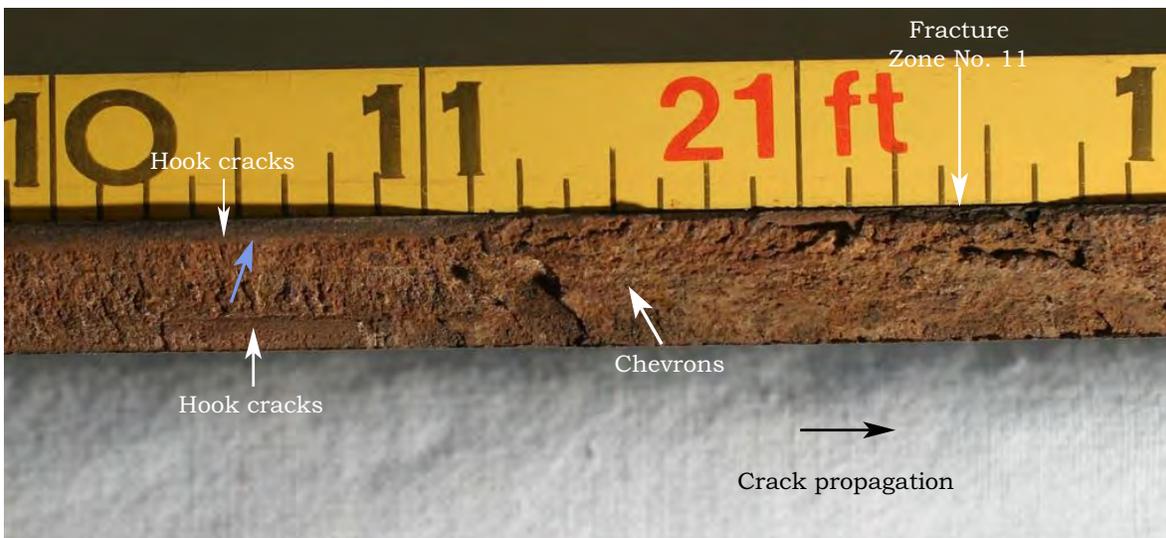
The photograph displays a close-up view of the fracture face between a distance of 20' 4" and 20' 8" from the north girth weld, showing vertical radial lines emanating from the hook cracks, which are marked by the blue arrows, indicating the primary fracture initiation sites which resulted in the 22' 3" long fracture along the ERW seam of the 49' 9-1/2" long pipe.

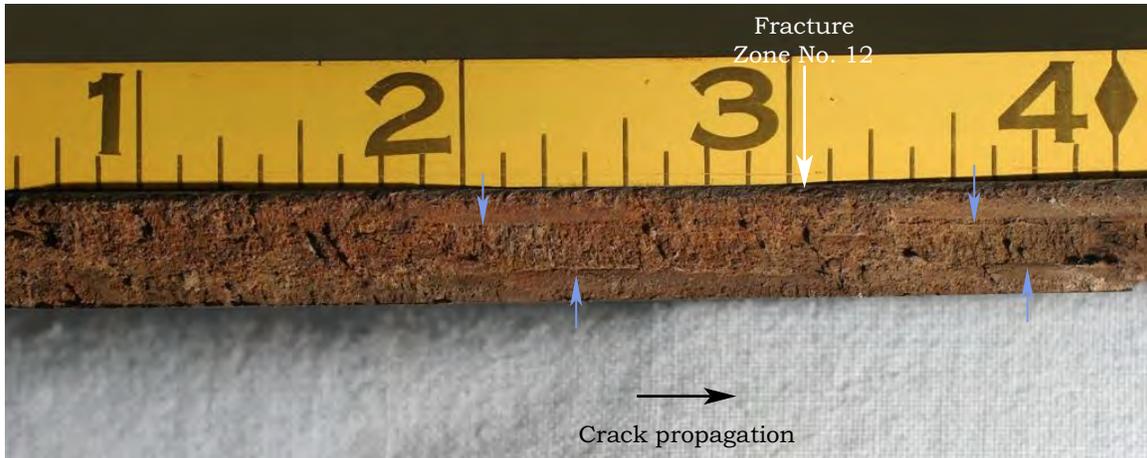
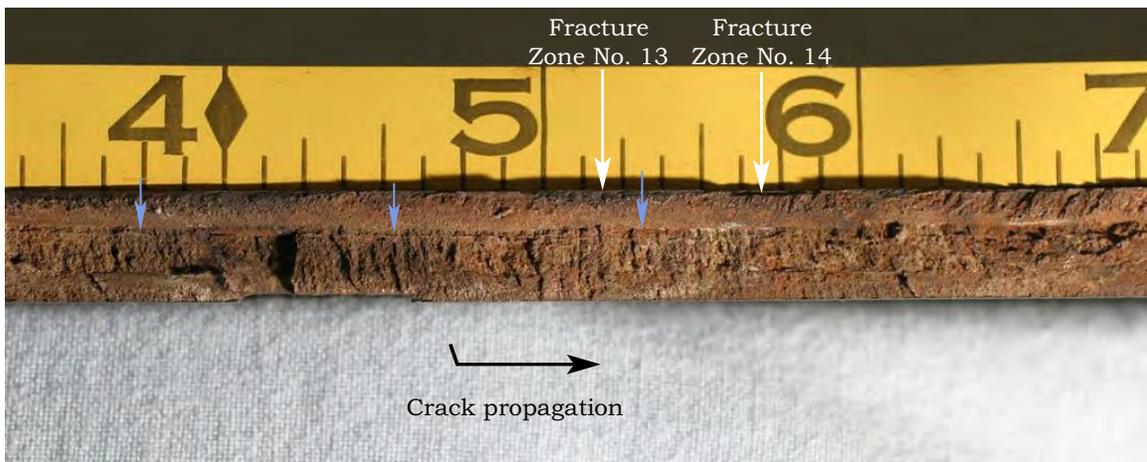
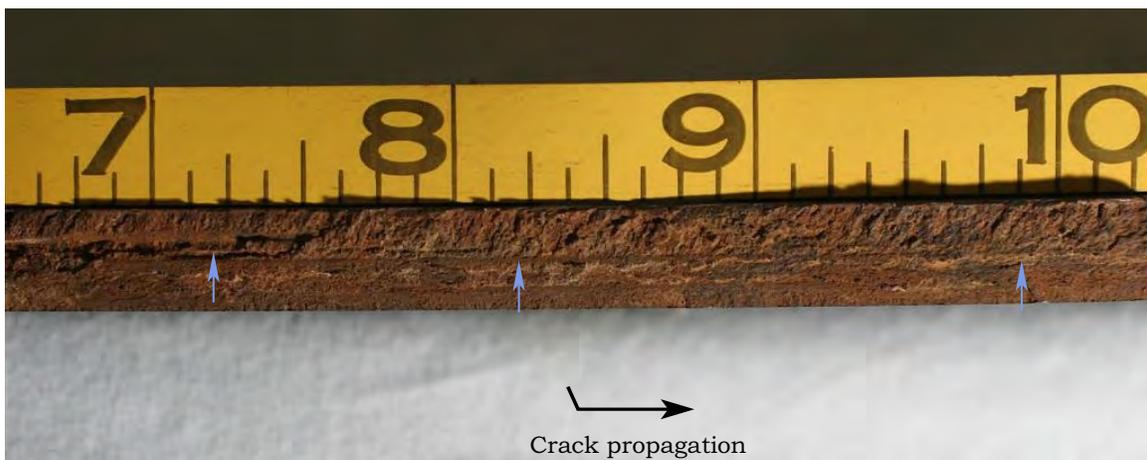
The photographs display close-up views of the fracture face between a distance of 20' 8" and 21' 1" from the north girth weld, showing radial lines emanating from the hook cracks, marked by the blue arrow, and chevrons pointing to the cracks, revealing some of the final fracture origins.

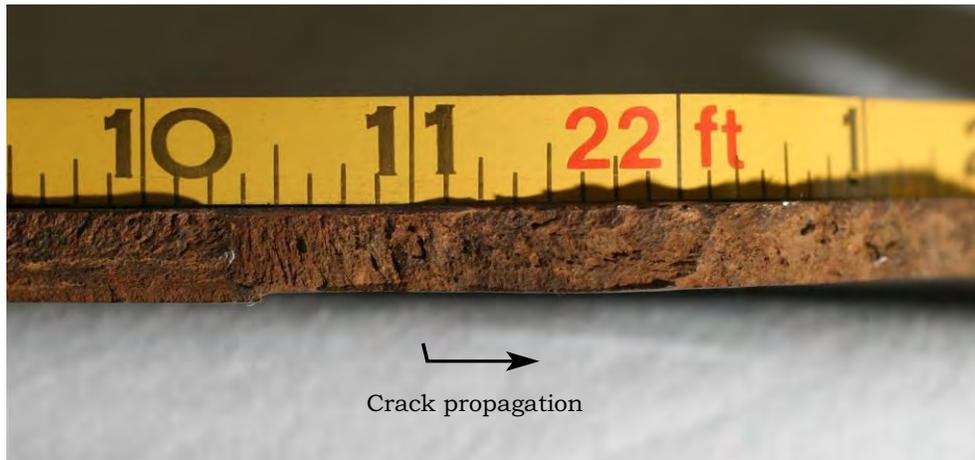
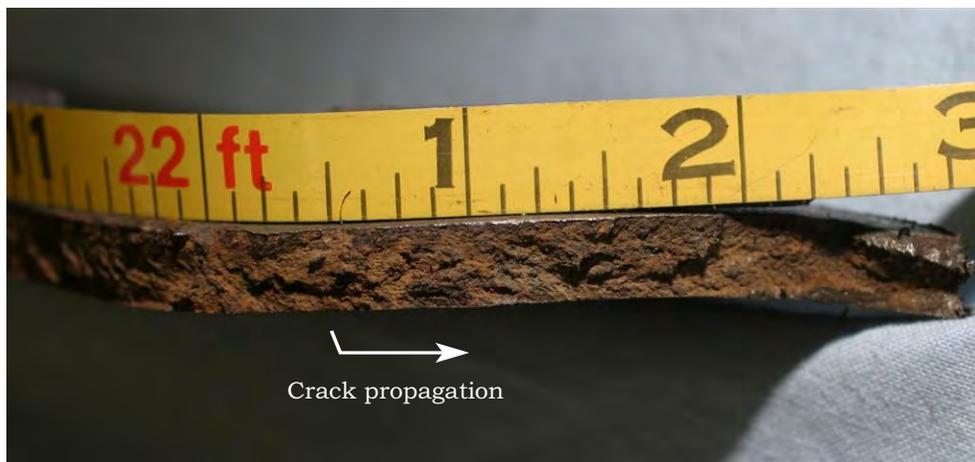
The photographs display close-up views of the fracture face between a distance of 21' 1" and 21' 10" from the north girth weld showing radial lines emanating from the hook cracks. The blue arrows point to the radial lines, indicative of some of the final fracture initiation sites.

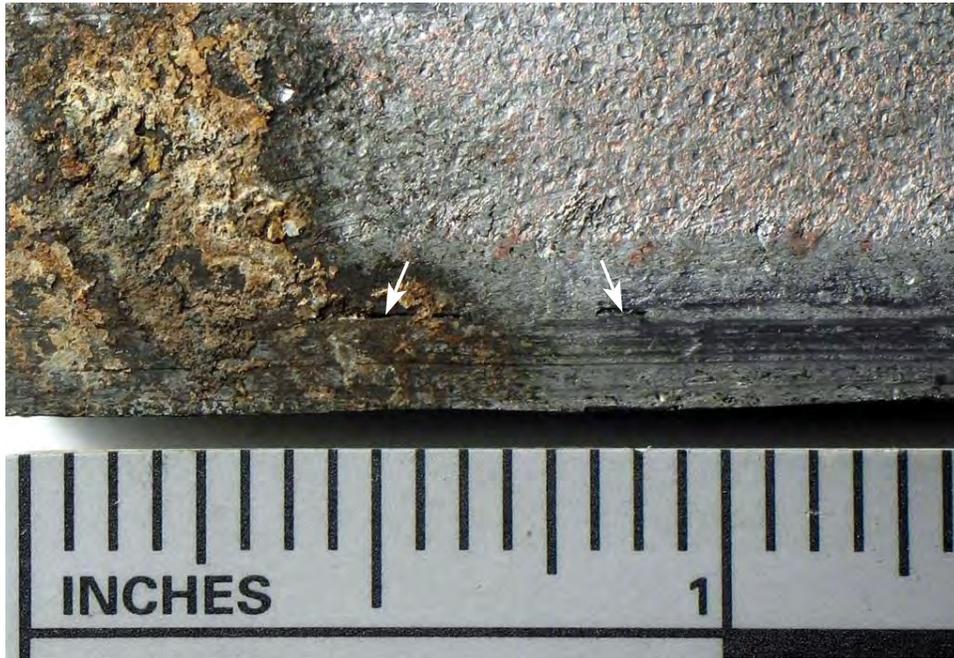
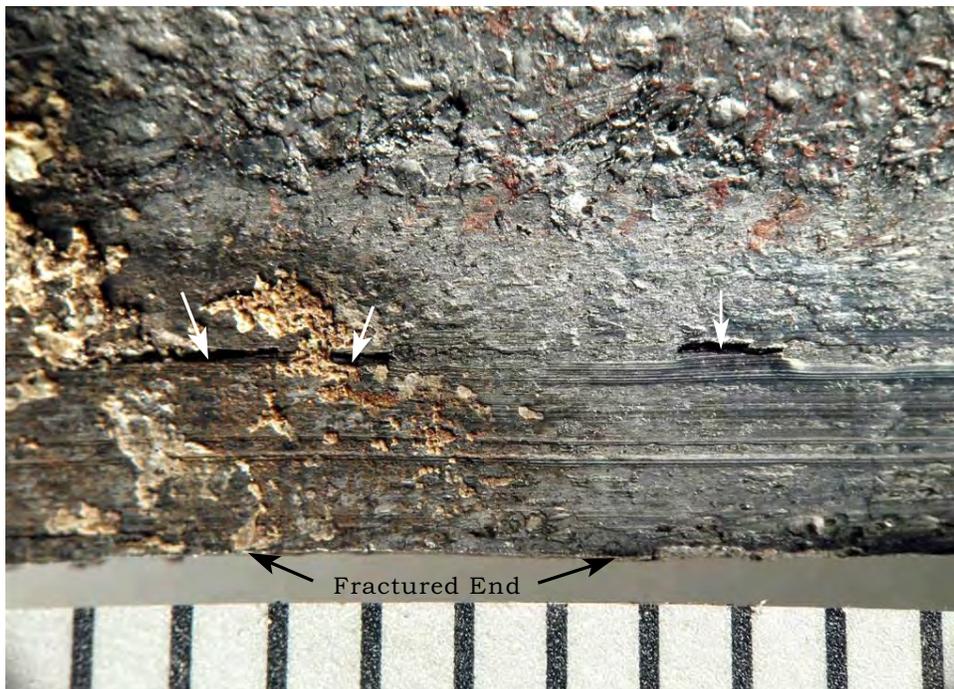
The photographs display the O.D. and I.D. surfaces adjacent to one of the mating fracture faces which contained multiple hook cracks. The arrow points to an area where the coating was apparently damaged prior to the incident.

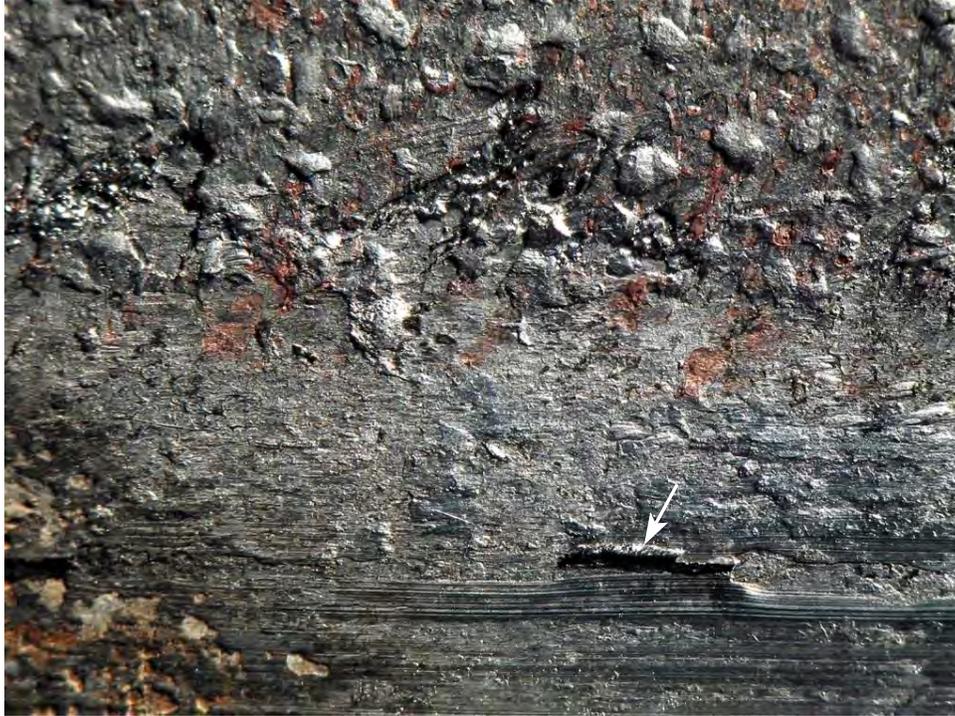
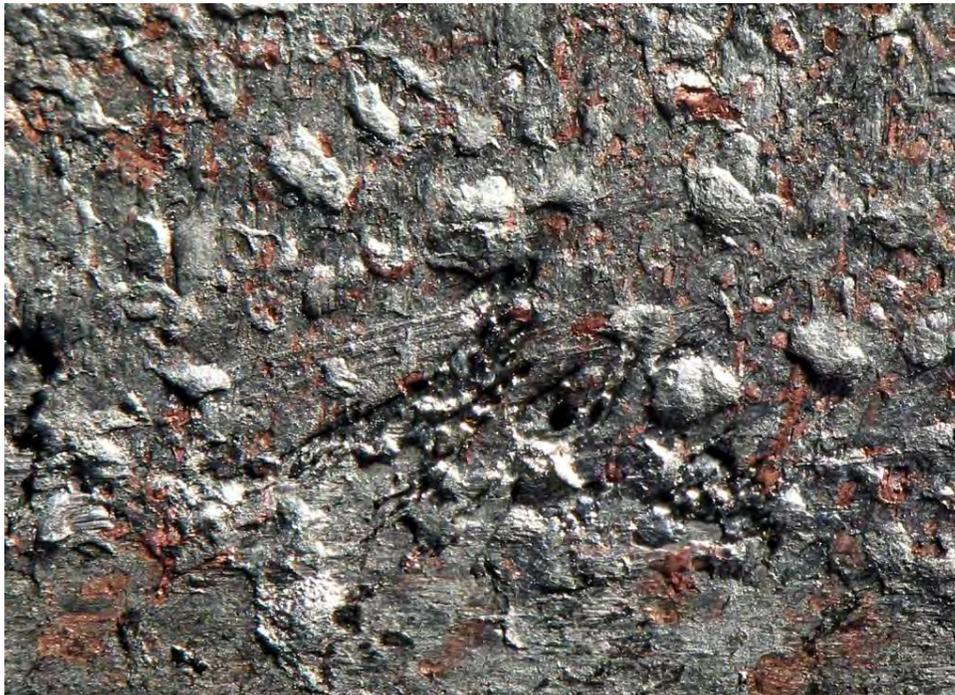
The photographs of the outside surface of the fractured ERW seam at a distance between 20' 4-1/2" and 20' 6" from the north girth weld show evidence of what appears to be crack or melting caused by copper electrode contacts during the ERW seam fabrication. The arrows point to these imperfections.

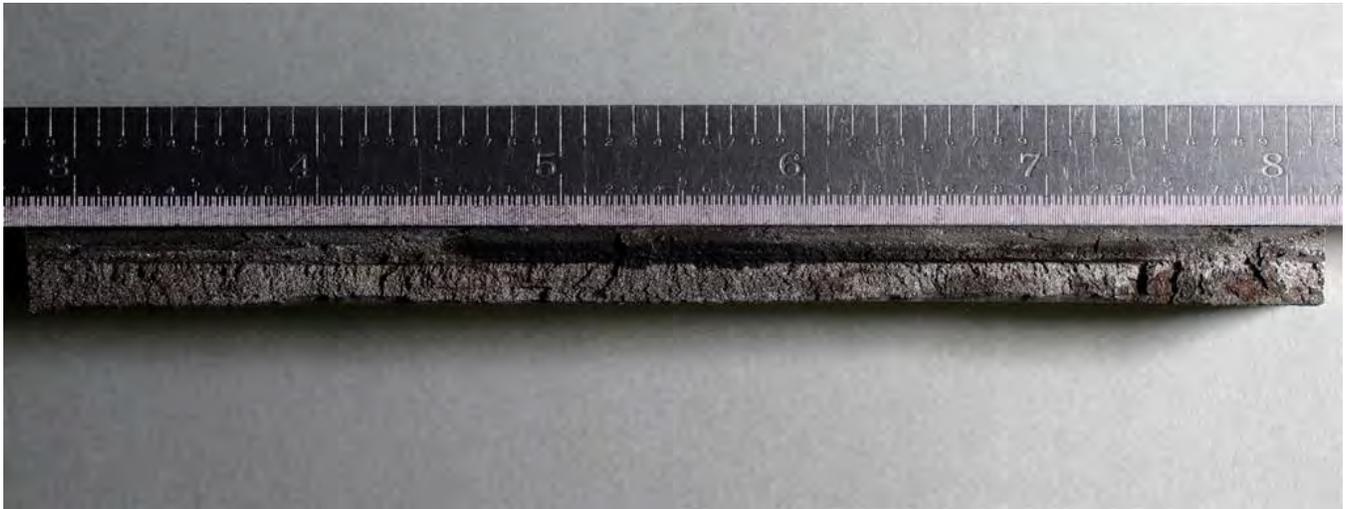
Photograph No. 117

The photographs display close-up views of the copper electrode contact marks in the heat-affected zone of the ERW seam, at the arrow, on the O.D. surface and the presence of copper.

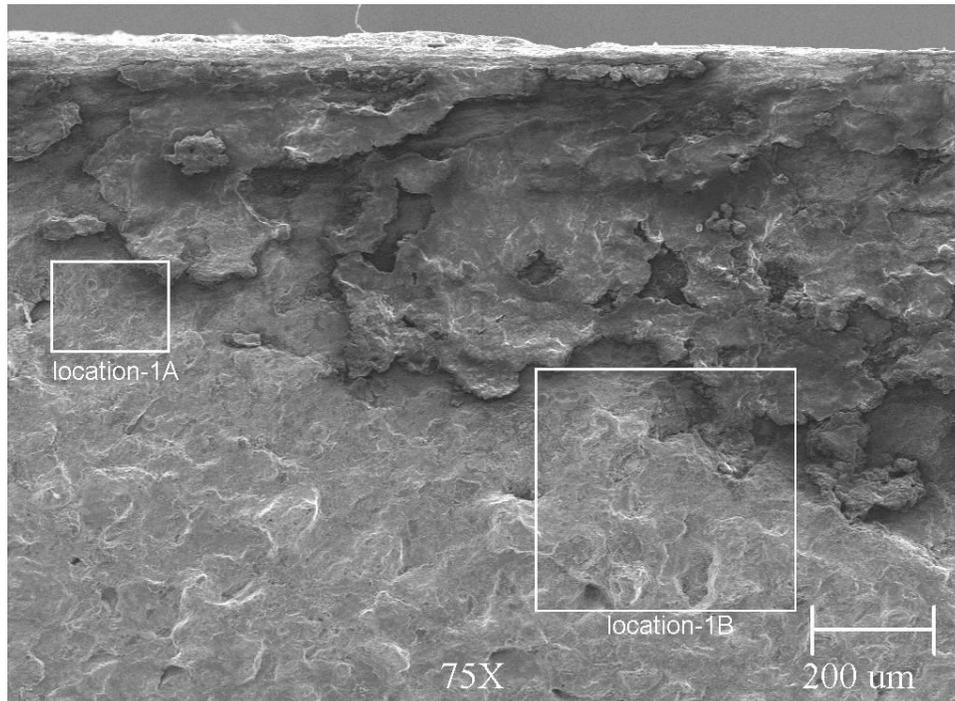
Area-A
Photograph No. 124

The SEM fractograph taken of one of the final fracture origin sites at a distance of 20' 5-5/16" from the north girth weld shows an hook crack and the final fracture zone. The fracture locations within the rectangles were examined at high magnifications to further characterize the fracture morphologies. The dotted line denotes the transition zone between the hook cracks and the final fracture.

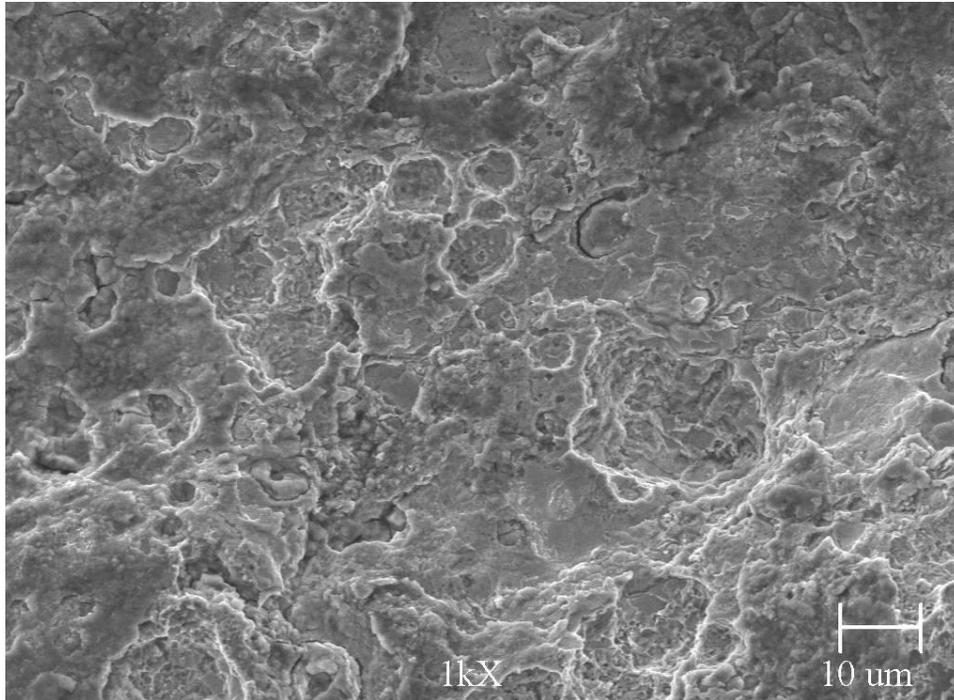
Area-A, Location-1A
Photograph No. 125

The SEM fractograph taken of the Area-A of the hook crack near the O.D. surface, as displayed in Photograph No. 123, displays essentially a nondescript featureless fracture surface. Note the absence of any fracture features, likely due to the metal-to-metal contact from the mating fracture faces of the crack and post-crack oxidation. The fracture locations labeled as Location-1A and Location-1B were examined at higher magnifications to further characterize the fracture morphology.

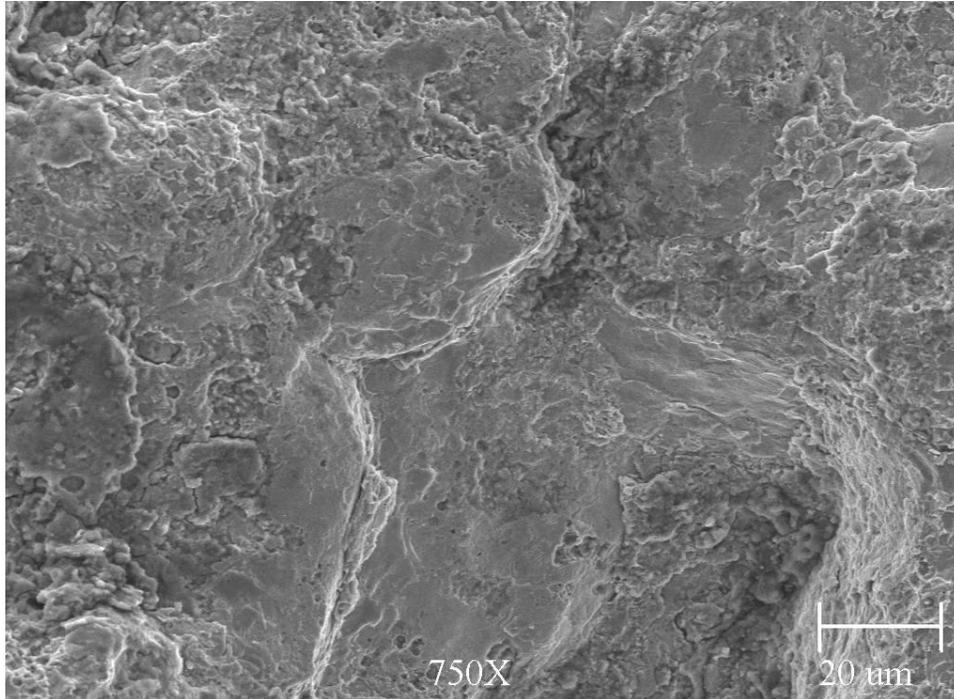
Area-A, Location-1B
Photograph No. 126

The SEM fractographs of the two (2) fracture locations labeled as Location-1A and Location-1B in Area-A of the hook crack zone near the O.D. display tightly adhered oxidation product, suggesting that the crack had occurred some time prior to the final fracture.

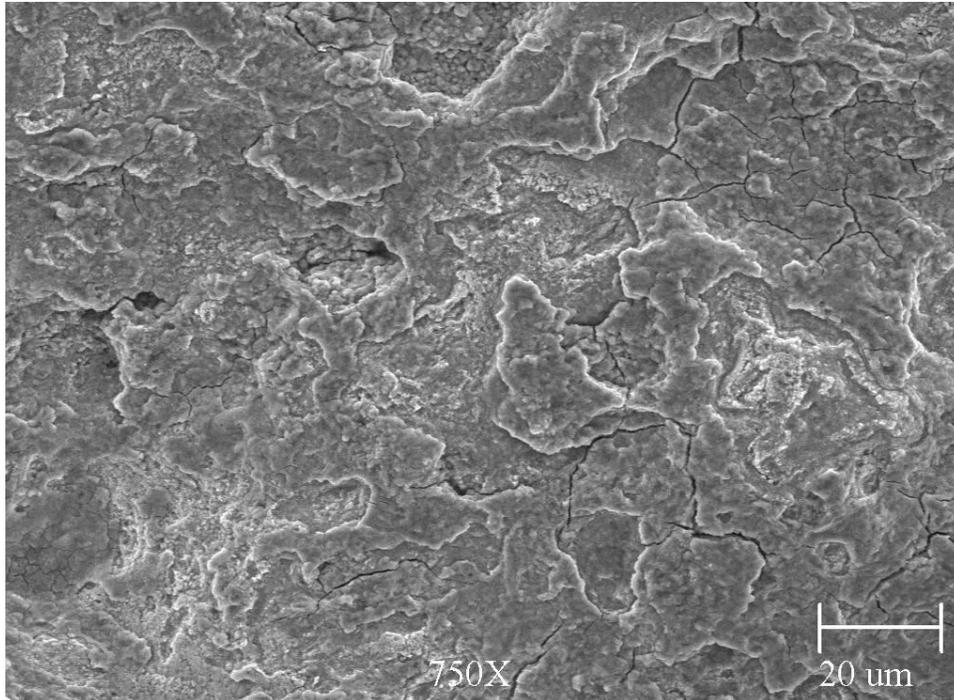
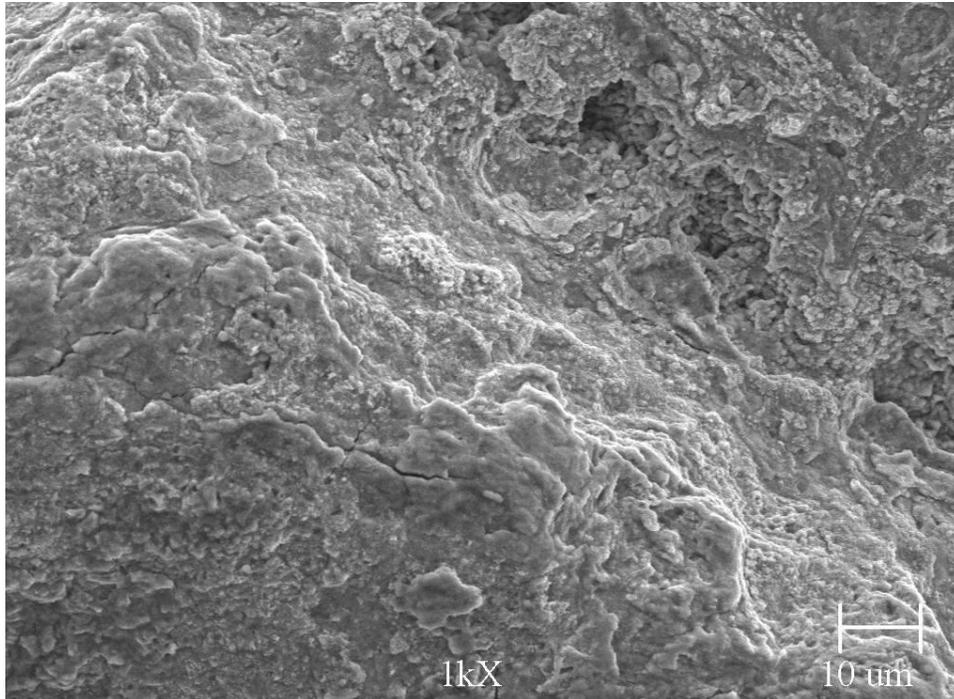
The SEM fractographs taken of the Area-C at Location-3A and Location-3B of the hook crack zone, as displayed in Photograph No. 129, reveal tightly adhered oxidation product.

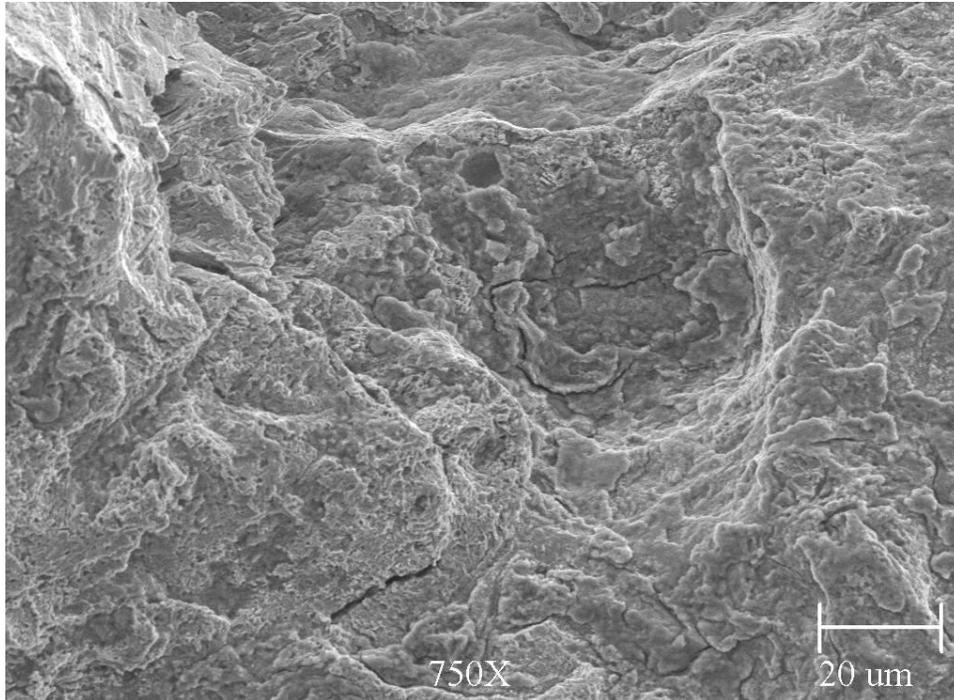
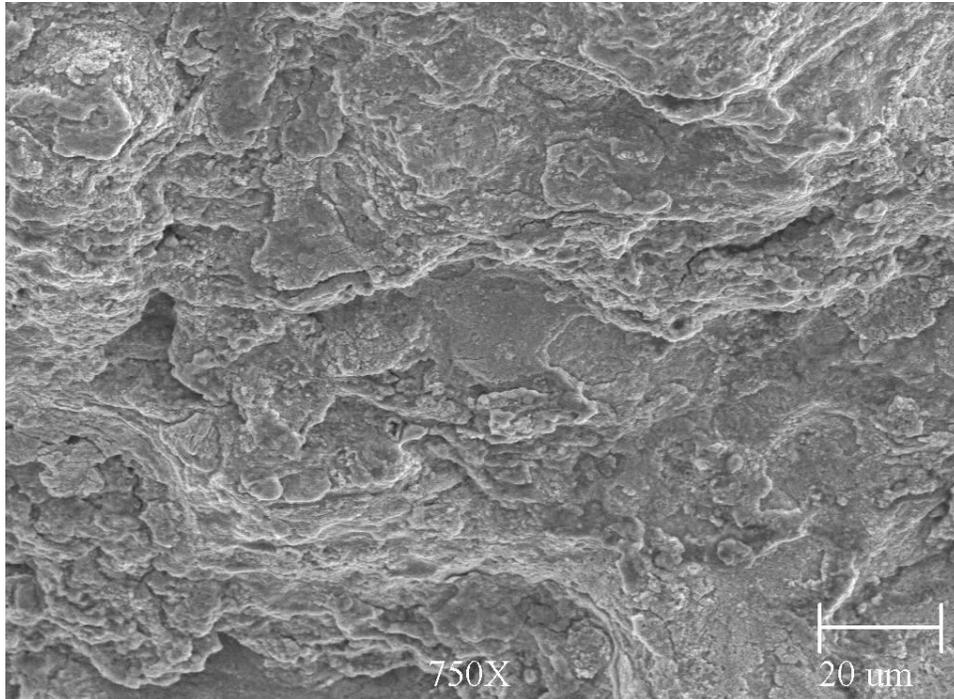
The SEM fractographs taken of the Area-C at Location-3C and Location-3D of the hook crack zone, as displayed in Photograph No. 129, reveal tightly adhered oxidation product.
