DOT US Department of Transportation
PHMSA Pipelines and Hazardous Materials Safety Administration
OPS Office of Pipeline Safety
Southwest Region

Date of Report October 23, 2013
Subject Failure Investigation Report – Mobil Pipe Line Company; Pegasus Pipeline, Mayflower, AR

Failure Investigation Report – Mobil Pipeline Pegasus Rupture
March 29, 2013

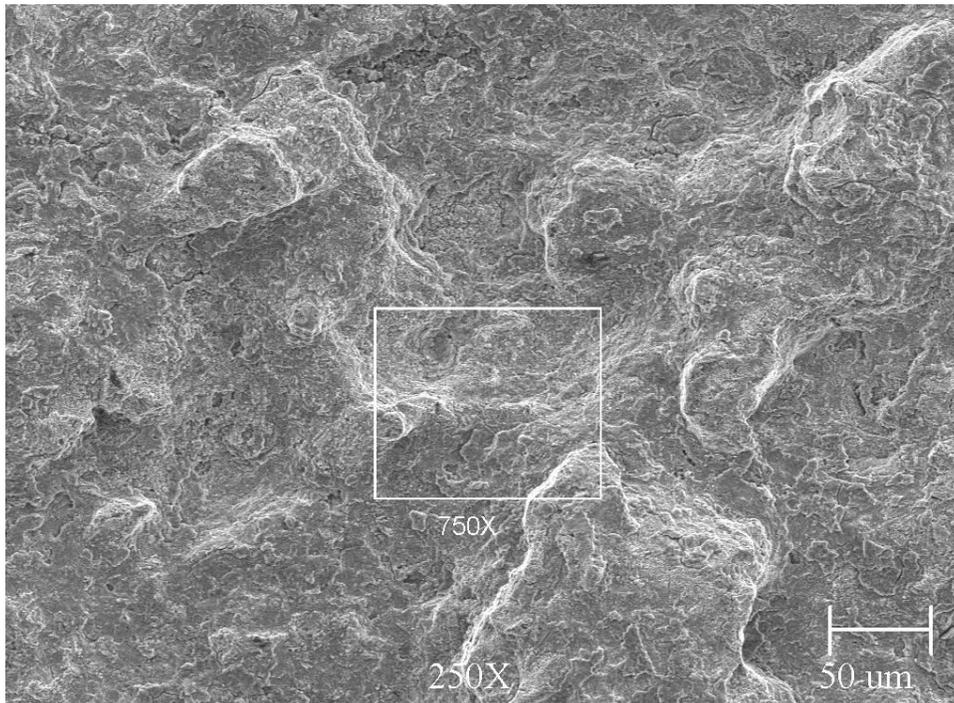
Area-D
Photograph No. 134

The SEM fractograph taken of the Area-D of the hook crack zone, as displayed in Photograph No. 123, reveals a nondescript, featureless fracture surface. The fracture location within the rectangle was examined at a higher magnifications to characterize the fracture morphology.

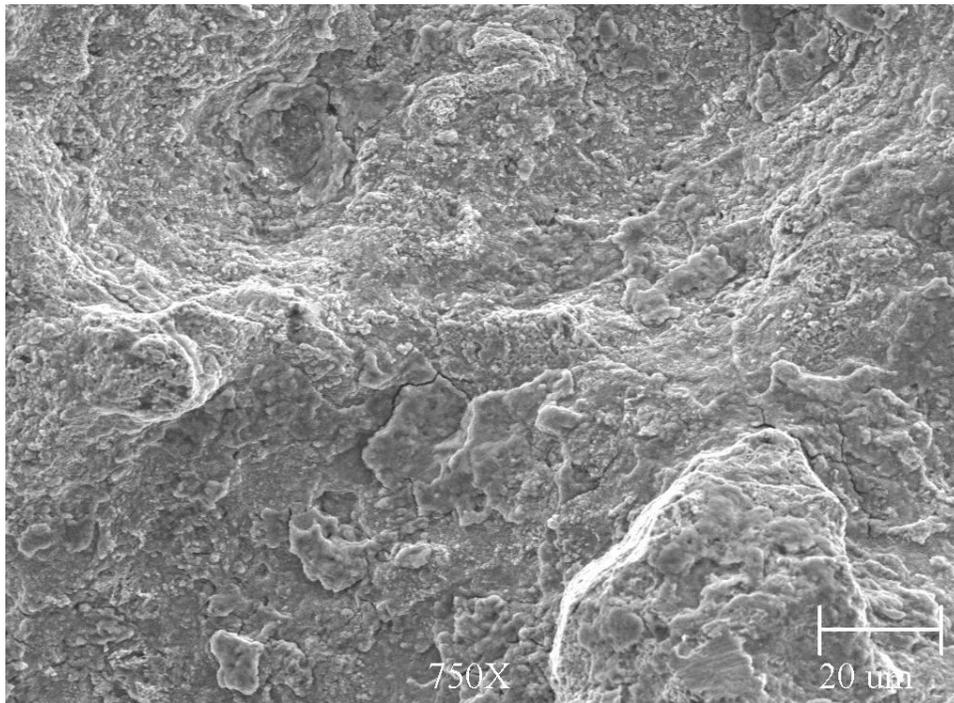
Area-D within the rectangle
Photograph No. 135

The SEM fractograph taken of the Area-D within the rectangle of the hook crack zone, as displayed in Photograph No. 134, reveals tightly adhered oxidation product.

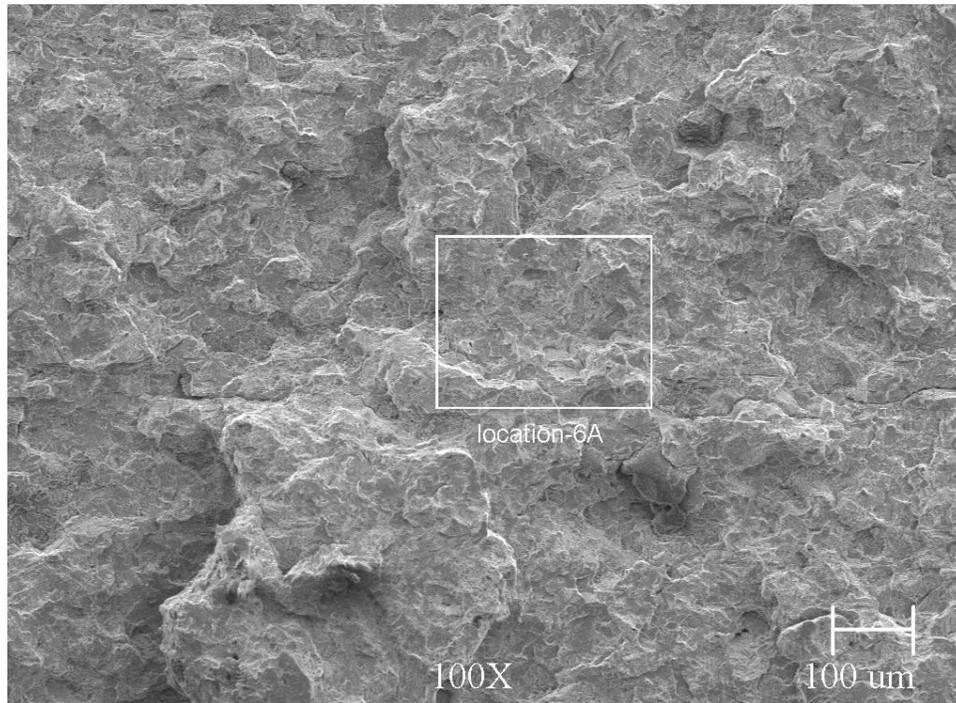
Area-F
Photograph No. 139

The SEM fractograph taken of the Area-F of the final fracture zone, as shown in Photograph No. 123, displays unresolved cleavage separation fracture features and faint evidence of ductile microvoid coalescence.

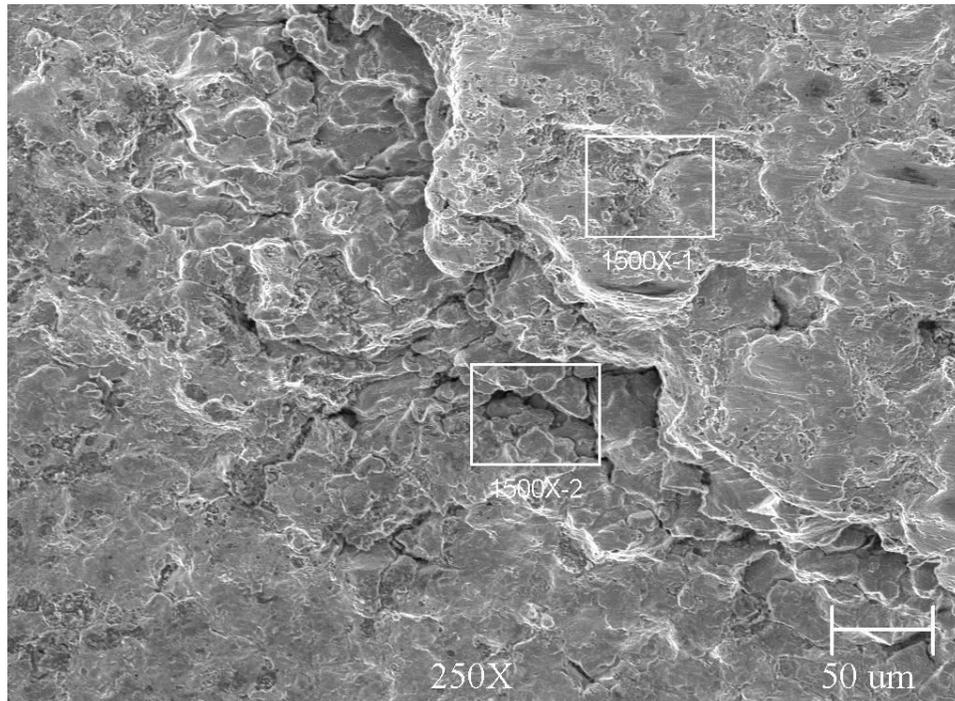
Area-1
Photograph No. 142

The SEM fractograph taken of the Area-1 of the hook crack fracture zone, as displayed in Photograph No. 141, reveals a highly oxidized fracture surface. The fracture areas, labeled as 1 and 2, were examined at higher magnification to further characterize the fracture morphologies.

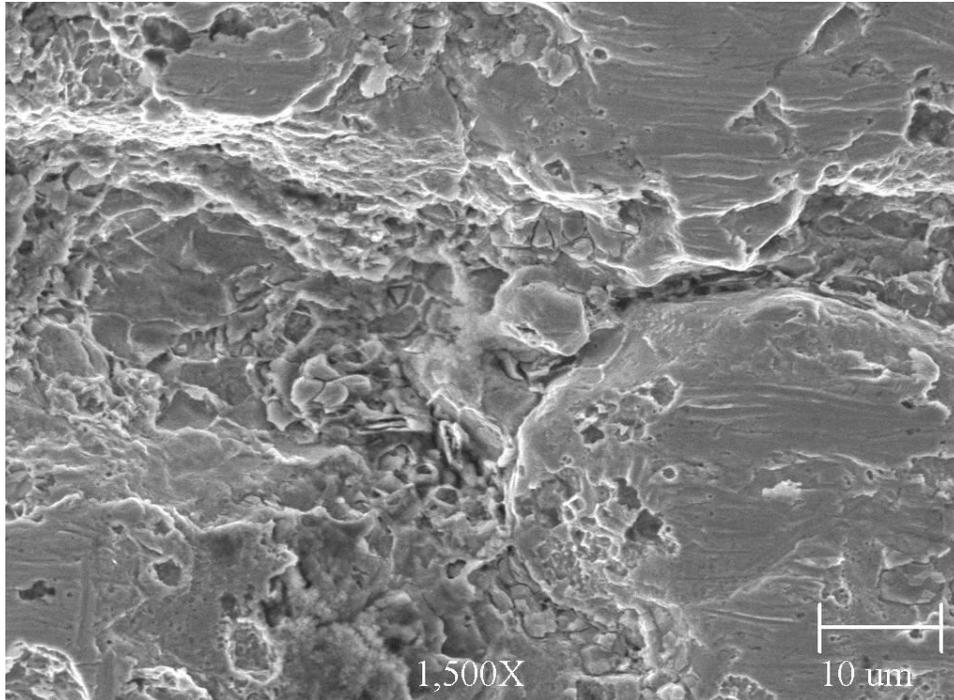
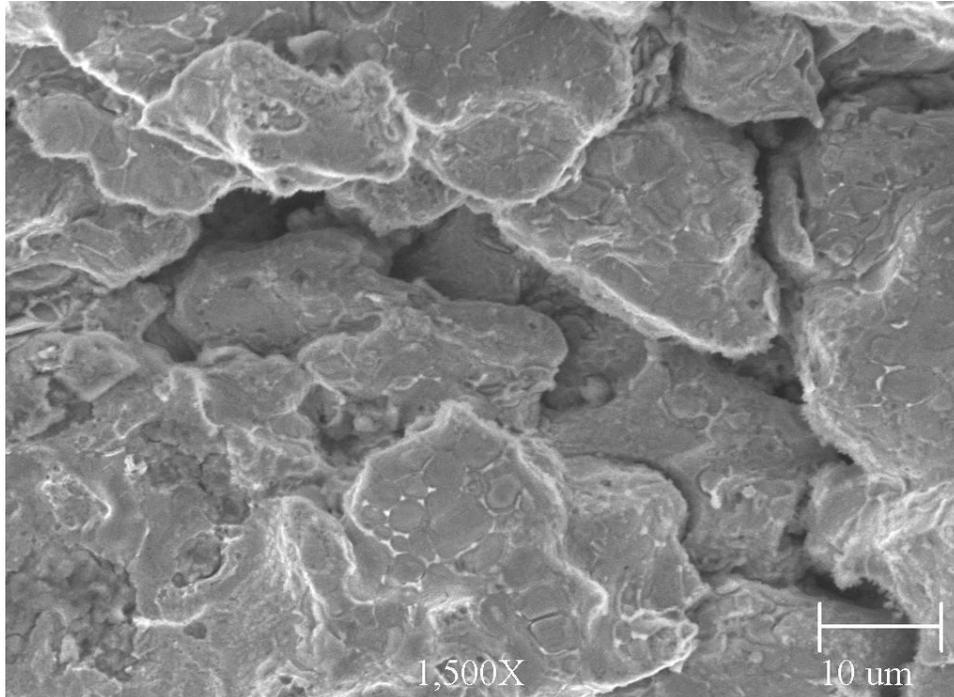
The SEM fractographs taken of the fracture zones labeled as Location-1 and Location-2 in Area-1 of the hook crack reveal a highly oxidized surface and evidence of what appears to be intergranular fracture in a very small fracture zone, respectively. The intergranular fracture may have resulted along the ferrite grain boundaries.

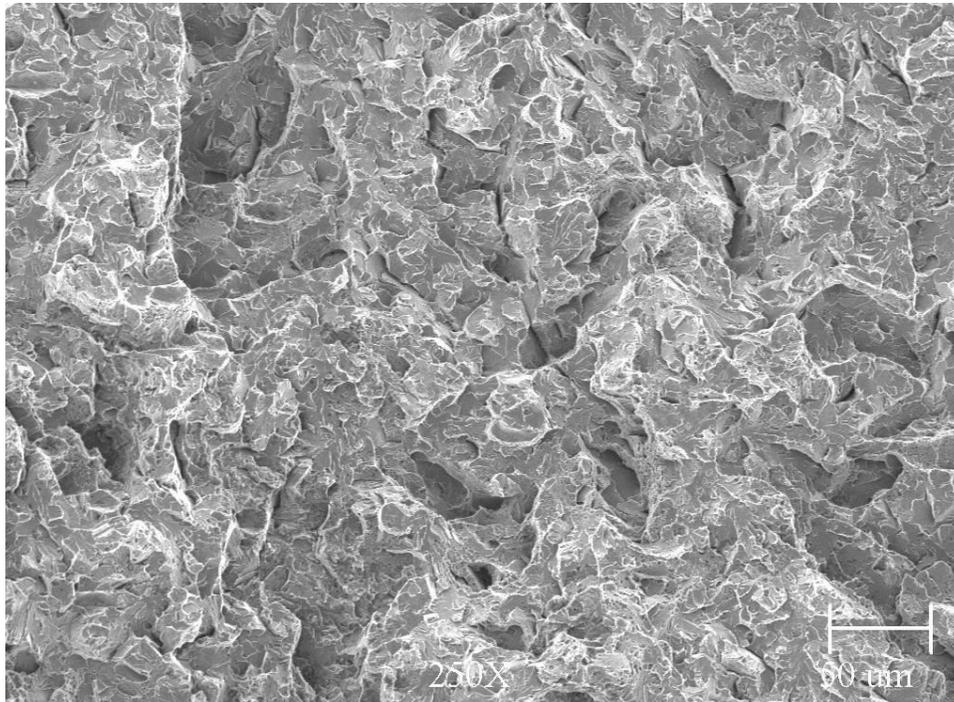
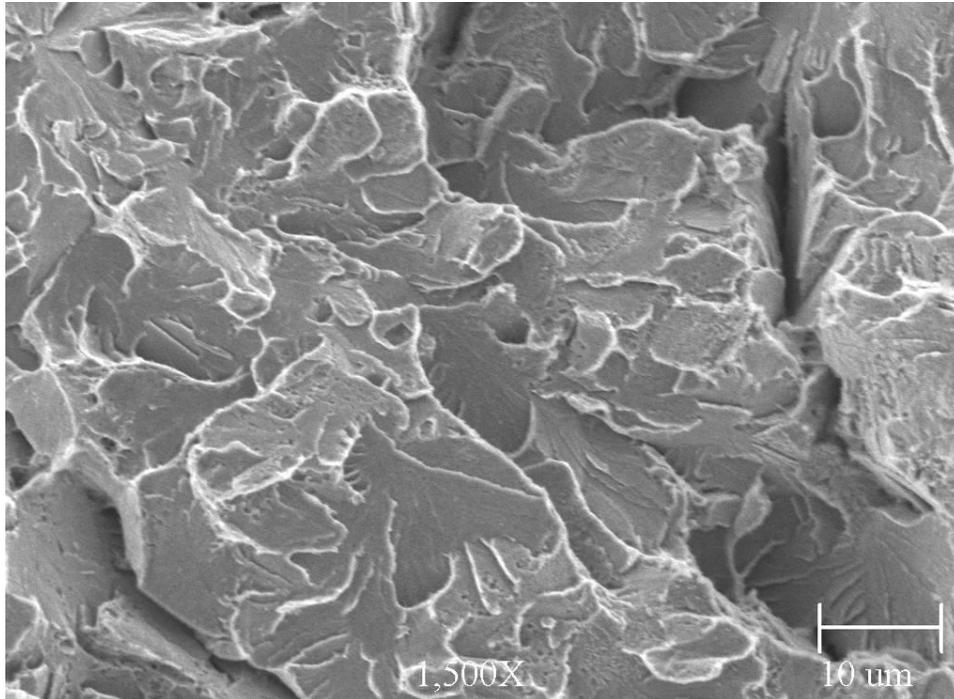
The SEM fractographs taken of the Area-3 of the final fracture zone, as displayed in Photograph No. 141, reveal cleavage separation, indicative of brittle failure.

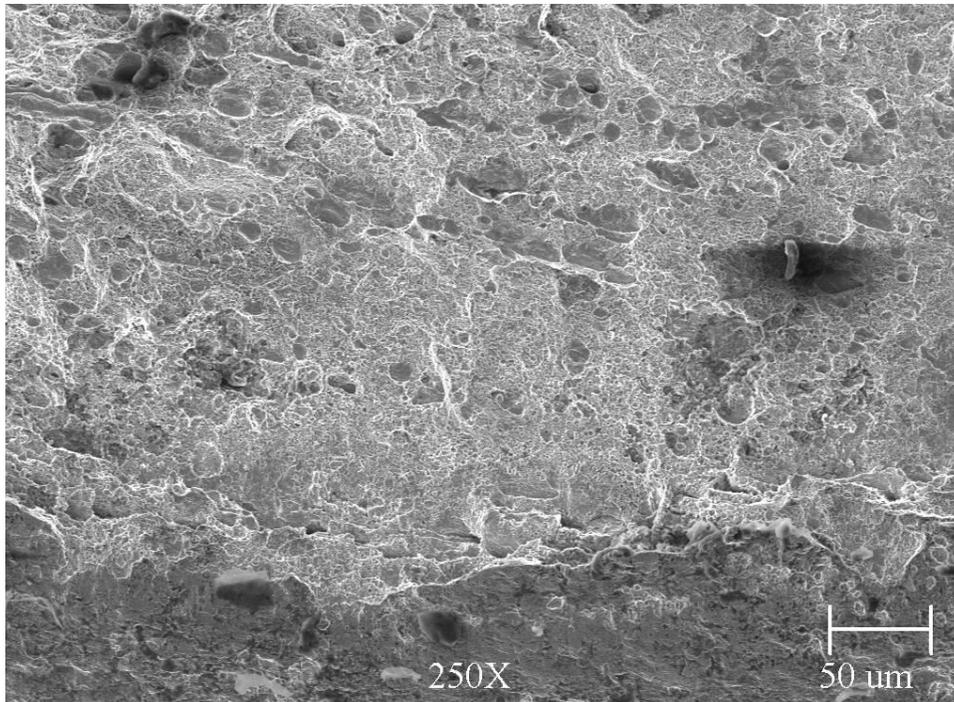
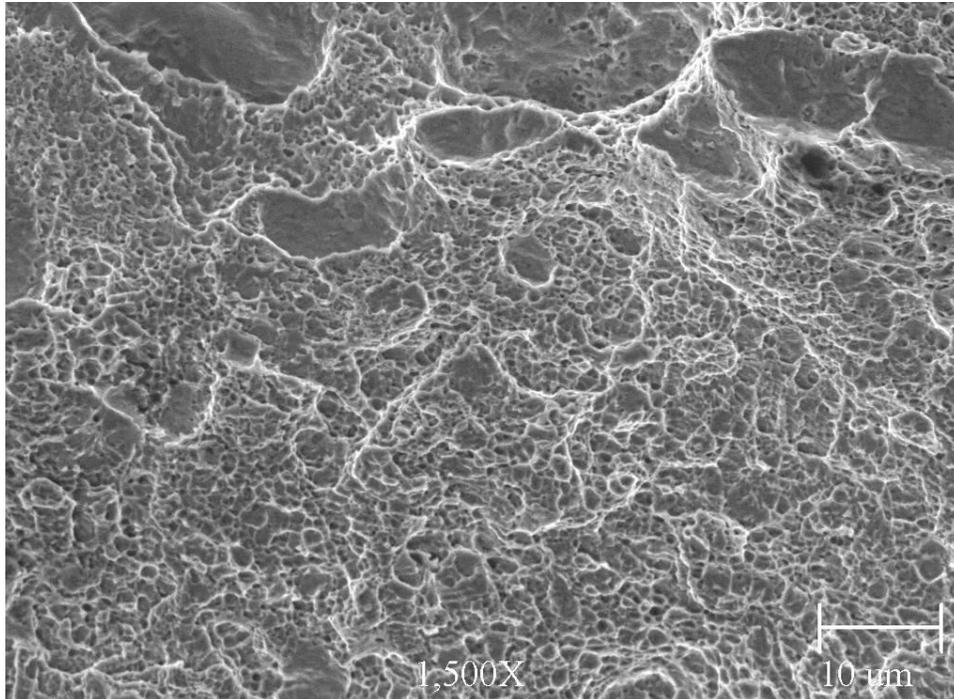
The SEM fractographs taken of the Area-4 of the final shear fracture zone at the I.D. of the pipe reveal evidence of microvoid coalescence, indicative of rapid ductile failure.

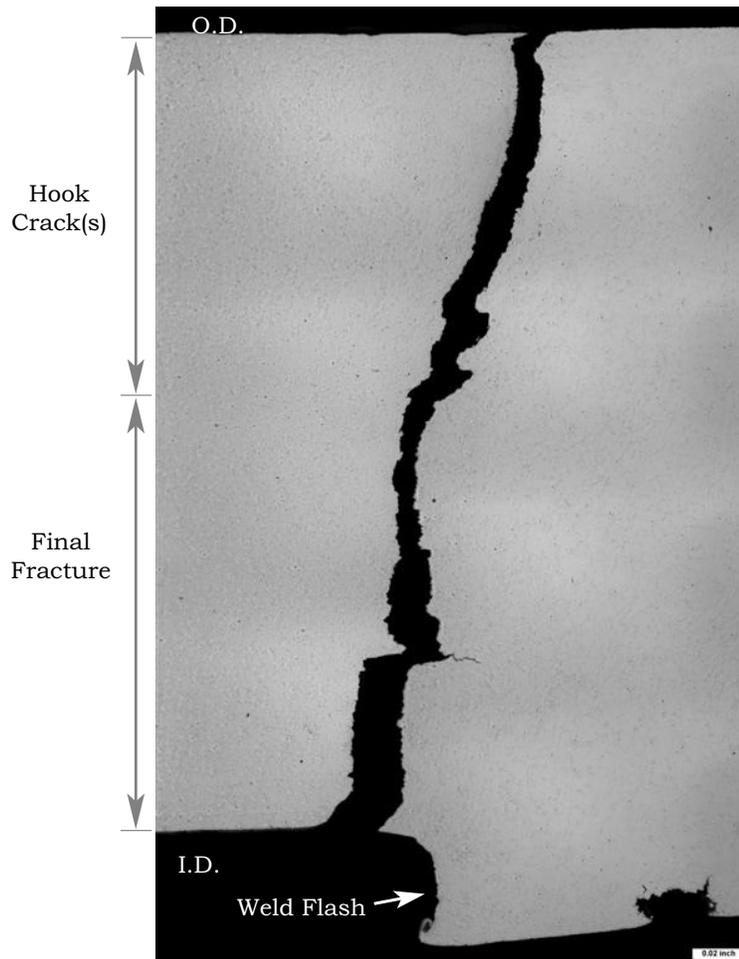
20' 4-7/8" from the North Girth Weld
As-polished, ~25x
Photograph No. 151

A composite view of the mating cross-sections removed through the fracture origins area at a distance of 20' 4-7/8" from the north girth weld and prepared for metallographic examination displays evidence of nonmetallic inclusions along the fracture faces and also parallel to the fusion line near the upper half of the pipe wall. Note that the weld flash on the I.D. surface of the pipe was not trimmed off flush with the I.D. surface.

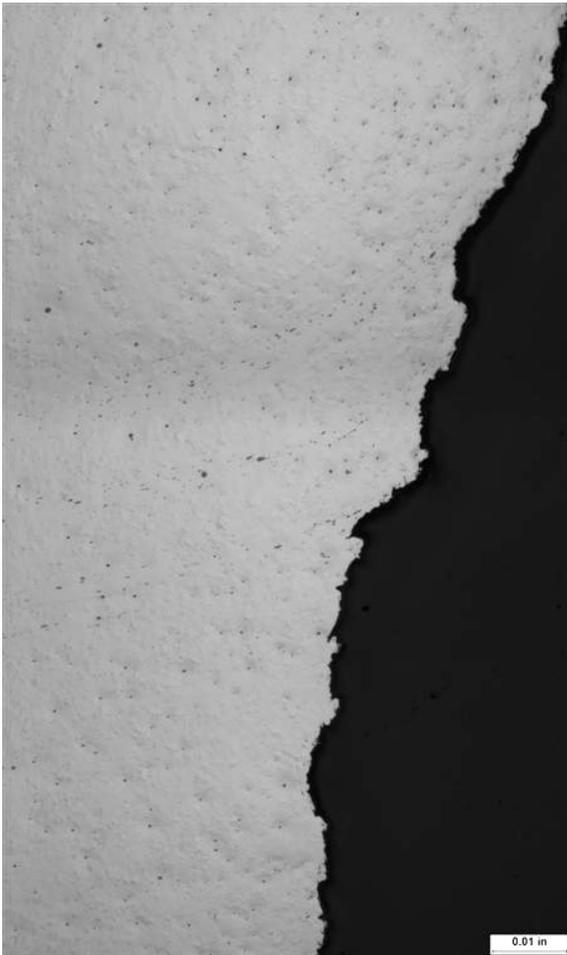
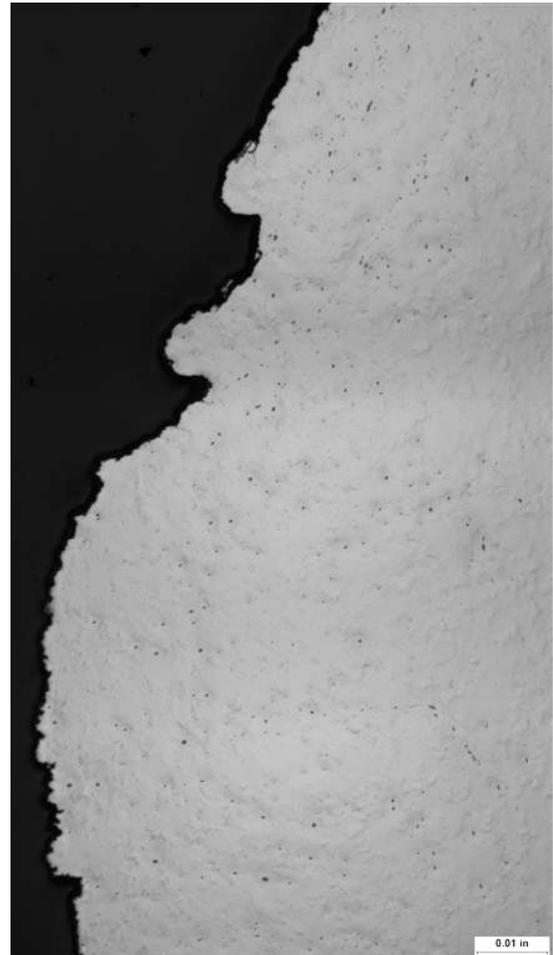
The micrographs display the upturned inclusions essentially parallel to the fusion line in the ERW upset/HAZ area, as well as along the fracture faces. Note that vertically aligned inclusions are one of the main contributing factors to the formation of hook cracks.

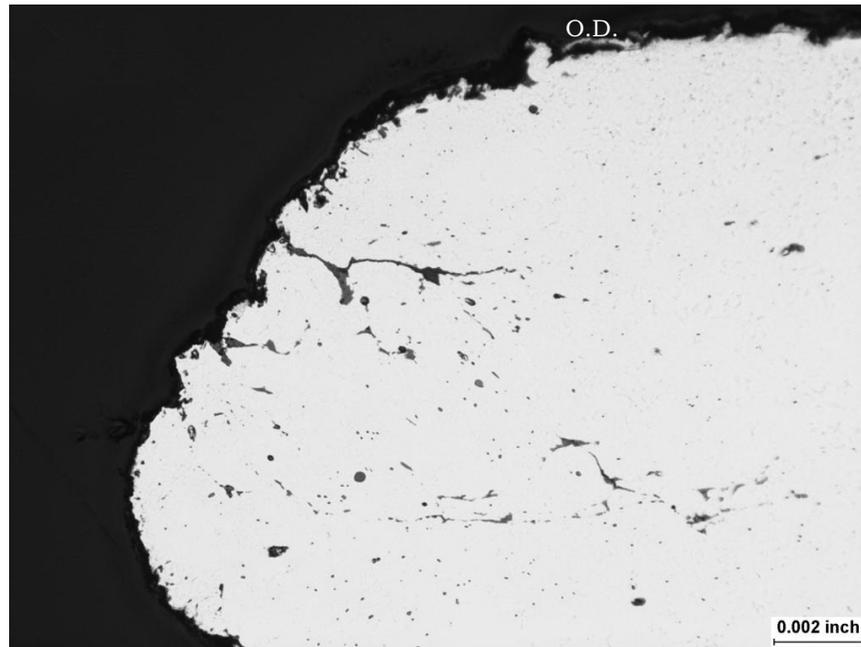
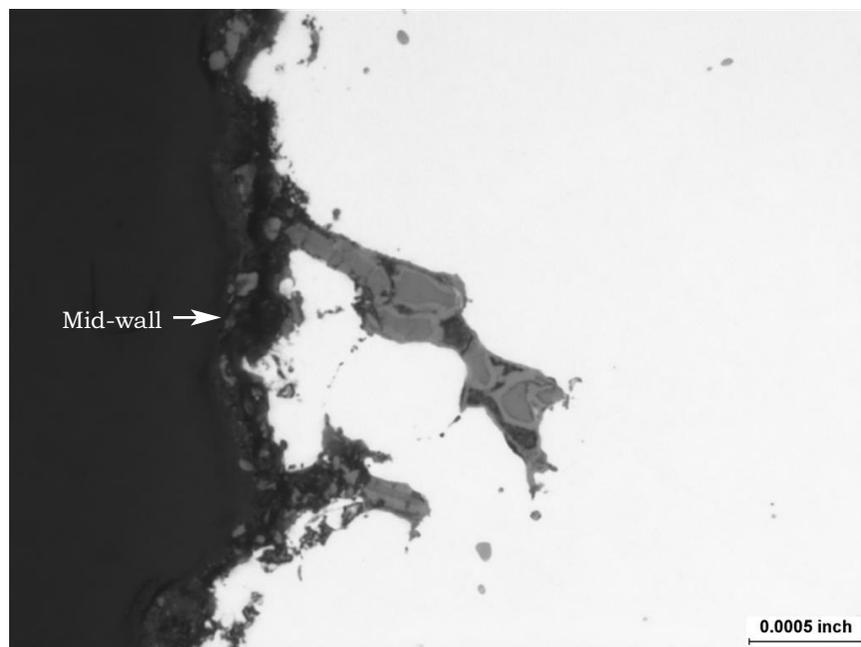
The micrographs display evidence of folds at the O.D. surface at the fusion line, which was apparently not fully fused, and the presence of post-fracture oxidation at the mid-wall area along the hook crack fracture face.

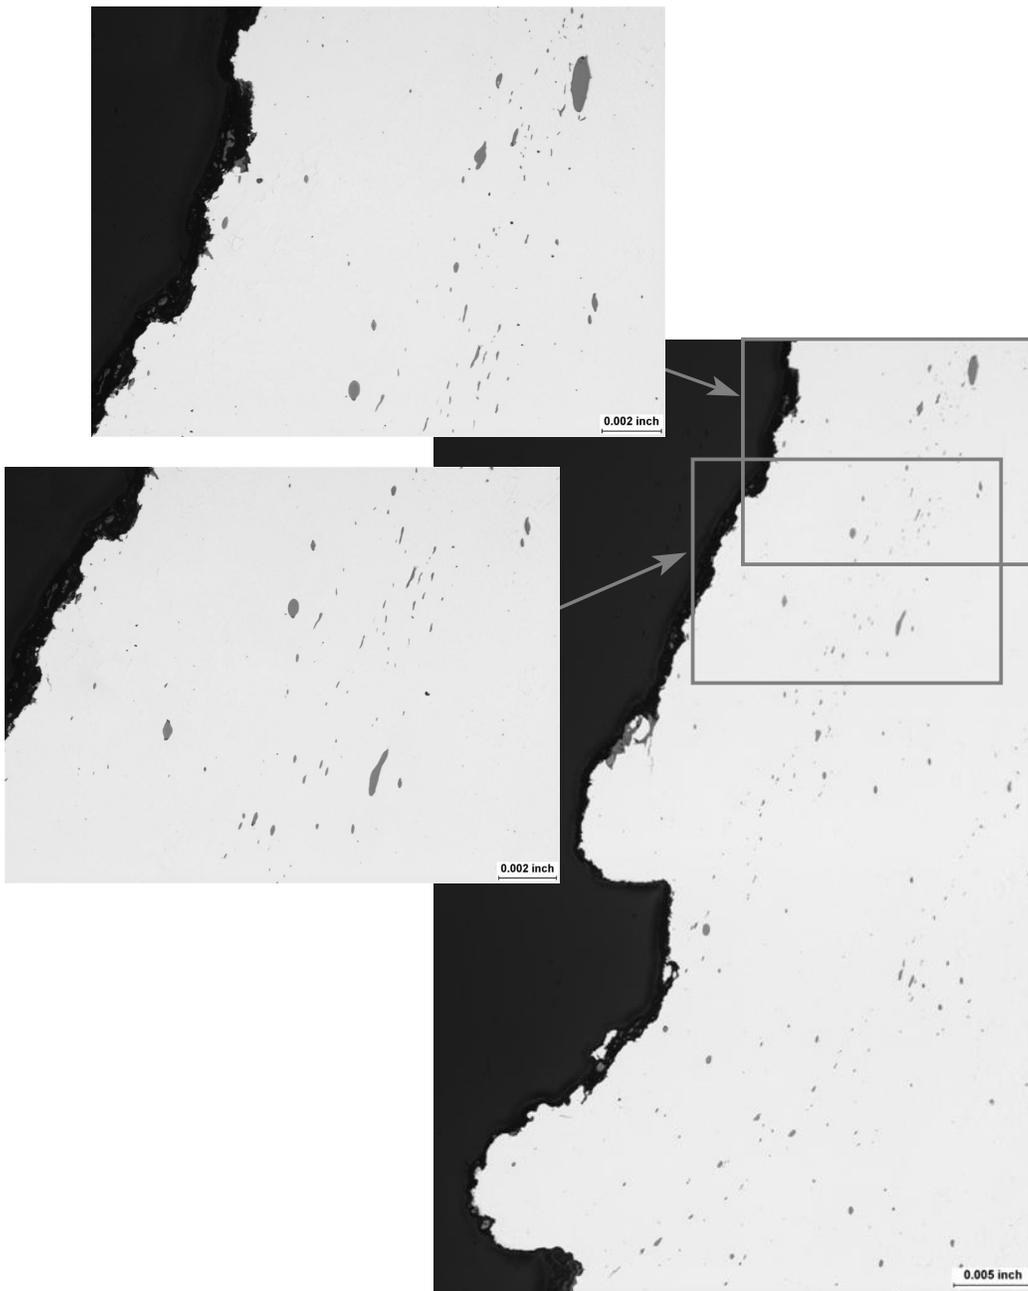
20' 4-7/8" from the North Girth Weld
As-polished, ~100x
Photograph No. 156

The micrographs display an excessive amount of elongated manganese sulfide inclusions in the diagonal and vertical planes in the upset/HAZ area of the ERW seam. Note the hook crack along and through the realigned inclusions.

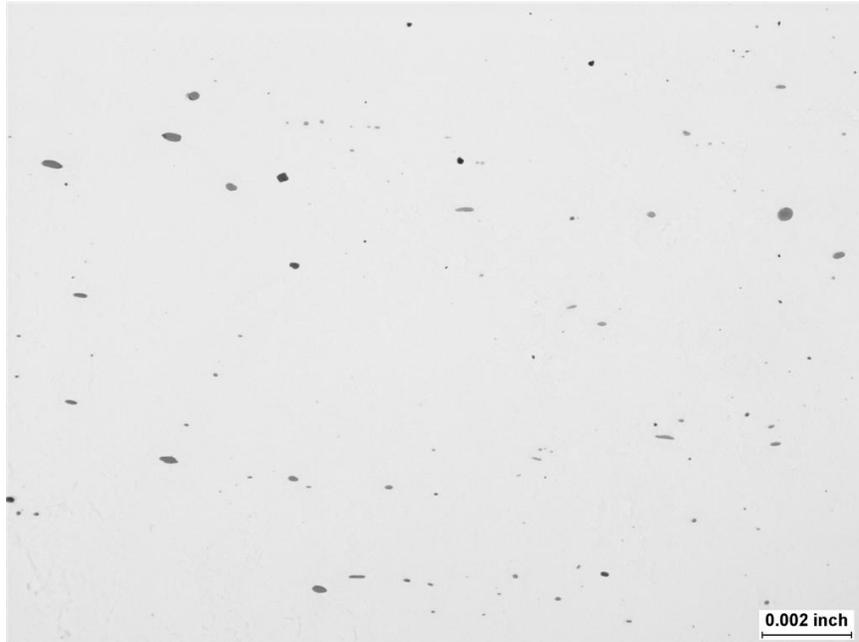
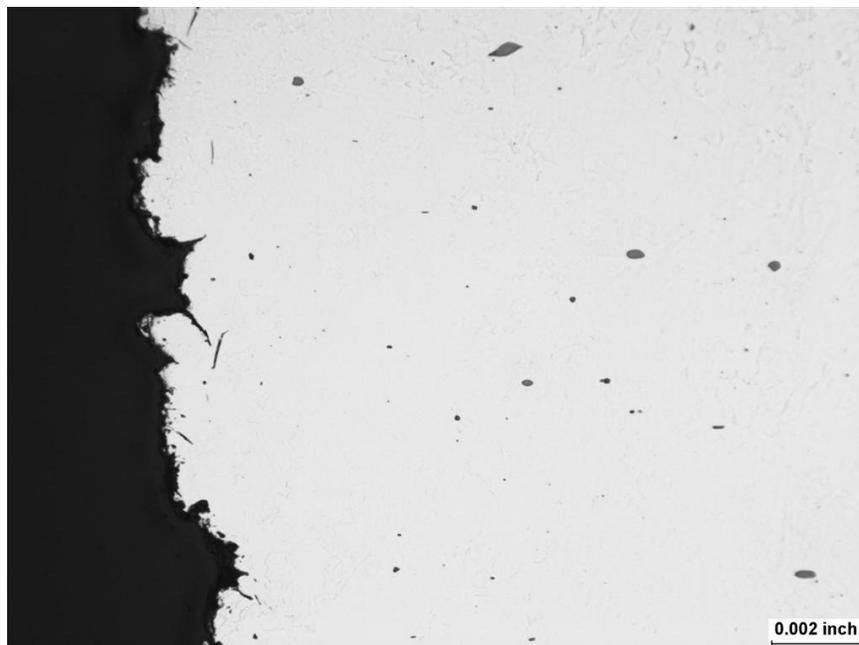
The micrographs display the manganese sulfide inclusions in the axial direction of the pipe near the I.D. surface of the ERW, which were not affected by the welding process.

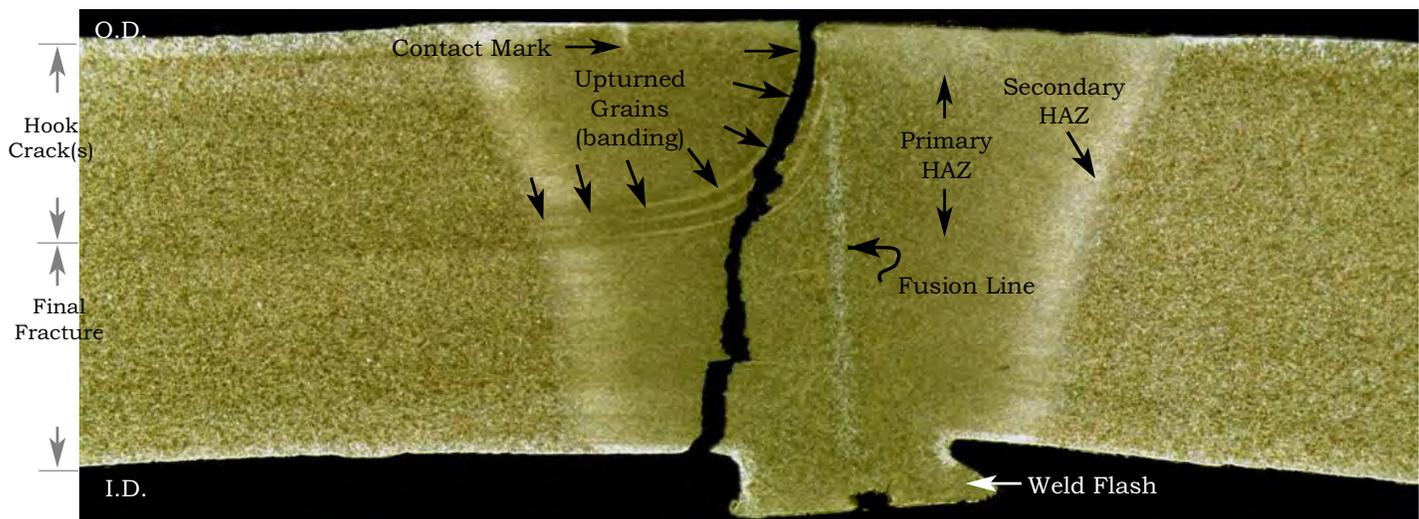
20' 4-7/8" from the North Girth Weld
2% Nital etch, ~20x
Photograph No. 159

A composite view of the mating cross-sections removed through the fracture origins area at a distance of 20' 4-7/8" from the north girth weld and prepared for metallographic evaluation shows hook cracks along the brittle upturned bands in the upset/HAZ area, and the final failure from the tip(s) of the hook crack(s). Again, note that the weld flash was not trimmed off flush with the I.D. surface.

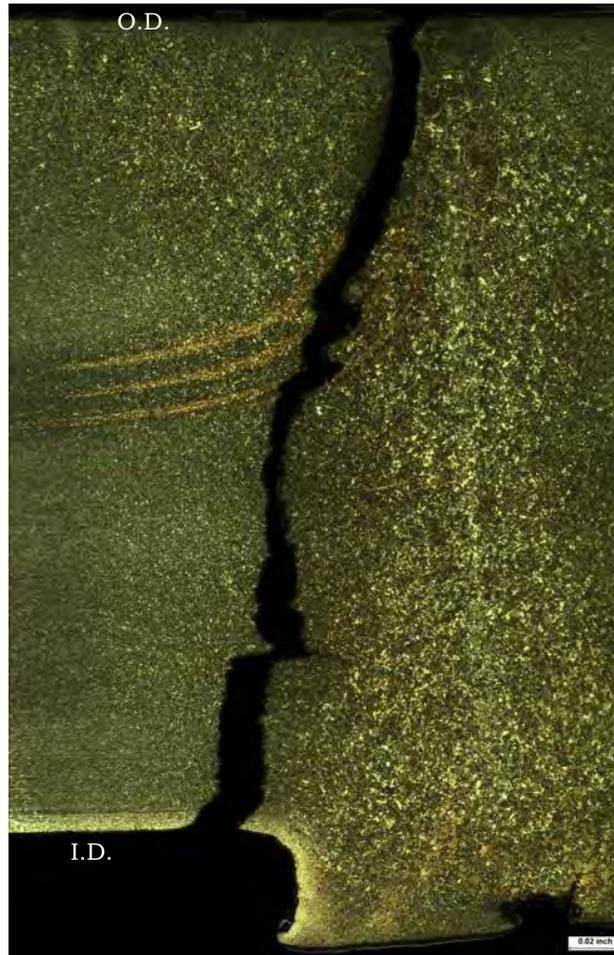
20' 4-7/8" from the North Girth Weld
2% Nital etch, ~25x
Photograph No. 160

The micrograph displays a hook crack through the upturned bands, which consists of untempered brittle martensite in the upset/HAZ of the ERW seam.

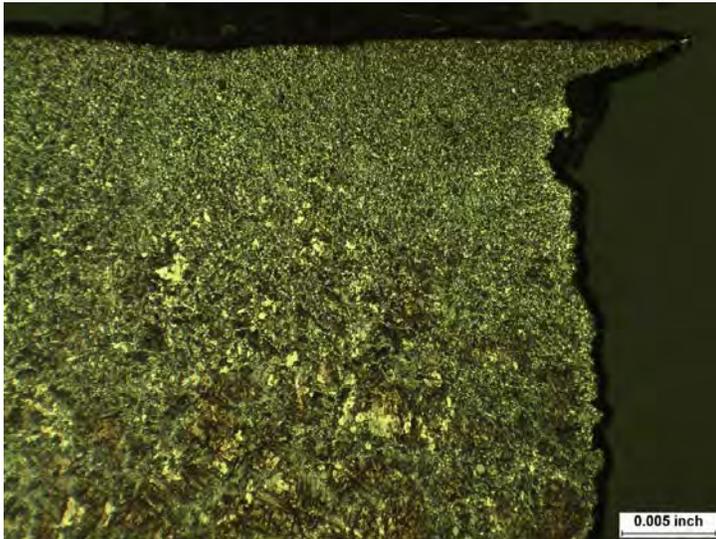
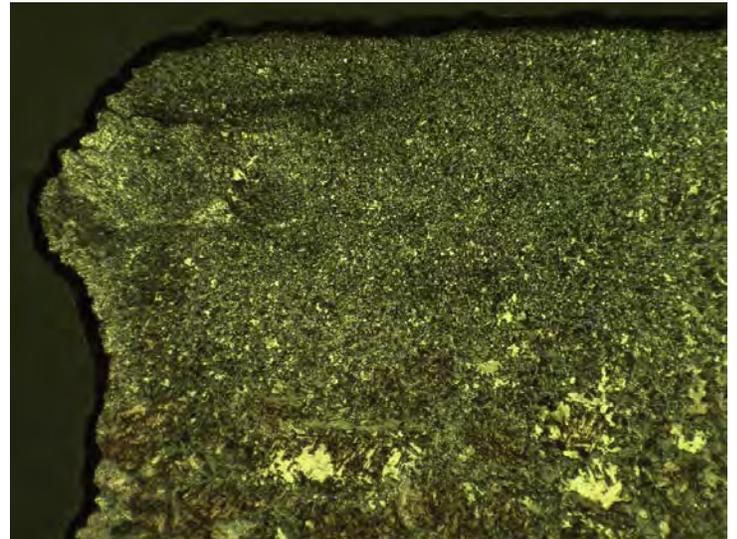
The micrographs display the mating fracture faces of hook cracks near the O.D. of the ERW joint. The microstructure consists of grain boundary ferrite and unresolved bainite with some acicular martensite.

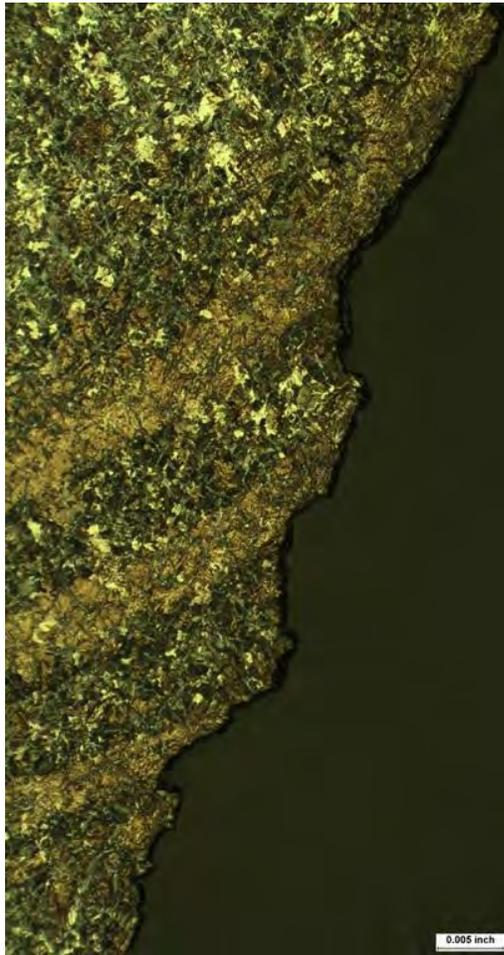
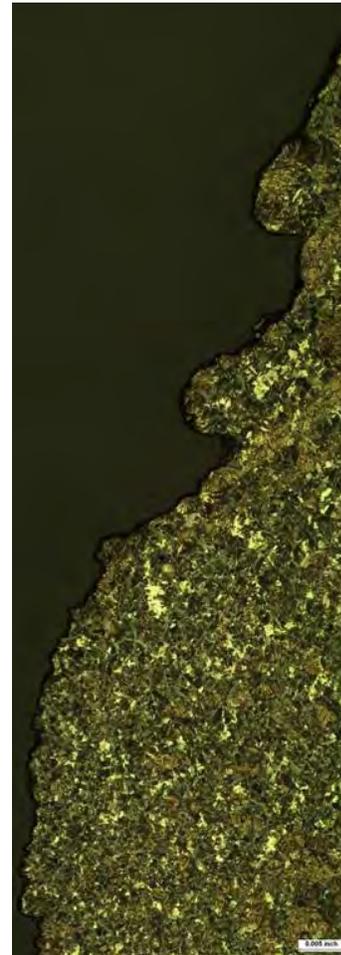
The micrographs display the mating fracture faces of the hook cracks near the mid-wall of the ERW joint. Note the presence of mix-microstructure in the upset/HAZ of the ERW seam. The upturned bands consist of essentially untempered brittle martensite and the matrix outside of the bands consists of ferrite and unresolved bainite.

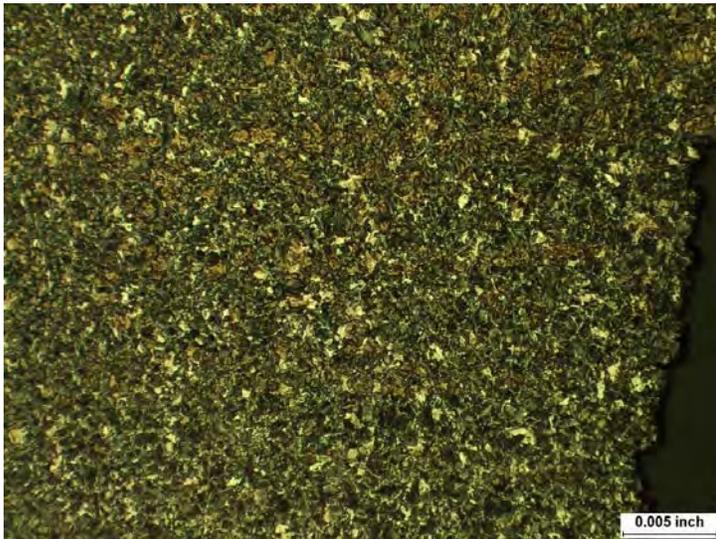
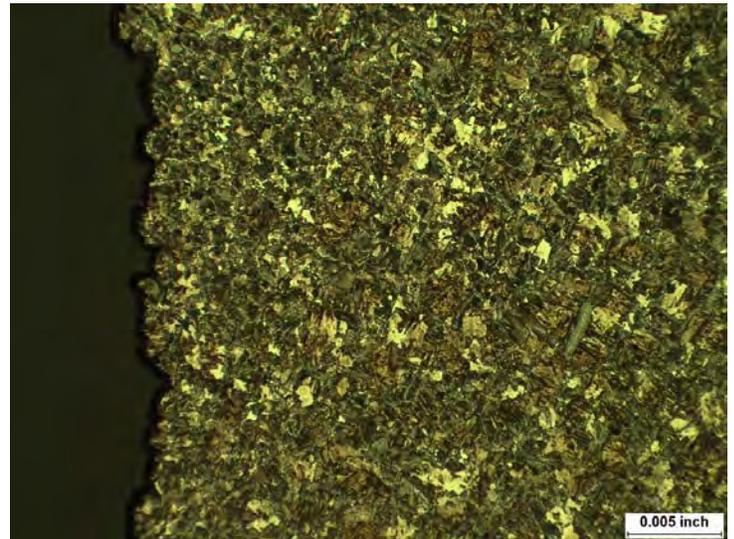
The micrographs display the mating fracture faces of the final crack near the I.D. of the ERW joint. Note the presence of mix-microstructure in the HAZ of the ERW seam consisting of patches of untempered acicular martensite, grain boundary ferrite, and unresolved bainite.

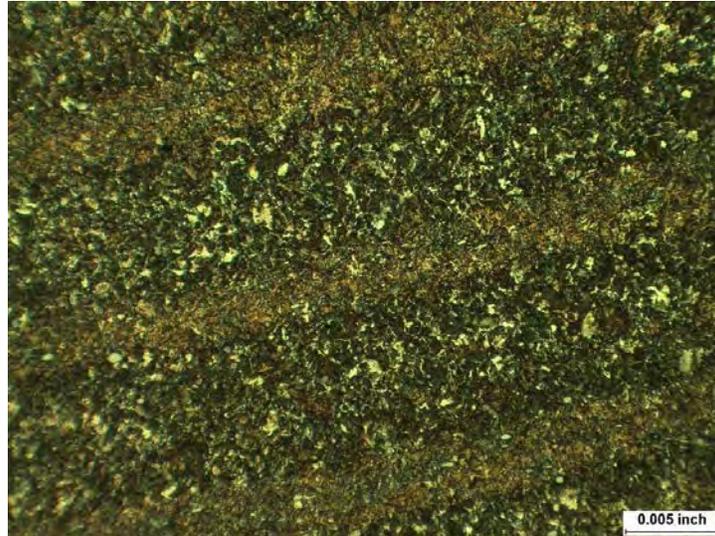
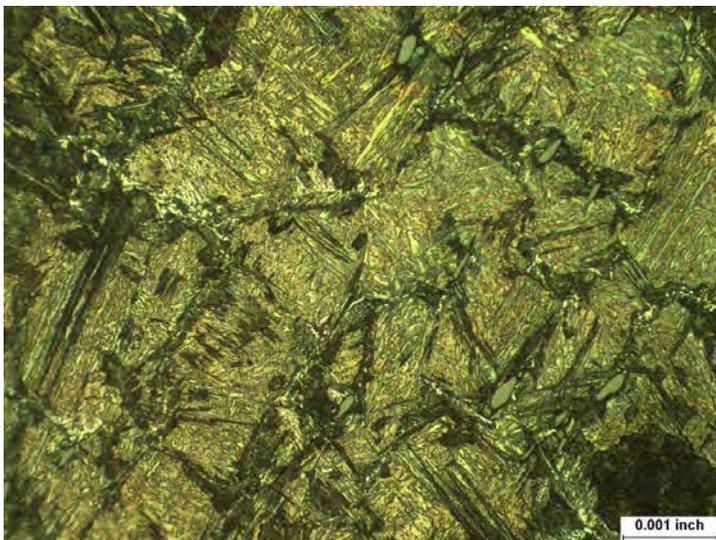
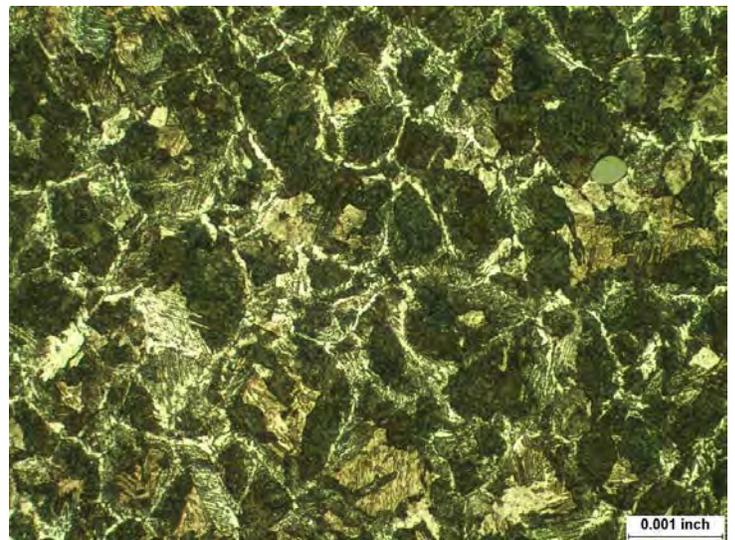
The micrographs display the microstructure of the material in the upset/HAZ between the O.D. and the mid-wall where the upturned bands were formed during the ERW seam manufacturing, consisting of the untempered brittle martensite in the banded area and essentially grain boundary ferrite and unresolved bainite with some patches of untempered martensite in the non-banded area.

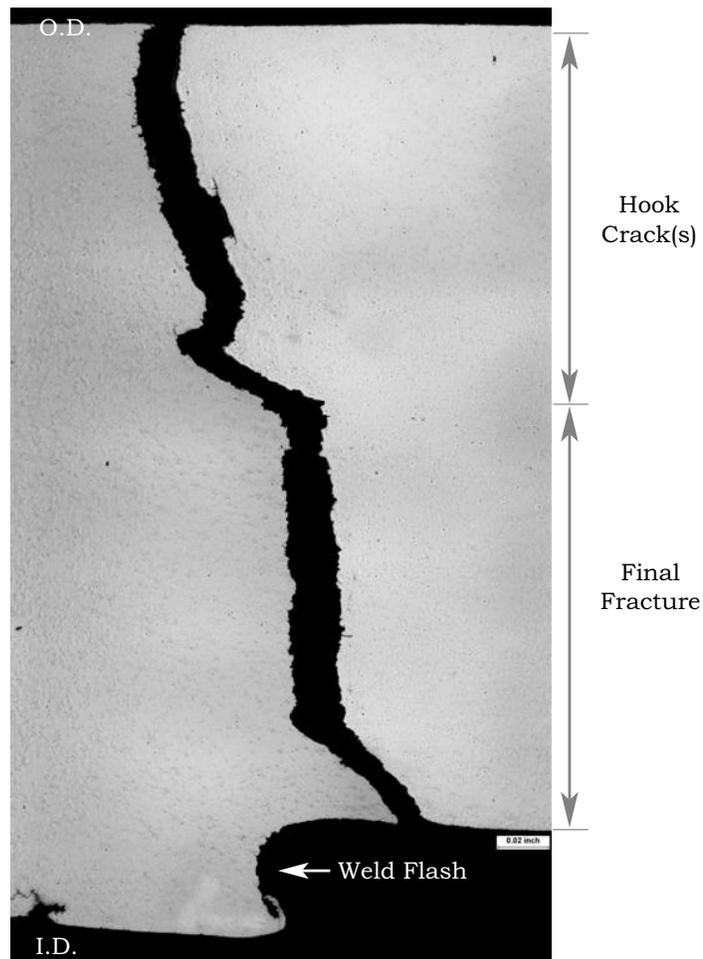
20' 6-13/16" from the North Girth Weld
As-polished, ~25x
Photograph No. 170

A composite view of the mating cross-sections removed through the fracture origins area at a distance of 20' 6-13/16" from the north girth weld and prepared for metallographic examination displays evidence of nonmetallic inclusions along the fracture faces, and also parallel to the fusion line near the upper half of the pipe wall. Note that the weld flash on the I.D. surface was not trimmed off flush with the I.D. surface of the pipe.

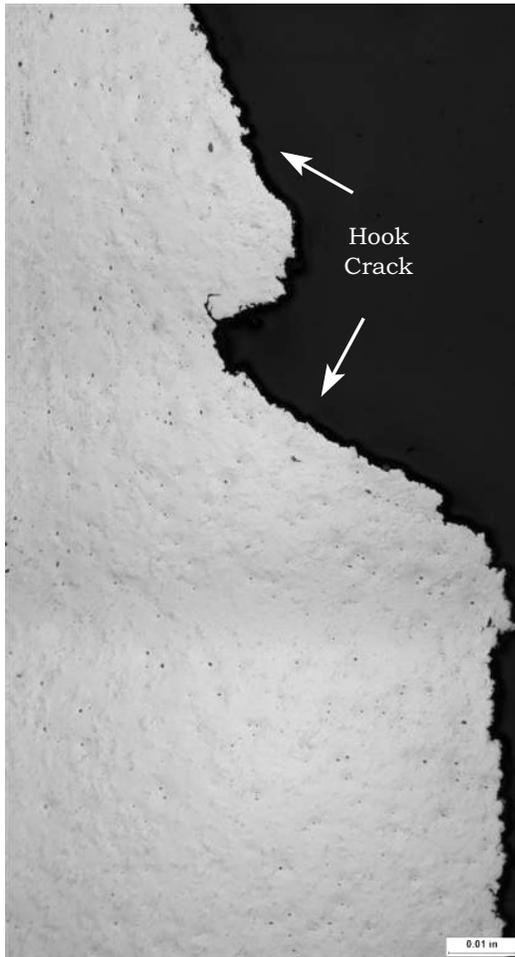
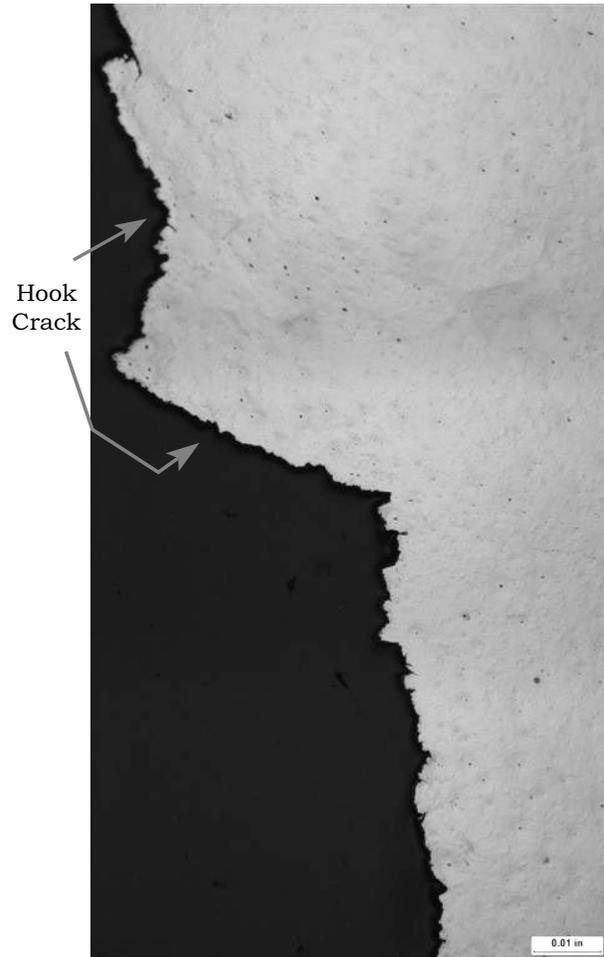
The micrographs display the upturned inclusions essentially parallel to the fusion line in the ERW upset/HAZ area, as well as along the fracture faces.

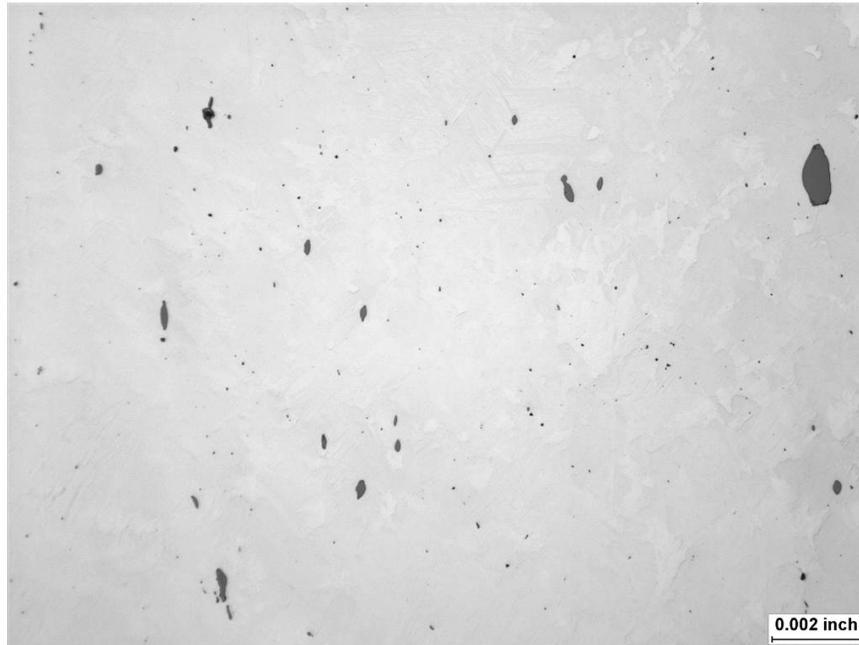
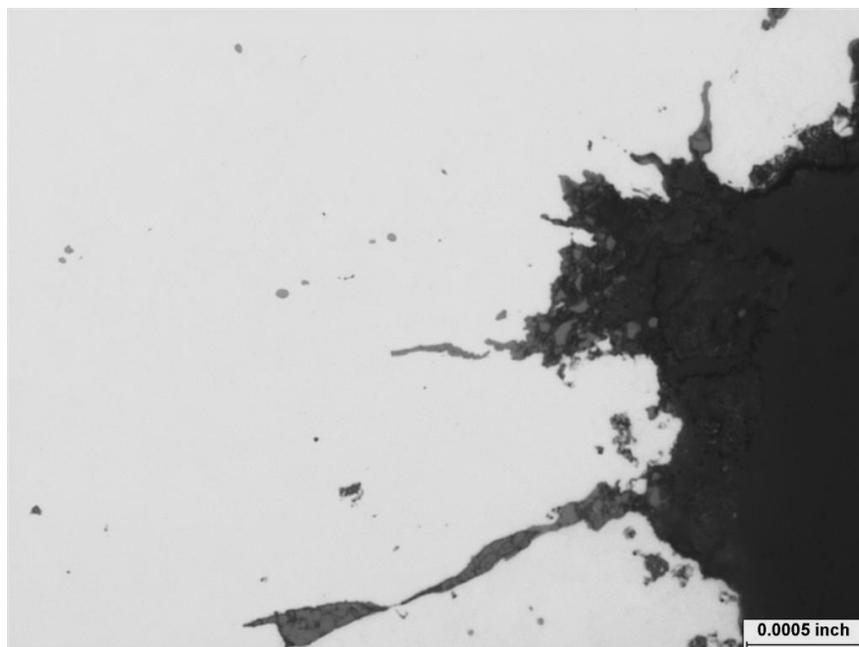
The micrographs display the presence of several manganese sulfide inclusions aligned parallel to the fusion line and evidence of some post-hook crack oxidation along the fracture face near the mid-wall.

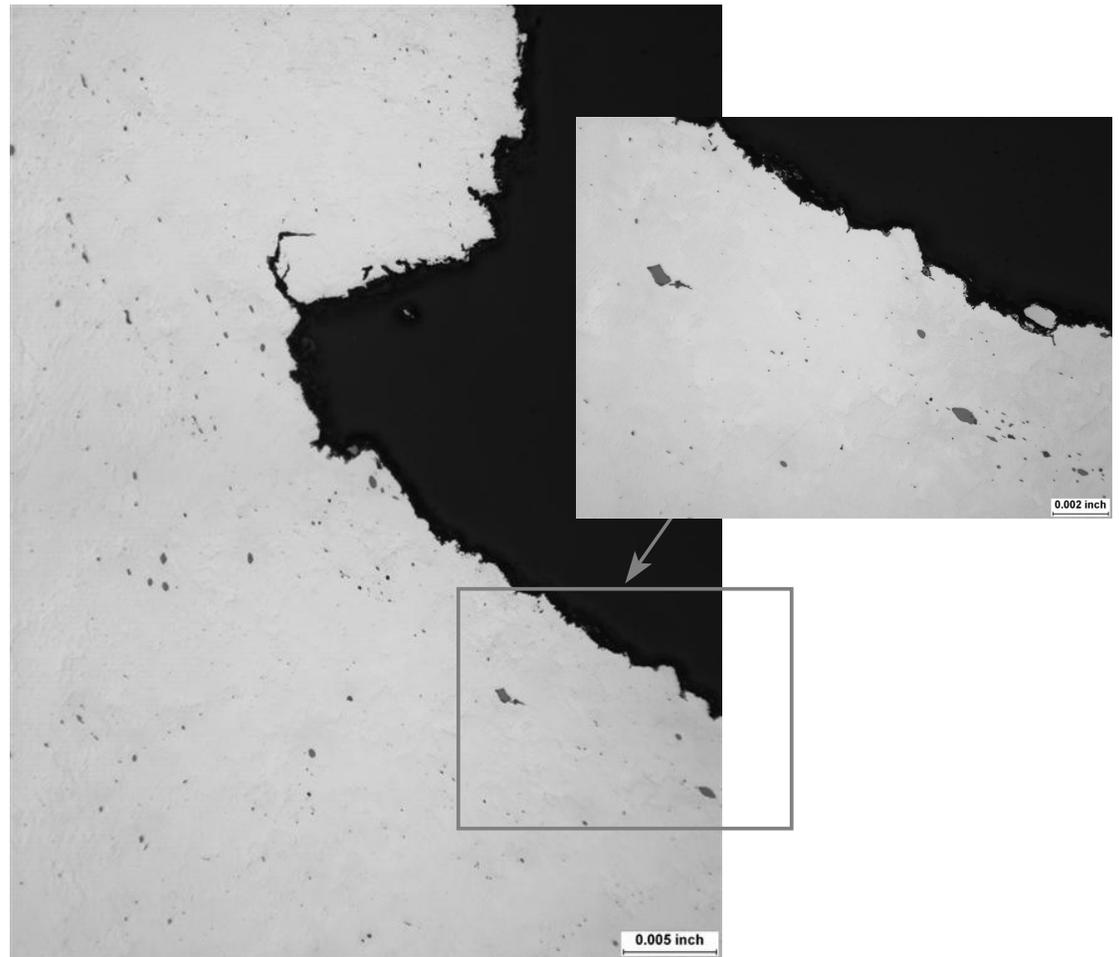
20' 6-13/16" from the North Girth Weld
As-polished, ~100x
Photograph No. 175

The micrographs display an excessive amount of elongated manganese sulfide inclusions aligned in the diagonal and vertical planes in the upset/HAZ area of the ERW seam. Note the hook crack(s) along and through the realigned inclusions.

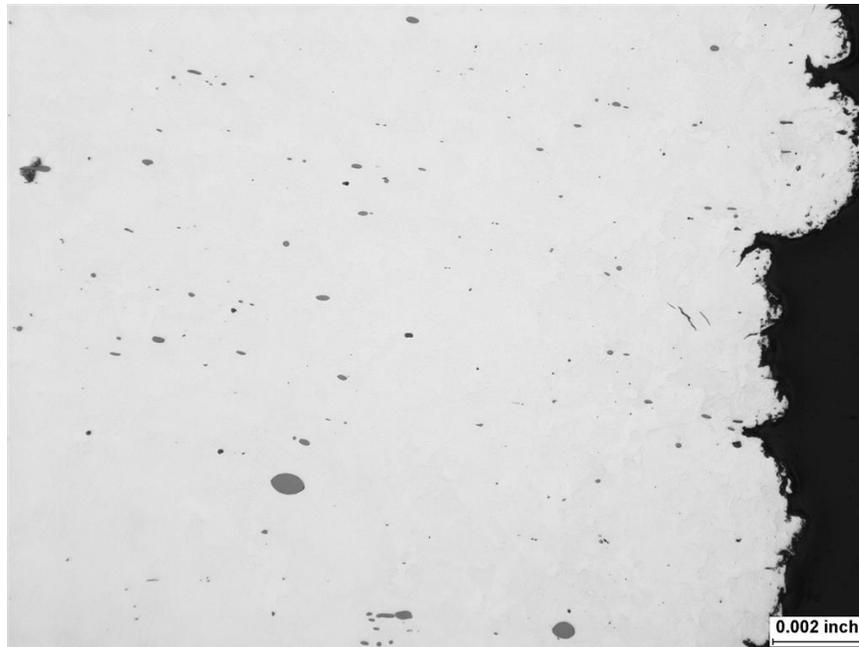
20' 6-13/16" from the North Girth Weld
As-polished, ~200x
Photograph No. 176

The micrograph displays the manganese sulfide inclusions in the axial direction of the pipe near the I.D. surface of the ERW, which were not affected by the welding process.
