DOT US Department of Transportation
PHMSA Pipelines and Hazardous Materials Safety Administration
OPS Office of Pipeline Safety
Southwest Region

Date of Report October 23, 2013
Subject Failure Investigation Report – Mobil Pipe Line Company; Pegasus Pipeline, Mayflower, AR

Failure Investigation Report – Mobil Pipeline Pegasus Rupture
March 29, 2013

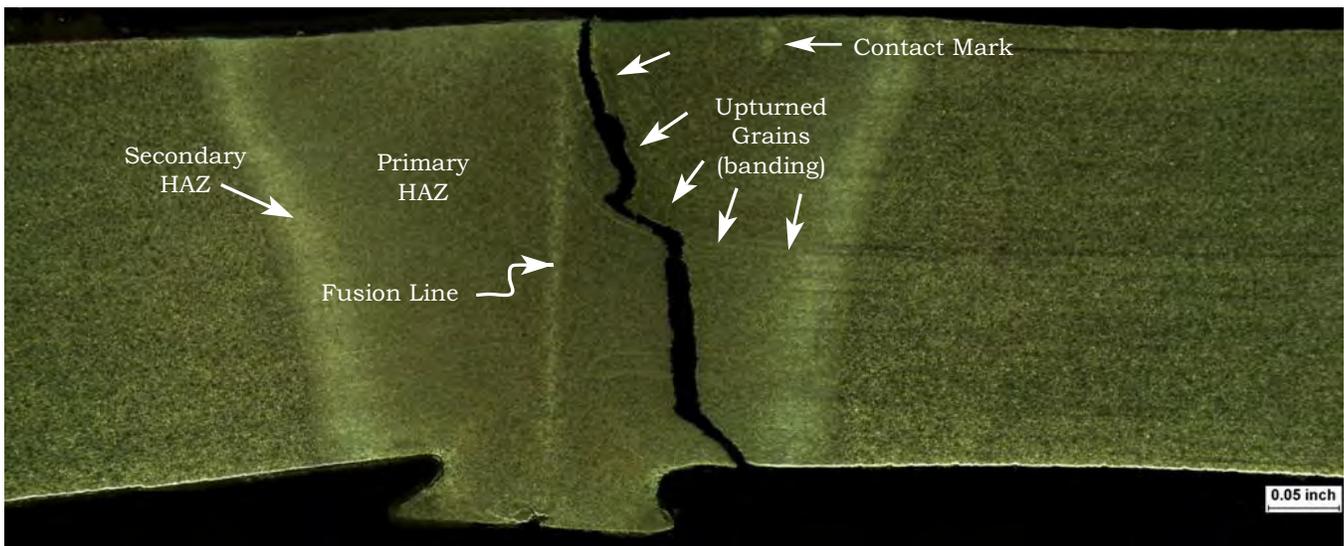
20' 6-13/16" from the North Girth Weld
2% Nital etch, ~20x
Photograph No. 177

The composite view of the mating cross-sections removed through the fracture origins area at a distance of 20' 6-13/16" from the north girth weld and prepared for metallographic evaluation shows hook crack(s) following the upturned grains and inclusions in the upset/HAZ area.

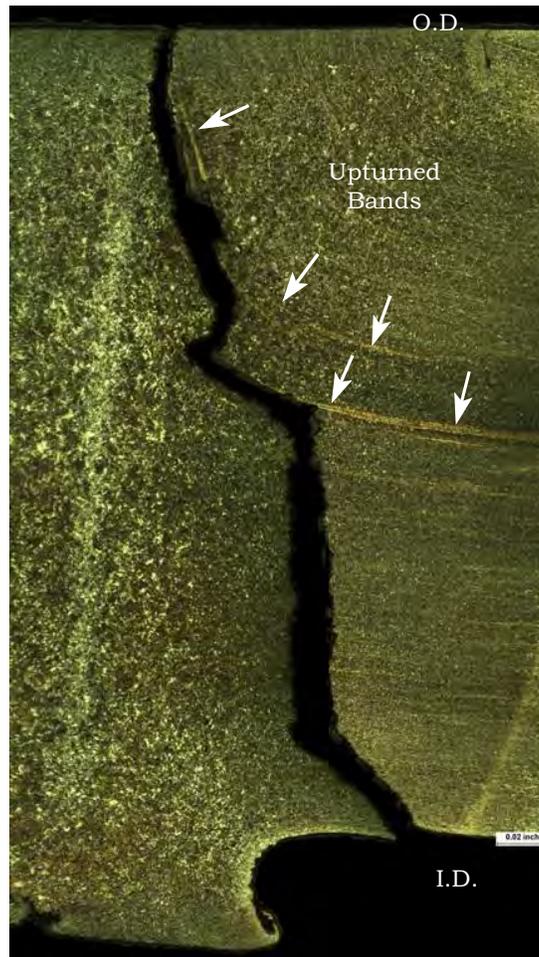
20' 6-13/16" from the North Girth Weld
2% Nital etch, ~25x
Photograph No. 178

The micrograph displays the hook crack(s) following the upturned bands, which consists of untempered brittle martensite.

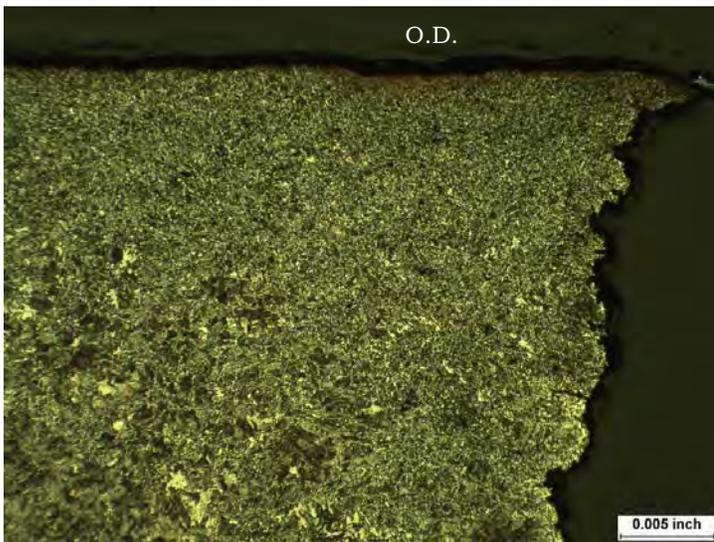
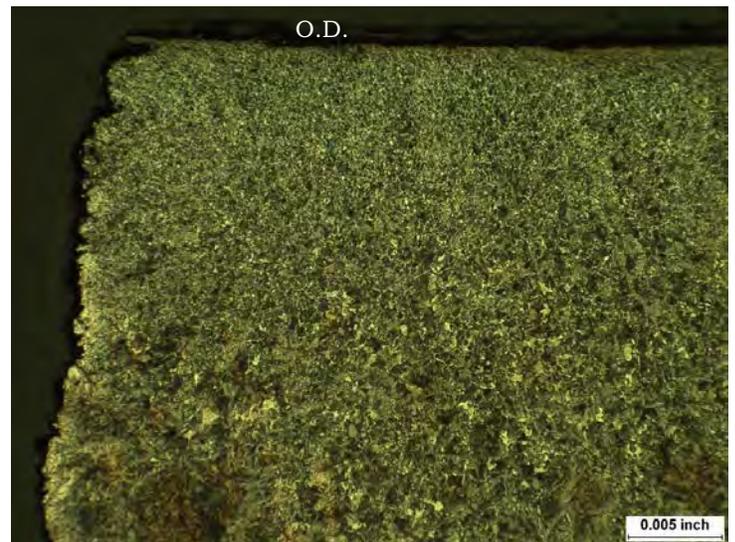
The micrographs display the mating faces of the hook crack(s) at the O.D. in the ERW seam. The microstructure consists of grain boundary ferrite and unresolved bainite with some acicular martensite.

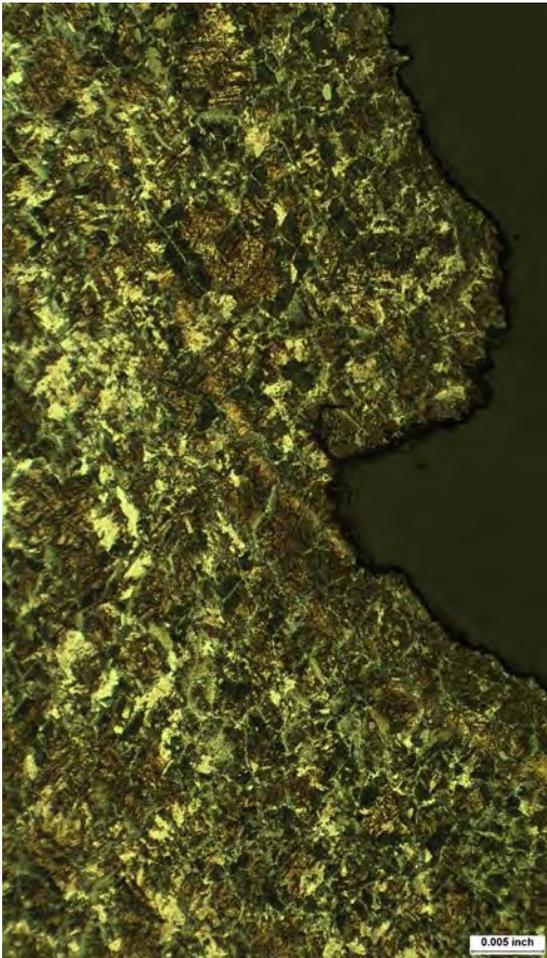
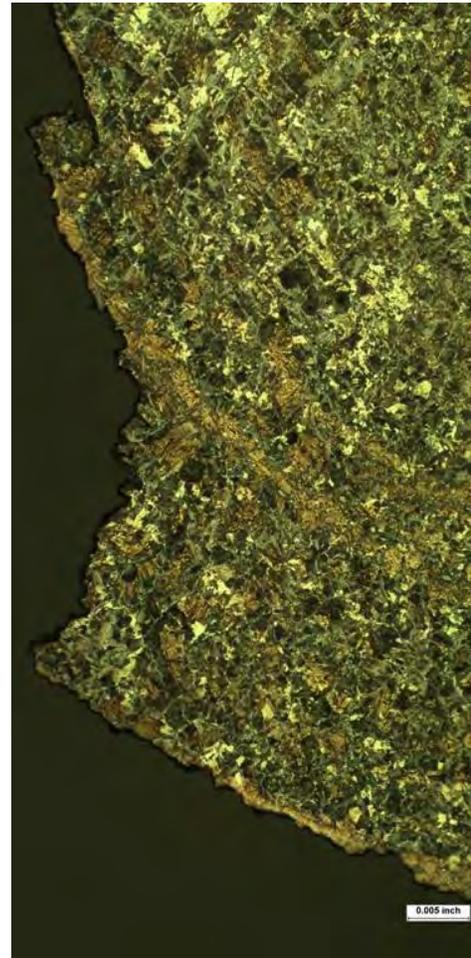
The micrographs display hook crack(s) following the upturned bands of acicular martensite and manganese sulfide inclusions.

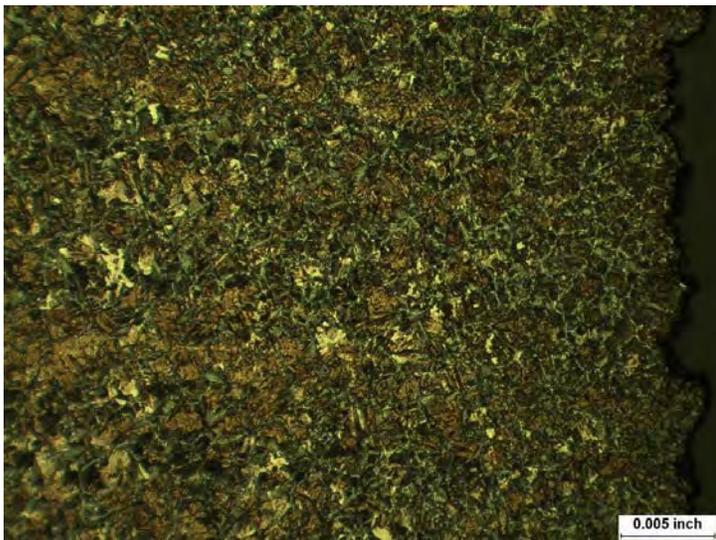
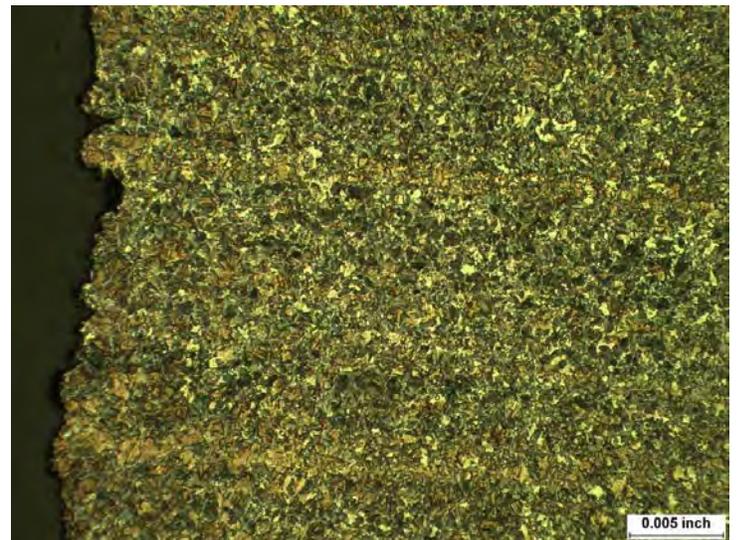
The micrographs display the mating fracture faces of the final fracture near the I.D. of the ERW joint. The microstructure consists of grain boundary ferrite, unresolved bainite, and bands of acicular untempered martensite.

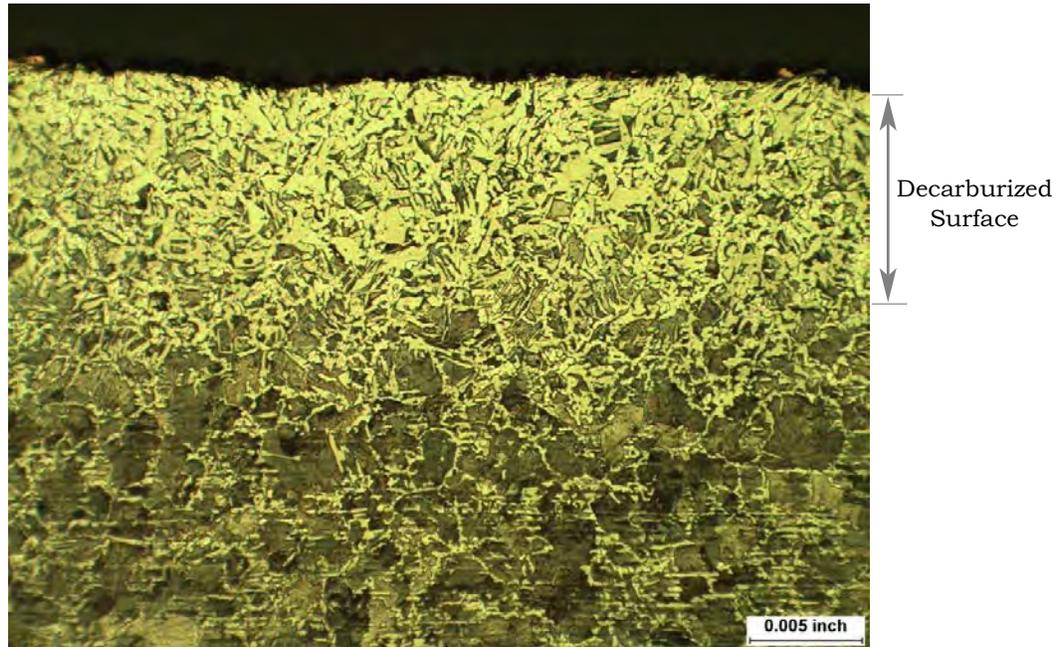
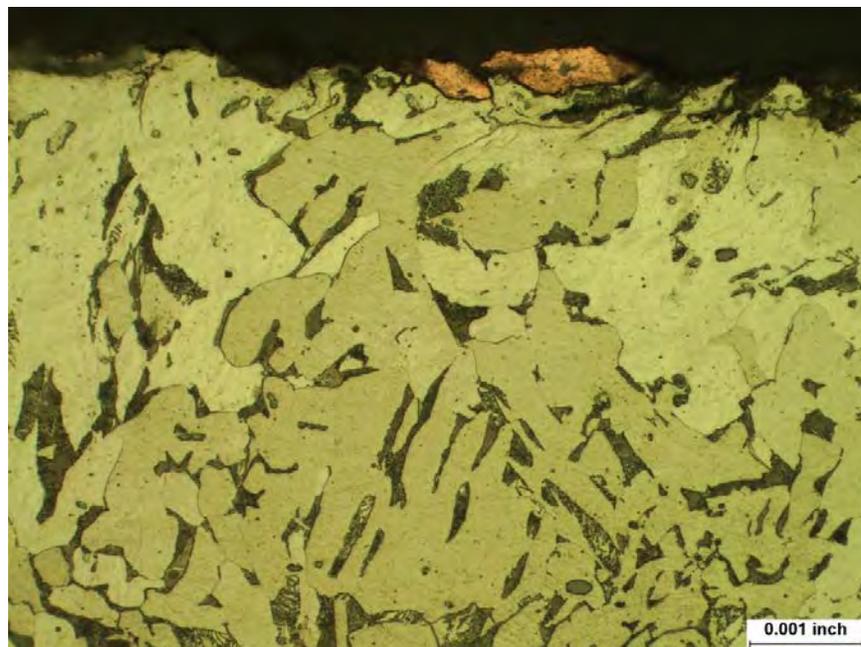
The micrographs display the evidence of surface decarburization along the O.D. surface near the ERW seam and the presence of copper from the electrode contact during the initial seam welding of the pipe.

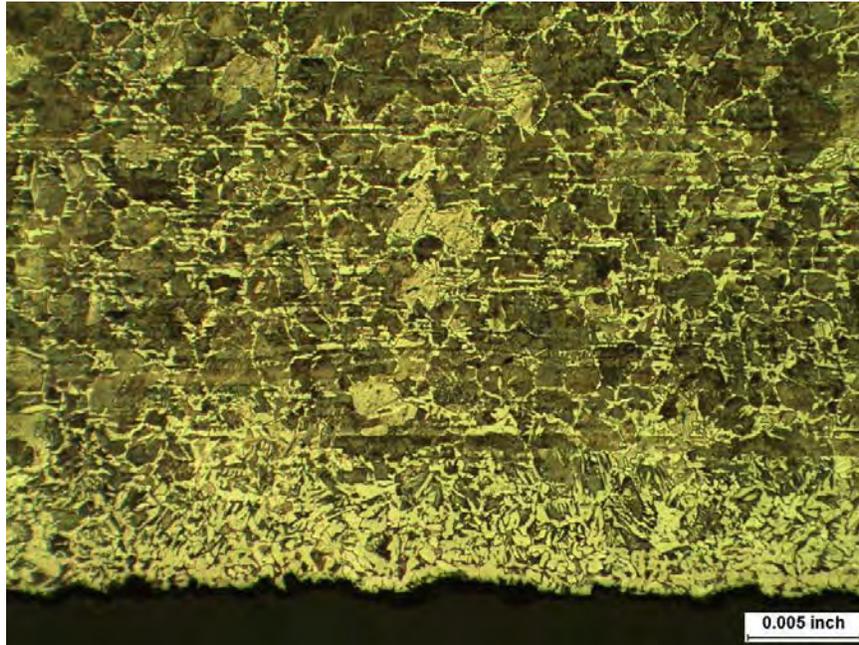
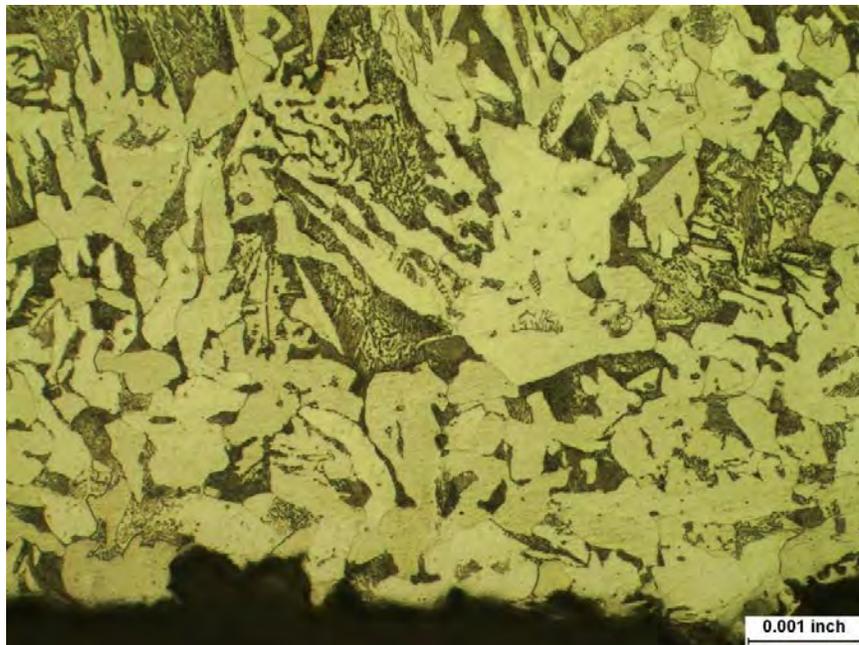
The micrographs display the evidence of surface decarburization along the I.D. surface near the ERW seam.

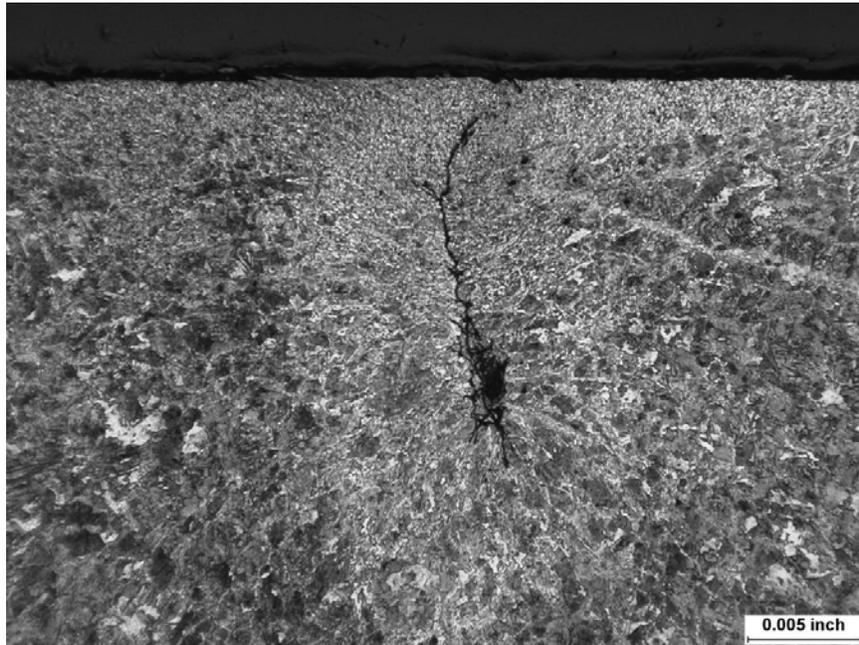
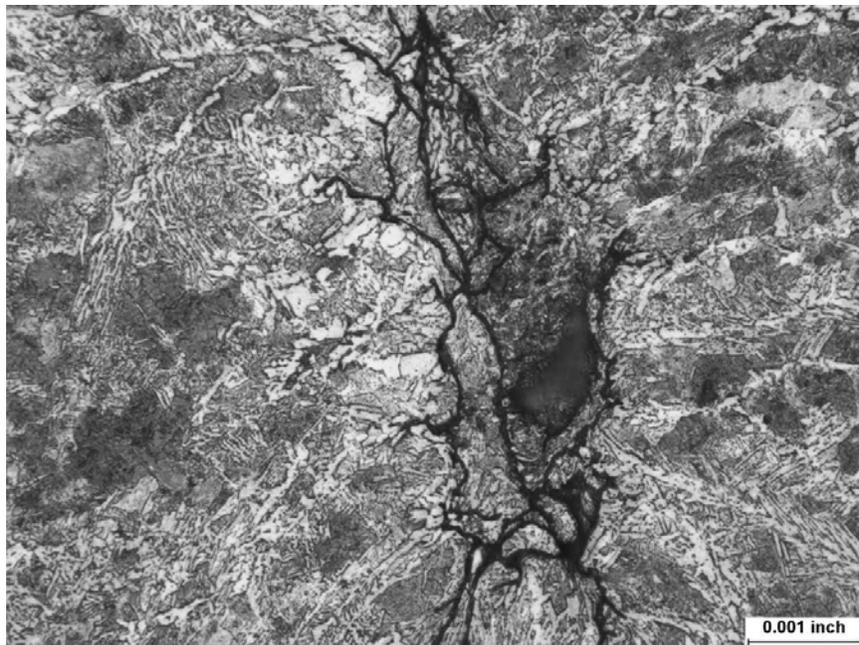
The micrographs display one of the contact marks which resulted from the electrical contact between the electrode supplying the welding current and the pipe surface. Note cracks through resolidified metal near the ERW seam within the primary HAZ.

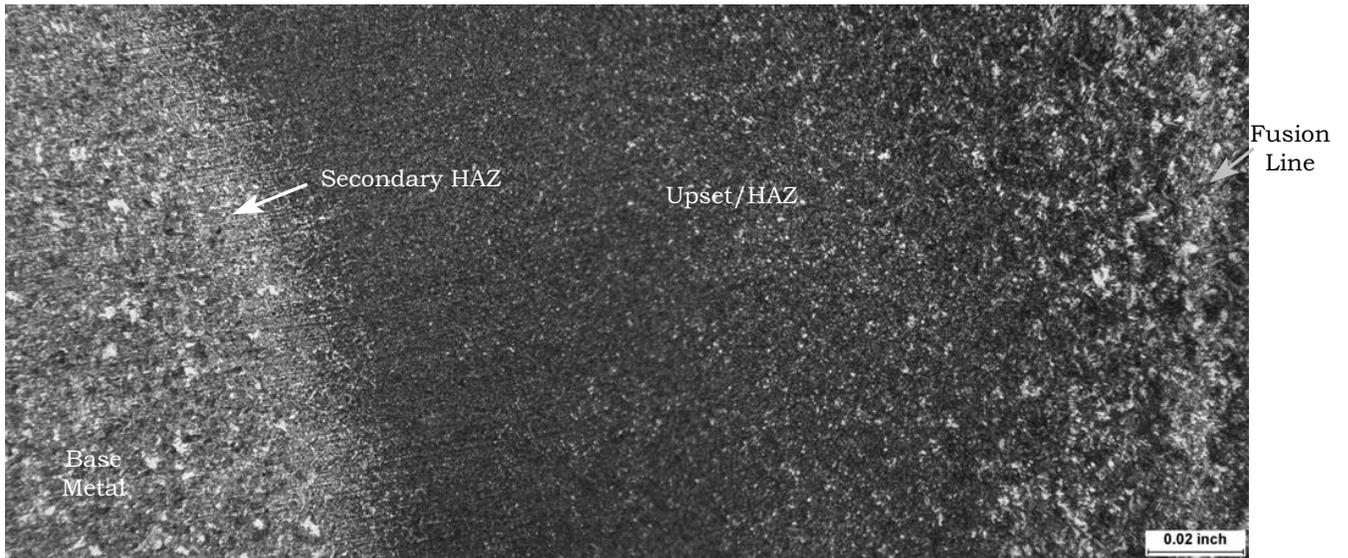
Fusion Line to Base Metal
2% Nital etch, ~25x
Photograph No. 191

The micrograph displays the microstructural phases between the fusion line and the base metal of the ERW seam.

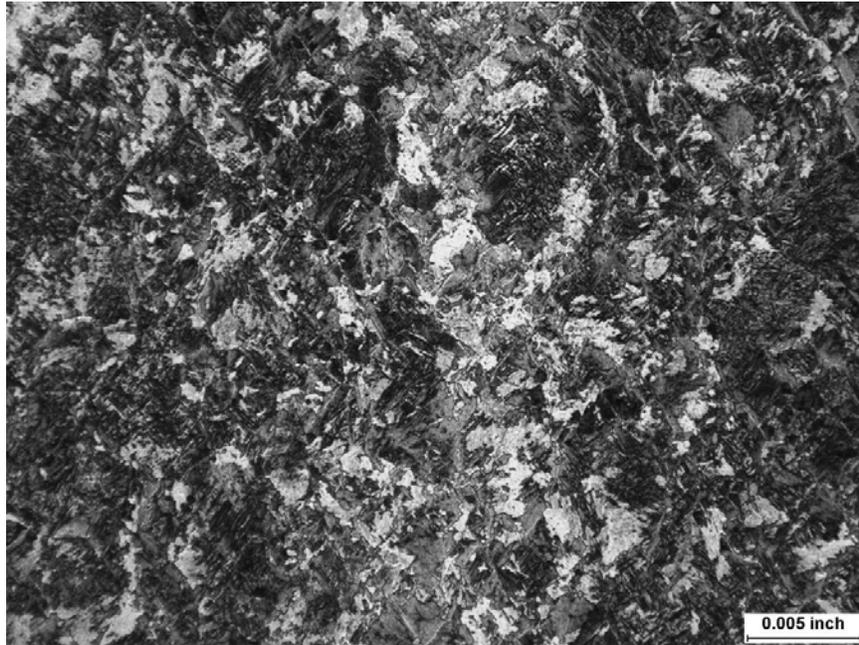
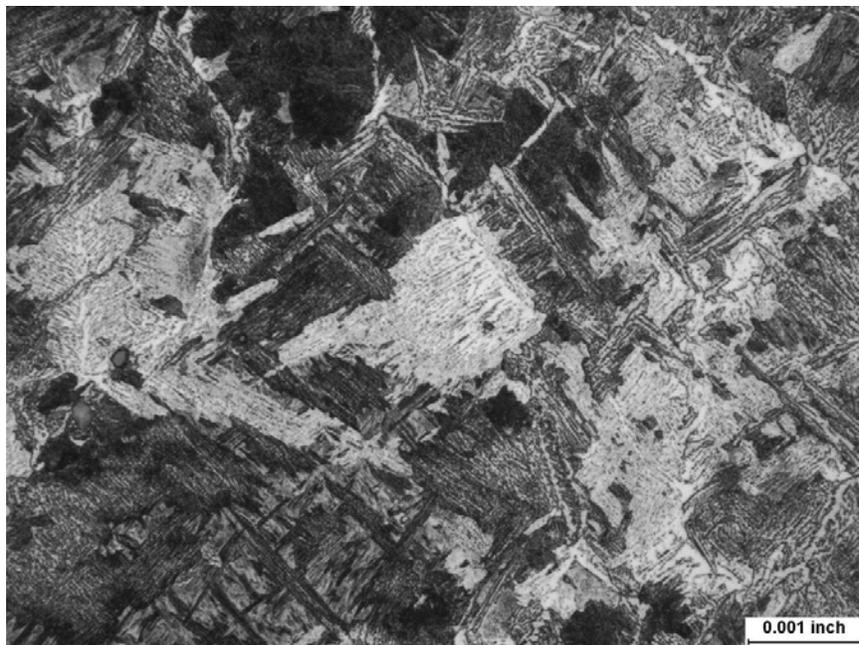
The micrographs display untempered bainitic/martensitic microstructure at the fusion line of the ERW seam.

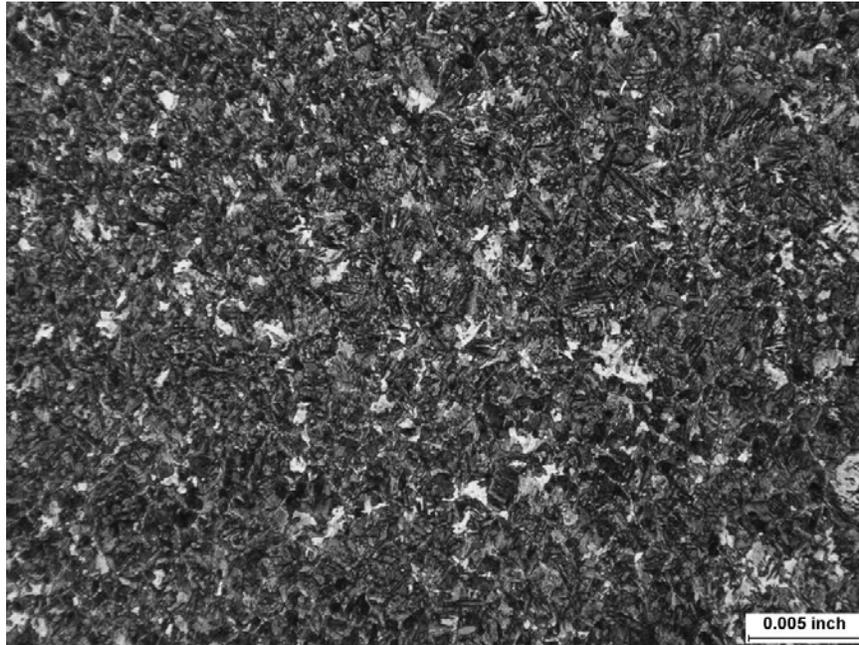
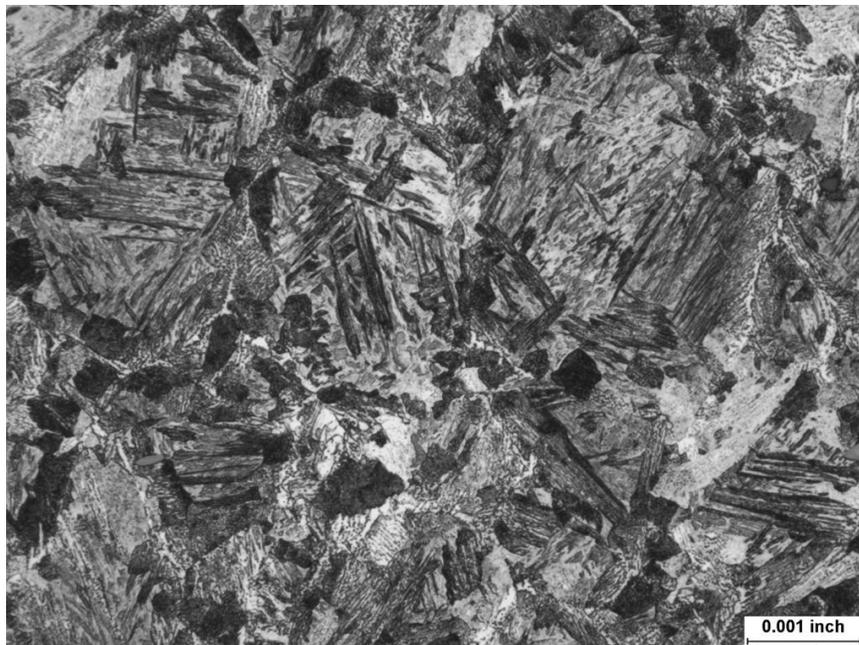
The micrographs of the primary HAZ display mix-microstructure consisting of grain boundary ferrite and untempered acicular martensite.

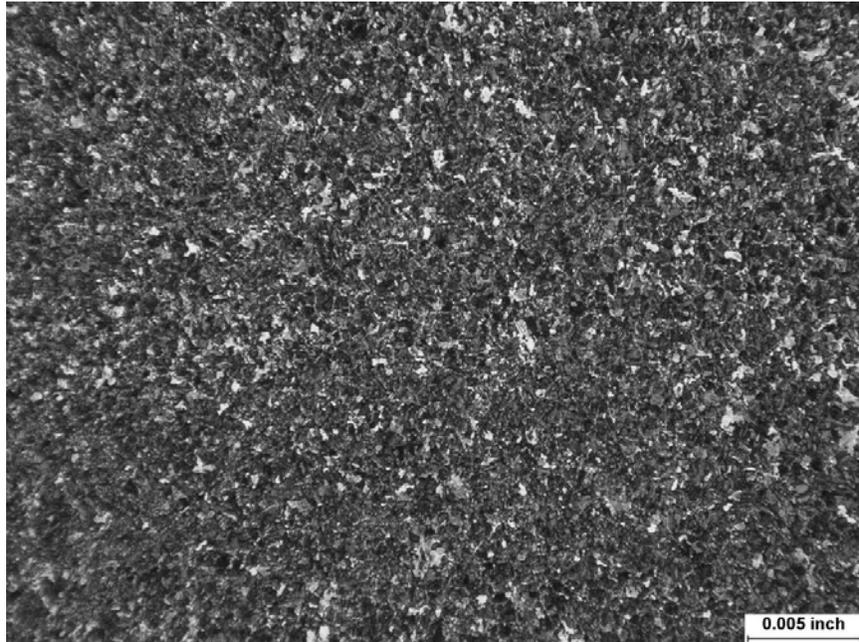
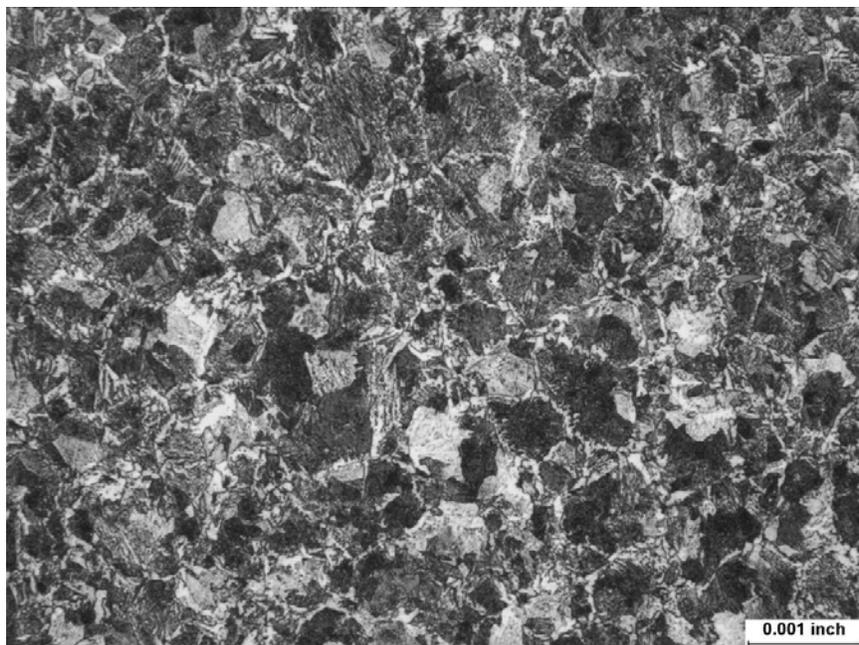
The micrographs of the secondary HAZ display essentially the grain boundary ferrite and unresolved pearlite.

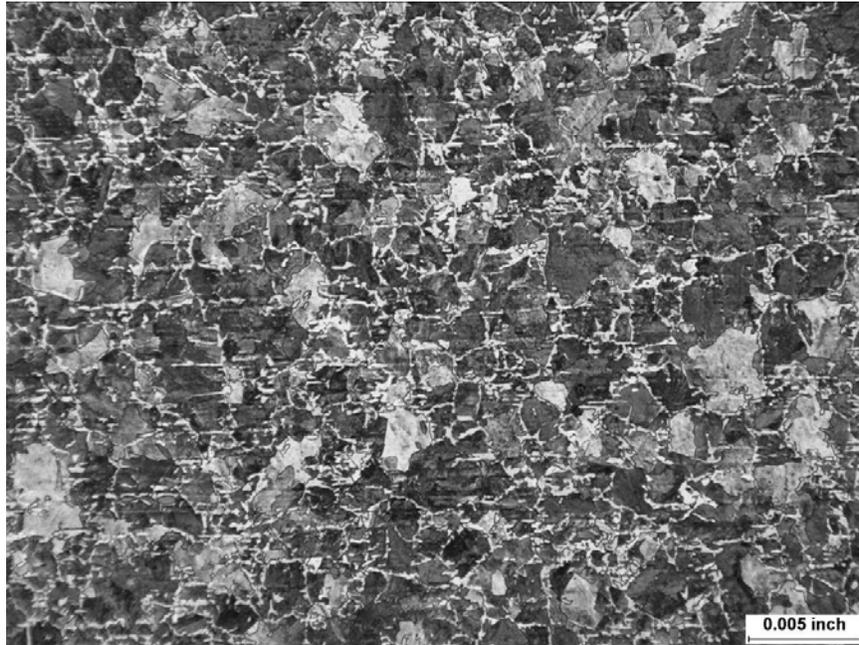
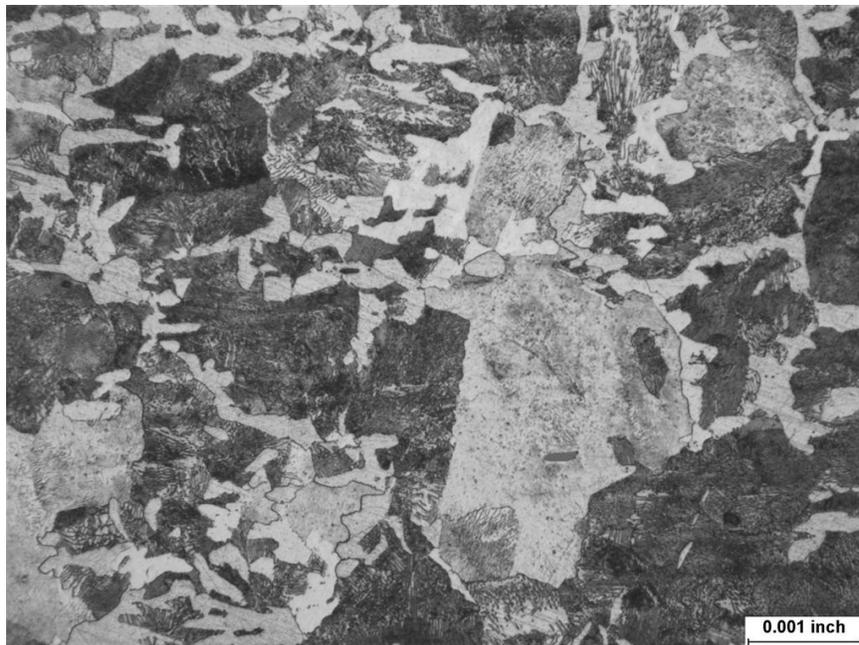
The micrographs of the base metal display the grain boundary ferrite and lamellar pearlite.

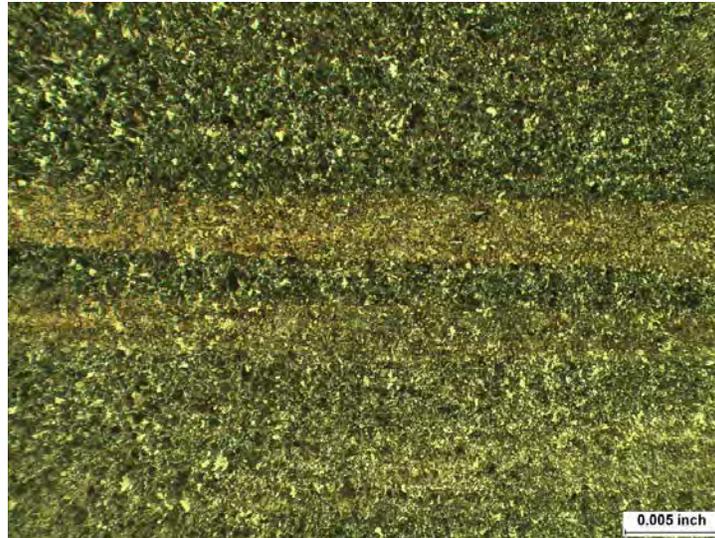
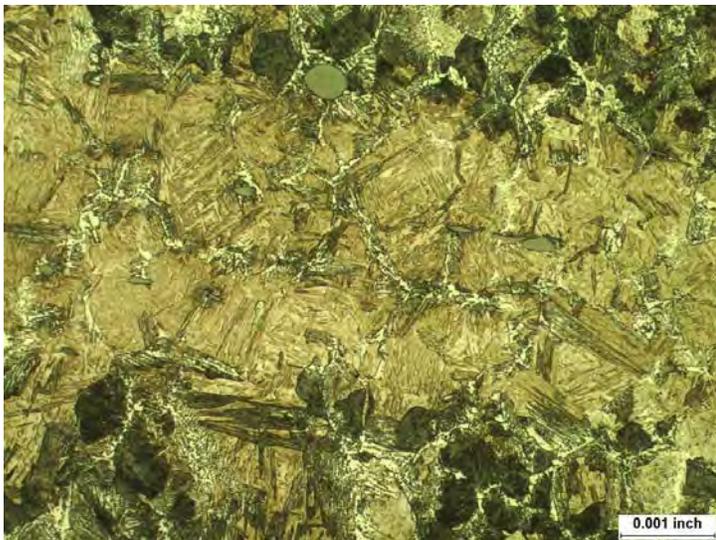
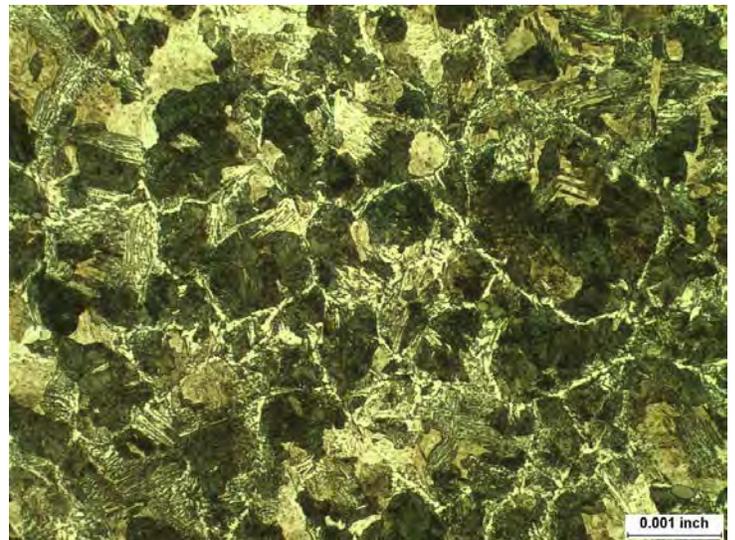
The photographs display banded microstructure in the ERW upset area adjacent to the fusion line, consisting of untempered acicular martensite with entrapped ferrite and ferrite with unresolved bainite in the adjacent non-banded matrix.

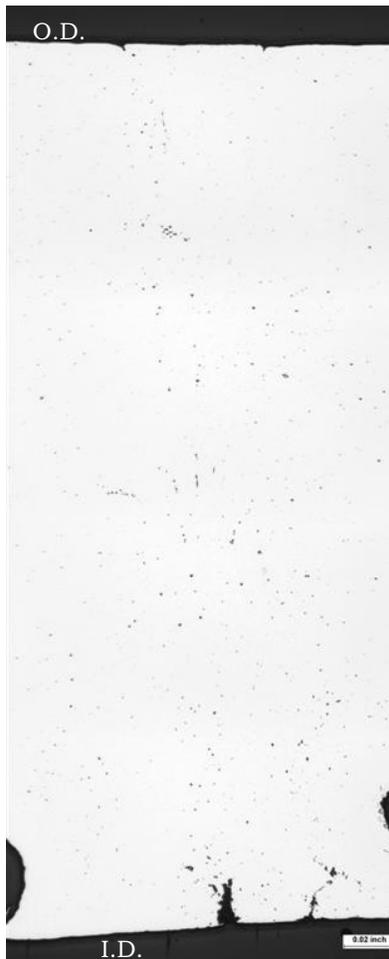
35' 8-1/2" from the North Girth Weld
As-polished, ~25x
Photograph No. 203

The microstructural examination revealed excessive amounts of predominantly manganese sulfide stringers and some oxide inclusions, several of them aligned parallel to the fusion line in the upset area of the ERW seam, which is a highly undesirable condition and can lead to the formation of hook cracks. The microstructural examination of the cross-section following etching in a 2% Nital solution revealed the presence of some upturned bands, however not as severe as those found in the fractured seam. The microstructure of the upturned bands consisted of brittle untempered martensite, while the upset/HAZ away from the bands consisted of mix-microstructure of grain boundary ferrite, bainite, and some untempered martensite. Photographs No. 203 through No. 220 document the microstructural condition of the intact ERW seam.

The micrograph of a cross-section removed from the intact ERW seam at a distance of 35' 8-1/2" from the north girth weld displays an excessive amount of manganese sulfide inclusions, some aligned parallel and diagonal to the fusion line during the seam welding process.

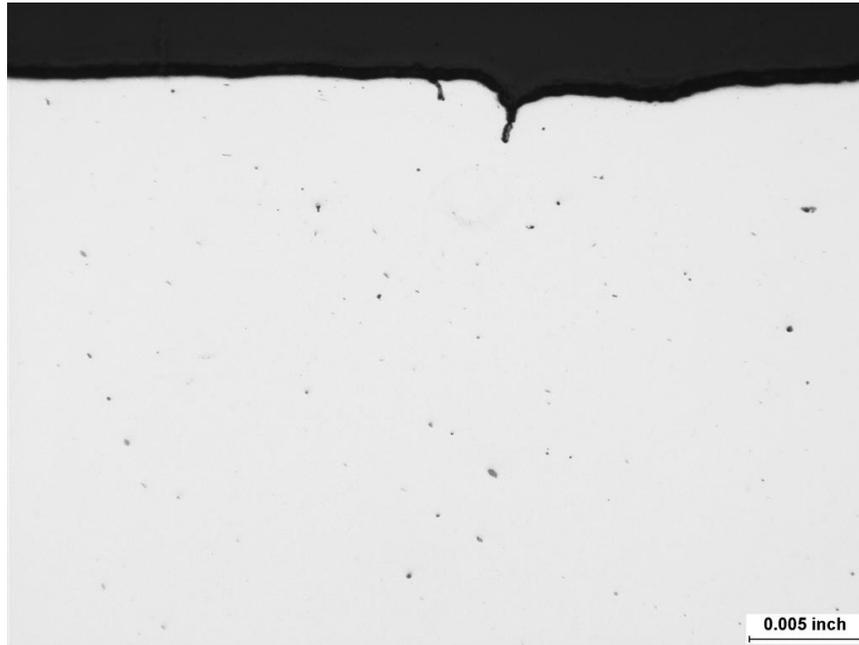
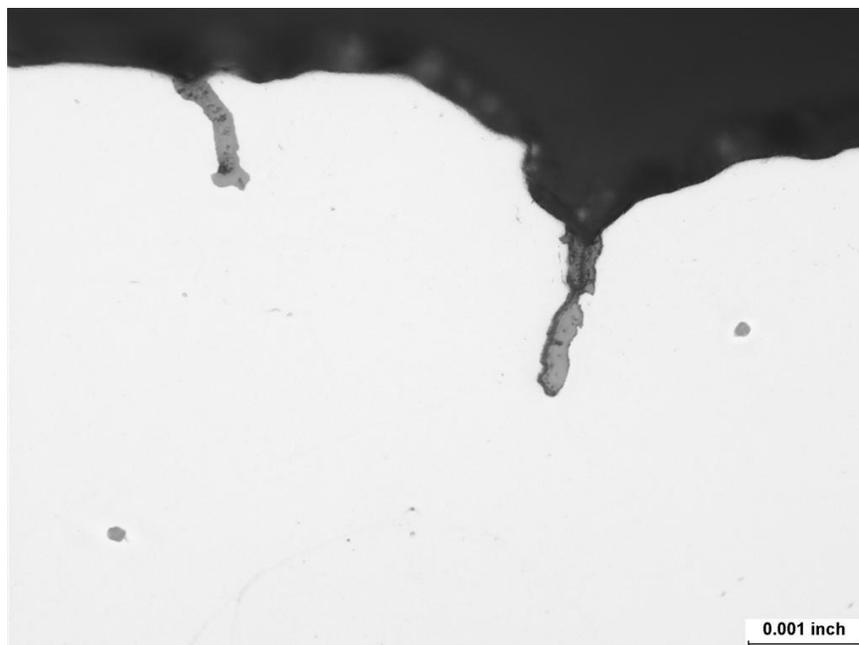
The micrographs display evidence of some oxidation to a shallow depth of 0.0015" in the upset/HAZ.

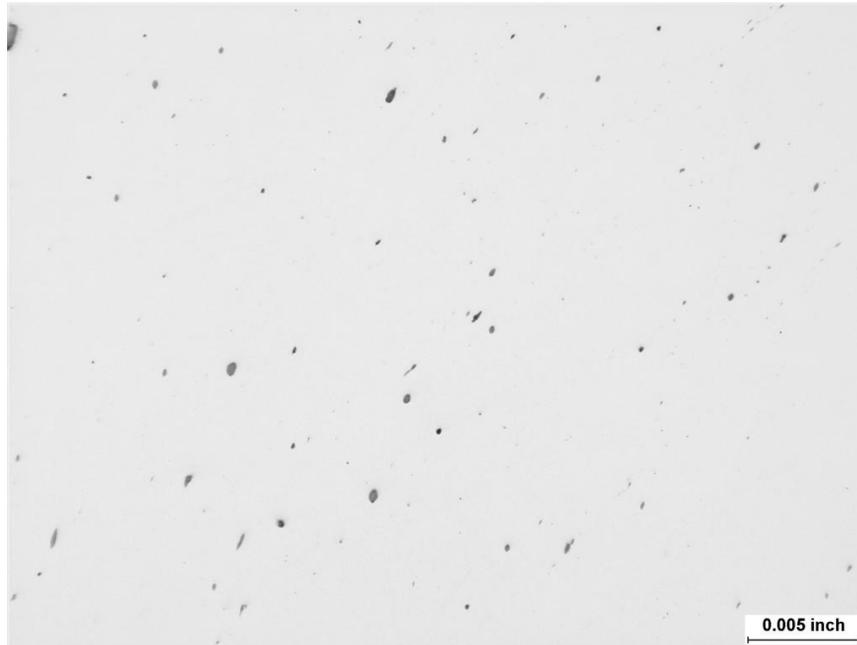
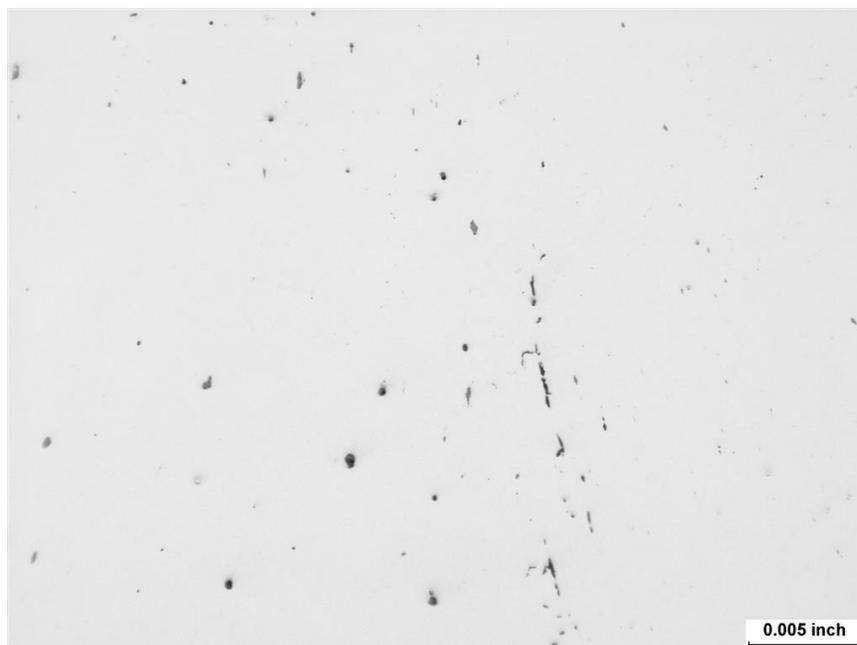
The micrographs display an excessive amount of manganese sulfide inclusions aligned parallel and diagonal to the fusion line in the upset/HAZ near the O.D. of the ERW seam joint.

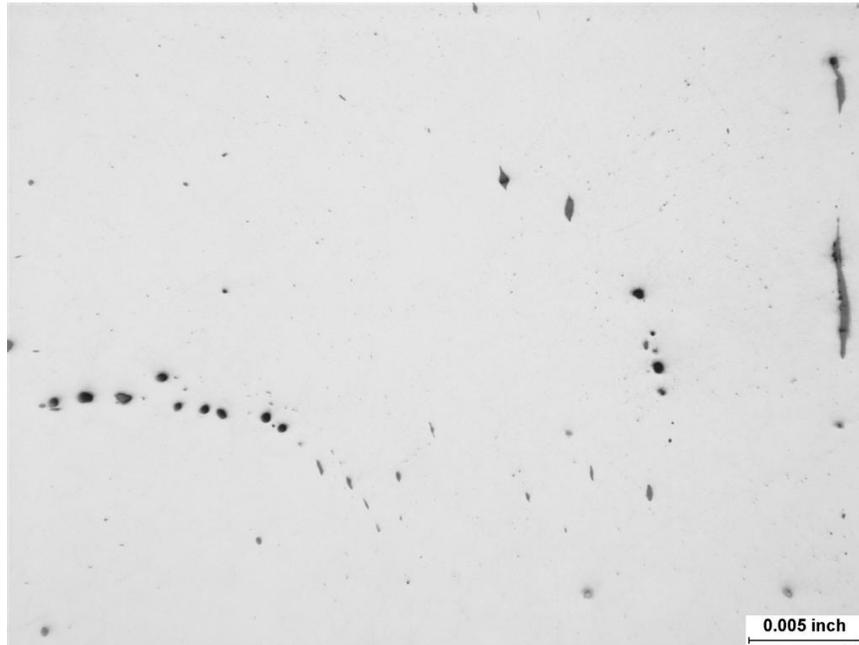
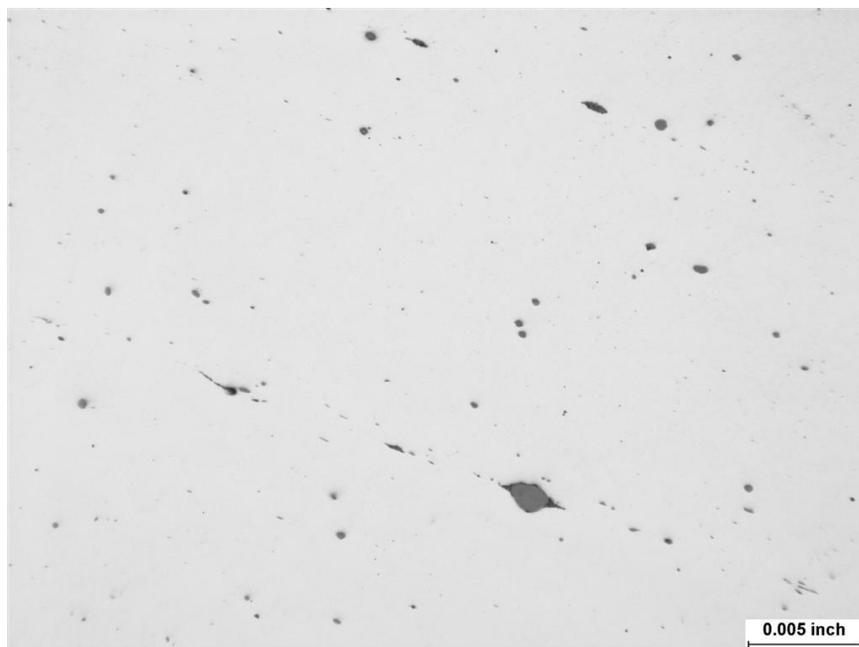
The micrographs display an excessive amount of manganese sulfide inclusions aligned parallel and diagonal to the fusion line in the upset/HAZ near the mid-wall of the ERW seam joint.

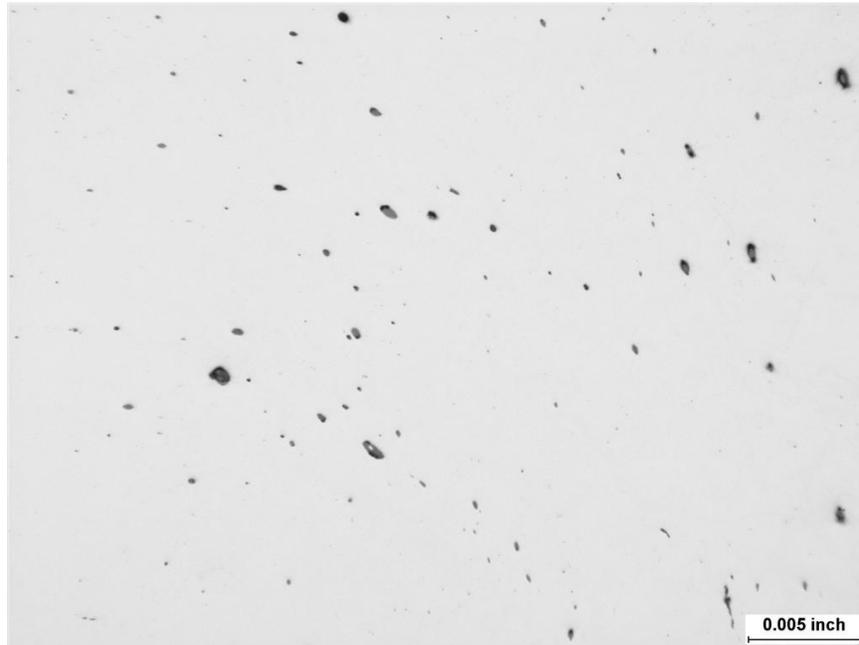
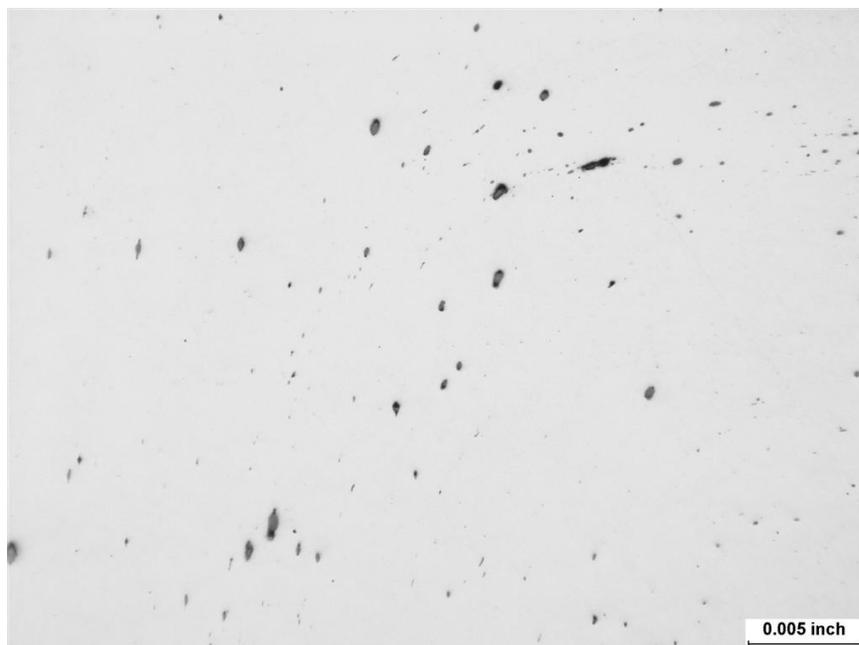
The micrographs display an excessive amount of manganese sulfide inclusions, many of them aligned parallel and diagonal to the fusion line in the upset/HAZ near the I.D. of the ERW seam joint.

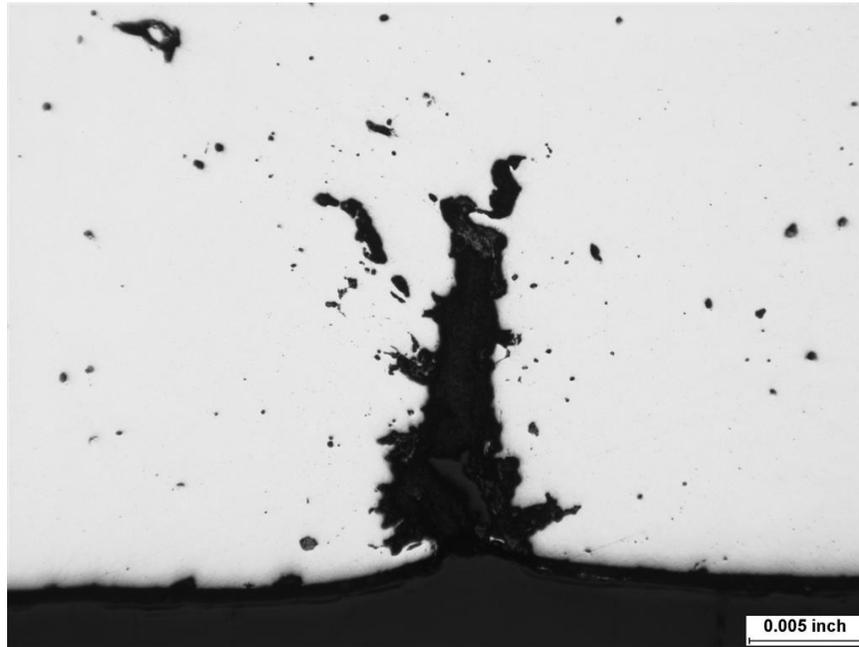
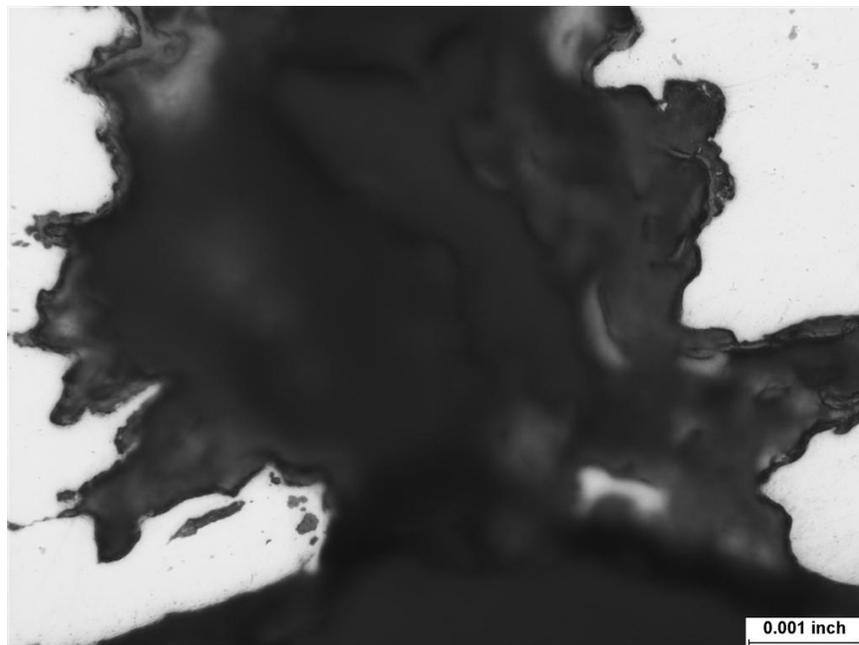
The micrographs display unfused, expelled weld flash near the I.D. of the ERW seam joint.

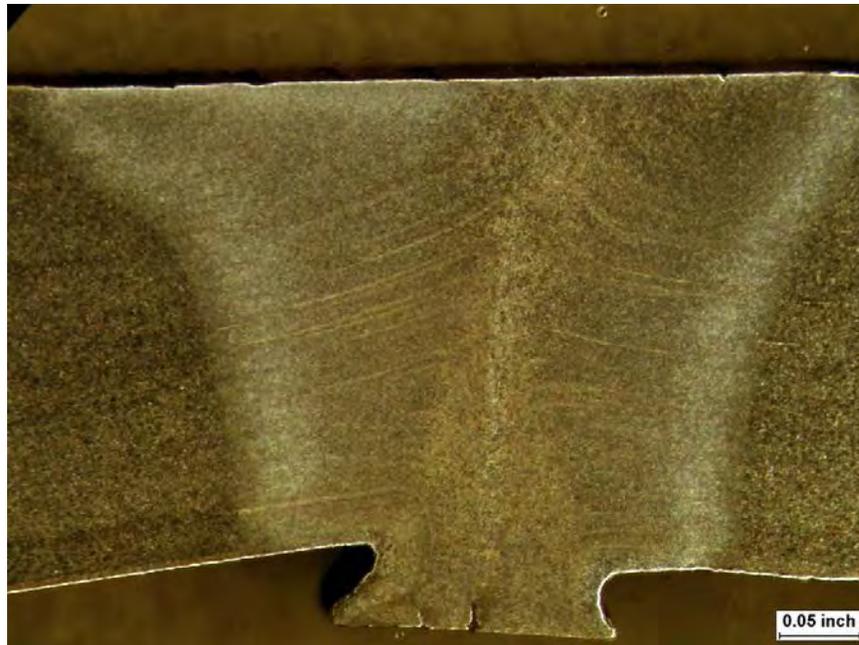
35' 8-1/2" from the North Girth Weld
2% Nital etch, ~20x
Photograph No. 214

The micrograph of the cross-section removed through the intact ERW seam at a distance of 35' 8-1/2" from the north girth weld and prepared for metallographic examination shows upturned as well as downturned bands in the upset/HAZ, with some bands aligned parallel to the fusion line.

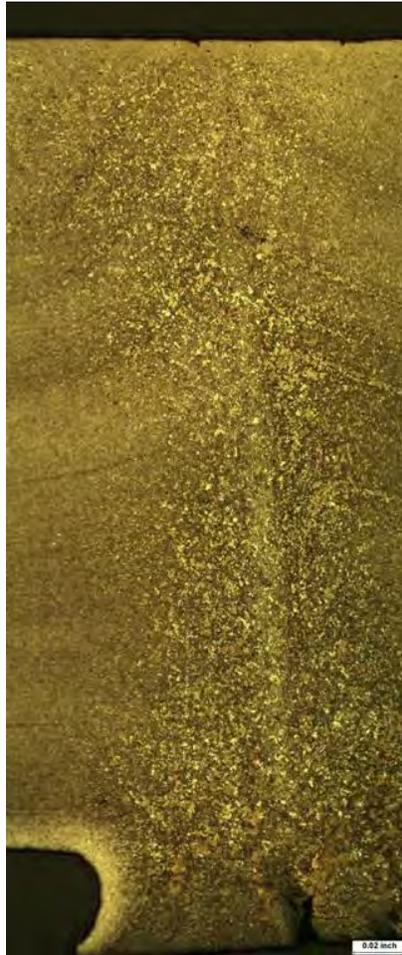
35' 8-1/2" from the North Girth Weld
2% Nital etch, ~25x
Photograph No. 215

The micrograph displays a composite view of the ERW seam cross-section following etching in a 2% Nital solution revealing some upturned grains parallel to the fusion line.

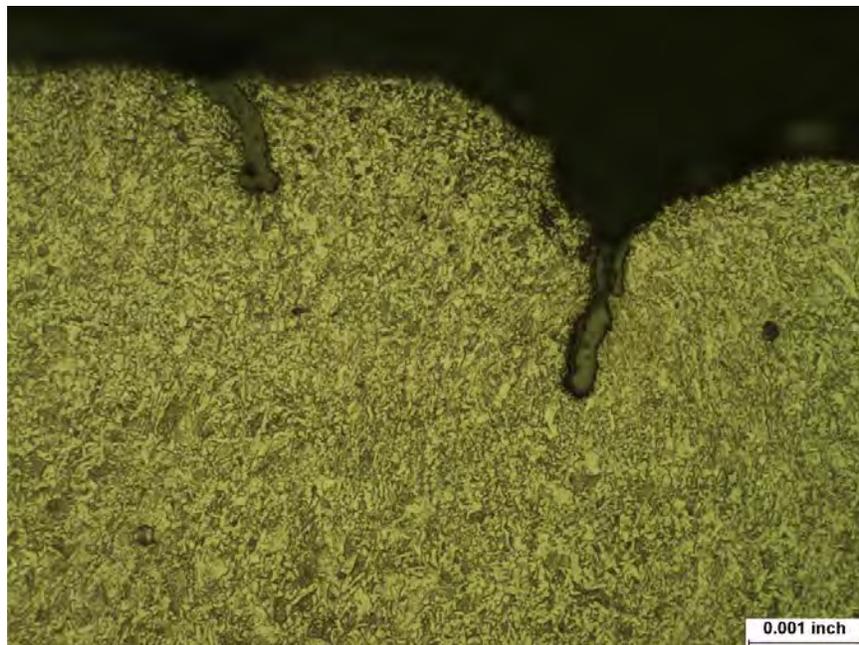
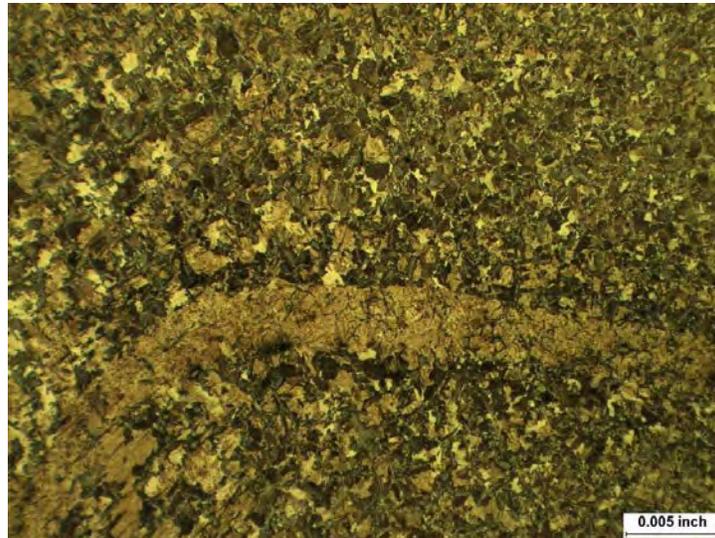
35' 8-1/2" from the North Girth Weld
2% Nital etch, ~500x
Photograph No. 217

The micrographs display evidence of some oxidation near the O.D. in the upset/HAZ of the ERW seam joint. The microstructure near the O.D. consists of essentially ferrite and pearlite.
