DOT US Department of Transportation
PHMSA Pipelines and Hazardous Materials Safety Administration
OPS Office of Pipeline Safety
Southwest Region

Date of Report October 23, 2013
Subject Failure Investigation Report – Mobil Pipe Line Company; Pegasus Pipeline, Mayflower, AR

Failure Investigation Report – Mobil Pipeline Pegasus Rupture
March 29, 2013

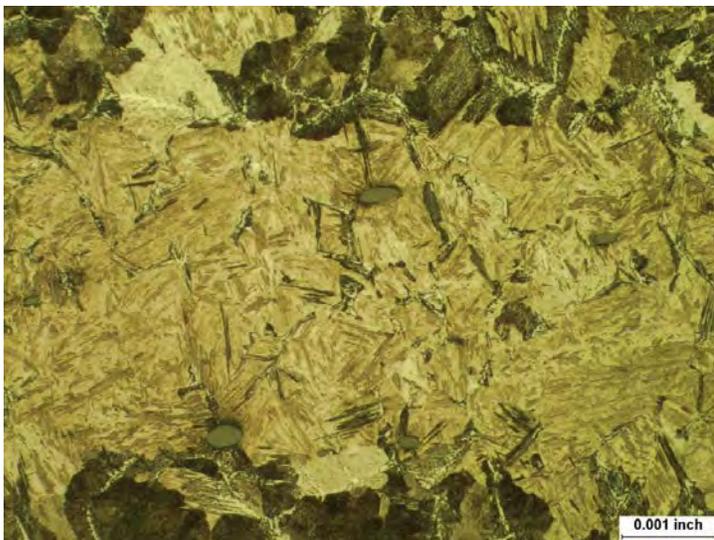
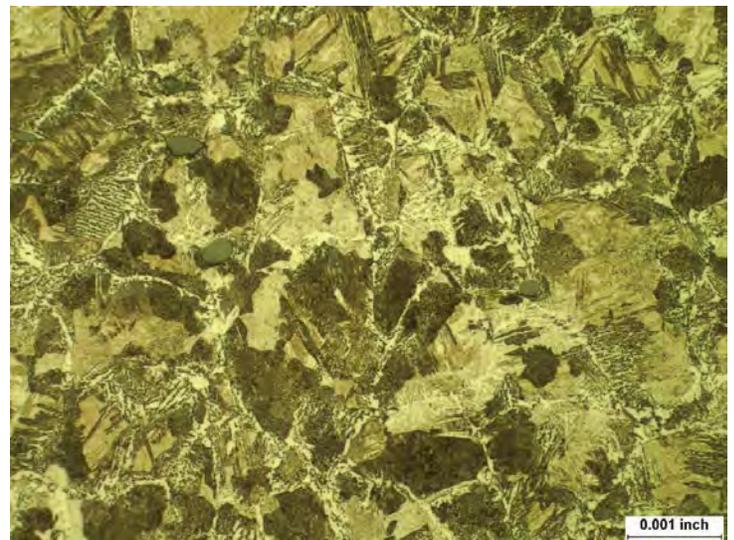
35' 8-1/2" from the North Girth Weld
2% Nital etch, ~500x
Photograph No. 220

The micrographs display untempered brittle martensite in the bands in the upset/HAZ of the ERW seam joint.

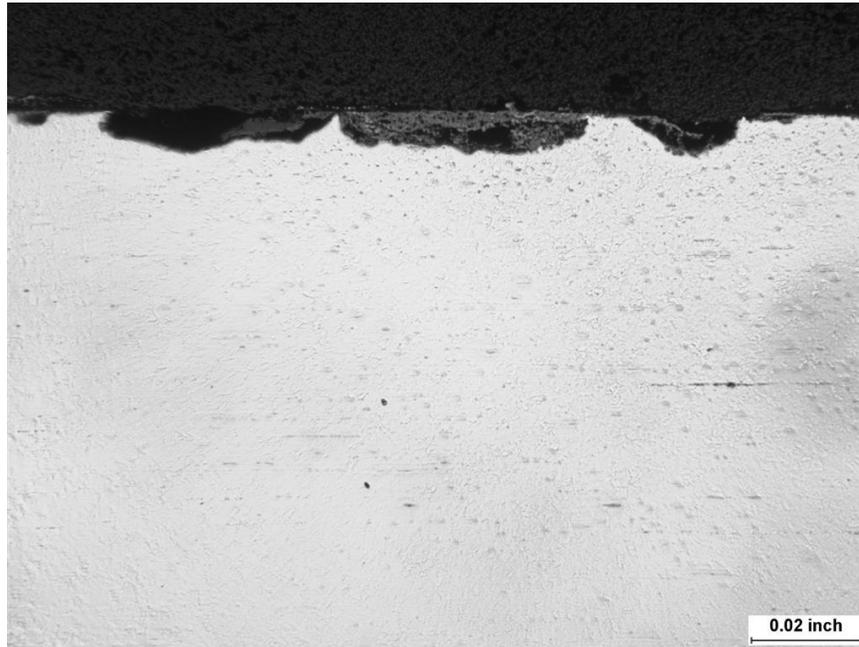
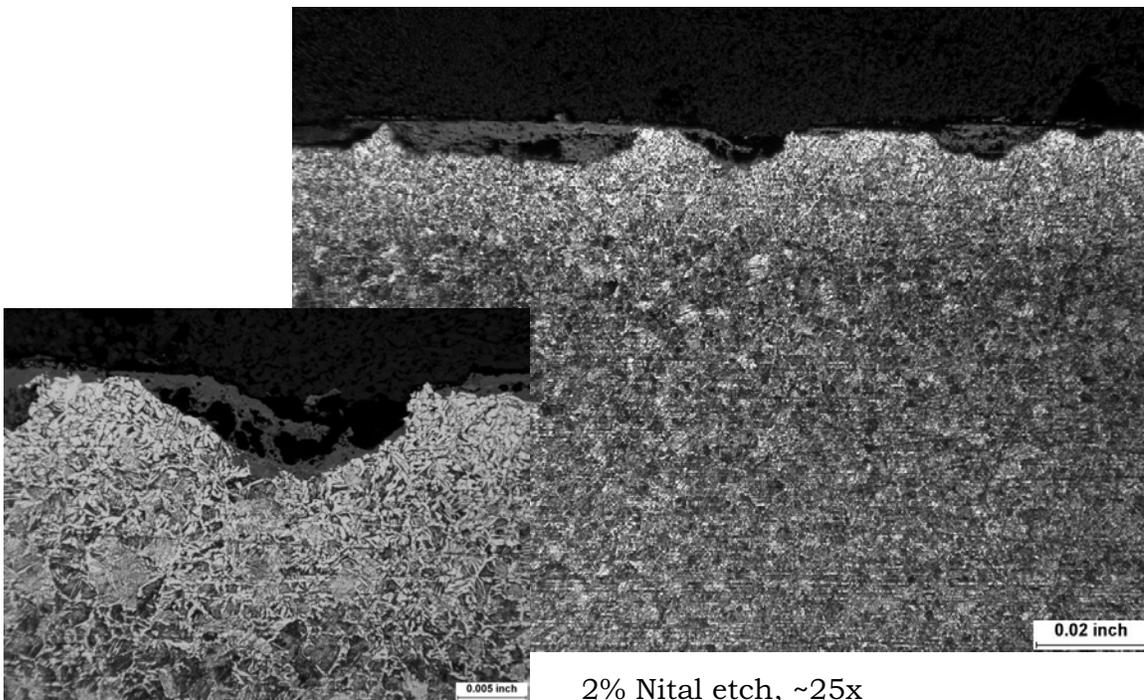
2% Nital etch, ~25x
Photograph No. 222

The micrographs display the microstructural condition at a representative area of the O.D. surface of the pipe, showing the loss of material due to pitting corrosion and the corrosion products adhered to the surface. The insert photograph shows a higher magnification view of a single corrosion pit. The maximum depth of the corrosion pits at this location measured 0.008".

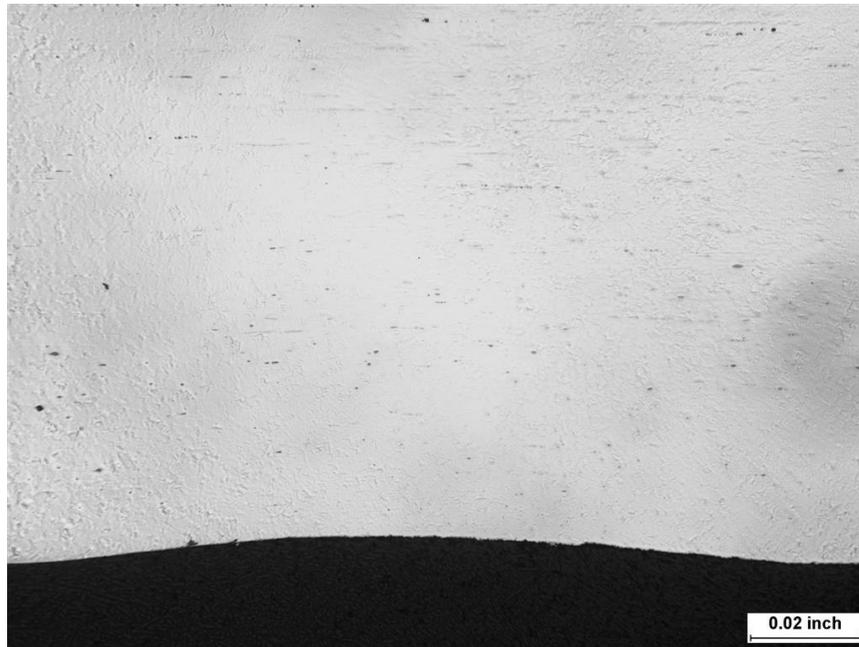
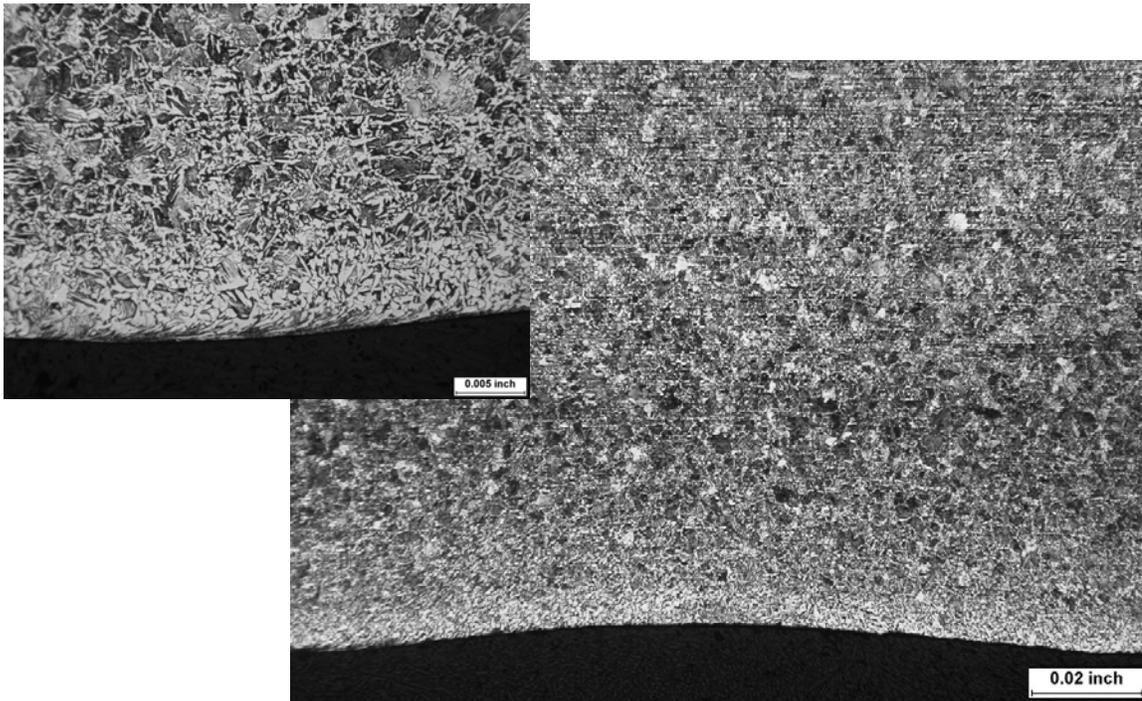
2% Nital etch, ~25x
Photograph No. 224

The micrographs display the microstructural condition at a representative area of the I.D. surface of the pipe, showing one of the shallow indentations observed during the visual examination. Note the uniform layer of partial decarburization on the I.D. surface and the grain flow deformation shown in the insert photograph, both indicating that the shallow depression is due to a mechanical indentation, most likely when the pipe was manufactured, and not corrosion pitting. The impression measured 0.137" wide and 0.005" deep.

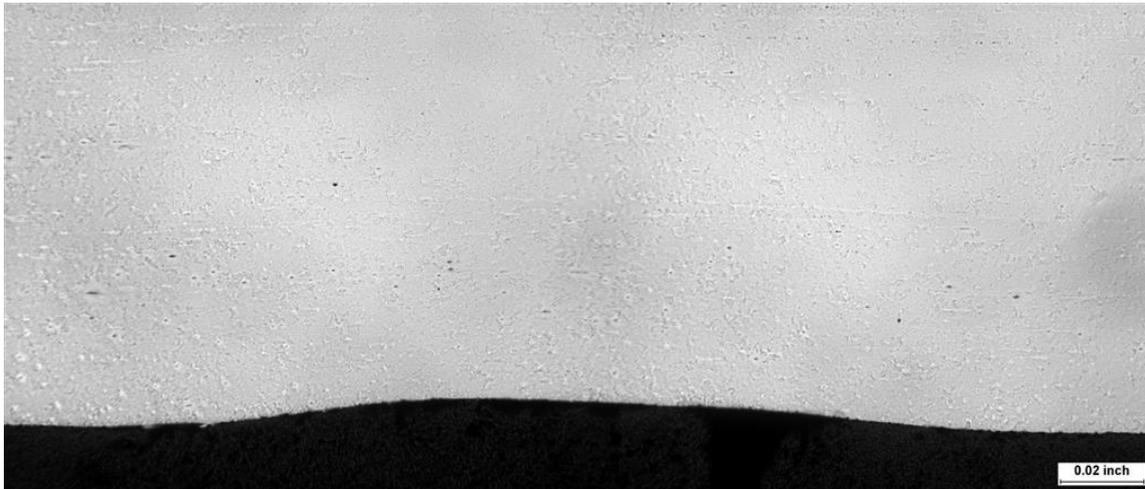
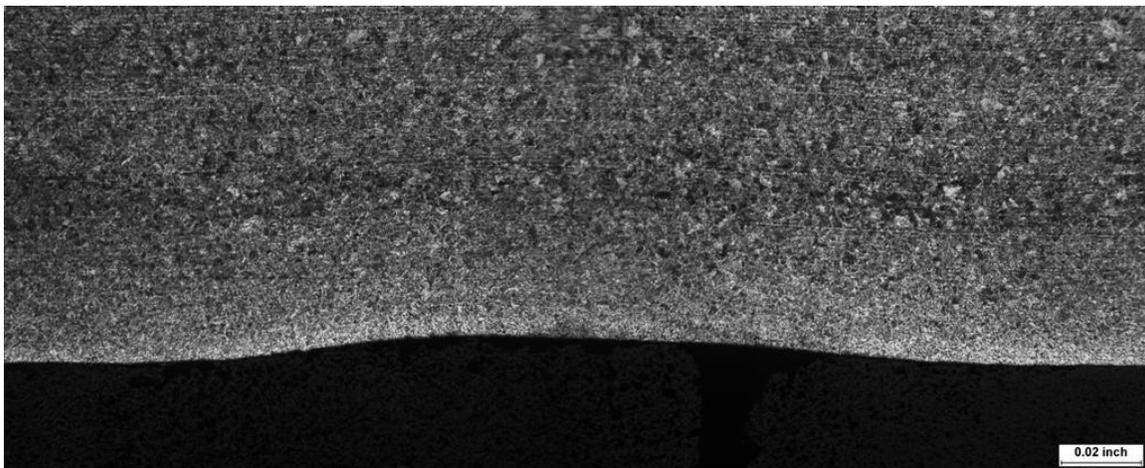
2% Nital etch, ~25x
Photograph No. 226

The composite micrographs display the microstructural condition at another representative area of the I.D. surface of the pipe, showing one of the shallow indentations observed during the visual examination. Note the uniform layer of partial decarburization on the I.D. surface, indicating that the shallow depression is due to a mechanical indentation, most likely when the pipe was manufactured, and not corrosion pitting. The impression measured 0.189" wide and 0.007" deep.

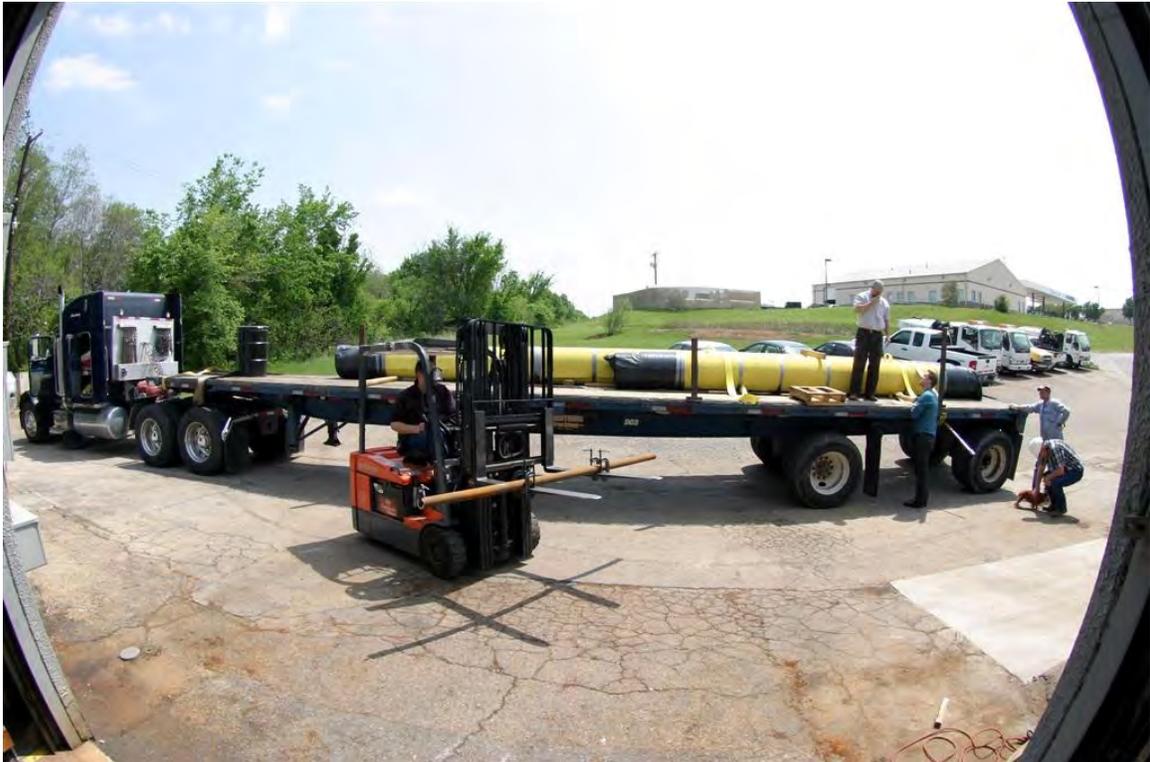
The photograph displays the pipe sections in the as-received condition with the protective wrapping on the outside surface of the pipe sections that was applied to prevent any damage during transportation.

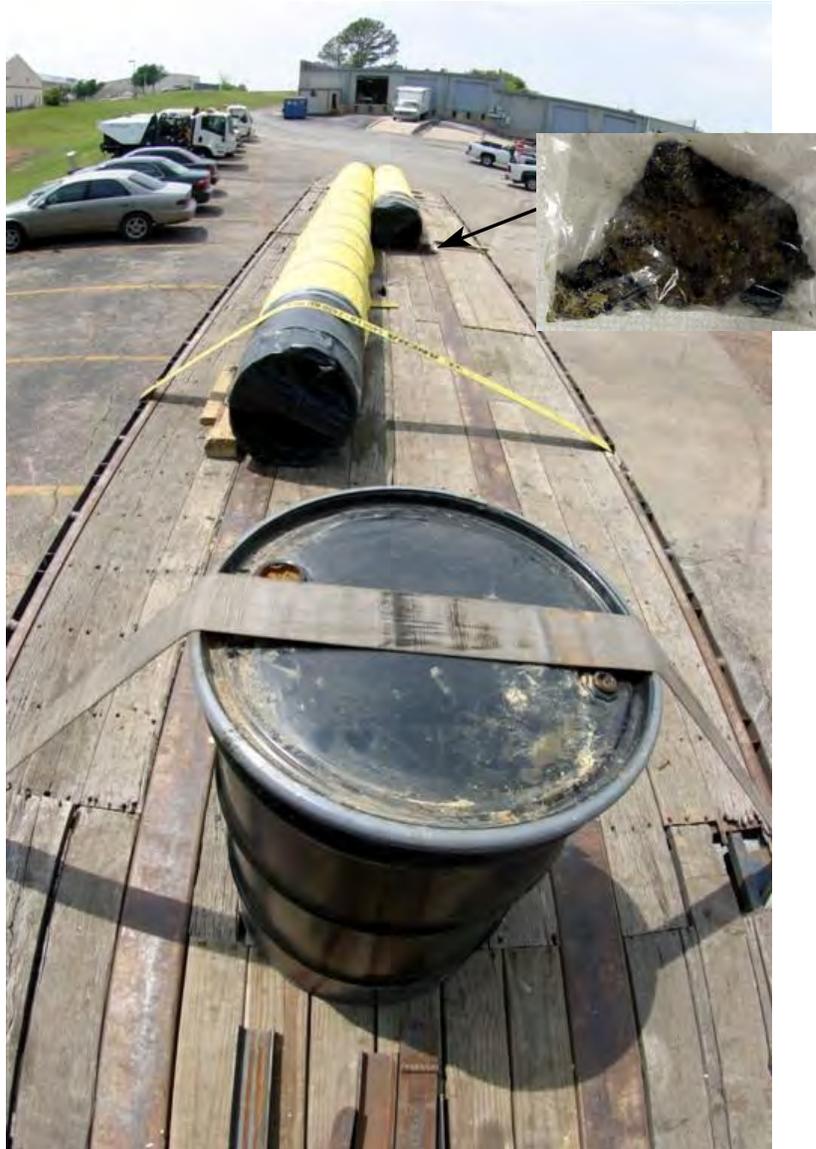
The photograph displays the pipe section, a drum containing the coating material that was removed in the field prior to sectioning of the cracked pipe and a bag containing possible calcareous deposit.

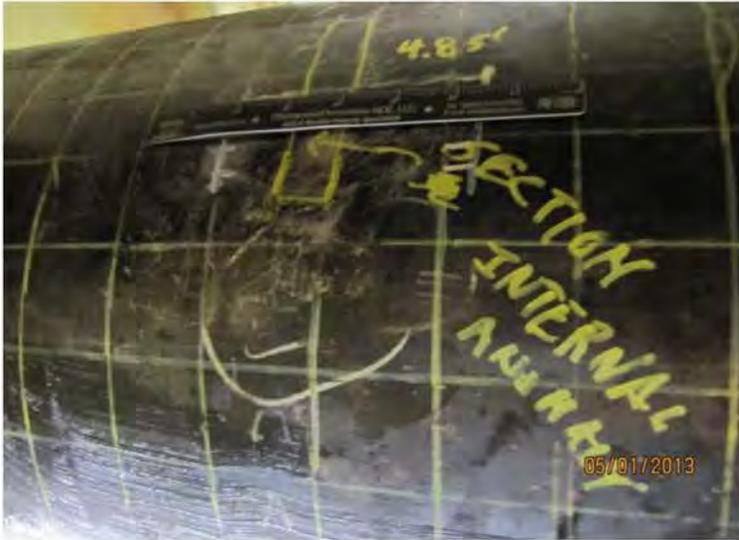
| | | | Description of photograph Anomaly 1 Area Marked on Pipe for Sectioning | | |

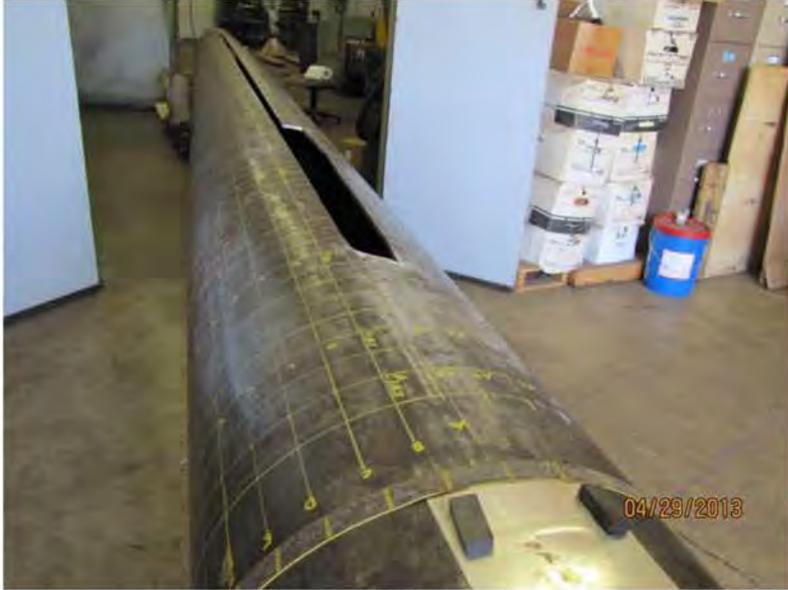
| NG=Not Given NV=Not Verified NA=Not Applicable VI=Verified by Dig Inspector NDE Remarks: A "map" of ultrasonic thickness measurements were taken from 12 inches upstream of the girth weld to 12 inches downstream of the rupture for 360 degrees around the pipe surface. The thickness measurements were taken around the entire circumference along the length of pipe at 2 inch grid intervals. No internal corrosion areas were identified during the ultrasonic examination. The pipe thickness readings varied from 0.288" to 0.316" along the pipe. The grid rows identified as "A" and "AE" on the thickness map represent the 2" areas immediately adjacent to the rupture face. Column "7" represents the upstream girth weld cap. (A1 to AE147) | | | | | | | | | | | | | | | | | |

| | Description of photograph Gridded Pipe looking upstream (pipe gridded 12" downstream of rupture). |

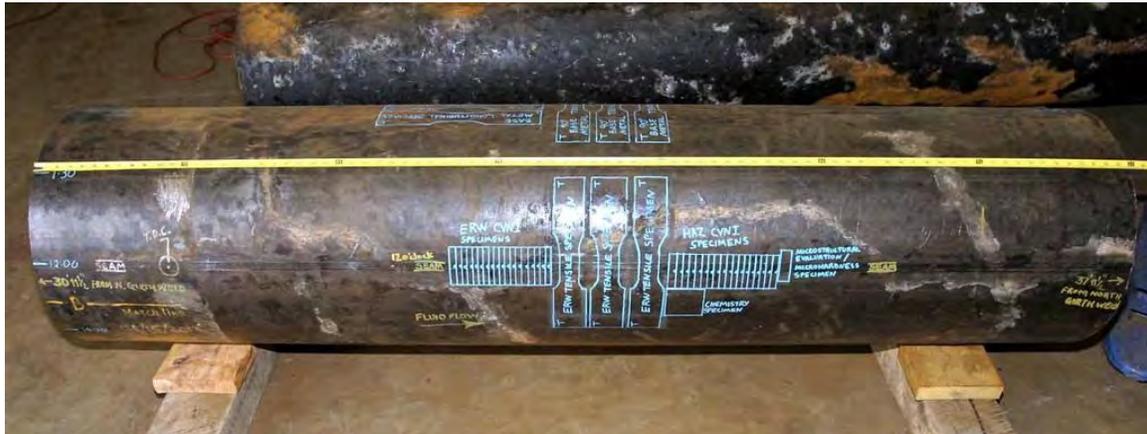
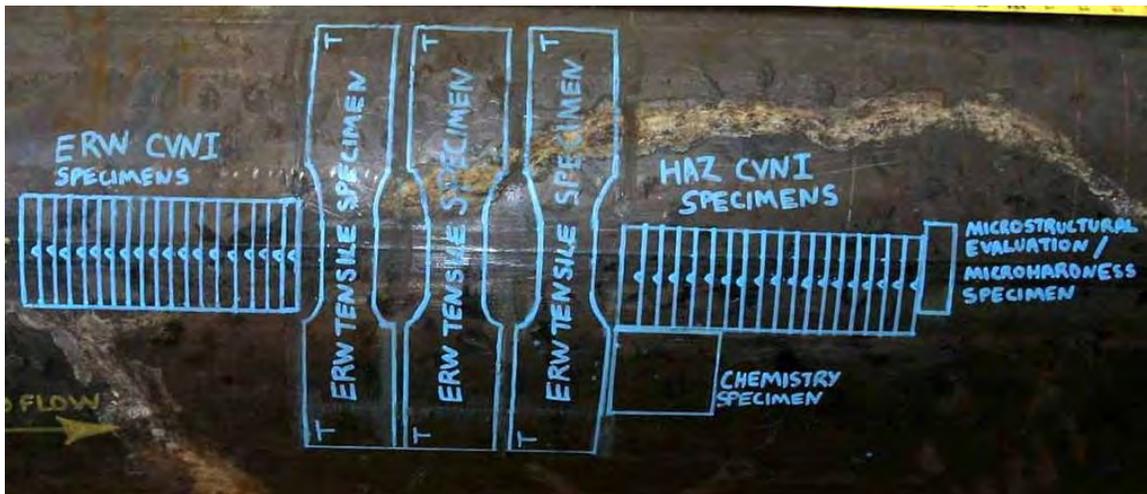
The photographs display an overall view of the area along the ERW seam on the intact 19' 10" long section of the pipe, and a closer view of the area where the ERW seam test specimens were removed from.

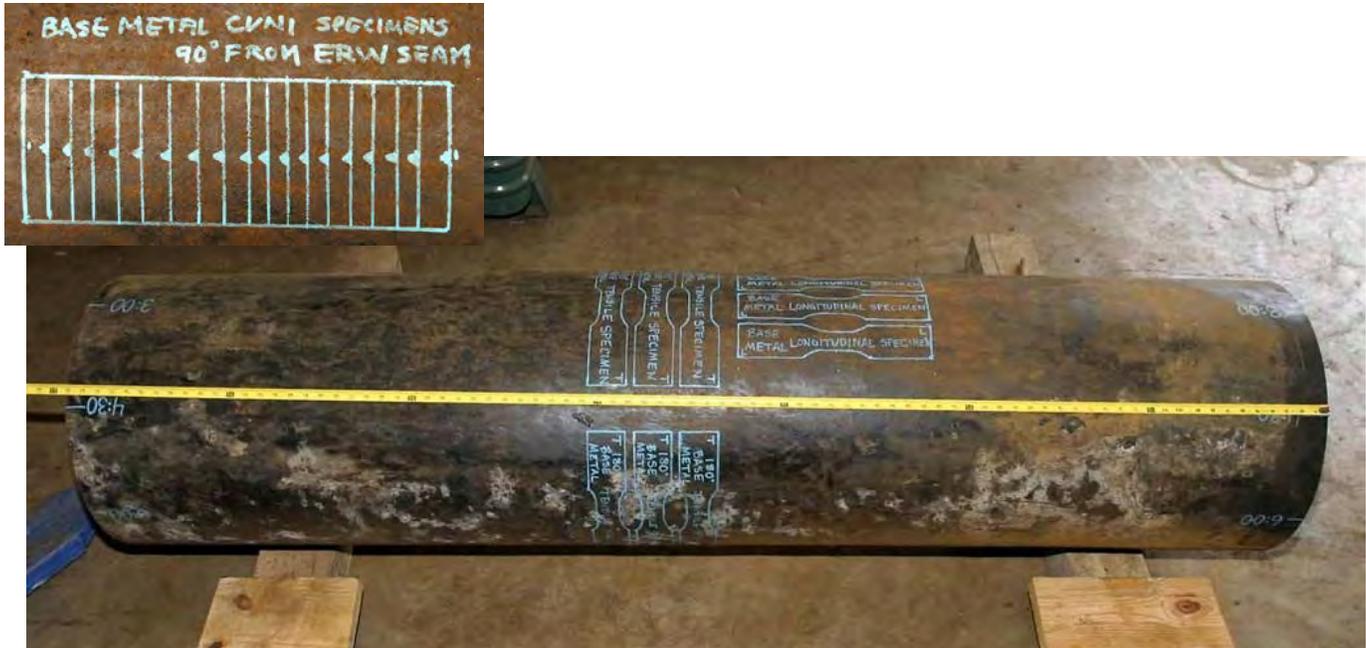
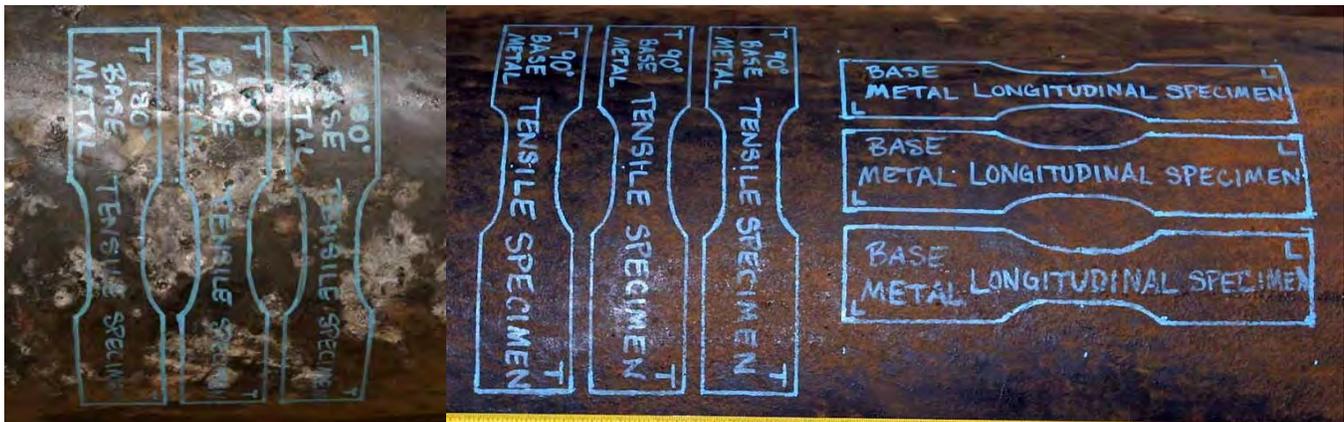
The photographs display an overall view of the area opposite the ERW seam on the intact 19' 10" long section of the pipe, showing where the longitudinal and transverse base metal test specimens were removed from. The insert photograph shows the location of the base metal CVN impact test specimens.

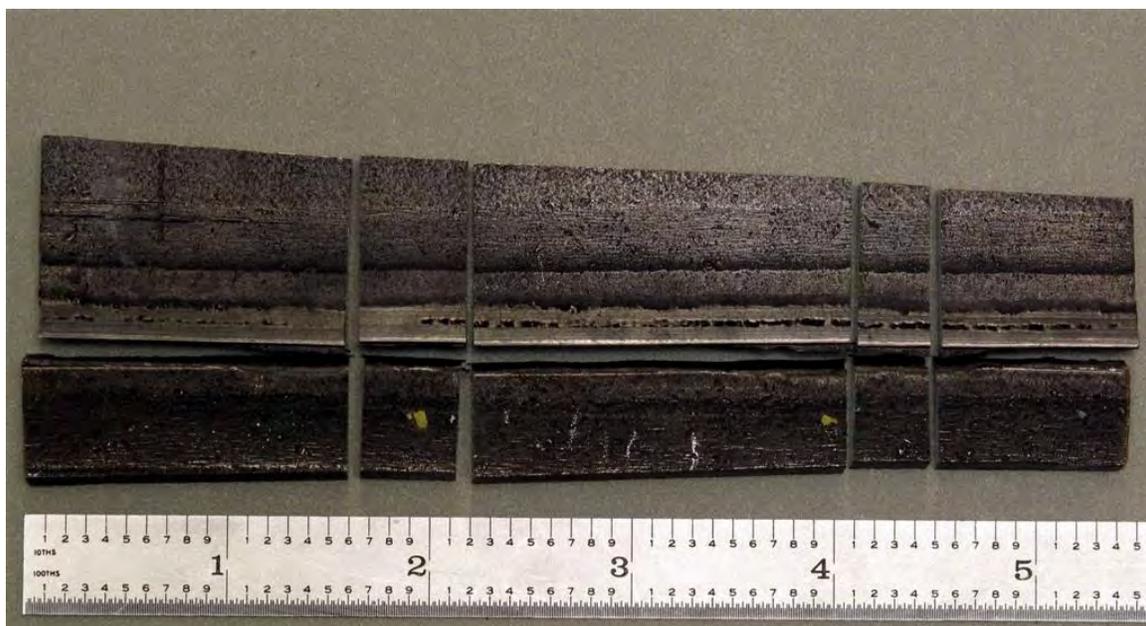
The photographs display the O.D. and I.D. surface, respectively, at the locations where the cross-sections were removed through the fractured area of the ERW seam and metallographically prepared for microstructural evaluation.

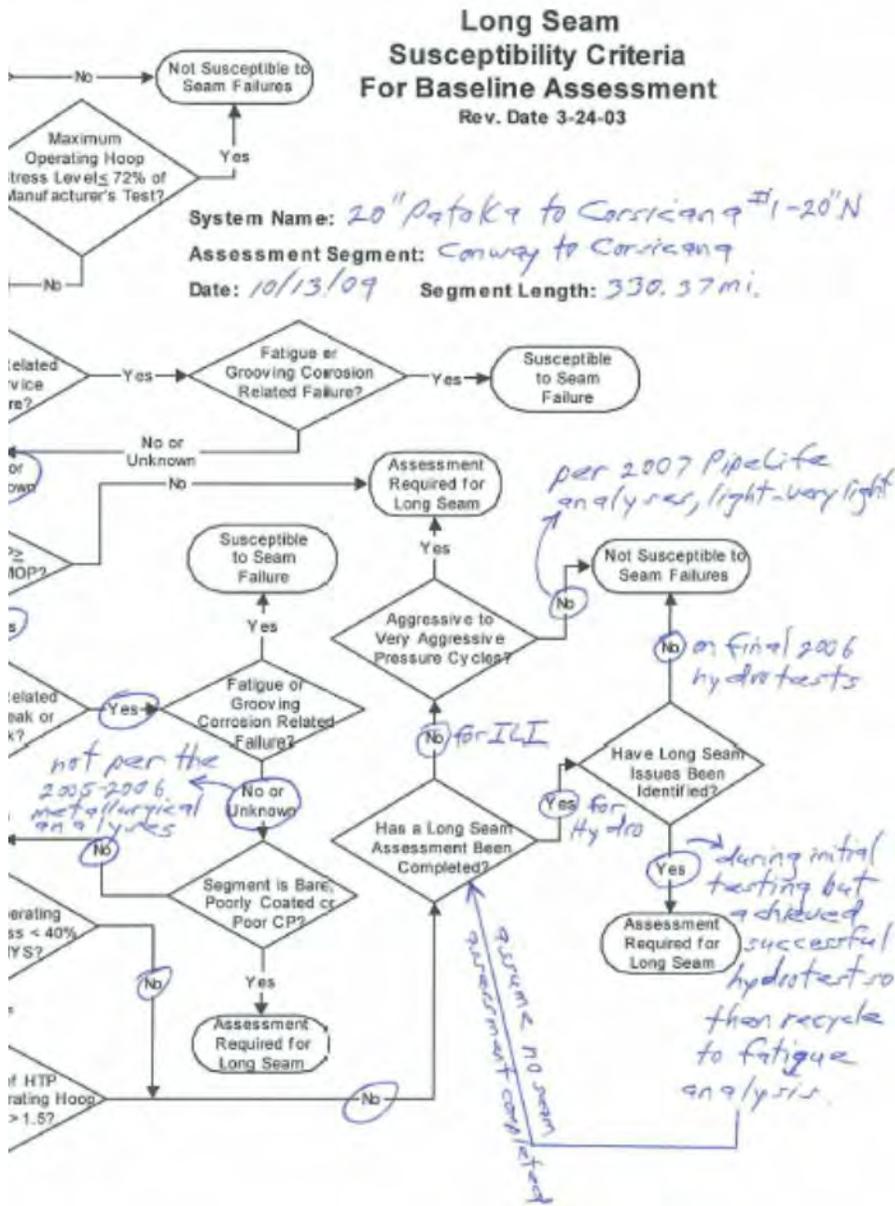
The SFSA analysis process flow chart dealt with only two possible time-dependent threats, fatigue or grooving corrosion, and did not consider other possibilities such as pressure reversals or hydrogen embrittlement that were potential growth mechanisms, as indicated by the results in the Hurst metallurgical reports.

The baseline assessment results were not addressed by the flow chart process. The October 13, 2009 SFSA analysis further modified the process on the flow chart and “assumed no seam assessment was ever completed,” and then deferred to the fatigue analysis when in fact this was not part of the flow chart path.

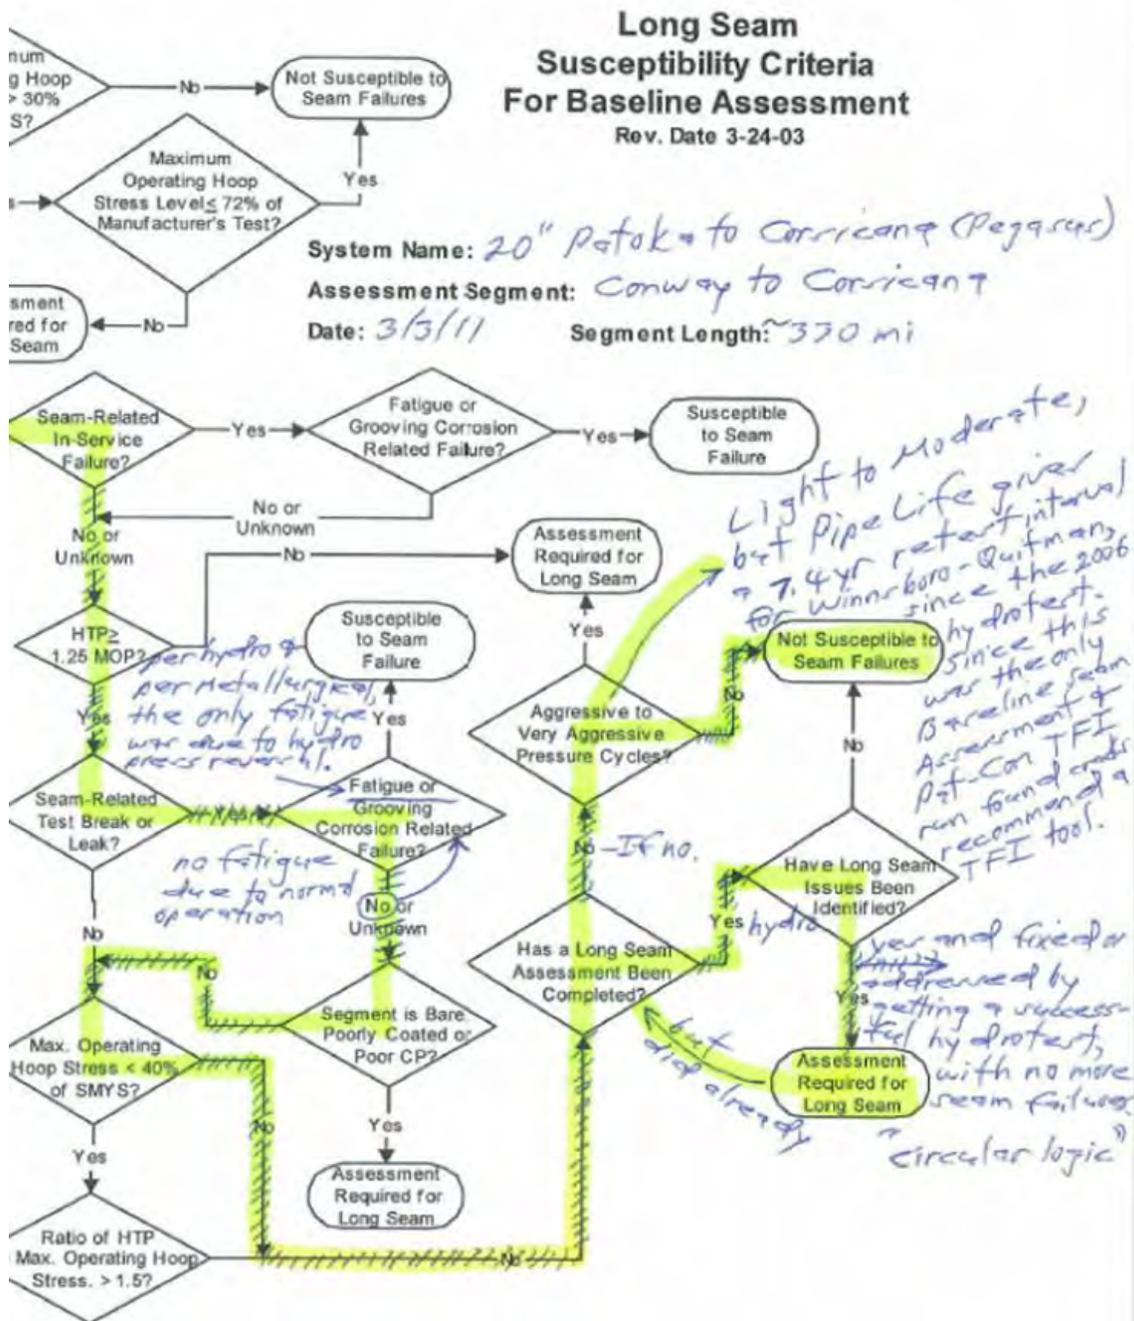
The note that distinguishes “operational fatigue” from “hydro pressure reversals” is the only place that these concepts were observed in the EMPCo IM processes. The March 3, 2011 SSF analysis modifications to were documented on the process flow chart as follows.

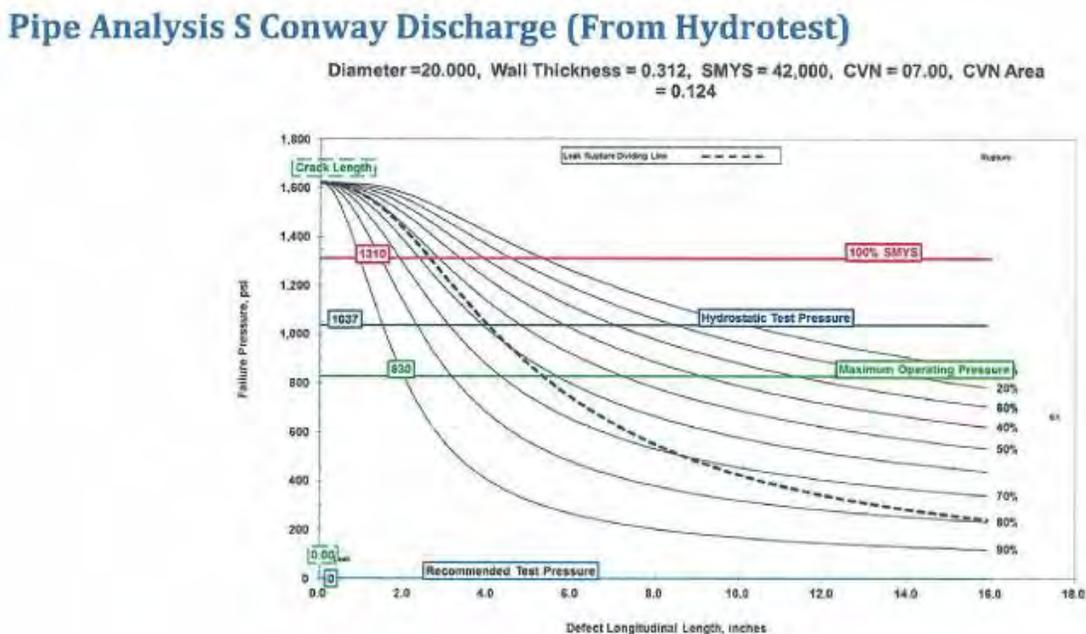
Figure Y – 2012 Pipe Analysis – Conway Discharge Results

In July 2012, EMPCo ran a fatigue analysis for the entire Pegasus System using 30 days of operating data from May 1 through May 31, 2012. The predicted maximum retest intervals from the 2005-2006 hydrotest were significantly different for several line segments from the earlier fatigue analyses, including intervals that resulted in dates that were already in the past. The operating conditions used in the 2012 fatigue analyses reflected post 2009 expansion operating pressure cycles. The IM personnel concluded that EMPCo “can’t use, makes it past due, and didn’t operate this way 2006 -2009” for all line segments that were past due. The Conway Discharge Pipe Analysis Results as modeled in the July 2012 fatigue analysis resulted in the graph shown in Figure Y. Using the reported defect size of 13.25-inches and a d/t ratio of 0.44 results in a predicted failure rupture pressure of about 650 psig. The actual failure pressure was calculated to be 708 psig at the failure location. The difference in failure pressures can be explained by the actual SMYS being much higher, and the measured CVN value being lower than modeled in the analysis.

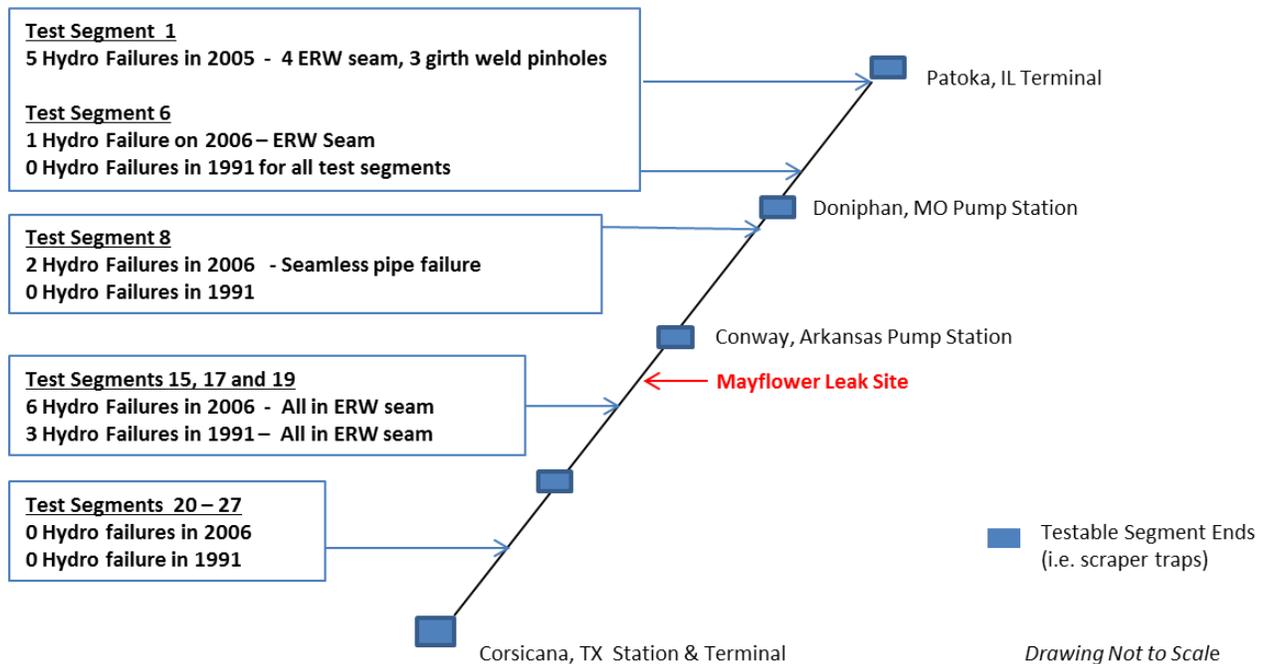
Patoka to Corsicana Hydrotest Failure Locations

During the 2005 to 2006 hydrotesting of the Patoka to Corsicana pipe, six (6) of the 27 tests experienced a total of twelve (12) pipe joint ruptures. There were also three pinhole leaks in two test sections that were repaired in place and did not require replacement of pipe. EMPCo prepared a summary of learnings from the 2005-2006 hydrotest failures and metallurgical reports in a Memo to File prepared by IM personnel. The 'Memo to File' summarized the cause of the failures for the eleven (11) failures in the ERW seam as having *“failed in the ERW seam vs. body due to the presence of multiple mill defects in the seam that made its design strength weaker than that of the body of the pipe. Failures were below, at, or above 1991 test pressures...The defects included multiple lack of fusion, hook cracks, inclusions, hot tearing, generally low metallurgical mechanical properties/strength, or other mill related imperfections.”* The memo went on to conclude that *“CVN toughness testing, and researching the 1991 hydrotest revealed lower test temperature was likely a contributing factor in why they failed at less pressure than what they were tested to in 1991. This is as opposed to other time dependent defects like preferential corrosion or pressure cycling fatigue of the seam.”* However, for the failures where the 2005-2006 test pressures were higher than the 1991 test pressures, EMPCo concluded that *“We know from our CVN toughness testing that test temperature had to also be a factor but to which extent higher pressures or lower temperatures played a role in the failures we don’t know.”*

The first test section was Test Section 1 from Patoka, IL MP 604.98 to 647.73. Test Section 1 was tested, and five test failures occurred before a successful hydrotest was completed. Four of the failures resulted from ERW long seam failures and the fifth test failure was due to pinhole leaks in girth welds. The fifth hydrotest was successfully completed after the pinhole leaks were repaired in place, but the line segment was ultimately tested at a lower pressure than planned in the design basis. The following table summarizes the test results for Test Segment 1.

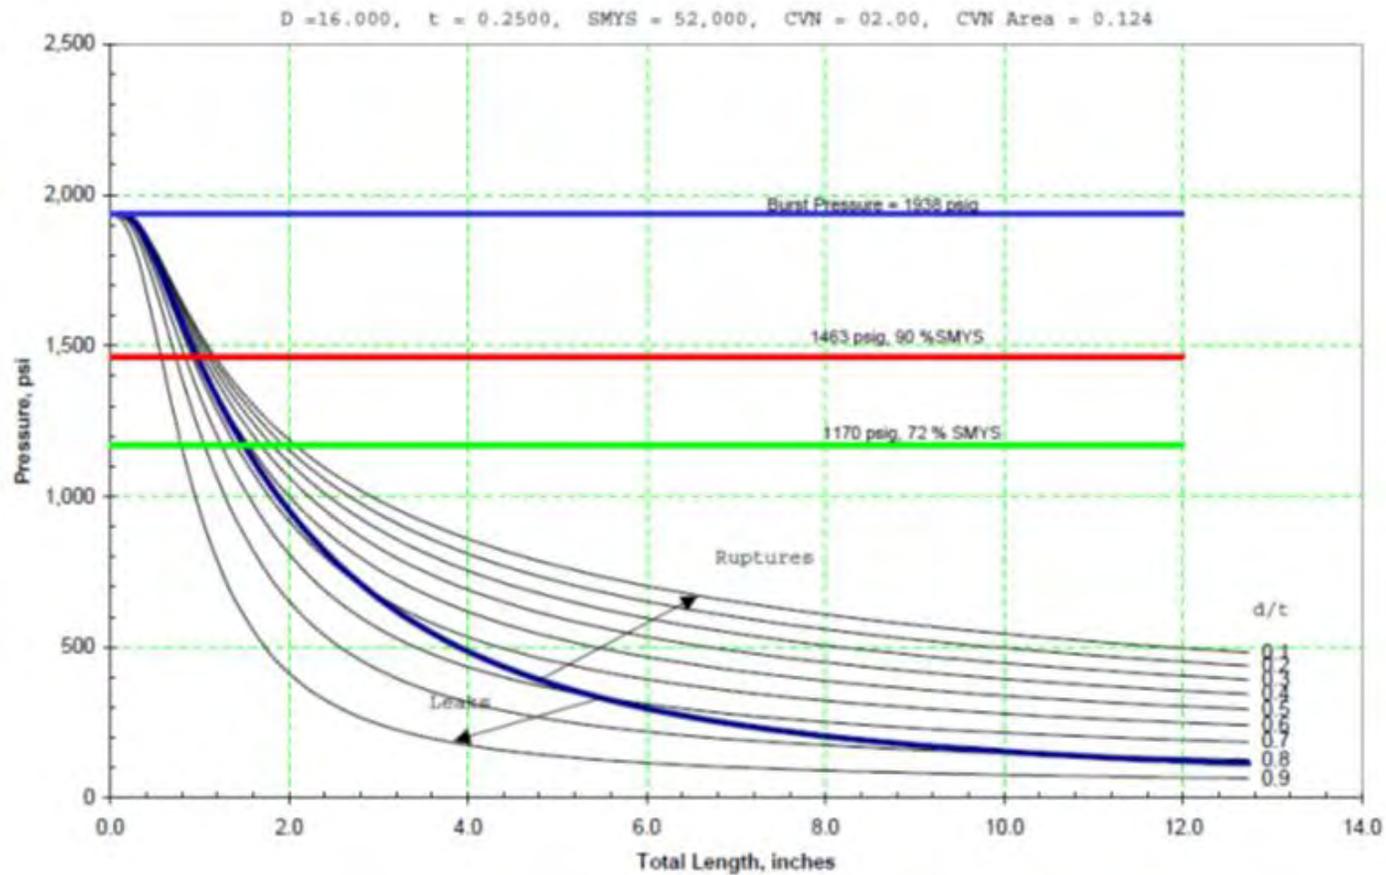
Figure 8.4 Relationship Between Failure Pressure and Flaw Size in Low Toughness Seams (2 ft-lb)

Figure 8.4 (2 ft-lb) and Figure 8.5 (0.2 ft-lb) represent the ranges of effective responses of the bondline regions of low-frequency-welded, dc welded, and flash-welded materials. It is obvious in both figures that these materials are extremely flaw intolerant. At first glance, this tends to be much more alarming than it actually needs to be. As it turns out, both logic and practical experience suggest that once a material such as this receives a satisfactory initial “proof” test, it cannot contain any defects of significant size. Therefore, the relatively small remaining defects pose little or no threat to the integrity of the pipeline because they are too small to become enlarged by fatigue. In fact, the author knows of no case where a small bondline flaw failed because it became enlarged by fatigue crack growth. Moreover, attempts to produce fatigue failures at such flaws within reasonable numbers of cycles have failed.

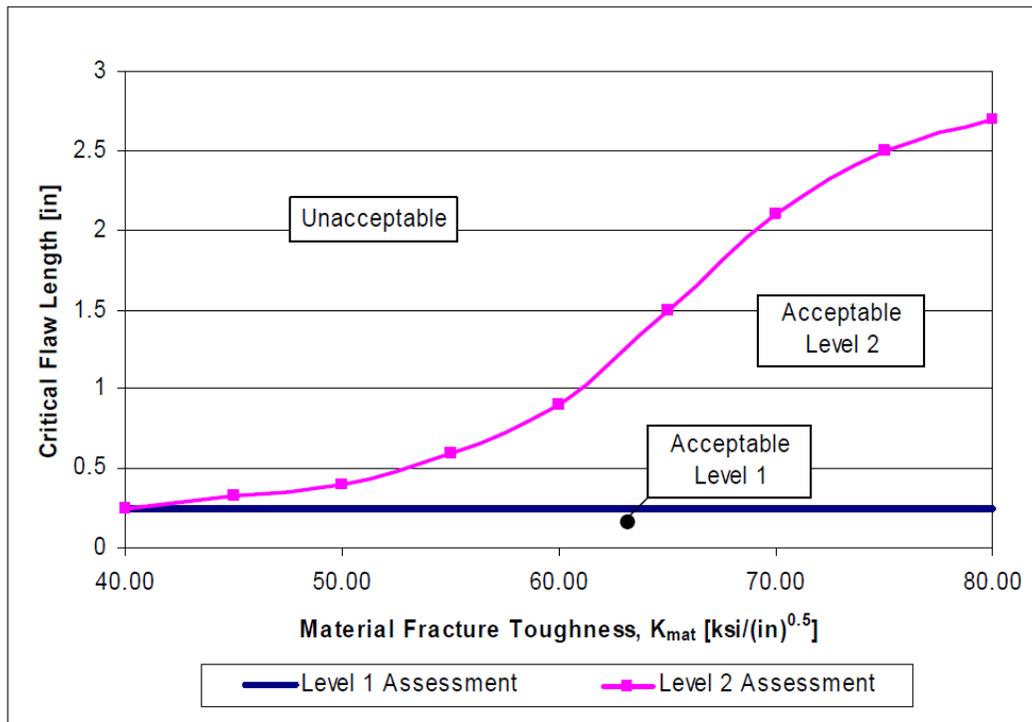
Figure 6.3 Flaw Length versus Material Toughness Relationship

The relationships between critical flaw length and material toughness developed by the Level 1 and Level 2 assessments conducted for the hypothetical pipeline are presented in Figure 6.3. It should be noted that in most cases a pipeline operator will not have performed the type of tests necessary to determine the fracture toughness, K_{Ic} , required to perform an assessment according to API 579. Rough correlations do exist between the CVN impact toughness upper shelf absorbed energy, which measures resistance to fracture propagation, and the static fracture initiation toughness, K_{Ic} . An understanding of the relationship between fracture initiation and

Figure 6.3 clearly shows that since the Level 1 assessment does not consider material fracture toughness, it results in a conservative evaluation of critical flaw length for all cases. However, if the material fracture toughness of material being evaluated can be determined, a Level 2 assessment will potentially reduce the level on conservatism in the analysis by a significant amount.
