Failure Investigation Report – Sunoco Pipeline L.P., Darby Creek Tank Leak

Principal Investigator Christian Sellu
Senior Accident Investigator Michael Yazemboski
Region Director Byron Coy
Date of Report 7/12/2013
Subject Failure Investigation Report – Sunoco Pipeline L.P.,
Darby Creek Tank Leak

Failure Investigation Report – Sunoco Pipeline L.P., Darby Creek Tank DC9 Leak

Failure Date 02/08/2011

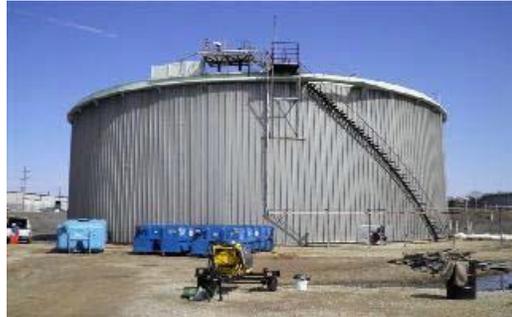
At 12:13 p.m. on February 8, 2011, crude oil was discovered in the dike area of Tank DC9 in the Sunoco Logistics (Sunoco) Darby Creek Tank Farm (DCTF). Tank DC9 is designated as a break-out tank and is regulated under Part 195 of the Code of Federal Regulations (CFR). The leak originated from a hole in the bottom of the tank resulting in a spill of approximately 38 barrels of crude oil within the tank dike area. The cause of the leak was due to corrosion located on the internal topside and underside of the tank floor. The Tank is located in a designated high consequence area (HCA) and an Unusually Sensitive Area (USA) per Sunoco's Integrity Management program (IMP). The tank area is approximately 500 feet from a local highway and 600 feet from a residential community. There were no injuries or fatalities, evacuations, or supply disruptions as a result of the incident. The tank will remain out-of-service until remediation efforts can be completed.
