# Pipeline Failure Investigation Report

**Pipeline System:** Houstonia 200 Line                      **Operator:** Panhandle Eastern Pipeline Company, LP  
**Location:** Mile Post 21.6                                      **Date of Occurrence:** 8/25/2008  
**Medium Released:** Natural gas                              **Quantity:** 13,518,578 CF

# Metallurgical Analysis of 24-Inch Houstonia 200 Service Failure at MP 21.6 (8/25/08)

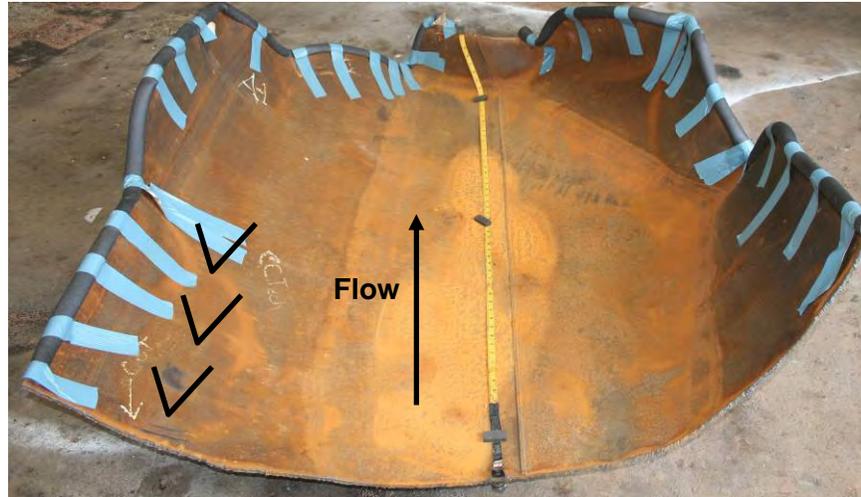
Figure 1 is a photograph of the internal surface of Pipe Segment A1 in the as-received condition. The pipe segment was approximately 6.5 feet in length and was the D/S mating

Figure 1. Photograph of Pipe Segment A1 (internal surface) in the as-received condition.

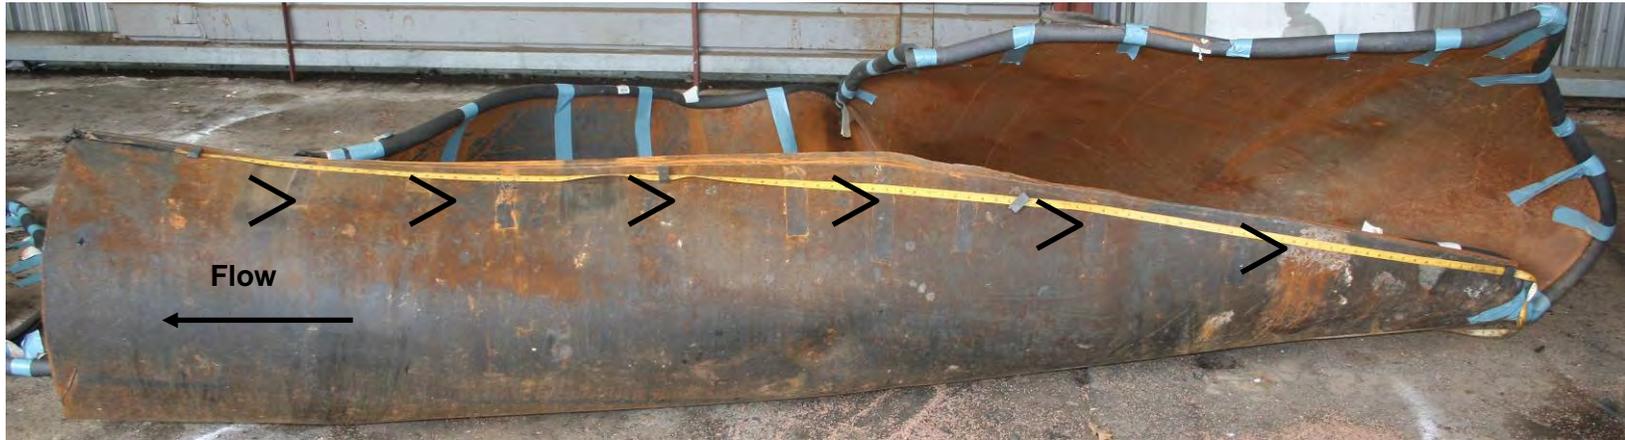
Figure 2 is a photograph of the external and internal surfaces of Pipe Segment B1 in the as-received condition. Pipe Segment B1 was approximately 11 feet in length from the joint that ruptured, and contained the D/S portion of rupture arrest. Again, the orientation of the chevron markings on the rupture surfaces indicated that the failure origin was U/S of this segment.

Figure 2. Photograph of Pipe Segment B1 in the as-received condition.

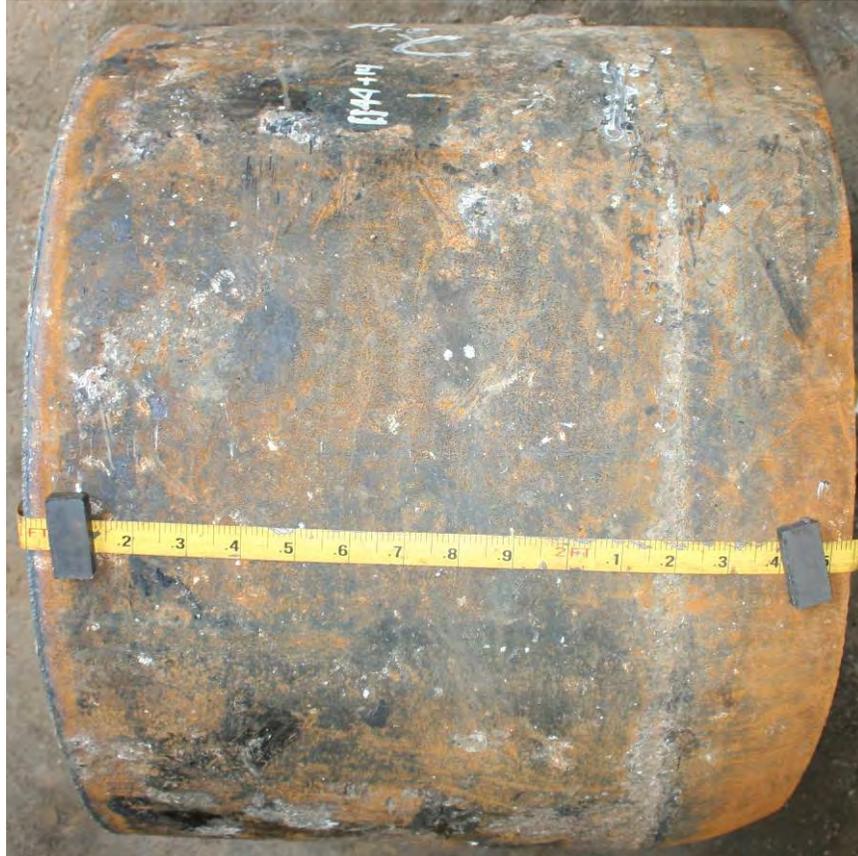
Figure 3 is a photograph of the external surface of Pipe Segment C in the as-received condition. The pipe segment was approximately 1.5 feet in length, was from the joint D/S of the joint that ruptured, and was intact. The diameter of the pipe segment was 23.9 inches, which is consistent with a nominal diameter of 24 inches.

Figure 3. Photograph of Pipe Segment C in the as-received condition.

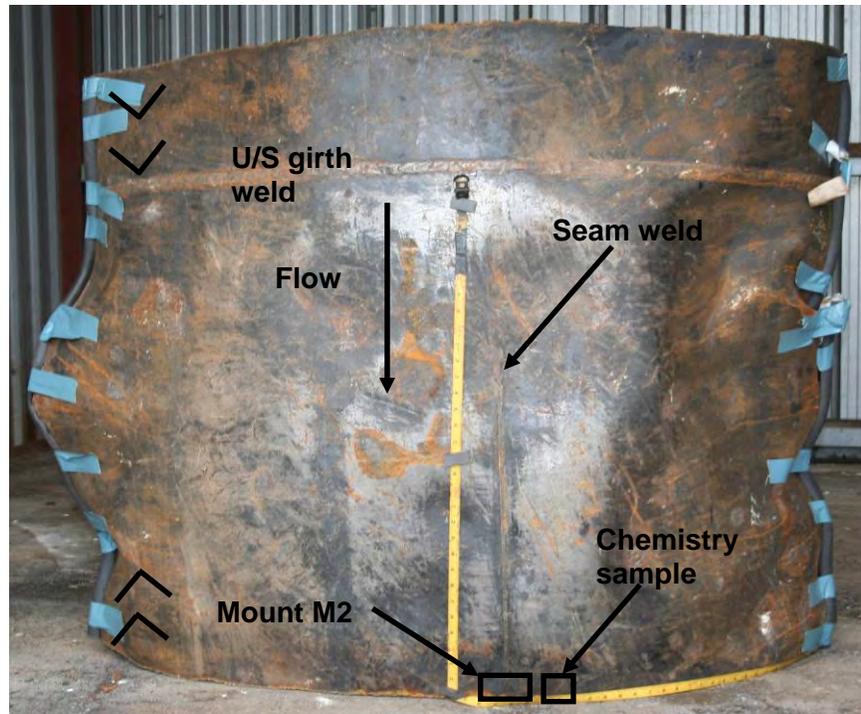
Figure 4 is a photograph of Pipe Segment A2 in the as-received condition. The pipe segment was approximately 4.2 feet in length and U/S of Pipe Segment A1. Chevron markings that were located on the fracture surfaces pointed to a rupture origin in the segment. Figure 5 and Figure 6 are photographs of the external pipe surface on the clockwise and counter-clockwise side of the rupture path, respectively. Corrosion wall loss is located on the external pipe surface on adjacent surfaces. The corroded region extended 0.5 feet to 1.79 feet from the U/S girth weld and the fracture surface within the region was at a 45° angle, indicating a shear type of failure. Outside of the region, the fracture surface contained chevron marks and was predominantly perpendicular to the pipe surface.

Figure 4. Photograph of Pipe Segment A2 (external surface) in the as-received condition.

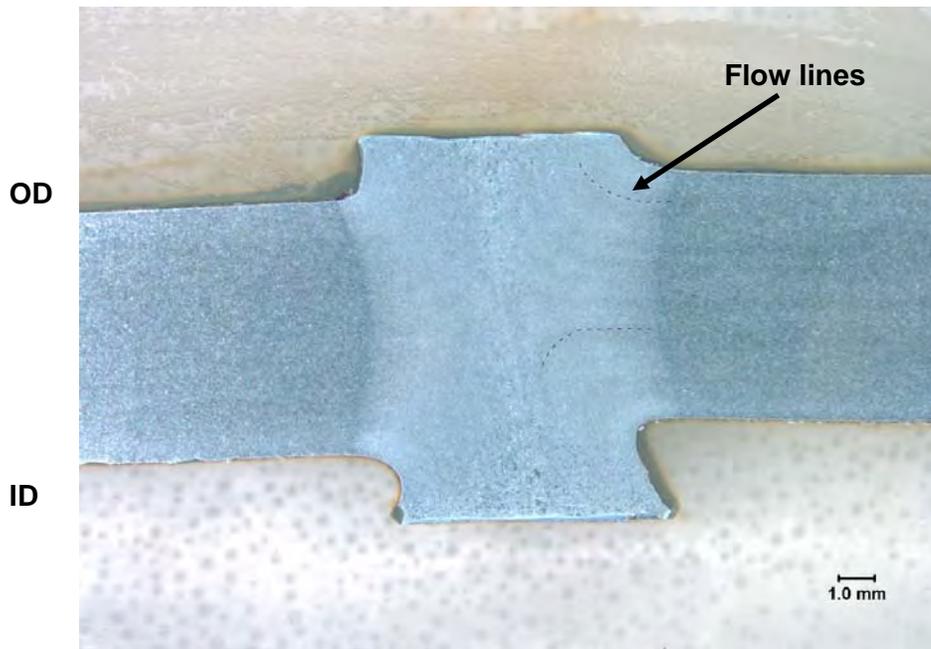
Figure 11 is a stereo light photomicrograph of the mounted cross-section that was removed from the seam weld. The morphology of the weld is consistent with an EFW seam.

Figure 11. Stereo light photomicrograph of the seam weld cross-section (Mount M2, 4% Nital Etchant).

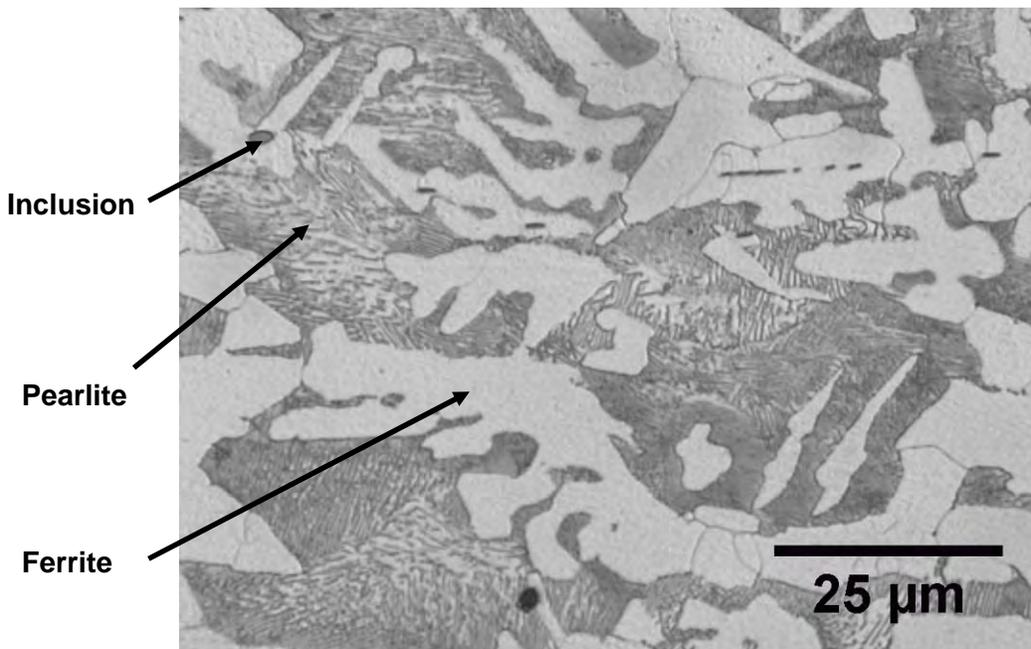
Figure 12 is a light photomicrograph of the typical microstructure of the base metal from Mount M2. The microstructure consists of ferrite (white areas), pearlite (dark areas consisting of lamellae), and inclusions. This microstructure is typical for this vintage and grade of line pipe steel.

Figure 12. Light photomicrograph of the typical base metal microstructure from Mount M2 (4% Nital Etchant).

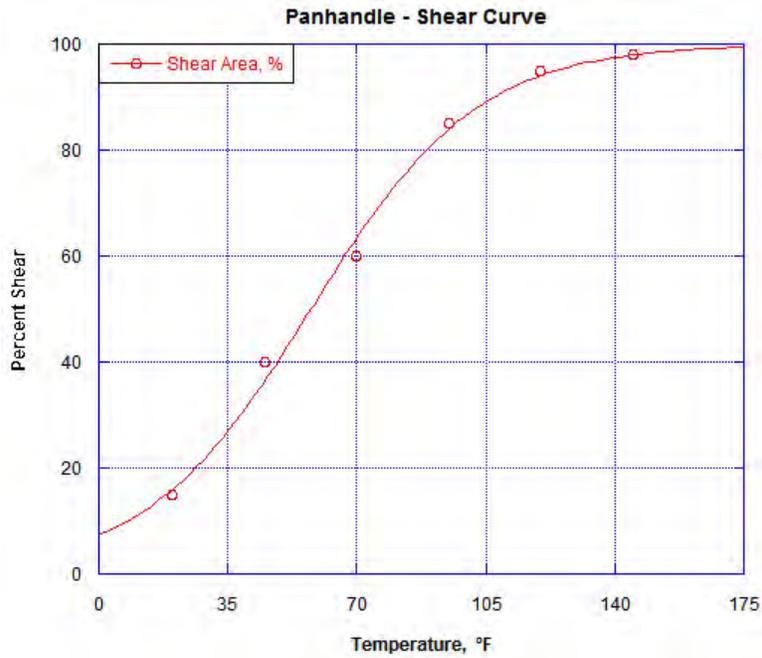
Table 5 summarizes the results of the Charpy testing while Figure 14 and Figure 15 show the Charpy percent shear and impact energy curves, respectively. An analysis of the data indicates that the 85% FATT is 96.8°F and the upper shelf Charpy energy is 38.8-ft·lbs, full size. The CVN test results can be adjusted to account for material constraint effects by applying temperature shifts to the data.\* The modified transition temperatures (brittle-to-ductile fracture initiation temperature) for the pipe segment were estimated as 90.4°F, based on a pipe wall thickness of 0.281 inches; see Table 6. Based on this analysis, the tested material is expected to exhibit ductile fracture propagation behavior above 90.4°F.

Figure 14. Plot of percent shear from Charpy V-notch tests as a function of temperature for samples removed from Pipe Segment C.

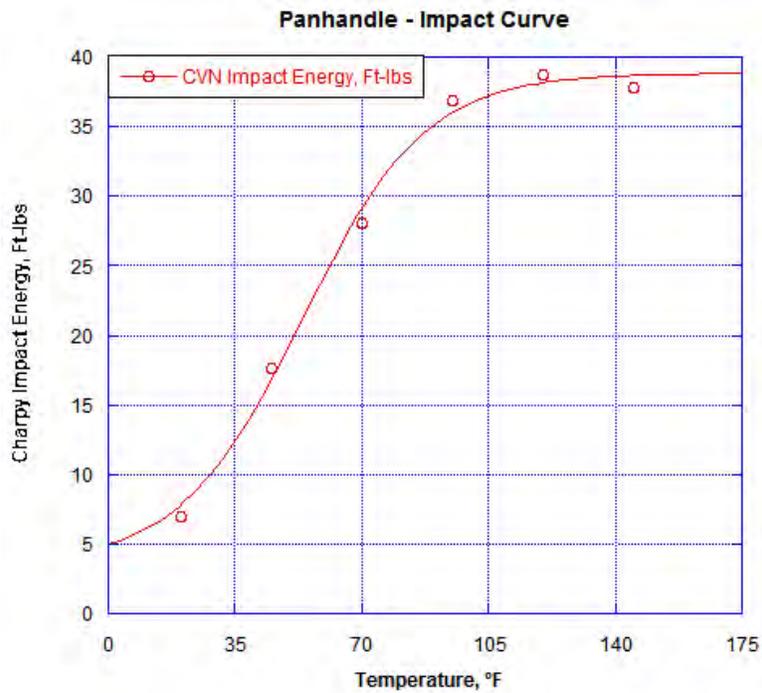
Figure 15. Plot of Charpy V-notch impact energy as a function of temperature for samples removed from Pipe Segment C.
