Principal Investigator Michael Yazemboski
Senior Accident Investigator Michael Yazemboski
Region Director Byron E. Coy
Date of Report 2/24/2016
Subject Failure Investigation Report—Enterprise Products Operating, LLC:
ATEX Ethane Pipeline Failure, Follansbee, West Virginia

Failure Investigation Report—Enterprise Products Operating, LLC
ATEX Ethane Pipeline Failure
Follansbee, Brook County, West Virginia
[Failure Date 1/26/2015]

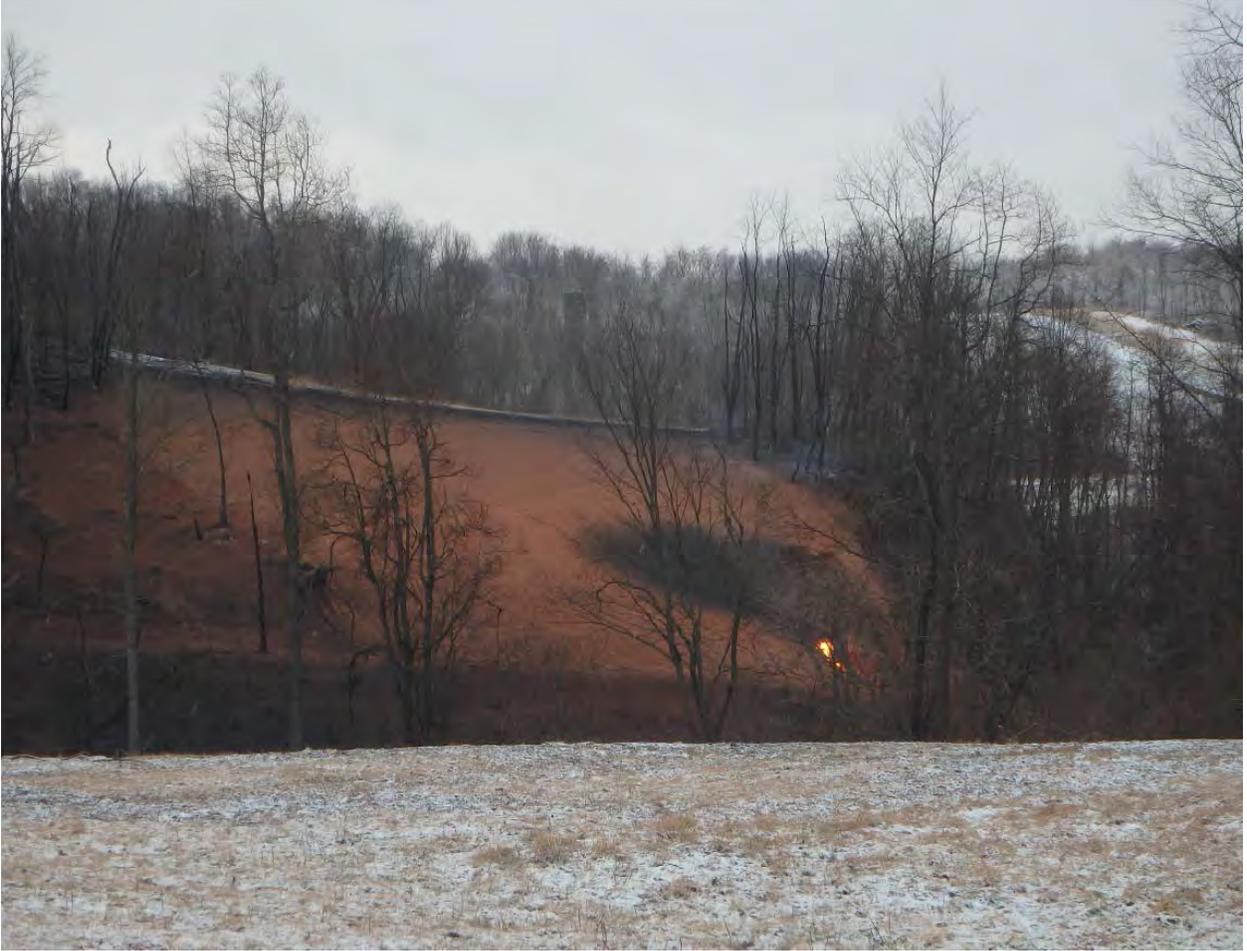
Photo 1 : (Jan 26, 2015)

8. The explosion and fire that resulted from the pipeline rupture burned approximately 5 acres of woodlands. However, there was no impact to waterways due to the rapid vaporization of the liquid ethane, and the area is not considered an HCA.

The explosion and fire that resulted from the pipeline rupture burned approximately 5 acres of woodlands. There was no impact to waterways due to the rapid vaporization of the liquid ethane.
