**Principal Investigator** Molly Atkins  
**Region Director** R.M. Seeley  
**Date of Report** 6/10/2016  
**Subject** Failure Investigation Report – Texas Gas Transmission, LLC, Gas Pipeline Rupture in Farmerville, LA

## **Failure Investigation Report – Texas Gas Transmission, LLC**

September 9, 2015 | Farmerville, LA

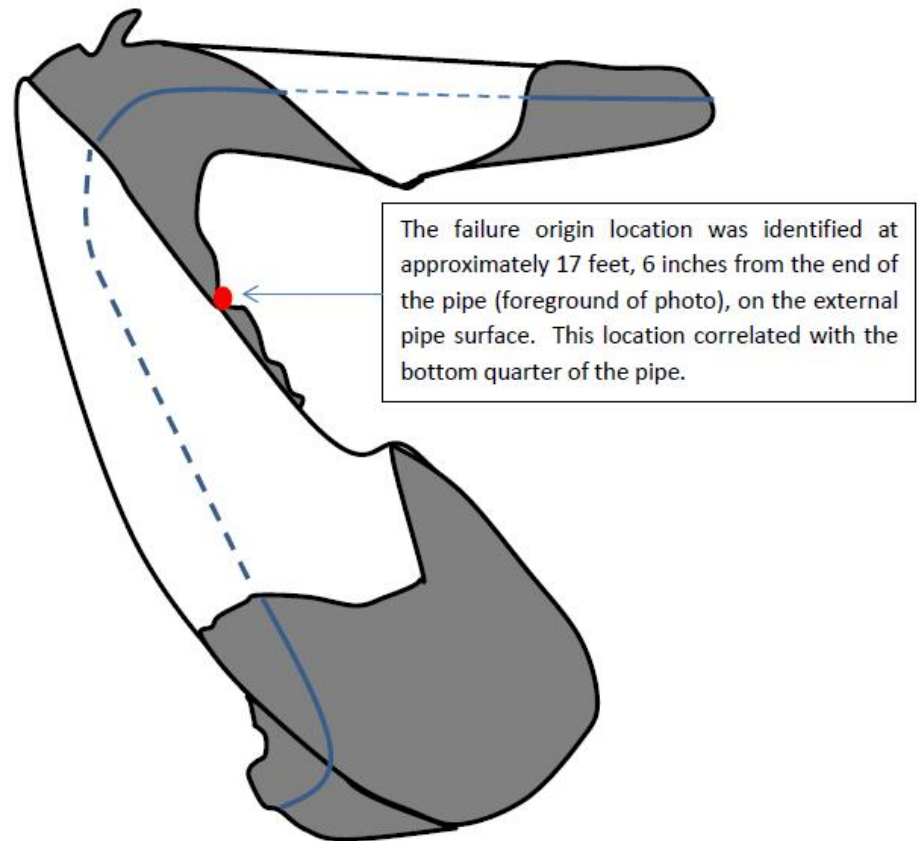
The origin of failure was identified on the bottom quarter of the segment of pipe that was ejected from the ditch, as depicted in a diagram sketched by PHMSA and shown in Figure 3:

Based on field observations, the SES and PHMSA stated that the preliminary determination of the cause of failure was localized environmental cracking in combination with external corrosion. The failure originated on the bottom of the pipe where it rested on a rock ledge outcrop in the otherwise relatively homogenous clay-like material of the ditch. The photos in Figure 4 show this outcropping, which is the dark grey, rocky material surrounded by orange clay soil. A more detailed description of the soil conditions can be found in the metallurgical failure analysis report in Appendix D.
