# NATIONAL TRANSPORTATION SAFETY BOARD

MATERIALS LABORATORY FACTUAL REPORT

Place	: Amherst, South Dakota
Date	: November 16, 2017
Vehicle	: TransCanada Keystone pipeline
NTSB No.	: PLD18LR001
Investigator	: Kalu Kelly Emeaba, RPH-20

Section of pipeline and piece of concrete set-on pipeline weight.

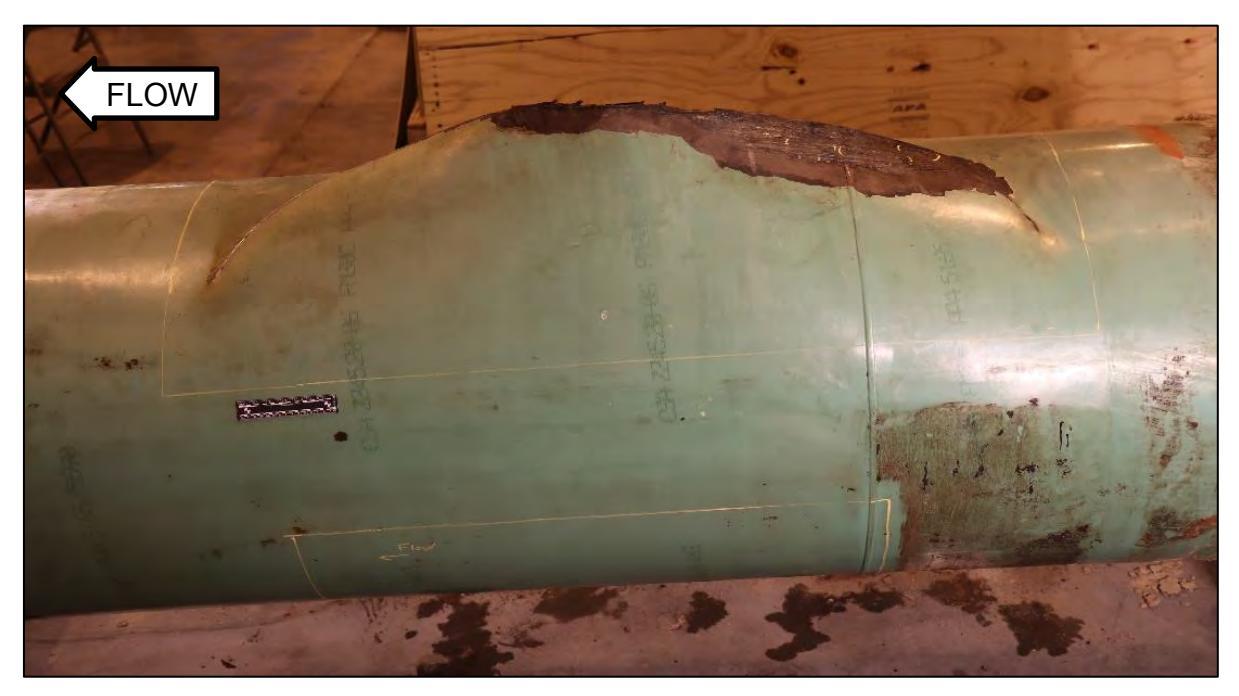
Figure 12. View of the left side of the pipe after cleaning and before sectioning.

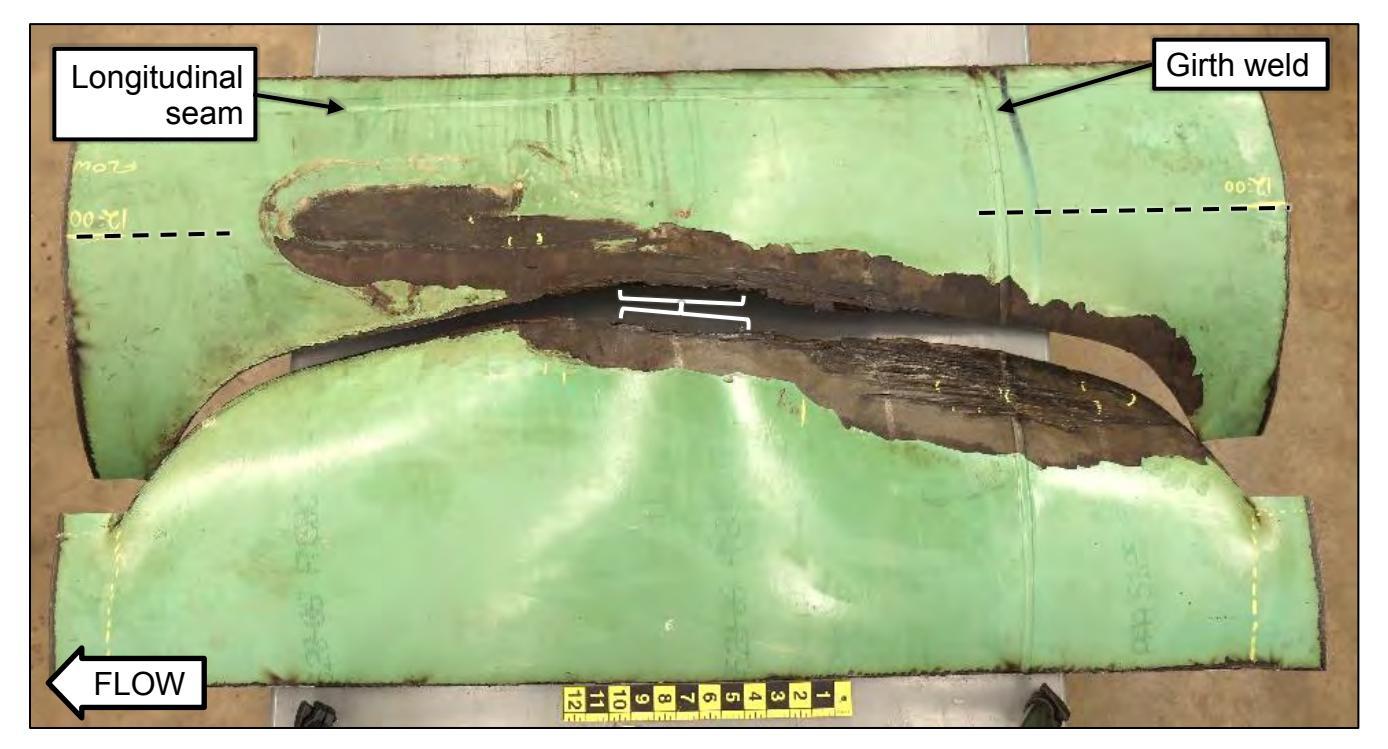
Figure 13. Overall view of the exterior surface after sectioning with the two sides of the fracture placed in close proximity. Dashed lines indicate the 12 o'clock position, and unlabeled brackets indicate the fatigue crack region.

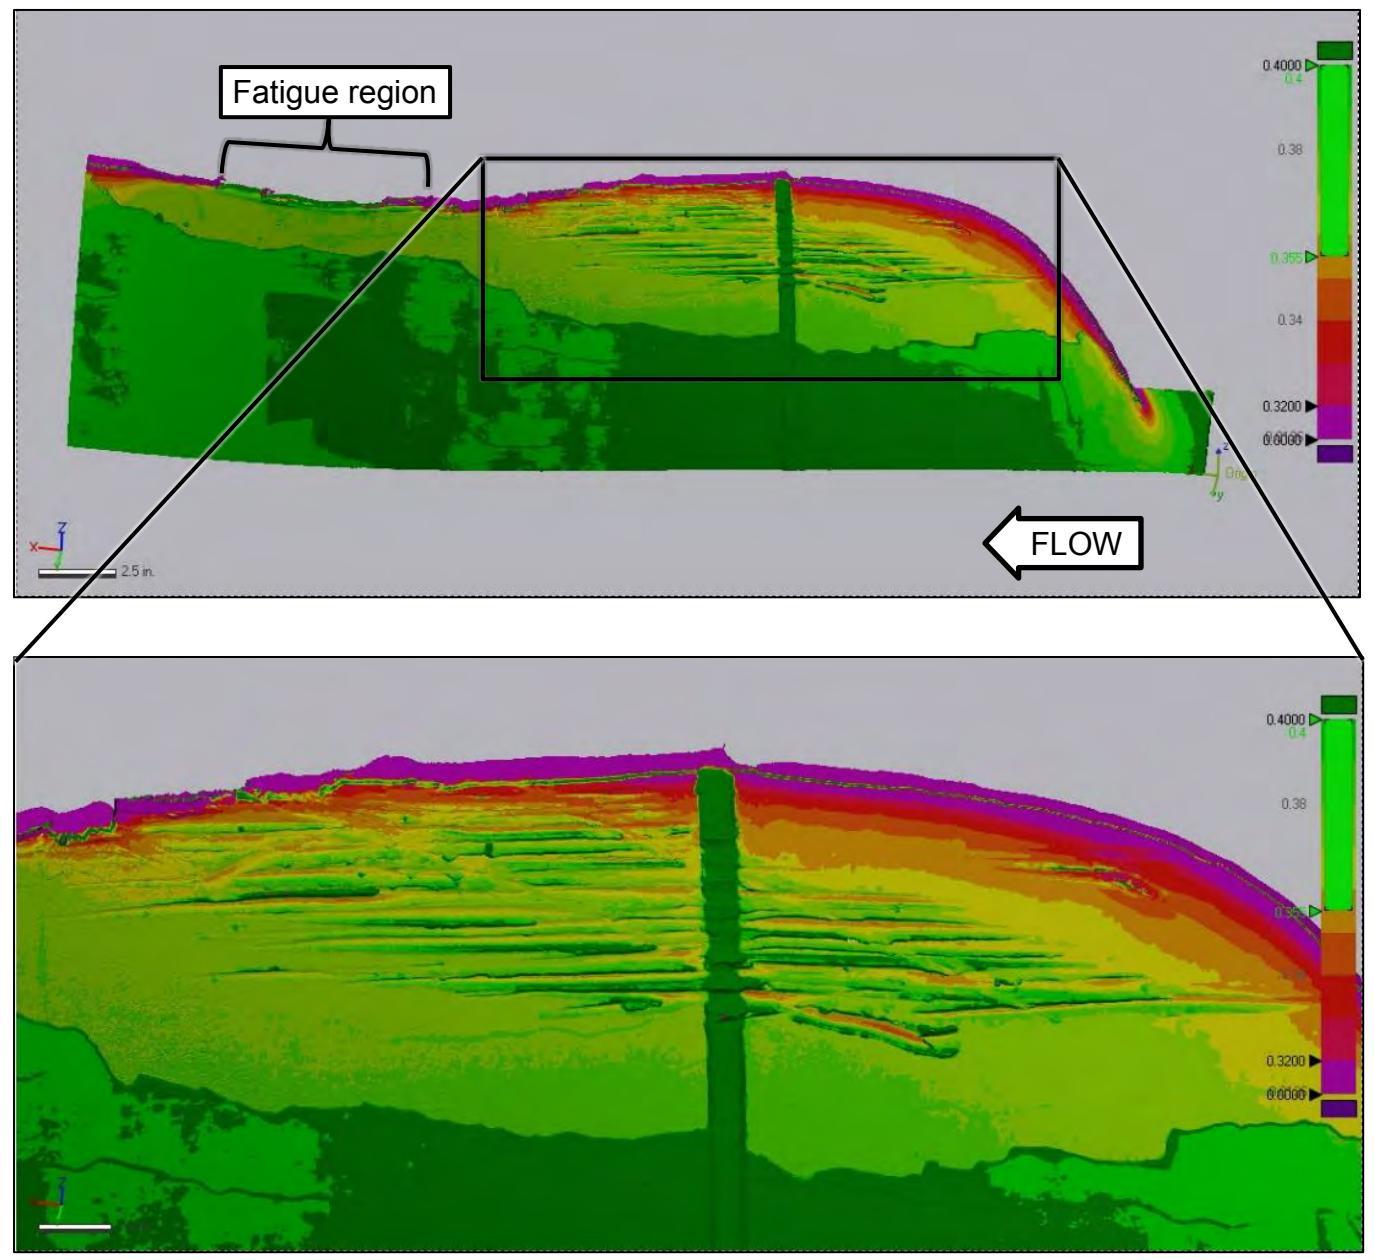
Figure 16. Thickness contour maps generated from a 3-dimensional laser scan of the pipe piece with the left side of the fracture.

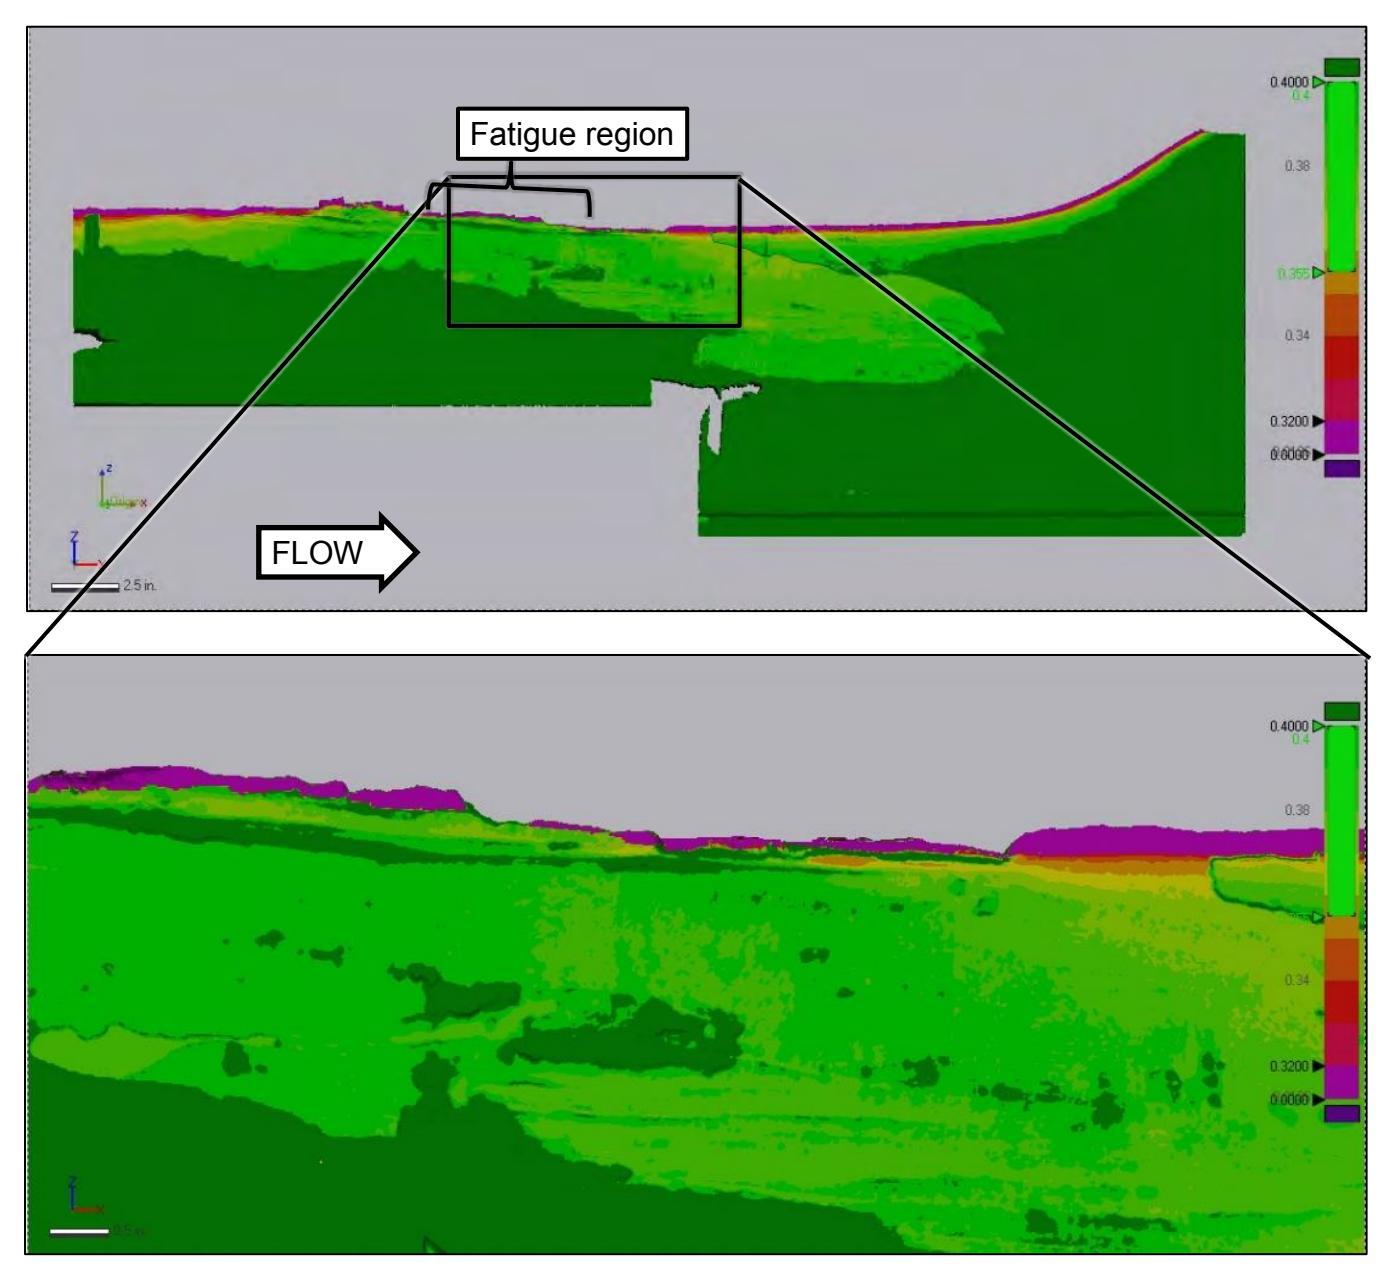
Figure 17. Thickness contour maps generated from a 3-dimensional laser scan of the pipe piece with the right side of the fracture.

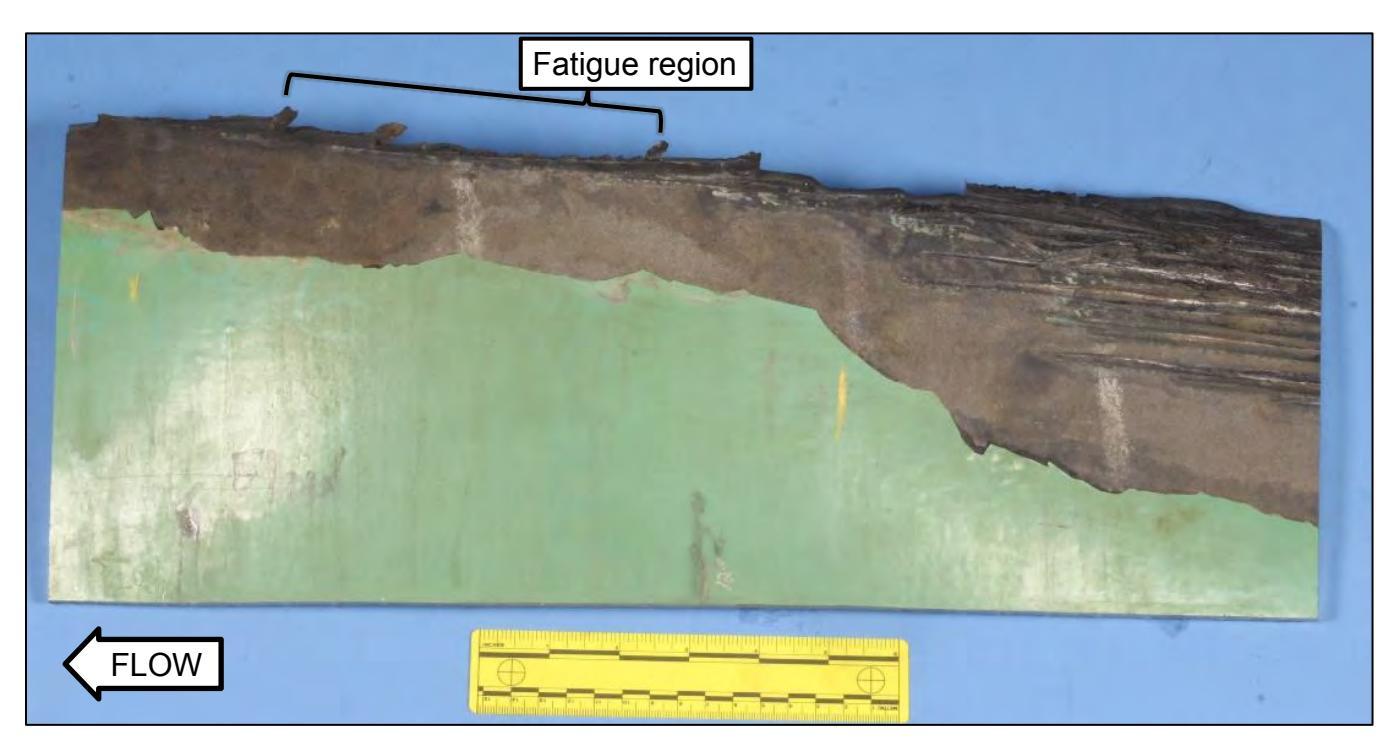
Figure 18. Piece with a portion of the left side of the fracture including the fatigue region and a portion of the sliding contact marks. The piece was cleaned using a soft-bristle brush and a solution of Alconox and water followed by an ethanol rinse.

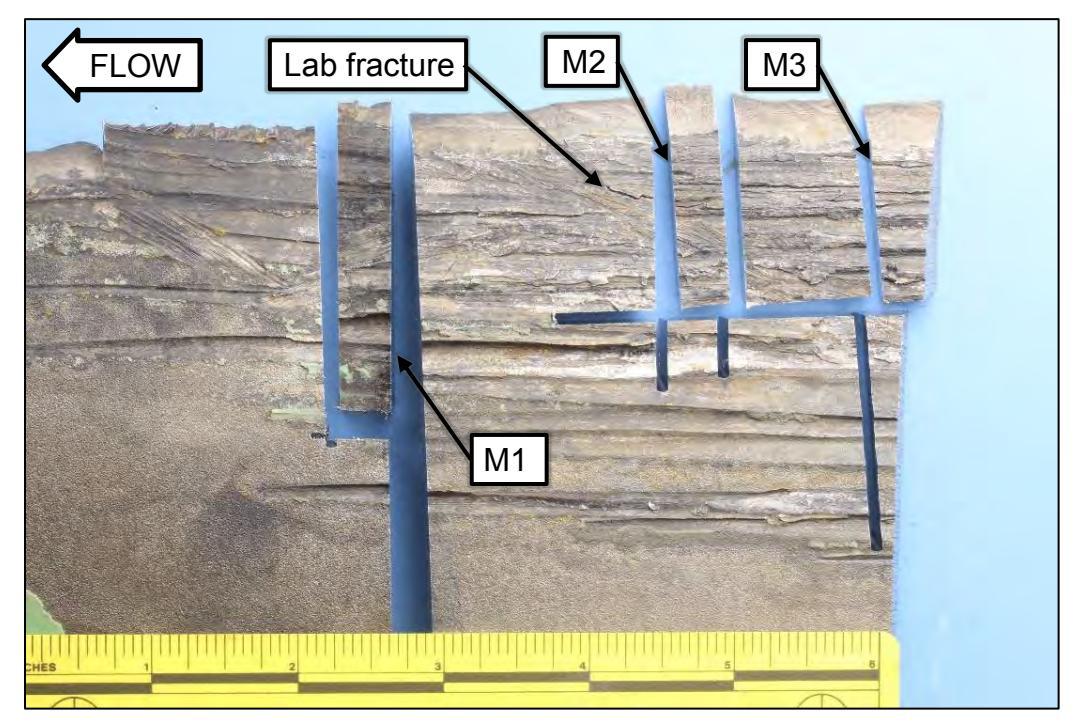
Figure 28. Area of sliding contact marks adjacent to the left fracture that was sectioned for metallographic examination of mounts M1, M2, and M3, for a lab fracture, and for SEM/EDS examination of the exterior surface.

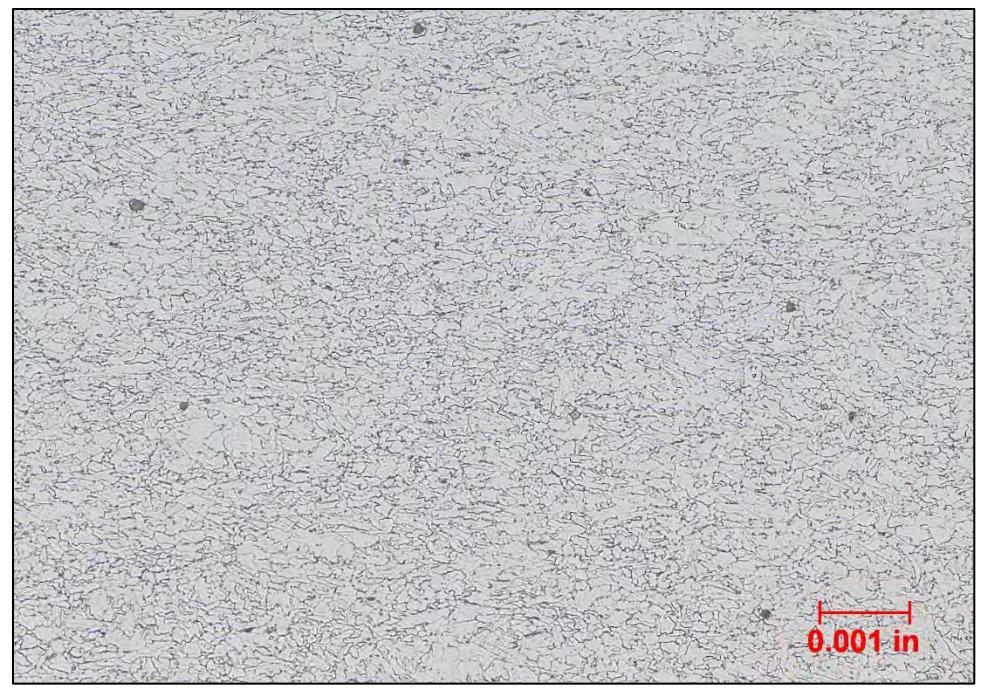
Figure 29. Typical microstructure of the pipe material (etched with 4% nital).

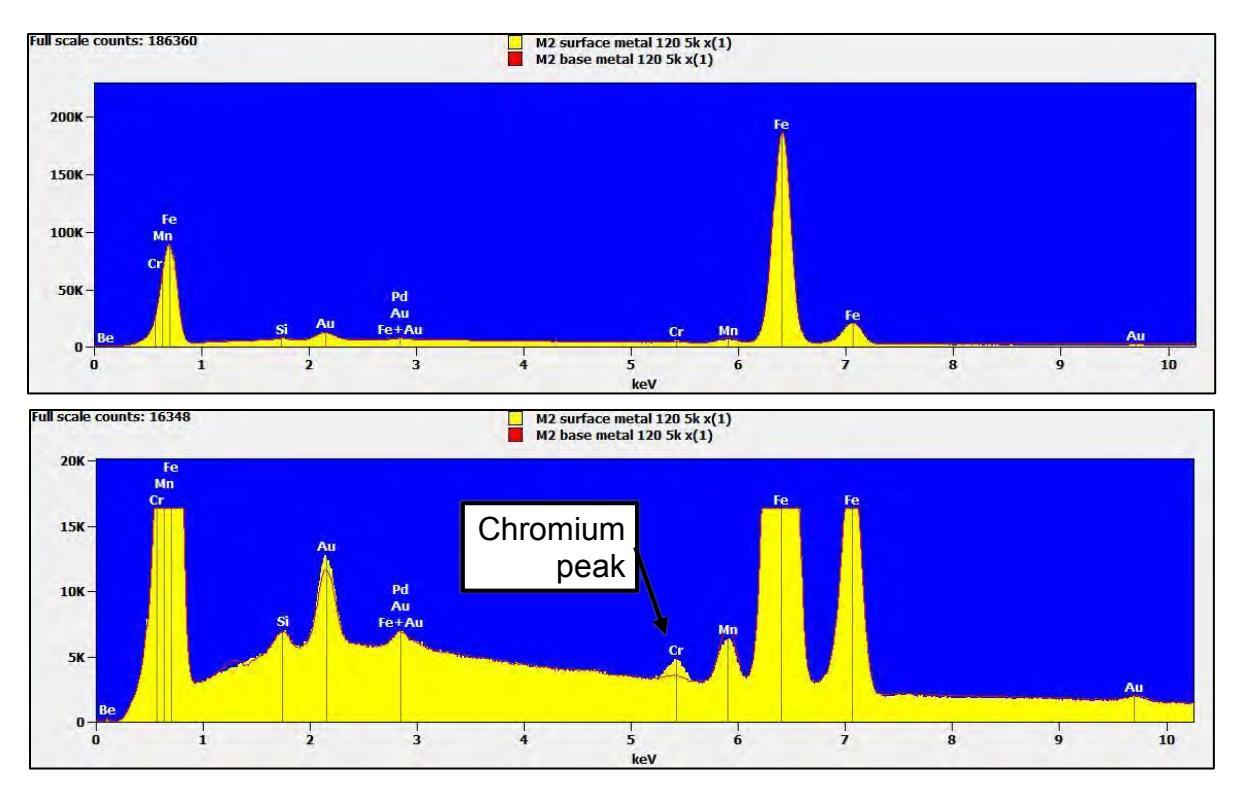
Figure 31. EDS spectrum of the surface material (yellow areas) compared to the spectrum for the underlying pipe material (red outline) in mount M2 after coating with a thin layer of gold/palladium. The upper image shows the spectrum at full scale, and the lower image shows the same data with the scale of the vertical axis reduced to highlight smaller peaks.

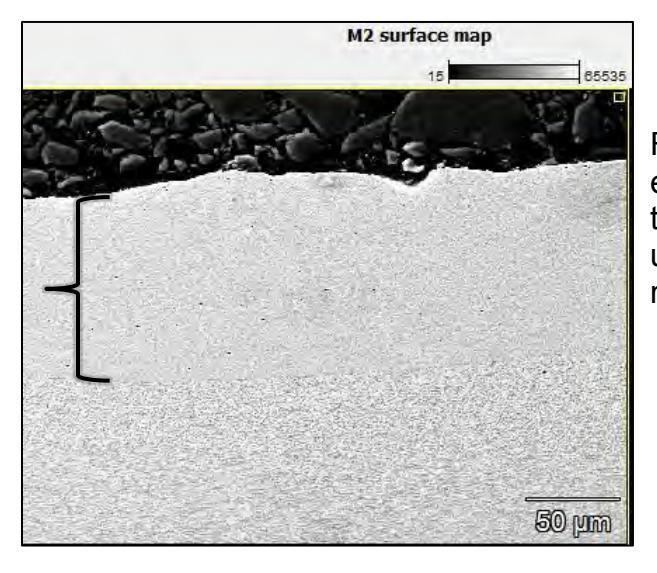
Figure 32. SEM image using the backscattered electron detector showing the area of mount M2 that was scanned using EDS mapping. An unlabeled bracket indicates the layer of deposited metal.

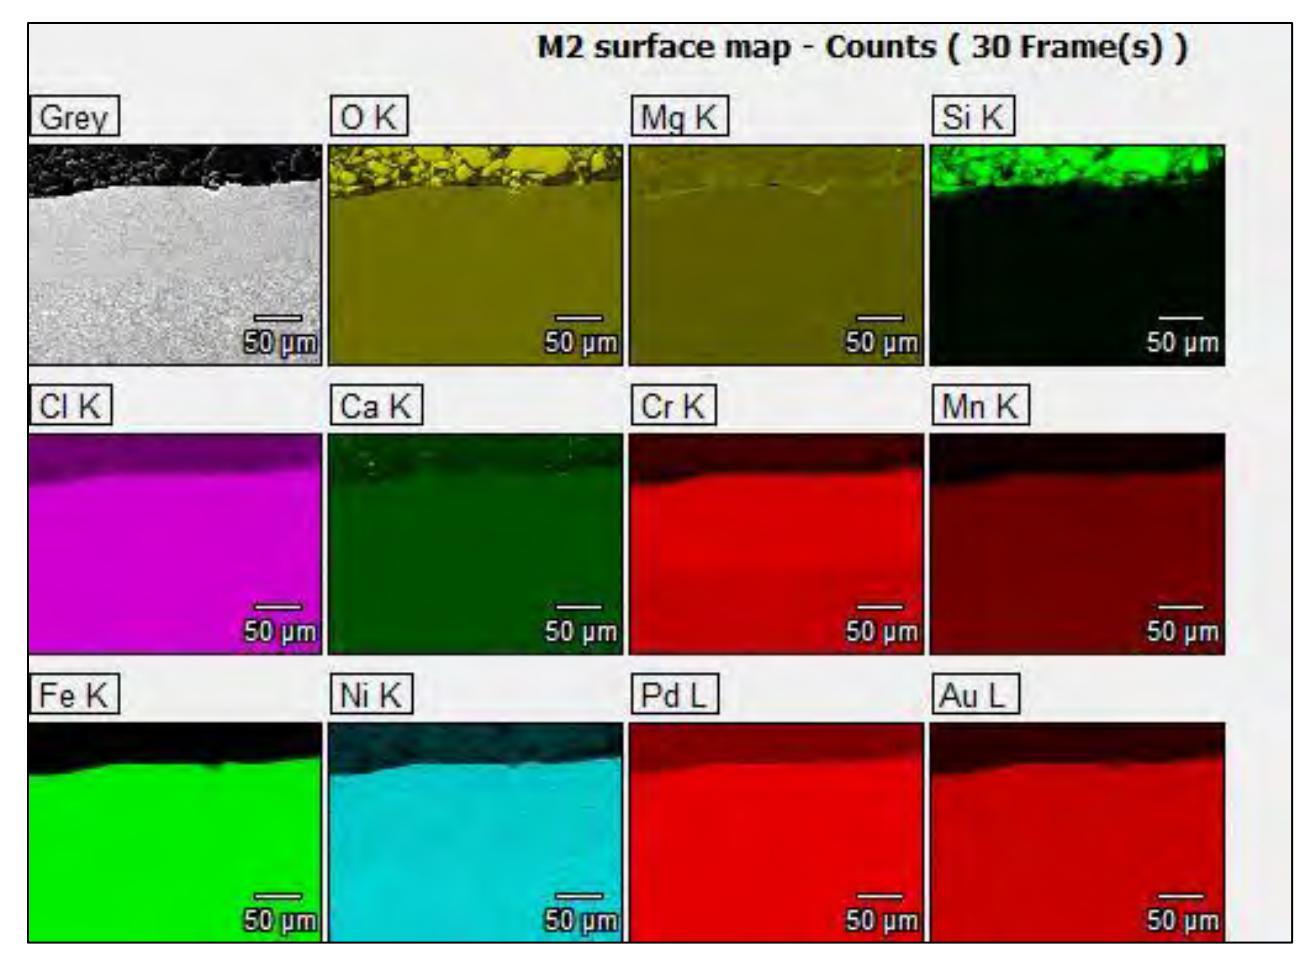
Figure 33. EDS maps of elements detected in the area shown in figure 32. See figure 34 for closer views of the maps for chromium and manganese. The specimen was coated with a thin layer of a gold/palladium alloy for SEM examination.

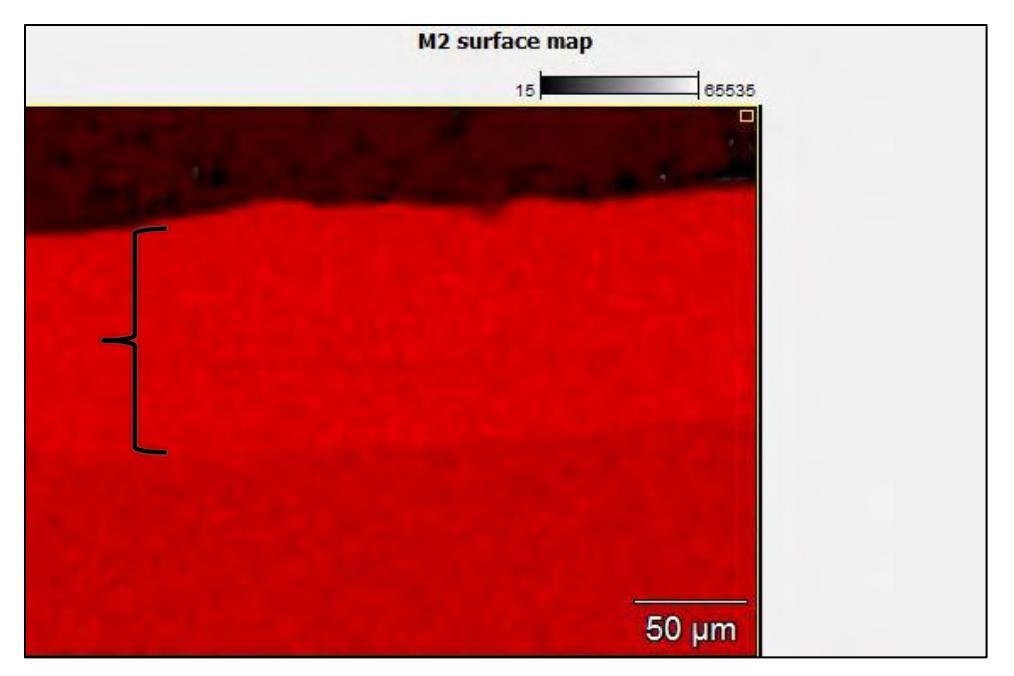
Figure 34. EDS map for chromium in the area shown in figure 32. An unlabeled bracket indicates the surface deposit where higher levels of chromium were detected as evident by higher brightness.

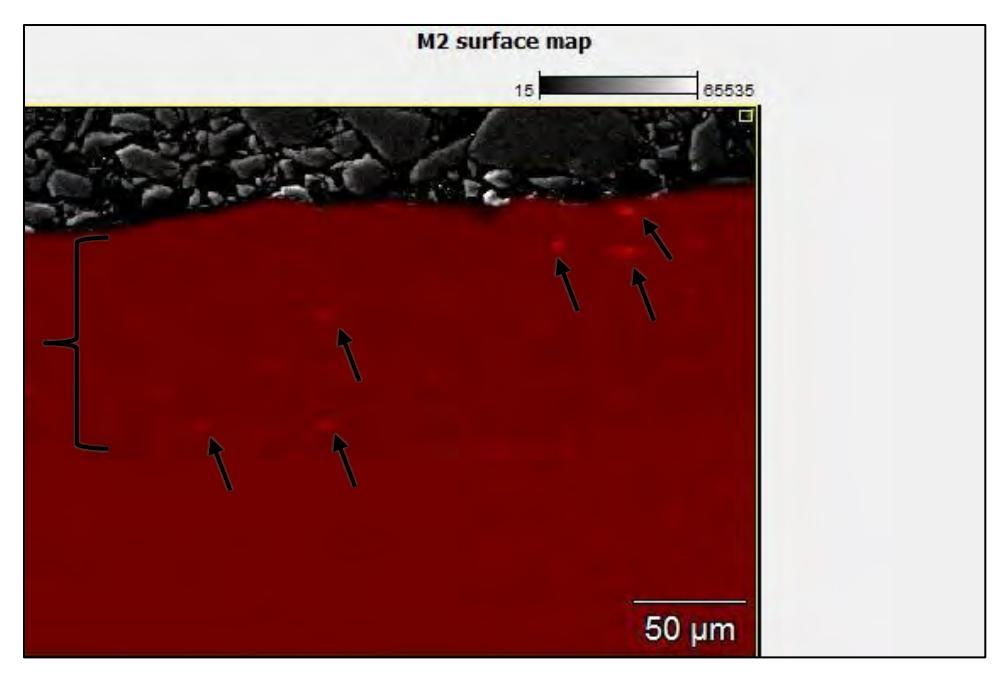
Figure 35. EDS map for manganese in the area shown in figure 32. An unlabeled bracket indicates the surface deposit which generally appeared slightly darker than the underlying pipe material. Bright spots (indicated with arrows) consistent with concentrations of manganese (likely manganese sulfide precipitates) were present in the surface deposit but not in the underlying pipe material.

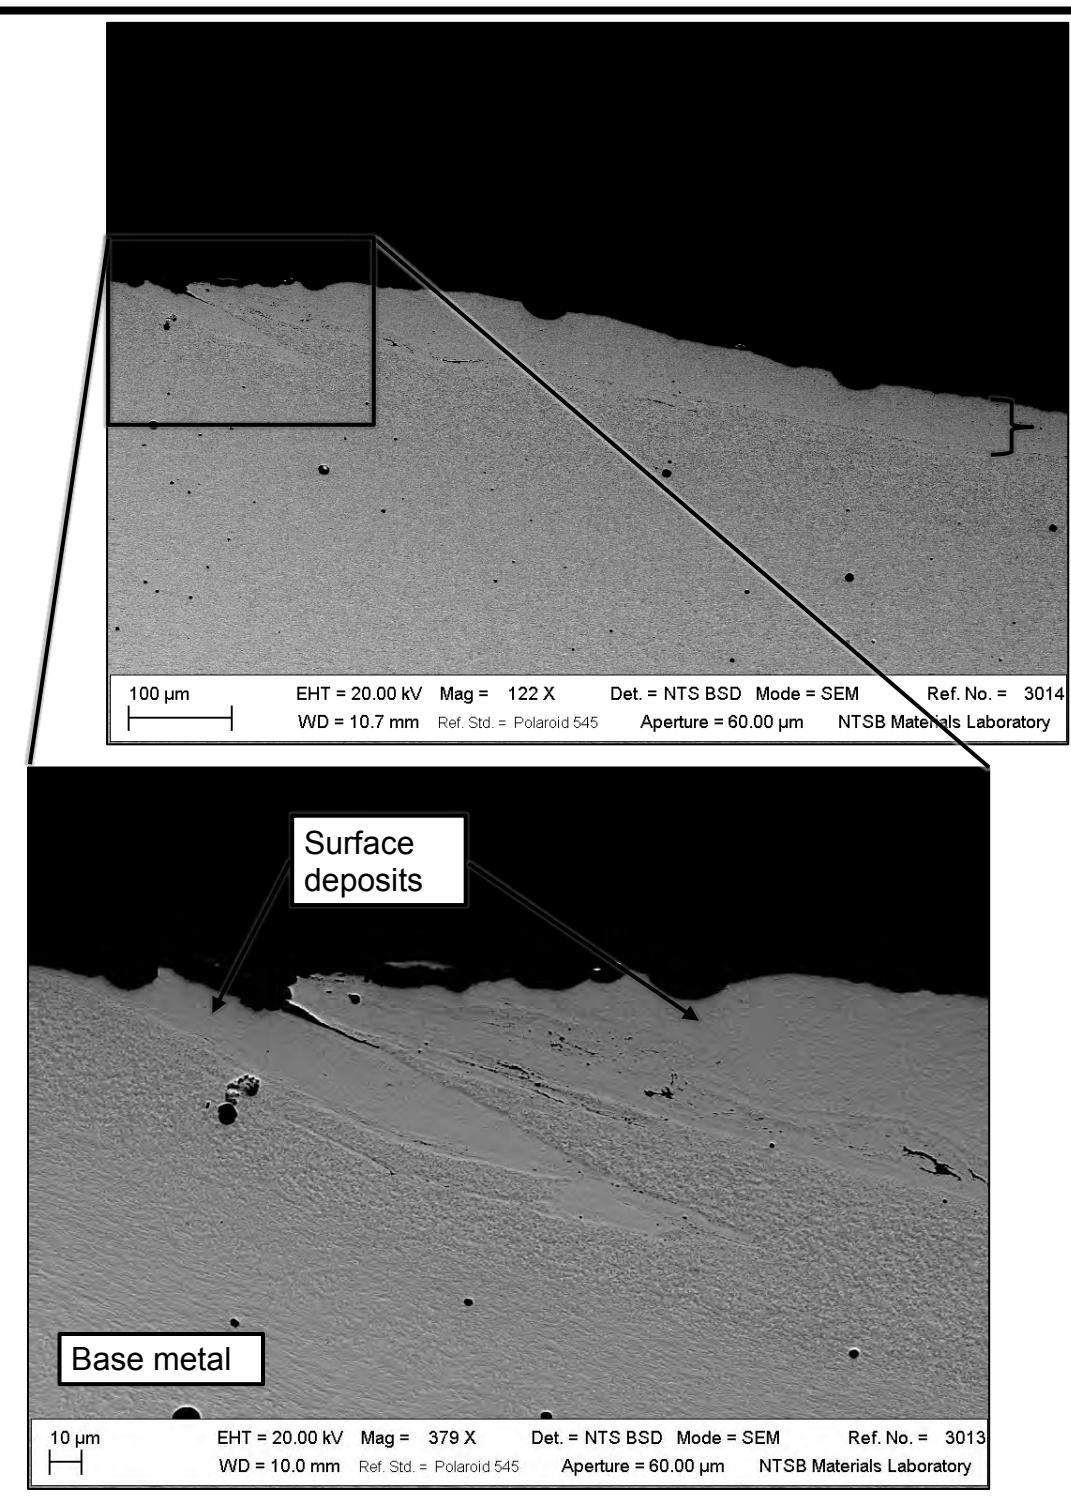
Next, the polished and etched mount M1 was coated with a gold/palladium alloy for SEM and EDS analysis. SEM images using the backscattered electron detector of steel surface layers on the surface of M1 in the area of sliding contact are shown in figure 37. A bracket in the upper image indicates the thickness of the surface layer that appeared relatively smoother and brighter compared to the pipe material. A higher magnification view of the surface is shown in the lower image in figure 37, where overlapping layers of the surface deposit were observed. An EDS spectrum of the surface layer showing a small peak of chromium and a corresponding spectrum of the pipe material below the surface layer where the chromium peak was absent are shown in figure 38.

Figure 37. SEM image of mount M1 using the backscattered electron detector showing the microstructure near the surface in the sliding contact area. An unlabeled bracket in the upper image indicates a surface layer with higher chromium relative to the base metal and appearing smoother and slightly lighter gray. In some areas, overlapping layers of deposits were present such as in the location shown in the lower image. (Etched with 4% nital.)

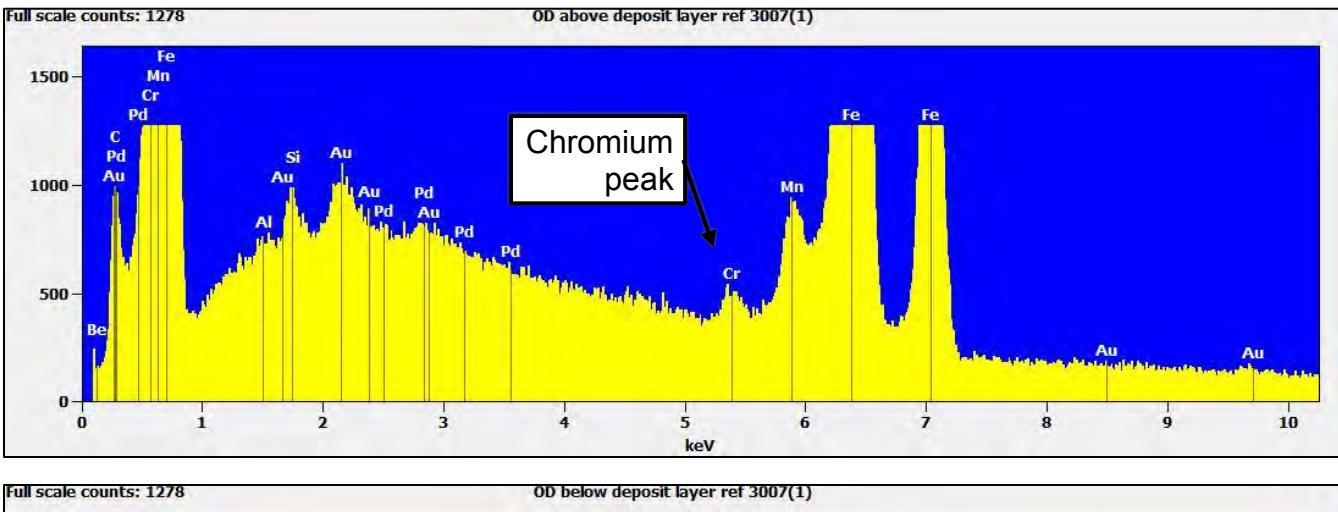
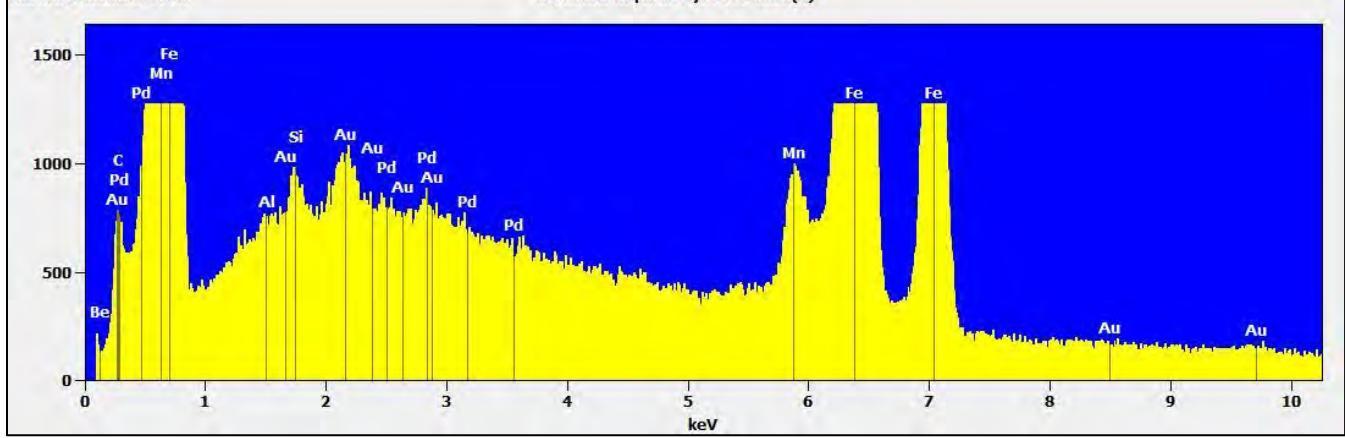
Figure 38. EDS results on sample M1 (coated with gold and palladium to avoid charging issues from the nonconductive mount) showing a distinct chromium (Cr) peak for the surface deposit (upper spectrum) versus the adjacent base material (lower spectrum).

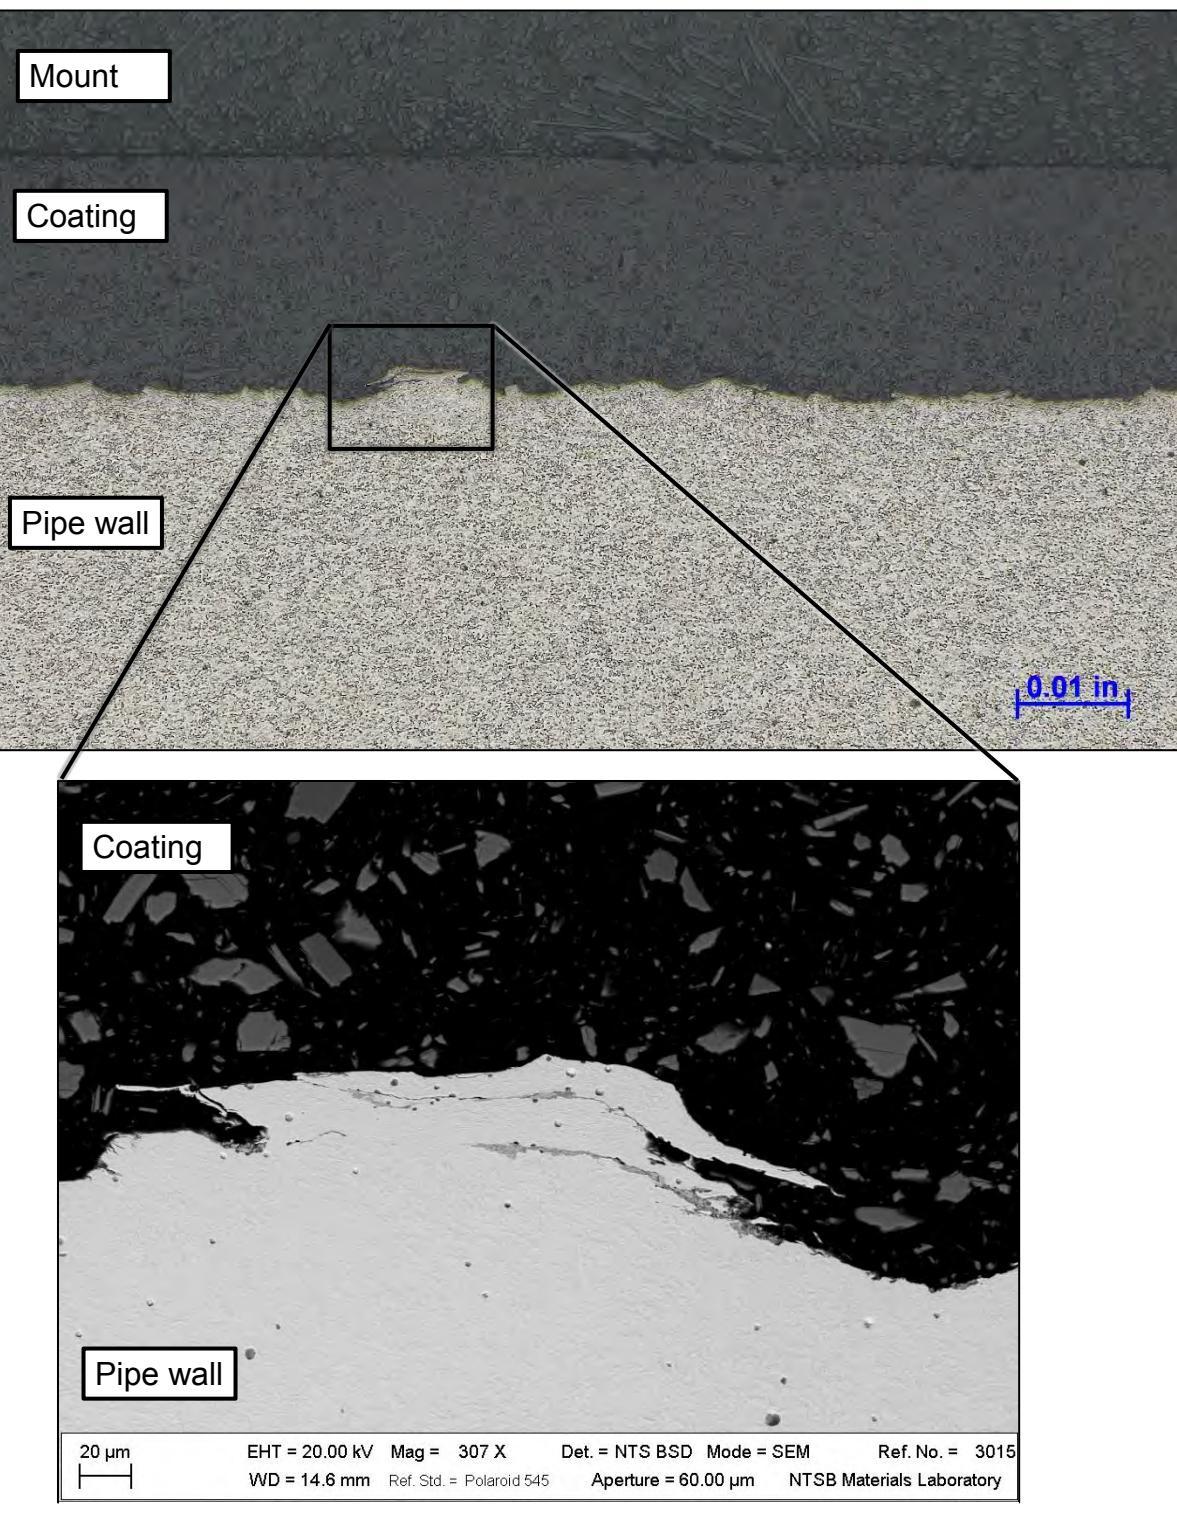
An optical metallograph image of the exterior surface of the mounted sample from an area with intact coating is shown in figure 39. The exterior surface was rough with no evidence of a deposited surface layer between the coating and the pipe surface. The mounted sample was coated with gold/palladium and examined with an SEM, and no evidence of a layer with a chromium peak was detected.

Figure 39. Metallographic cross-sections of a sample from an area where the coating was intact. The exterior surface of the pipe was imaged using the metallograph (upper image) and in the SEM using the backscattered electron detector (lower image). No layer of higher chromium was present. (Etched with 4% nital.)

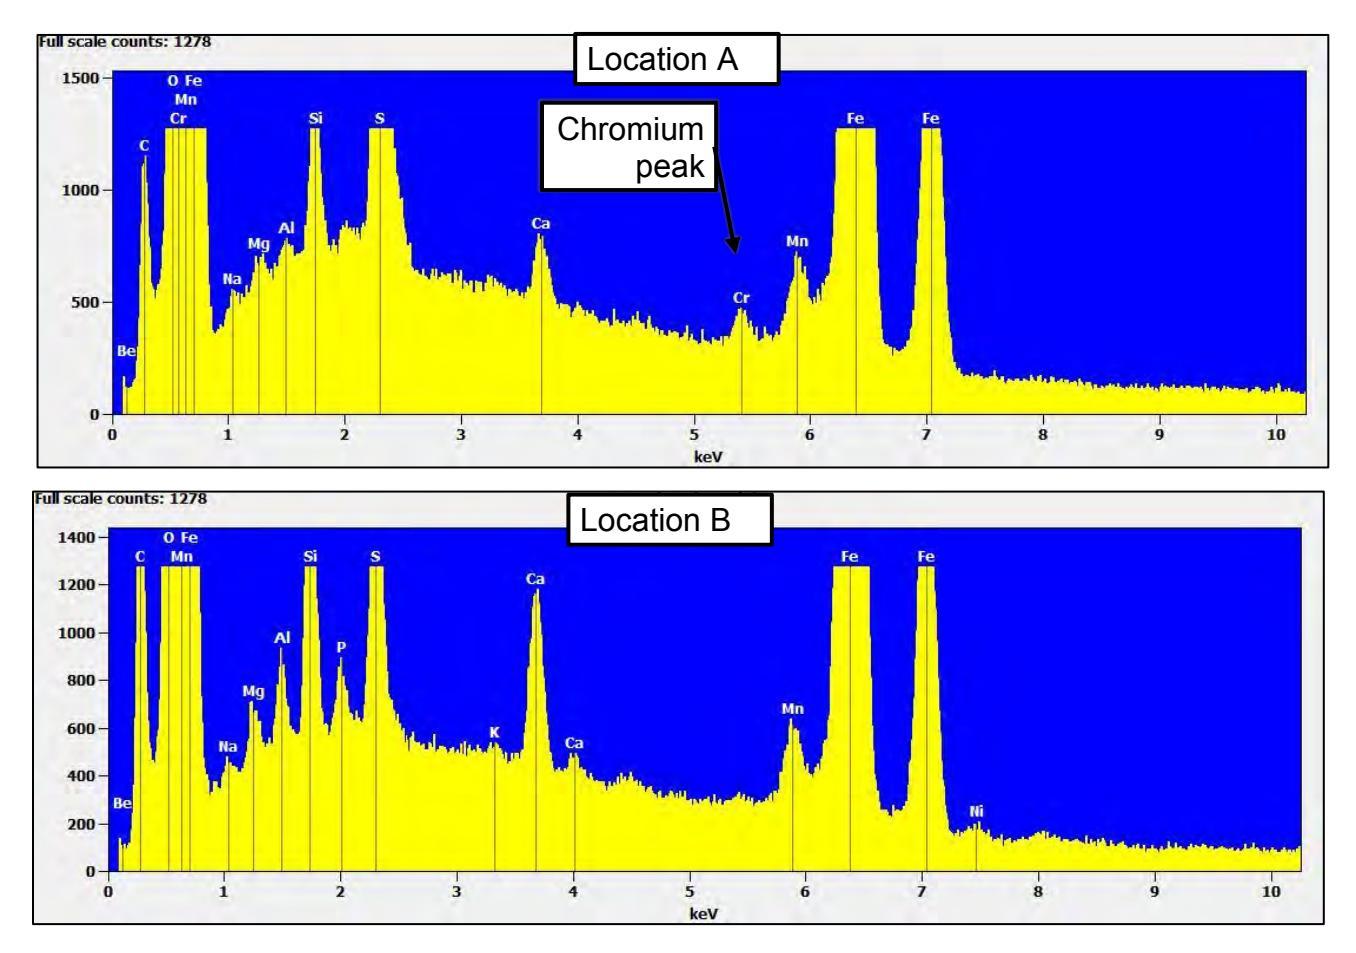
Areas of the exterior surface on the largest piece shown in figure 28 were also examined using the SEM and EDS. As the surface was examined, a difference in the EDS spectra was noted in areas within the sliding contact grooves versus undisturbed areas between the grooves. The examined area of sliding contact damage is shown in figure 41 before samples were taken for metallographic examination. Areas with relatively light gray and more reflective surfaces in the sliding contact marks are shown circled. In figure 42, a typical spectrum from an area with the lighter gray appearance (location A in figure 41) is shown. The EDS spectra in these areas contained a distinct peak of chromium consistent with the deposited steel layer observed in the metallographic mounts. By comparison, the chromium peak was largely absent from the surfaces between the sliding contact marks such as location B noted in figure 41 with the corresponding spectrum shown in figure 42.

Figure 42. EDS spectra at locations indicated in figure 41. A small peak of chromium was consistently present in areas circled in figure 41 such as location A (upper spectrum) and was mostly absent in areas between sliding contact marks such as location B (lower spectrum).

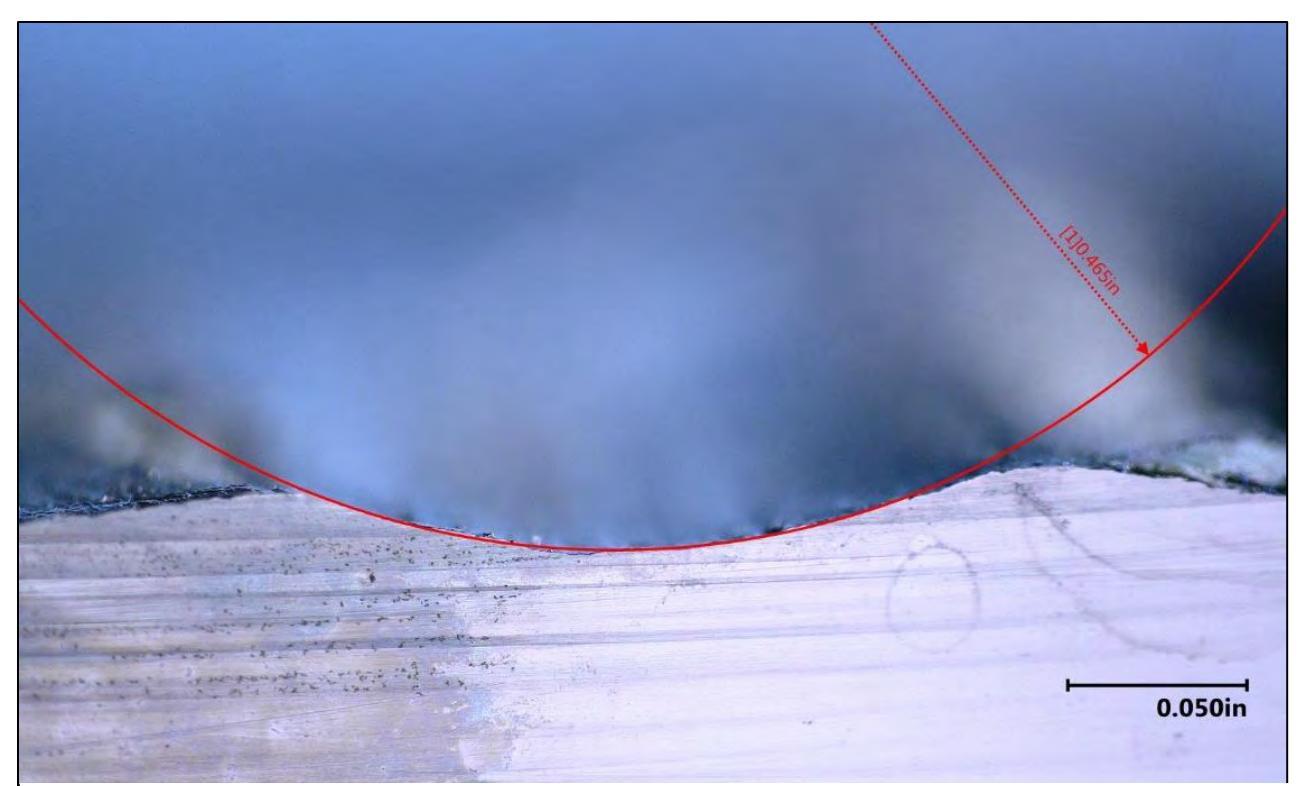
The longitudinally-oriented sliding contact grooves generally had a rounded profile at the bottom of the grooves. The cut face for the piece upstream of mount M1 is shown in figure 43 where the groove profiles are visible. The radii of several of the grooves that were distinctly separate from overlapping damage were measured, and the measured grooves are labeled 1 through 5 in figure 43. An example of the measurement for groove 1 is shown in figure 44 where the radius of curvature measured approximately 0.233 inch. The radius of curvature for grooves 2 through 5 measured 0.116 inch, 0.103 inch, 0.085 inch, and 0.108 inch, respectively.

Figure 44. Optical image of groove 1 (see figure 43). The radius of curvature was approximately 0.233 inch.

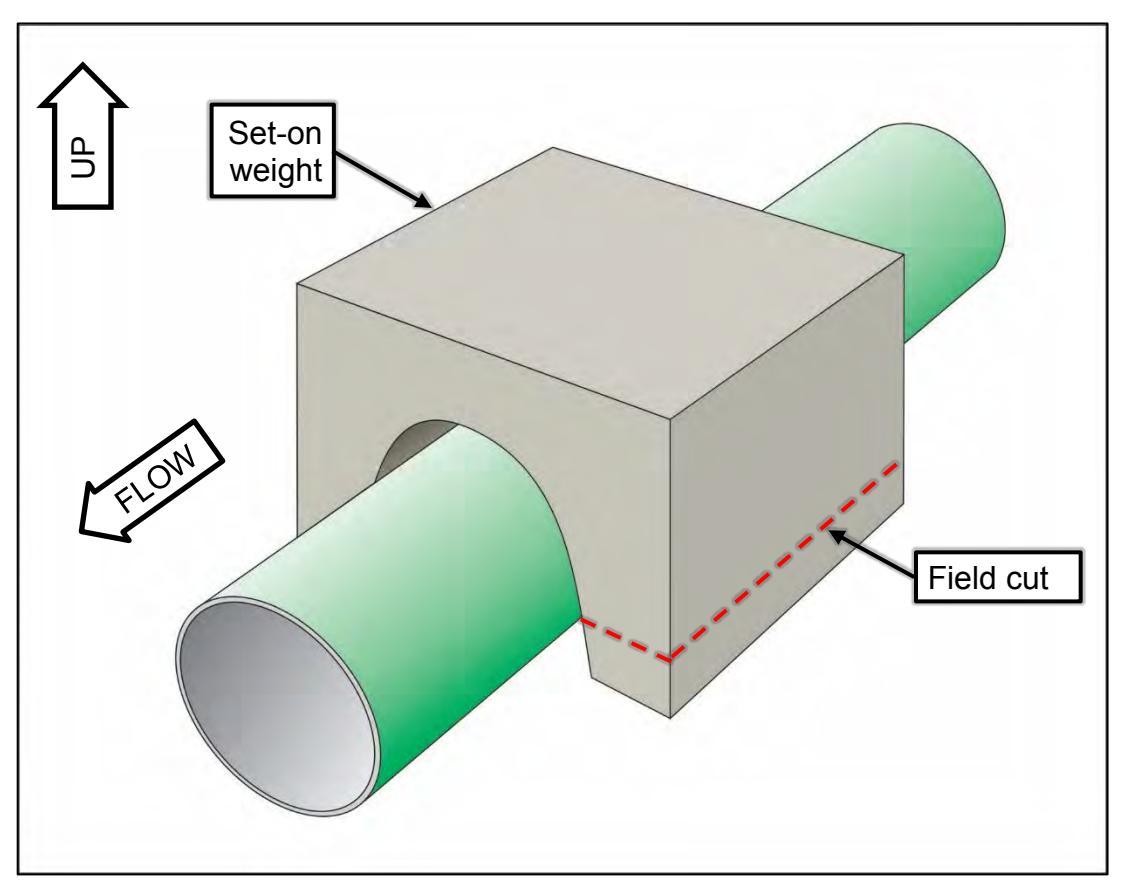
A schematic drawing of a concrete set-on weight installed on a pipeline is shown in figure 45. The weight had an upside-down U shape with the pipe running between the legs of the U. The interior faces of the weight were lined with an integral protective fibrous pad. The piece of the set-on weight that was received in the lab was the lower end of the left leg cut from the weight as indicated in figure 45.

Figure 45. Schematic drawing of a concrete set-on weight installed on a pipeline. A dashed line indicates the approximate location where the weight upstream of the rupture was cut to facilitate shipment for further examination.

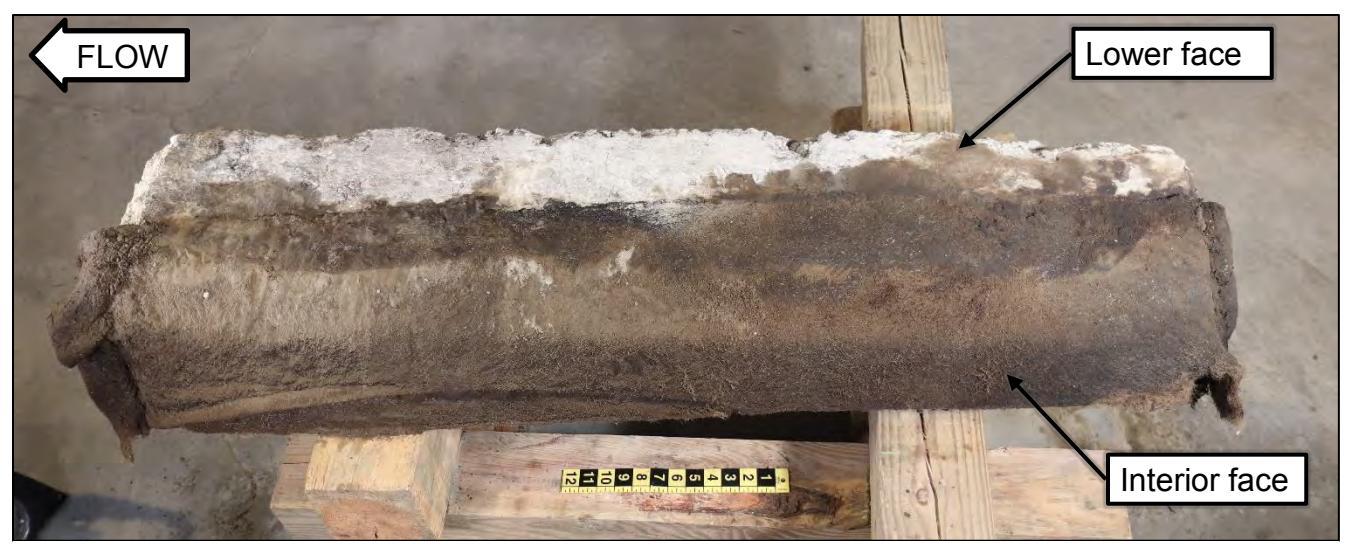
Figure 46. Concrete set-on piece after cleaning with soft-bristle brushes using mineral oil, acetone, and a solution of Alconox and water to remove oil and dirt from the surface. Portions of the corner between the exterior face and the lower face were also chipped away using the wood handle of the brush.
