# NATIONAL TRANSPORTATION SAFETY BOARD

MATERIALS LABORATORY FACTUAL REPORT

Place	: Amherst, South Dakota
Date	: November 16, 2017
Vehicle	: TransCanada Keystone pipeline
NTSB No.	: PLD18LR001
Investigator	: Kalu Kelly Emeaba, RPH-20

Section of pipeline and piece of concrete set-on pipeline weight.

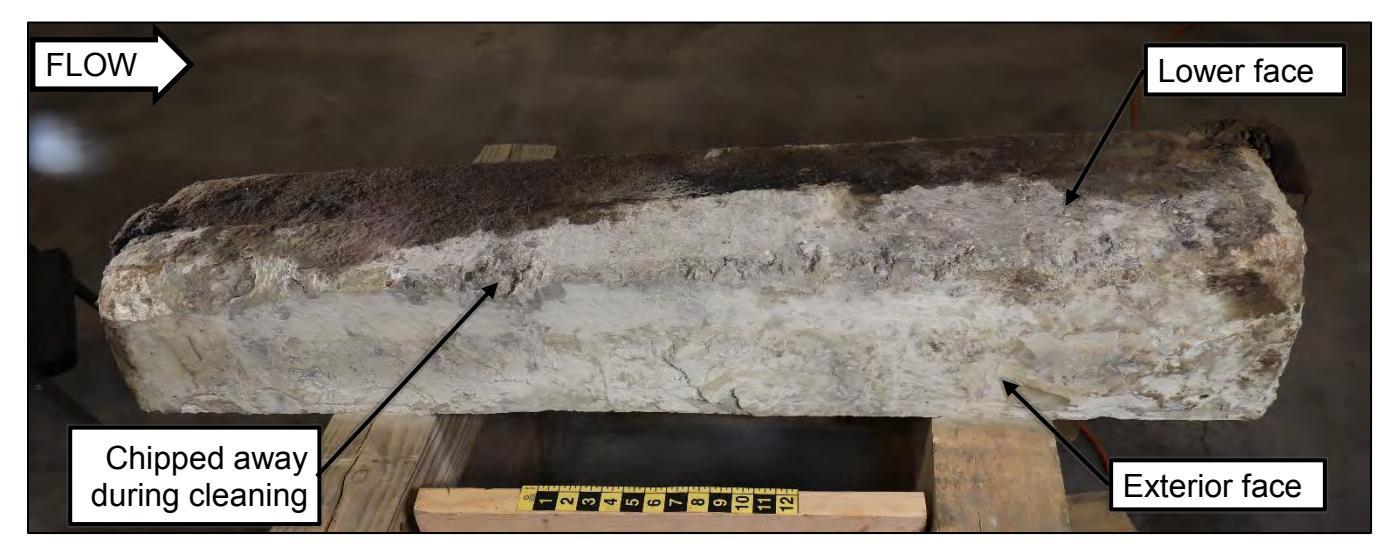
The lower face of the set-on weight piece shown in figure 2 was mostly covered with oily dirt deposits, but a piece of the upstream end corner between the exterior face and the lower face was fractured away and appeared relatively clean consistent with a recent fracture. The set-on weight piece was cleaned using a solution of Alconox and water and acetone as needed with a soft-bristle brush and wood scrapers to remove oil and dirt deposits on the surface, and the resulting cleaned piece is shown in figures 46 and 47. During the cleaning process, chunks of the corner between the exterior face and the lower face were chipped away with a wood brush handle in the area indicated in figure 47.

Figure 47. Another view of the cleaned set-on weight piece showing an area that was chipped away with a wood brush handle during cleaning.

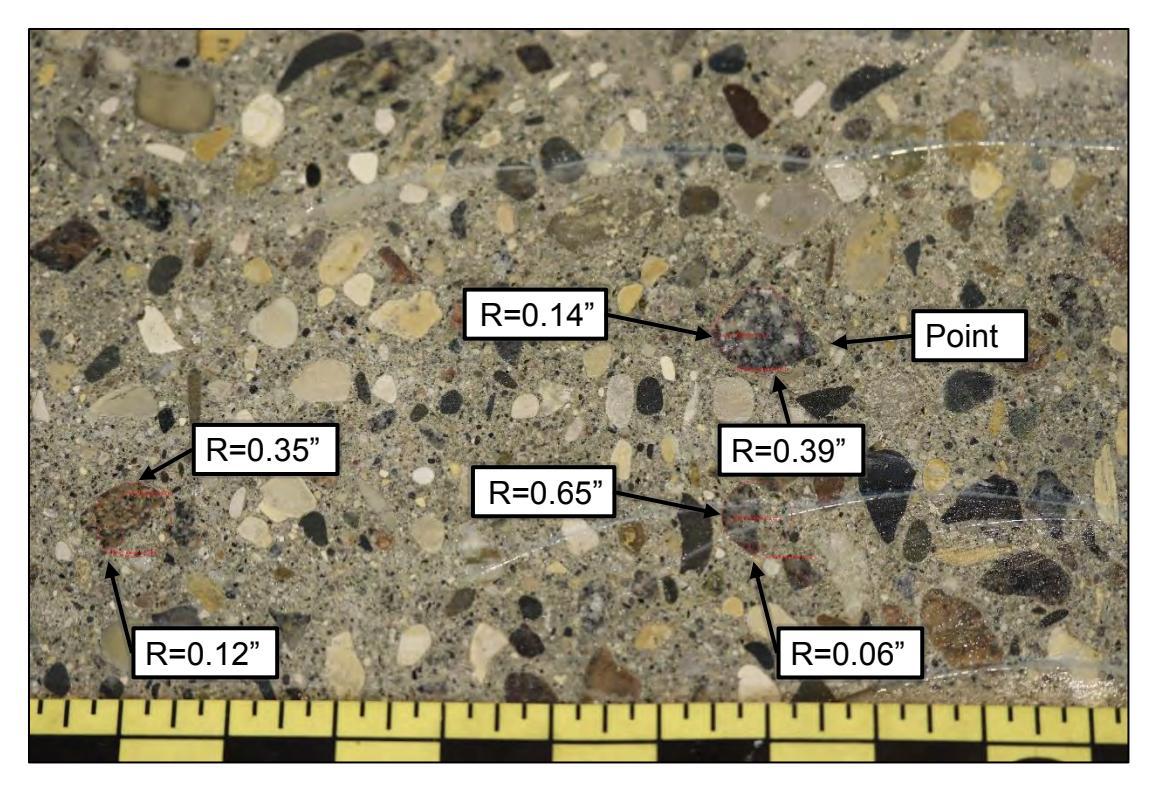
Next, the weight piece was rotated onto its lower face to view the cut face. The cut face was then wetted with water to more clearly reveal the aggregate size and distribution, and a photograph of the wet cut face is shown in figure 48. The shapes of the aggregate were irregular, and the edges had varying radii of curvature in the plane of the cut. Approximate radius measurements at multiple locations around several of the pieces of aggregate are shown indicated in figure 48. Radii of curvature on the pieces ranged from a point with nearly zero radius up to a 0.65-inch radius.

Figure 48. Cut surface of the set-on weight piece after wetting with water showing radius measurements on several pieces of quartzite plus feldspar aggregate pieces in the plane of the cut.

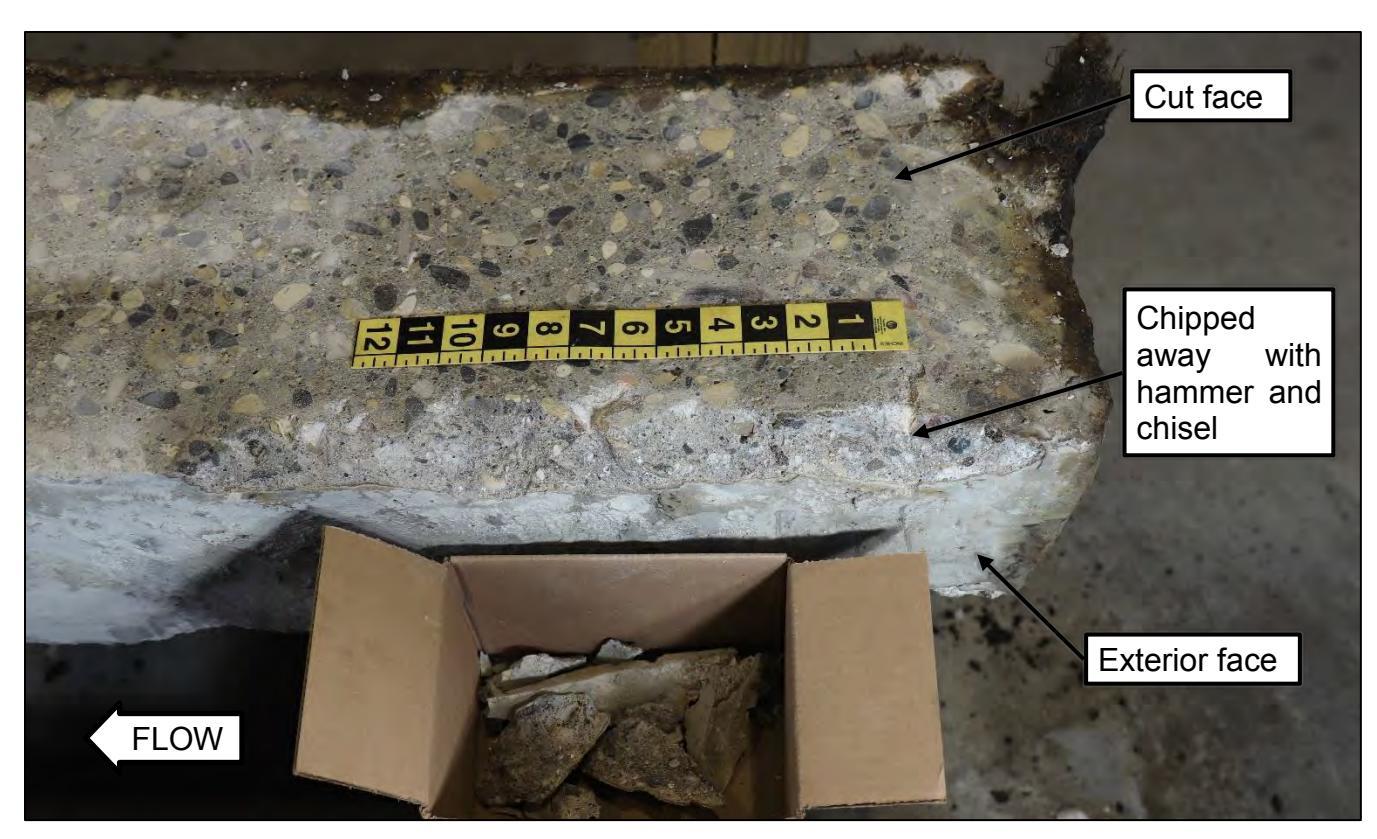
Concrete samples from the corner between the cut face and the exterior face were chipped away near the upstream end of the weight piece. A hammer and steel chisel were required to chip the pieces away. A view of the weight piece after removing the samples is shown in figure 49, and several of the pieces chipped from the weight are shown in figure 50. The concrete samples were examined by a geologist at the Smithsonian Institution. Several of the larger pieces of aggregate within the samples were identified as quartzite and a mix of quartzite and feldspar as indicated in figure 50. Typical hardness values for quartzite and feldspar were higher than typical hardness of other aggregate pieces in the samples. The larger pieces that were identified as harder materials as indicated in figure 50 ranged from 1 inch or more across to less than ½ inch across. Smaller pieces of the harder rock are also scattered within the concrete matrix.

Figure 49. Cut face of the set-on weight piece after wetting with water. A hammer and chisel were used to chip away samples of the concrete at the corner shown.

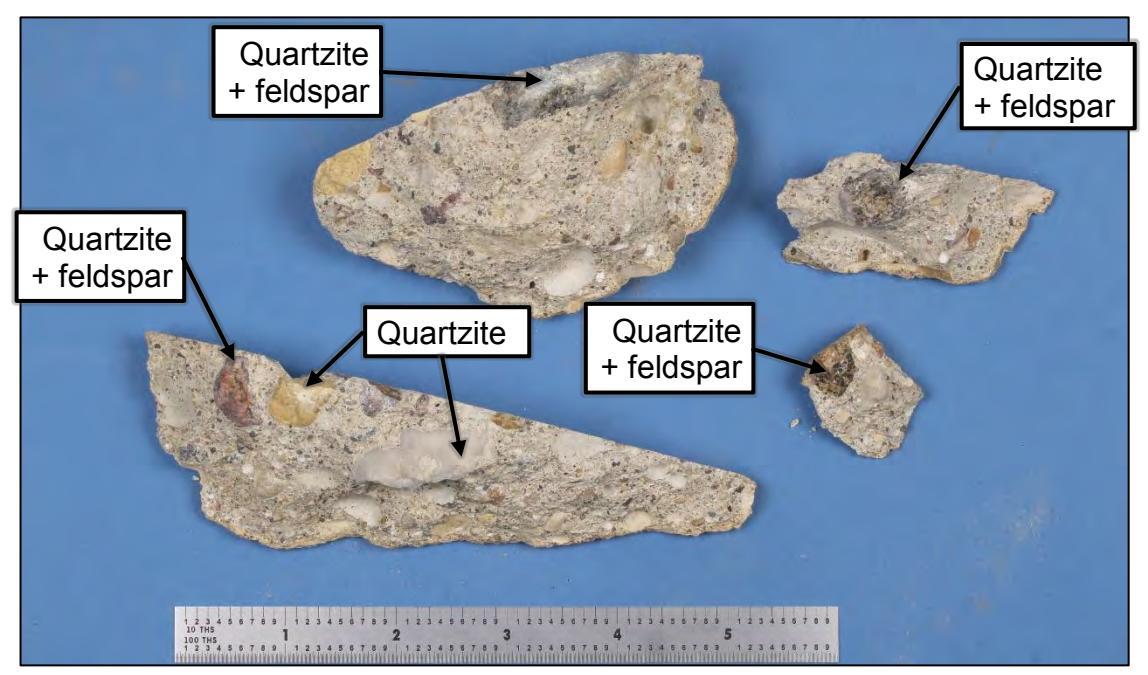
Figure 50. Several pieces of concrete chipped from the set-on weight. Some exposed pieces of aggregate identified as quartzite and quartzite plus feldspar are indicated.
