Principal Investigator Molly Atkins
Region Director R.M. Seeley
Date of Report 2/24/2014
Subject Failure Investigation Report – Enbridge Pipelines, LLC, Tank 3013 24-inch Fill Line failure in Cushing, OK

Failure Investigation Report – Enbridge Cushing Tank Farm

May 17-18, 2013

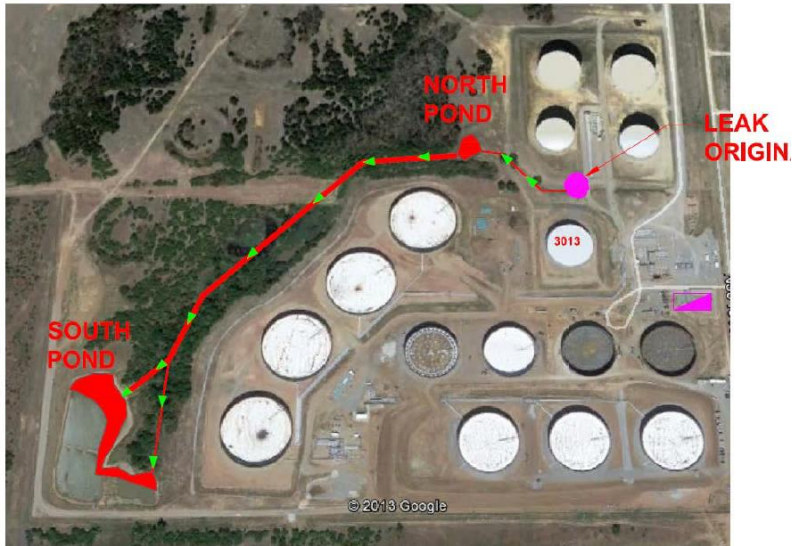
Tank 3013 Site Layout

Shortly after 1:00 p.m. CT, operations personnel confirmed that oil was leaking from the 24-inch-diameter line connected to Tank 3013 at a low point in the line where it crossed below a drainage ditch. Oil was found to have migrated from the drainage ditch into a nearby containment pond and then into a second, larger containment pond via a connecting drainage creek. Upon confirmation of the leak, all connecting tank and manifold valves were closed to stop the outflow of oil. The outside technician closed the Tank 3013 isolation valve and provided the controller with leak confirmation on the Tank 3013 fill line. The controller initiated spill response notifications and set up the incident command at the Cushing Terminal office location.
