## **Valve Integrated Pressure Regulator Examination (DOT DUNS #079807449)**

Report Number:  
**R-WHA-15113-0-A-EX1**

**Mark Toughiry  
Pipeline and Hazardous Materials Safety Administration  
1200 New Jersey Avenue, SE  
East Building, 2nd Floor, Room E21-338  
Washington, DC 20590**

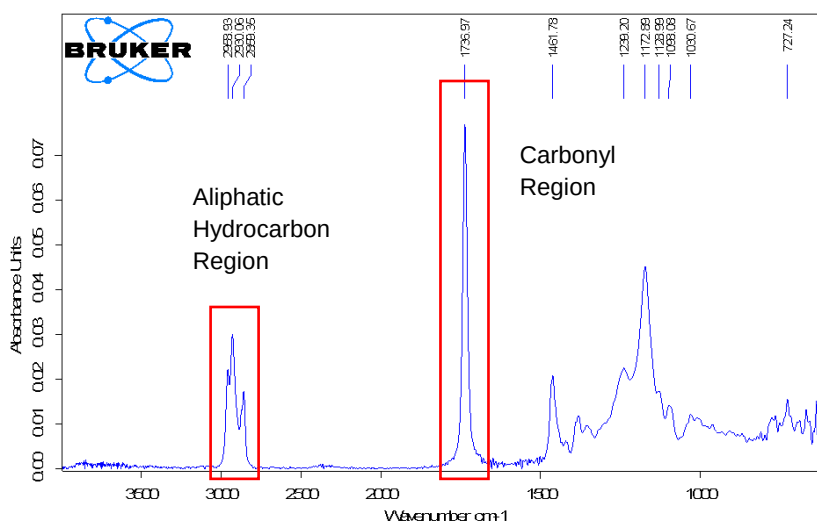
**Figure 16 - Dioctyl Sebacate Characteristic FTIR Spectra**

Some investigations on Grab-n-Go VIPR fires have attributed critical contamination to an EPDM o-ring gland seal that provides the seal between the VIPR and cylinder. In the present investigation, the gland seal o-ring was PTFE and not EPDM. However, these allegations persist. Contamination from EPDM gland seals have been attributed to a plasticizer incorporated into the seal to provide flexibility, primarily Dioctyl Sebacate (DOS), that is alleged to have migrated from the o-ring during service. **Figure 16** shows FTIR spectra for this plasticizer (plasticizer spectra only, not identified with this evidence).

As shown, DOS plasticizers exhibit a characteristic stretch in the aliphatic hydrocarbon region, located between approximately  $2800\text{ cm}^{-1}$  and  $3100\text{ cm}^{-1}$ . DOS also exhibits a characteristic carbonyl stretch at  $1737\text{ cm}^{-1}$ . It is noteworthy that the carbonyls relative absorbance peak amplitude is characteristically greater than the aliphatic hydrocarbons relative peak amplitude.

In contrast to **Figure 16** for DOS (only), the contamination found in the VIPR and cylinder were predominantly aliphatic hydrocarbons inconsistent with only DOS. **Figure 13**, **Figure 14**, and **Figure 15** depict weak carbonyl stretches; however, the ratio of the carbonyls relative absorbance to the hydrocarbons relative absorbance indicates that an unidentified hydrocarbon-based contaminant was predominant in the samples. If the contamination were solely due to DOS, the spectrum would show a larger carbonyl peak as compared to the aliphatic hydrocarbon peak, which was not the case. Therefore, the hydrocarbon-based contaminant observed on the incident components was primarily an unidentified saturated hydrocarbon<sup>3</sup>.

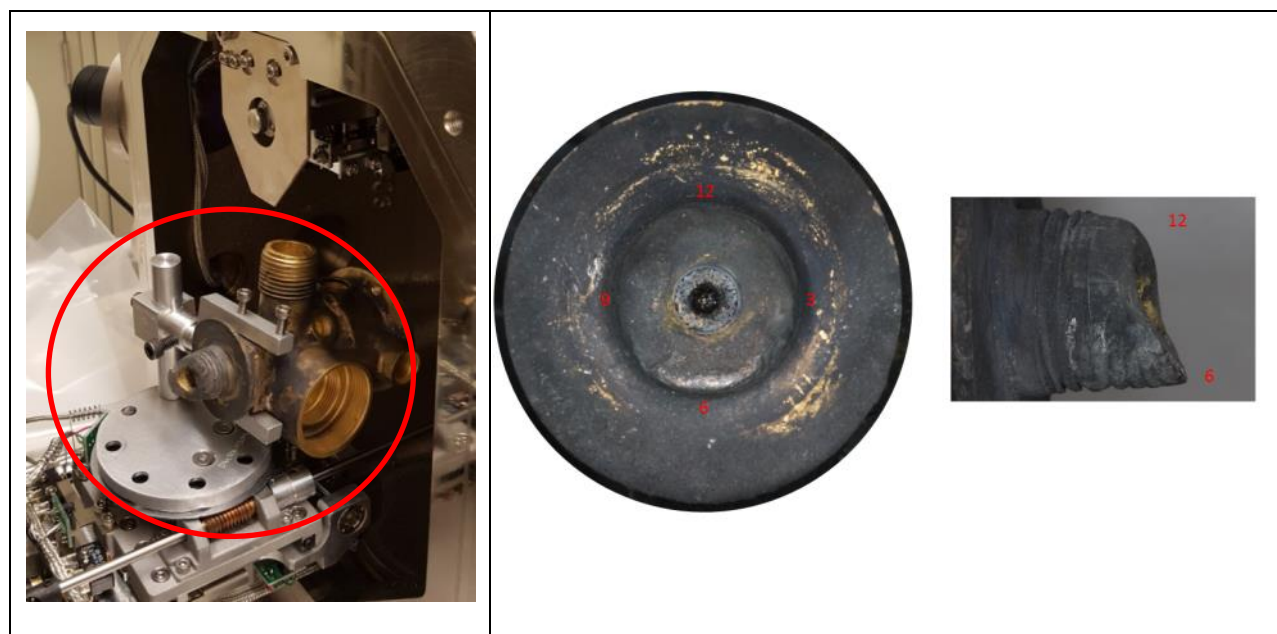
**Figure 17** – SEM Chamber Positioning Fixture and Orientation of VIPR Threads for Elemental Characterization of Residues

In general, the threads were analyzed at the 12, 3, 6, and 9 o'clock positions and EDS elemental analysis was obtained from the bottom remaining portions of the threads up to the flange. The heaviest melt/flow and consumption patterns on the brass threads was designated as the approximate 12 o'clock position. The least melt/flow and consumption was observed at the approximate 6 o'clock position (see **Figure 17**).

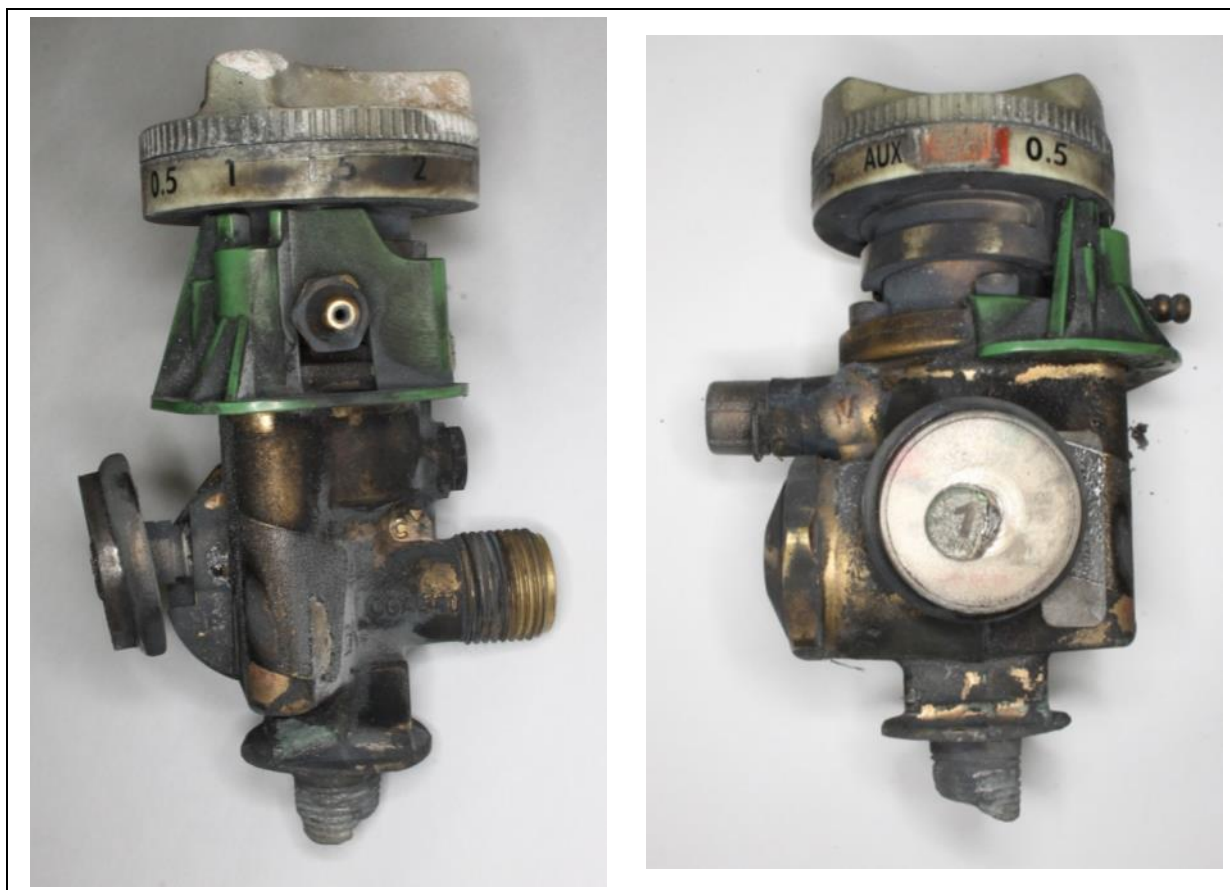
**Figure 20 – External views of the incident VIPR**

The VIPR exhibited combustion and slag deposits on the majority of its external components and external surfaces. However, external fire damage to the VIPR was generally limited to the cylinder-to-VIPR thread connection. Fire damage to the thread connection was also heaviest on the lower 12 o'clock region of the threads away from the flange and flange O-ring seal. VIPR damage to the cylinder thread post is shown in **Figure 20**. Noteworthy bending, consistent with impact, was also observed on the flange and the pressure gauge at 6 o'clock (**Figure 6**).

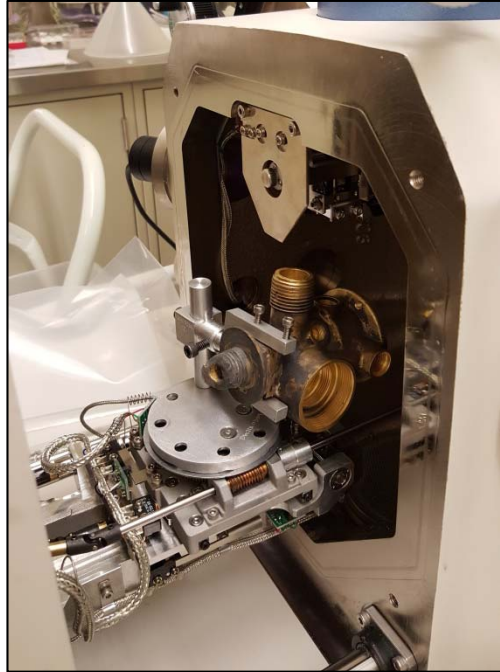
The VIPR was mounted in a Scanning Electron Microscope Chamber for elemental analysis using a specially fabricated holding fixture as shown in the figure to the left. The holding fixture allowed orientation of the VIPR into a variety of positions and was fixed securely to the SEM chamber stage. The full 360 degrees of the threads were accessible using the fixture and the tilt functions of the SEM chamber.

In general the threads were analyzed at the 12, 3, 6, and 9 O'clock positions and EDS elemental analysis was obtained from the base of the threads to the flange.

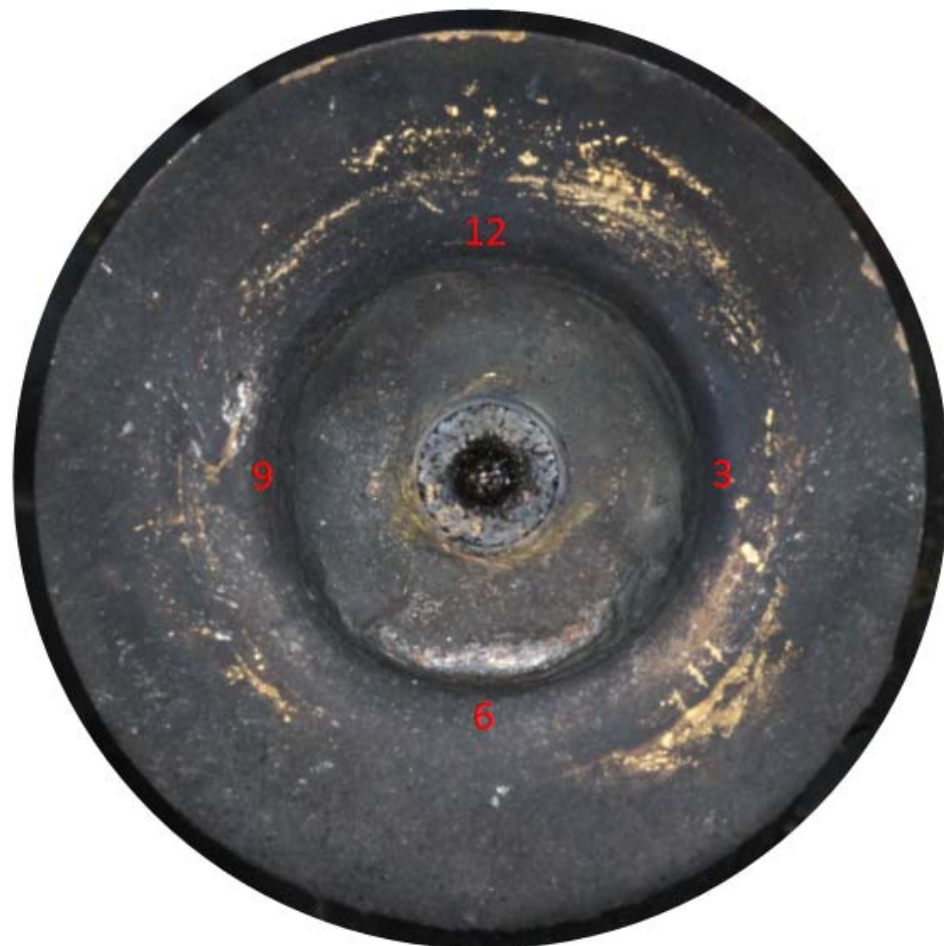
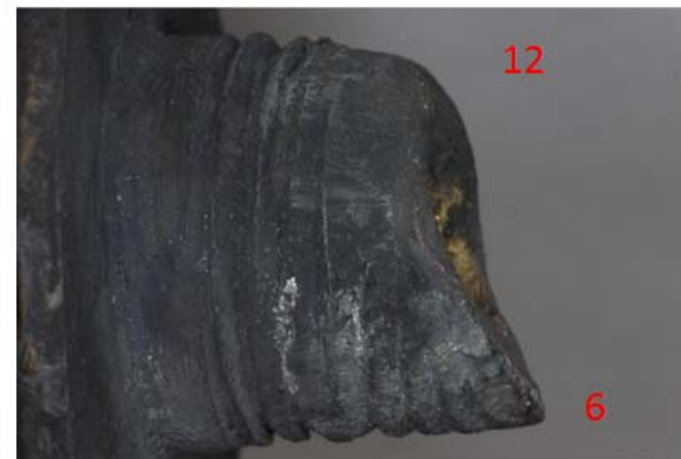
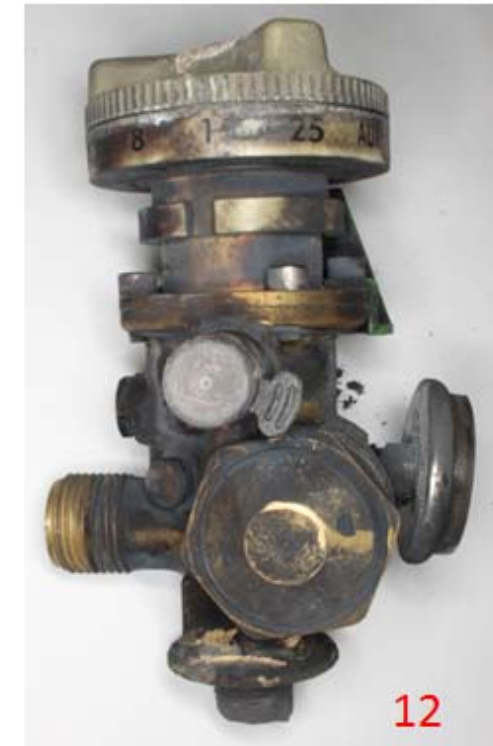
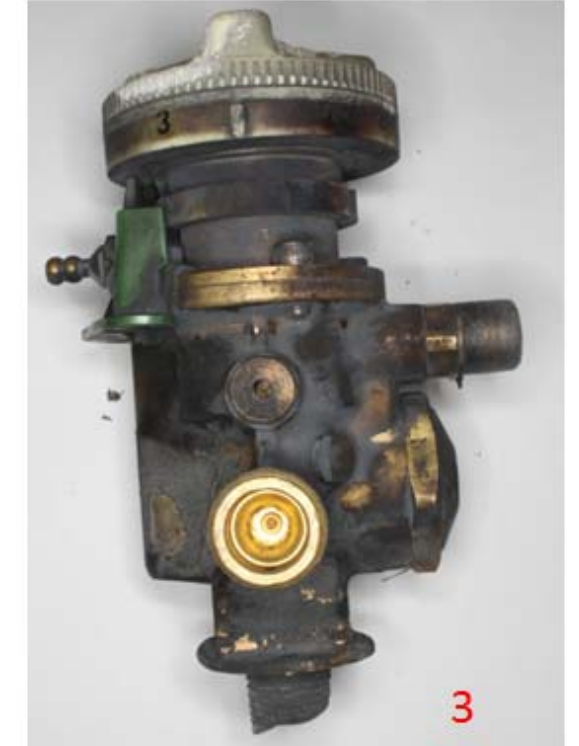
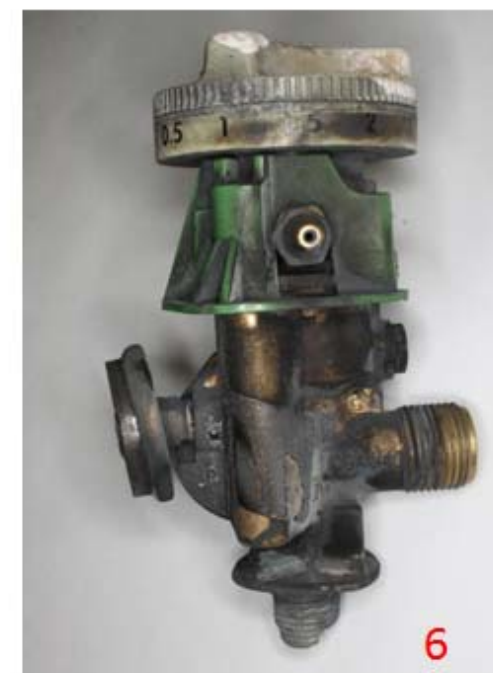
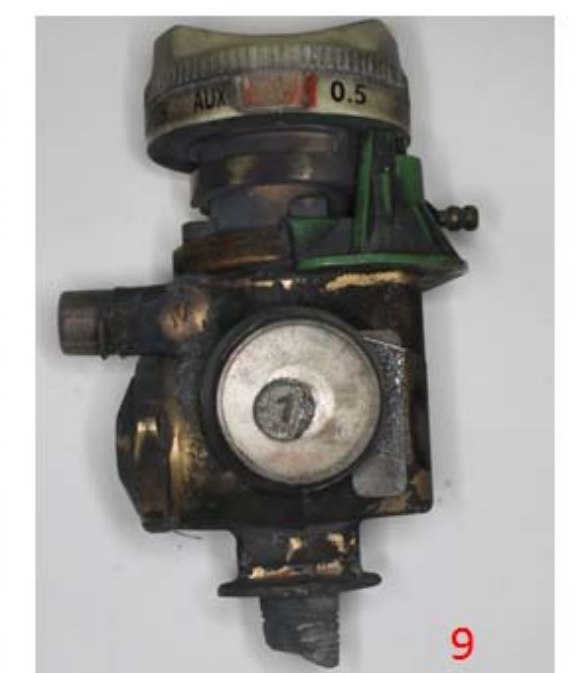
Flange bend  
corresponds to  
6 o'clock thread  
region

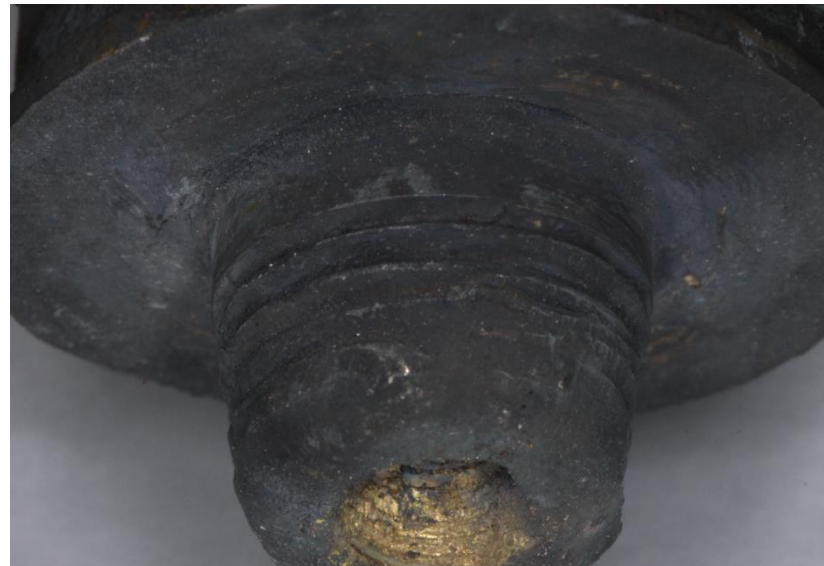
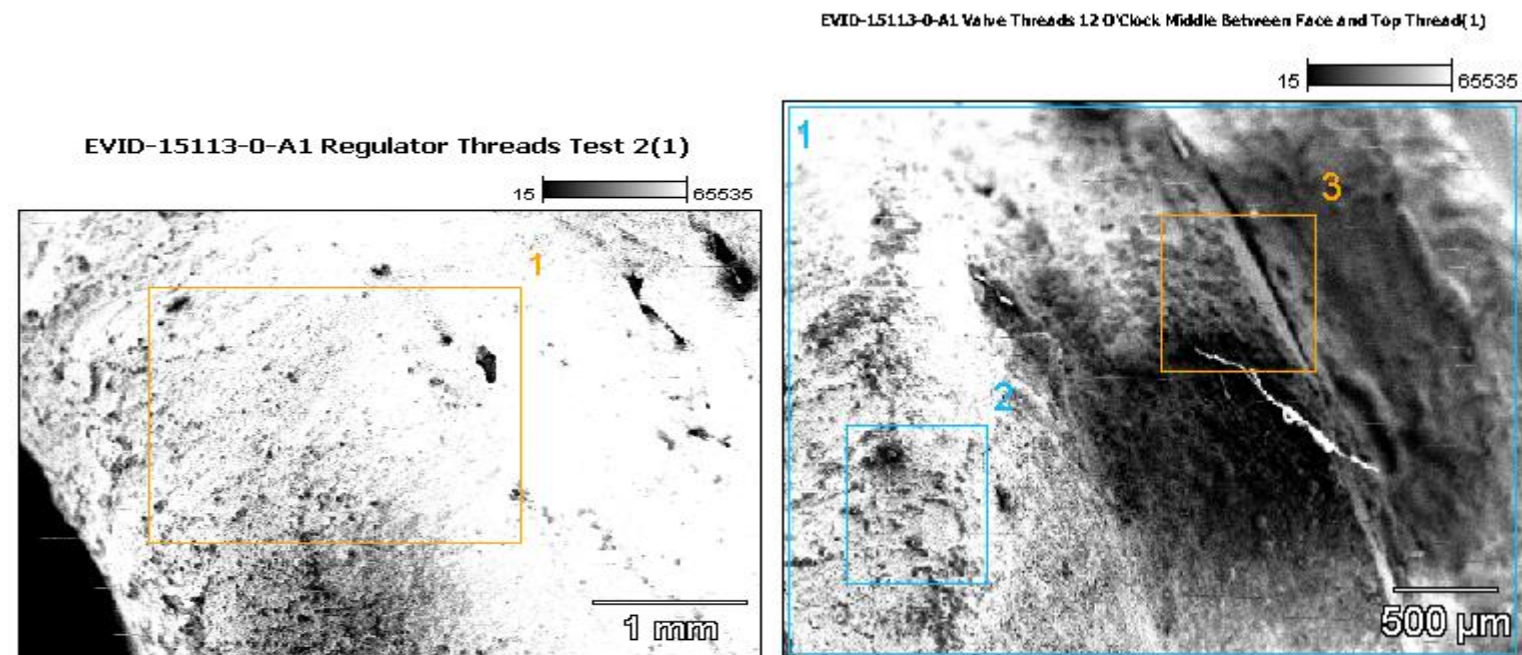
- Al (~10%) generally consistent throughout thread region from damaged end to flange
- F generally higher on middle and flange regions
- Mo and Pb seem to be present more toward the damaged end
- C and O generally higher on damaged and middle thread regions
- Cu (~13%) consistent throughout thread region from damaged end to flange
- Zn highest near flange and decreases moving toward damaged end, Zn content generally higher on this thread position than all other regions, note this end experienced most material loss during event

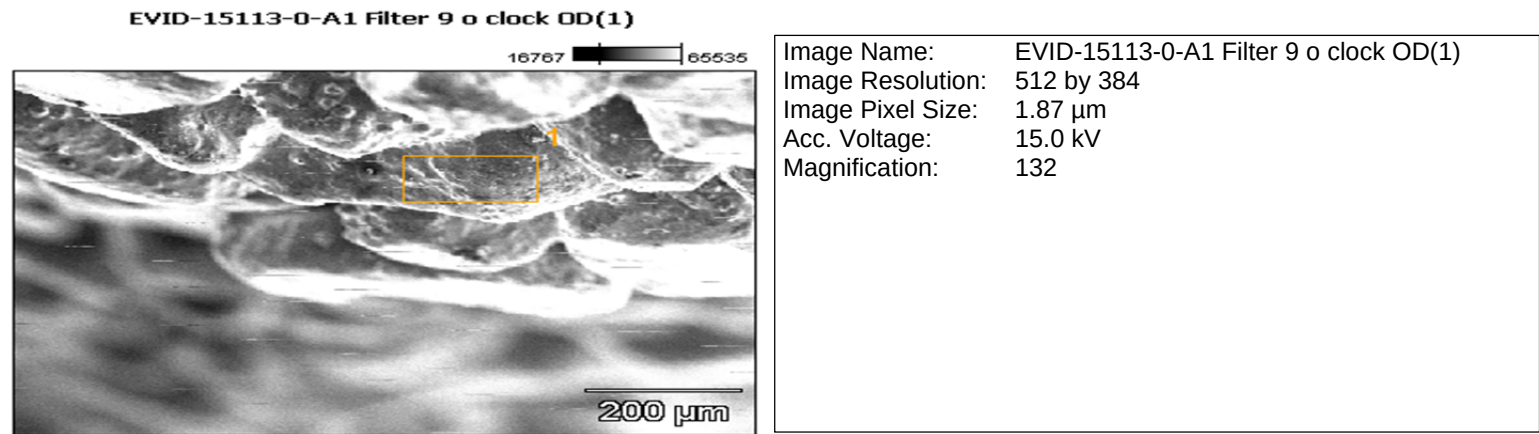
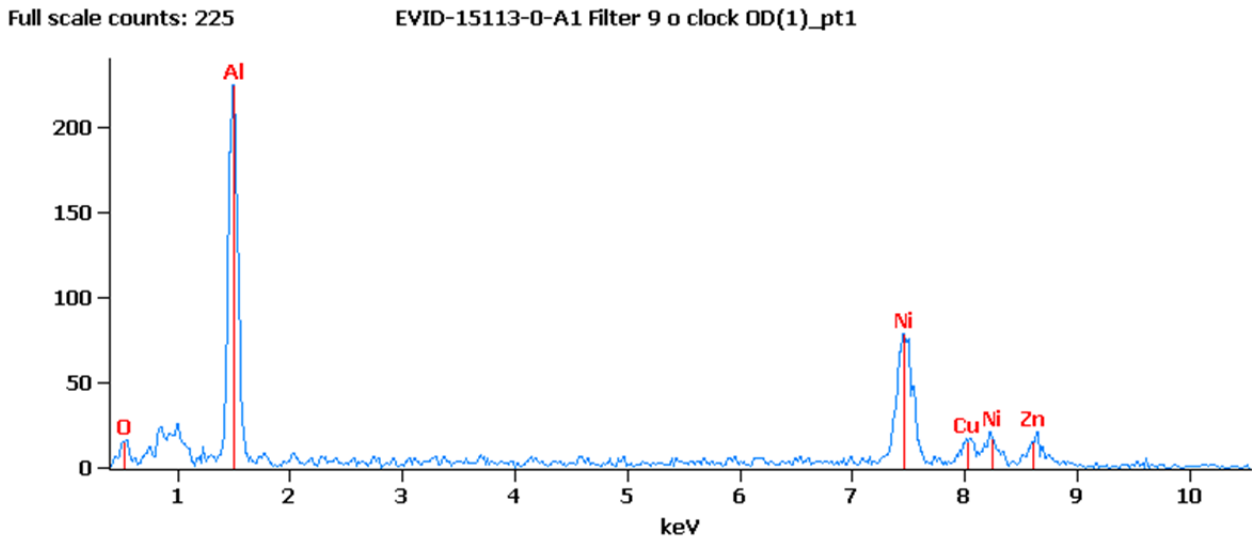
EVID 15113-0-A1 Valve Stem Filter Exterior Near Filter Face Facing Cylinder 9 O'clock Quadrant 4: First Scan Magnified

**Area of analysis uncertain**- Analysis was shot on the outside of the filter at an angle that would have the beam hitting the sample clamp and reflecting into the detector. The sample clamp analysis is included below

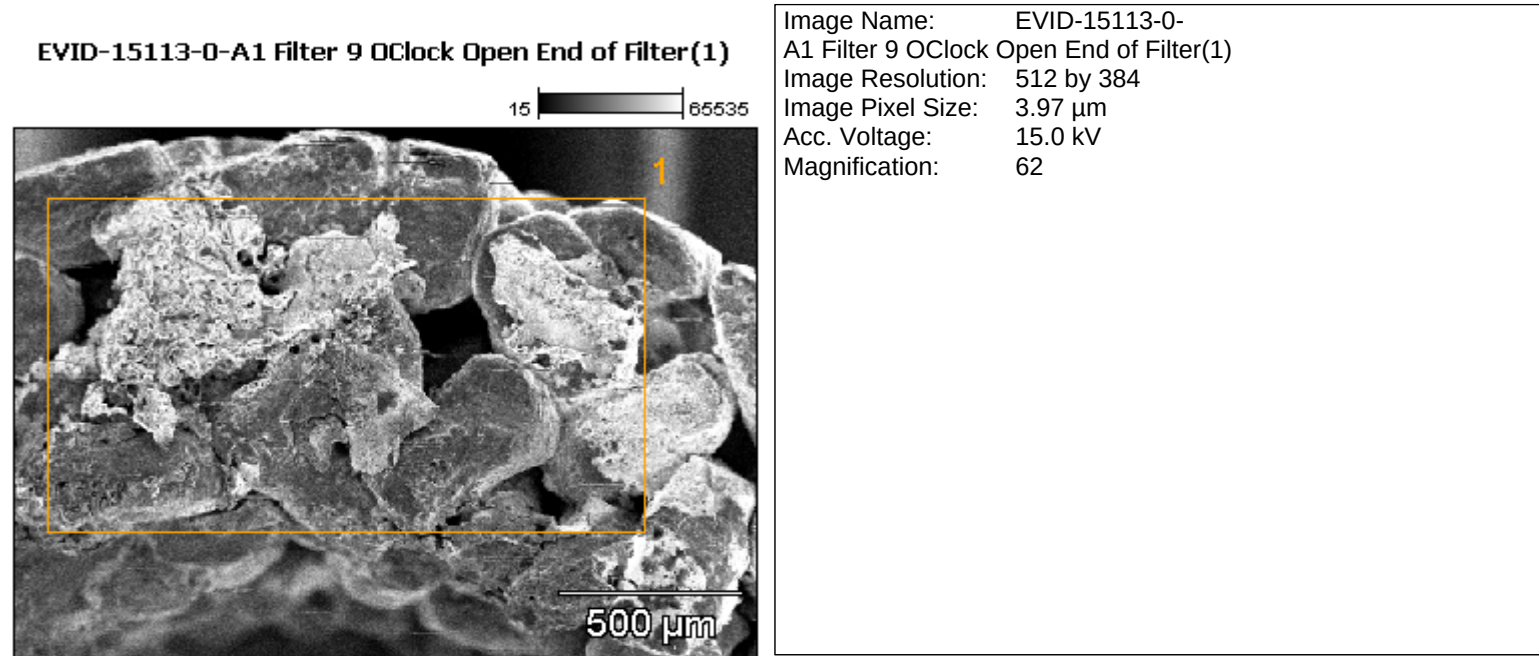
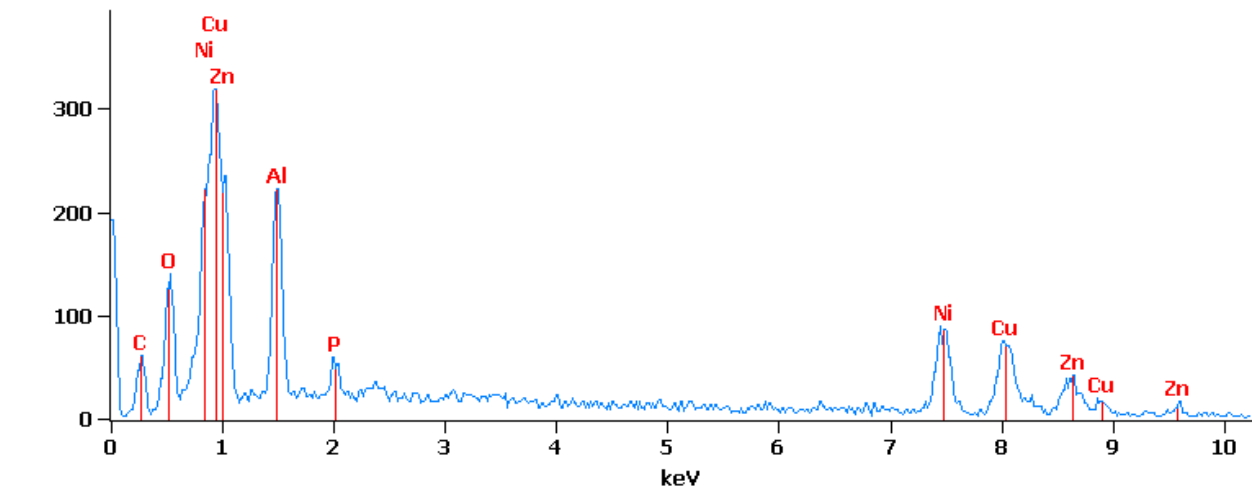
EVID 15113-0-A1 Valve Stem Filter Face Facing Cylinder 9 O’Clock Quadrant 4: First Scan

Full scale counts: 319 EVID-15113-0-A1 Filter 9 OClock Open End of Filter(1)\_pt1

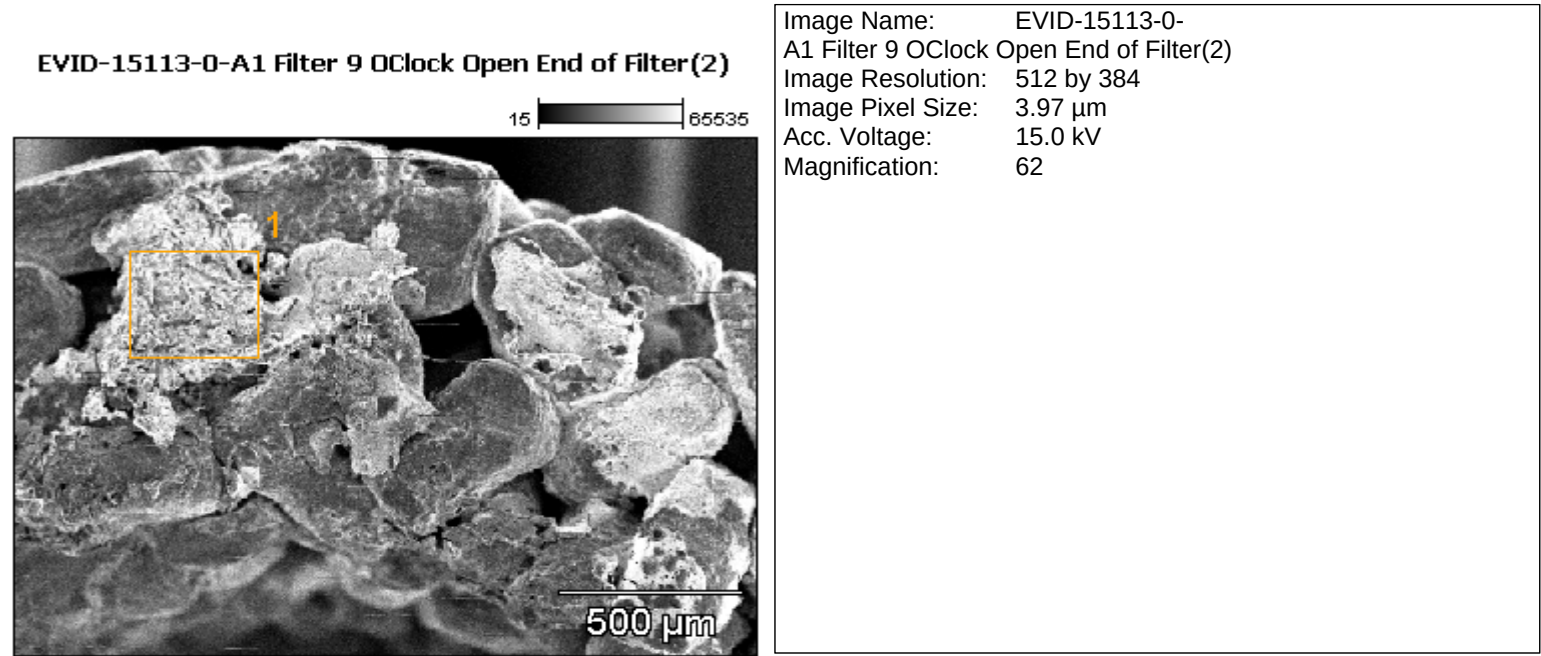
EVID 15113-0-A1 Valve Stem Filter Face Facing Cylinder 9 O’Clock Quadrant 4: First Scan

Full scale counts: 811 EVID-15113-0-A1 Filter 9 O’clock Open End of Filter(2)\_pt1

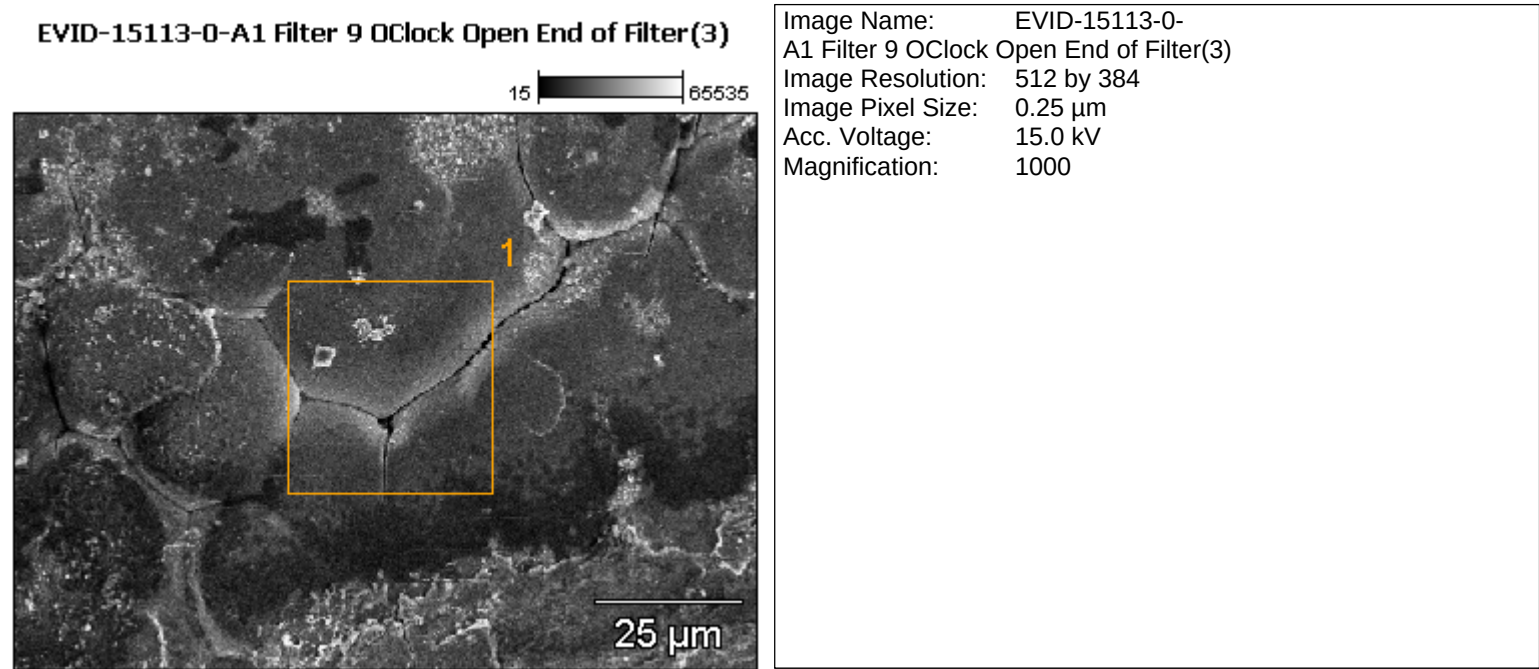
EVID 15113-0-A1 Valve Stem Filter Face Facing Cylinder 9 O’Clock Quadrant 4: Second Scan High Magnification

Full scale counts: 1258 EVID-15113-0-A1 Filter 9 OClock Open End of Filter(3)\_pt1

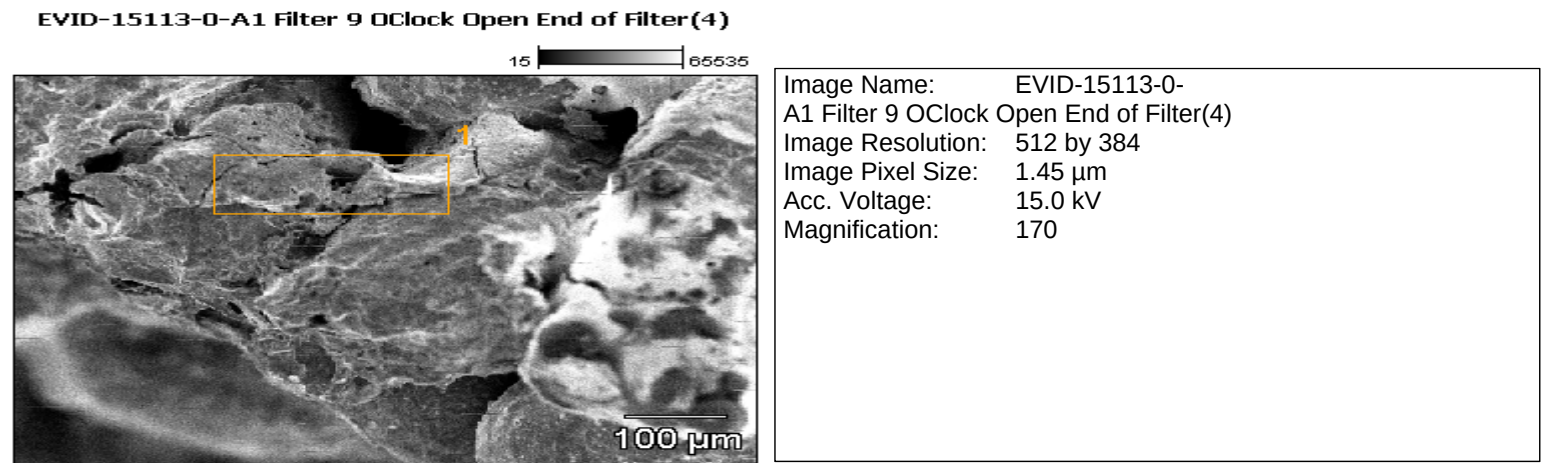
EVID 15113-0-A1 Valve Stem Filter Face Facing Cylinder 9 O’Clock Quadrant 4: Second Scan Magnified

Full scale counts: 867 EVID-15113-0-A1 Filter 9 OClock Open End of Filter(4)\_pt1

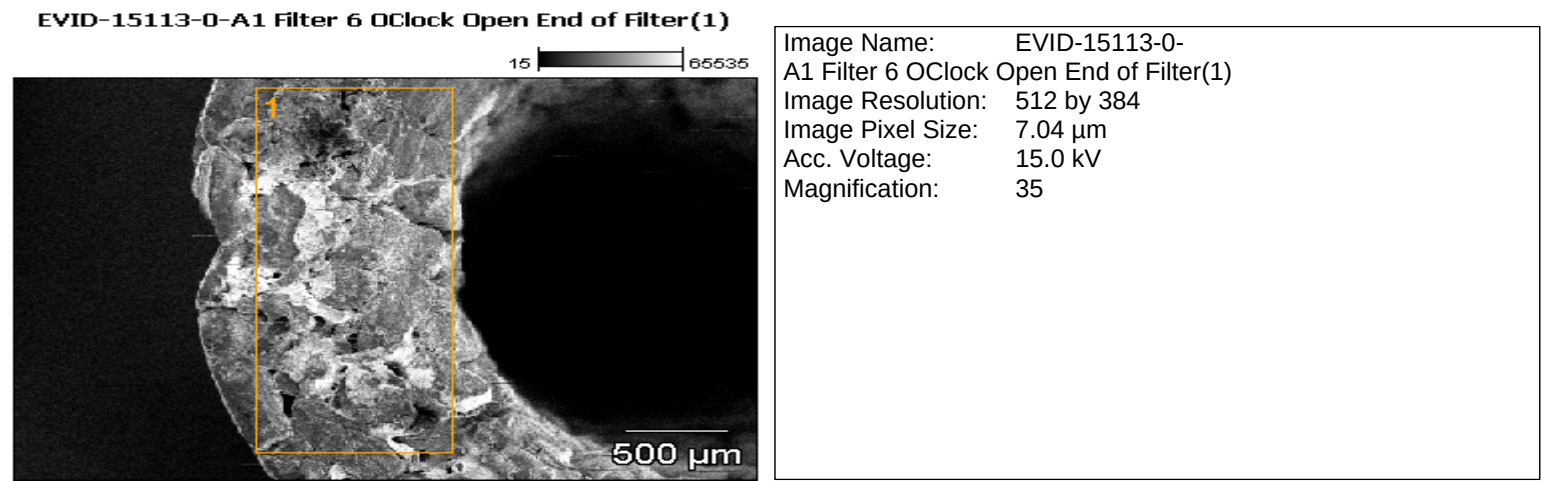
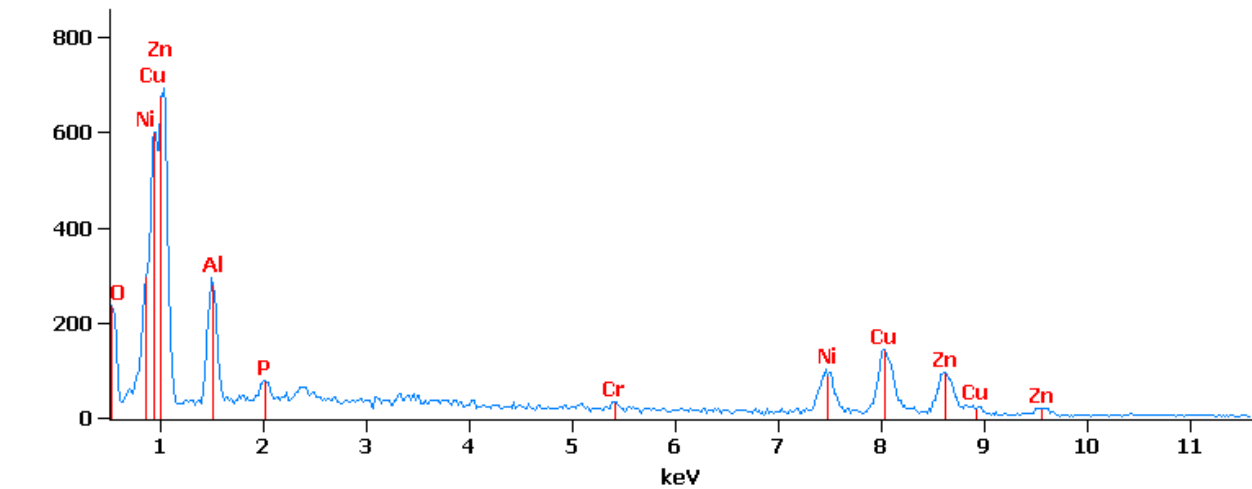
EVID 15113-0-A1 Valve Stem Filter Face Facing Cylinder 6 O’Clock Quadrant 3: First Scan

Full scale counts: 691 EVID-15113-0-A1 Filter 6 OClock Open End of Filter(1)\_pt1

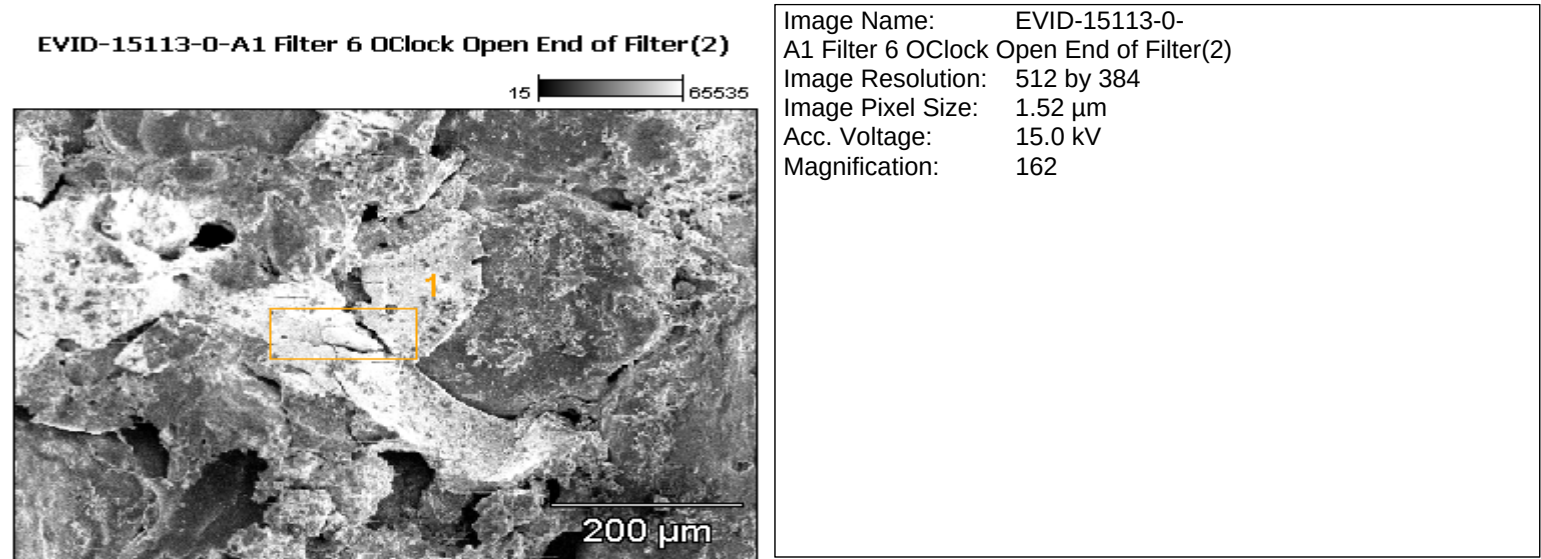
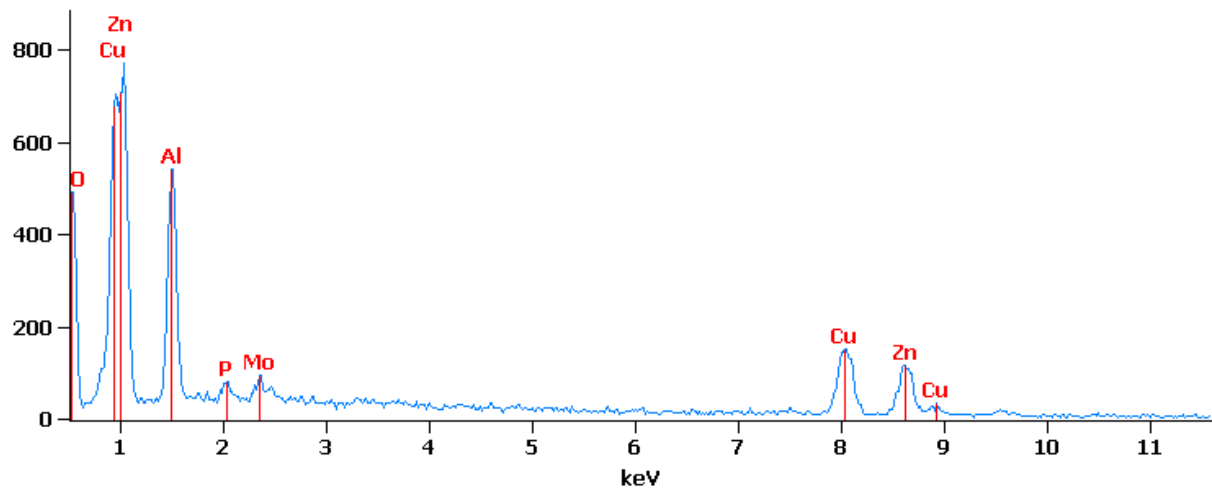
EVID 15113-0-A1 Valve Stem Filter Face Facing Cylinder 6 O’Clock Quadrant 3: Second Scan Magnified

Full scale counts: 771 EVID-15113-0-A1 Filter 6 OClock Open End of Filter(2)\_pt1

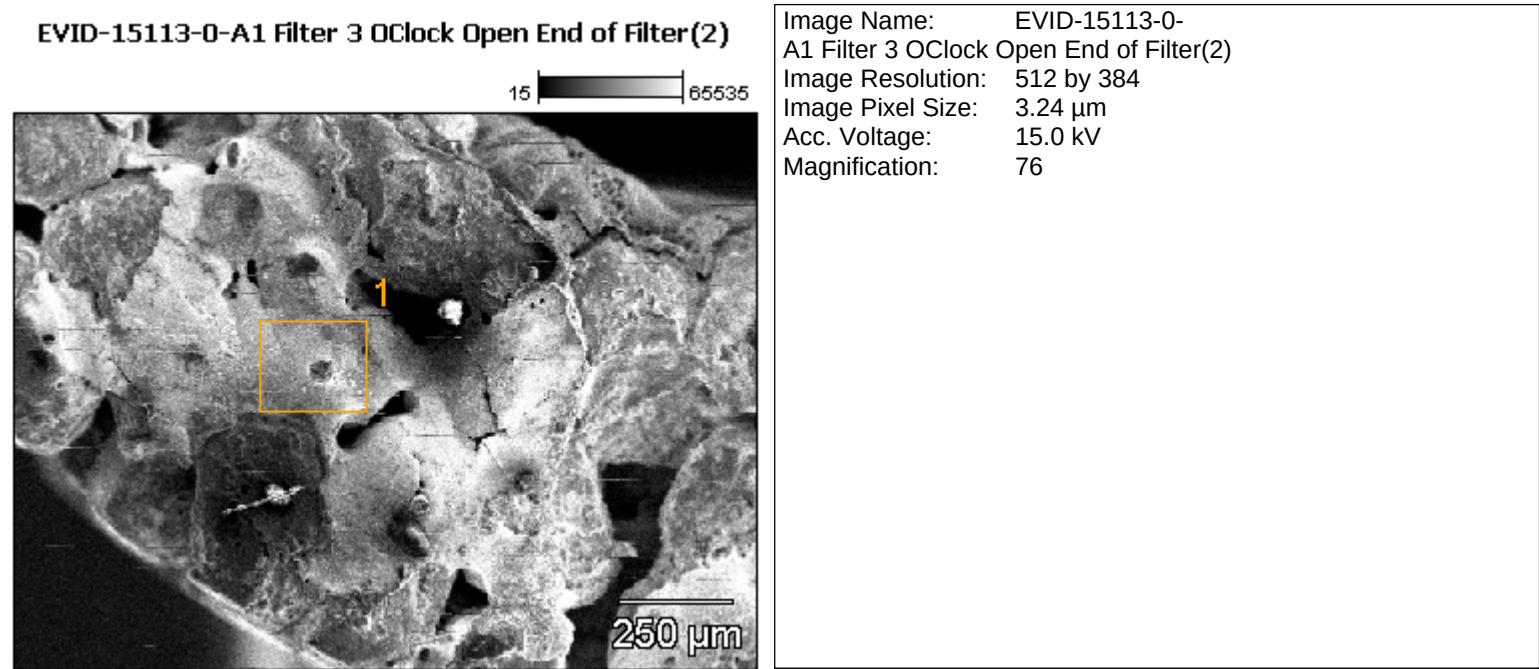
EVID 15113-0-A1 Valve Stem Filter Face Facing Cylinder 3 O’Clock Quadrant 2: First Scan

Full scale counts: 708 EVID-15113-0-A1 Filter 3 OClock Open End of Filter(2)\_pt1

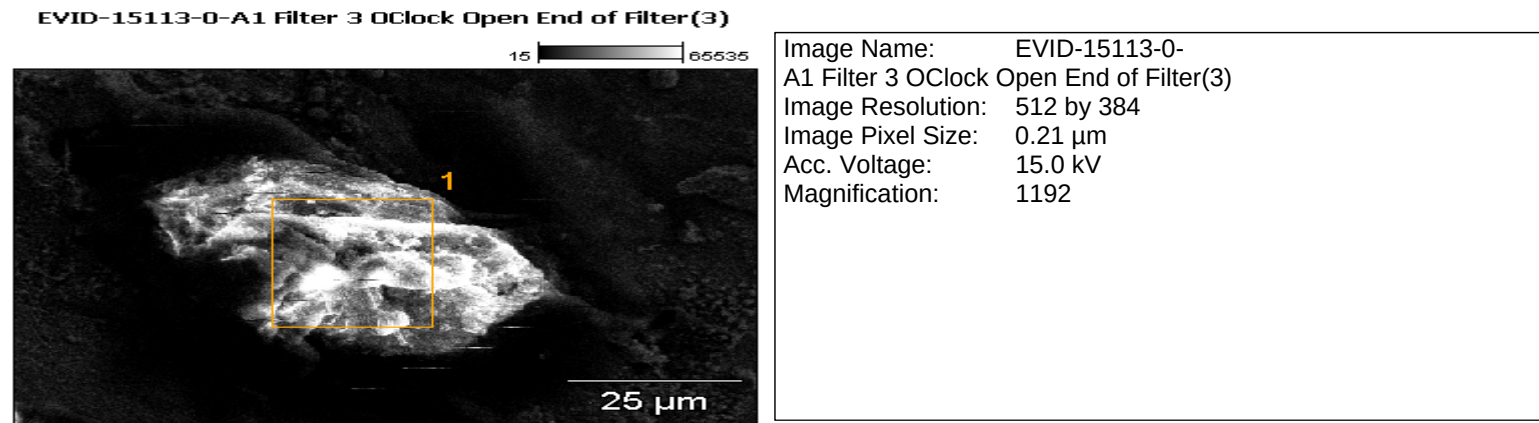
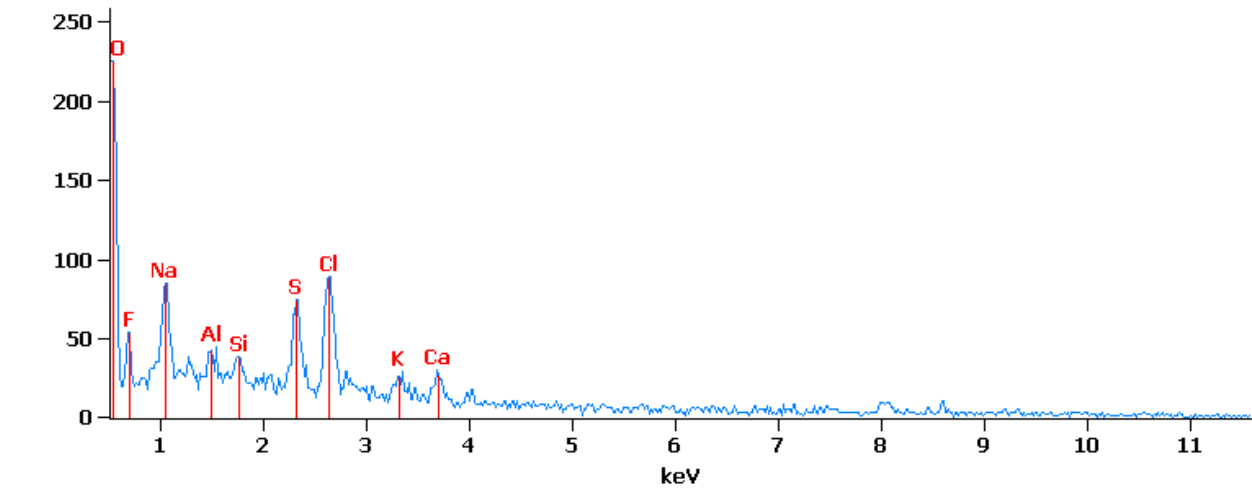
EVID 15113-0-A1 Valve Stem Filter Face Facing Cylinder 3 O’Clock Quadrant 2: Second Scan High Magnification

Full scale counts: 225 EVID-15113-0-A1 Filter 3 OClock Open End of Filter(3)\_pt1

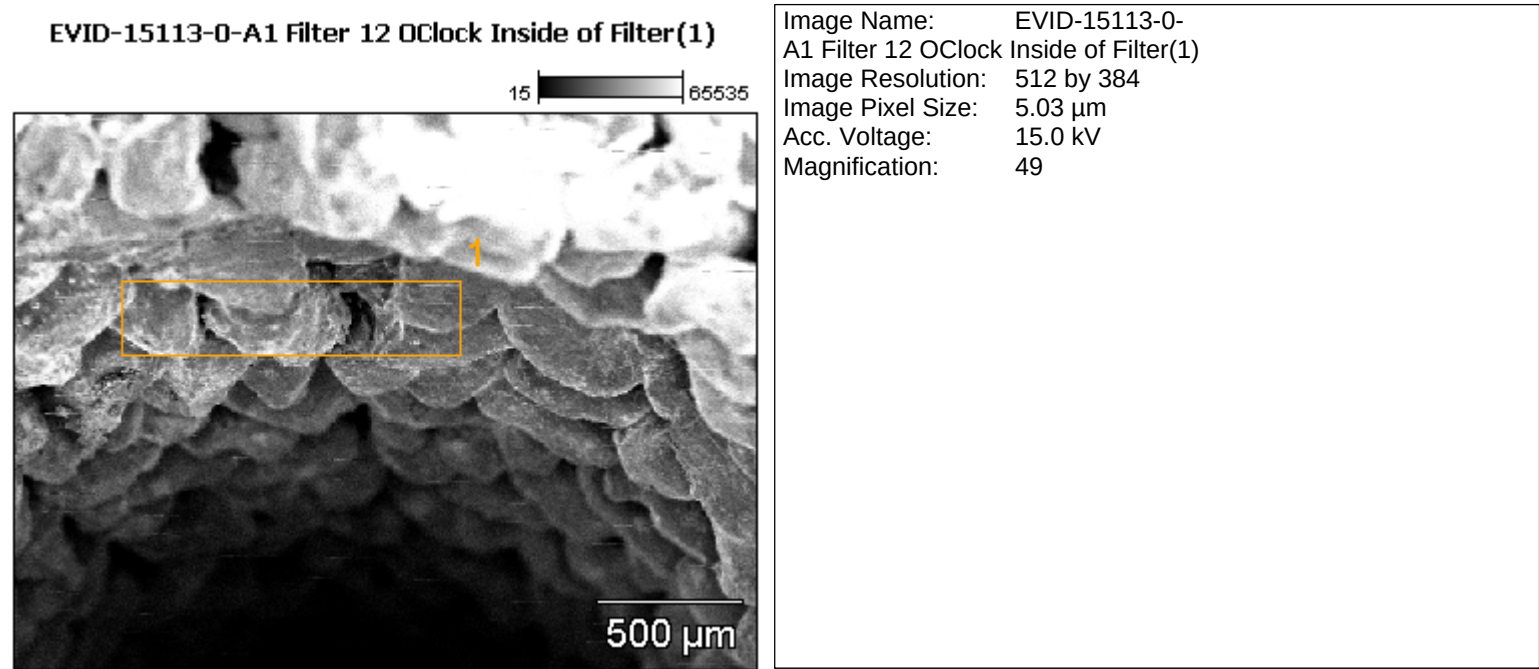
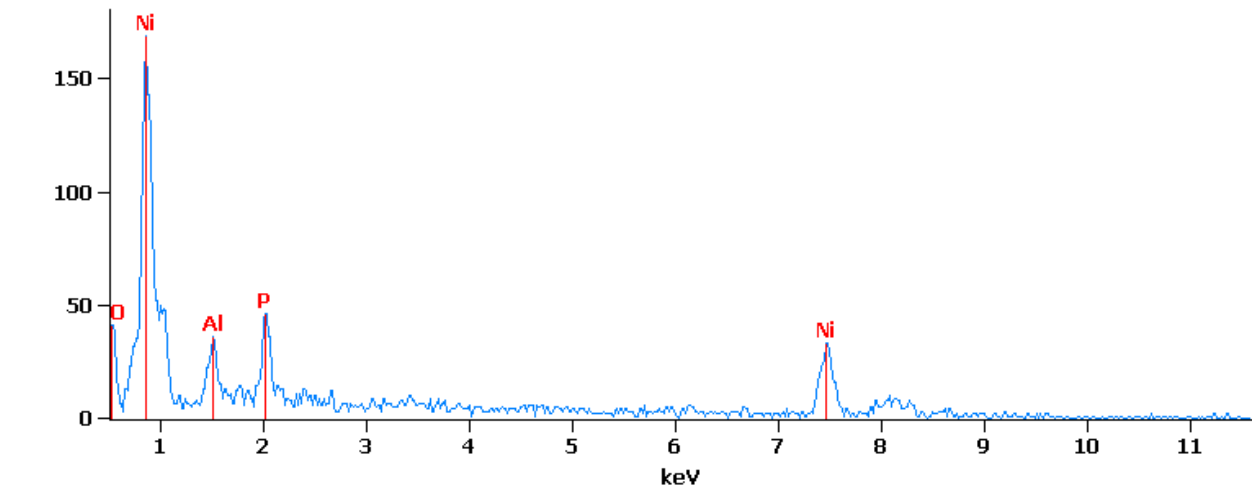
EVID 15113-0-A1 Valve Stem Filter Interior 12 O’Clock Quadrant 1: First Scan Magnified

Full scale counts: 169 EVID-15113-0-A1 Filter 12 OClock Inside of Filter(1)\_pt1
