Valve Integrated Pressure Regulator Examination (DOT DUNS #079807449)

Report Number:
R-WHA-15113-0-A-EX1

WHA International Inc., (WHA) was requested by the Pipeline and Hazardous Materials Safety Administration (PHMSA) to document and evaluate the valve portion of a ruptured DOT 3AL cylinder that had been involved in a fire during high-pressure oxygen service, and to determine the following:

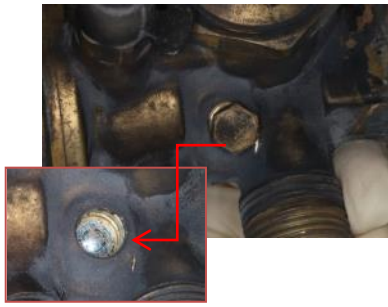
A - Burst Disk and Gasket

- Burst Disk (rupture disc and gasket intact)
- Fill Valve Assembly (inlet filter, poppet, spring, and O-rings intact)
- Pressure Gauge and “Snubber” Orifice (components intact and orifice visibly clean)
- Regulator Assembly (PTFE Seat and O-rings intact; evidence that external combustion products had projected through the regulator atmospheric vent port; but, no evidenced of internal combustion)
- Relief Valve Assembly (valve components, spring, O-rings intact; evidence of external heat affecting the lubricant consistency, but internal combustion patterns not evident)
- Auxiliary Port Assembly (poppet and O-rings intact)
- Flow Head Assembly (components and O-rings intact)
- Shuttle Valve Assembly (components, O-rings, and backup rings intact; evidence of external combustion residue projecting into portions of the shuttle valve, but, no evidence of internal combustion evident)

The components listed above were inspected and documented by all parties present during the WHA joint inspection. During disassembly, WHA observed combustion product deposits inside some component housings. However, analysis revealed the residue was not associated with internal combustion. Several components have ports drilled into them that allow communication with the external environment, such as the regulator atmospheric sensing port (**Figure 10**). The combustion deposits were consistent with the external fire depositing combustion products on these components through the external ports onto surfaces within the VIPR housing. However, the VIPR did not exhibit internal fire-damage, melt-flow patterns, or propagation patterns that were consistent with fire originating inside or within the VIPR.

Figure 11 shows that all the internal soft goods, springs, and valve assemblies were intact and did not appear to be fire-damaged or substantially changed from their original condition. As component assemblies were removed, documentation of the condition of the ports was obtained with still photography and with boroscope examination (as necessary to visually access deeper porting). No evidence of internal combustion or combustion propagation was observed (see **Appendix A** documentation package).

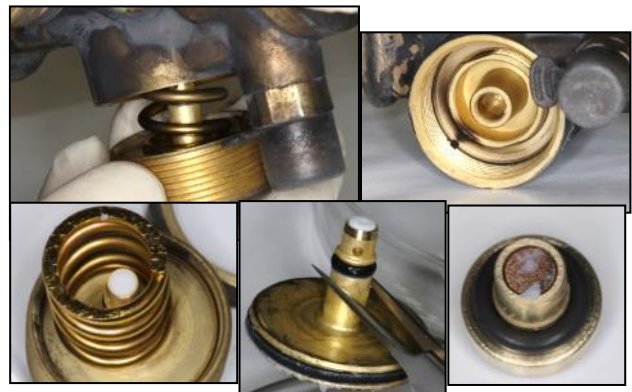
D - Regulator Assembly, PTFE Piston, Spring and Inlet Filter (lubricant on filter surface)

not exhibit evidence of fire involvement. A lubricant was also identified in the chemical analysis as consistent with Krytox (perfluoropolyether lubricant), which is considered a superior oxygen compatible lubricant similar to PTFE materials. None of the internal plastics or elastomers exhibited evidence of ignition or combustion, as indicated in the photographs in **Figure 11** (see also the **Appendix A** documentation package).

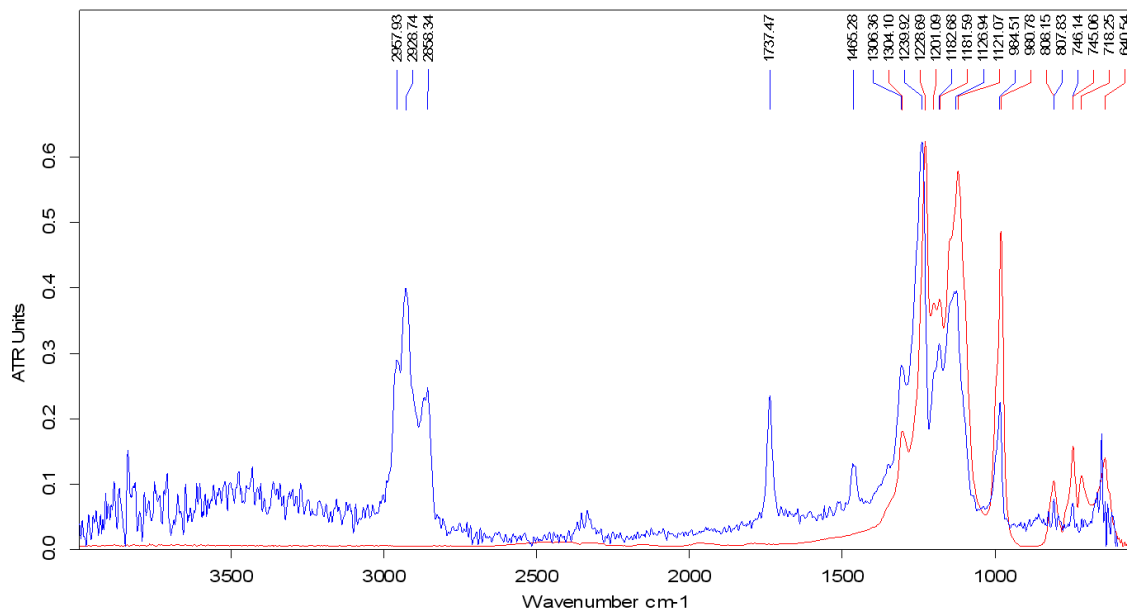
Figure 14 – FTIR Comparison of Exterior Solvent Rinse of Cylinder-to-VIPR Filter with Krytox

Figure 13 depicts the results of the FTIR sampling, comparing the fill port filter and the cylinder filter (interior and exterior). Each sample taken from these filters exhibited aliphatic hydrocarbon functionality (~2800 to 3000 wavenumbers) consistent with contamination. **Figure 14** depicts the FTIR sampling of the cylinder-to-VIPR filter, which also exhibited predominant hydrocarbon contamination and weaker functionality for Dioctyl Sebecate (discussed later). These samples also exhibited functionality consistent with a perfluoropolyether grease (**Figure 14**, Krytox or equivalent, ~900 to 1300 wavenumbers), which was a common finding with many samples, considered a result of the lubrication of the VIPR assemblies with an oxygen-compatible grease during assembly.

In contrast to **Figure 16** for DOS (only), the contamination found in the VIPR and cylinder were predominantly aliphatic hydrocarbons inconsistent with only DOS. **Figure 13**, **Figure 14**, and **Figure 15** depict weak carbonyl stretches; however, the ratio of the carbonyls relative absorbance to the hydrocarbons relative absorbance indicates that an unidentified hydrocarbon-based contaminant was predominant in the samples. If the contamination were solely due to DOS, the spectrum would show a larger carbonyl peak as compared to the aliphatic hydrocarbon peak, which was not the case. Therefore, the hydrocarbon-based contaminant observed on the incident components was primarily an unidentified saturated hydrocarbon³.

- 4) Evidence of hydrocarbon contamination was observed in the chemical analysis of the VIPR filters and threads¹⁰. Figures 13 -15 are consistent with an outside-to-inside migration of hydrocarbon contaminant that migrated through the VIPR and to the cylinder-to-VIPR threads. Since the inlet filter (fill-port) exhibited the same type of contamination as observed elsewhere, it is considered more likely than not that the source was external due to handling and/or external filling operations.

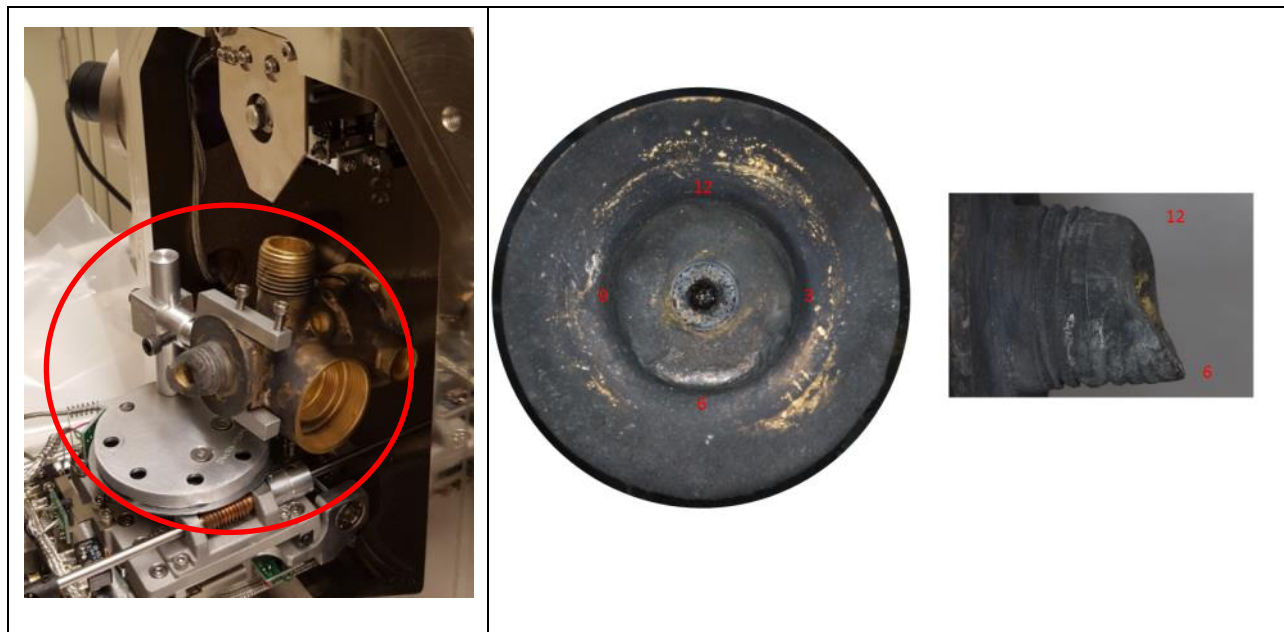
Figure 17 – SEM Chamber Positioning Fixture and Orientation of VIPR Threads for Elemental Characterization of Residues

In general, the threads were analyzed at the 12, 3, 6, and 9 o'clock positions and EDS elemental analysis was obtained from the bottom remaining portions of the threads up to the flange. The heaviest melt/flow and consumption patterns on the brass threads was designated as the approximate 12 o'clock position. The least melt/flow and consumption was observed at the approximate 6 o'clock position (see **Figure 17**).

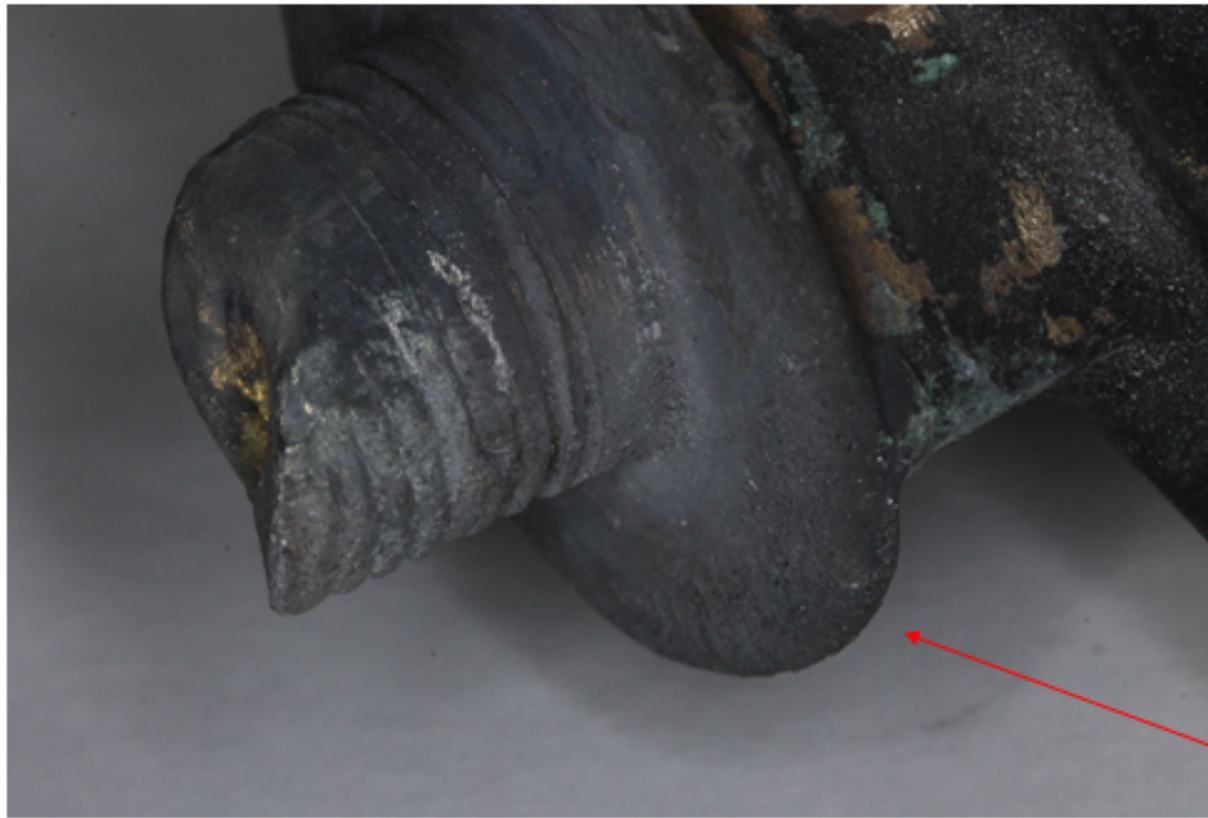
Flange bend
corresponds to
6 o'clock thread
region

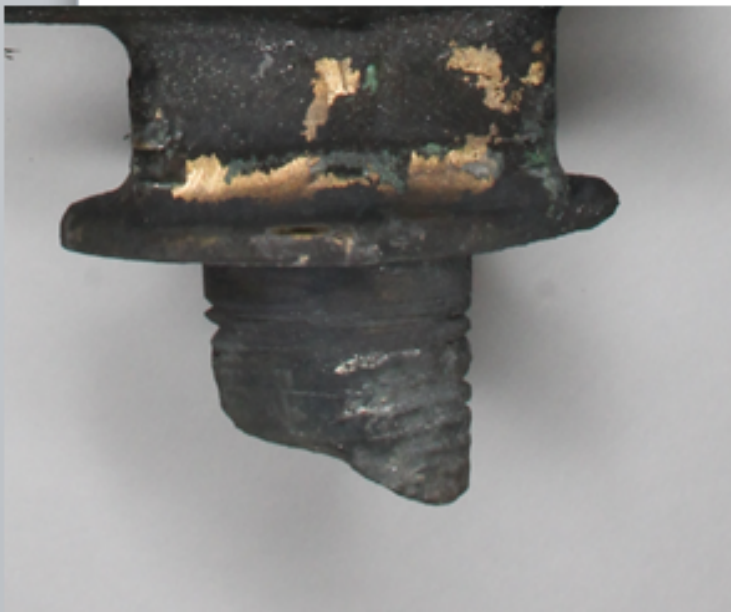
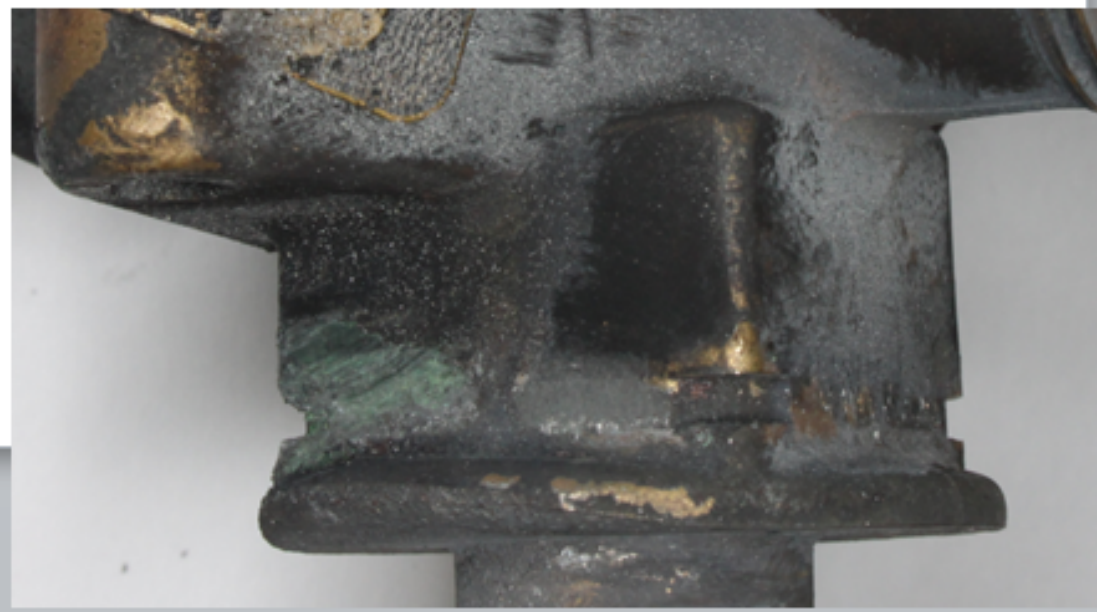
Thread Position Region (O'Clock)	Location	Al	Cu	Zn	F	C	O	Mo	Pb	Other	Notes
12	Damaged End 1	5.36	11.17	78.01	1.06	-	4.16	-	-	Ca <1	Localized region
	Damaged End 2	13.98	14.23	45.70	0.81	8.89	13.91	1.51	-	Si, Ca <1	Localized region
	Damaged End 3	8.68	13.55	48.47	0.93	13.10	12.19	1.56	-	Si, P, Cl, Ca <1	Overall
	Damaged End 4	8.74	16.08	44.86	0.45	14.51	12.03	-	1.68	Si, P, Cl, Ca <1	Localized region
	Damaged End 5	9.04	14.53	48.44	0.80	11.68	12.60	-	1.90	Si, Ca <1	Localized region
	Middle Region 1	8.72	14.55	52.60	1.86	11.37	9.30	-	1.48	S <1	Overall
	Middle Region 2	7.82	11.30	52.39	0.55	15.23	11.10	-	-	Si, S, Cl, Ca <1	Localized region, thread crest nearest damaged end
	Middle Region 3	9.11	16.29	51.39	1.93	11.97	7.69	-	1.62	none	Localized region, thread crest nearest middle thread region
	Region near flange 1	10.03	14.30	56.05	4.63	7.32	7.67	-	-	none	Overall
	Region near flange 2	12.40	13.09	55.99	4.23	6.03	8.26	-	-	none	Localized region, top thread

Region near flange 3	9.59	11.90	58.36	3.91	7.20	8.37	-	0.66	none	Localized region, flat surface near flange shoulder

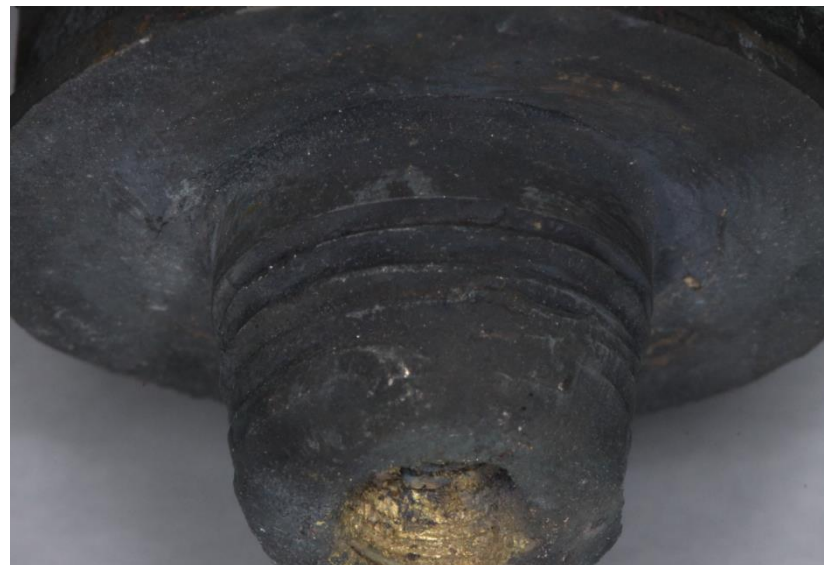
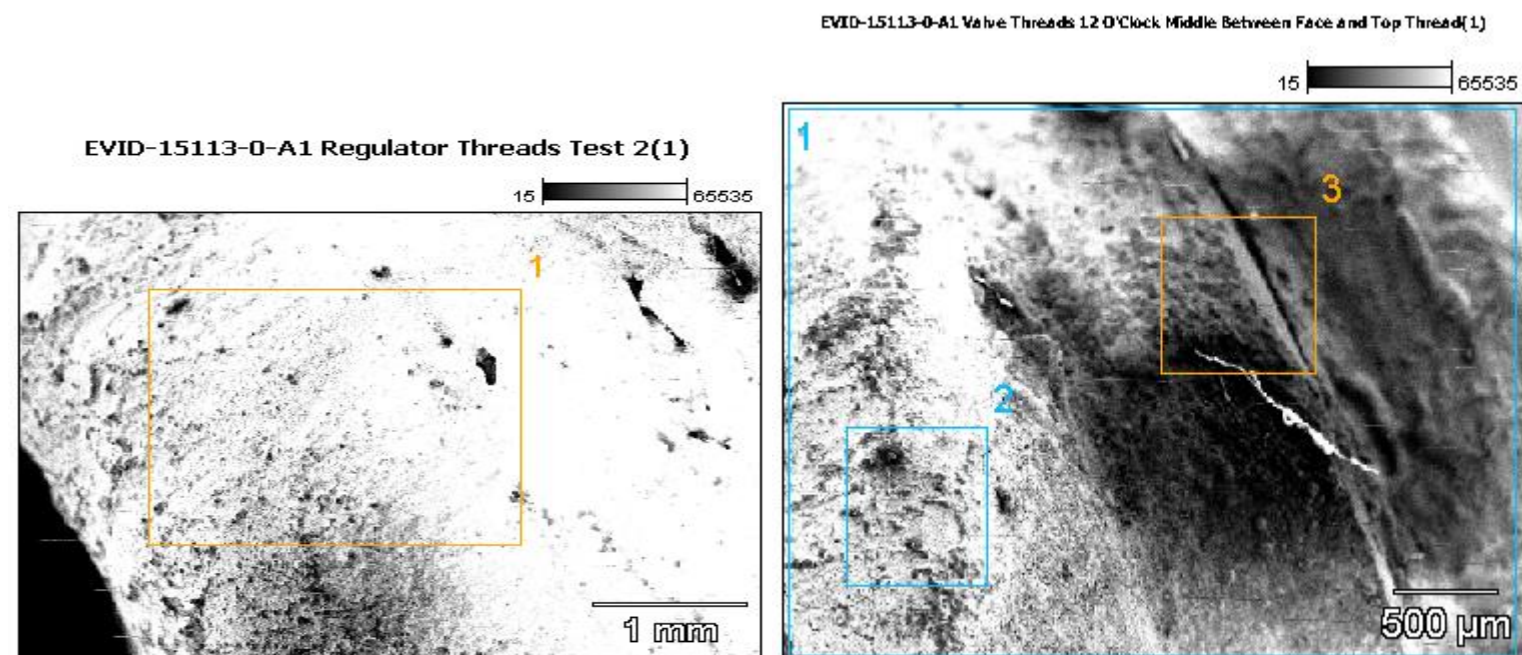
- Al (~10%) generally consistent throughout thread region from damaged end to flange
- F generally higher on middle and flange regions
- Mo and Pb seem to be present more toward the damaged end
- C and O generally higher on damaged and middle thread regions
- Cu (~13%) consistent throughout thread region from damaged end to flange
- Zn highest near flange and decreases moving toward damaged end, Zn content generally higher on this thread position than all other regions, note this end experienced most material loss during event

- *Generally more Pb and Mo observed at damaged end of thread positions*
 - 6 o'clock position observed this trend for Mo but there was no Pb (region of lesser material consumption)

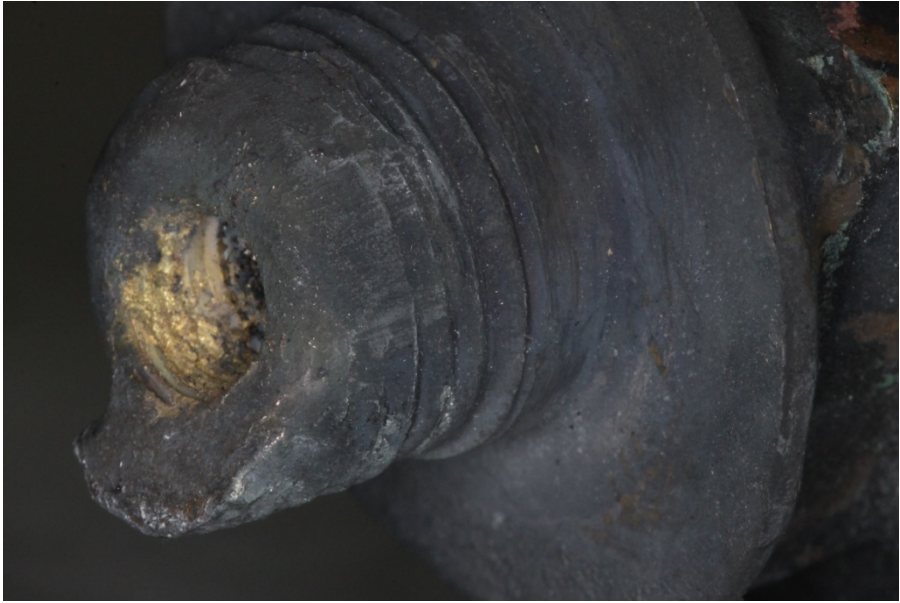
- Al generally higher on damaged end and decreasing moving toward flange region
- F generally higher on middle, upper, and flange regions of threads
- Pb higher on damaged end, no Pb detected on flanged region
- C and O generally higher on near damaged end
- Cu generally higher near flanged region and less on damaged end (Cu content lowest in middle thread region)
- Zn content higher on middle, upper and flange regions and above base material percentage (~46%)

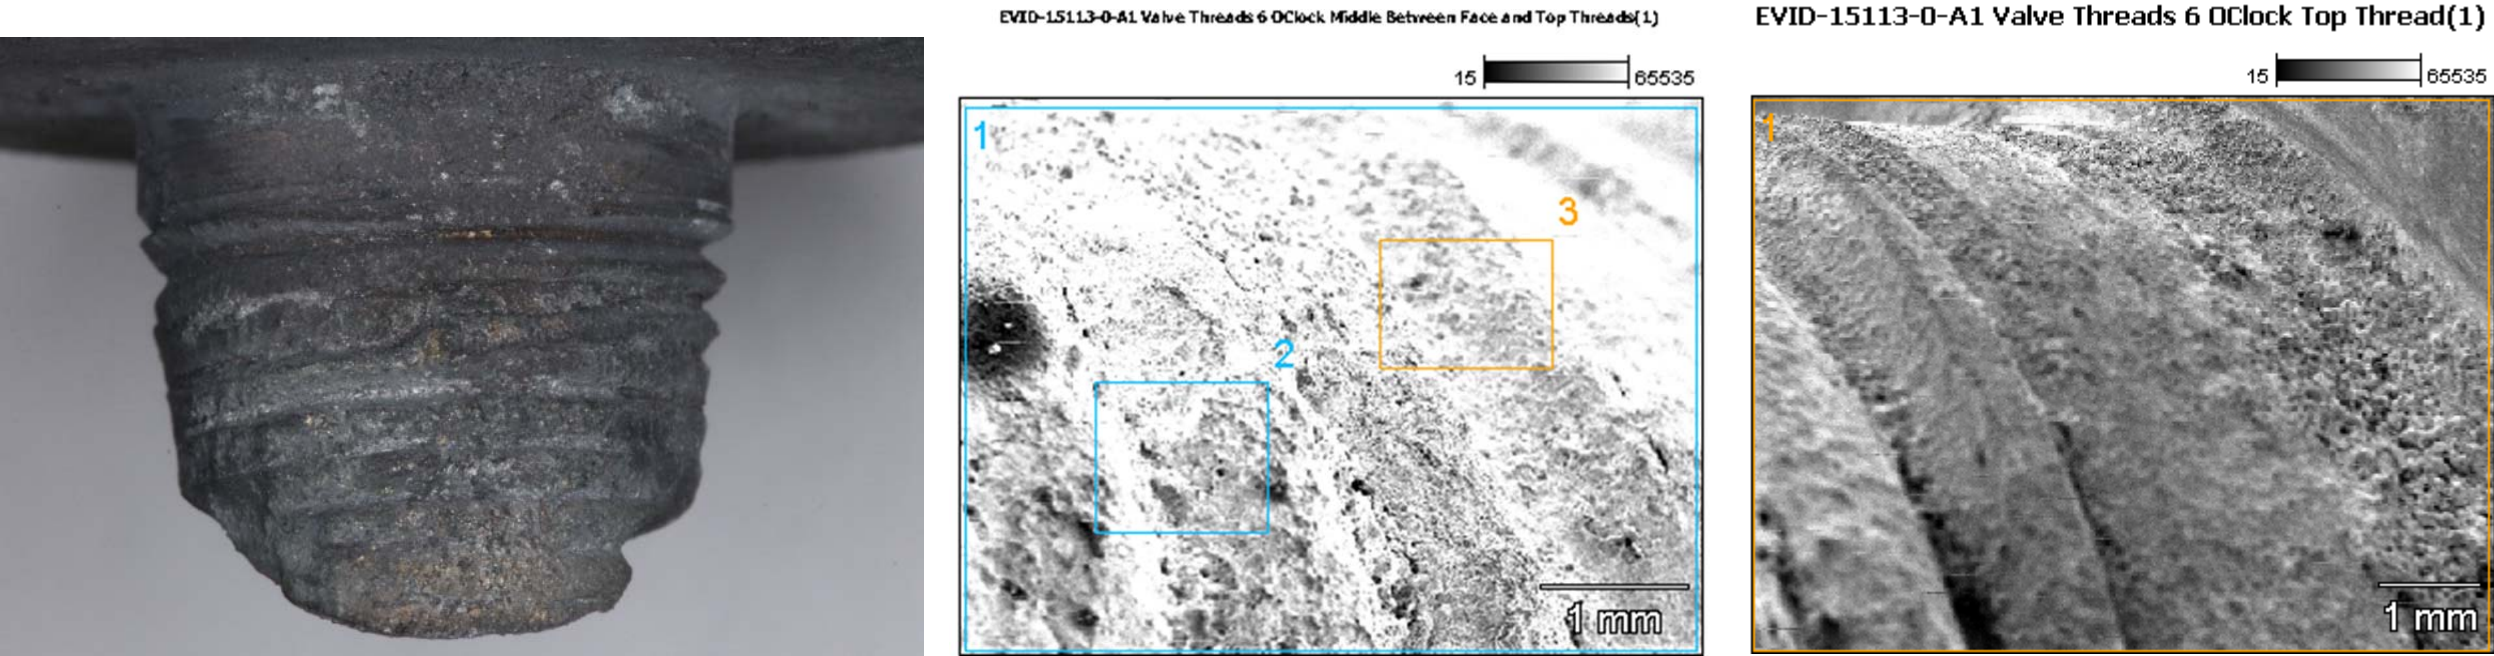
- Al content significantly higher on this side of threads, Al content generally increases moving from damaged end to flanged region
- No F detected on damaged end, detected F on middle and flanged regions
- O remains generally consistent throughout thread region
- C generally higher on damaged end, lesser C on top thread and flanged regions
- No Pb detected on this region of thread
- Mo generally higher on damaged end and decreases moving toward flange. No Mo detected on flange region.
- Zn (~20%) generally consistent throughout thread region
- Cu (~20%) generally consistent throughout thread region

- *Al content was greatest for the 6 o'clock thread position (region of thread that experienced less material loss)*
 - 12 o'clock position: Al content (~10%) generally consistent throughout thread position from damaged end to flange
 - 3 o'clock position: Al content generally higher on damaged end (~12%) than flanged end (~6%)
 - 6 o'clock position: Al content generally increasing from damaged end (~18%) to flanged end (~30%)
 - 9 o'clock position: Al content (~12%) consistent throughout thread region from damaged end to flange, highest amount of Al (~18%) on thread region near flange

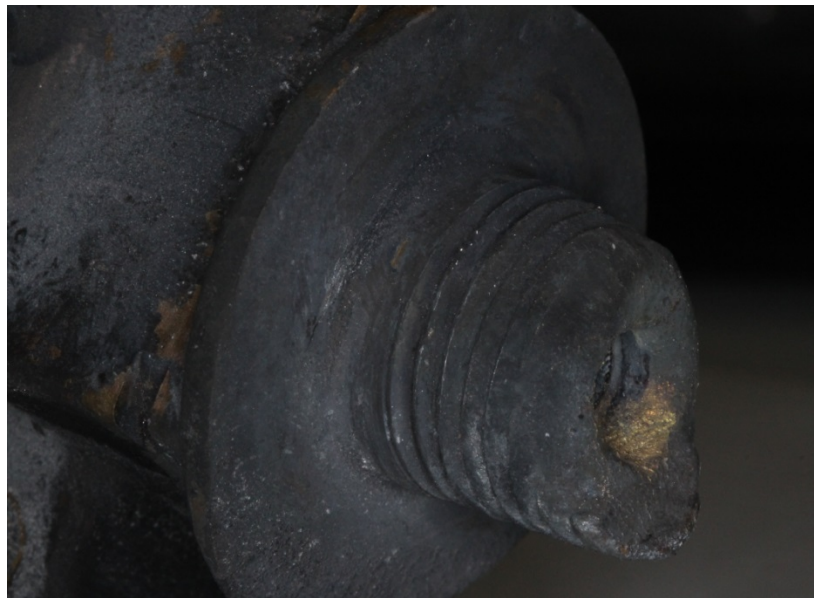
- Aluminum (~12%) consistent throughout thread region from damaged end to flange, highest amount of Al (~18%) on thread region near flange
- F generally higher on middle and top thread regions
- Zn (~40-45%) generally consistent throughout threaded region
- Cu generally consistent through threaded region, Cu content higher at top thread region
- C and O generally higher on damaged end
- Generally more Pb on damaged and middle thread regions
- Generally more Mo on middle and top threads regions

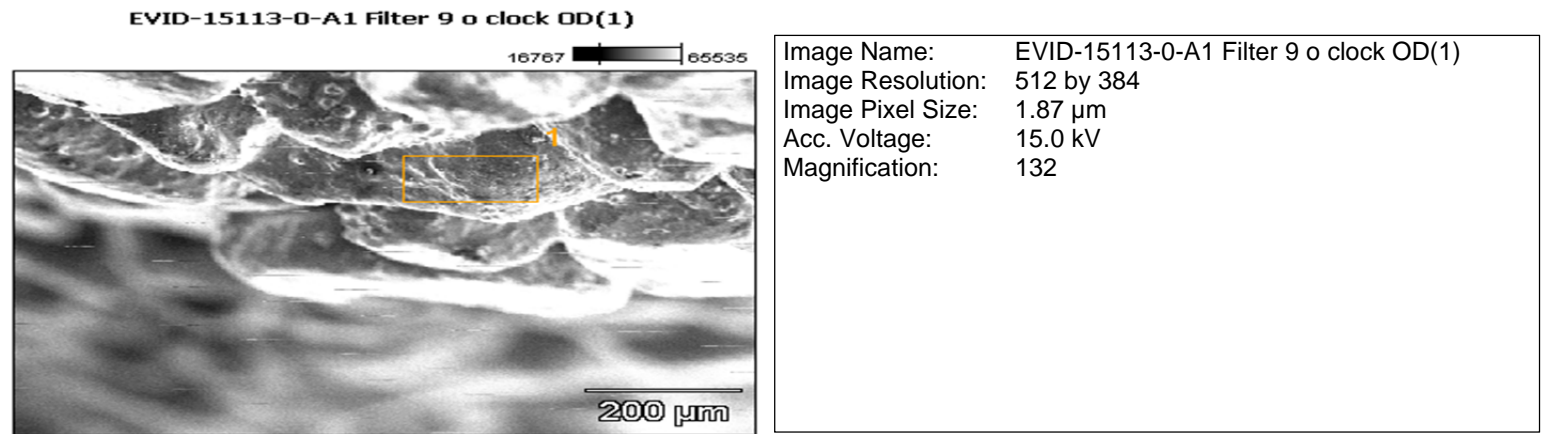
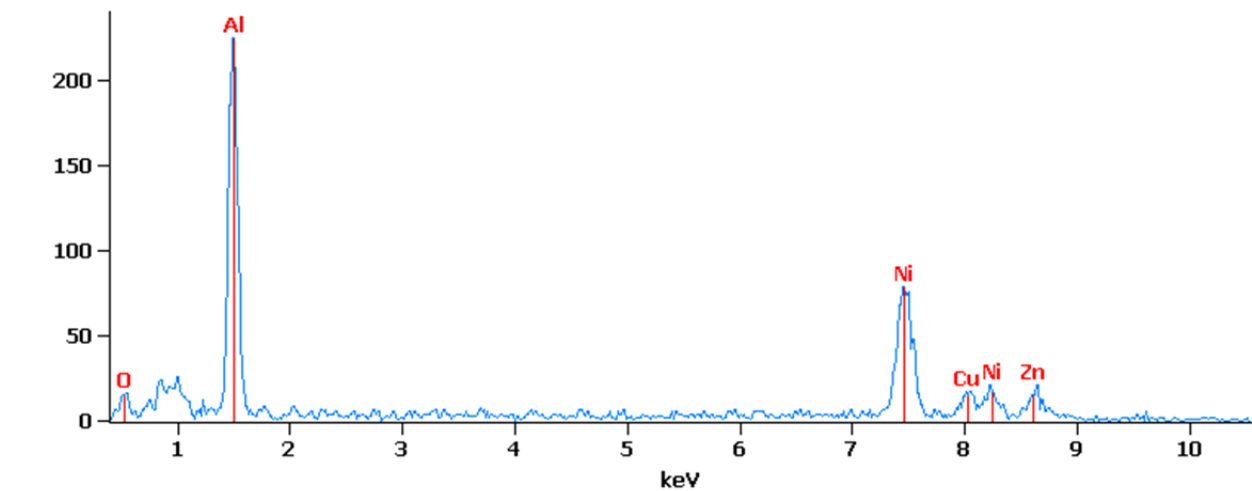
EVID 15113-0-A1 Valve Stem Filter Exterior Near Filter Face Facing Cylinder 9 O'clock Quadrant 4: First Scan Magnified

Area of analysis uncertain- Analysis was shot on the outside of the filter at an angle that would have the beam hitting the sample clamp and reflecting into the detector. The sample clamp analysis is included below

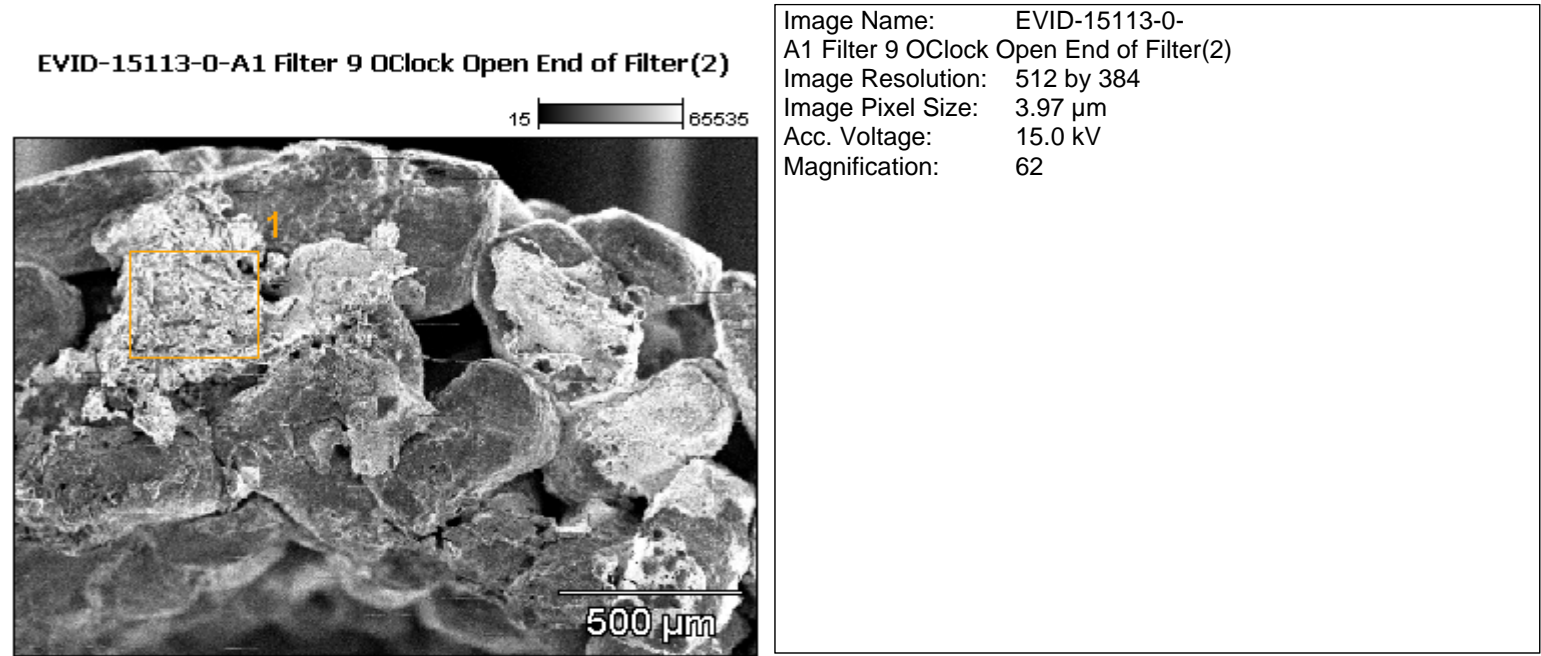
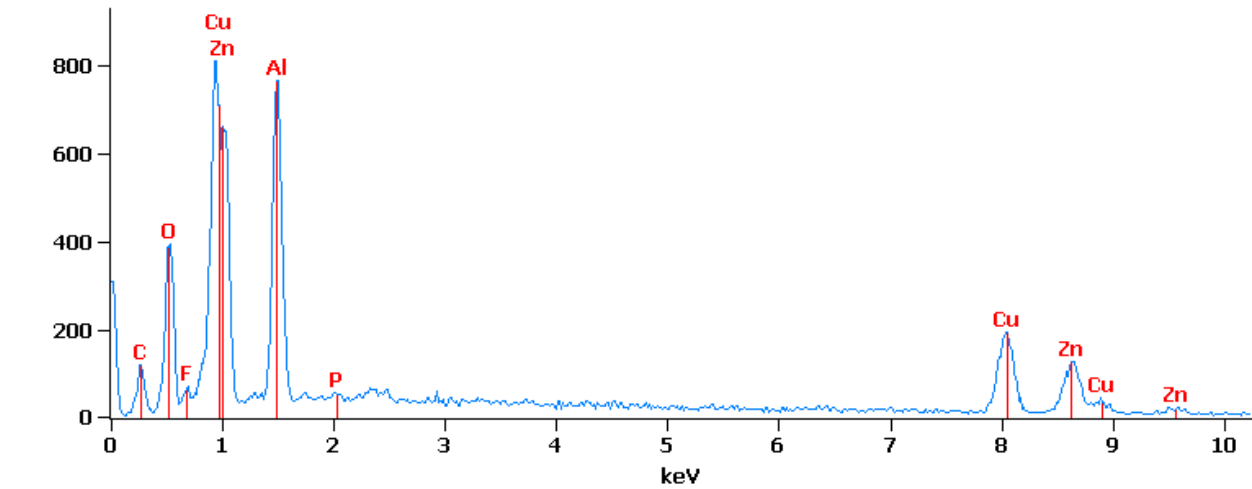
EVID 15113-0-A1 Valve Stem Filter Face Facing Cylinder 9 O’Clock Quadrant 4: First Scan

Filter Fit				
Chi² value: 1.196				
Correction Method: Proza (Phi-Rho-Z)				
Acc.Voltage: 15.0 kV Take Off Angle: 35.6°				
Element Line	Element Weight %	Element Weight % Error ±	Atom Weight %	Atom Weight % Error ±
C K	8.94	0.39	24.29	1.05
O K	12.86	0.33	26.24	0.68
F K	1.10	0.20	1.88	0.33
Al K	11.89	0.18	14.38	0.21
P K	0.26	0.05	0.28	0.06
Cu K	35.18	1.48	18.07	0.76
Zn K	29.77	1.99	14.86	1.00
Total	100	---	100	---

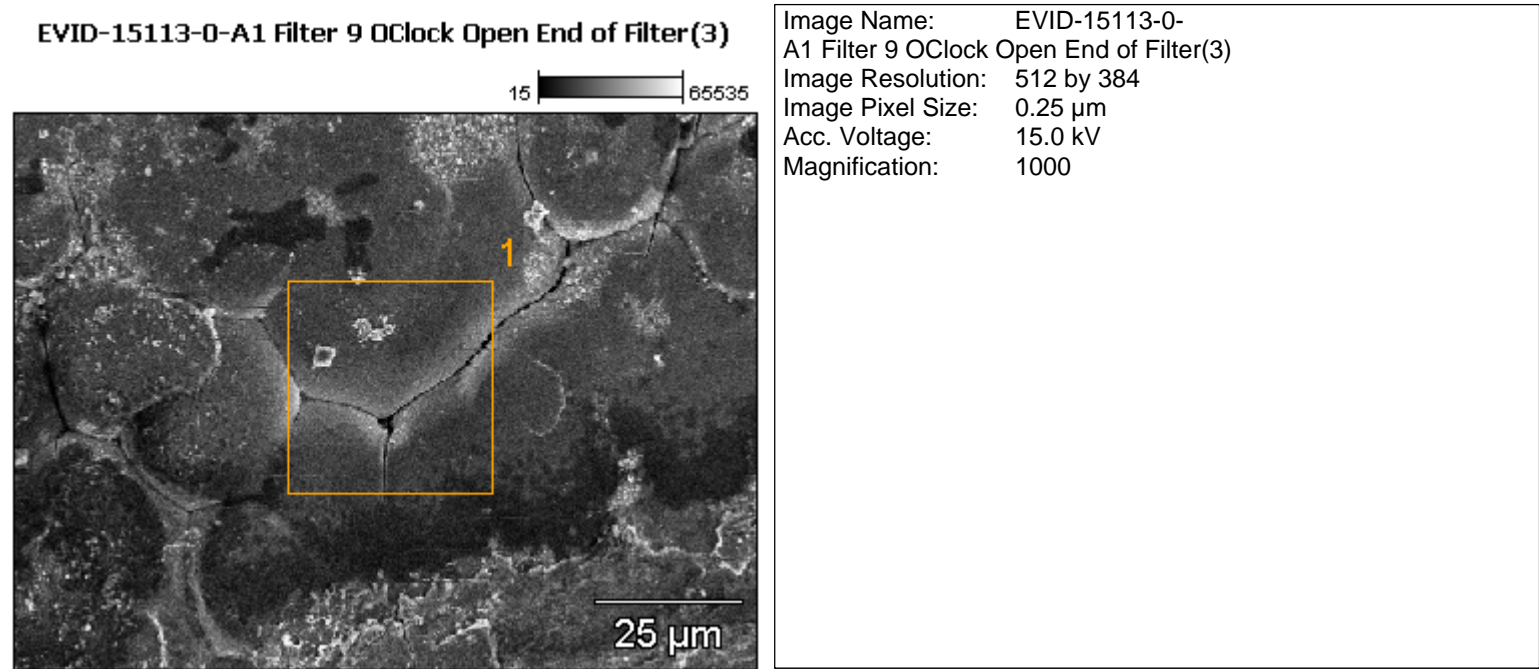
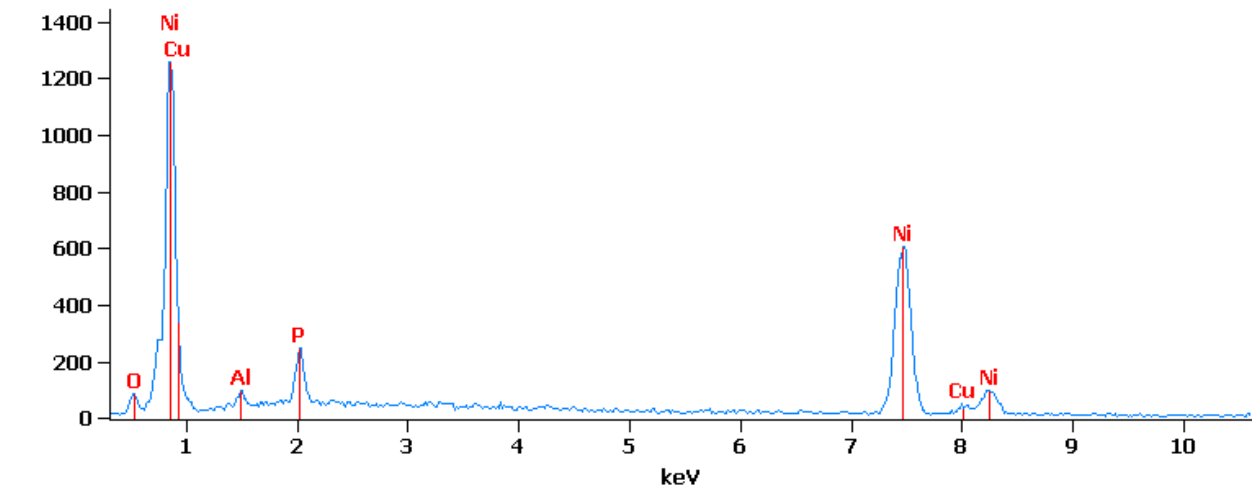
EVID 15113-0-A1 Valve Stem Filter Face Facing Cylinder 9 O’Clock Quadrant 4: Second Scan High Magnification

Filter Fit Chi² value: 1.436 Correction Method: Proza (Phi-Rho-Z) Acc.Voltage: 15.0 kV Take Off Angle: 35.8°				
Element Line	Element Weight %	Element Weight % Error	Atom Weight %	Atom Weight % Error
C K	3.64	0.26	14.78	1.06
O K	1.25	0.16	3.80	0.48
Al K	0.73	0.07	1.32	0.12
P K	2.65	0.08	4.18	0.13
Ni K	87.26	1.58	72.50	1.31
Cu K	4.47	0.73	3.43	0.56
Total	100	---	100	---

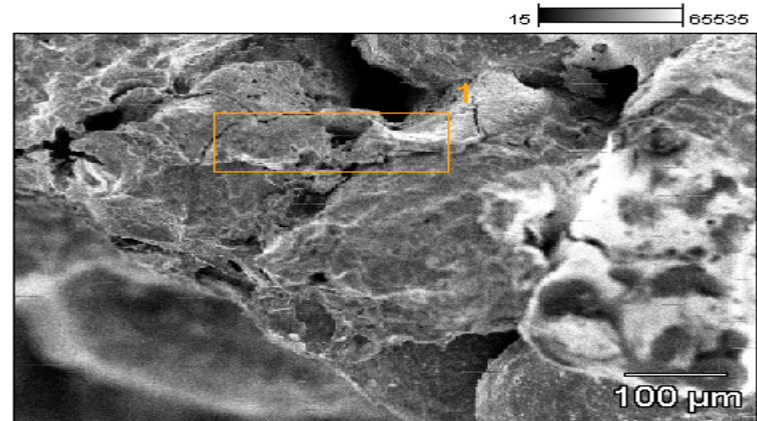
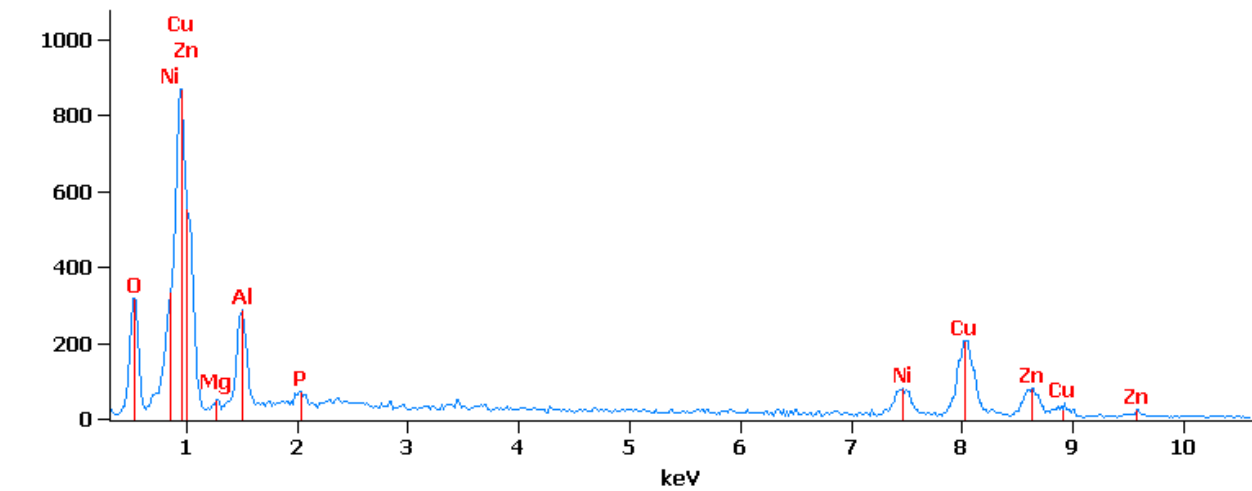
EVID 15113-0-A1 Valve Stem Filter Face Facing Cylinder 9 O’Clock Quadrant 4: Second Scan Magnified

Filter Fit				
Chi ² value: 0.771				
Correction Method: Proza (Phi-Rho-Z)				
Acc.Voltage: 15.0 kV Take Off Angle: 35.8°				
Element Line	Element Weight %	Element Weight % Error	Atom Weight %	Atom Weight % Error
C K	5.66	0.41	18.17	1.30
O K	10.95	0.29	26.36	0.69
Mg K	0.13	0.12	0.21	0.19
Al K	5.00	0.11	7.14	0.16
P K	0.74	0.11	0.92	0.14
Ni K	10.87	0.94	7.14	0.61
Cu K	45.45	1.87	27.56	1.13
Zn K	21.18	2.13	12.49	1.26
Total	100	---	100	---

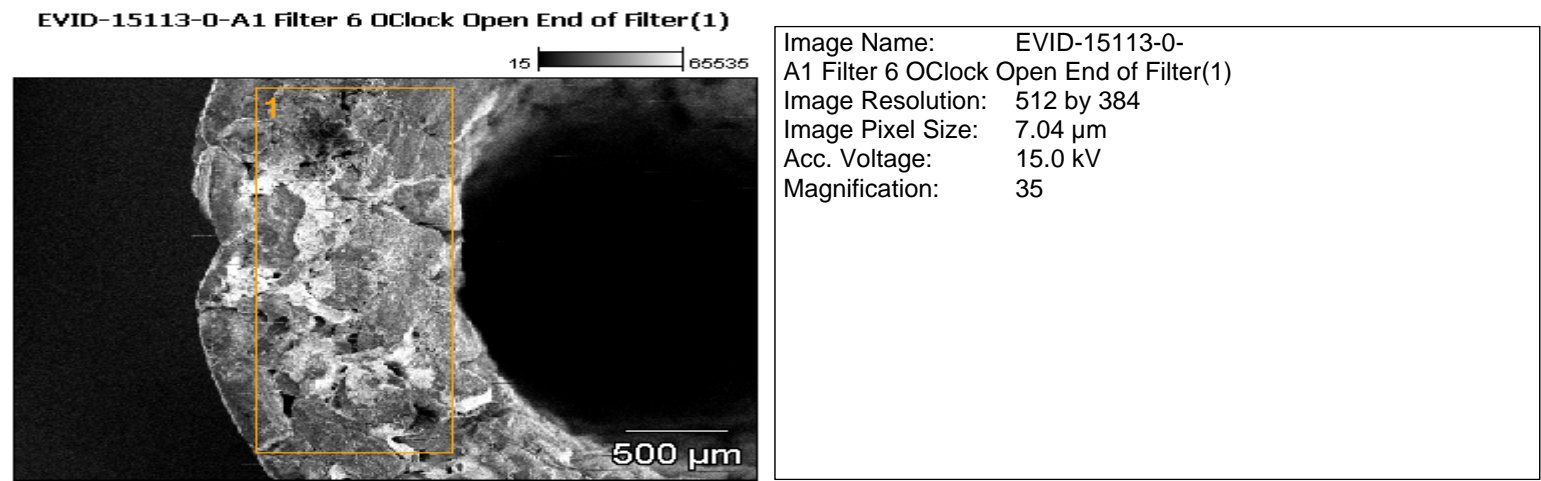
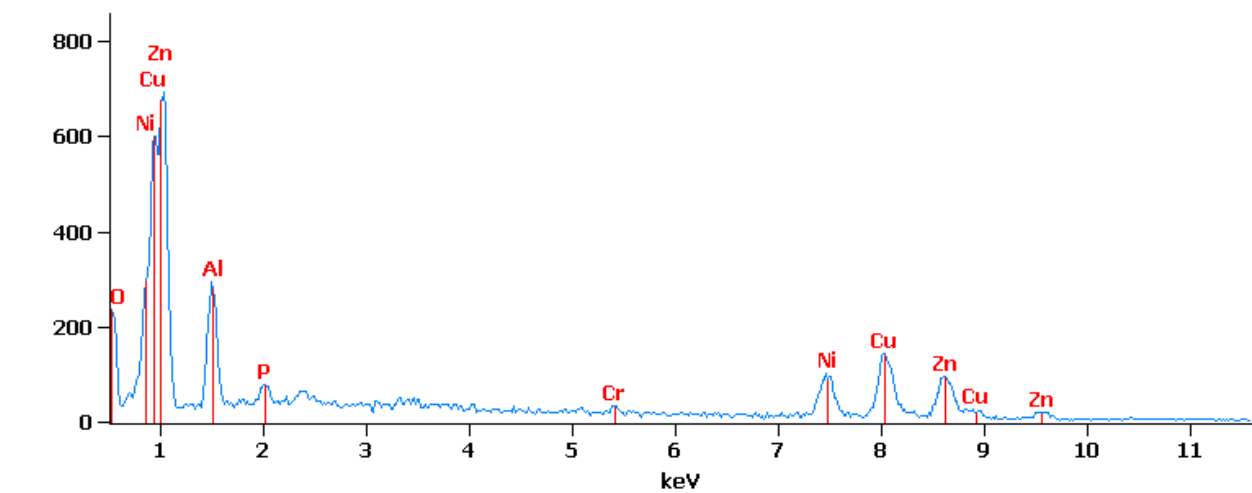
EVID 15113-0-A1 Valve Stem Filter Face Facing Cylinder 6 O’Clock Quadrant 3: First Scan

Filter Fit				
Chi² value: 0.845				
Correction Method: Proza (Phi-Rho-Z)				
Acc.Voltage: 15.0 kV Take Off Angle: 35.8°				
Element Line	Element Weight %	Element Weight % Error	Atom Weight %	Atom Weight % Error
C K	9.05	0.33	28.02	1.02
O K	7.62	0.37	17.72	0.85
Al K	6.00	0.16	8.27	0.22
P K	0.85	0.07	1.02	0.09
Cr K	0.64	0.15	0.46	0.11
Ni K	13.06	0.97	8.27	0.61
Cu K	31.39	0.75	18.37	1.03
Zn K	31.40	1.41	17.86	0.80
Total	100	---	100	---

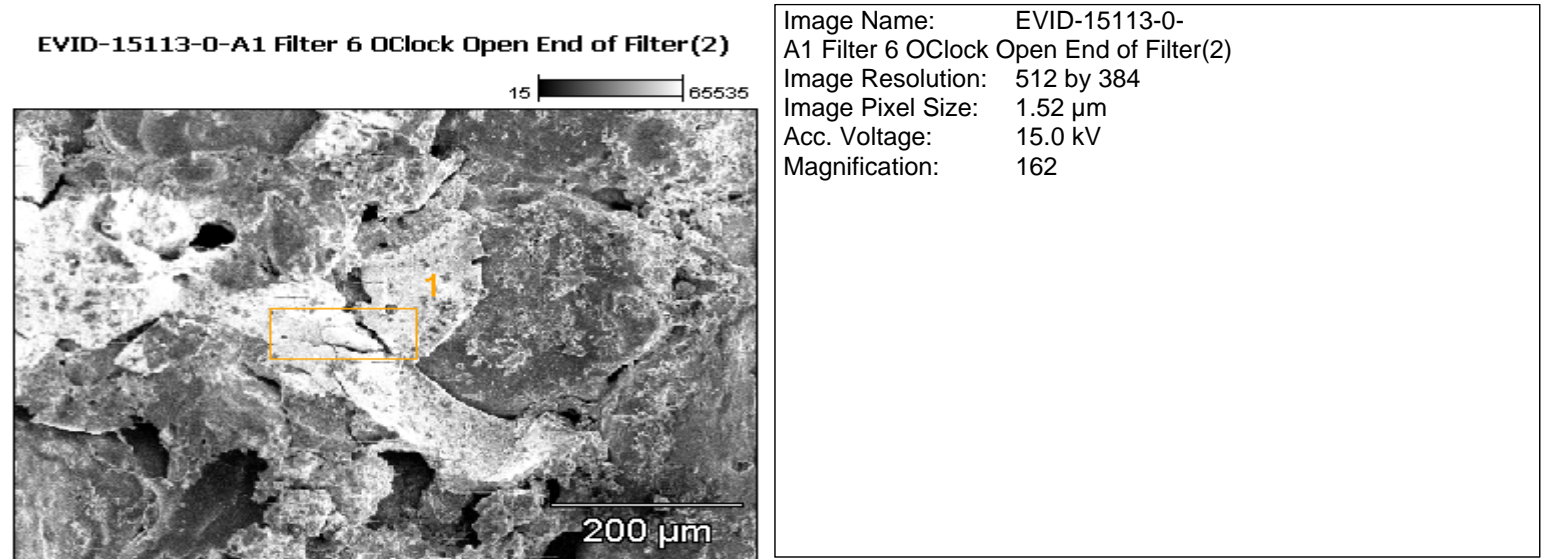
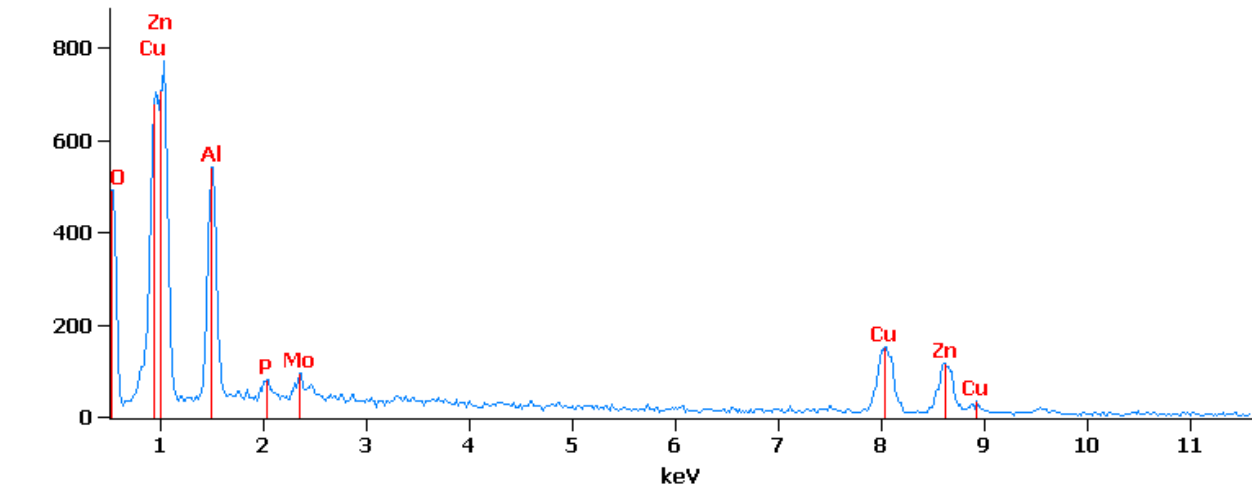
EVID 15113-0-A1 Valve Stem Filter Face Facing Cylinder 6 O’Clock Quadrant 3: Second Scan Magnified

Filter Fit				
Chi² value: 0.949				
Correction Method: Proza (Phi-Rho-Z)				
Acc.Voltage: 15.0 kV Take Off Angle: 35.6°				
Element Line	Element Weight %	Element Weight % Error	Atom Weight %	Atom Weight % Error
C K	5.95	0.28	16.74	0.80
O K	16.80	0.31	35.46	0.66
Al K	9.95	0.18	12.45	0.23
P K	0.61	0.07	0.67	0.08
Cu K	33.78	1.64	17.95	0.87
Zn K	31.29	2.16	16.16	1.11
Mo L	1.61	0.30	0.57	0.11
Total	100	---	100	---

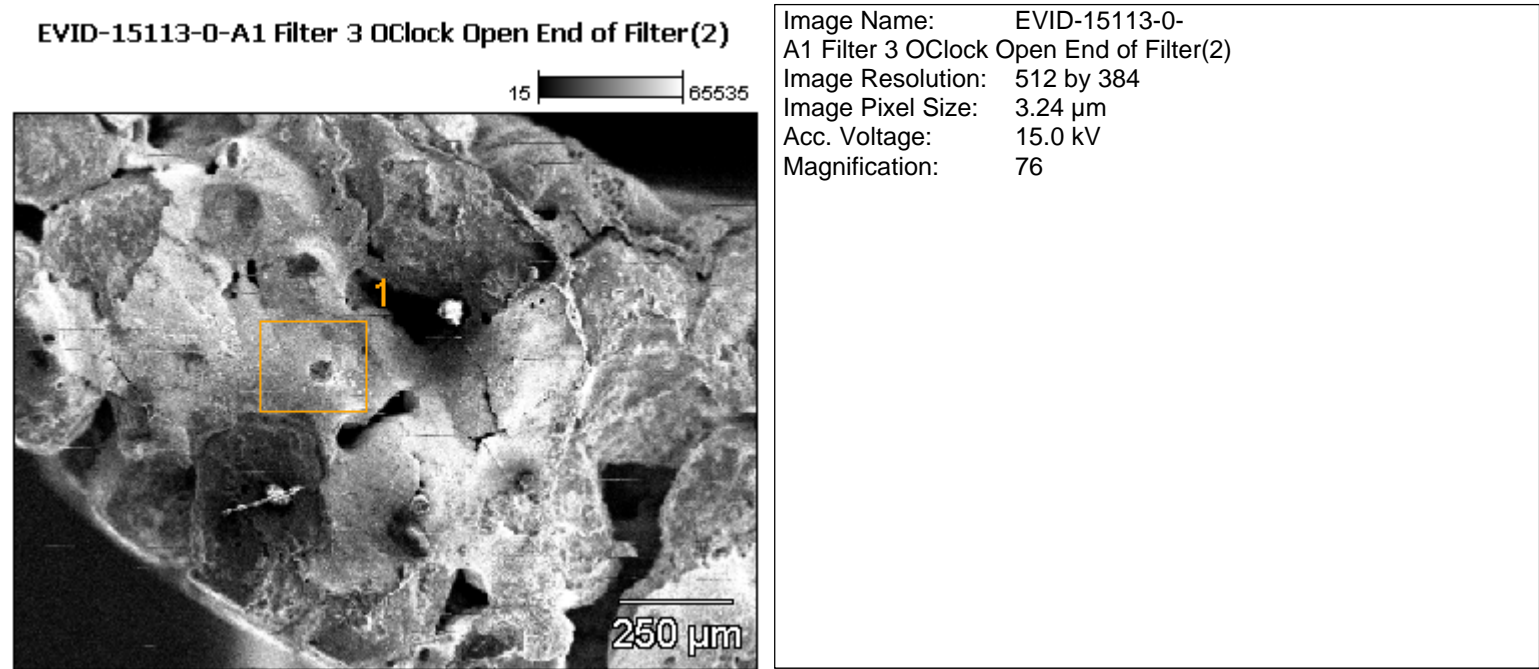
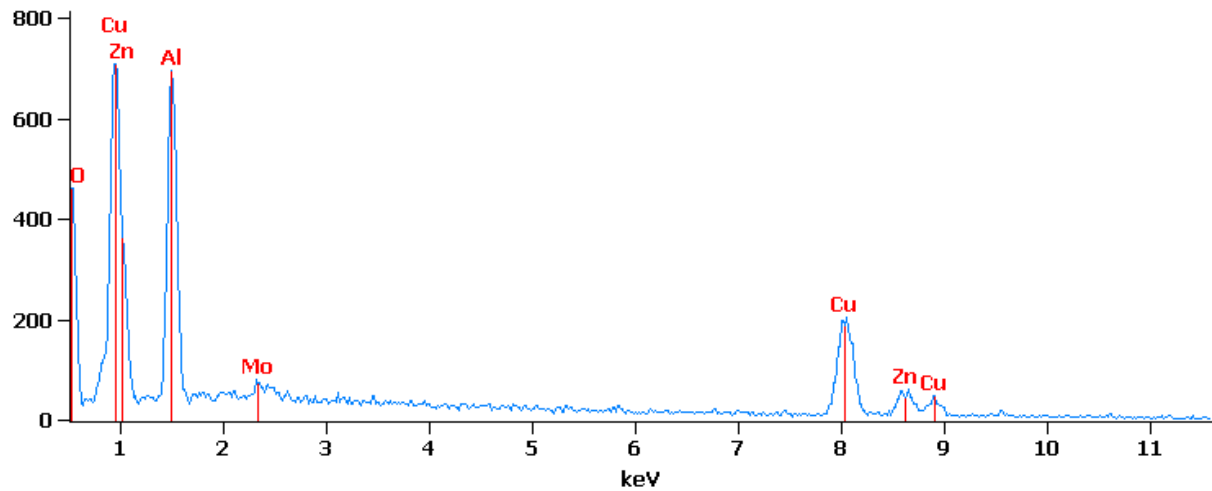
EVID 15113-0-A1 Valve Stem Filter Face Facing Cylinder 3 O’Clock Quadrant 2: First Scan

Filter Fit				
Chi² value: 1.204				
Correction Method: Proza (Phi-Rho-Z)				
Acc.Voltage: 15.0 kV Take Off Angle: 35.5°				
Element Line	Element Weight %	Element Weight % Error	Atom Weight %	Atom Weight % Error
C K	6.29	0.32	17.39	0.88
O K	15.56	0.31	32.31	0.65
Al K	13.89	0.21	17.10	0.26
Cu K	49.28	1.87	25.76	0.97
Zn K	13.89	2.00	7.06	1.01
Mo L	1.09	0.20	0.38	0.07
Total	100	---	100	---
