Valve Integrated Pressure Regulator Examination (DOT DUNS #079807449)

Report Number:
R-WHA-15113-0-A-EX1

WHA International Inc., (WHA) was requested by the Pipeline and Hazardous Materials Safety Administration (PHMSA) to document and evaluate the valve portion of a ruptured DOT 3AL cylinder that had been involved in a fire during high-pressure oxygen service, and to determine the following:

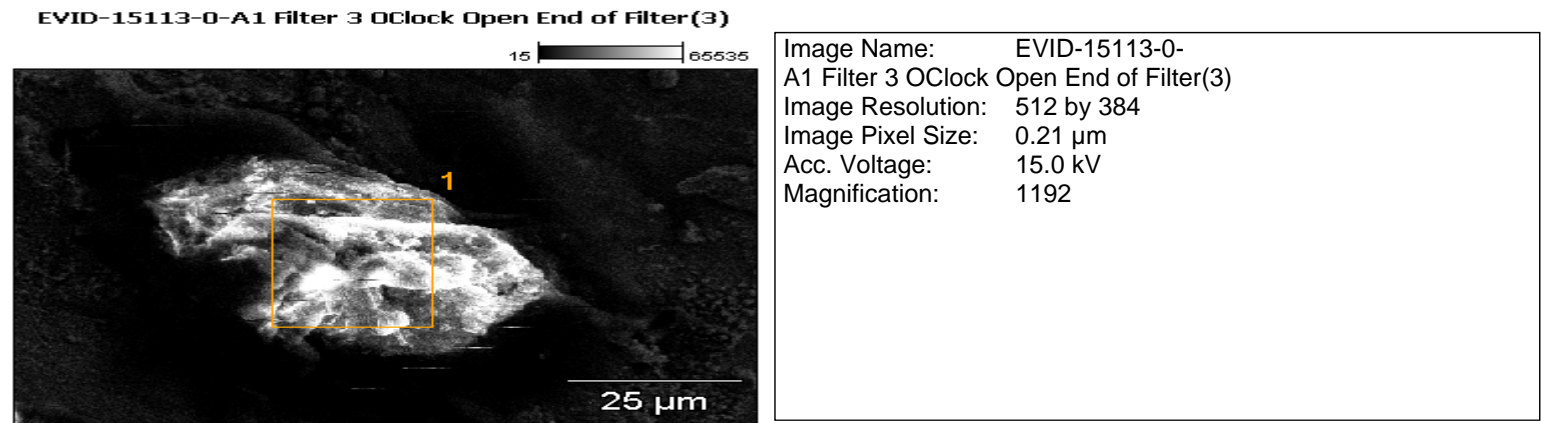
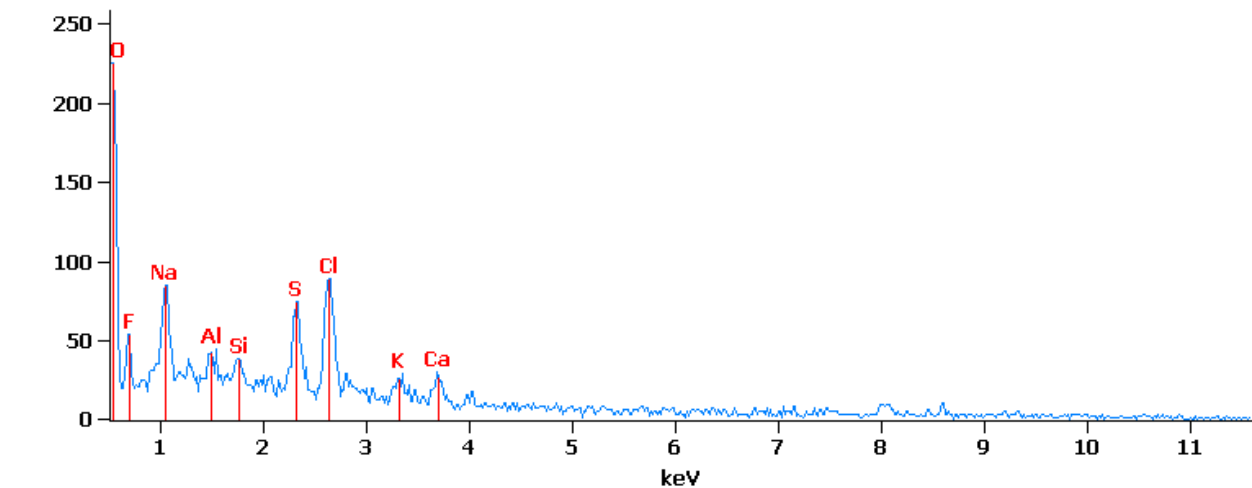
EVID 15113-0-A1 Valve Stem Filter Face Facing Cylinder 3 O’Clock Quadrant 2: Second Scan High Magnification

Filter Fit				
Chi² value: 0.823				
Correction Method: Proza (Phi-Rho-Z)				
Acc.Voltage: 15.0 kV Take Off Angle: 35.6°				
Element Line	Element Weight %	Element Weight % Error	Atom Weight %	Atom Weight % Error
C K	67.89	0.69	76.01	0.77
O K	23.17	0.69	19.48	0.57
F K	2.44	0.38	1.73	0.27
Na K	1.28	0.13	0.75	0.08
Al K	0.30	0.05	0.15	0.02
Si K	0.24	0.05	0.12	0.02
S K	1.24	0.12	0.52	0.05
Cl K	2.21	0.09	0.84	0.03
K K	0.43	0.07	0.15	0.02
Ca K	0.78	0.08	0.26	0.03
Total	100	---	100	---

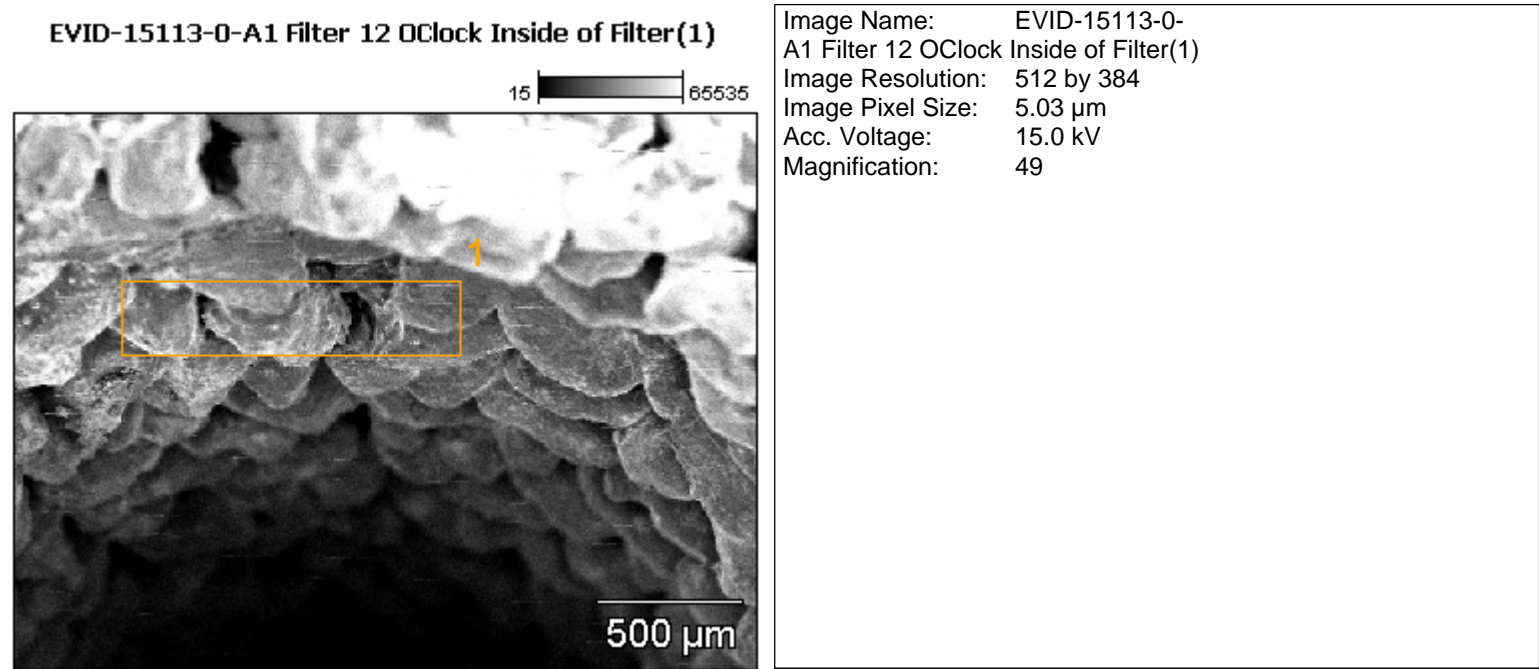
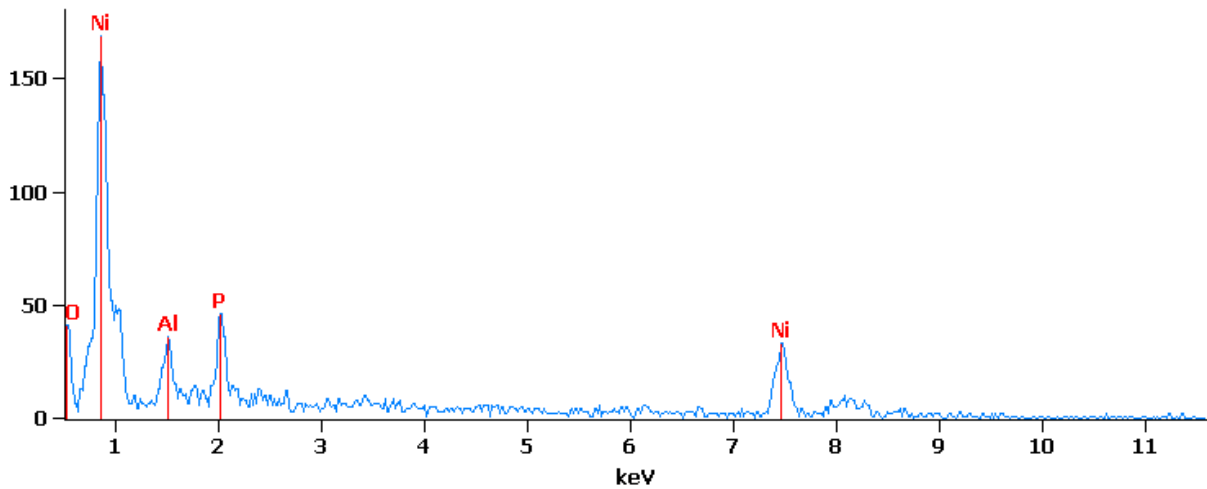
EVID 15113-0-A1 Valve Stem Filter Interior 12 O’Clock Quadrant 1: First Scan Magnified

Filter Fit				
Chi² value: 3.303				
Correction Method: Proza (Phi-Rho-Z)				
Acc.Voltage: 15.0 kV Take Off Angle: 35.0°				
Element Line	Element Weight %	Element Weight % Error	Atom Weight %	Atom Weight % Error
C K	17.56	2.03	37.85	4.38
O K	17.49	1.56	28.30	2.48
Al K	5.37	0.60	5.15	0.56
P K	6.17	0.64	5.15	0.54
Ni K	53.41	5.25	23.55	2.30
Total	100	---	100	---
