**Assessment of Pipeline Integrity  
of Kinder-Morgan Conversion  
Of the Rancho Pipeline**

**City of Austin Texas**

**June, 2004**

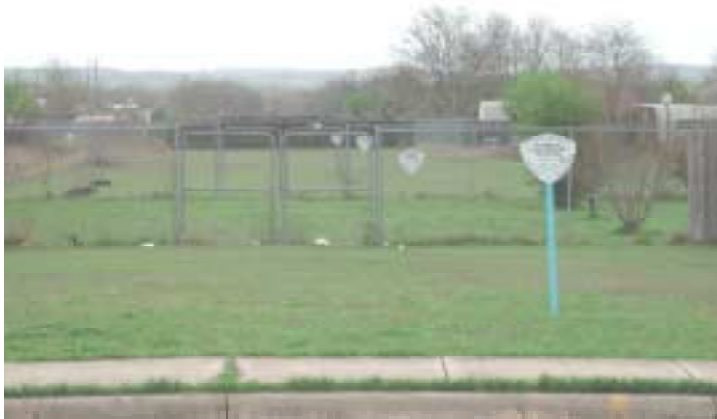
**Figure 8. Rancho Pipeline Proximity to Backyards and Houses**

The building proximity was reviewed by visually observing the distance from the pipeline to occupied buildings in driving along the pipeline route and by reviewing aerial photographs of the pipeline and the adjacent buildings. Figures 8 and 9 present views of the pipeline showing its proximity to houses. In Figure 8, the house is about 70 feet from the pipeline as indicated by the white sign. In Figure 9, the pipeline right of way is in a utility corridor that is about 100 feet from houses and apartments. There are other areas along the line where the pipeline is remote from houses and apartments and is in a Class 1 location. While the housing location is diverse our focus was on the buildings in close proximity to the pipeline.

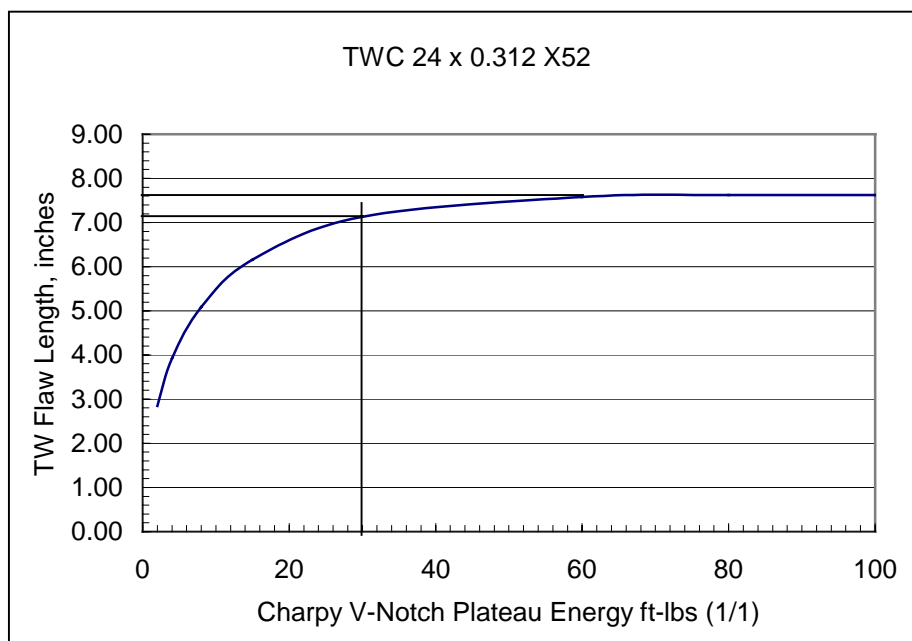
**Figure 10. Through-Wall Flaw Length Versus Charpy Energy**

Figure 7 presented the flaw lengths and depths of part-through flaws that can be tolerated in 24 x 0.312 inch wall thickness X52 pipe. (Note: the 0.344 inch wall thickness pipe with a similar toughness will tolerate slightly larger flaws.) As an example of the usage of the figure, at a failure stress of 50%SMYS (operating stress level), this pipe can tolerate a rectangular shaped flaw that is 90% of the wall thickness in depth and 1.75 inches in length. Similarly at the same stress level, a flaw that is 10% through the wall can be tolerated that is 15.5 inches long. At this stress level the length of flaw that will lead to rupture is 7.2 inches as indicated by the TWC (through wall curve); shorter flaws will lead to leaks.

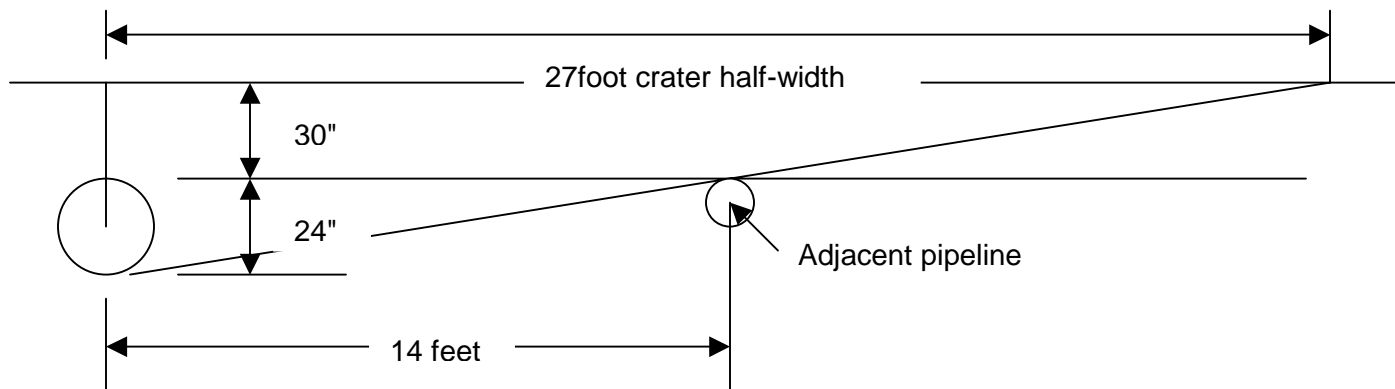
**Figure 11. Sketch of Crater Width Effect on Adjacent Pipeline**

A sketch has been made to illustrate the effect of a 27 foot crater half width or radius. Figure 11 shows that for the 27 foot crater half-width that for an adjacent pipeline to be partially exposed it would have to be located within about 14 feet of the Rancho pipeline for the worst-case soil conditions. For the pipeline to be completely exposed it would have to be located several feet closer still. This is closer than pipelines are typically placed (usually 25 feet) and indicates that there is a very remote chance that the rupture of the Rancho natural gas line removing the overburden would expose an adjacent line to sufficient force to cause its rupture.

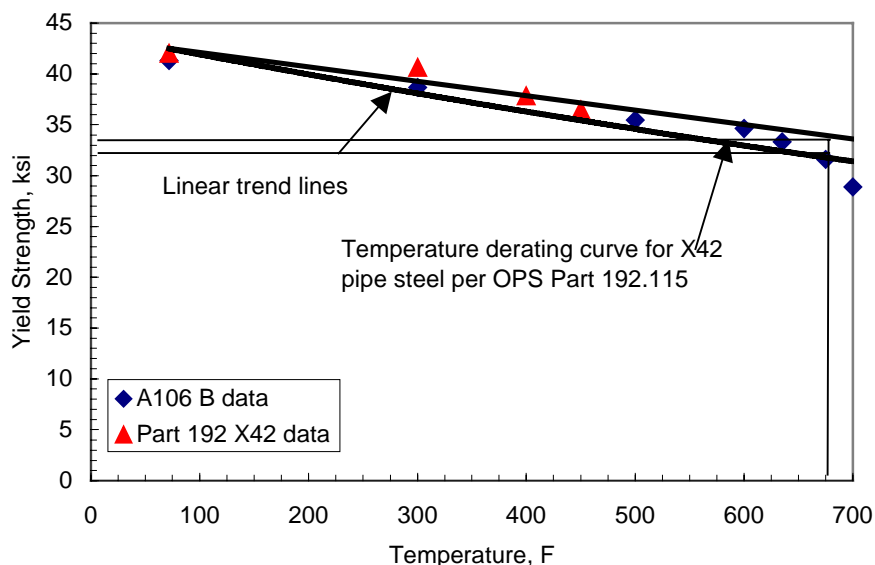
**Figure 12. Temperature Effects on Line Pipe**

As shown in Table 8 the adjacent pipelines are X42, X60 and X65 grades. The following section assesses the pressure stress in the adjacent pipelines compared to the yield strength at 675F. High temperature strength data are presented in Figure 12 from two sources. The top curve presents the temperature derating requirements for X42 grade pipe that exist in the Federal Regulations for natural gas pipelines, 49 CFR Part 192.115. At room temperature, the yield strength is 42,000 psi. The bottom curve represents tensile tests that were conducted by the author on A106B pipe which is a plain carbon steel that has not been cold worked in the formation of the pipe and therefore its room temperature yield strength is lower but the trend of the data is the same. The observation that the two curves are essentially parallel allows extrapolation of the X42 curve to higher temperatures.

The highest hoop stress that could exist in an adjacent X42 pipeline is 72% SMYS which creates a stress of 30,240 psi. The lowest yield strength that can be expected at 675F (used in place of 662F) according to Figure 12 for X42 pipe is between 32,000 and 34,000 psi. Therefore, the imposed stresses are lower than the reduced yield strength at temperature and would be safe if it has a 25 or more foot spacing from the ruptured line. The higher grades of pipe, X60 or X65, will also be safe as the stress in the pipes will be 43,200 psi or 46,800 psig at a 72% design factor and the yield strengths were calculated (similar to Figure 12) to be 48,000 psi and 53,000 psi respectively. In both cases, the stress levels are below the yield strengths at temperature. Therefore, the adjacent pipelines were found to be safe from thermal effects if the pipe is uncovered and the adjacent pipeline is not shut down. The above calculations assume that the flow is maintained in the adjacent lines as the flow removes the heat input into the pipe
