U.S. Department of Transportation
Pipeline and Hazardous Materials
Safety Administration

Construction Issues

Gery Bauman

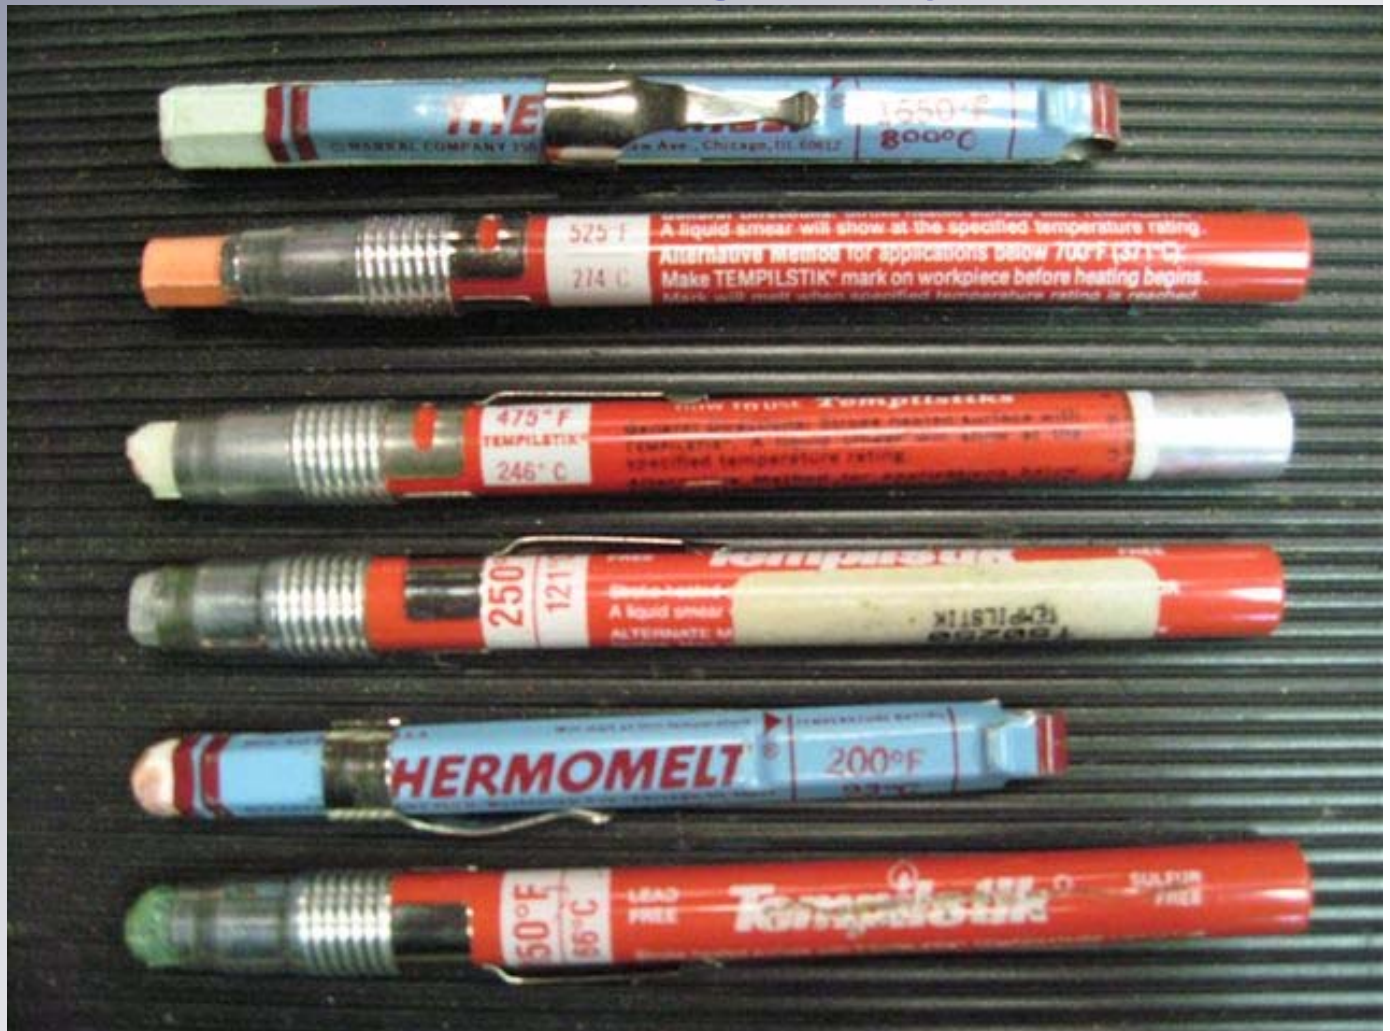
Temperature Indicating Crayons

The crayon
holder
specifies the
melt
temperature

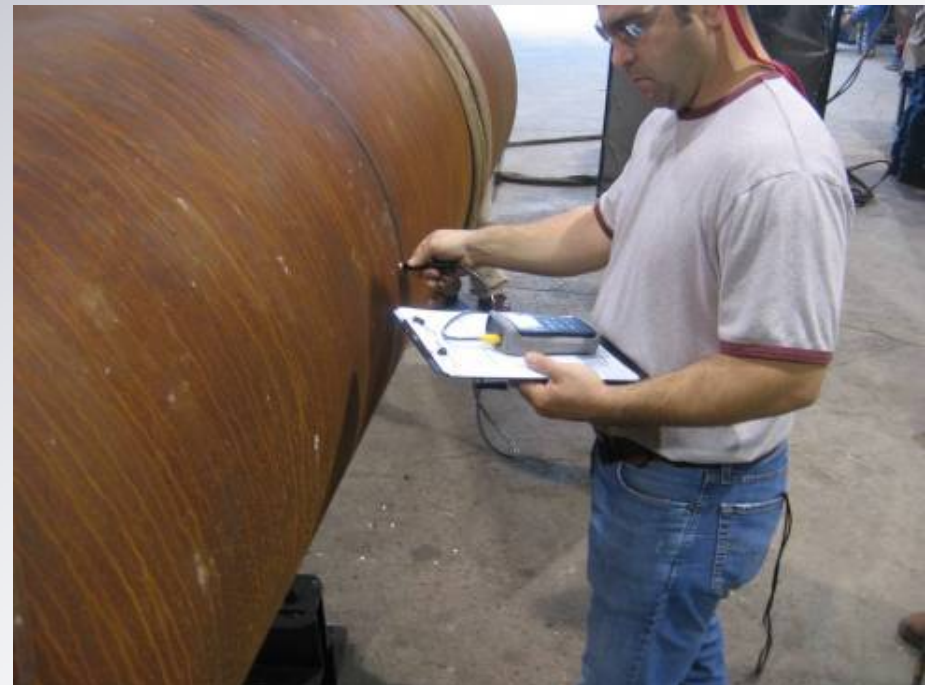
- Contact pyrometers and infrared thermometers can be also used to verify preheat.
- Caution infrared thermometers are not accurate on sand blasted surfaces and values can change based on the emissivity of the weld area

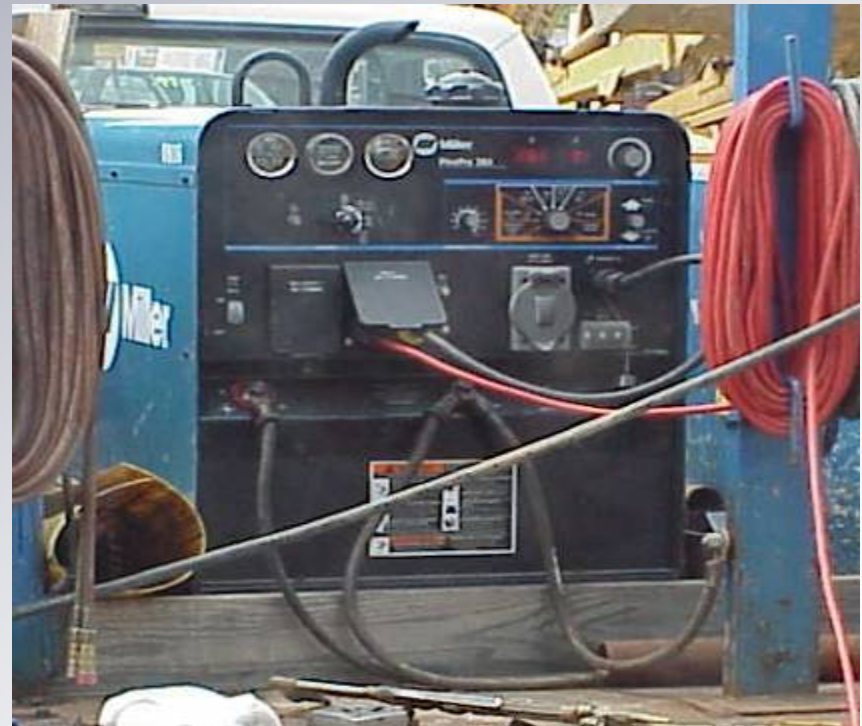
Electrical Characteristics

- Values should be within the ranges specified on the welding procedure

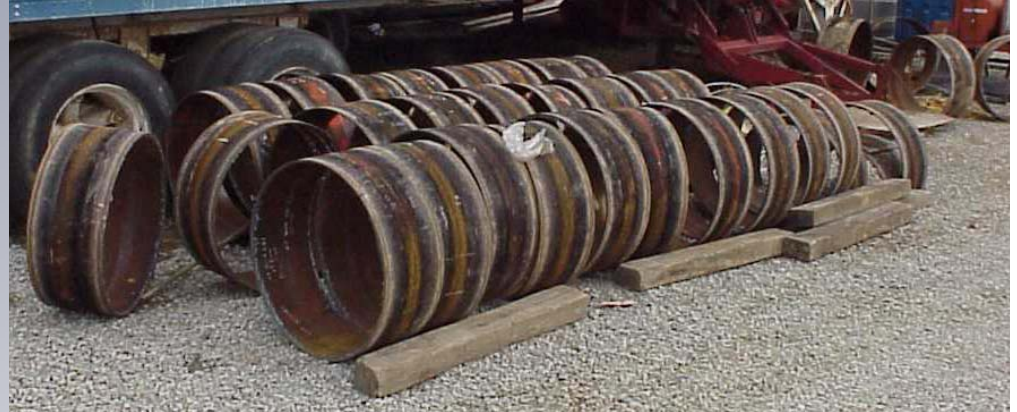
Causes of High Defect Rate

- Equipment issues
- Pipe sizing issues
- Inexperienced welders
- Start up issues
- Stacked defects
- Allowing contractors to set up equipment while welding main line pipe
- X-ray or AUT falling behind eliminates timely feed back. Feed back is a valuable tool to improve weld quality.
- Root-Hot pass welding way out front of fill and cap

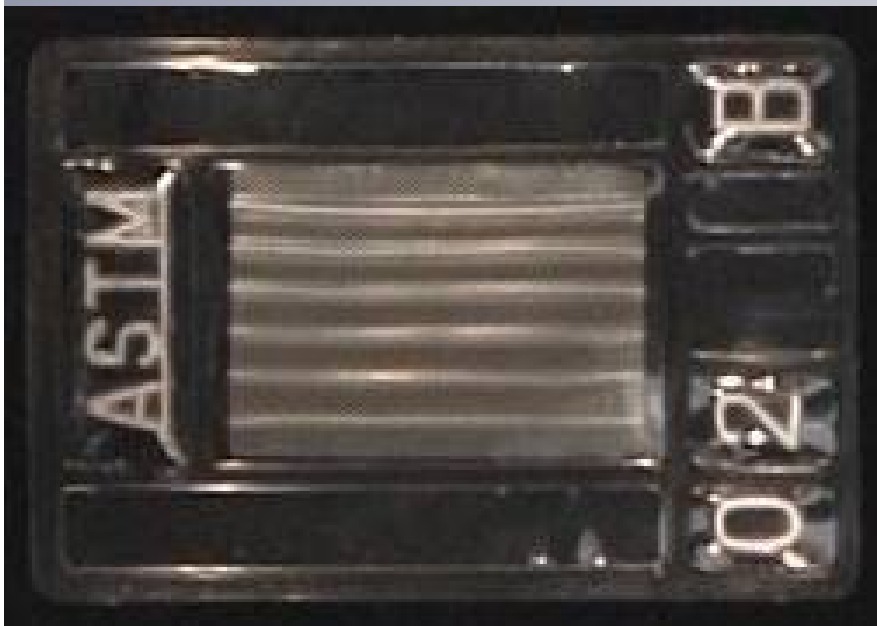
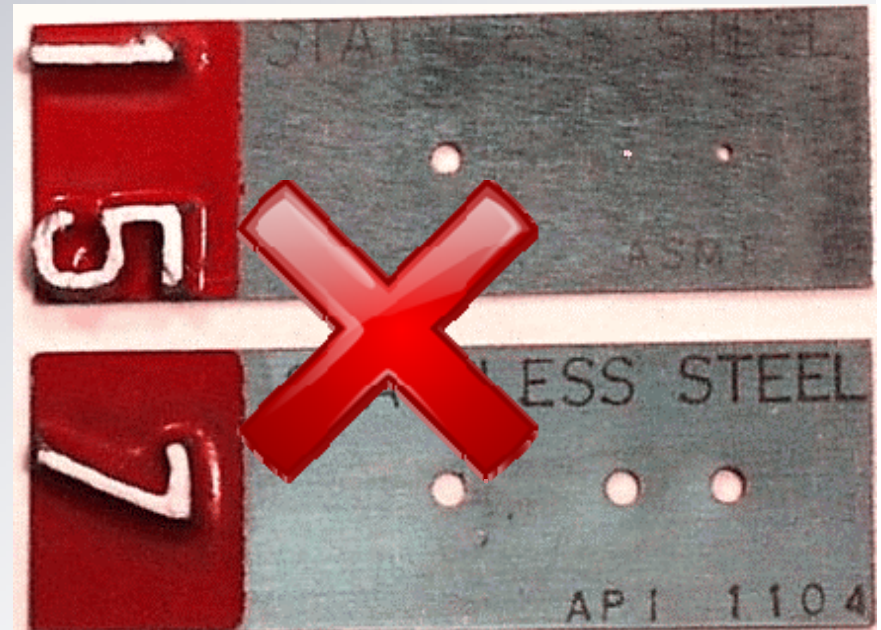
Image Quality Indicators (Penetrameters)

- PHMSA recognizes the 20th edition of API 1104. The 20th edition **only** allows the use of Wire Type Image Quality Indicators.

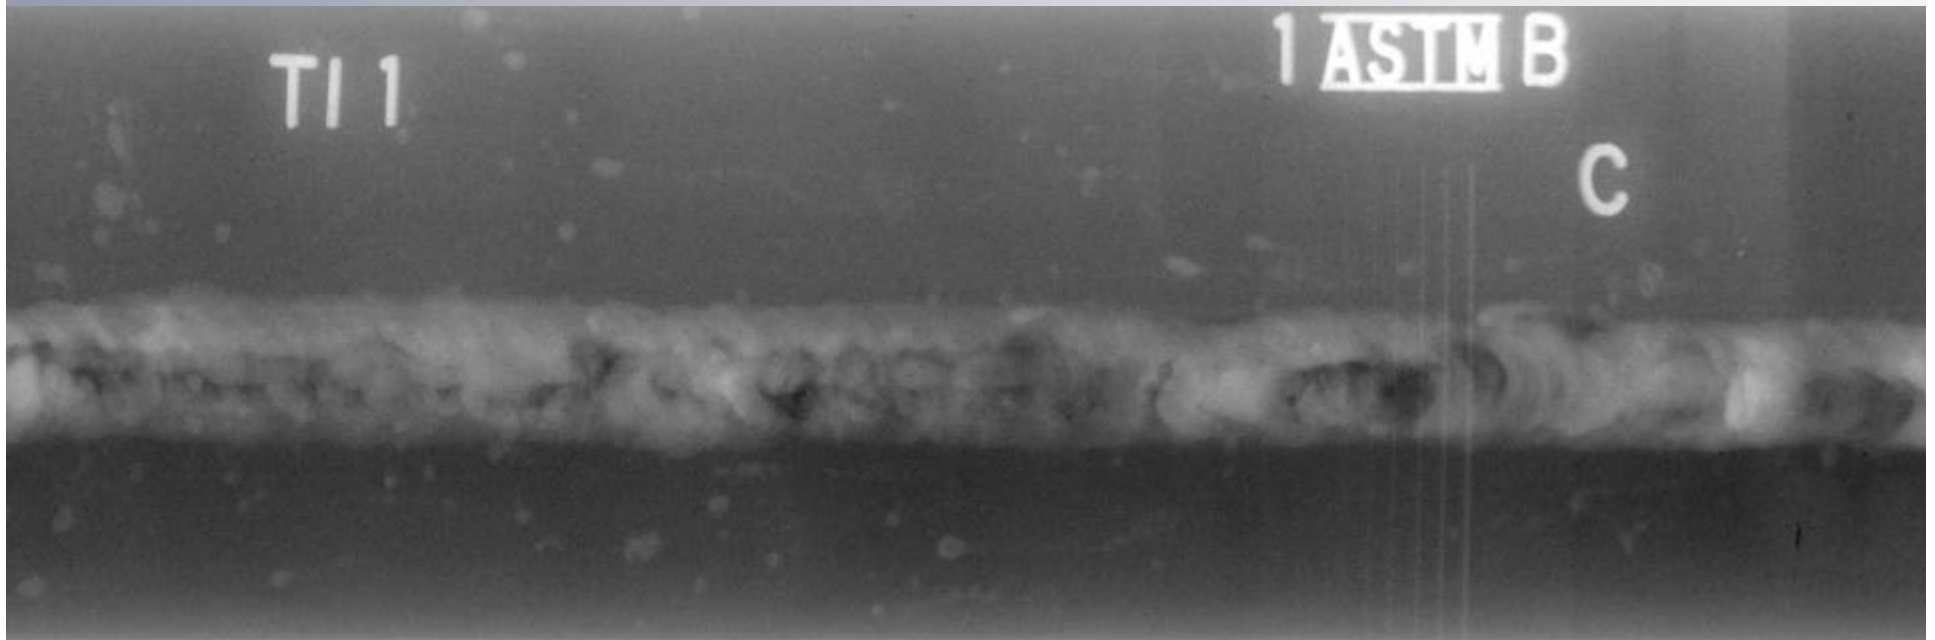
ASTM Type B Packet

The complete outline of the essential wire must be visible. Essential wire should not be obscured.

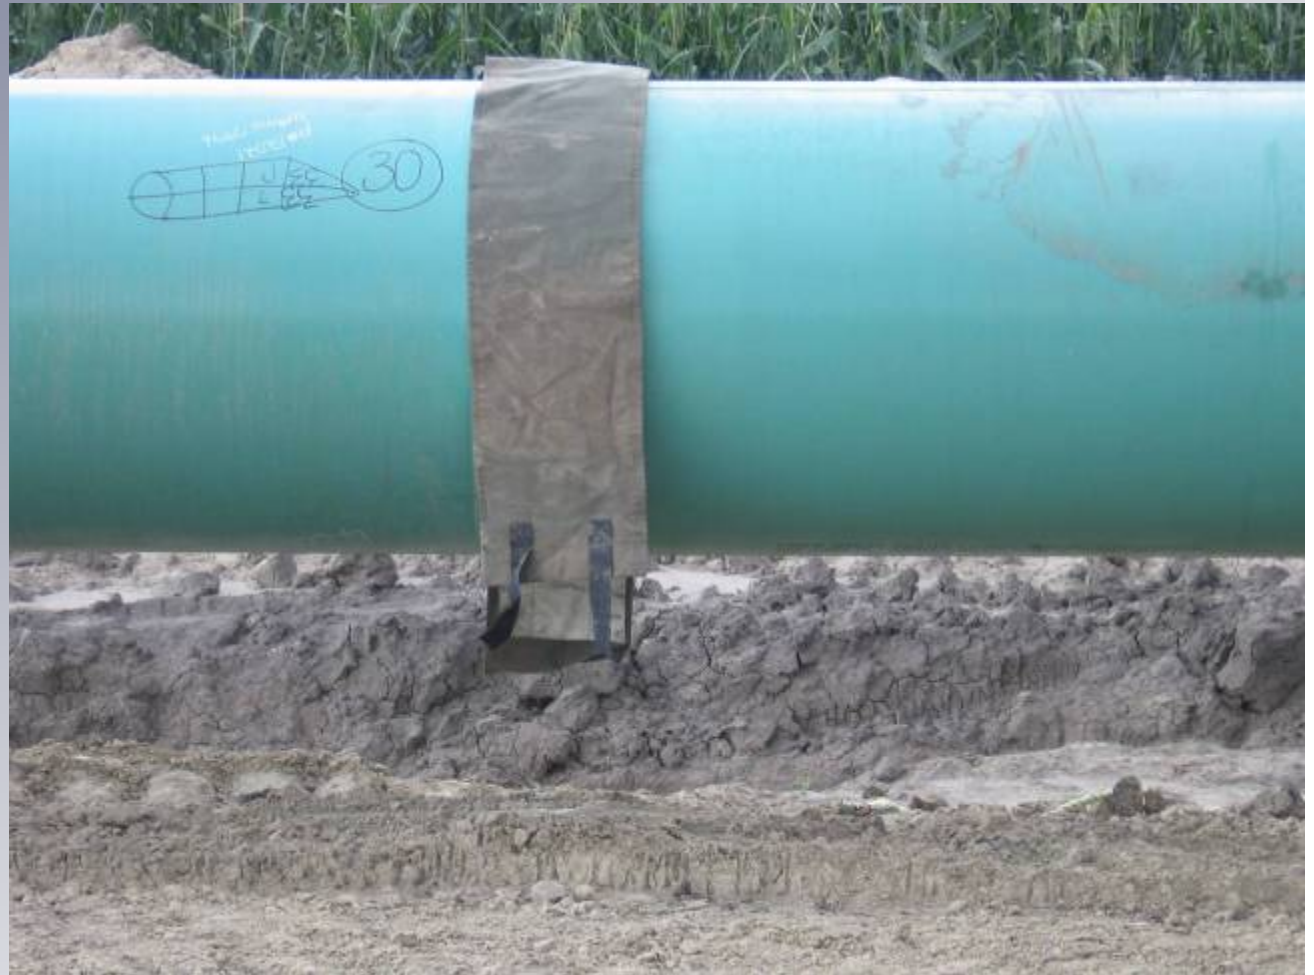
- §192.231
Protection from weather.
- The welding operation must be protected from weather conditions that would impair the quality of the completed weld.
- Wind blowing shielding gases, rain quenching welds, cold pipe impacts preheat and minimum interpass temperature.
