U.S. Department of Transportation

Pipeline and Hazardous Materials Safety Administration

Reference No. 17-0056

PHOTOS OF 3AAX CYLINDERS WITHOUT EXTERNAL NECK THREADS

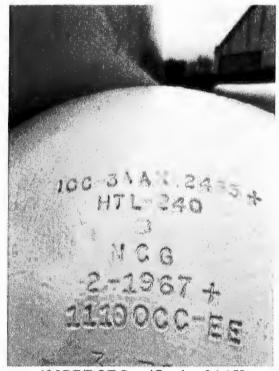
1] ICC/DOT Specification 3AAX

For this reason, customers of FIBA Technologies, Inc. (FIBA) are asking FIBA to machine threads to the OD surface of the tube necks that have not had threads applied since the day they were manufactured. We feel that it is appropriate to do this under the regulations found in 49 CFR § 180.212(b)(2) despite it being a threading process, rather than a re-threading process. We are confident that the machining of threads to these cylinders will not increase risk to safety or property. In fact, it will reduce risk.

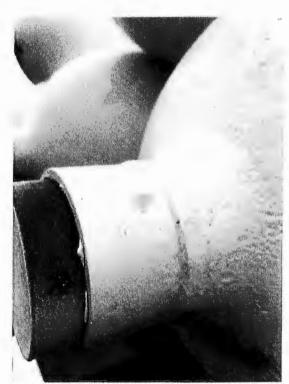
2] Tube Secured by Set Screws
