**Report No. DTRS56-96-C-0002-008**

# **REPORT ON THE USE OF IN-LINE INSPECTION TOOLS FOR THE ASSESSMENT OF PIPELINE INTEGRITY**

**General Physics Corporation  
6700 Alexander Bell Drive, Suite 400  
Columbia, Maryland 21046**

**June 2002**

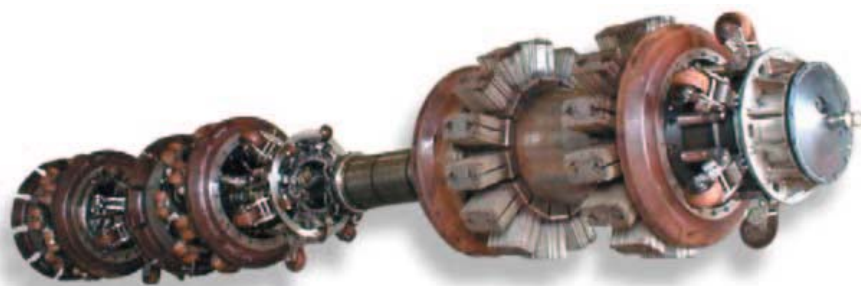
**Figure A-5 Elastic Wave UT Tool<sup>23</sup>**

To overcome the need to run a Shear Wave UT tool in a liquid medium, the Elastic Wave Tool was developed. In the elastic wave tool the UT sensors are mounted in wheels that are maintained in tight contact with the pipe wall. The Elastic Wave Tool is not as accurate as the Standard Shear Wave Tool but can be used without the need for a liquid batch. Elastic Wave Tools have also been shown to be effective in detecting disbonding of certain types of coatings. Figure A-5 is a photograph of an elastic wave in-line inspection tool.

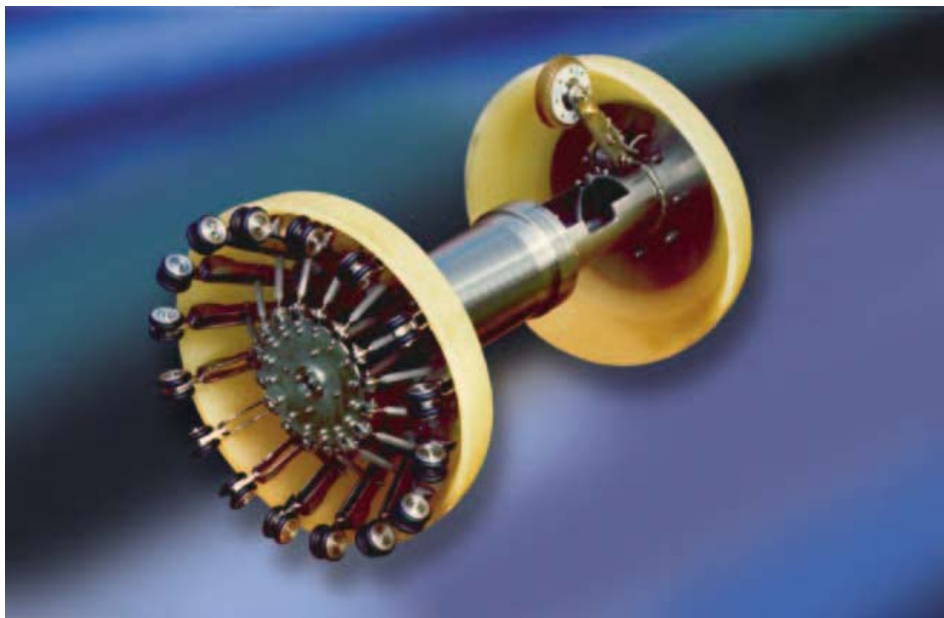
**Figure A-6 Geometry Inspection Tool<sup>24</sup>**

Geometry Inspection Tools use a series of lever arms to follow the pipe wall and measure changes in the pipe wall geometry as the tools moves through the pipeline. The lever arms are connected to a potentiometers to create a position signal that is recorded. The tool is also equipped with an odometer to measure the distance traveled by the tool. Geometry tools can detect and accurately locate circumferential welds, valves and tees.

Pipeline anomalies that are detected and characterized using Geometry Inspection Tools generally include dents, wrinkles, buckles, and pipe ovality. Some Geometry Inspection Tools have been equipped to measure changes in slope that occur with movement of the pipe and/or measure bend radius. A photograph of a typical geometry inspection tools is included as figure A-6.
