Natural Gas Distribution Infrastructure Safety and Modernization Grant Program York County Natural Gas Authority, Blacksburg, SC Tier 2 Site Specific Environmental Assessment NGDISM-FY22-EA-2023-32

Project Title	York County Natural Gas Authority Pipeline Replacement	
Project Location Blacksburg, Cherokee County, South Carolina		
Project Description/Proposed Action:

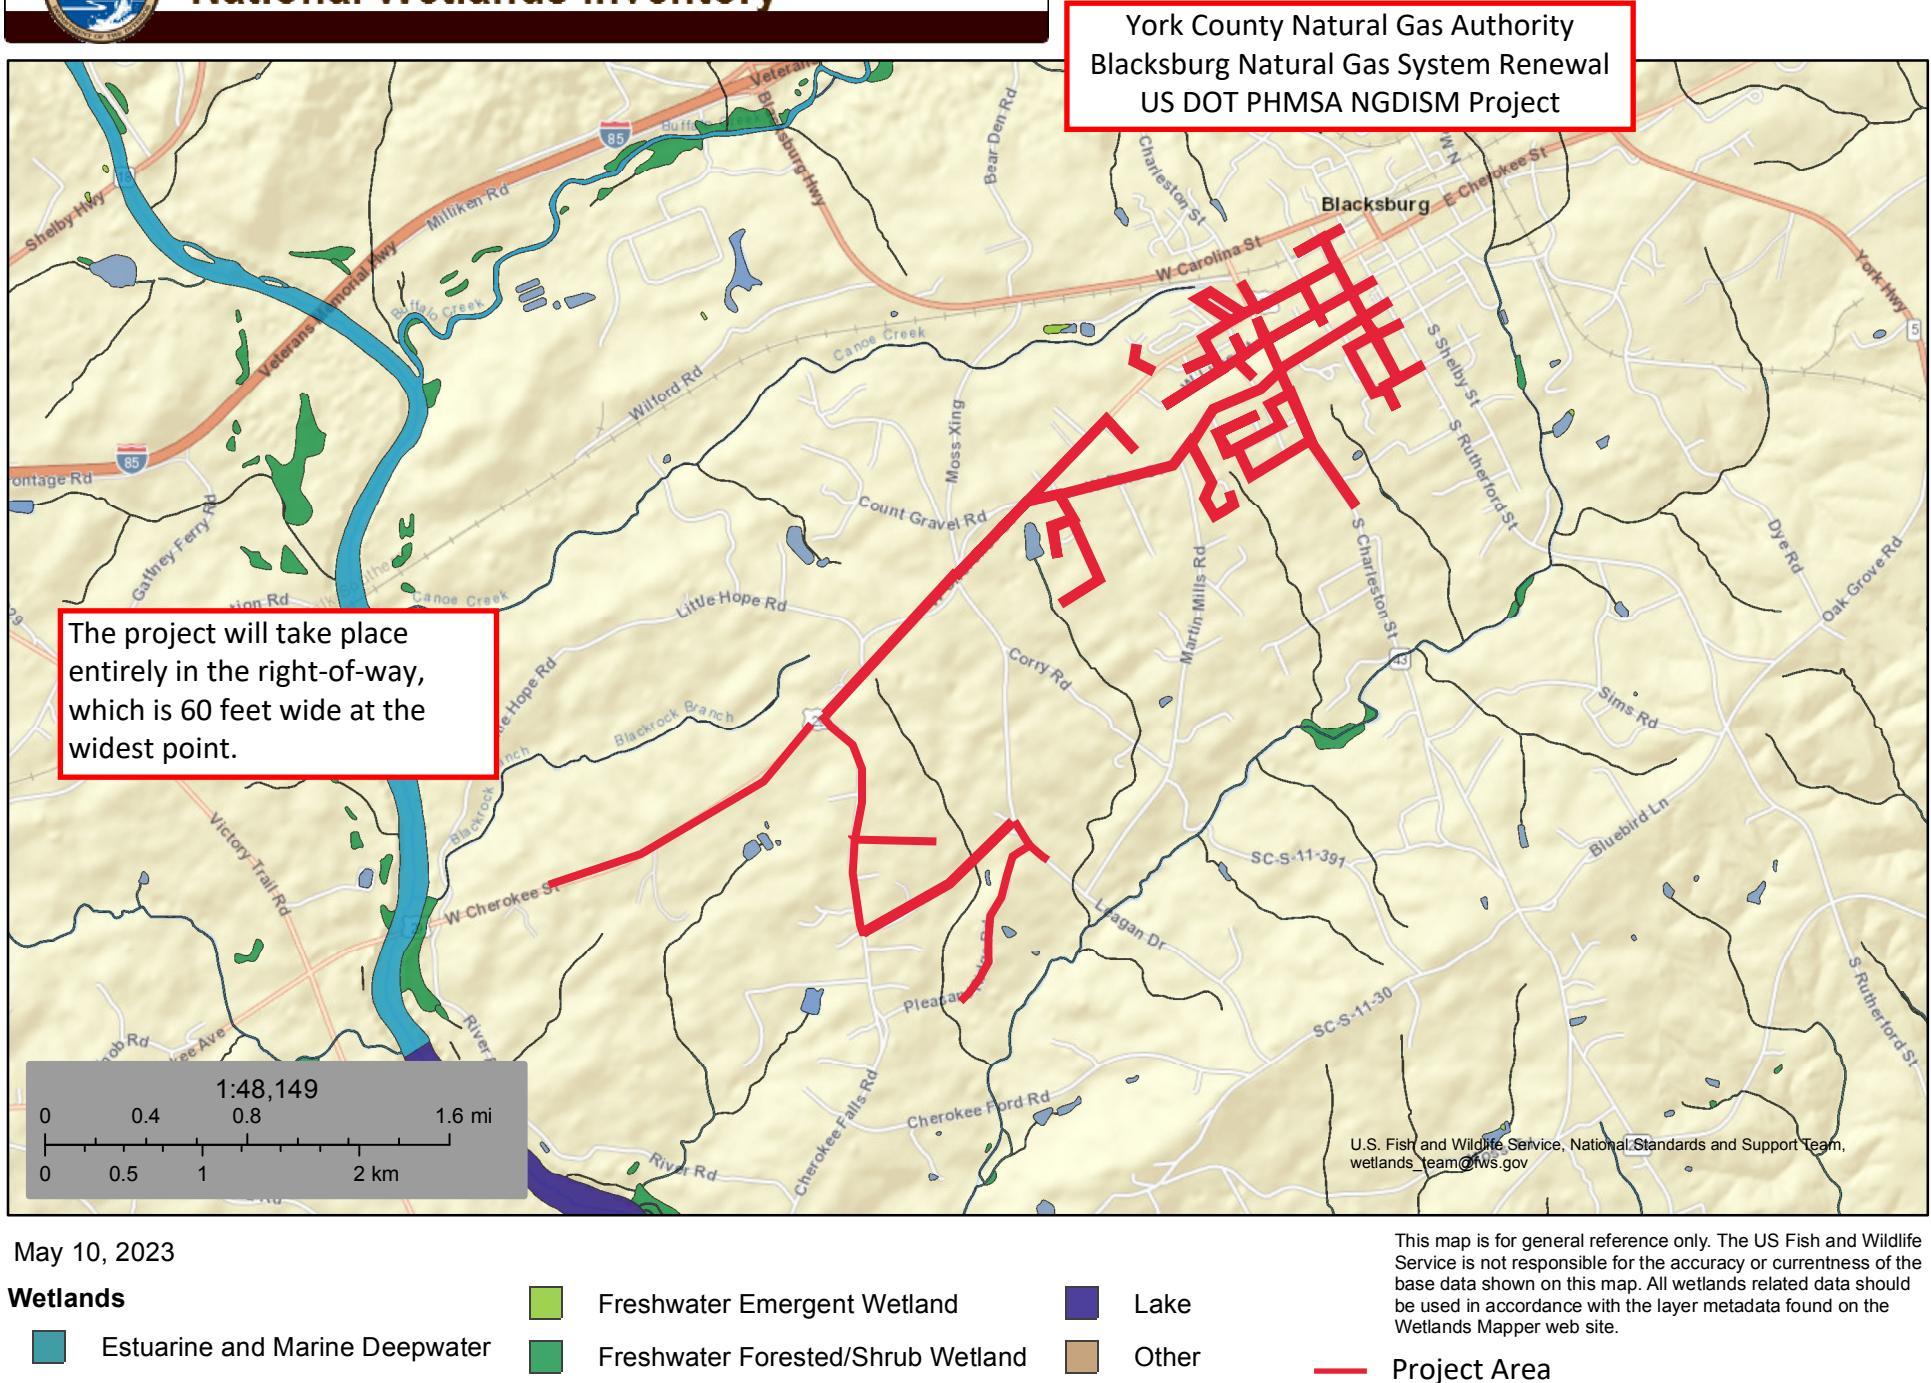
Wetlands Map

Riverine

Freshwater Pond

There is one area along Pleasant Hill Road where pipeline replacement activities would cross a tributary to Dottie Creek. The YCNGA would bore/ horizontal directional drill (HDD) underneath this riverine crossing at a depth and distance so as not to encroach or disturb the aquatic resource. HDD methods provide a way to avoid impacting sensitive areas, such as wetlands or streams, by boring relatively shallow arcs along a specific path underground using a surface drill rig. Directional boring begins with excavating pits where the pipe would enter and go underground and exit where the pipe would then come back to the surface to tie into existing pipelines. The pits collect the drilling fluids that are pumped to the cutting head or the drill to create and lubricate the passage of the new pipe. The fluids in the pits can then be collected and disposed of or reclaimed. To ensure no direct impacts occur to this aquatic resource, the contractor would construct/excavate entry and exit pits and ensure all construction activities are at least 100 feet back from the tributary on either side. Additionally, best management practices would be used during construction to control sediment and erosion and prevent pollutants from entering adjacent waterways. Because the pipeline in this area would be installed by boring under the tributary and appropriate buffers would remain between construction activities and aquatic resources and because best management practices would be used, PHMSA's assessment is that there would be no permanent impacts to water resources located within the project area. The pipeline placement and

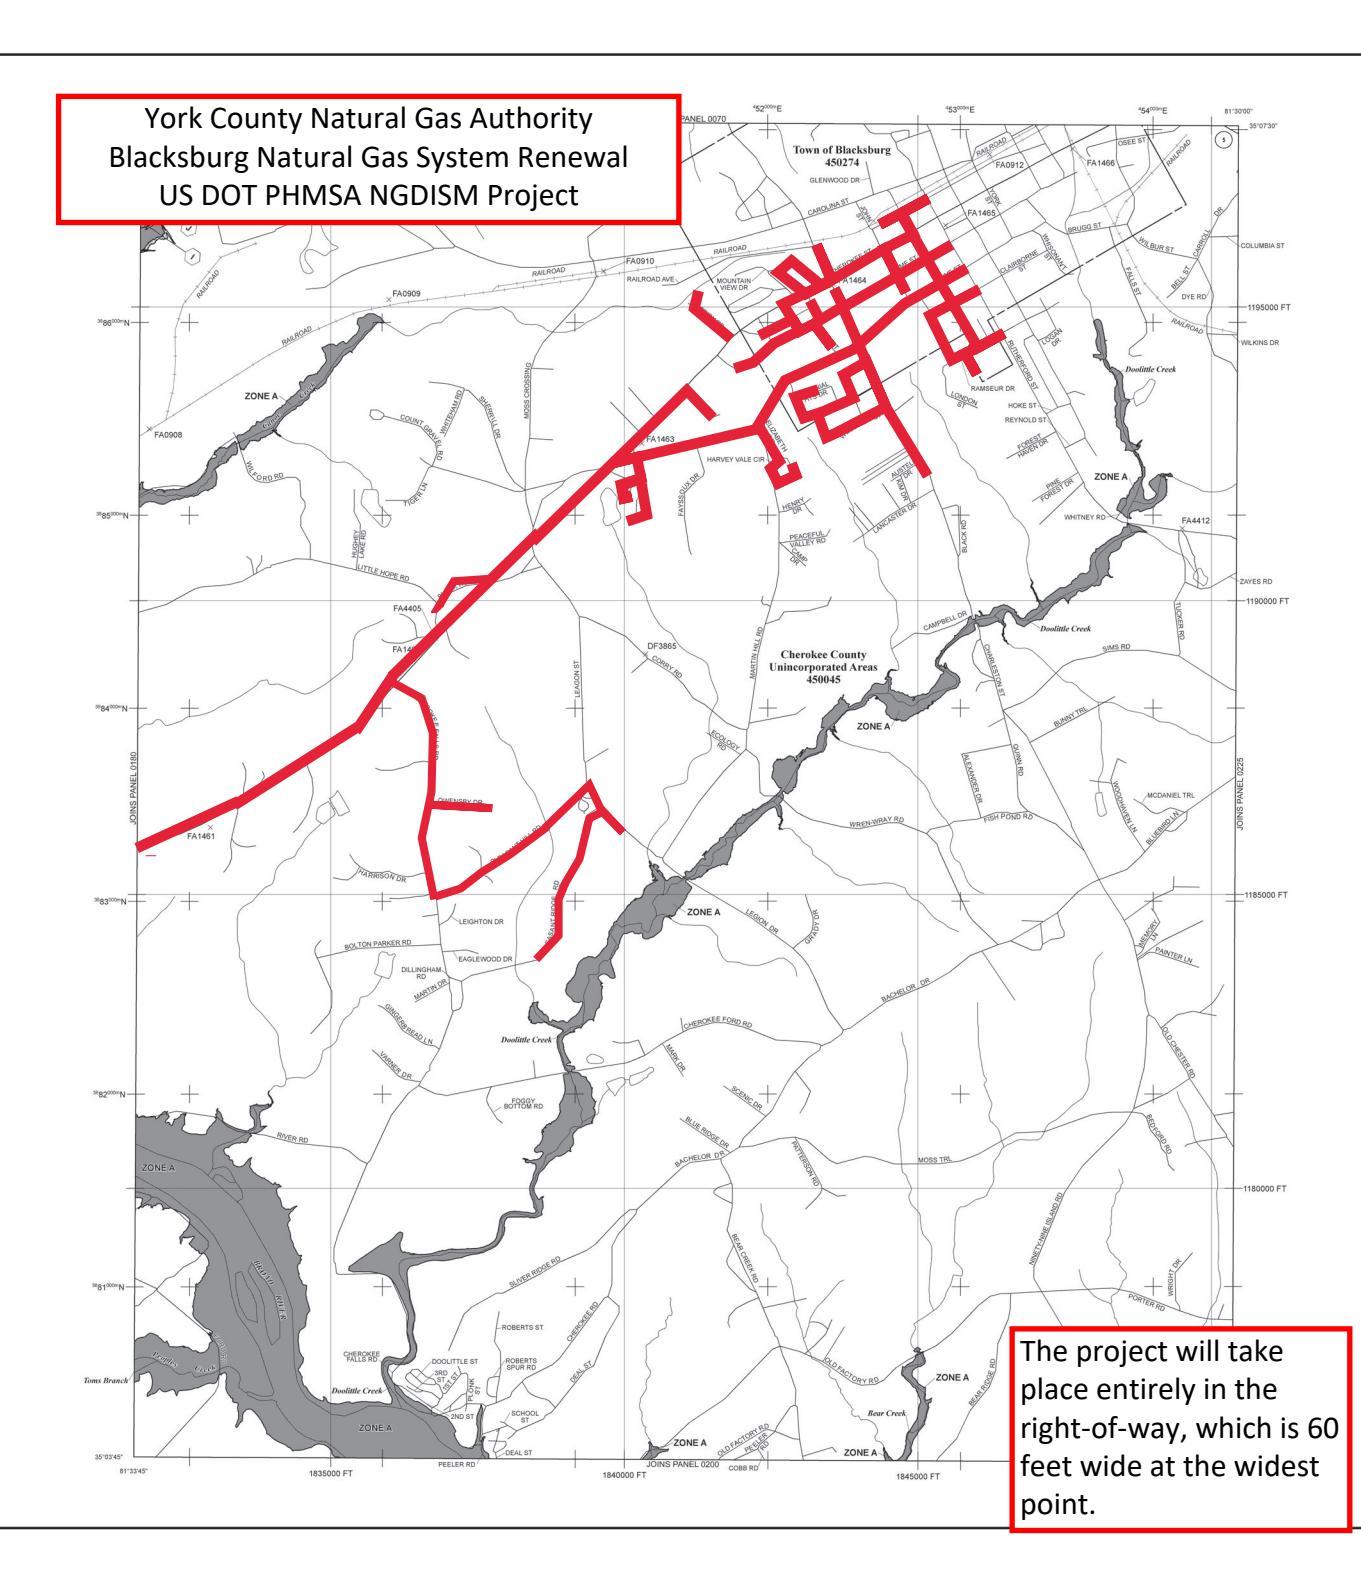
LEGEND SPECIAL FLOOD HAZARD AREAS SUBJECT TO INUNDATION BY 1% ANNUAL CHANCE FLOOD The 1% annual chance flood (100-year flood), also known as the base flood, is the flood that has i 1% chance of being equaled or exceeded in any given year. The Special Flood Hazard Area is the area subject to flooding by the 1% annual chance flood. Areas of Special Flood Hazard Includi Zones A, AE, AH, AO, AR, A99, V, and VE. The Base Flood Eleveiton is the water-surface eleveition of ZONE A No Base Flood Elevations determined. ZONE AF Base Ecord Elecations daterminad ZONE AU Flood depths of 1 to 3 feet (usually areas of ponding); Base Flood Ele Flood depths of 1 to 3 feet (usually sheet flow on sloping terrain); average depths determined. For areas of alluvial fan flooding, velocities also determined. ZONE A ireas to be protected from 1% annual chance flood event by a Federal floo protection system under construction; no Base Flood Elevations determined. ZONE Coastal flood zone with velocity hazard (wave action); no Base Flood Elevatio Coastal flood zone with velocity hazard (wave action); Base Flood Elevatio ZONE VE ///FLOODWAY AREAS IN ZONE AE The floodw encroachm flood heigh s the channel of a stream plus any adjacent floodplain areas that must be kept free o so that the 1% annual chance flood can be carried without substantial increases in OTHER FLOOD AREAS ZONE Areas of 0.2% annual chance flood; areas of 1% annual chance flood with average depths of less than 1 foot or with claimage areas less than 1 square mile; and areas protected by levees from 1% annual chance flood. OTHER AREAS ZONE Areas determined to be outside the 0.2% annual chance fil Areas in which flood hazards are undetermined, but possib ZONE D COASTAL BARRIER RESOURCES SYSTEM (CBRS) AREAS OTHERWISE PROTECTED AREAS (OPAs) CBRS areas and OPAs are normally located within or adjacent to Speci England houndary Zone D boundary CBRS and OPA boundar Boundary dividing Special Flood Hazard Are boundary dividing Special Flood Hazard Areas of Flood Elevations, flood depths, or flood velocities ~~ 513 ~~~ Base Flood Elevation line and value: elevation in feet* Base Flood Elevation value where uniform within (EL 987) * Referenced to the North Ar Vertical Datum of 1988 (A) Cross section line 23-------(23) Transect line Geographic coordinates referenced to the North Americ Datum of 1983 (NAD 83) HARN, Western Hemisphere 97'07'30". 32'22'30" 4275000mE 1000-meter Universal Transverse Mercator grid ticks, zone 17 5000-foot grid values: South Carolina State Plane coordinate system (FIPS20NE = 3900), Lambert projection Bench mark (see explanation in Notes to Users section of this 6000000 FT Bench mark (see explan DX5510, • M1.5 River Mile MAP RE DSITORIES ories list on Map Index EFFECTIVE DATE OF COUNTYWIDE FLOOD INSURANCE RATE MAP September 16, 2011 VE DATE(S) OF REVISION(S) TO THIS PANEL community map revision history prior to countywide mapping, refer to the or table located in the Flood Insurance Study report for this lurisdiction. mine if flood insurance is available in this community, contact your onal Flood Insurance Program at 1-800-638-6620. -MAP SCALE 1" = 1000" 500 1,000 1,500 2,000 PANEL 0185D PROGRAM FIRM FLOOD INSURANCE RATE MAP CHEROKEE COUNTY, SOUTH CAROLINA AND INCORPORATED AREAS FLOOD INSURANCE PANEL 185 OF 400 (SEE MAP INDEX FOR FIRM PANEL LAYOUT CONTAINS: NUMBER PANEL SUFFO COMMUNITY BLACKSBURG, TOWN OF 450274 0185 D 450045 0185 D CHEROKEE COUNTY, Project Area unity Number shown above to account to the subject MAP NUMBER **NATIONAL** 45021C0185D 45021C0185D EFFECTIVE DATE SEPTEMBER 16, 2011

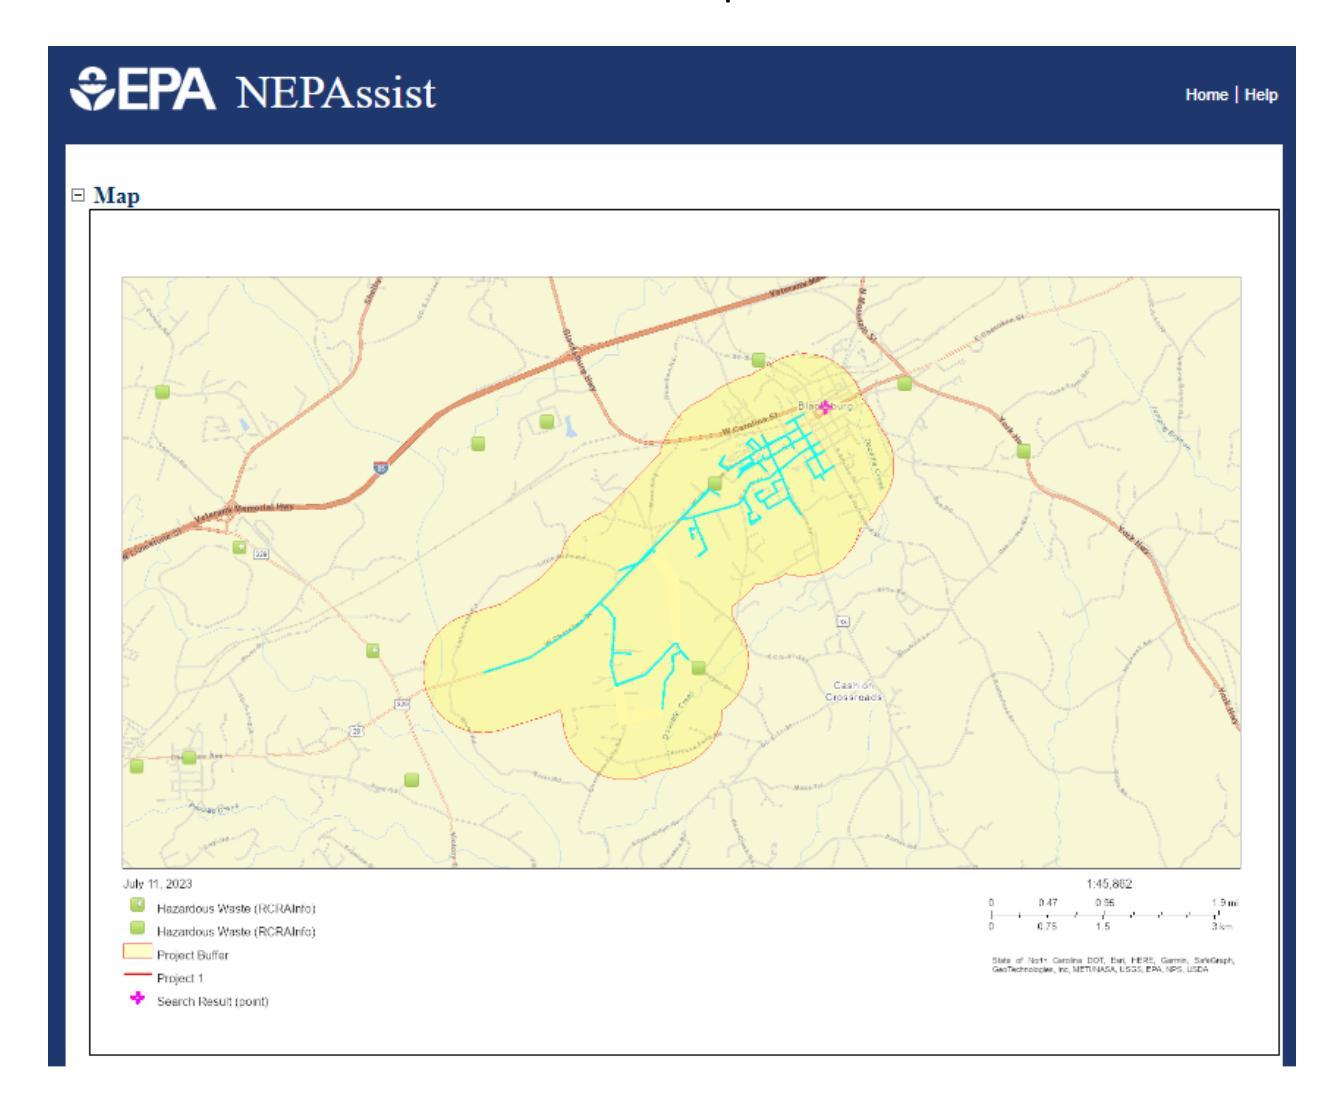
York County Natural Gas Authority Blacksburg Natural Gas System Renewal US DOT PHMSA NGDISM Project NEPAssist Report

Two Hazardous Waste (RCRAInfo) are within the Project Buffer. Neither is in the project area.

PHMSA reviewed EPA's NEPAssist website to identify any brownfields properties, hazardous waste sites, and superfund sites. There were two hazardous waste sites identified in close proximity to the project area. Hazardous waste information is identified in the Resource Conservation and Recovery Act Information (RCRAInfo), which is a national program that includes an inventory of all generators, transporters, treaters, storers, and disposers of hazardous waste that are required to provide information about their activities to state

environmental agencies.⁸ It is noted that the presence of a hazardous waste site does not indicate an identified environmental concern. The two sites identified that are hazardous waste generators are not associated with any identified leaks. There were no brownfields sites or superfund sites identified in the project area. (See Appendix D, Hazardous Materials).

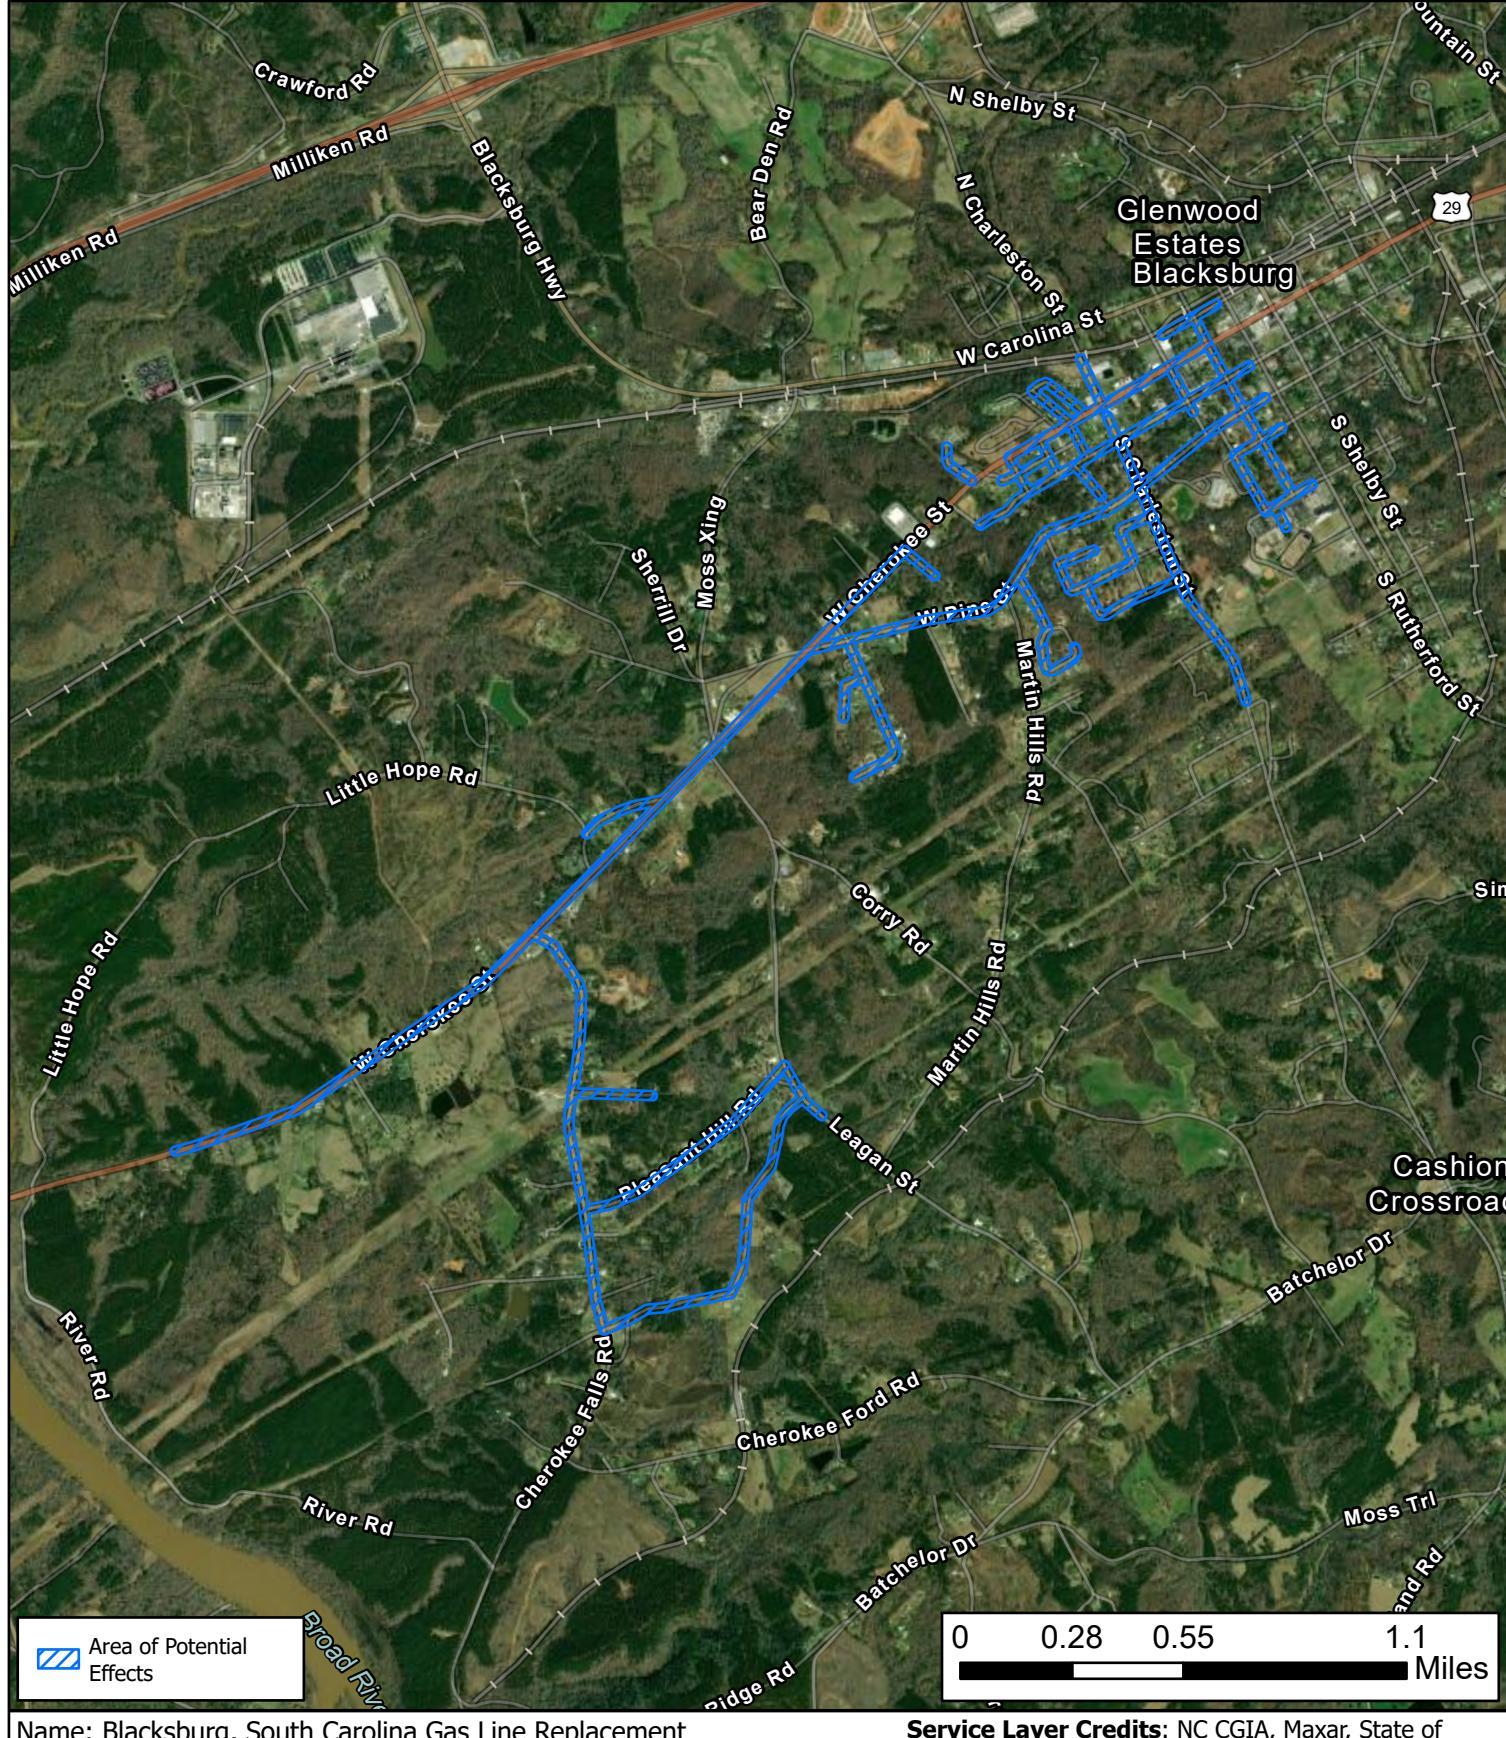
Name: Blacksburg, South Carolina Gas Line Replacement Scale: 30,000 Total Acreage: 185.4 Blacksburg, SC, Cherokee County

36 CFR 800.4(a)(1), the Area of Potential Effects (APE) is defined as the geographic area(s) within which the Undertaking may directly or indirectly affect historic resources. Based on the proposed scope of work, PHMSA has delineated the APE for this project to encompass the existing ROW in the areas proposed for replacement, which includes the limits of disturbance. The APE extends to the depth of proposed ground disturbance of up to 4 feet below grade. The Undertaking does not have the potential to cause visual or audible effects after the completion of construction. The existing ROW varies widely throughout the project area and is 60 feet wide at the widest point; it includes various roads, sidewalk, utilities (above and below ground), roadside ditches, curb & gutter, culverts, driveways, and mailboxes. See Appendix G, Cultural Resources for more information on the APE.

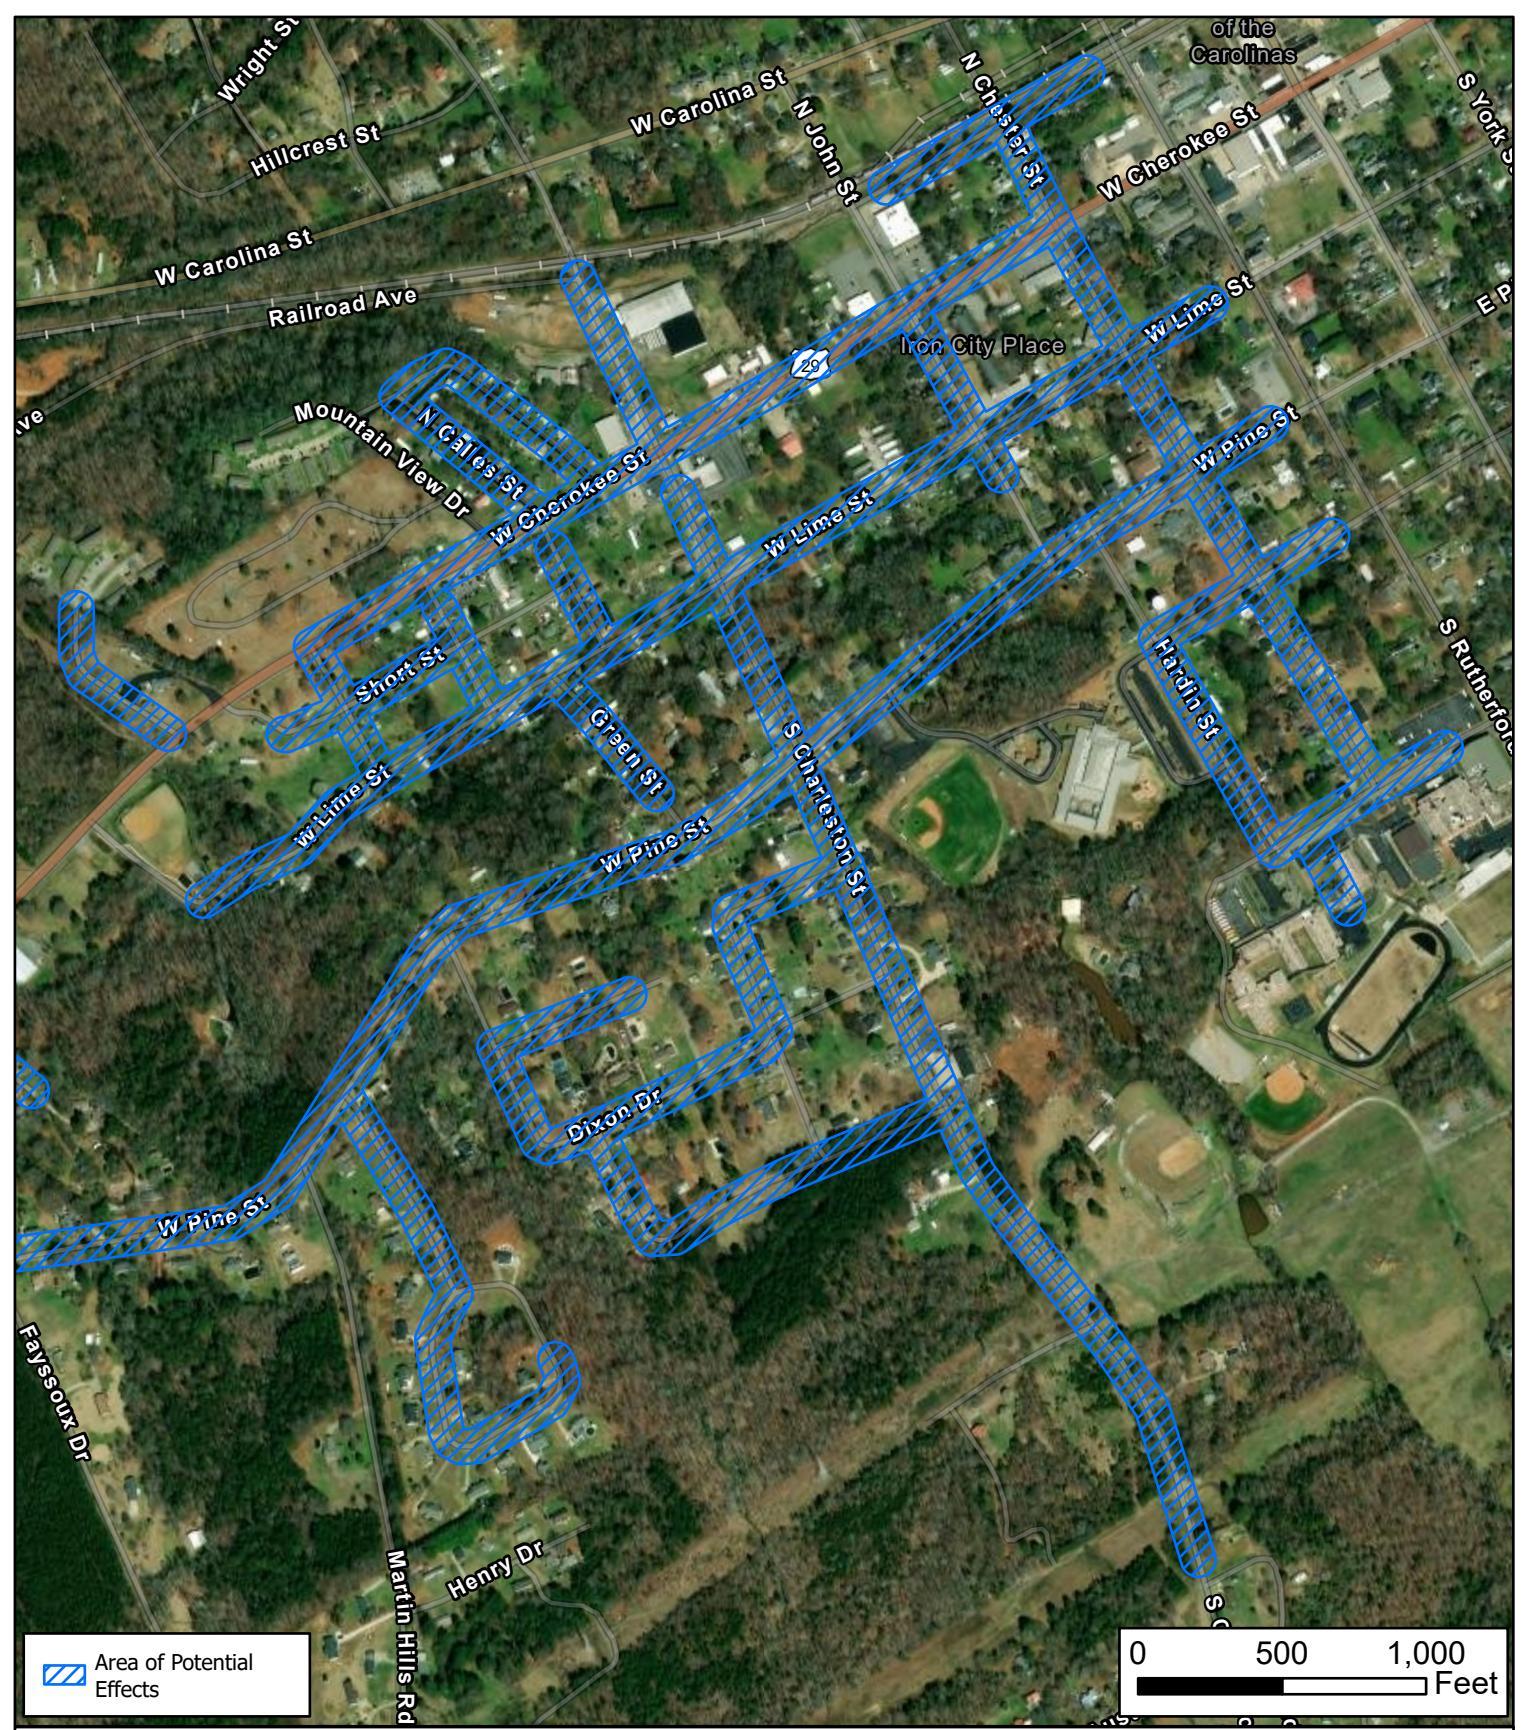
Name: Blacksburg, South Carolina Gas Line Replacement Scale: 8,000 Total Acreage: 185.4 Blacksburg, SC, Cherokee County

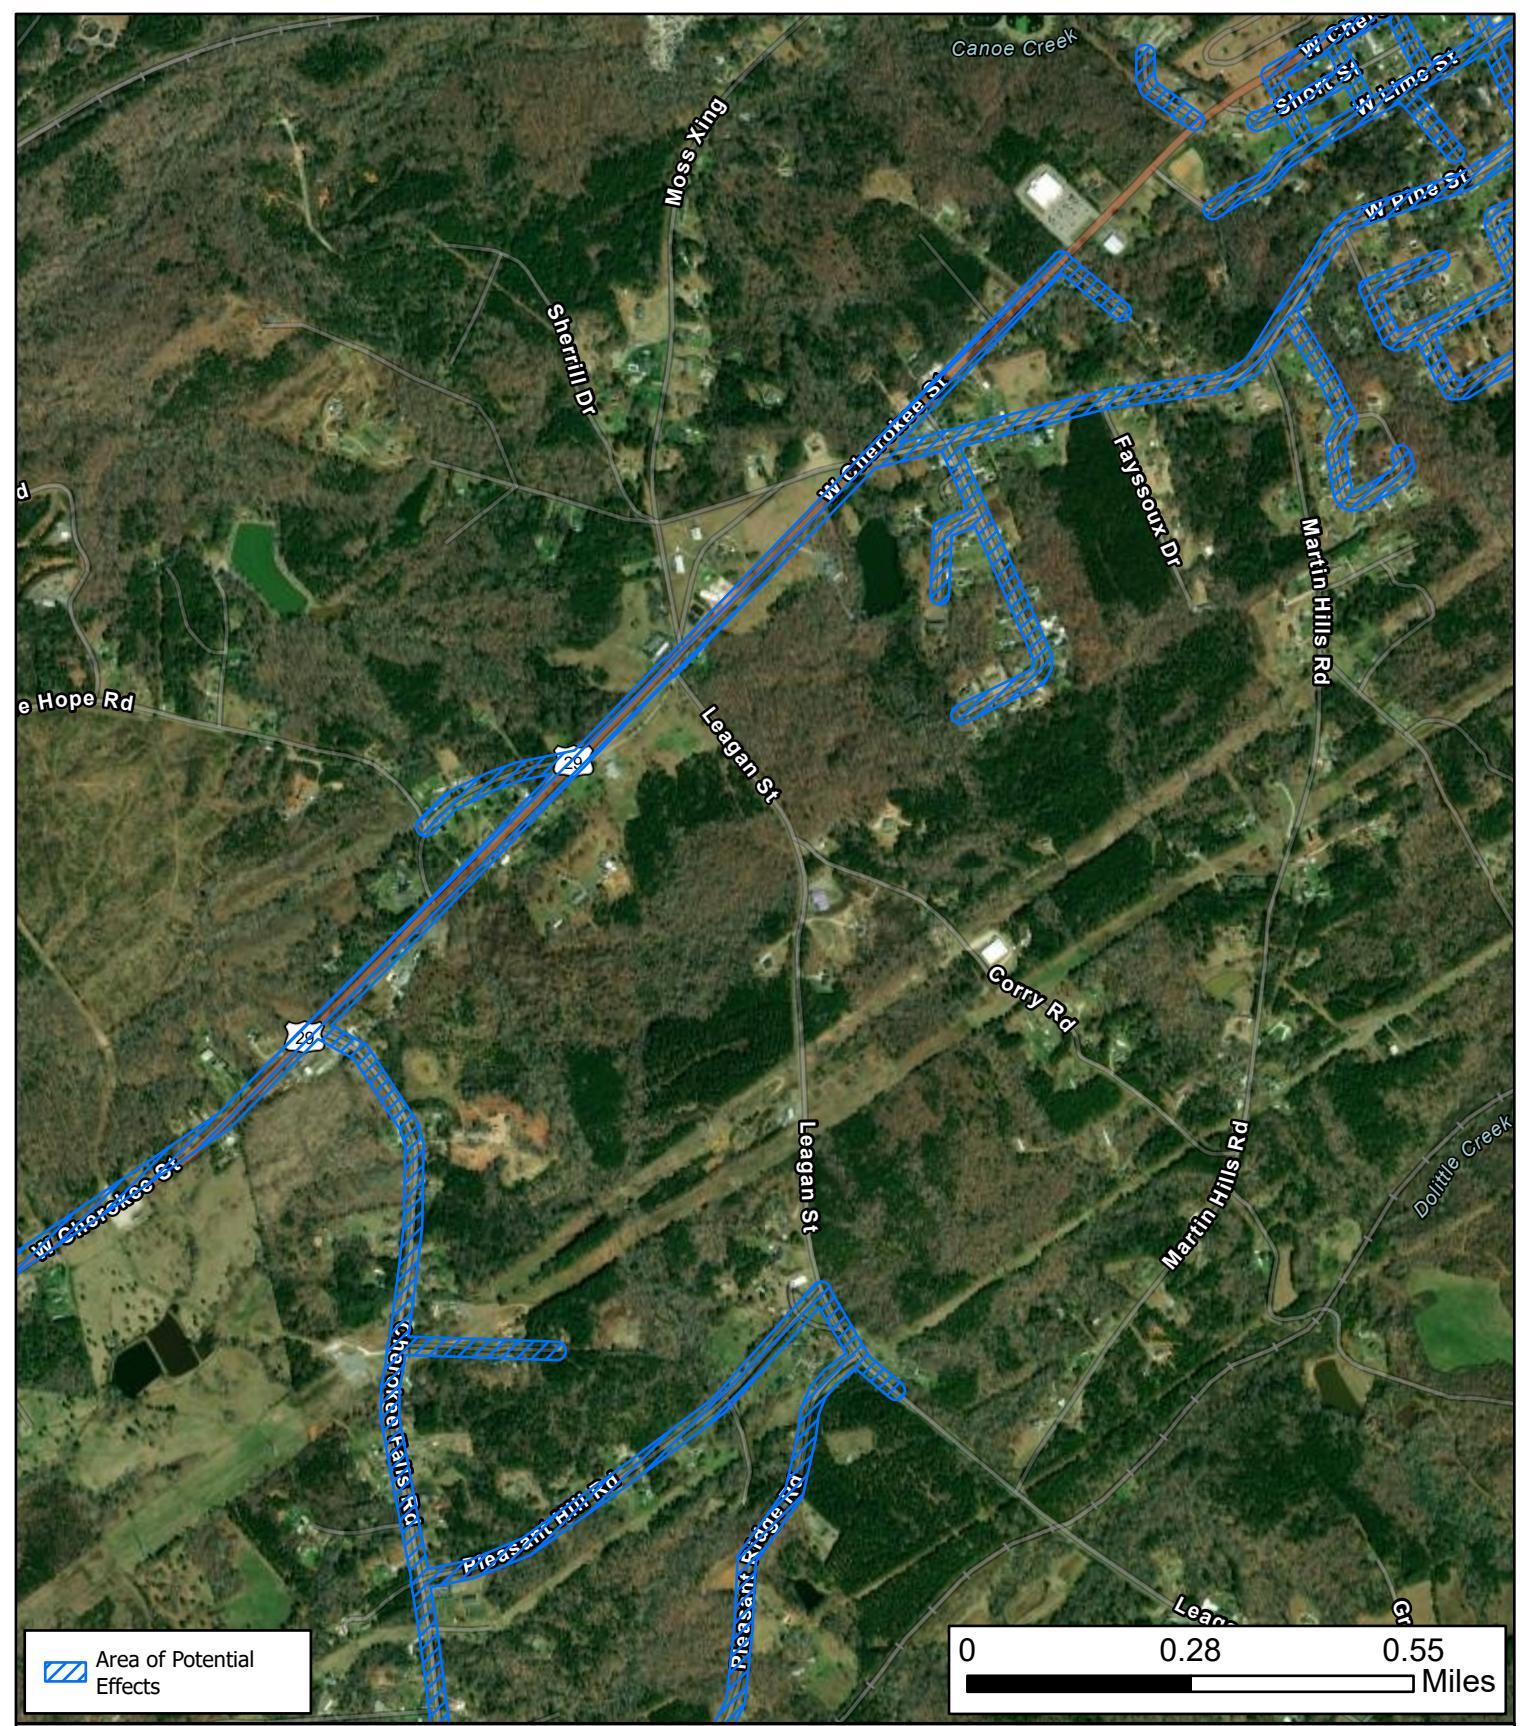
Name: Blacksburg, South Carolina Gas Line Replacement Scale: 15,000 Total Acreage: 185.4 Blacksburg, SC, Cherokee County

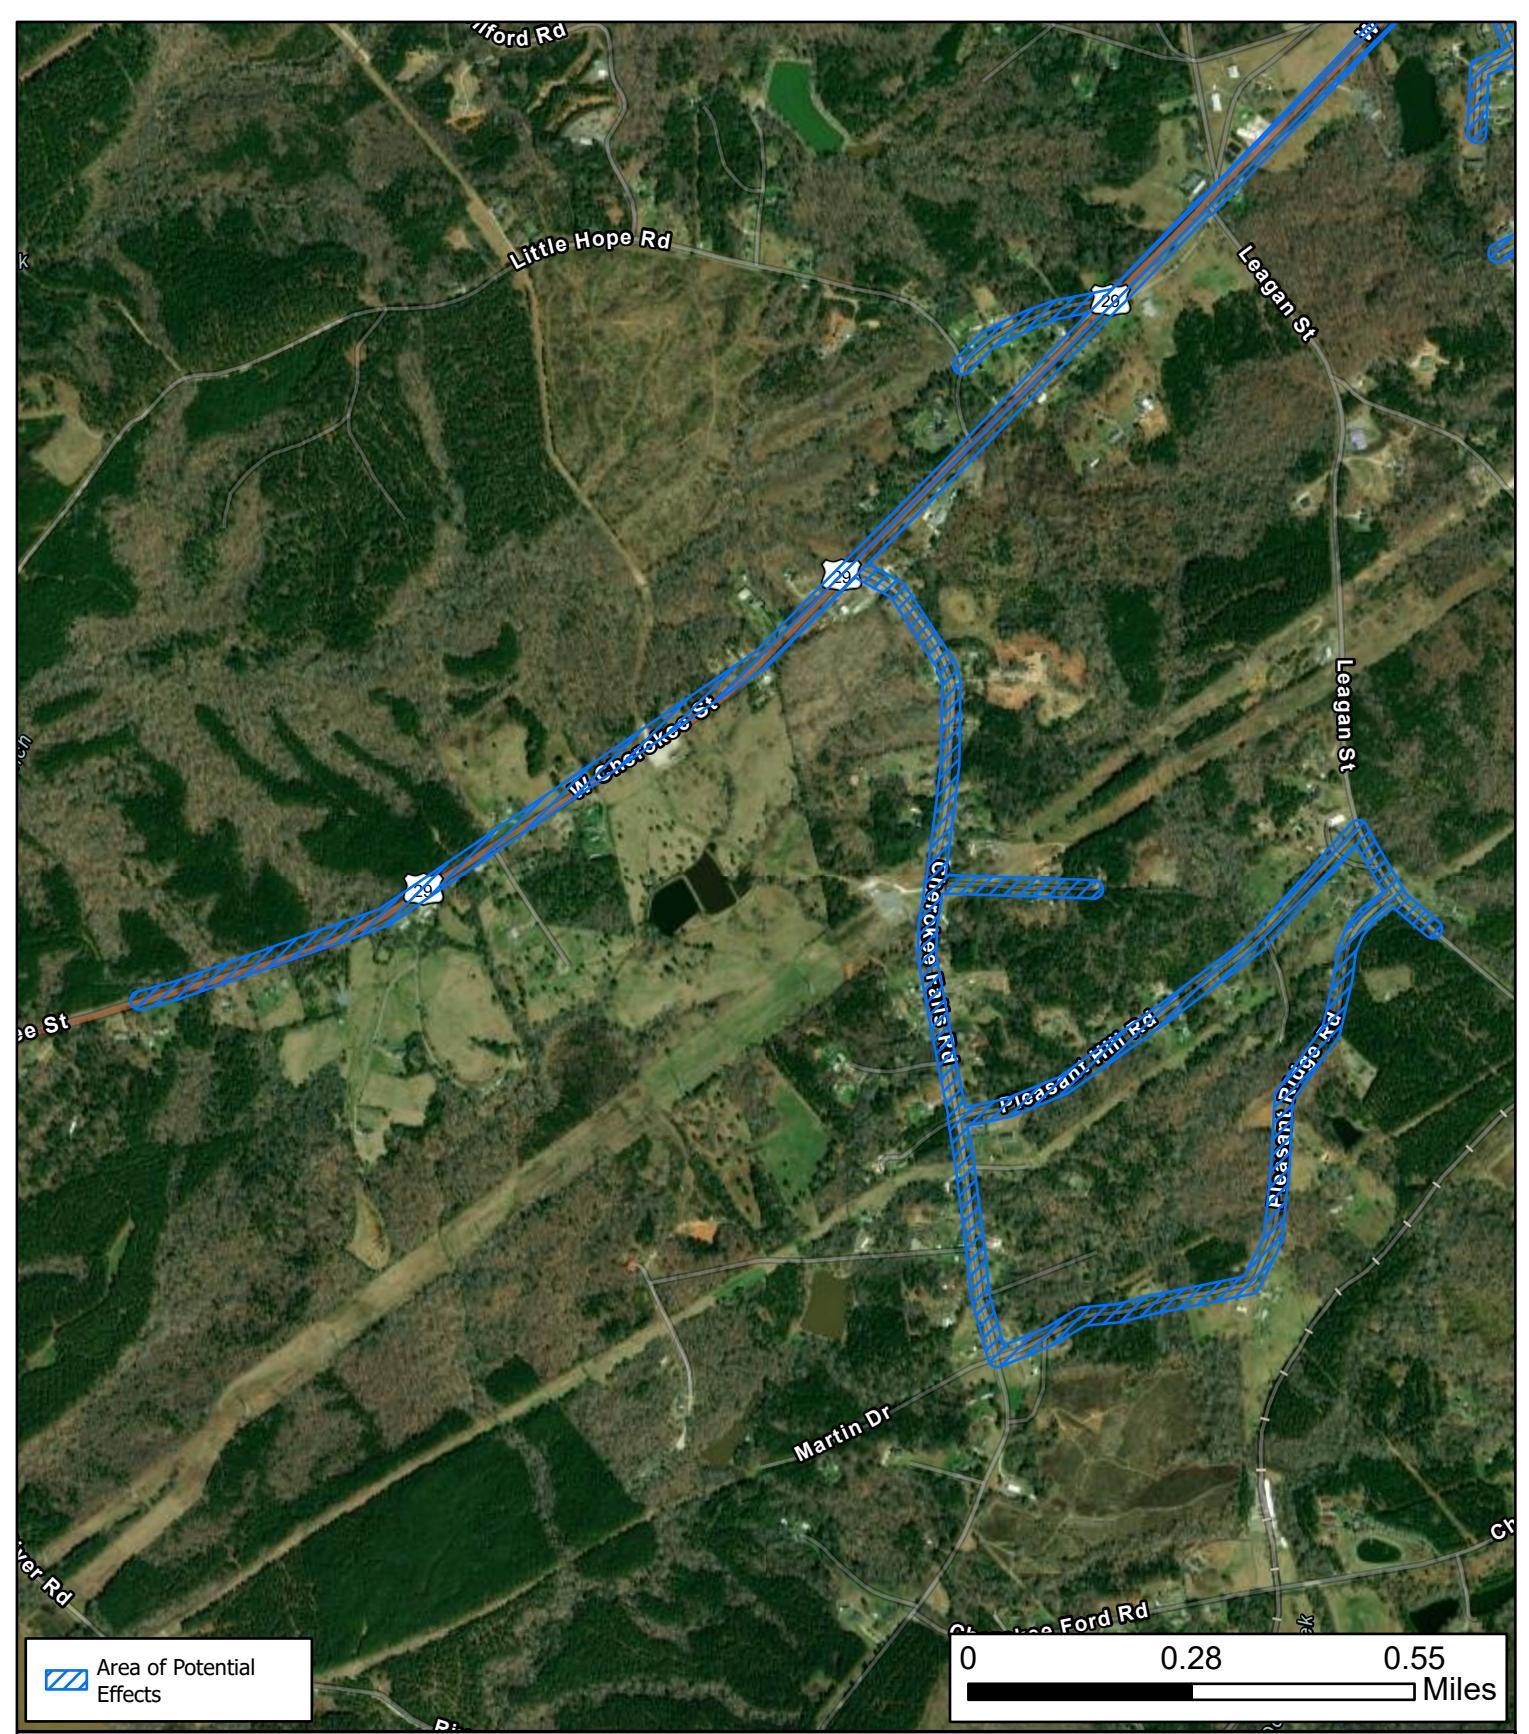
Name: Blacksburg, South Carolina Gas Line Replacement Scale: 15,000 Total Acreage: 185.4 Blacksburg, SC, Cherokee County
