DOTU.S. Department of TransportationPHMSAPipeline and Hazardous Materials Safety AdministrationOPSOffice of Pipeline Safety
Central Region

Principal Investigator	Gery Bauman/Public Utilities Commission of Ohio (PUCO)
Senior Accident Investigator	Brian Pierzina/Karen Butler
Region Director	David Barrett/Allan Beshore
Date of Report	7/30/2015
Subject	Failure Investigation Report—Tennessee Gas Pipeline Company—Material Failure—Girth Weld

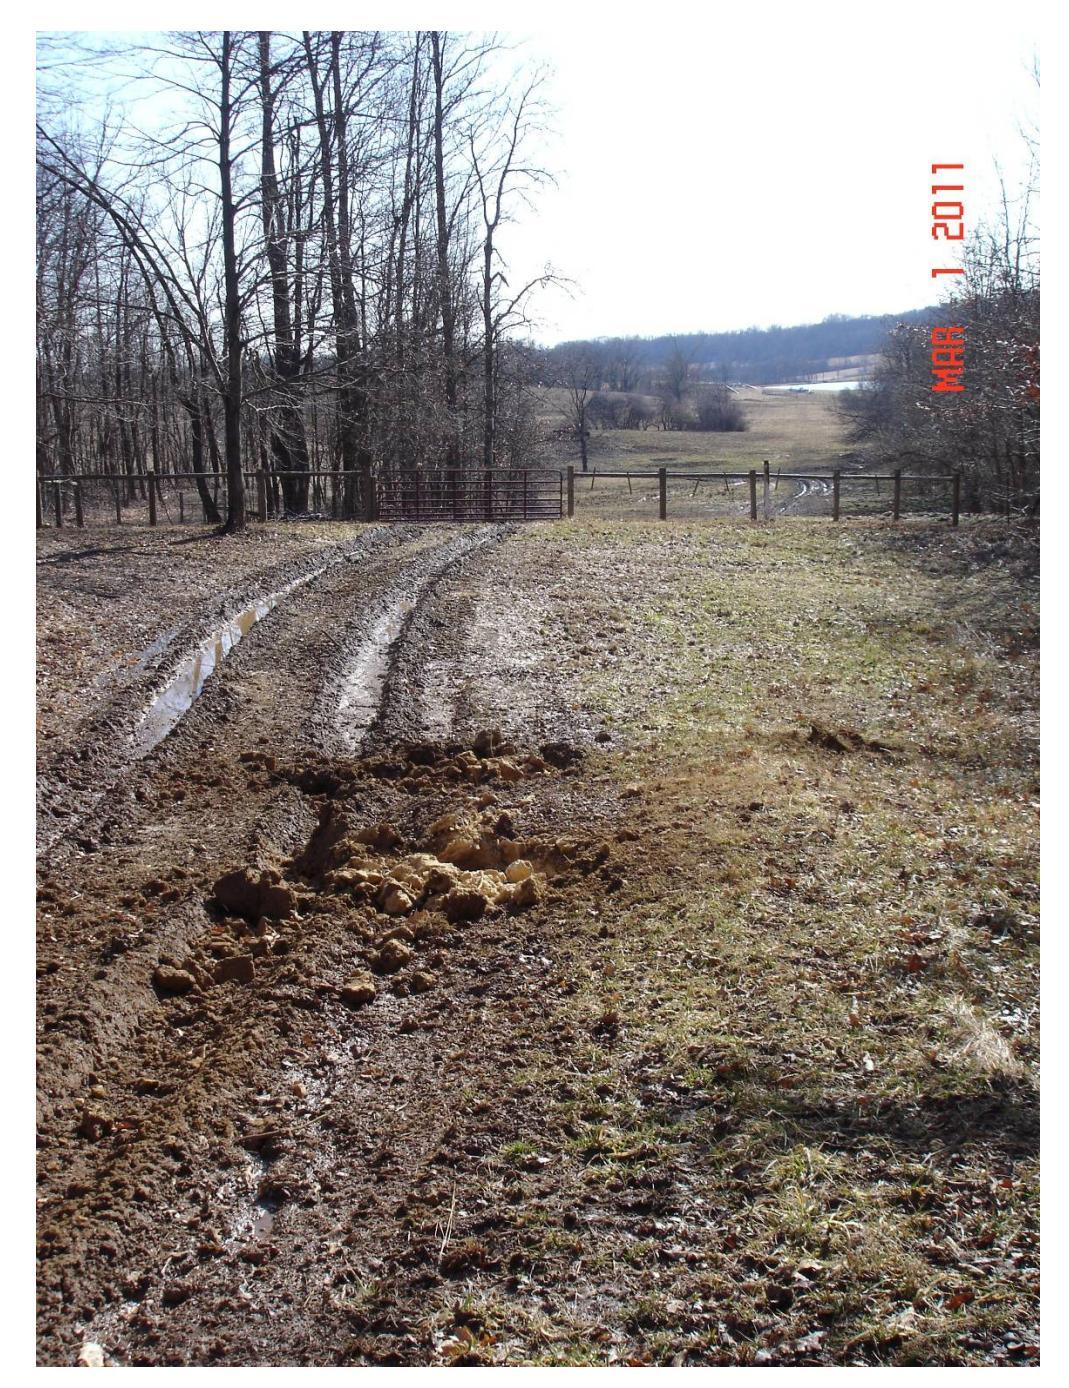
Photo 1 view of leak site looking south down the right-of-way. The compressor station can be seen in the distance. The disturbed soil was blown from the ground as a result of the failed girth weld.

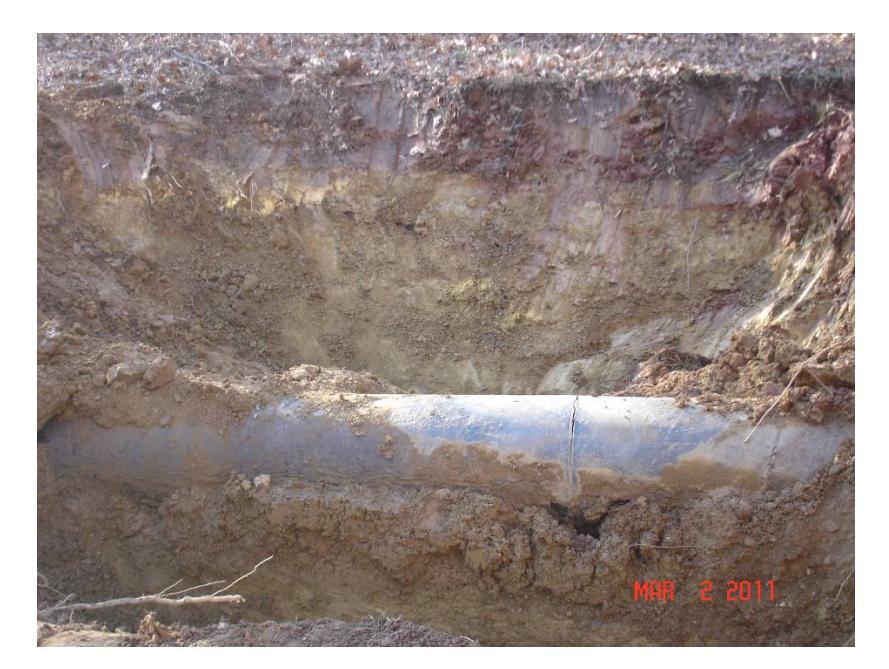
Photo 2 shows the excavation around the failed girth weld.

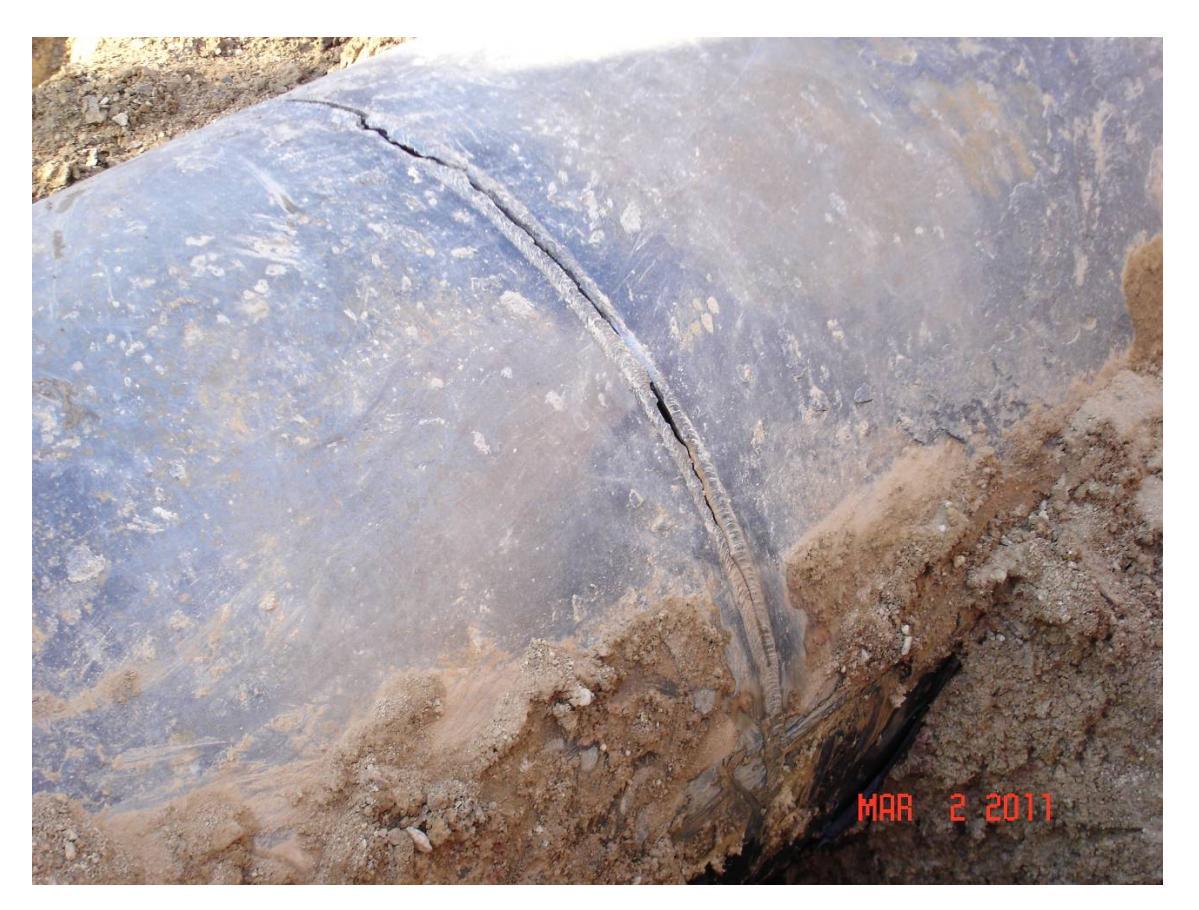
The results of the metallurgical analysis indicate that the leak initiated at a pre-existing crack in a field girth weld. The crack was 2.6 feet long, circumferentially, and was located on the inside of the pipe between the 10:00 and 2:40 o'clock orientations. The maximum depth of the crack was 0.317 inches (79% through wall based on a pipe wall/girth weld thickness of 0.399 inches). The pre-existing crack initiated at the toe of the root pass in the heat-affected zone of the weld. The crack propagated primarily in the weld metal. The crack did alternate between the upstream and downstream root pass as it propagated. This type of crack is referred to as an under-bead crack, cold crack, or hydrogen assisted crack. A discussion of the factors related to hydrogen-assisted cracking is given in Appendix B of the metallurgical report.

The primary cause of the leak was the presence of the pre-existing weld crack. A contributing factor in the failure was tensile axial stresses acting on the girth weld. The presence of the weld crack near the top of the pipe suggests that bending stresses acted on the pipe to place the crack in tension. This is consistent with shifting of the pipe after the initial field cut, in which the upstream end shifted upwards approximately 2.5 inches. Approximately 91 feet of the pipeline was excavated (approximately 45.5 feet on both sides of the failed girth weld) at the time of the initial cut.

Photo 3 shows the failed girth weld.

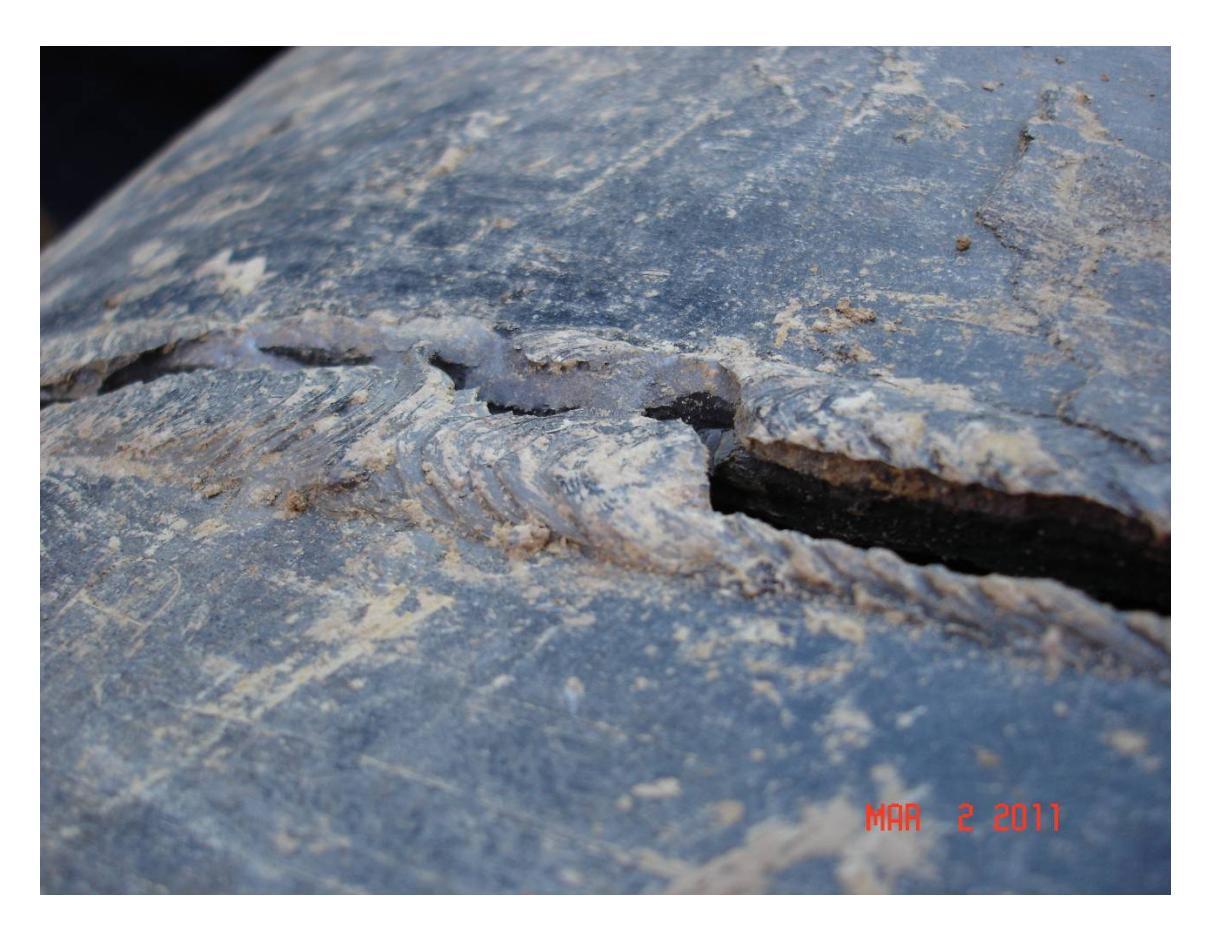
Photo 4 shows a close-up of the top of the failed girth weld.
