Elemental Sulfur and Di-thiazine Formation in Natural Gas Pipelines

Developed By:
The NAPSR / PHMSA Distribution Team

Elemental Sulfur and Di-Thiazine Formation in Natural Gas Pipelines

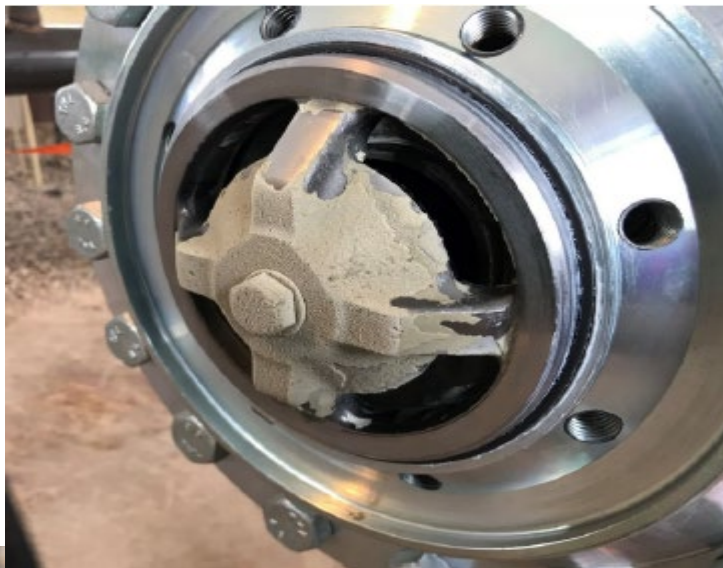
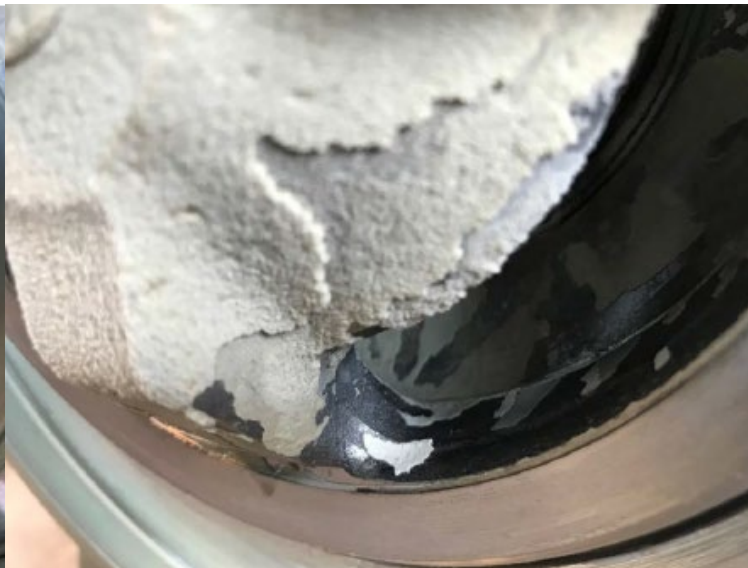
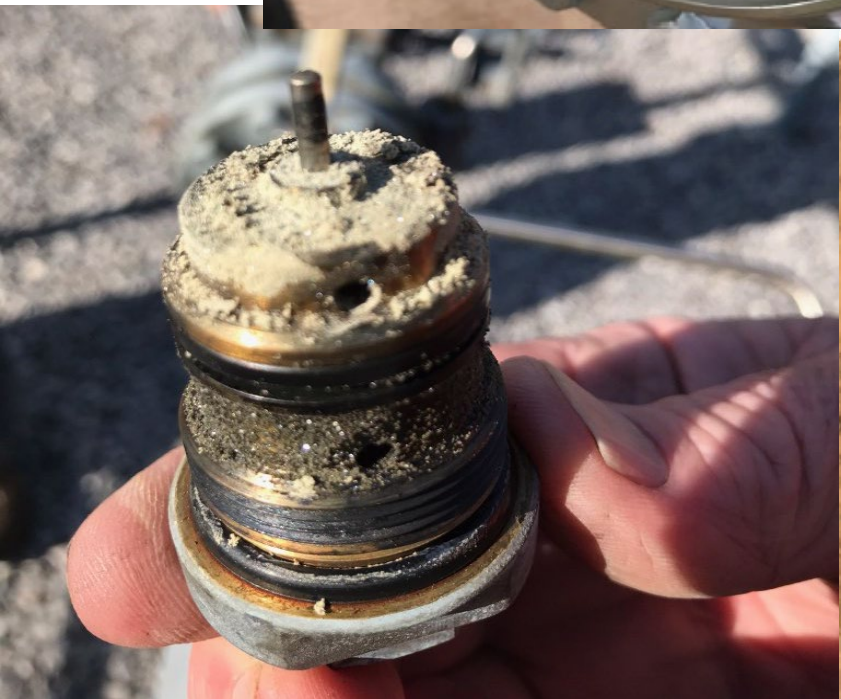
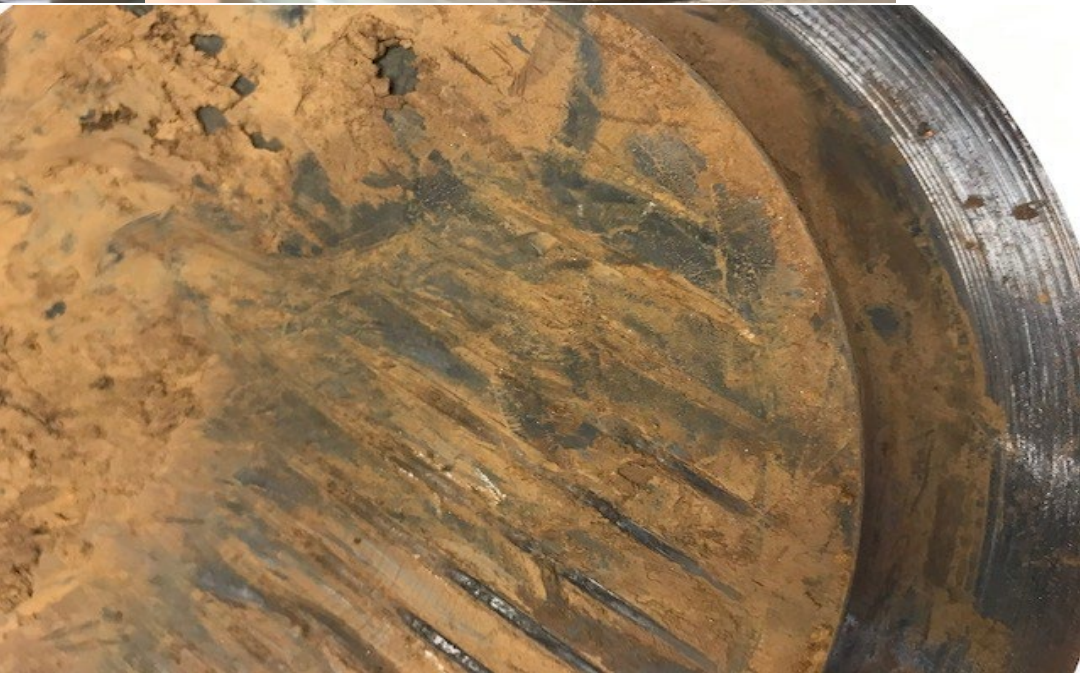
Photographs of Recent Deposits

Varying Appearances and Odors of Solid Deposits

- Observed colors of deposits vary from white to yellow to yellow-brown apparently depending on constituents in the gas stream and where the deposits forms (condenses) in pressure reduction equipment
- In some cases, the only odor is a normal pipeline odor or in a distribution system only the smell of odorant.
- H₂S has a rotten egg smell, and the lack of a rotten egg smell should not alleviate the need for analysis of the deposits

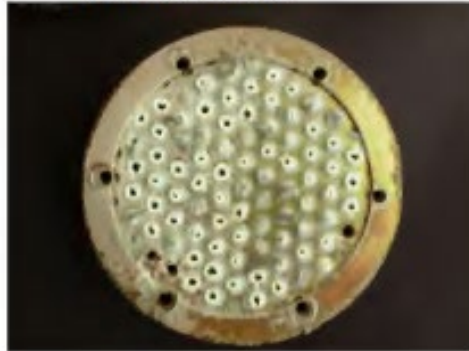
- Flow Restrictors

The following photographs illustrate the ESD phenomenon:

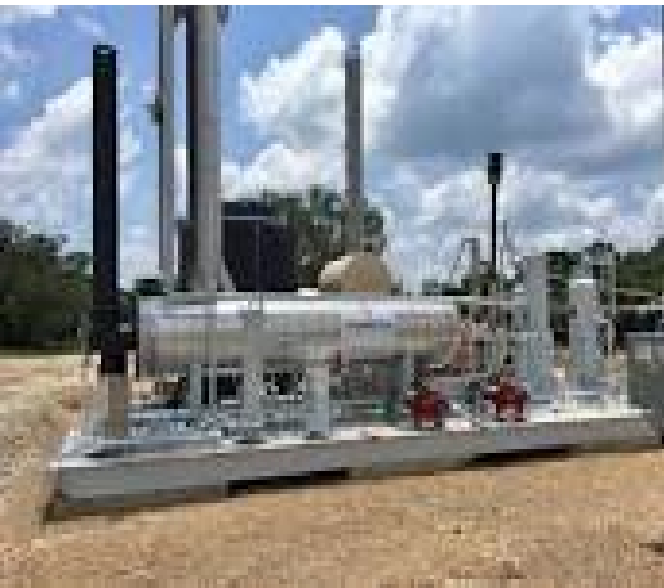
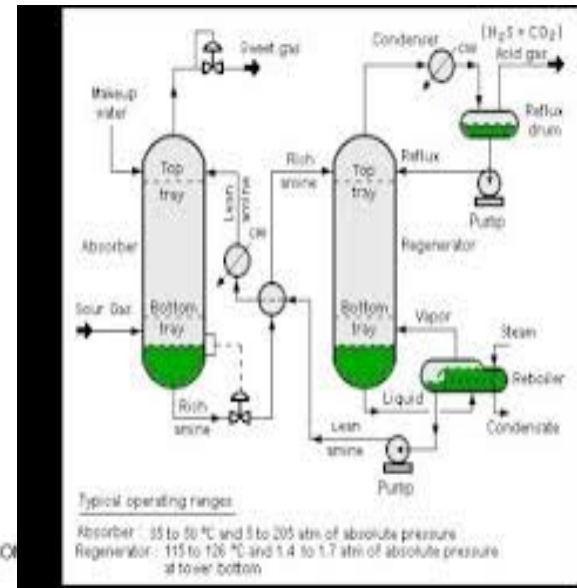
Di-thiazine is a result of H₂S scavengers

- Di-thiazine is a common result of many H₂S scavengers based on cyclic amine called Triazine (water soluble) which react with the H₂S to form the insoluble compound Di-thiazine.
- The Triazine scavengers are prevalent in the natural gas industry to treat gas streams containing Sulfur by either injecting Triazine scavengers directly into the transmission pipelines or by bubbling the gas through amine treater towers.

Di-thiazine Solids Formation

- While the Triazines are effective H₂S Scavengers capable of eliminating the hazards of H₂S and neutralizing the H₂S corrosivity, Di-thiazine and Sulfur vapors that are produced entrain in the gas stream.
- Elemental Sulfur and Di-thiazine solids form from vapors where pressure and flow are reduced and form as solids within pipelines and can cause equipment failure.
- Industry practices for removing Di-thiazine solids include mechanical and chemical cleaning processes or equipment replacement if solids cannot be removed efficiently.
- Internets searches using phrases such as “Di-thiazine solids formation in pipelines” yield useful information on issues and solutions.
