U.S. Department
of Transportation
**Pipeline and Hazardous
Materials Safety
Administration**

Reference No. 25-0105

Subject: Request for Additional Clarification in Interpretation 16-0166R

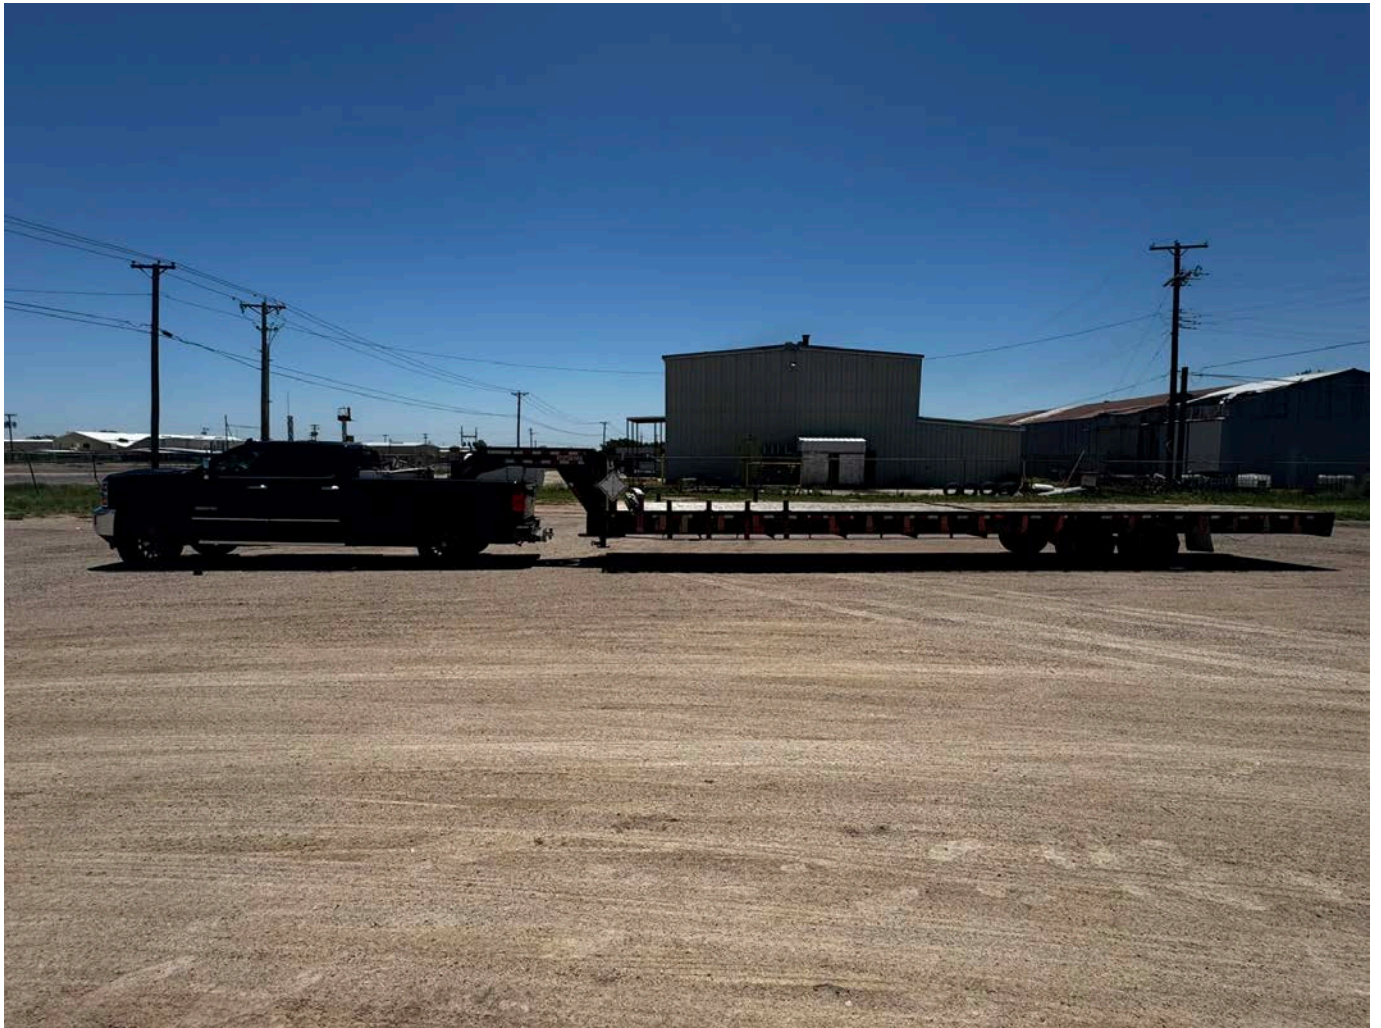
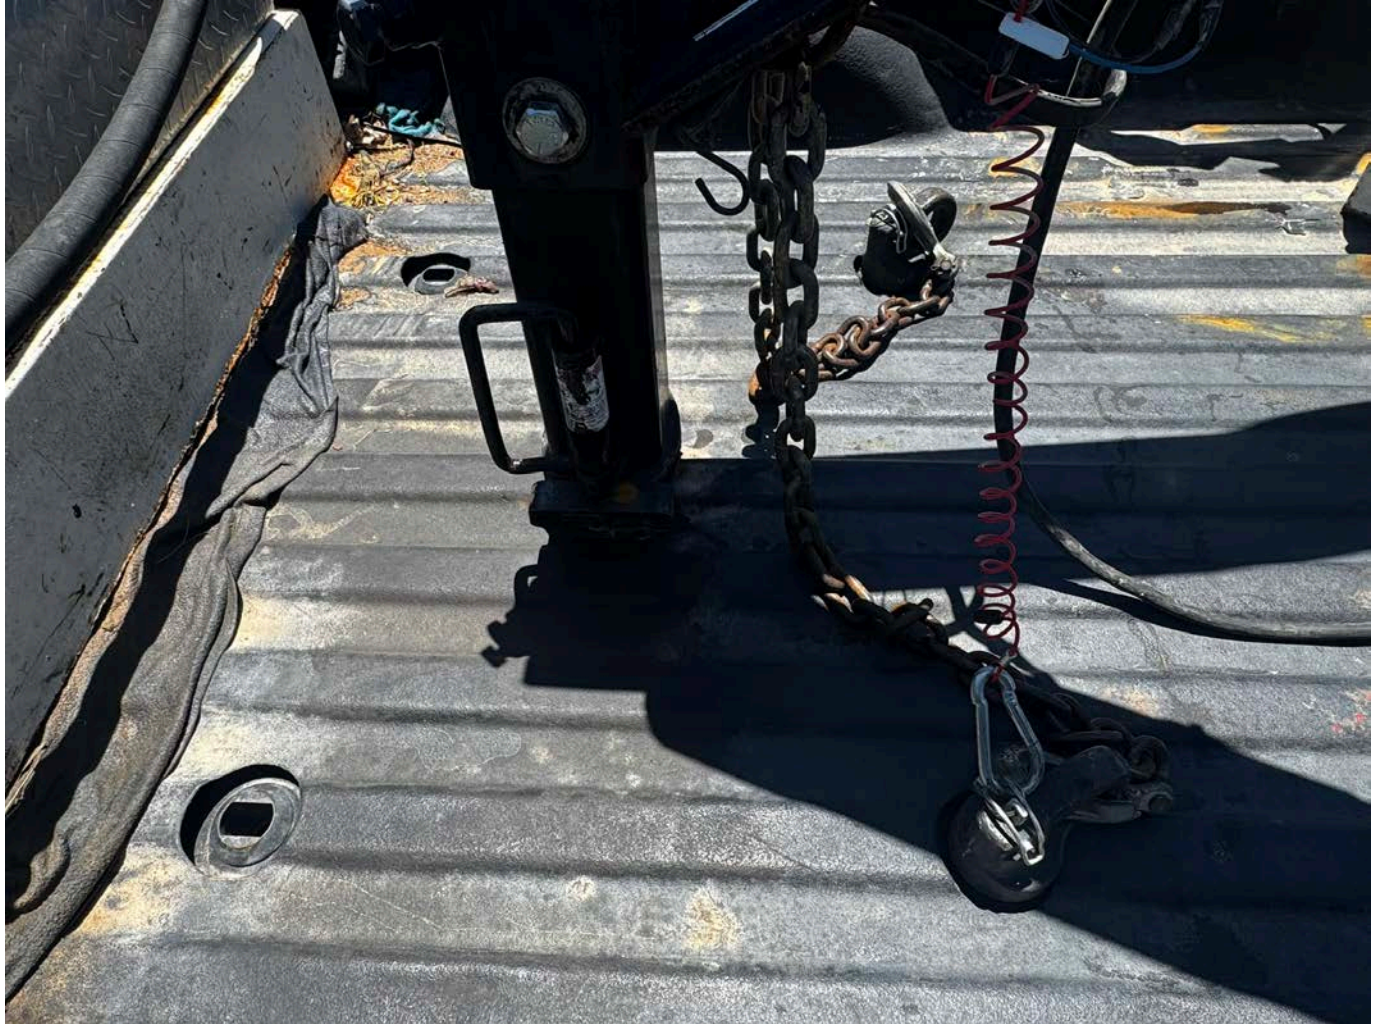
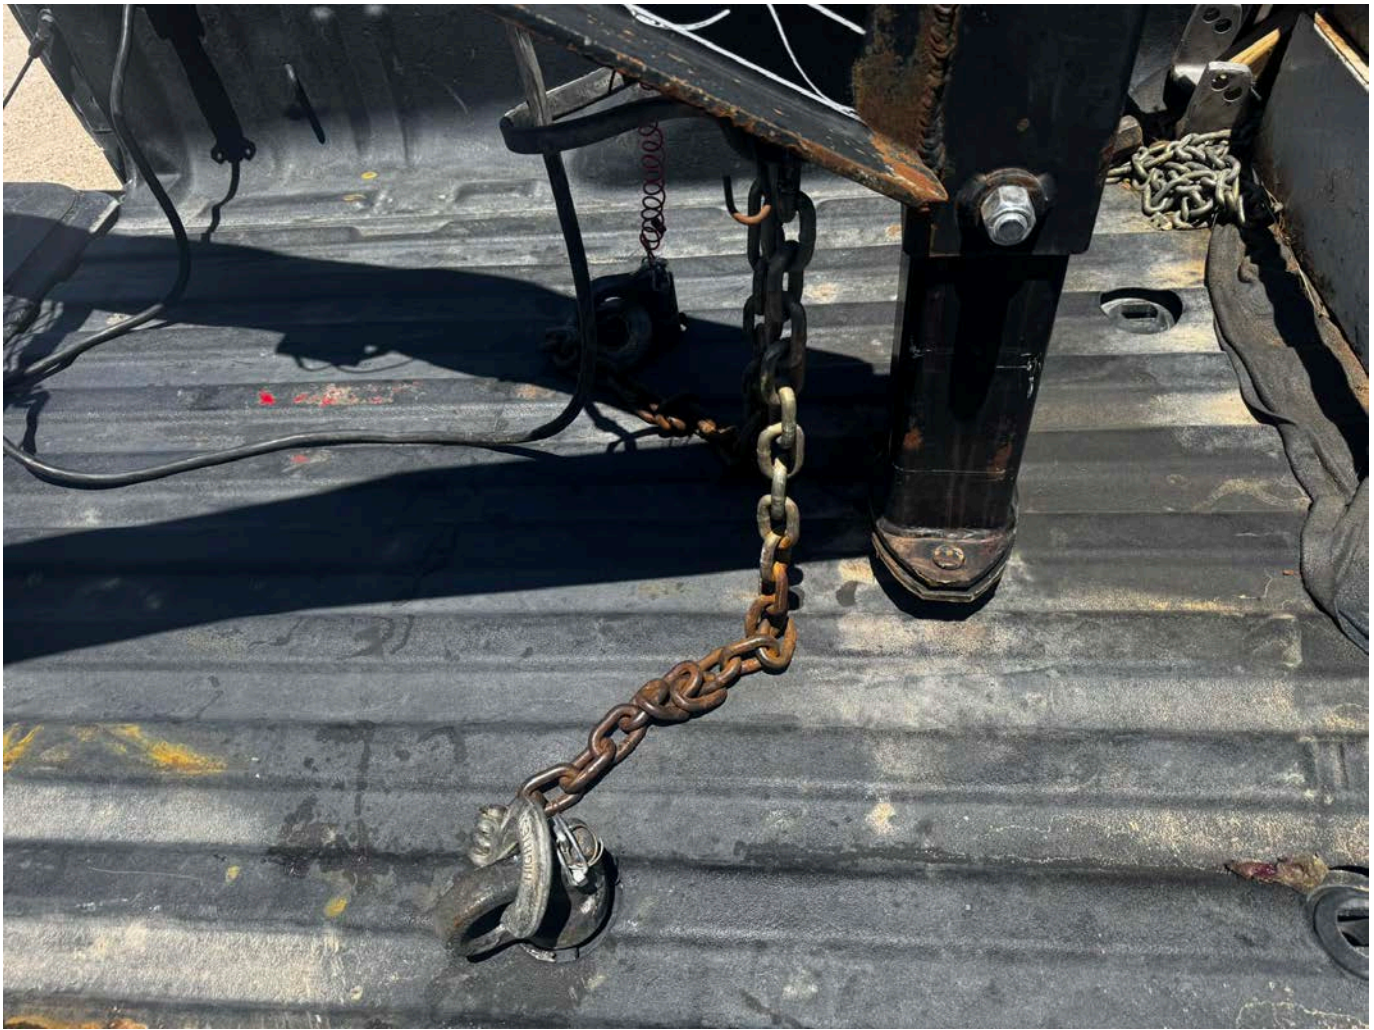
- Photo Documentation: Gooseneck/Neck-over Hitch Configuration

To aid in your review, I have attached photographs of a typical gooseneck (neck-over) hitch configuration. These images clearly show how the hitch occupies the truck bed space, rendering it unusable for general cargo and aligning functionally with the characteristics of a truck-tractor.

Yes. Based on the information and photographs provided, the pickup truck with the gooseneck hitch may be considered a “truck-tractor” for purposes of § 172.516(b). Therefore, the required placarding for the front of the motor vehicle may be on the front of the pickup truck instead of or in addition to placarding on the front of the trailer (*i.e.*, the cargo body).

Relevant Details: The trailer is secured just forward of the rear axle via a gooseneck hitch, rendering the truck bed unusable for carrying cargo. The hazardous materials are Division 1.4 explosives and are transported solely on the trailer. The trailer is not detached during transport nor delivery, and the operation occurs on public highways. The placards on the trailer's sides and rear meet the visibility and attachment requirements of § 172.516(a) and (c). Importantly, gooseneck hitches functionally eliminate the truck bed's cargo-carrying capacity, much like a fifth wheel hitch does. This physical constraint aligns with the criteria often used to differentiate truck-tractors from other vehicle types. While fifth wheel hitches can be installed in one-ton class pickup trucks, they are more commonly used to tow recreational vehicle (RV) trailers. In contrast, gooseneck hitches are the standard in both agricultural and commercial heavy-duty hauling, offering superior strength, durability, and performance in severe service applications.
