**Pipeline and Hazardous
Materials Safety
Administration**

Reference No. 19-0087

This letter is in response to your June 28, 2019, email requesting clarification of the Hazardous Materials Regulations (HMR; 49 CFR Parts 171-180) applicable to the visibility of a placard on the outside of a transport vehicle. Specifically, you ask whether the placards shown in the photographs provided are affixed on a contrasting background, in accordance with § 172.516(c)(7).

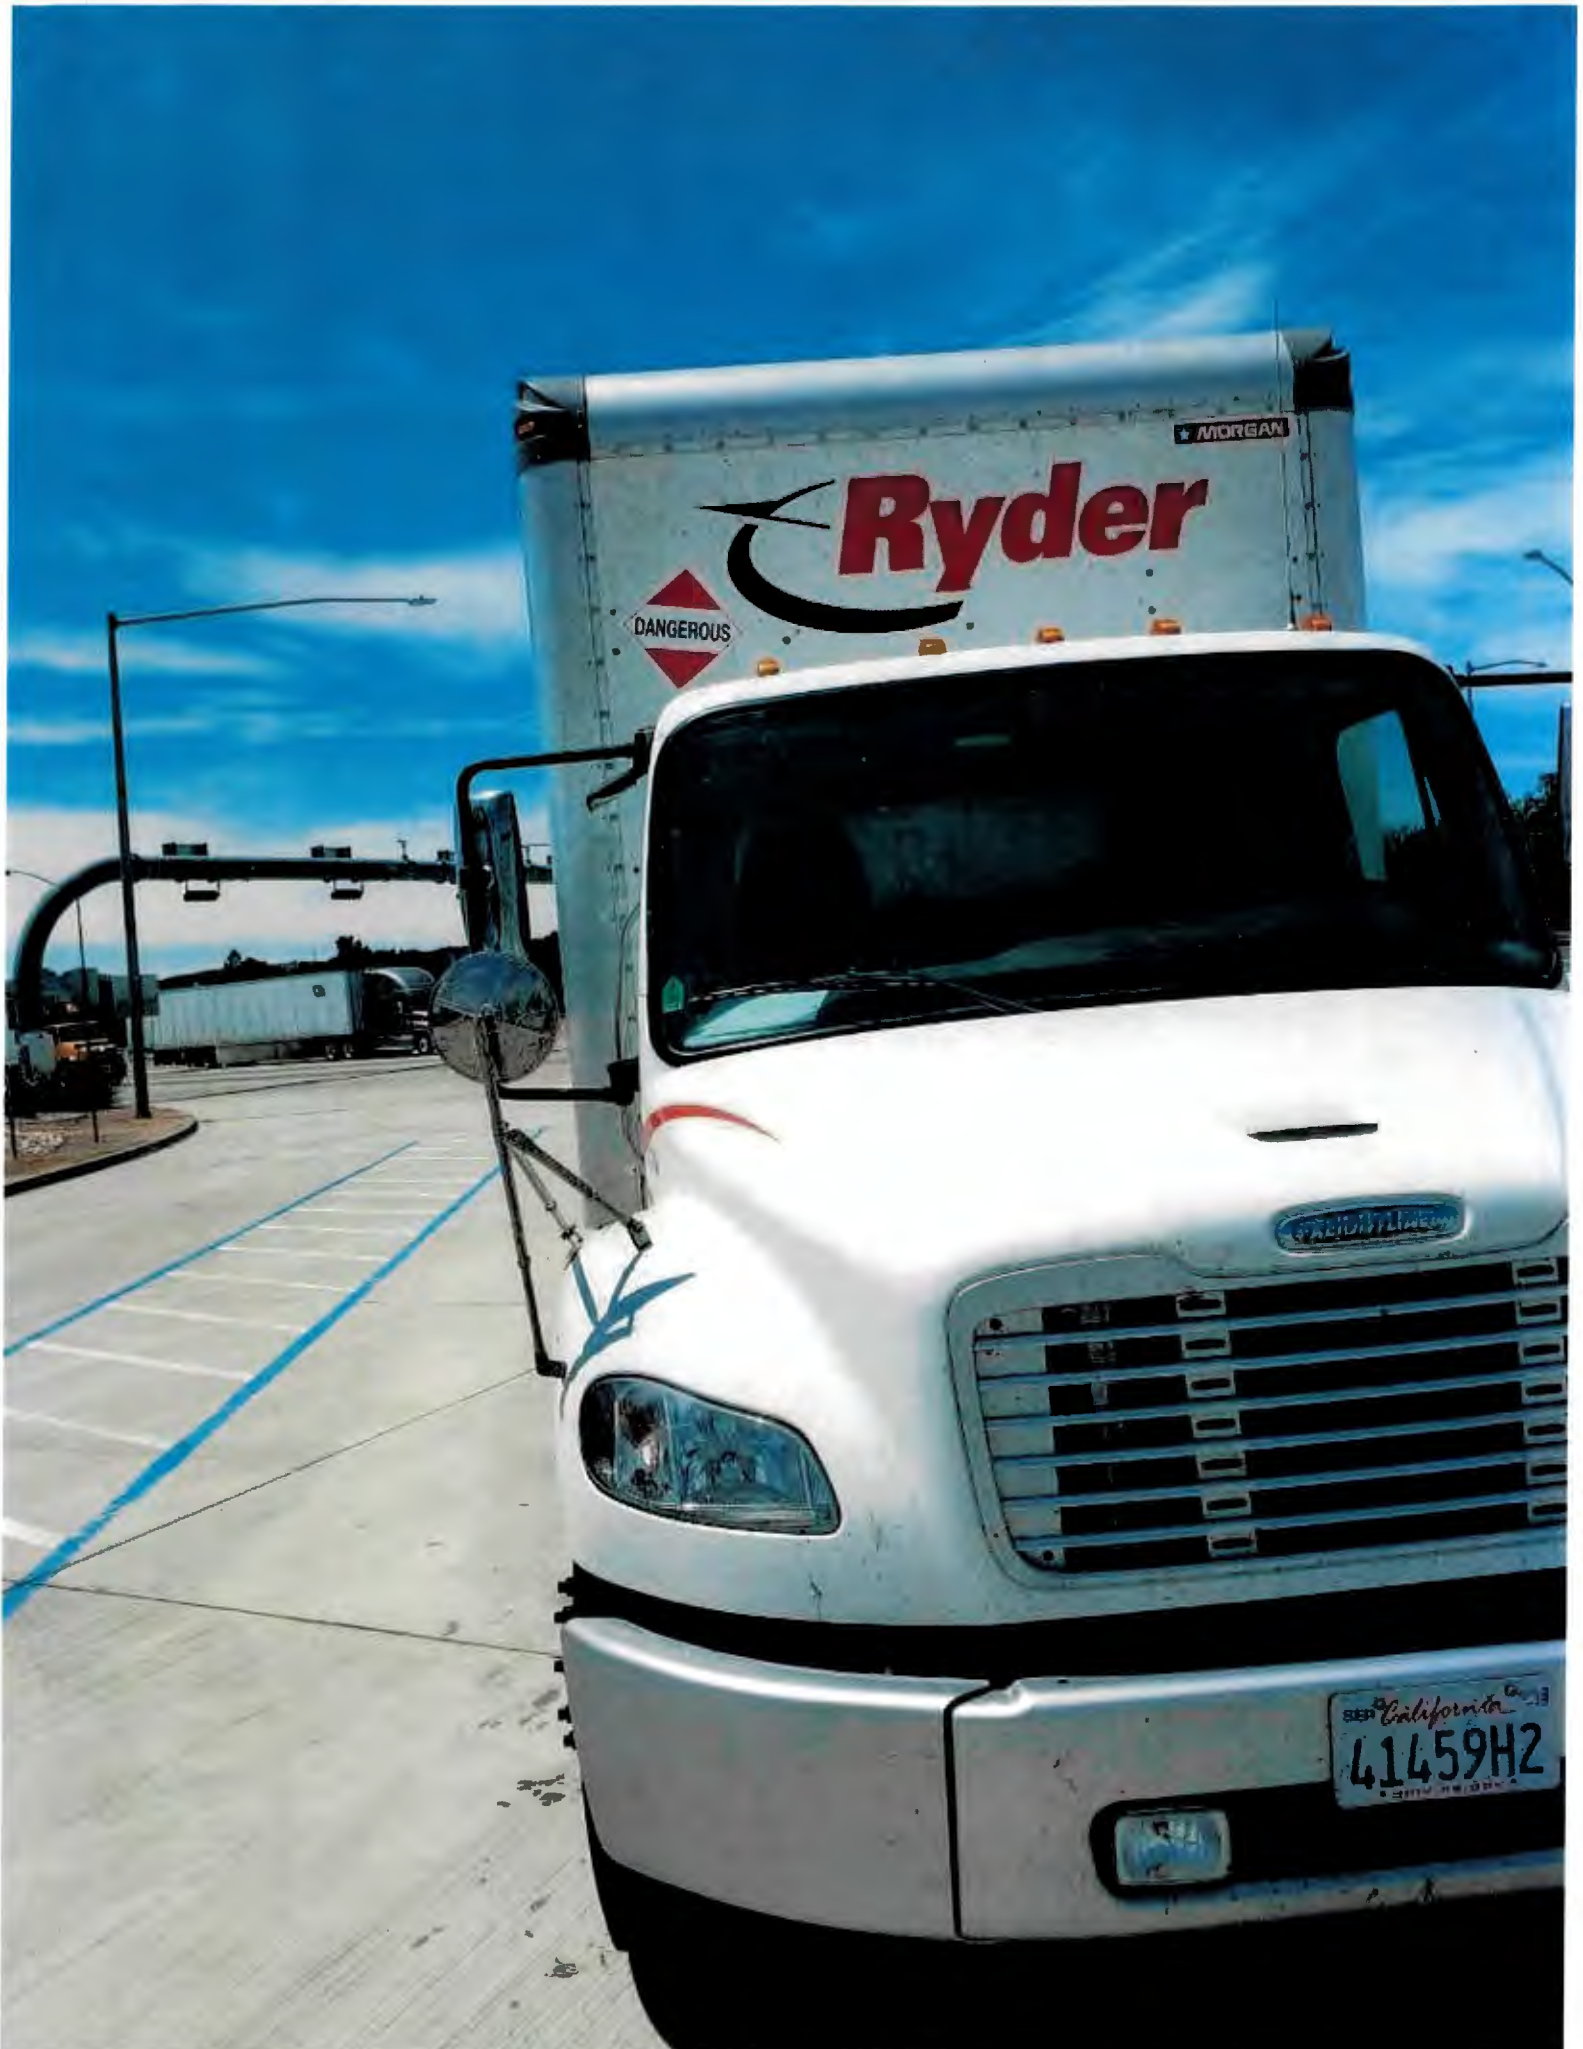
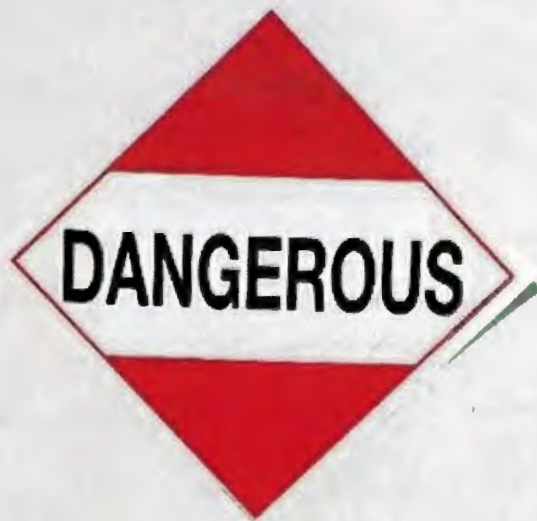
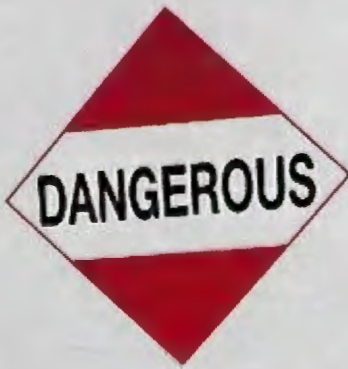
The answer is yes. Based on the photographic evidence, the red upper and lower triangles, and black inscription on the placard sufficiently contrast with the white background of the transport vehicle such that the placard is clearly visible.

The photographs show that the placards are displayed on a white box-truck vehicle. Please review the attached photos and advise if they appear to be displayed in compliance with 172.516 (c).
