**Pipeline and Hazardous
Materials Safety
Administration**

Reference No. 21-0112

From: Roy Terwilliger <rterwill@sheetz.com>
Sent: Wednesday, December 1, 2021 11:01 AM
To: INFOCNTR (PHMSA) <INFOCNTR.INFOCNTR@dot.gov>
Subject: Placard Display Interpretation Requested 49 CFR 172.516(c)

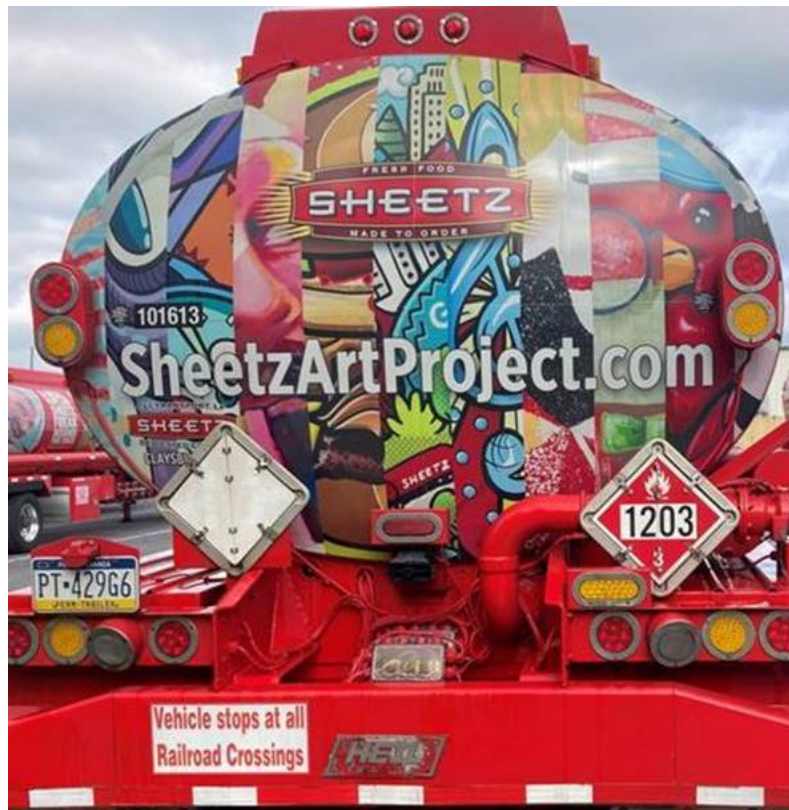
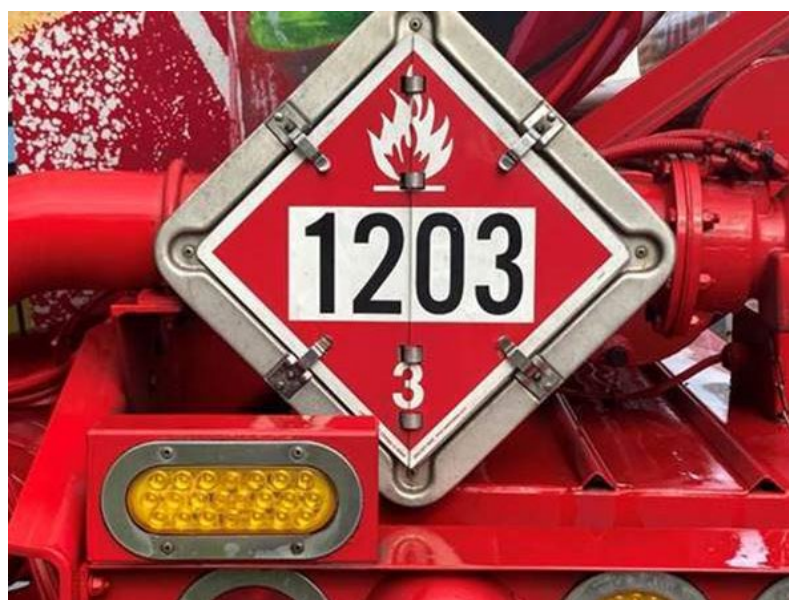
We are requesting an interpretation of a placard displayed below.

172.516(a) states that, "each placard on a motor vehicle and each placard on a rail car must be **clearly visible from the direction it faces**". In our photos below of our trailer this is the view of the placard from the "*direction it faces*".

172.516(c)(6) states that placards “Be maintained by the carrier in a condition so that the format, legibility, color and visibility of the placard will not be “**substantially reduced**” due to damage, deterioration or **obscurement** by dirt or other matter.

Based on the photographs you provided, it is the opinion of this Office that the display of the “UN1203” placard complies with the regulations for visibility and display of placards in § 172.516.

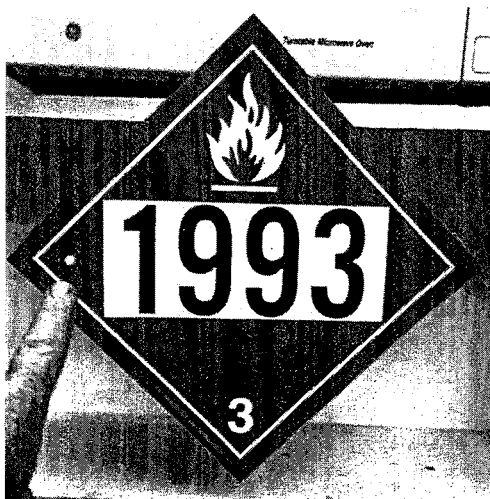
Does the 1993 placard pictured below meet the guidelines of 172.516(c)(6) and therefore would not be considered in violation? The area is a small circle just above the finger in the picture.

The answer is yes. It is the opinion of this Office that the placard depicted in your letter would be acceptable under § 172.516. As required by § 172.516(c)(6), each placard on a transport vehicle, bulk packaging, freight container or aircraft unit load device must be maintained by the carrier in a condition so that the format, legibility, color, and visibility of the placard will not be substantially reduced due to damage, deterioration, or obscurement by dirt or other matter. The Pipeline and Hazardous Materials Safety Administration (PHMSA) cannot make a broad determination about what would be considered substantial damage to a placard. Therefore, PHMSA must consider whether the condition of a placard is still acceptable on a case-by-case basis.

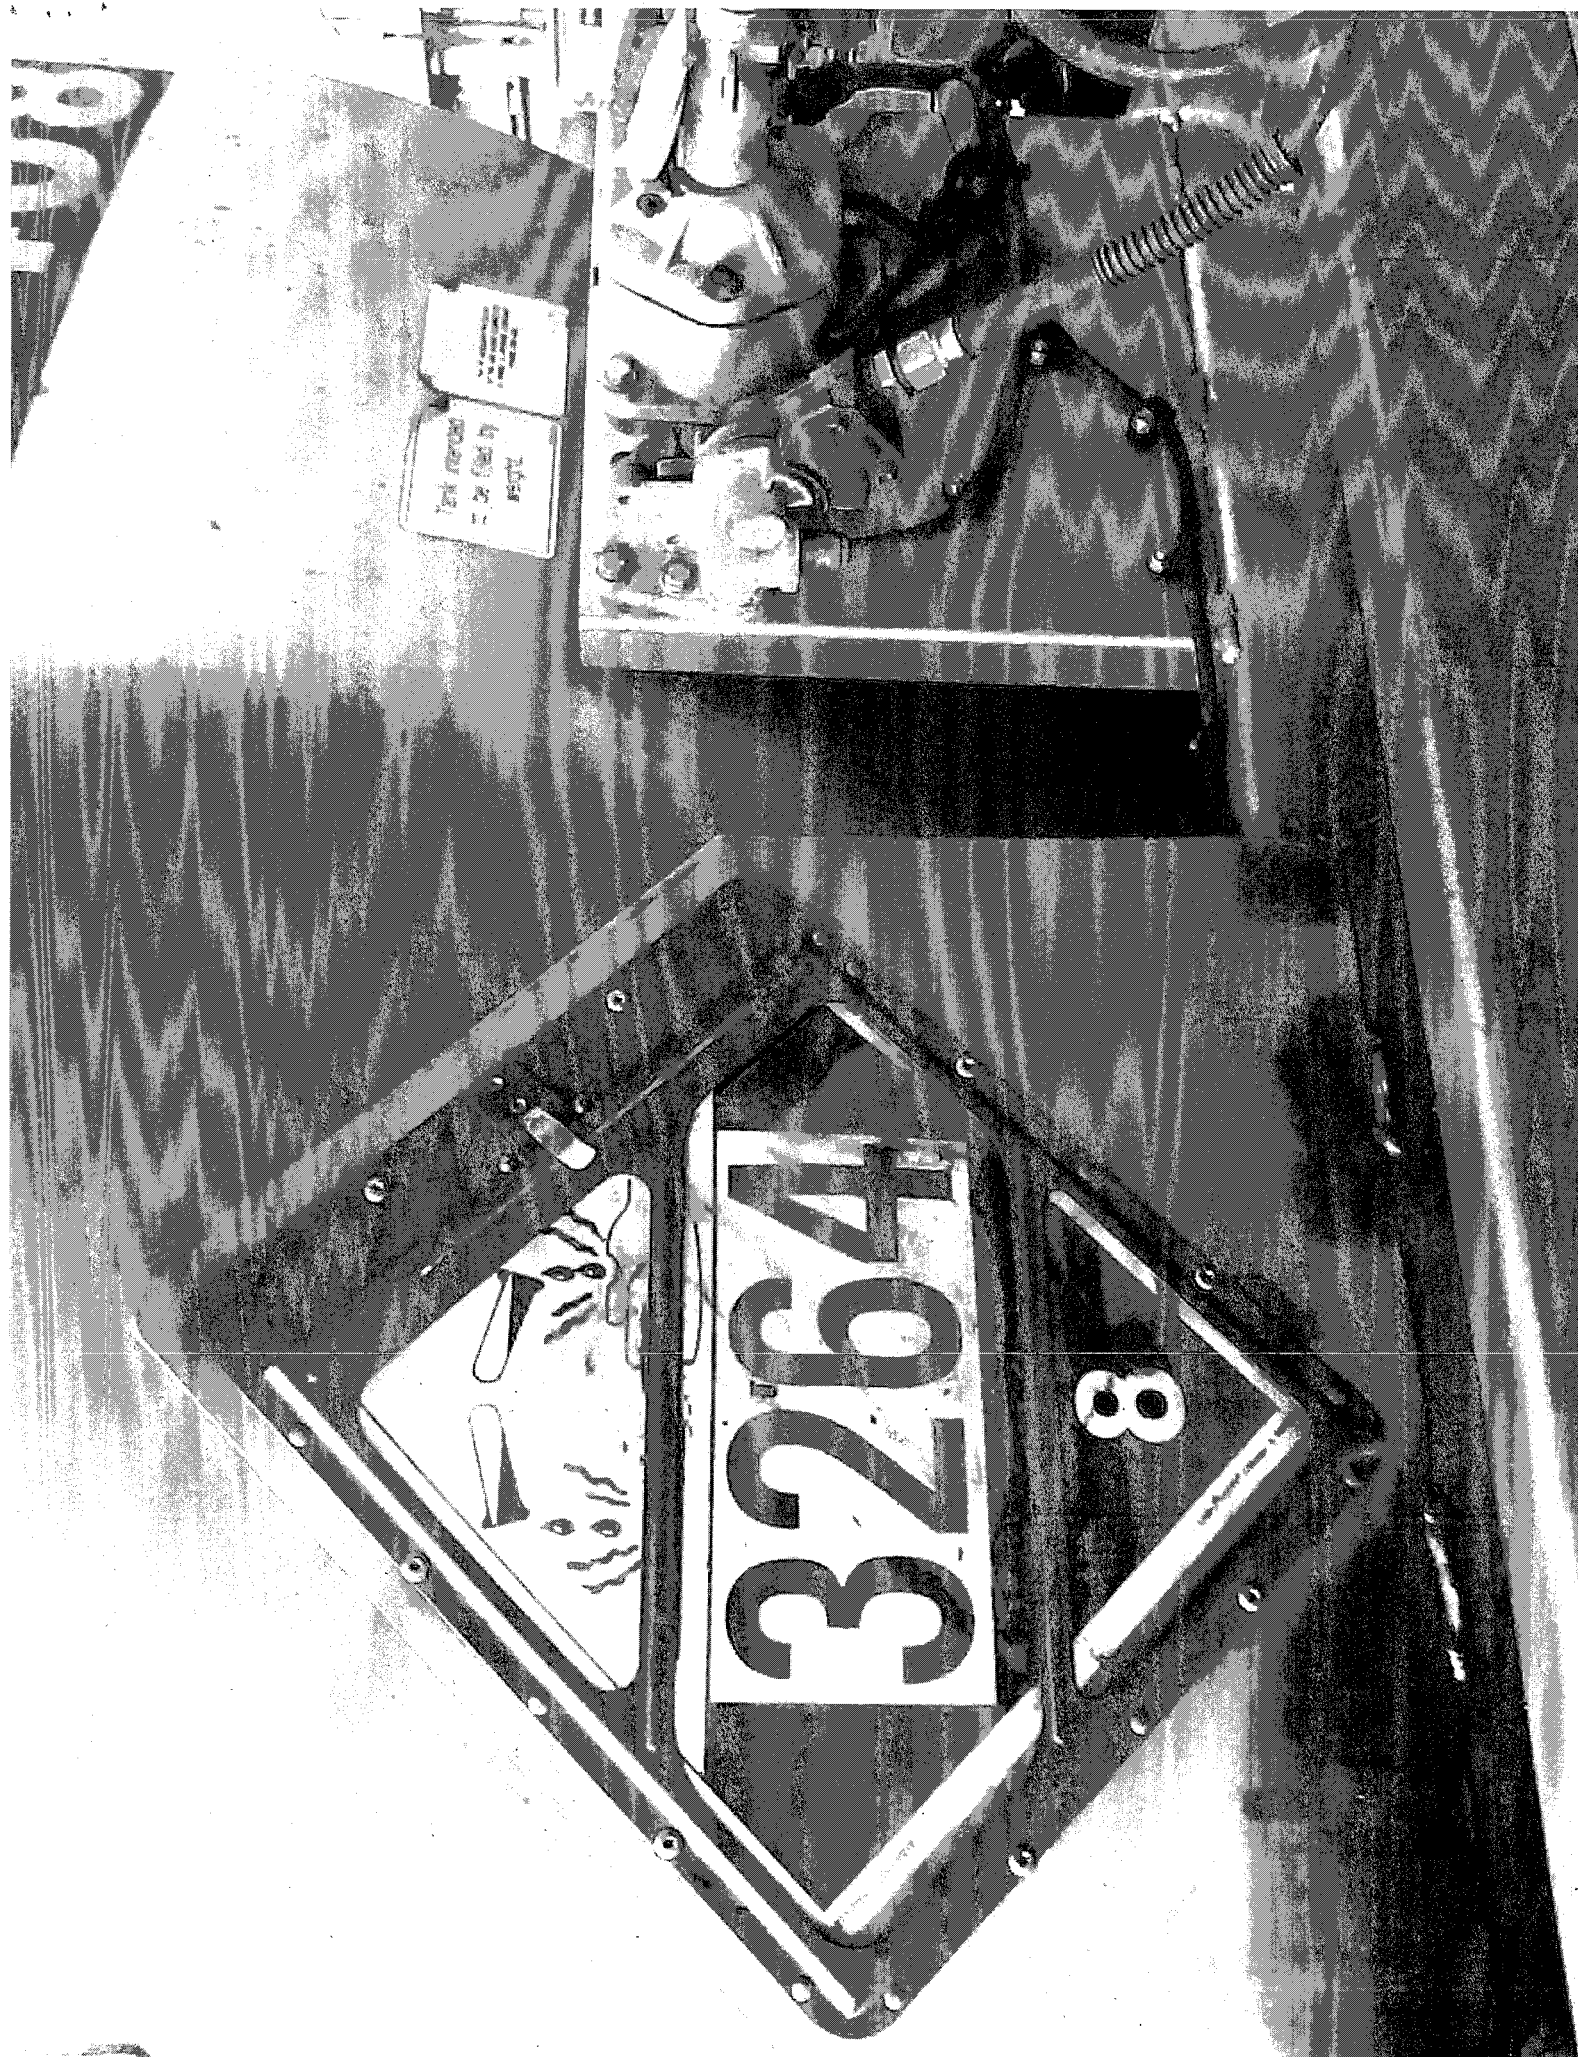
Attached is an example of a placard. Can you please advise if this would be considered damaged? Thank you for your help with this matter.

The answer is no. We do not consider the example placard provided to be damaged. However, we note that the picture you provided shows a placard that does not fit precisely in the placard holder, which appears to be designed according to the placard holder specifications in Appendix C to Part 172. The Dimensional Specifications for Recommended Placard Holder in Appendix C to Part 172 were originally adopted to be consistent with the larger minimum size requirements of 273 mm x 273 mm (or 10 ¾ in. x 10 ¾ in.) for placards prior to the publication of final rule HM-218F on July 20, 2011 [76 FR 43510]. The HM-218F rule reduced the placard minimum size requirements to 250 mm x 250 mm (~ 9 ¾ in. x 9 ¾ in.) to harmonize with international standards.

The horizontal cross members of the recommended placard holder do not obstruct or cover any of the essential design elements of the original larger minimum size placard (i.e., a 273 mm x 273 mm placard). Yet, if a placard is designed to the current minimum size requirements (i.e., a 250 mm x 250 mm placard), it would not fit precisely in a placard holder strictly designed to Appendix C standards. The specifications in Appendix C are not intended to be fixed and should be adjusted accordingly for consistency with the size of the placard it is intended to hold.

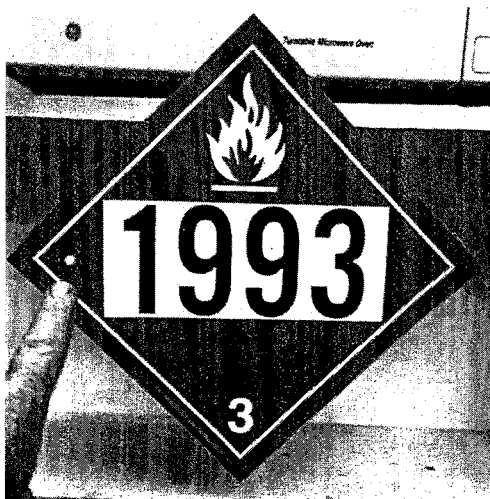
Does the 1993 placard pictured below meet the guidelines of 172.516(c)(6) and therefore would not be considered in violation? The area is a small circle just above the finger in the picture.

The answer is yes. It is the opinion of this Office that the placard depicted in your letter would be acceptable under § 172.516. As required by § 172.516(c)(6), each placard on a transport vehicle, bulk packaging, freight container or aircraft unit load device must be maintained by the carrier in a condition so that the format, legibility, color, and visibility of the placard will not be substantially reduced due to damage, deterioration, or obscurement by dirt or other matter. The Pipeline and Hazardous Materials Safety Administration (PHMSA) cannot make a broad determination about what would be considered substantial damage to a placard. Therefore, PHMSA must consider whether the condition of a placard is still acceptable on a case-by-case basis.

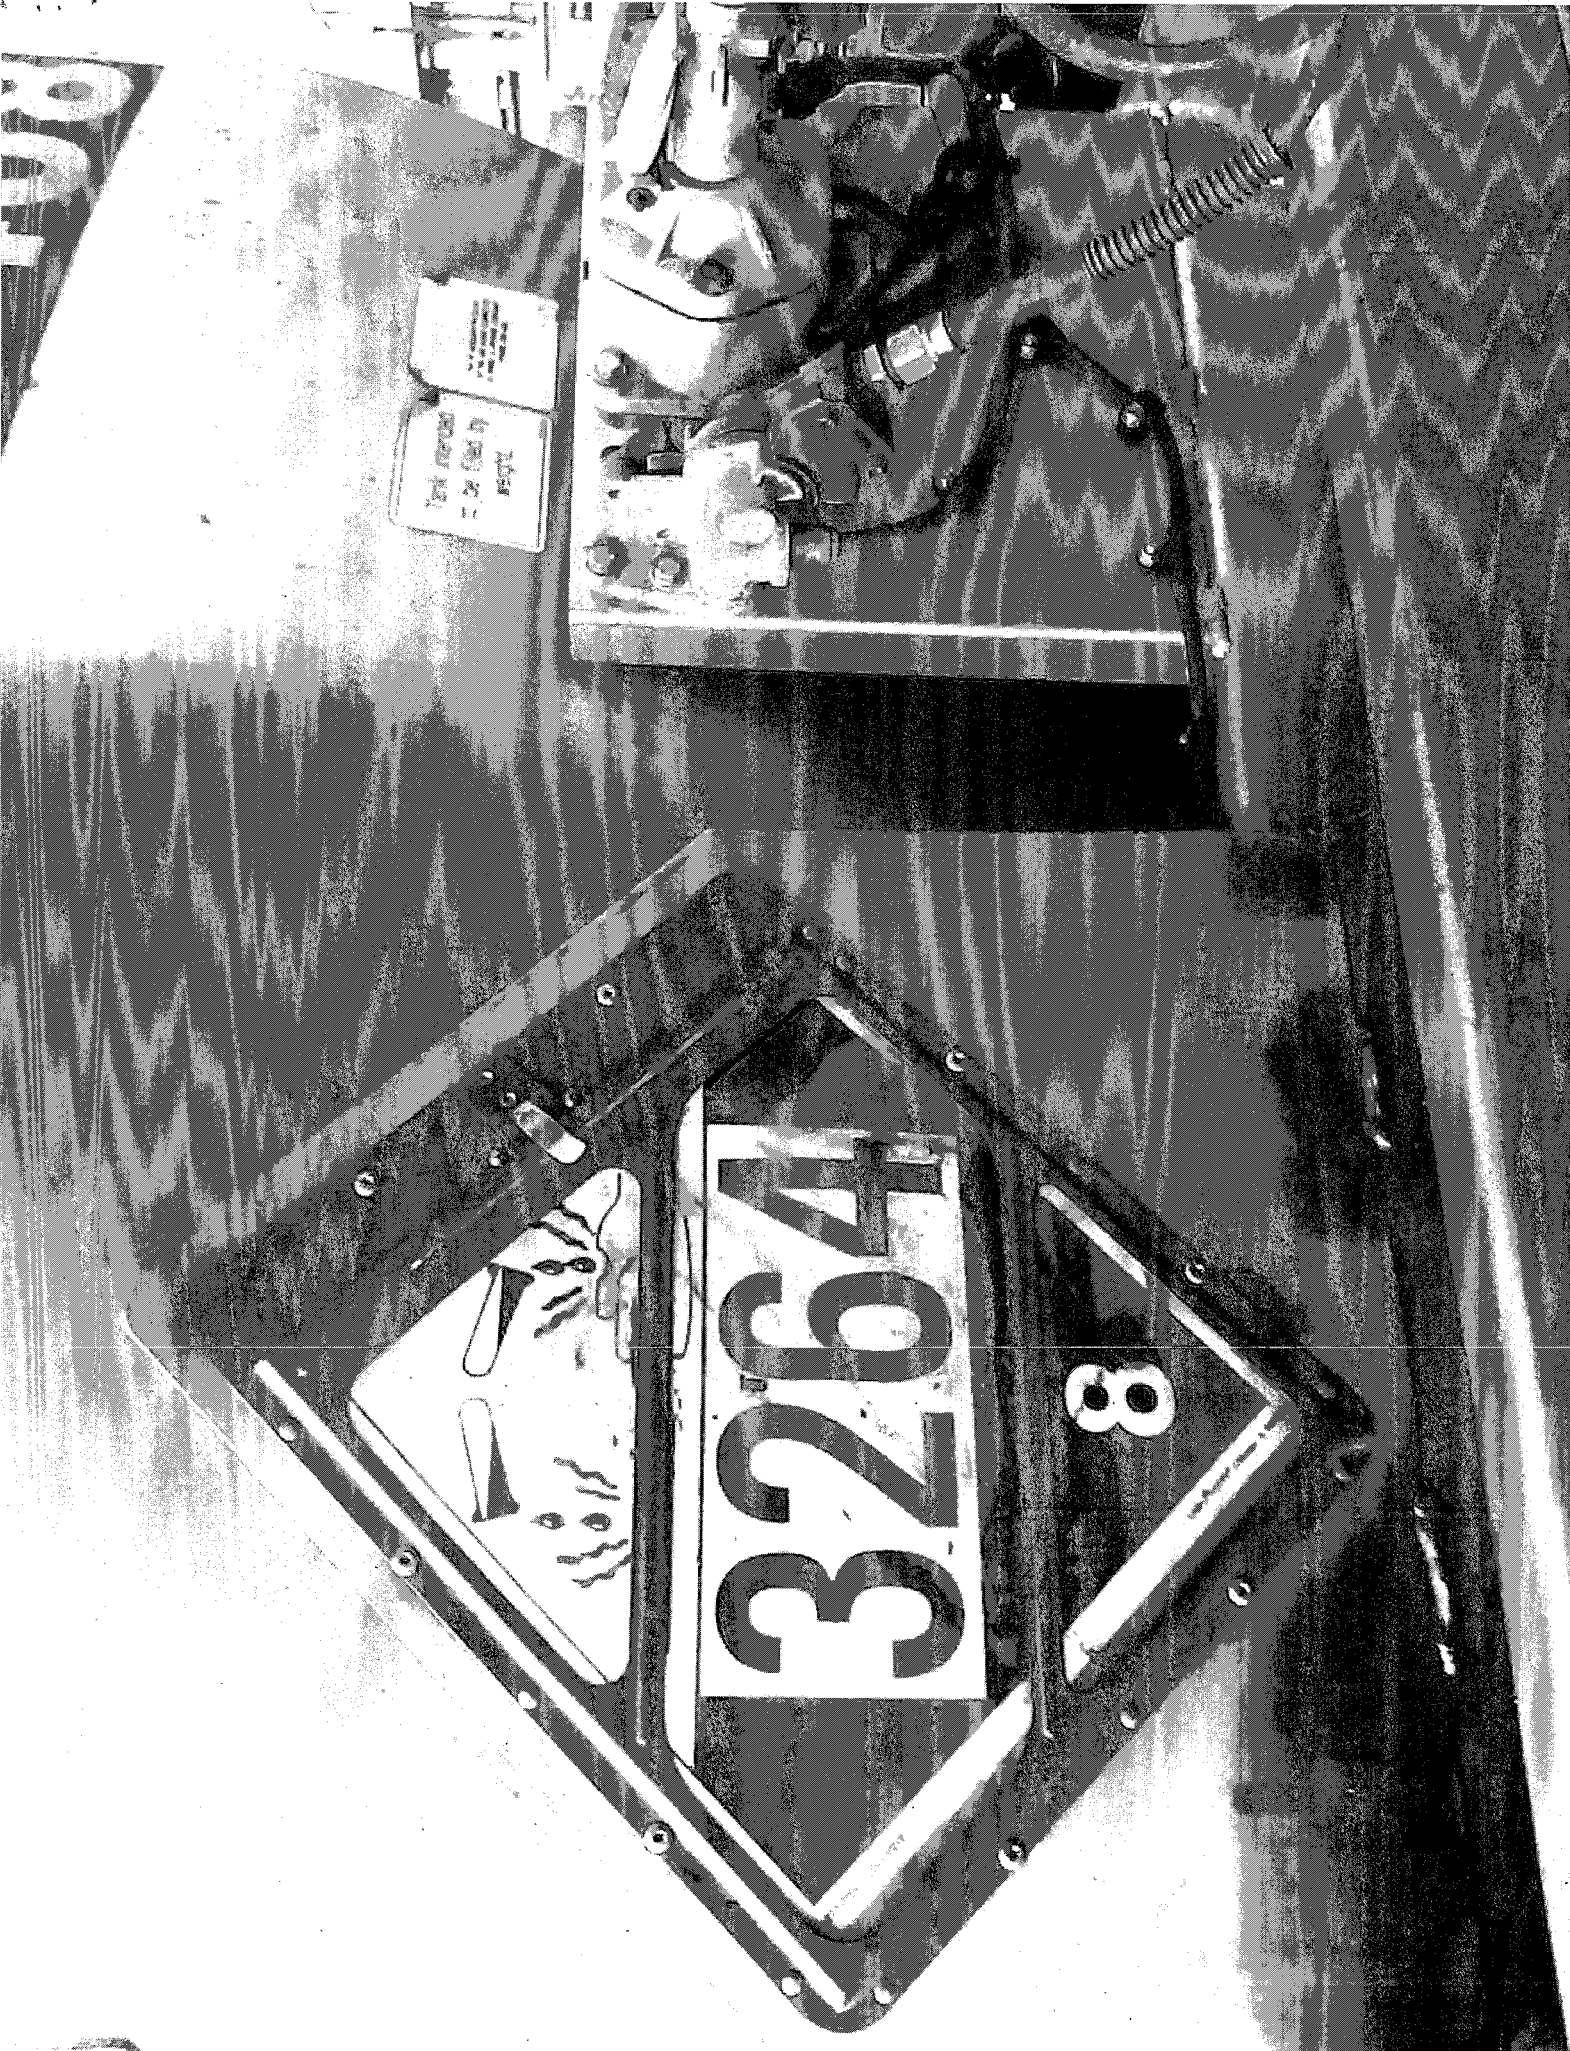
Attached is an example of a placard. Can you please advise if this would be considered damaged? Thank you for your help with this matter.

The answer is no. We do not consider the example placard provided to be damaged. However, we note that the picture you provided shows a placard that does not fit precisely in the placard holder, which appears to be designed according to the placard holder specifications in Appendix C to Part 172. The Dimensional Specifications for Recommended Placard Holder in Appendix C to Part 172 were originally adopted to be consistent with the larger minimum size requirements of 273 mm x 273 mm (or 10 ¾ in. x 10 ¾ in.) for placards prior to the publication of final rule HM-218F on July 20, 2011 [76 FR 43510]. The HM-218F rule reduced the placard minimum size requirements to 250 mm x 250 mm (~ 9 ¾ in. x 9 ¾ in.) to harmonize with international standards.

The horizontal cross members of the recommended placard holder do not obstruct or cover any of the essential design elements of the original larger minimum size placard (i.e., a 273 mm x 273 mm placard). Yet, if a placard is designed to the current minimum size requirements (i.e., a 250 mm x 250 mm placard), it would not fit precisely in a placard holder strictly designed to Appendix C standards. The specifications in Appendix C are not intended to be fixed and should be adjusted accordingly for consistency with the size of the placard it is intended to hold.
