# Mechanical Damage FINAL REPORT

U.S. Department of Transportation  
Pipeline and Hazardous Materials Safety Administration  
Office of Pipeline Safety

Integrity Management Program  
Under Delivery Order DTRS56-02-D-70036  
(Technical Task Order 16)

Michael Baker Jr., Inc.

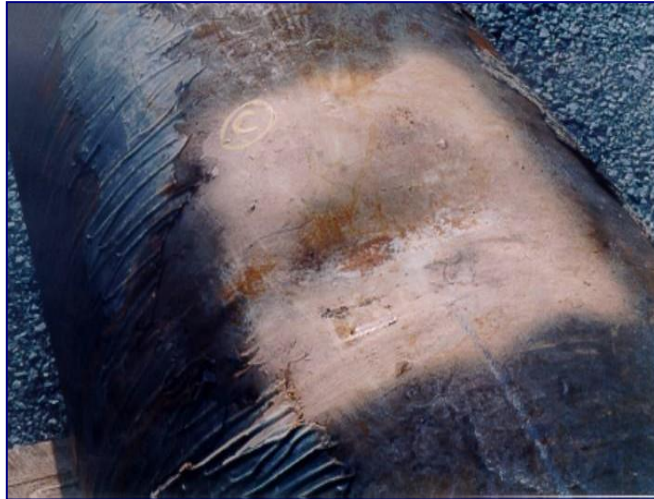
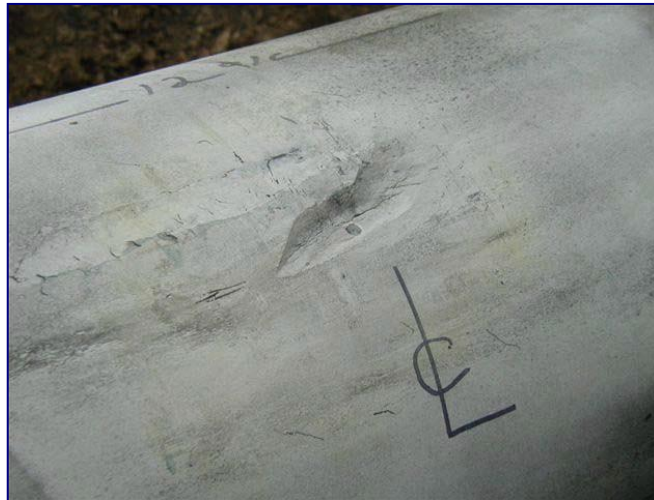
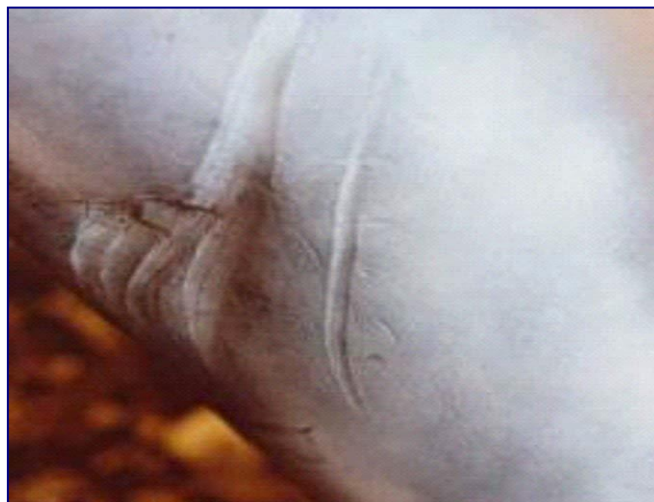
In this section, mechanical damage is discussed in three broad categories: dents, gouges, and combined dent/gouge defects. Figure 4.1 shows examples. Each mechanical damage defect reflects a unique combination of conditions, such as the indenter size and shape, as well as force, angle, orientation, and duration of impact. The different forms of damage can be generalized to facilitate assessment and prioritization of repairs, as explained below (Cosham and Hopkins, 2002).

A. Dent

B. Gouge

C. Dent with Gouge

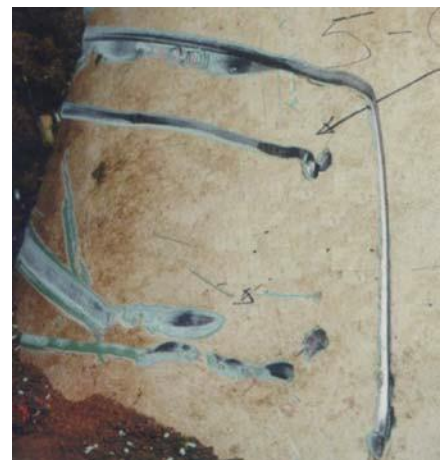
Gouges are typically formed when an object such as an excavator tooth is drawn across the surface of the pipe. The gouge acts as a stress concentrator which affects structural integrity. In addition, the gouge typically results in metallurgical damage in the form of strain hardening of the material and residual stress. These features differentiate gouges from many other metal loss defects, such as corrosion, which may result in reduced wall thickness of the pipe but do not involve metallurgical damage. The length and orientation of a gouge, as well as other characteristics, can vary significantly at a mechanical damage location, as shown in Figure 4.2.

**Figure 4.2 – Gouge Characteristics**

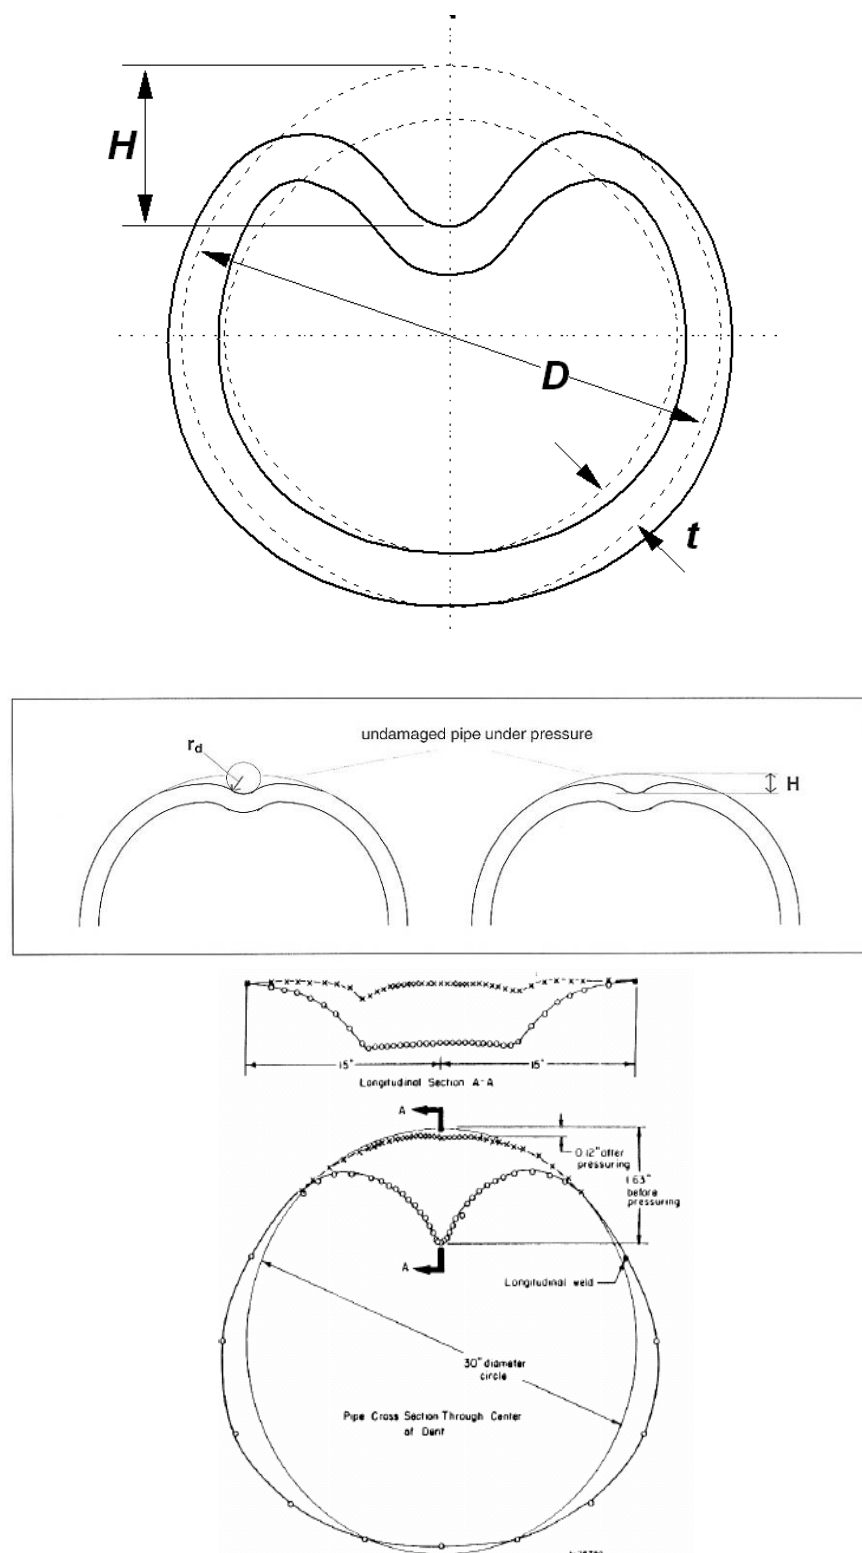
**Figure 4.3 – Dent Depth Measurement (Hopkins and Leis, 2003)**

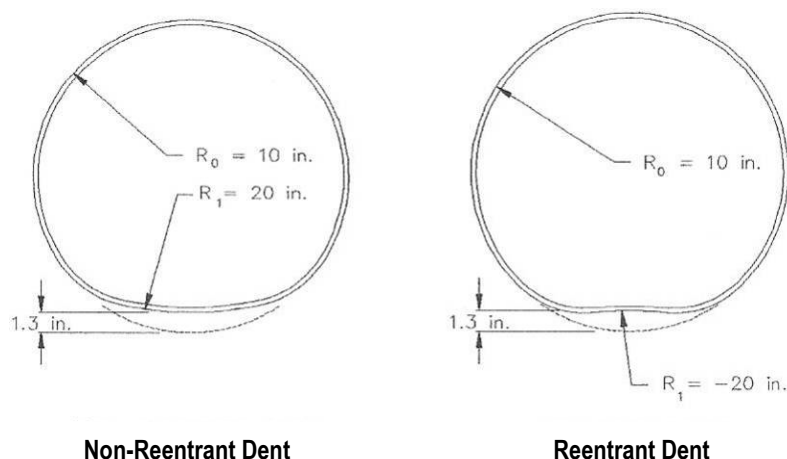
Dents can be described as either non-reentrant or reentrant (Figure 4.4). A positive radius value defines a non-reentrant dent, in which the outer surface of the pipe is flattened but retains its convexity. A negative radius value defines a reentrant dent, in which the outer surface of the pipe is dented deeply enough that it becomes concave. Dent shape has also been described in terms of the maximum angle subtended by the flanks of the dent (Baker, 2004)

**Figure 4.4** – Measurement of Re-Entrant and Non-Re-Entrant Dent Depth (Baker, Jr., M., 2004)

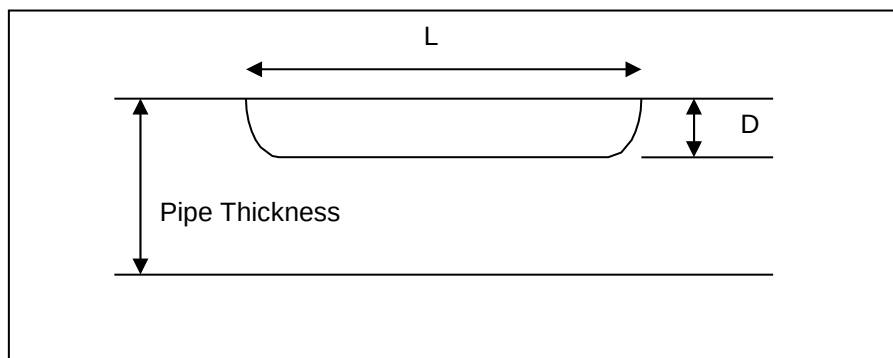
The geometric parameters used to characterize a gouge are the depth, length, width, and angle to axis, etc. These are usually measured from the undeformed outer radius of the pipe (Figure 4.5).

**Figure 4.5** – Gouge Depth Measurement (OPS TTO10, 2004)

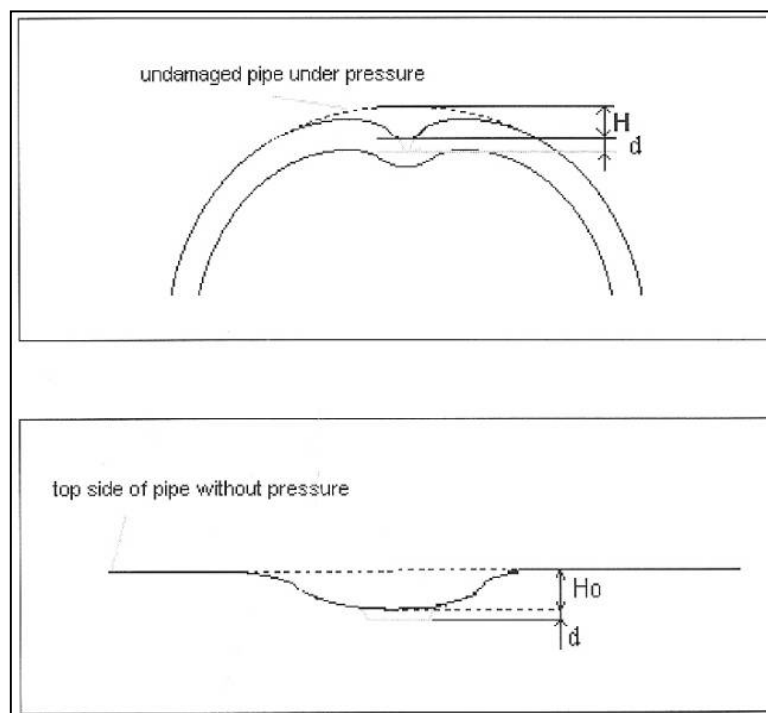
For combined dents and gouges, the gouge length and depth are usually measured from the metal surface at the shoulder of the gouge – that is, not including the depth or length of the dent (Figure 4.6). Similarly, the depths of cracks are measured from the metal surface, excluding the depth or length of the associated dent and/or gouge. However, for assessment purposes, it sometimes may be appropriate to add the gouge and crack depths (see Section 7).

**Figure 4.6 – Depth Measurement for Combined Dents and Gouges**

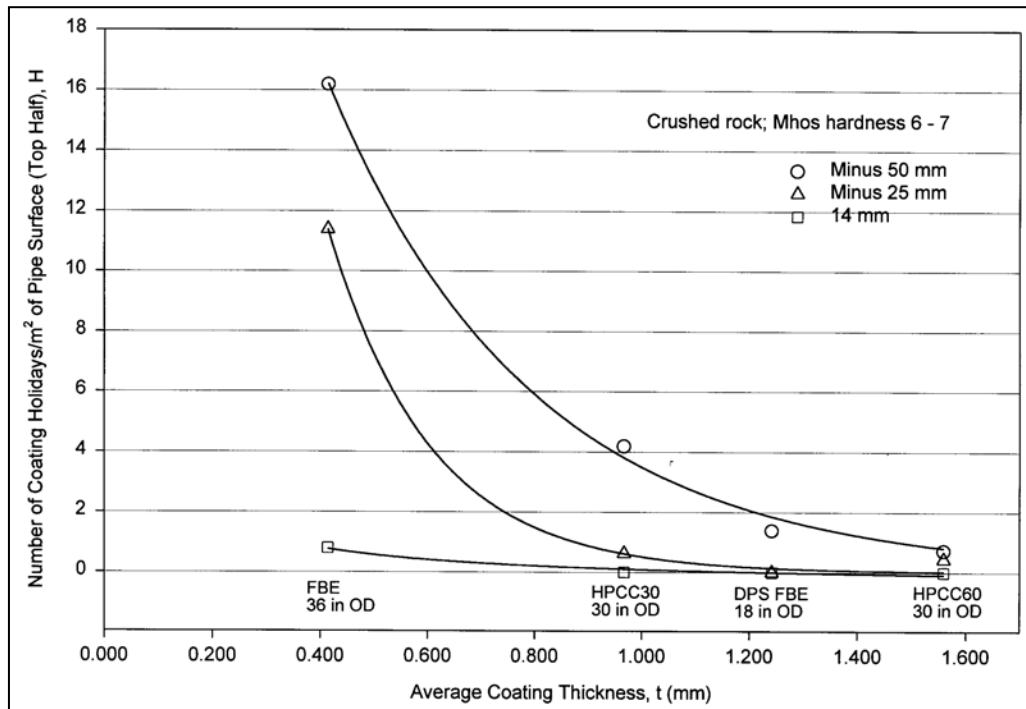
coating type. A quantitative relationship between coating damage and coating thickness was defined, as shown in Figure 5.2.

**Figure 5.2** – Number of Coating Holidays/m<sup>2</sup> of Pipe Surface (top half) Caused During a 12 Day Test of Coating Performance on Buried Pipe

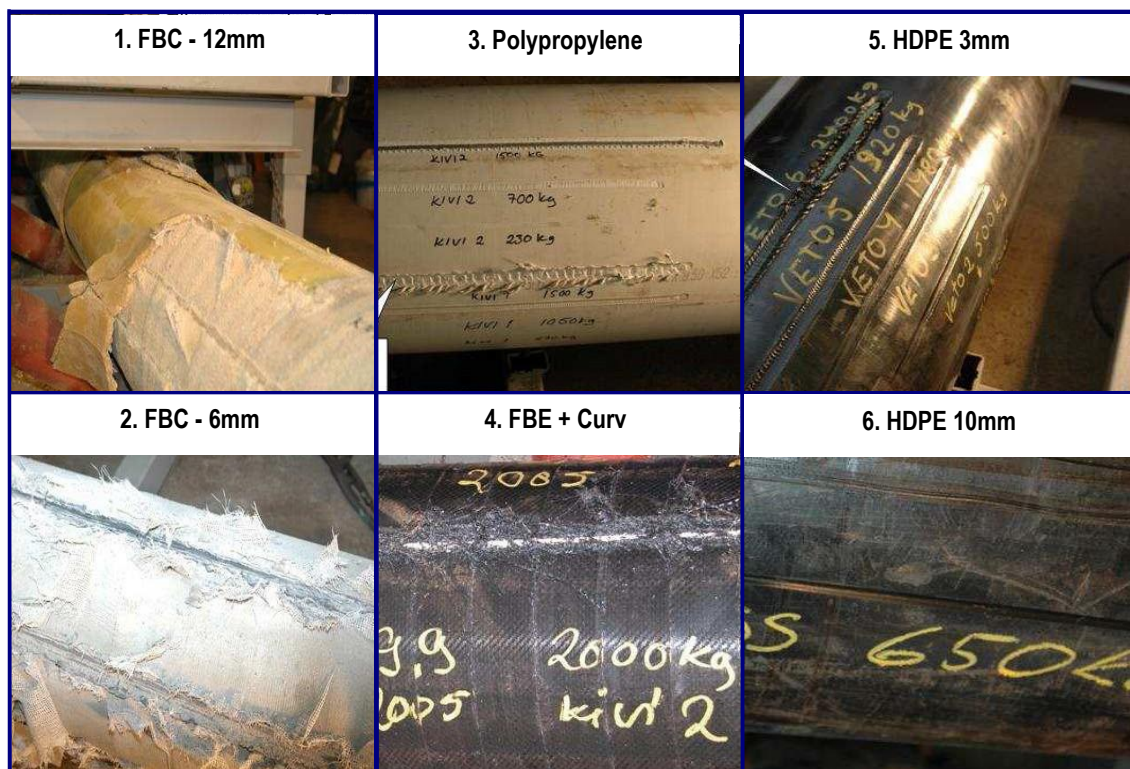
Figure 5.3 – Pipeline Coatings Tested for Severe Construction Conditions (Christianson, 2006)

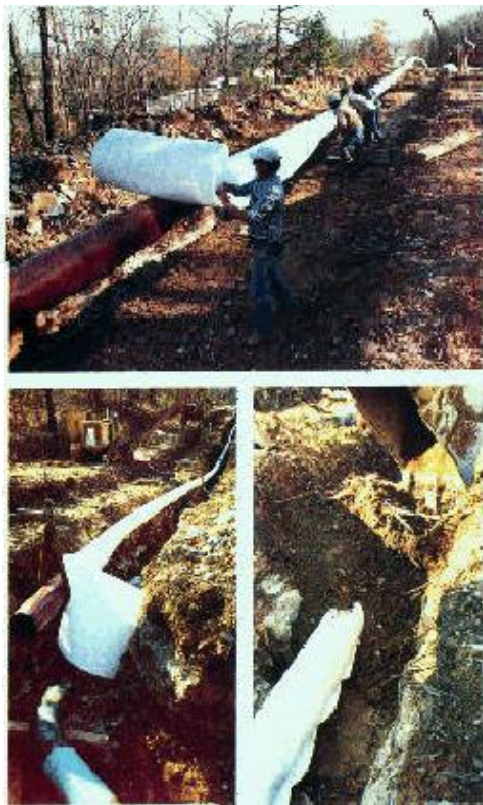
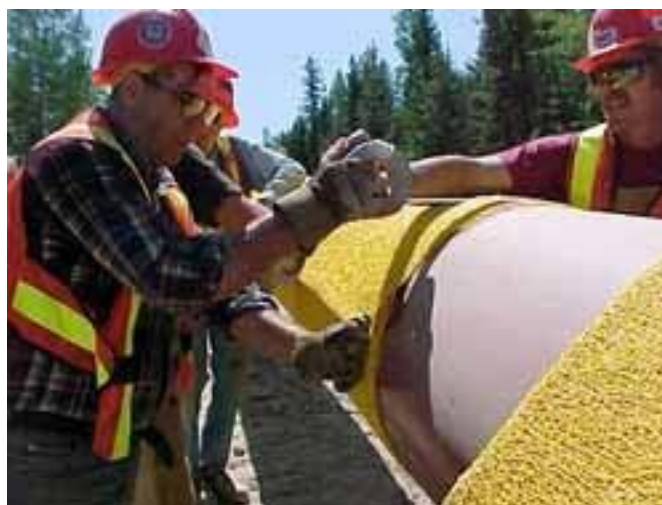
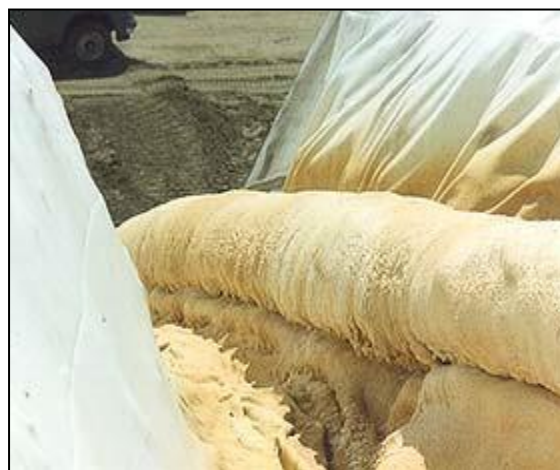
**Rock Shields.** There are a variety of coating types that are meant to protect the pipe from being damaged by rocks in the backfill. Many are wraparound products, similar in many respects to the geotextiles discussed above. Others are flexible mats placed above, below, or around the pipe. Still others are sprayed on in the ditch. Figure 5.4 illustrates such examples.

Composite Foam Cushion Wrap  
(<http://www.farwestcorrosion.com>)

Wrapped Rock Shield (<http://www.tuff-n-enough.com>)

Polyurethane Foam Rock Shield (<http://www.pedero.com/>)

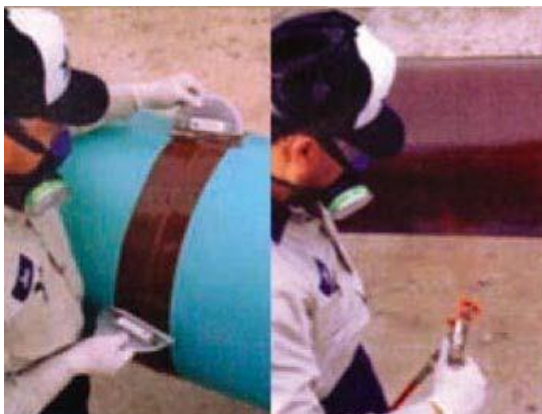
impact resistance and can also be used as a rockshield. Should any damage occur due to severe repeated blows, the area can be repaired easily by using the same material after cleaning, when the surface becomes dry. Figure 5.5 shows an application of Powercrete®.

**Figure 5.5** – Powercrete® pipeline coating application (<http://www.petropages.com/vendors/v19548.htm>)

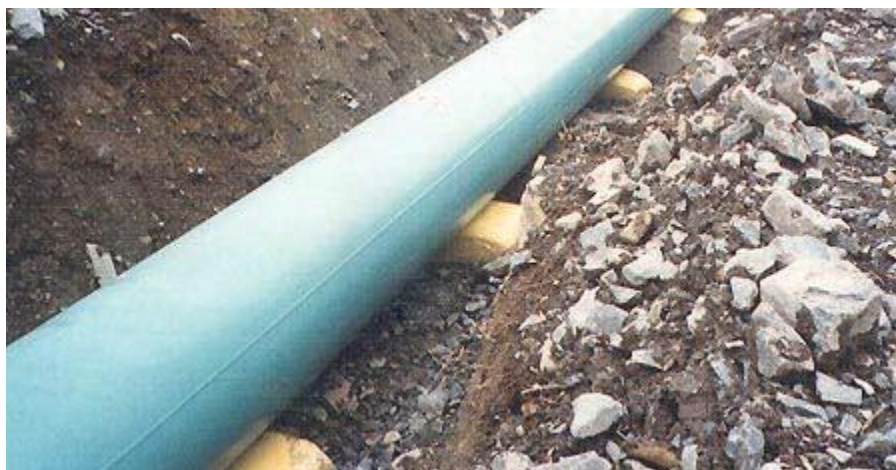
The pipe is lifted, moved, and lowered into the ditch. Long pipe sections are lowered into the trench by special pipe-laying tractors called “side booms.” The contractor must exercise care to ensure that the pipe coating is not damaged during the process. In rocky areas, the pipe is placed on one of several different types of supports or “pillows.” These supports also prevent the pipeline from laying directly on rock. Typical materials used are sandbags, foam bags, and pre-formed supports. An example is shown below in Figure 5.6.

**Figure 5.6** – Pipeline on Foam Supports (<http://www.pedero.com>)

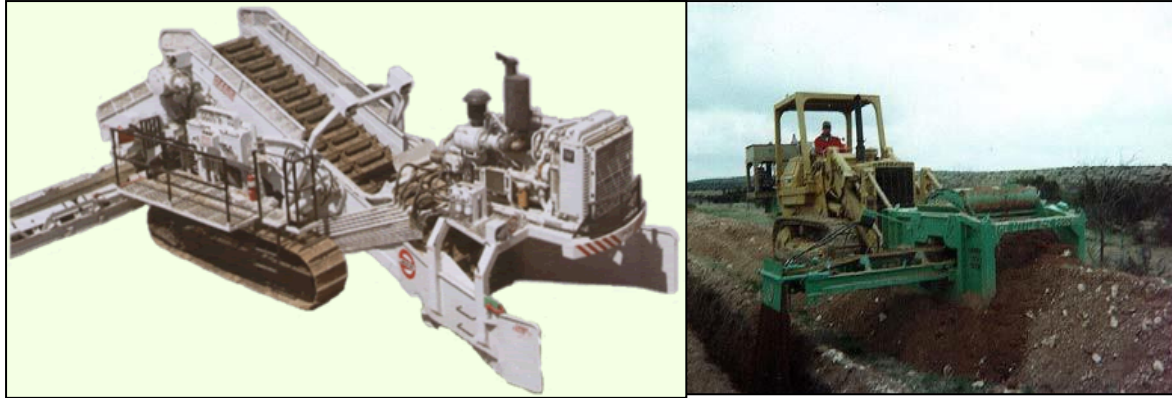
Most operators restrict the maximum size of rocks in the backfill. Specialized machines have been developed to shake and filter backfill material down to a specific maximum-size particle. Figure 5.7 shows typical equipment.

**Figure 5.7 – Backfill Screening and Padding Machines**  
 (<http://www.ozzies.com/> (left); <http://www.ezpadding.com/> [right]).

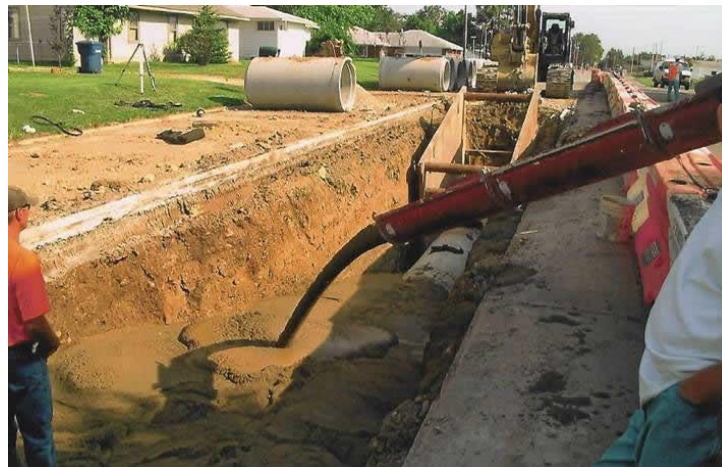
**Flowable Fill.** Flowable fill is an engineered, controlled, liquid-like fill material – typically a mixture of fly ash, cement, sand, and water – which is self placing, self leveling, self compacting, and nonsettling. Also referred to as controlled low-strength material (CLSM), flowable fill is primarily used as a backfill material in lieu of compacted granular fill. Figure 5.8 illustrates an application of flowable fill.

**Figure 5.8 – Flowable fill being poured to fill the pipe excavation area.** (<http://www.irmca.com/Topics/flow.asp>)

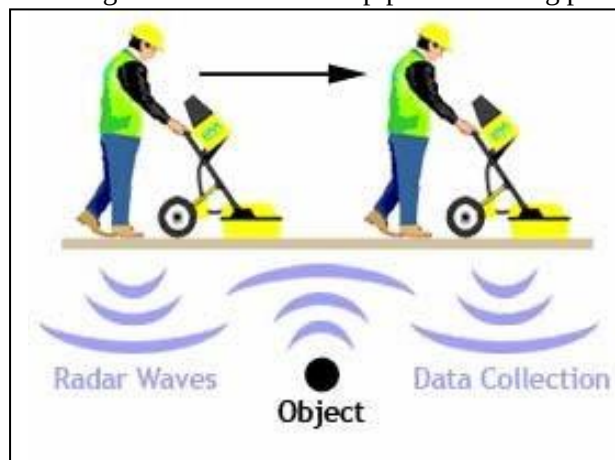
**Figure 5.12 – Ground Penetrating Radar (GPR)**  
Technique (Courtesy: <http://www.worksmartinc.net>)

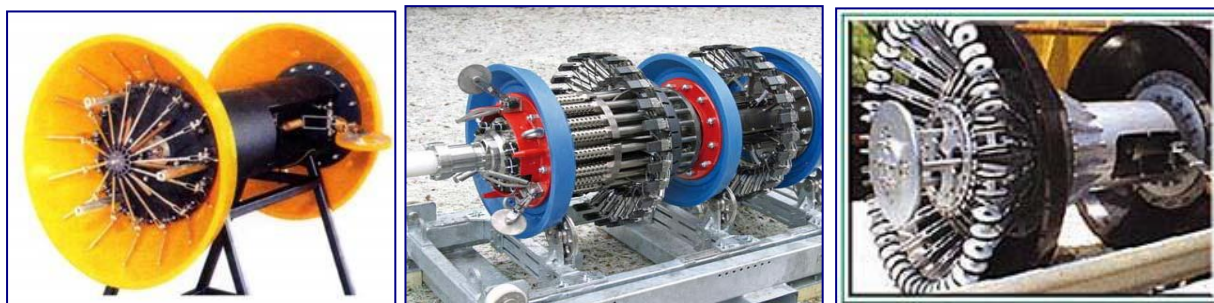
**Figure 6.1** – Mechanical Caliper Tools (photos courtesy of Enduro, Rosen, and RAS GmbH)

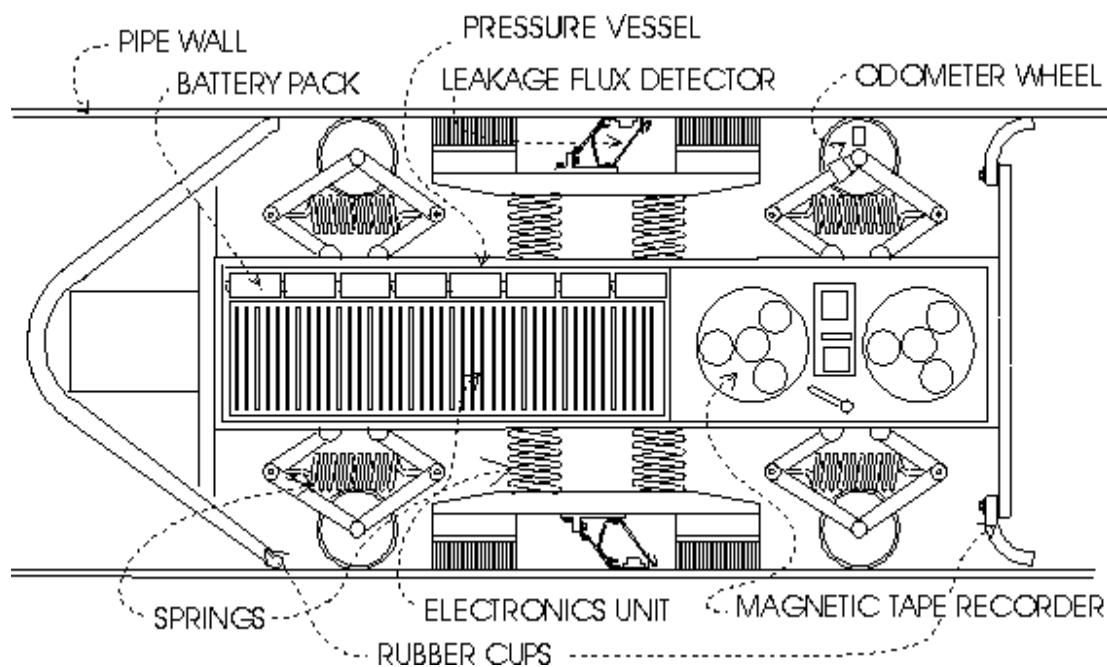
Figure 6.2 – Schematic of MFL Principle (Clapman et al., 2002)

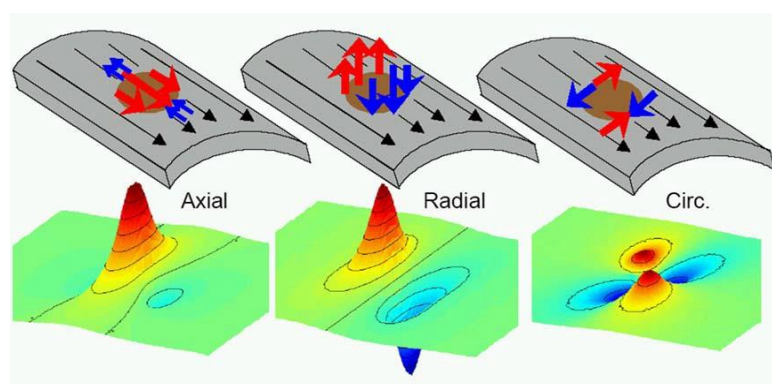
Figure 6.3 – Example of Axial, Radial and Circumferential MFL Signal at Metal Loss Region.

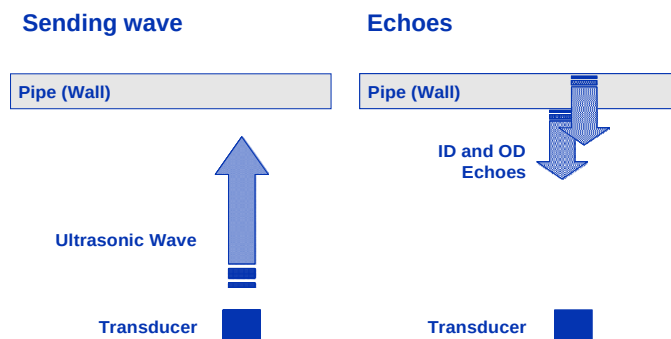
**Figure 6.4.** *Ultrasonic Wall Thickness Concept*

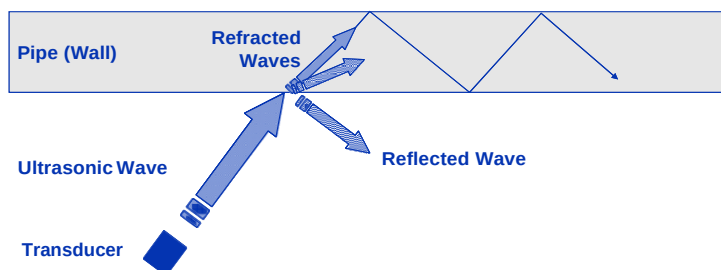
**Figure 6.5.** *Ultrasonic Shear Wave*

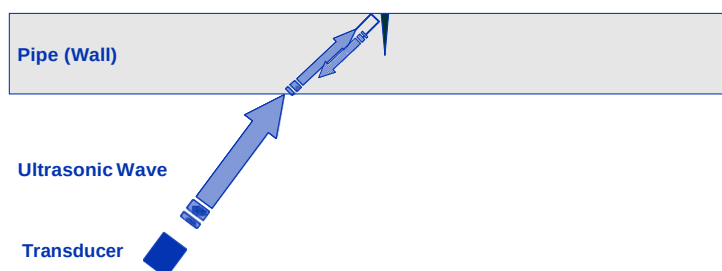
**Figure 6.6.** *Ultrasonic Wave Reflection from Crack*

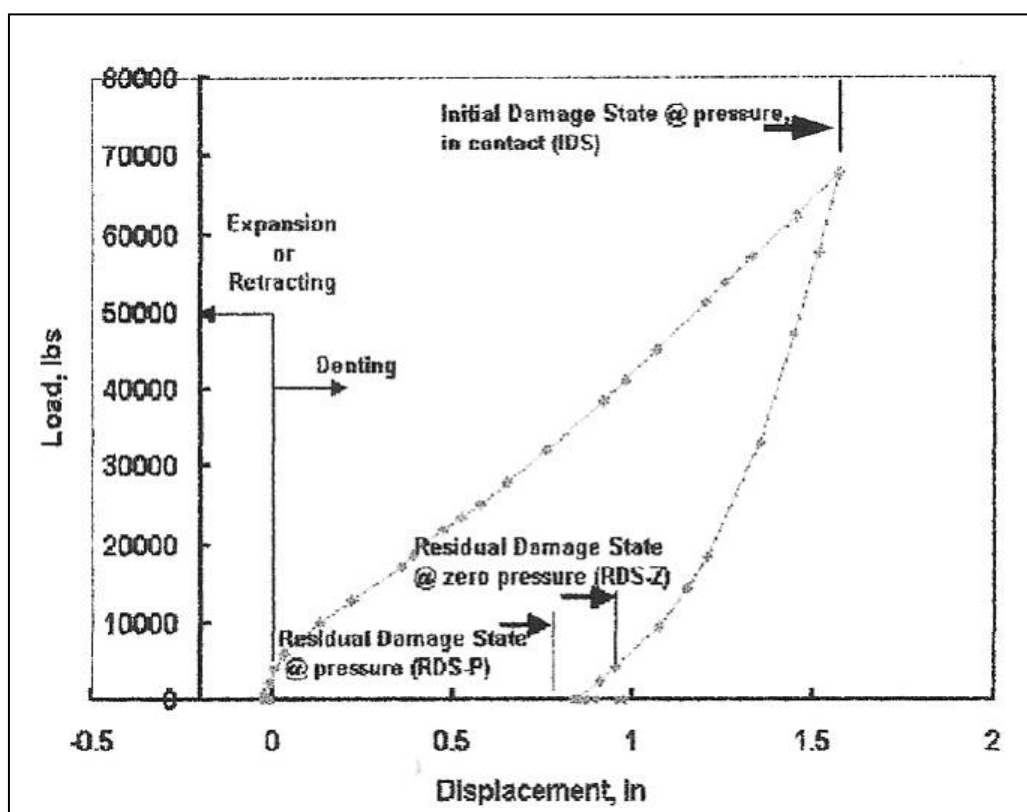
**Figure 7.1** – Validation of Predicted Load-Deformation Behavior During Denting and Re-Rounding (Leis and Hopkins, 2003)

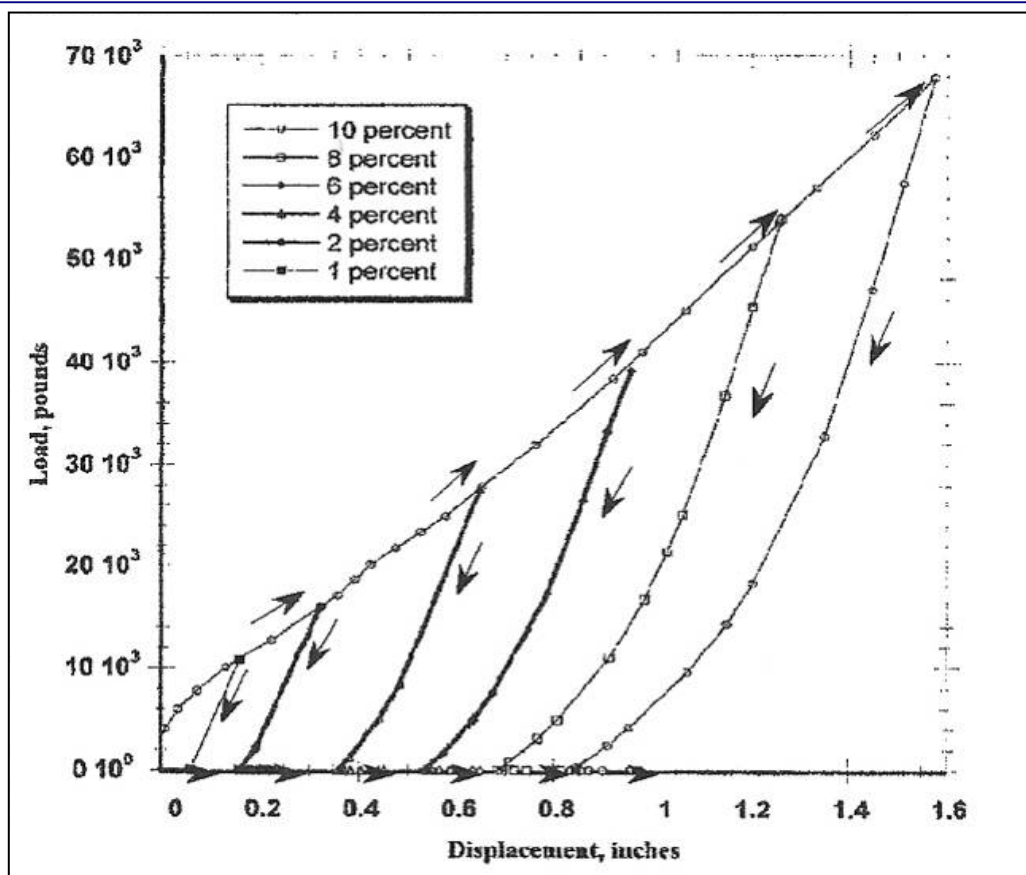
Figure 7.2 – Effect of Initial Dent Depth on Load-Displacement Behavior During Denting and Re-Rounding (Leis and Hopkins, 2003)

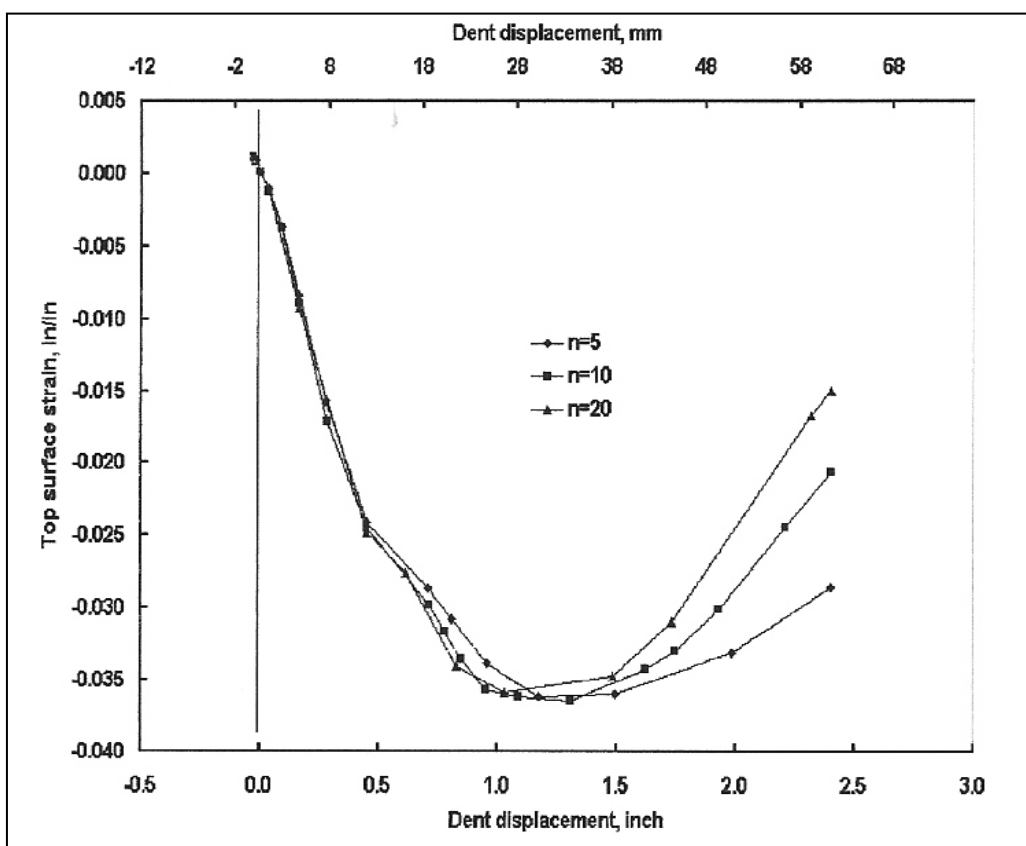
Figure 7.3 – Non-Linear Relationships Between Strain and Displacement at the Outside Centre of a Dent, During Denting to 8% of the Pipe Diameter (Leis and Hopkins, 2003)

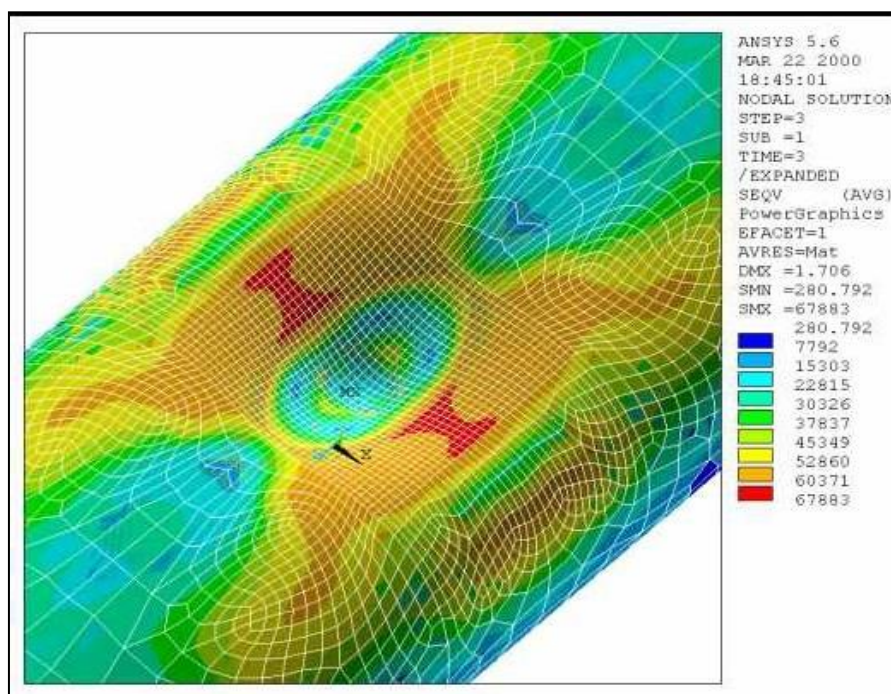
**Figure 7.4** – Finite Element Model of Stress Distribution Around a Re-Rounded Dent (Ironside and Carroll, 2002)

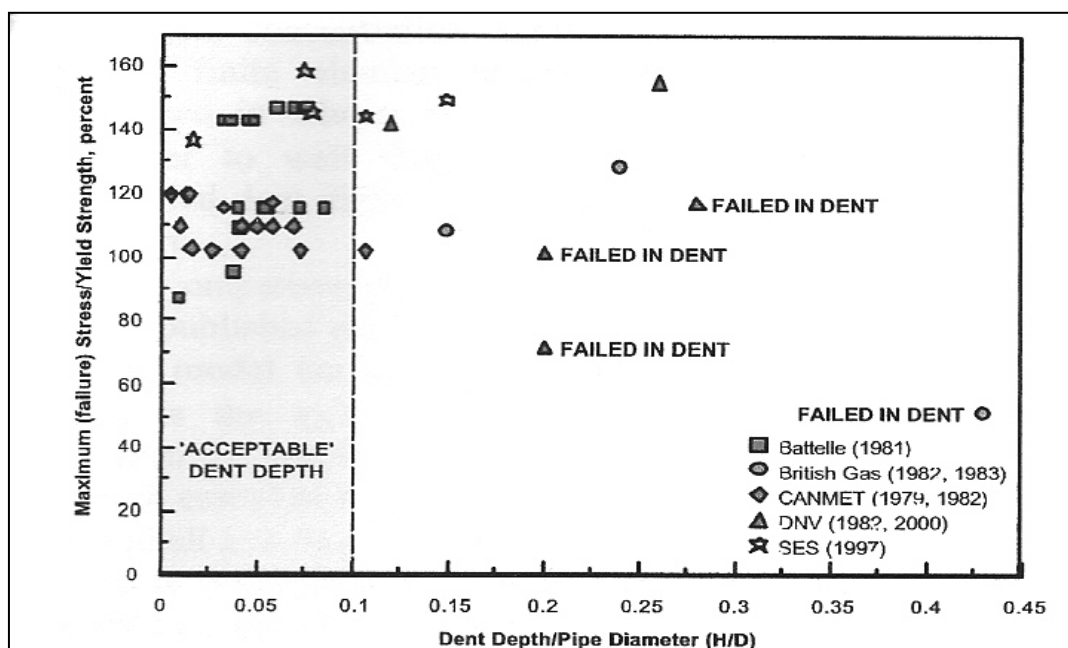
Figure 7.5 – Failure Behavior in Full-Scale Tests on Plain Dents (Cosham and Hopkins, 2004)

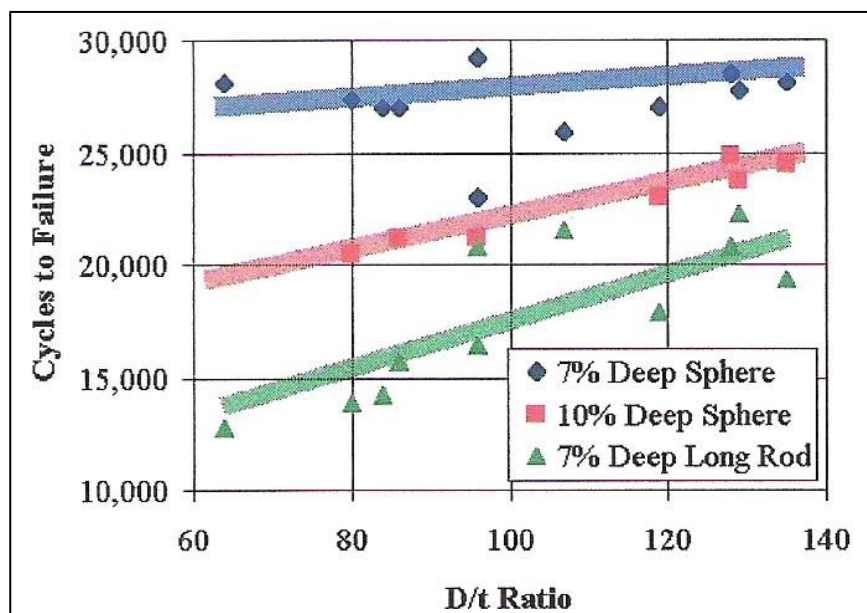
**Figure 7.7** – Effect of D/t Ratio and Damage Type on the Fatigue Life of Plain Dents (Dinovitser et al., 2002)

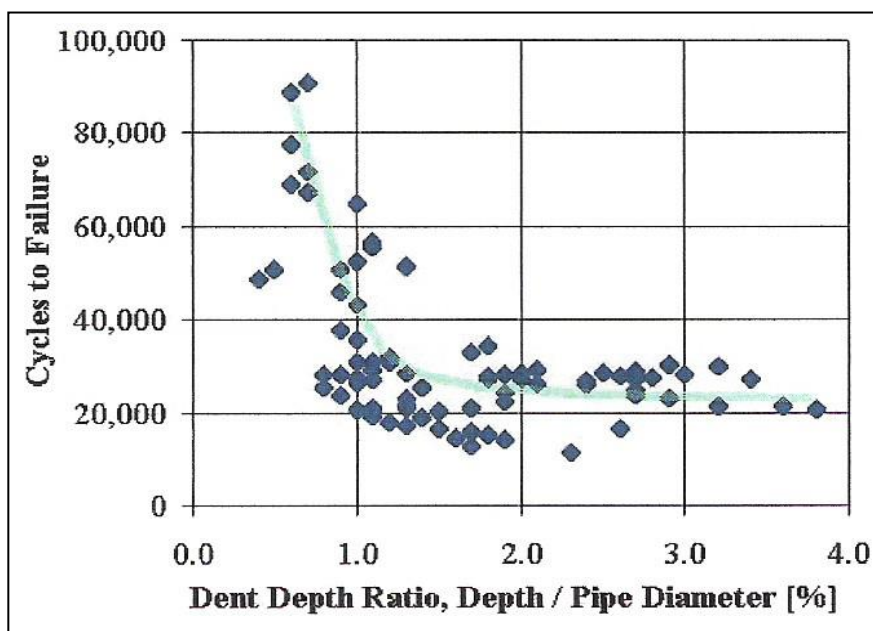
**Figure 7.8** – Effect of Dent Depth on Fatigue Life of Plain Dents (Dinovitser et al., 2002)

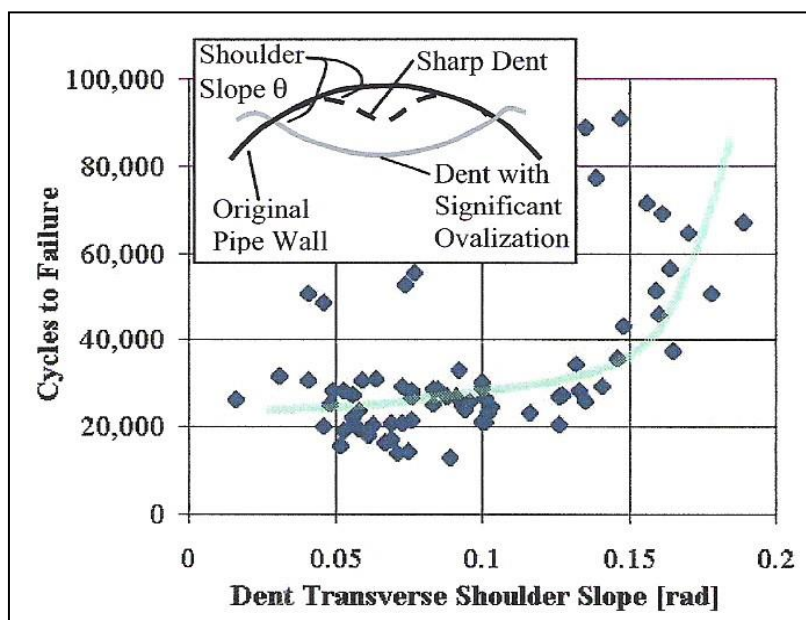
**Figure 7.9** – Effect of Dent Profile on Fatigue Life of Plain Dents  
(Dinovitzer et al., 2002)

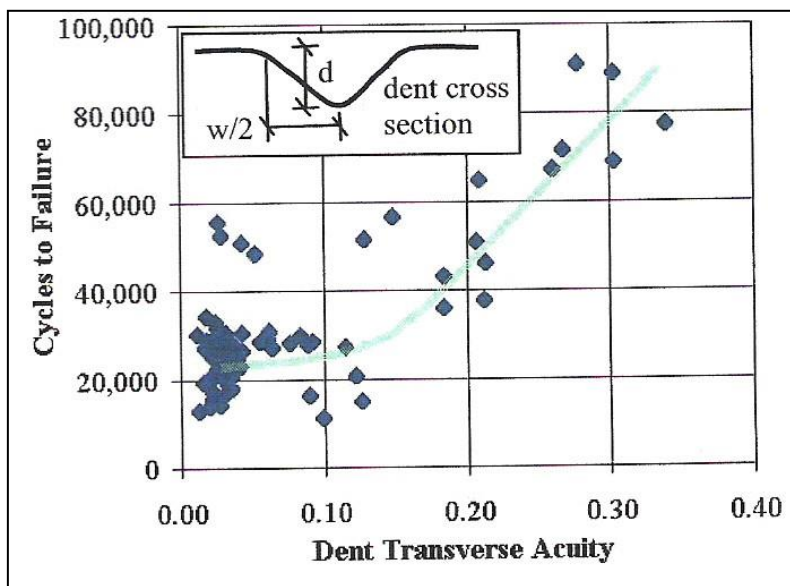
**Figure 7.10** – Effect of Acuity ( $w/2d$ ) on the Fatigue Life of Plain Dents  
(Dinovitzer et al., 2002)

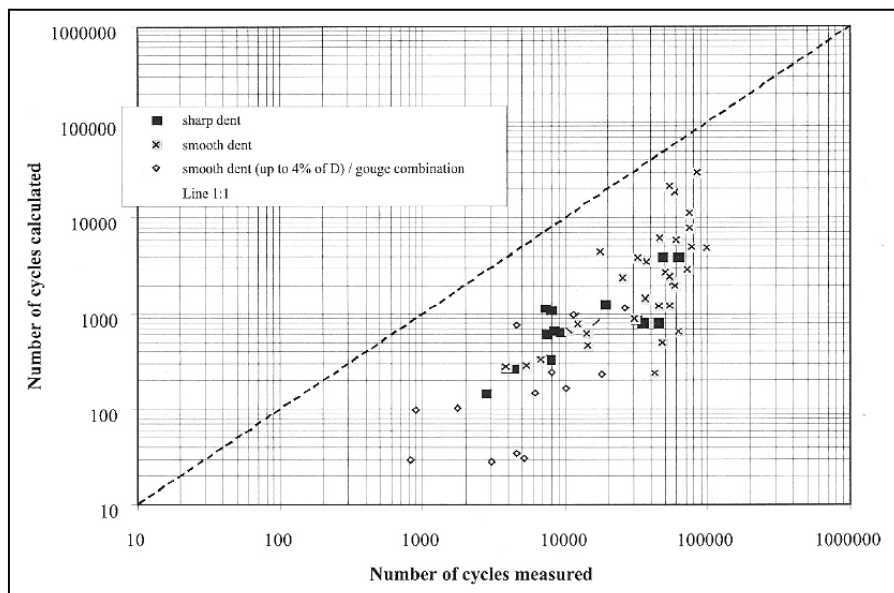
**Figure 7.11** – Comparison of Measured and Calculated Dent Fatigue Life, Including an Adjustment Factor of 10 on Predicted Fatigue Life (EPRG, 1999)

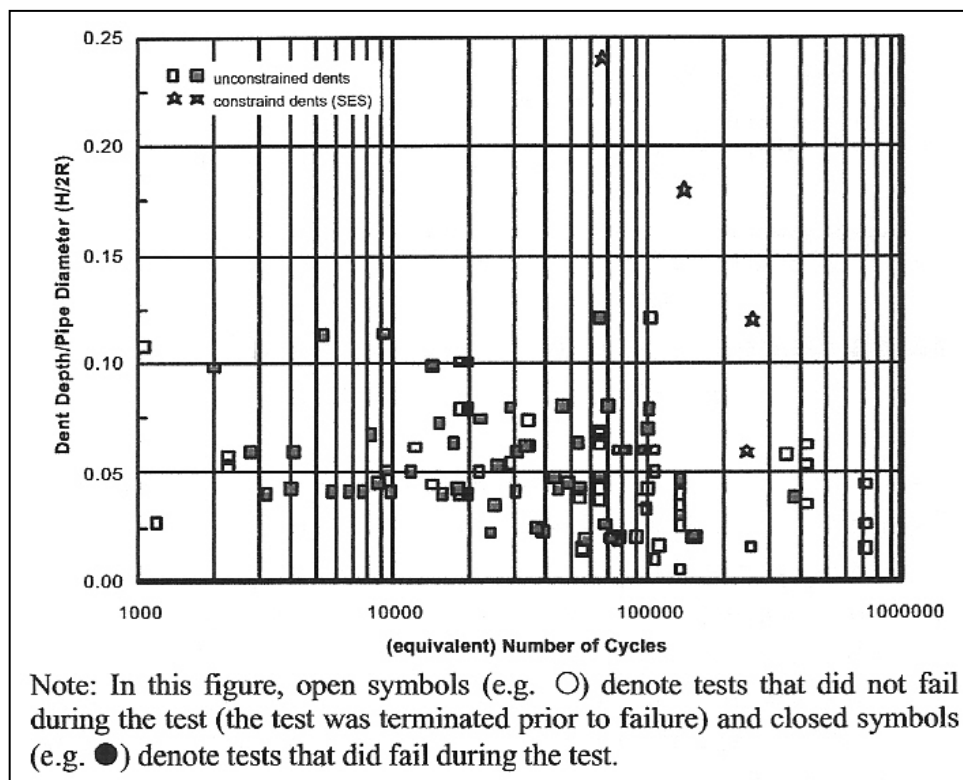
**Figure 7.12** – Fatigue Lives of Constrained and Unconstrained Plain Dents (Cosham and Hopkins, 2004)

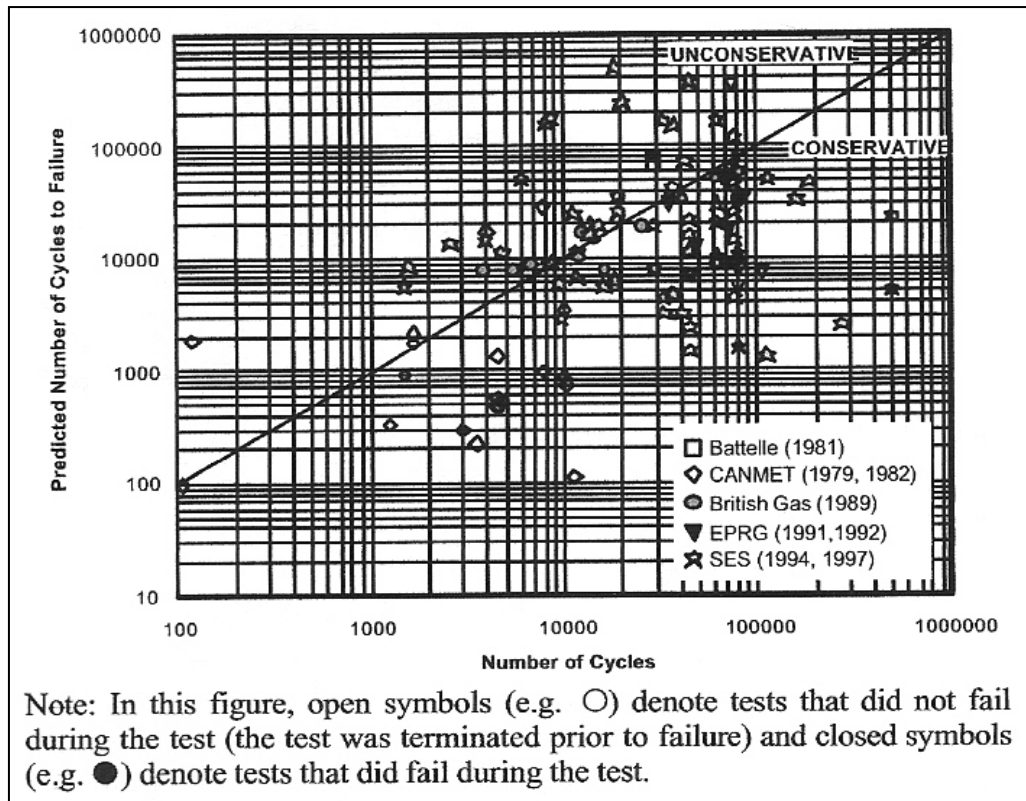
**Figure 7.13** – Predictions of the Fatigue Life of Plain Dents using the EPRG Model (Cosham and Hopkins, 2004)

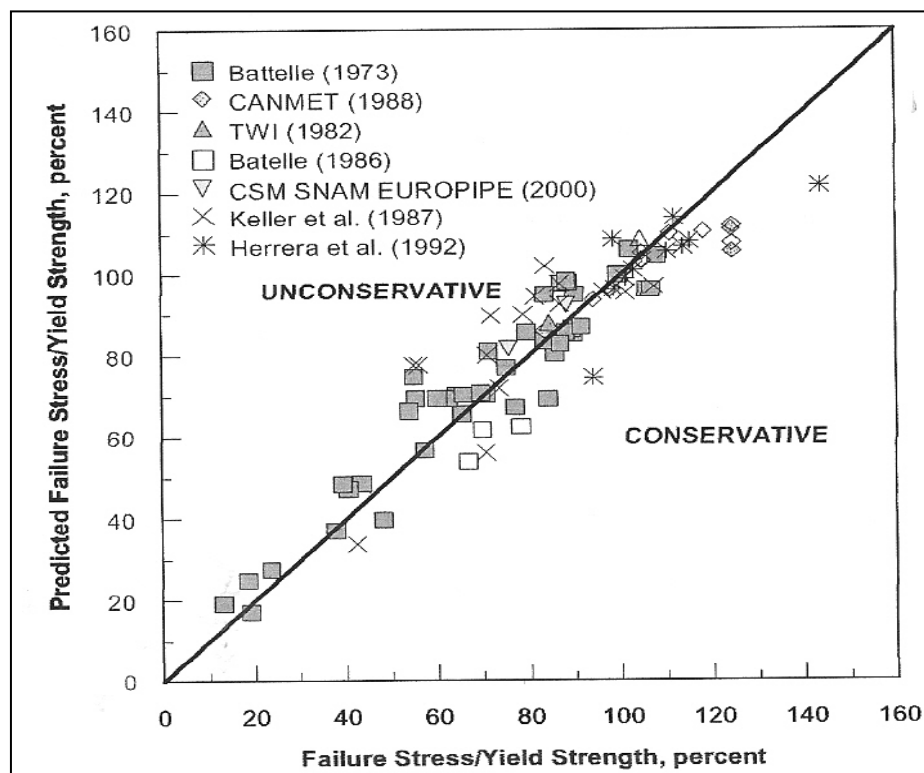
**Figure 7.14** – Predictions of the Failure Pressure of Axially Oriented Gouges Using the NG-18 Equation (Cosham and Hopkins, 2002)

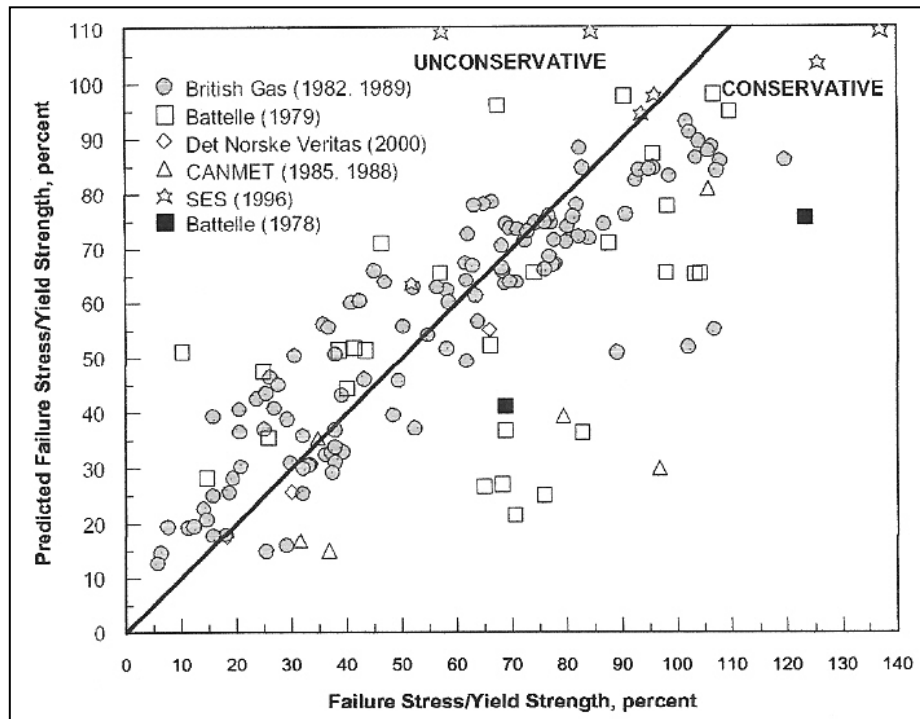
**Figure 7.15** – Failure Behavior of Combined Dent and Gouge Damage Predicted Using the Dent Fracture Model (Cosham and Hopkins, 2002)

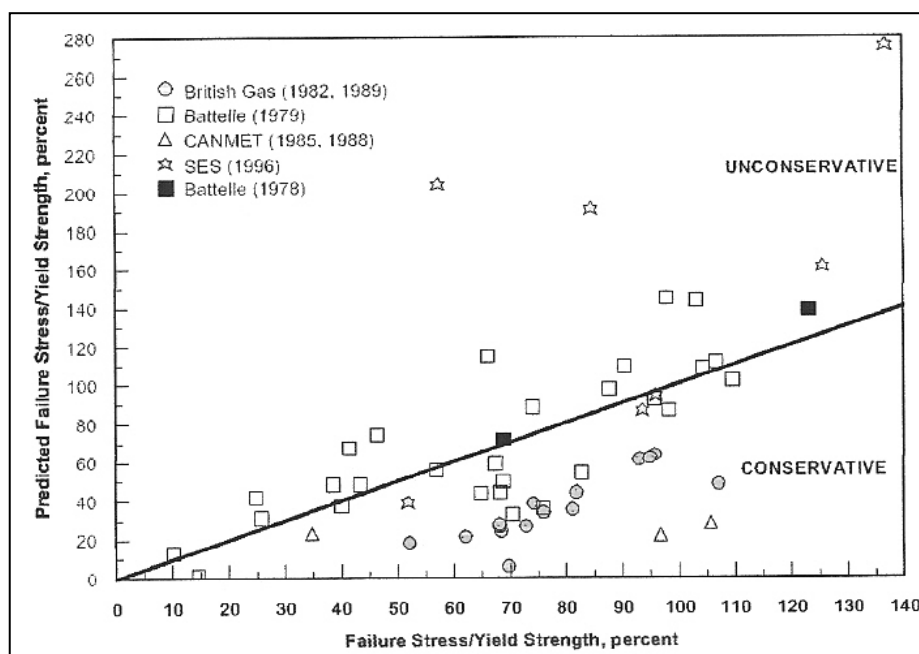
**Figure 7.16** – Failure Behavior of Combined Dent and Gouge Damage Predicted Using the Q-Factor Model (Cosham and Hopkins, 2002)

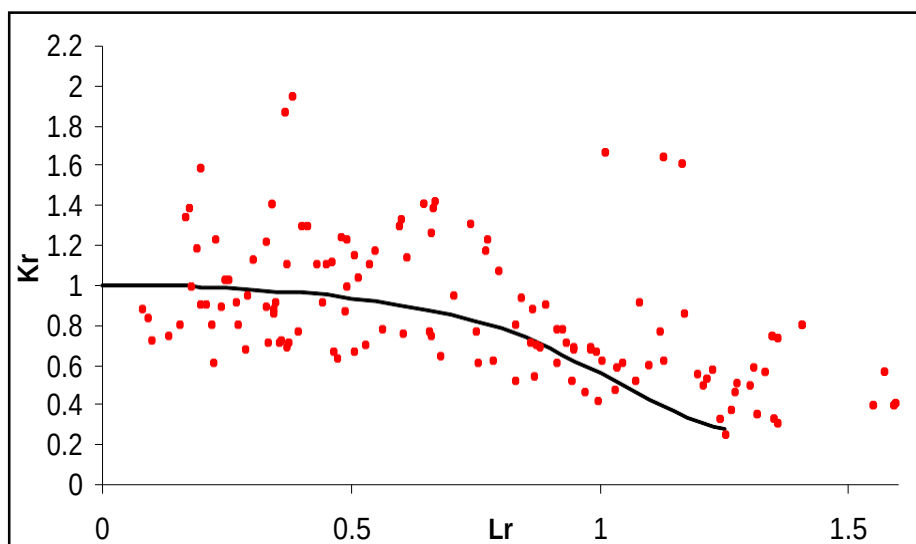
**Figure 7.17** – Comparison of the Dent Fracture Model Incorporating the New Limit State Function, with Full Scale Combined Dent and Gouge Damage Test Results (Francis et al., 2005)
